Appendix B

Geotechnical Data Report

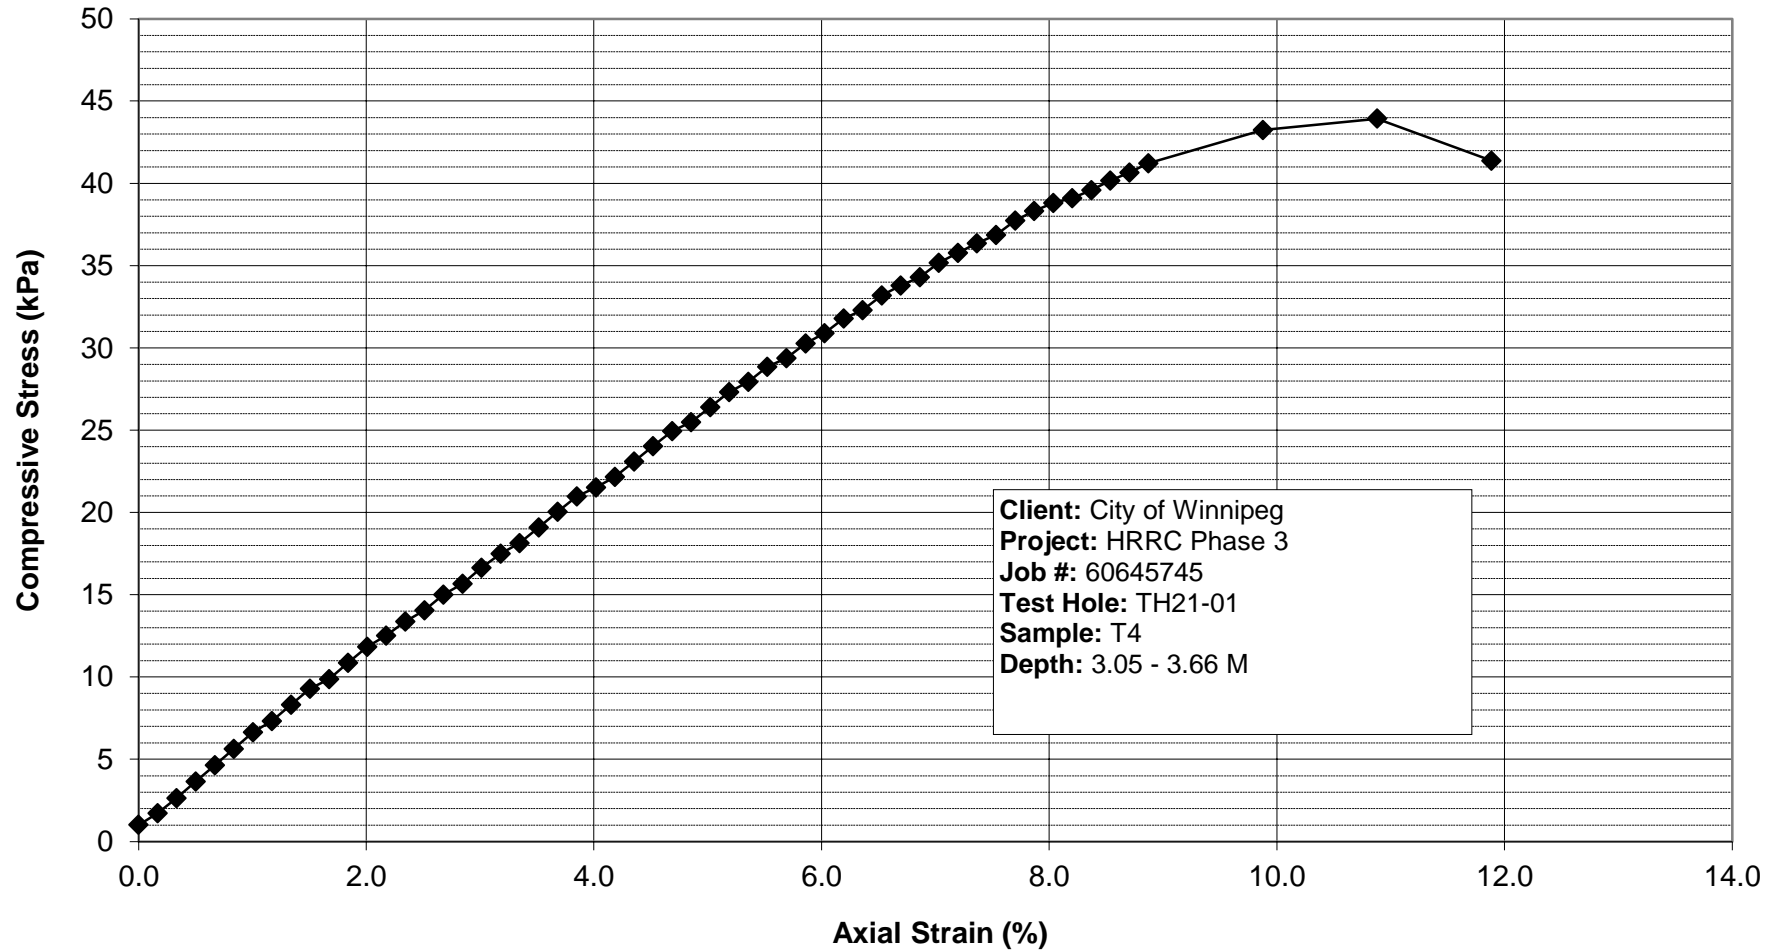
AECOM - SOILS LABORATORY
SHEAR STRENGTH, MOISTURE CONTENT & DENSITY CALCULATIONS

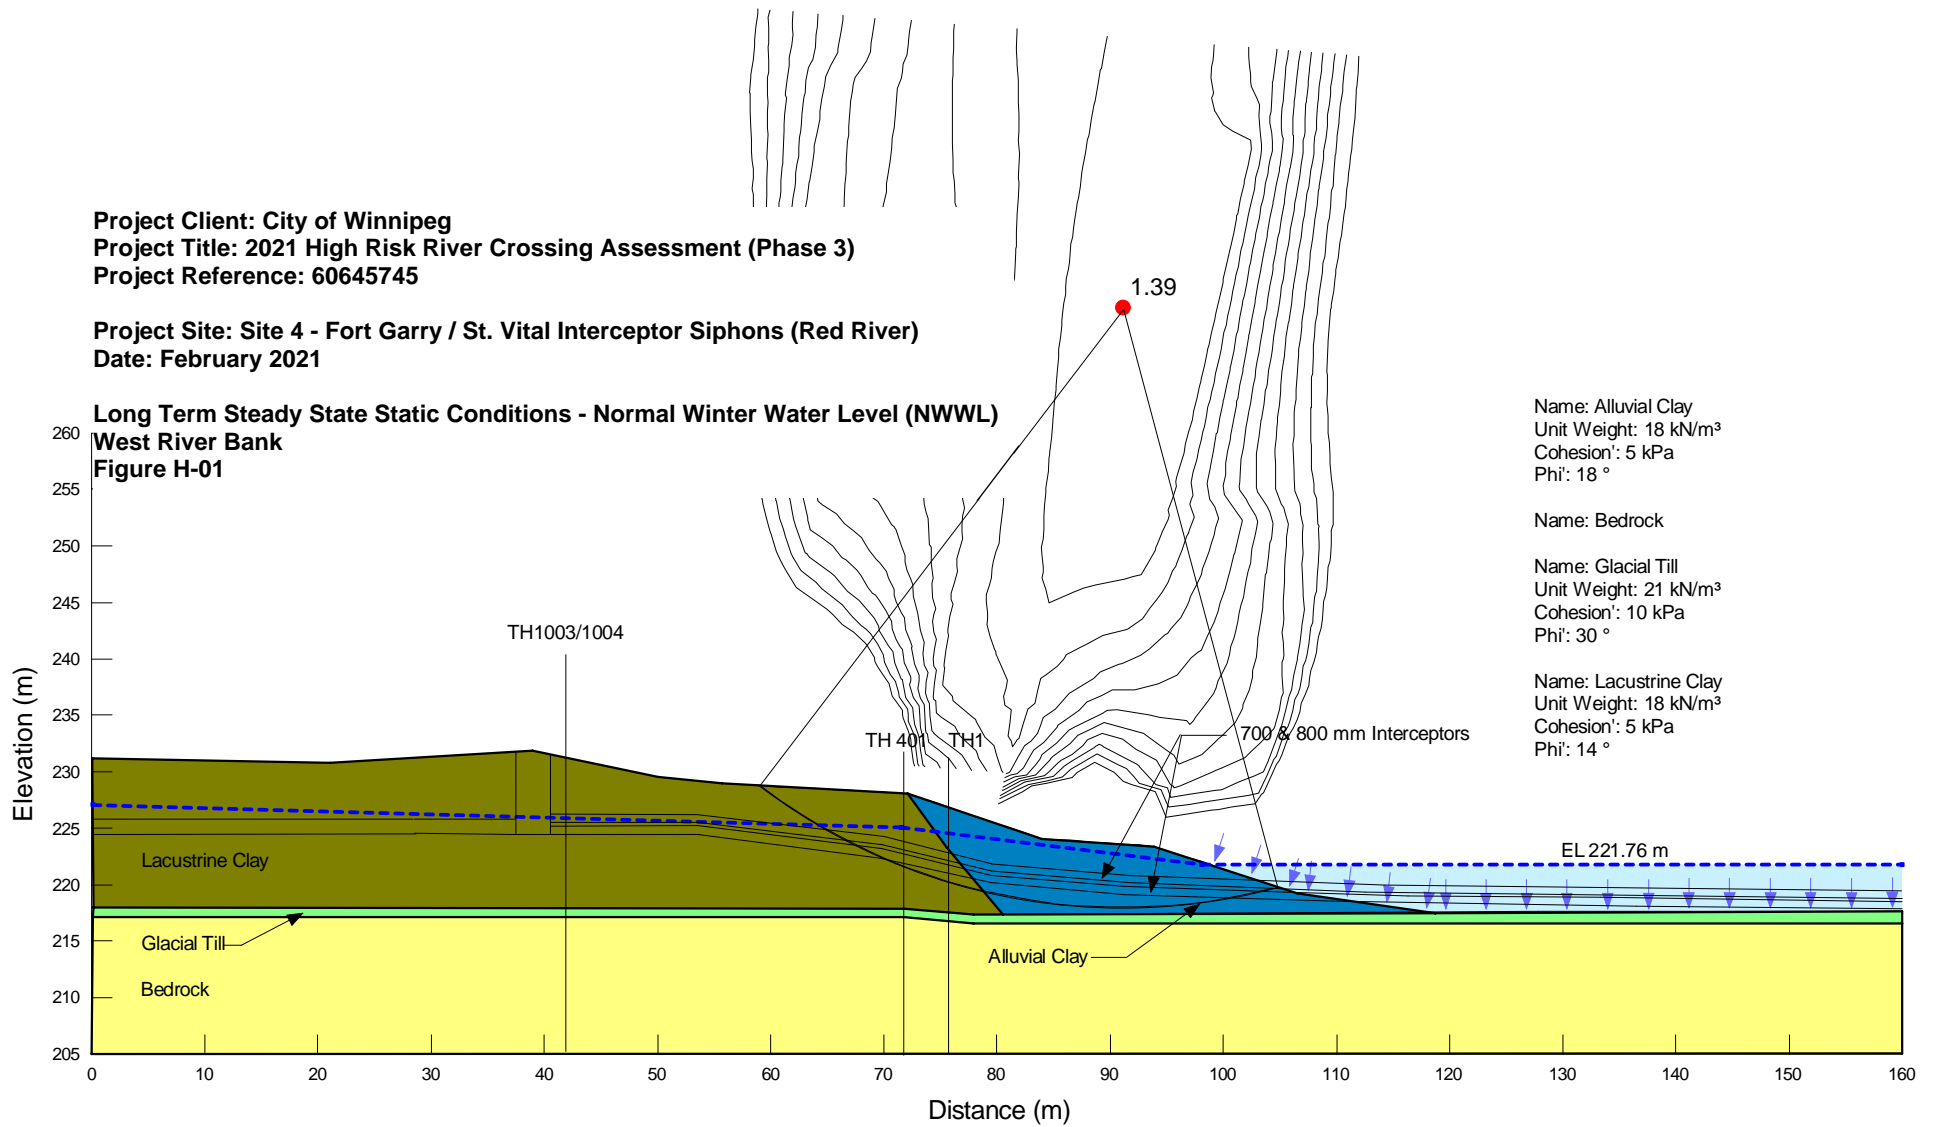
Project Client: City of Winnipeg
Project Title: 2021 High Risk River Crossing Assessment (Phase 3)
Project Reference: 60645745

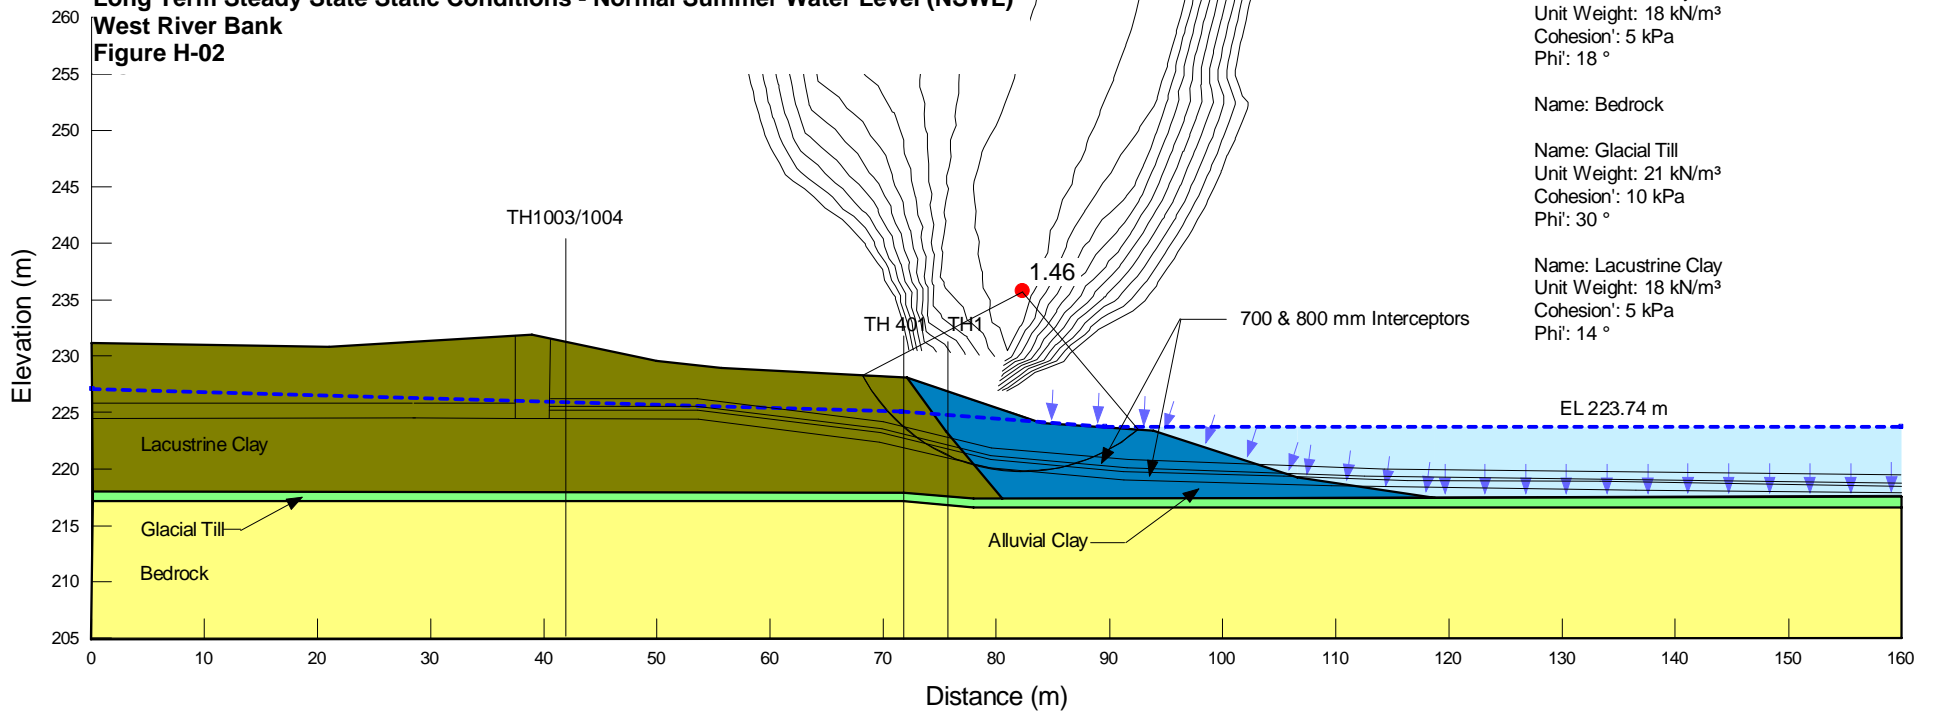
Project Client: City of Winnipeg
Project Title: 2021 High Risk River Crossing Assessment (Phase 3)
Project Reference: 60645745

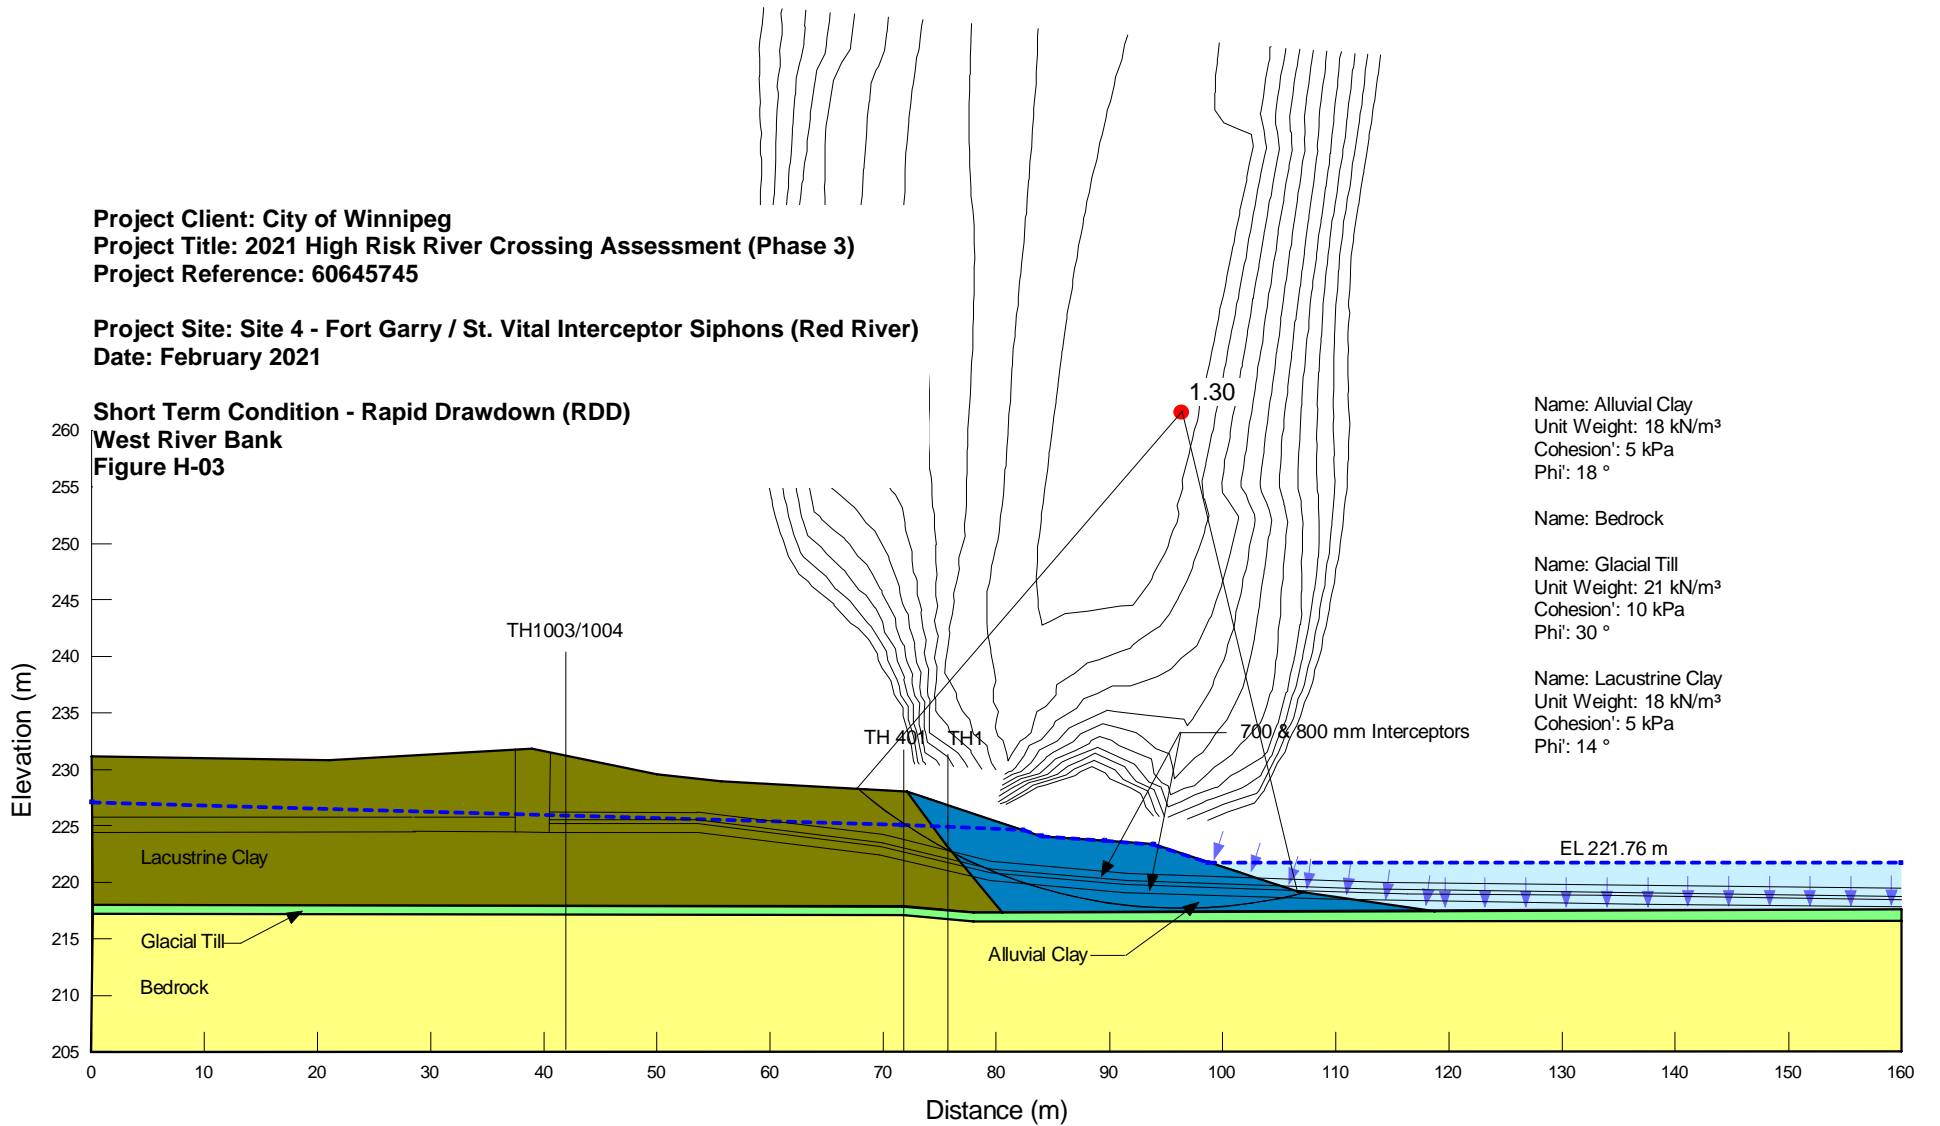
Project Client: City of Winnipeg
Project Title: 2021 High Risk River Crossing Assessment (Phase 3)
Project Reference: 60645745
