**FINAL REPORT
GEOTECHNICAL INVESTIGATION AND
FOUNDATION ENGINEERING FOR
STURGEON CREEK BRIDGE REPLACEMENT**

Prepared for
STANTEC
905 WAVERLEY STREET
WINNIPEG, MANITOBA
R3T 5P4

Prepared by
THE NATIONAL TESTING LABORATORIES LIMITED
199 HENLOW BAY
WINNIPEG, MANITOBA
R3Y 1G4

October 28, 2011

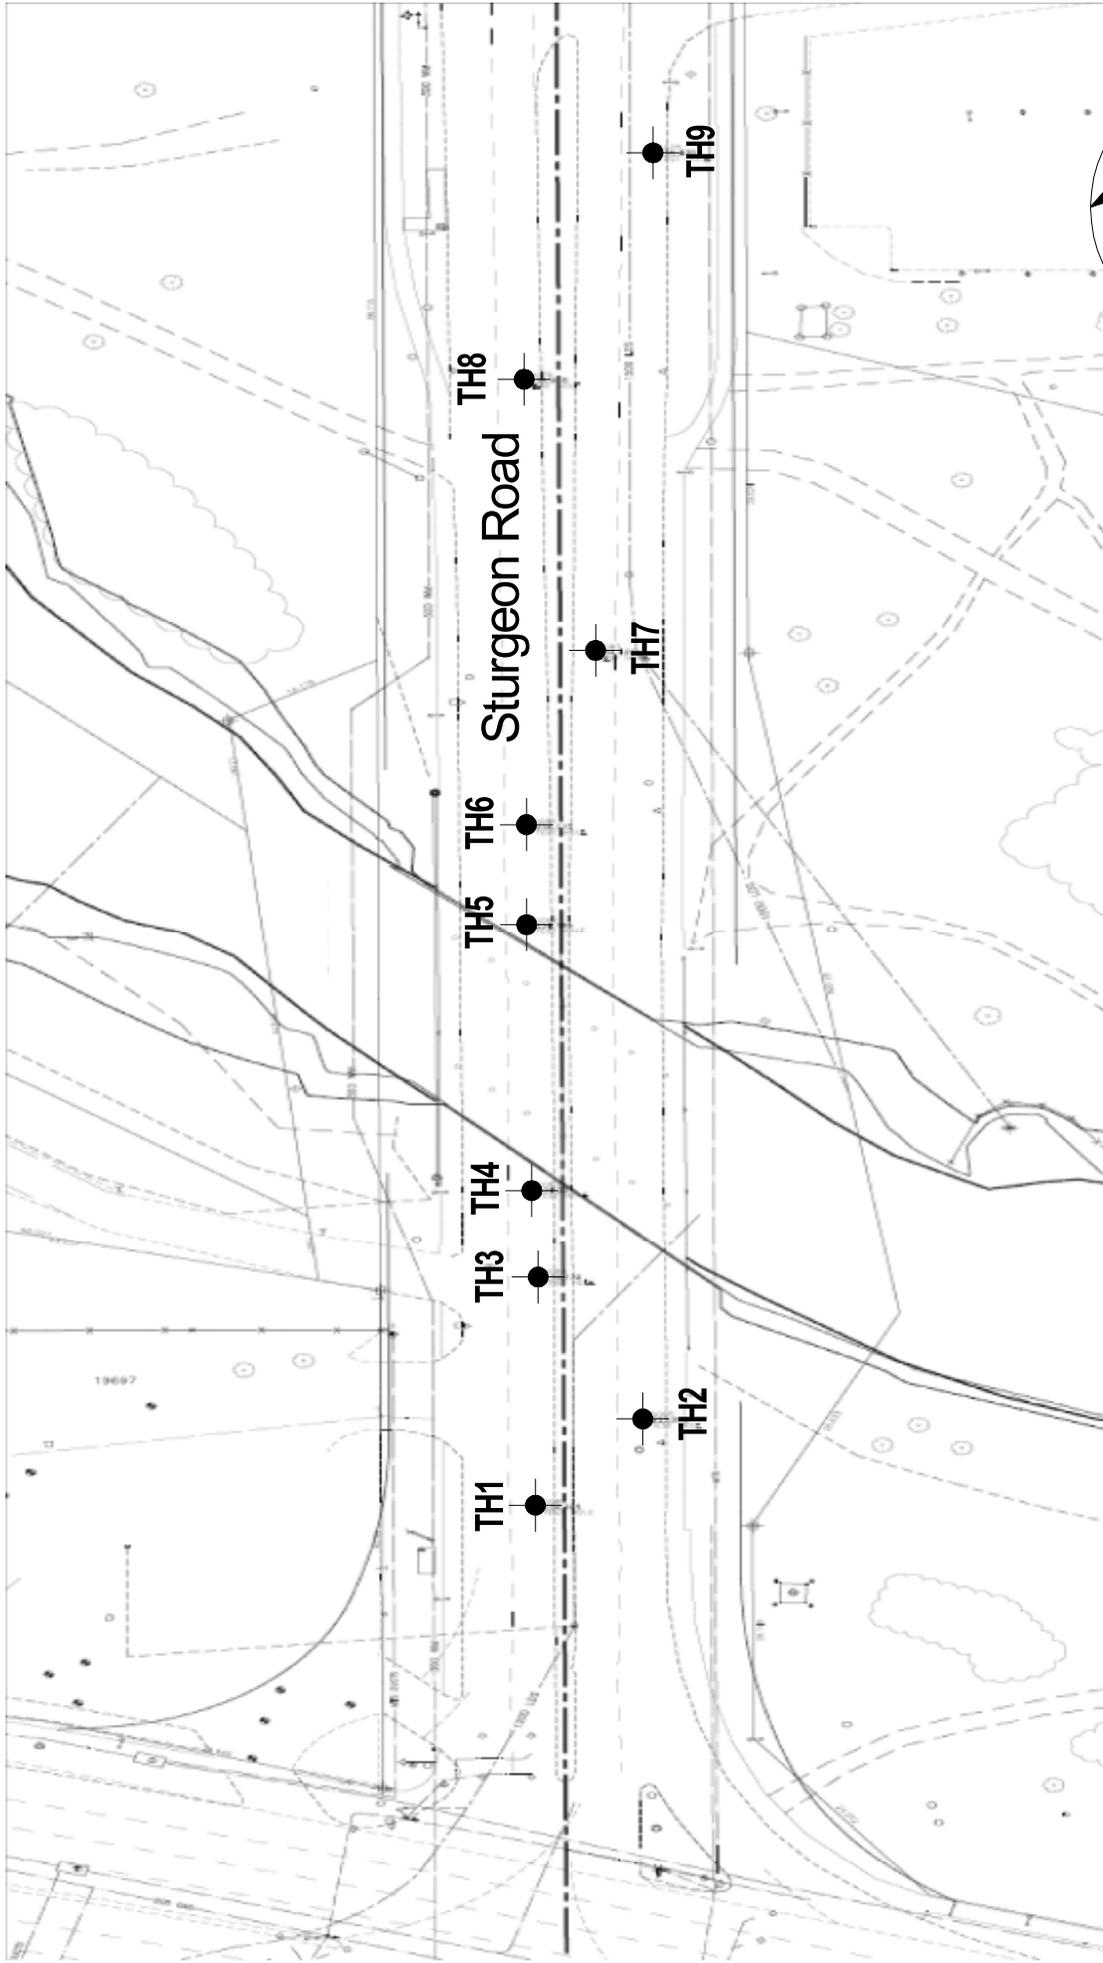
<p>THE NATIONAL TESTING LABORATORIES LIMITED Established in 1923</p>	<p>Project No. STA-1029</p>	<p>Drawn by: D.M</p>	<p>Figure: 1</p>	<p>Testhole Location Plan Replacement of Sturgeon Creek Bridge Winnipeg, Manitoba</p>
	<p>Date: October 4, 2010</p>	<p>Reviewed by: DF</p>	<p>Scale: NTS</p>

TESTHOLE LOCATION PLAN

The subsurface drilling and sampling program was conducted on July 15 and 16, 2010 with drilling services provided by Paddock Drilling Ltd. under the supervision of our geotechnical field personnel. A total of nine testholes (TH1 to TH9) were drilled using a truck-mounted drill rig at the locations shown on Testhole Location Plan provided in Appendix A. Testholes TH1, TH2, TH7, TH8 and TH9 were drilled to a depth of 3.1 m to evaluate the existing pavement structure. Testholes TH3, TH4, TH5 and TH6 were drilled to depths ranging from 10 to 13 m to evaluate the soil conditions for the bridge foundation. Testholes TH4 and TH5 were drilled through the concrete bridge deck and Testholes TH3 and TH6 were drilled in the approach slabs for the bridge. The testholes were advanced to auger refusal on suspected bedrock using 125 mm diameter solid stem augers. Testholes TH3 and TH5 were completed by coring to a depth of 3 m into the carbonate bedrock. Core samples were recovered from the carbonate bedrock and grab samples were obtained directly off the augers. Undisturbed samples of the clay soil were obtained in Shelby tubes. A Standard Penetration Test was conducted in Testhole TH3 to evaluate the relative density of the silt till. The testholes were logged based upon visual, physical, and textural properties observed in the field. Upon completion of drilling, the testholes were examined for evidence of sloughing and groundwater seepage. The samples were visually classified in the field and returned to our soils laboratory for additional examination and testing.

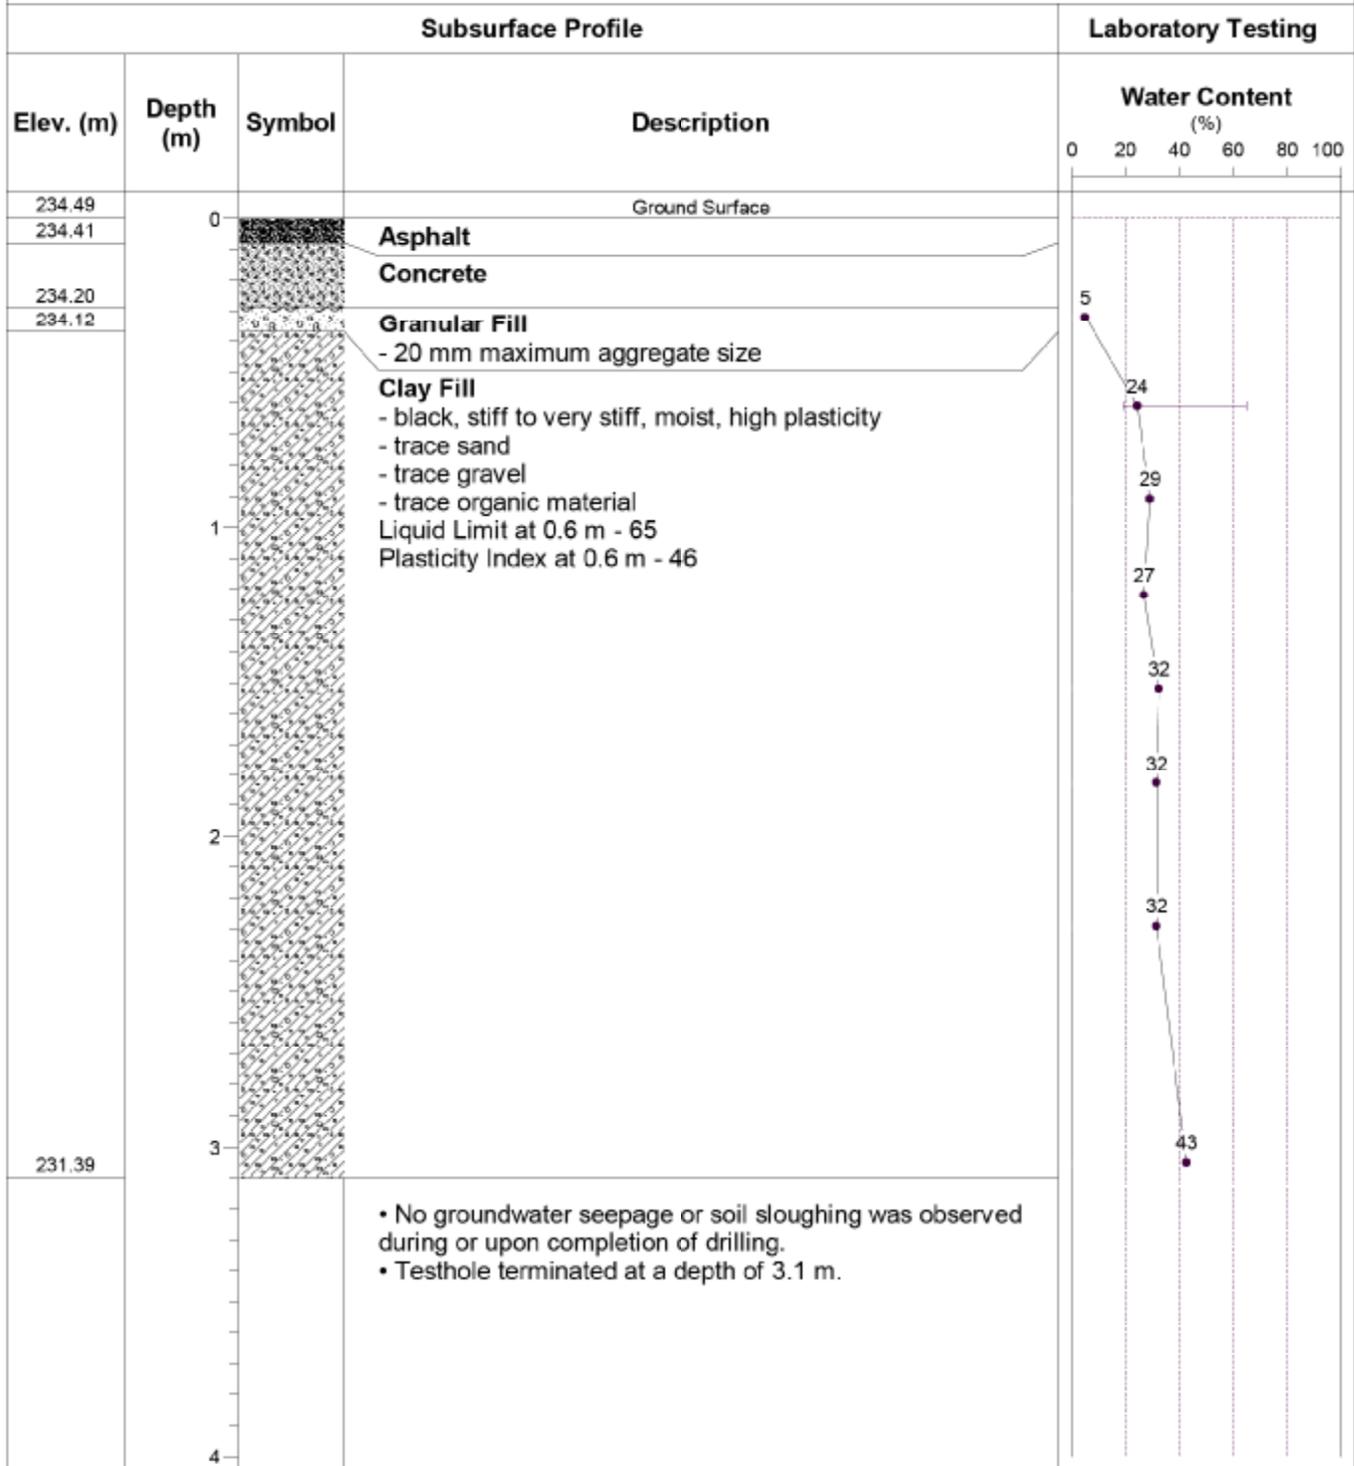
TESTHOLE TH1

Project Name: Replacement of Sturgeon Creek Bridge
Client: Stantec Consulting Ltd.
Drilling Contractor: Paddock Drilling Ltd.
Drilling Method: 125 mm Auger

Date Drilled: July 16, 2010
Depth of Testhole: 3.1 m
Testhole Elevation: 234.49 m
Logged By: Larry Presado

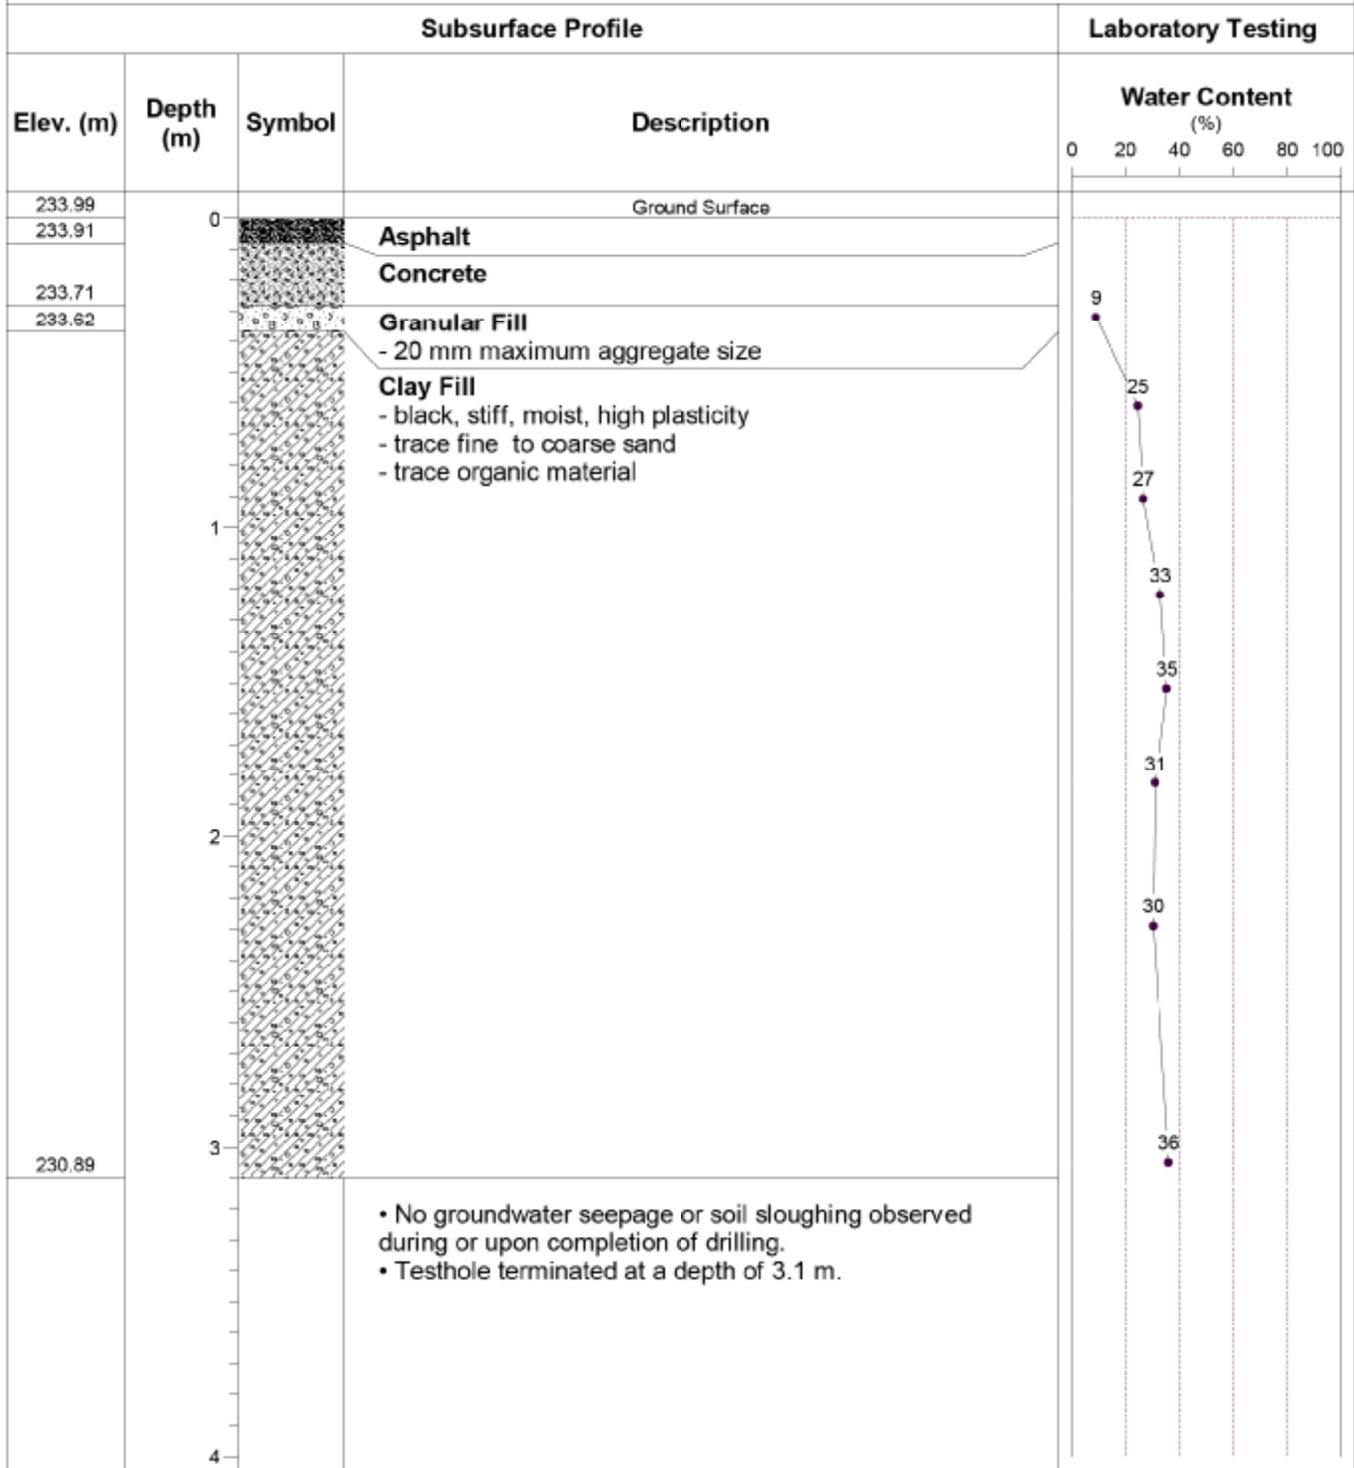
TESTHOLE TH2

Project Name: Replacement of Sturgeon Creek Bridge
Client: Stantec Consulting Ltd.
Drilling Contractor: Paddock Drilling Ltd.
Drilling Method: 125 mm Auger

Date Drilled: July 16, 2010
Depth of Testhole: 3.1 m
Testhole Elevation: 233.99 m
Logged By: Larry Presado

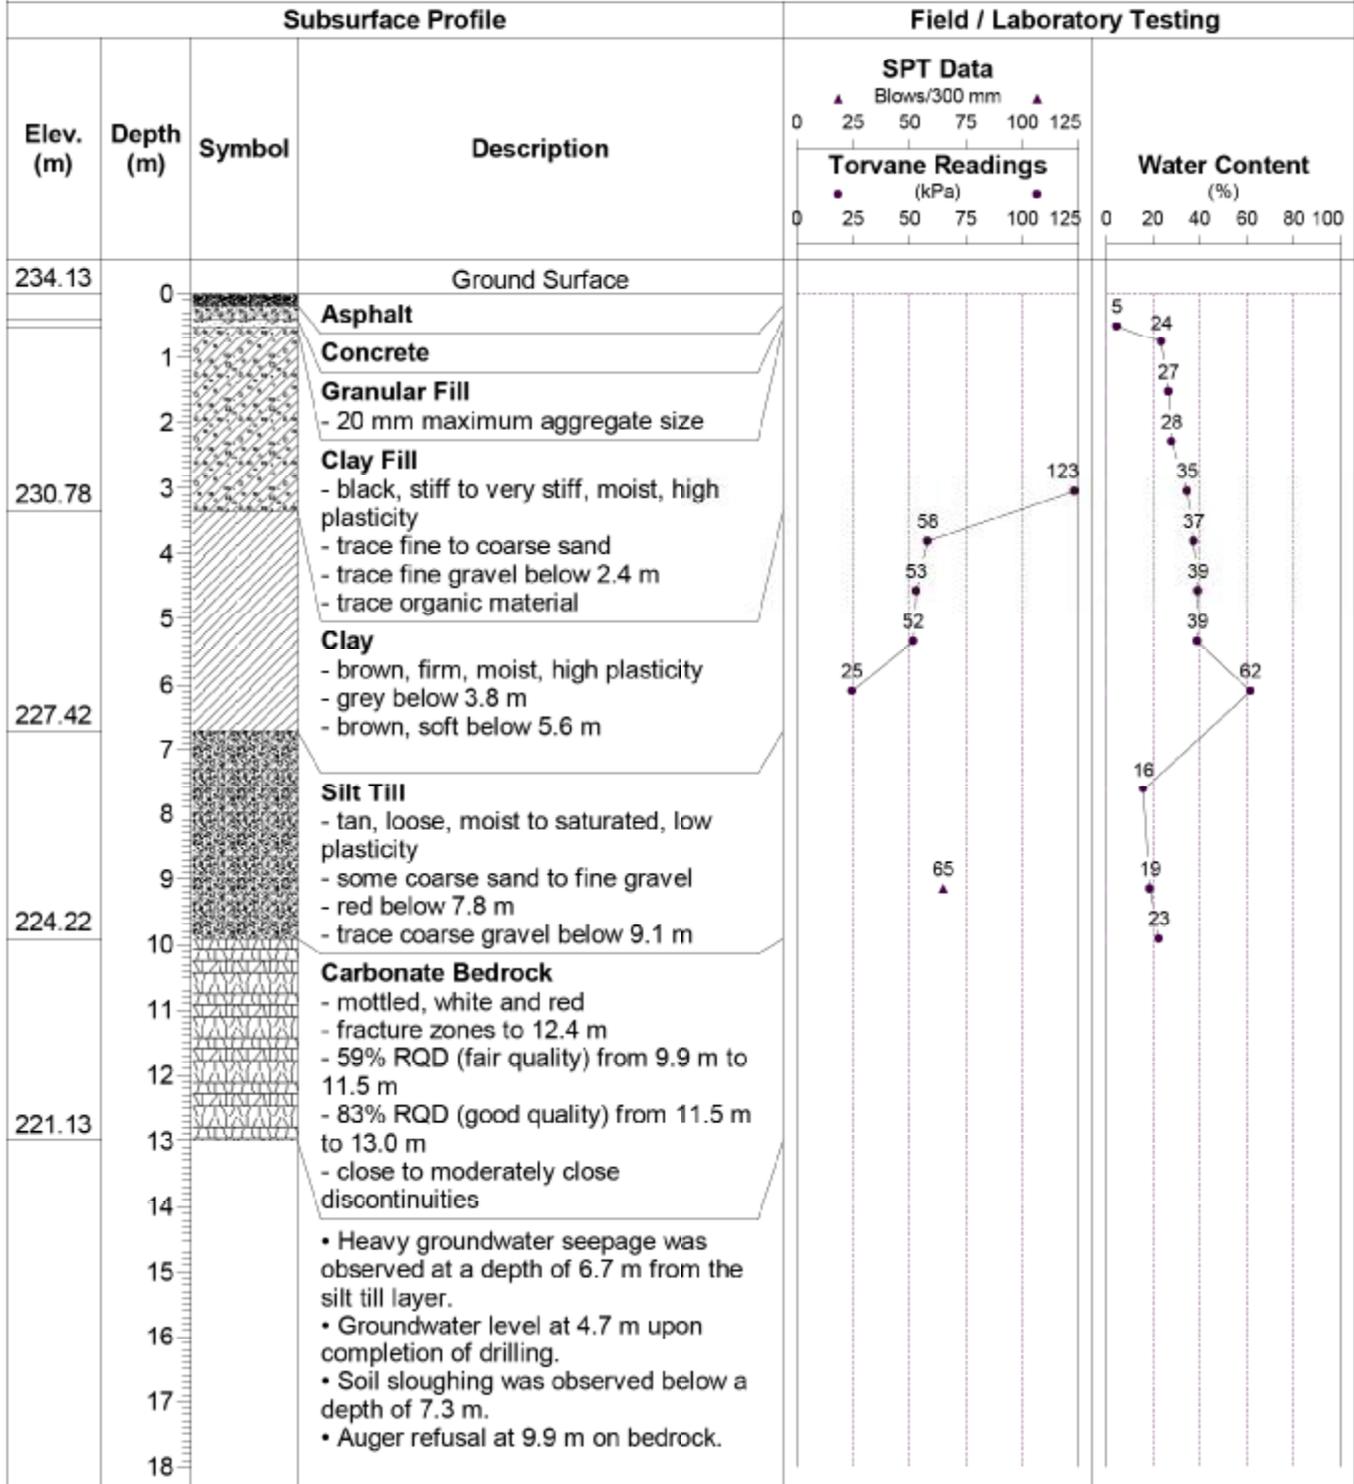
TESTHOLE TH3

Project Name: Replacement of Sturgeon Creek Bridge
Client: Stantec Consulting Ltd.
Drilling Contractor: Paddock Drilling Ltd.
Drilling Method: 125 mm Auger and 50 mm Core Bit

Date Drilled: July 15, 2010
Depth of Testhole: 13.0 m
Testhole Elevation: 234.13 m
Logged By: Larry Presado

Soil conditions encountered during the site investigation are shown on the testhole logs provided in Appendix B. The soil stratigraphy for the proposed bridge structure, as interpreted from the soil logs for Testholes TH3, TH4, TH5 and TH6, consists of clay fill, clay and silt till overlying carbonate bedrock.

Core samples recovered from Testholes TH3 and TH5 revealed the upper 2 to 2.5 m of the bedrock to be poor quality. Fracture zones were observed in Testhole TH3 to a depth of approximately 2.5 m below the surface of the bedrock. A horizontal fracture in filled with clay was observed in Testhole TH5 at a depth of 2.5 m below the surface of the bedrock. The carbonate bedrock was mottled, with colour varying from white to red. Examination of the core samples revealed the upper 2 to 2.5 m of the rock mass to be fair to poor quality with good to excellent rock quality below this depth. Photographs of the core samples are provided in Appendix C. The Rock Quality Designation (RQD) of the core samples recovered from the testholes is summarized in the following table.

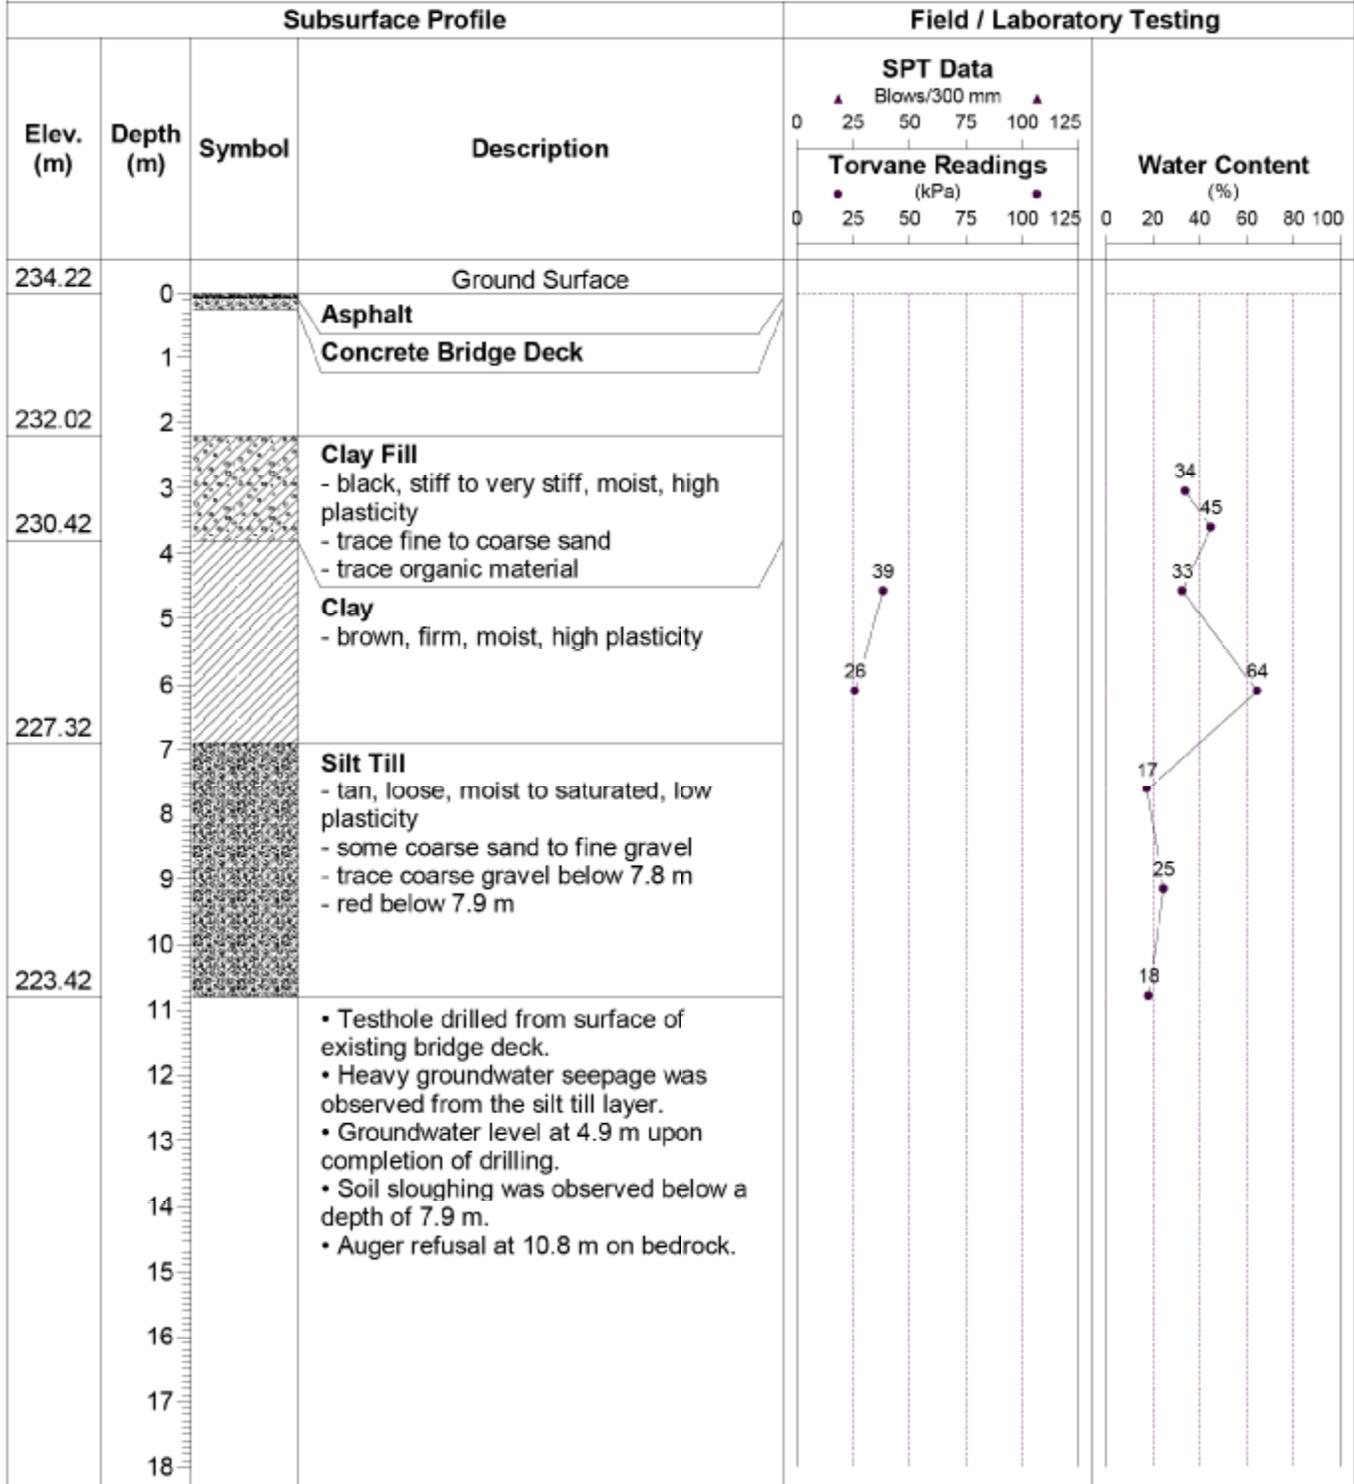
TESTHOLE TH4

Project Name: Replacement of Sturgeon Creek Bridge
Client: Stantec Consulting Ltd.
Drilling Contractor: Paddock Drilling Ltd.
Drilling Method: 125 mm Auger

Date Drilled: July 15, 2010
Depth of Testhole: 10.8 m
Testhole Elevation: 234.22 m
Logged By: Larry Presado

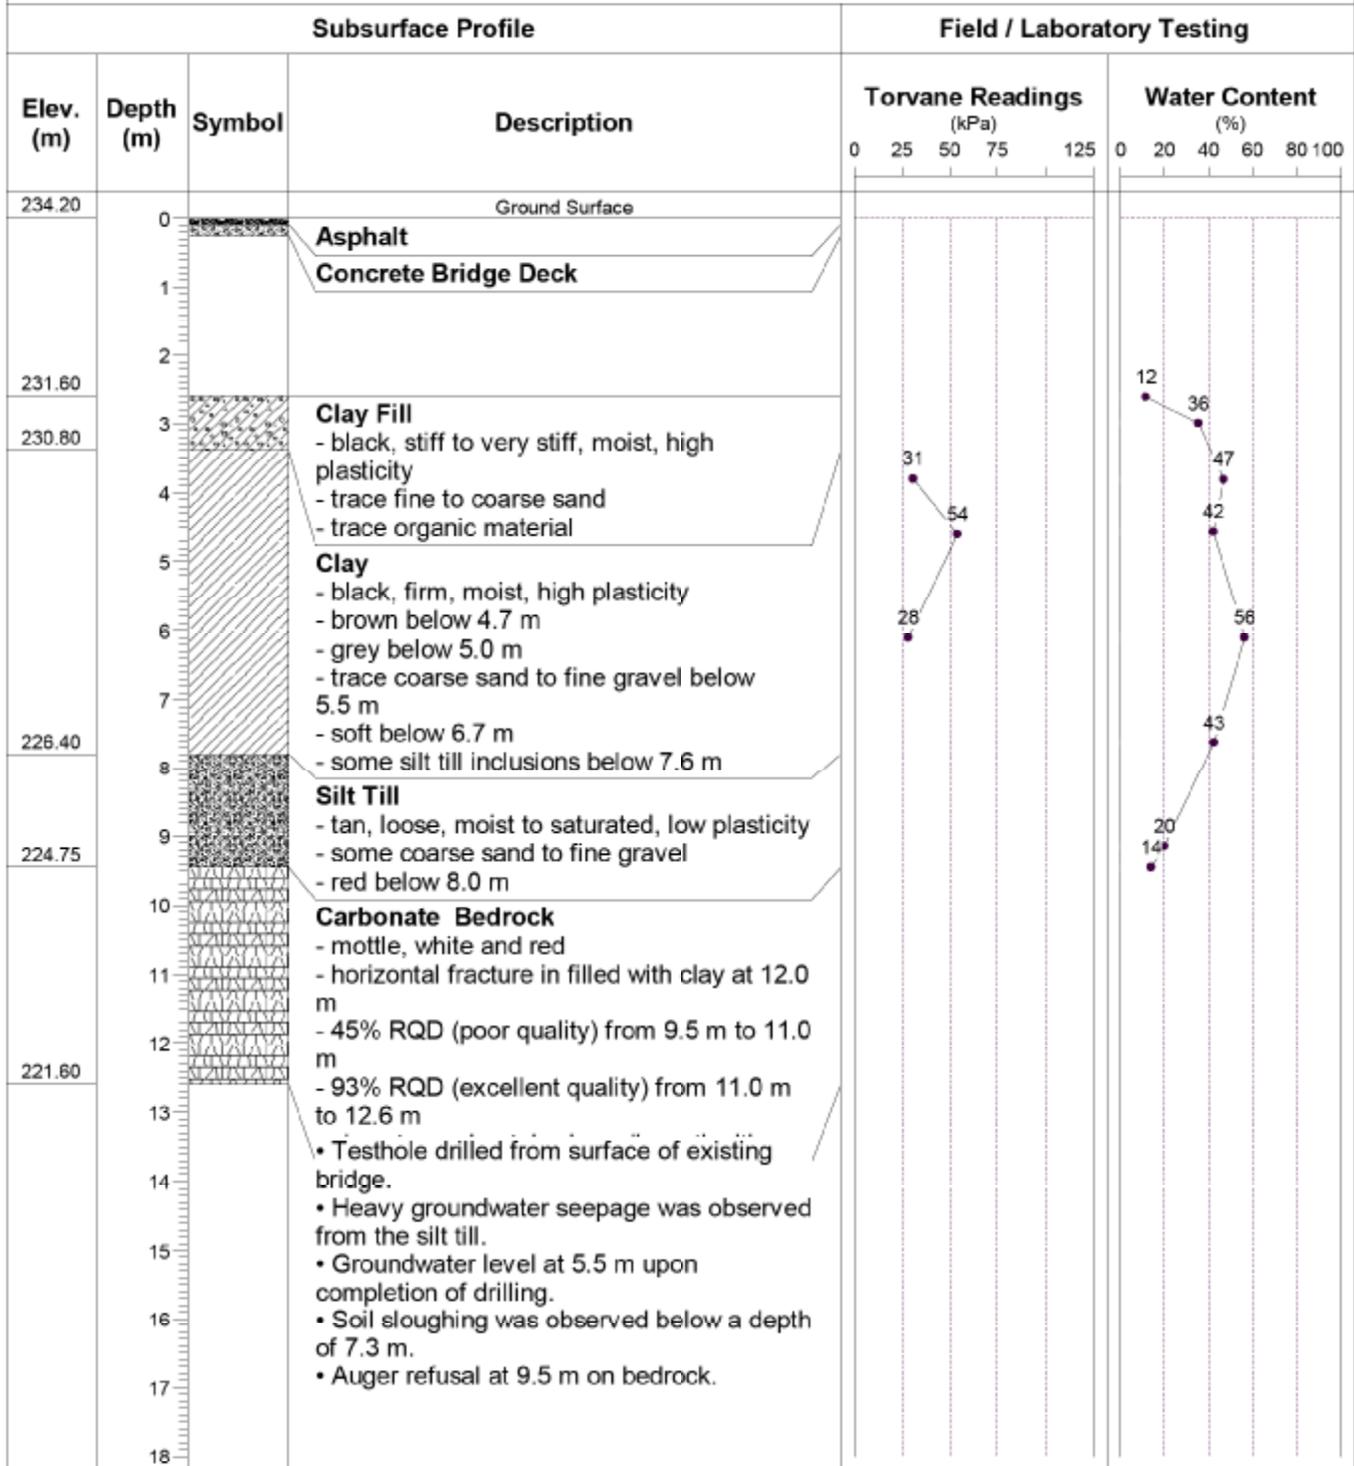
TESTHOLE TH5

Project Name: Replacement of Sturgeon Creek Bridge
Client: Stantec Consulting Ltd.
Drilling Contractor: Paddock Drilling Ltd.
Drilling Method: 125 mm Auger and 25 mm Core Bit

Date Drilled: July 15, 2010
Depth of Testhole: 12.6 m
Testhole Elevation: 234.20 m
Logged By: Larry Presado

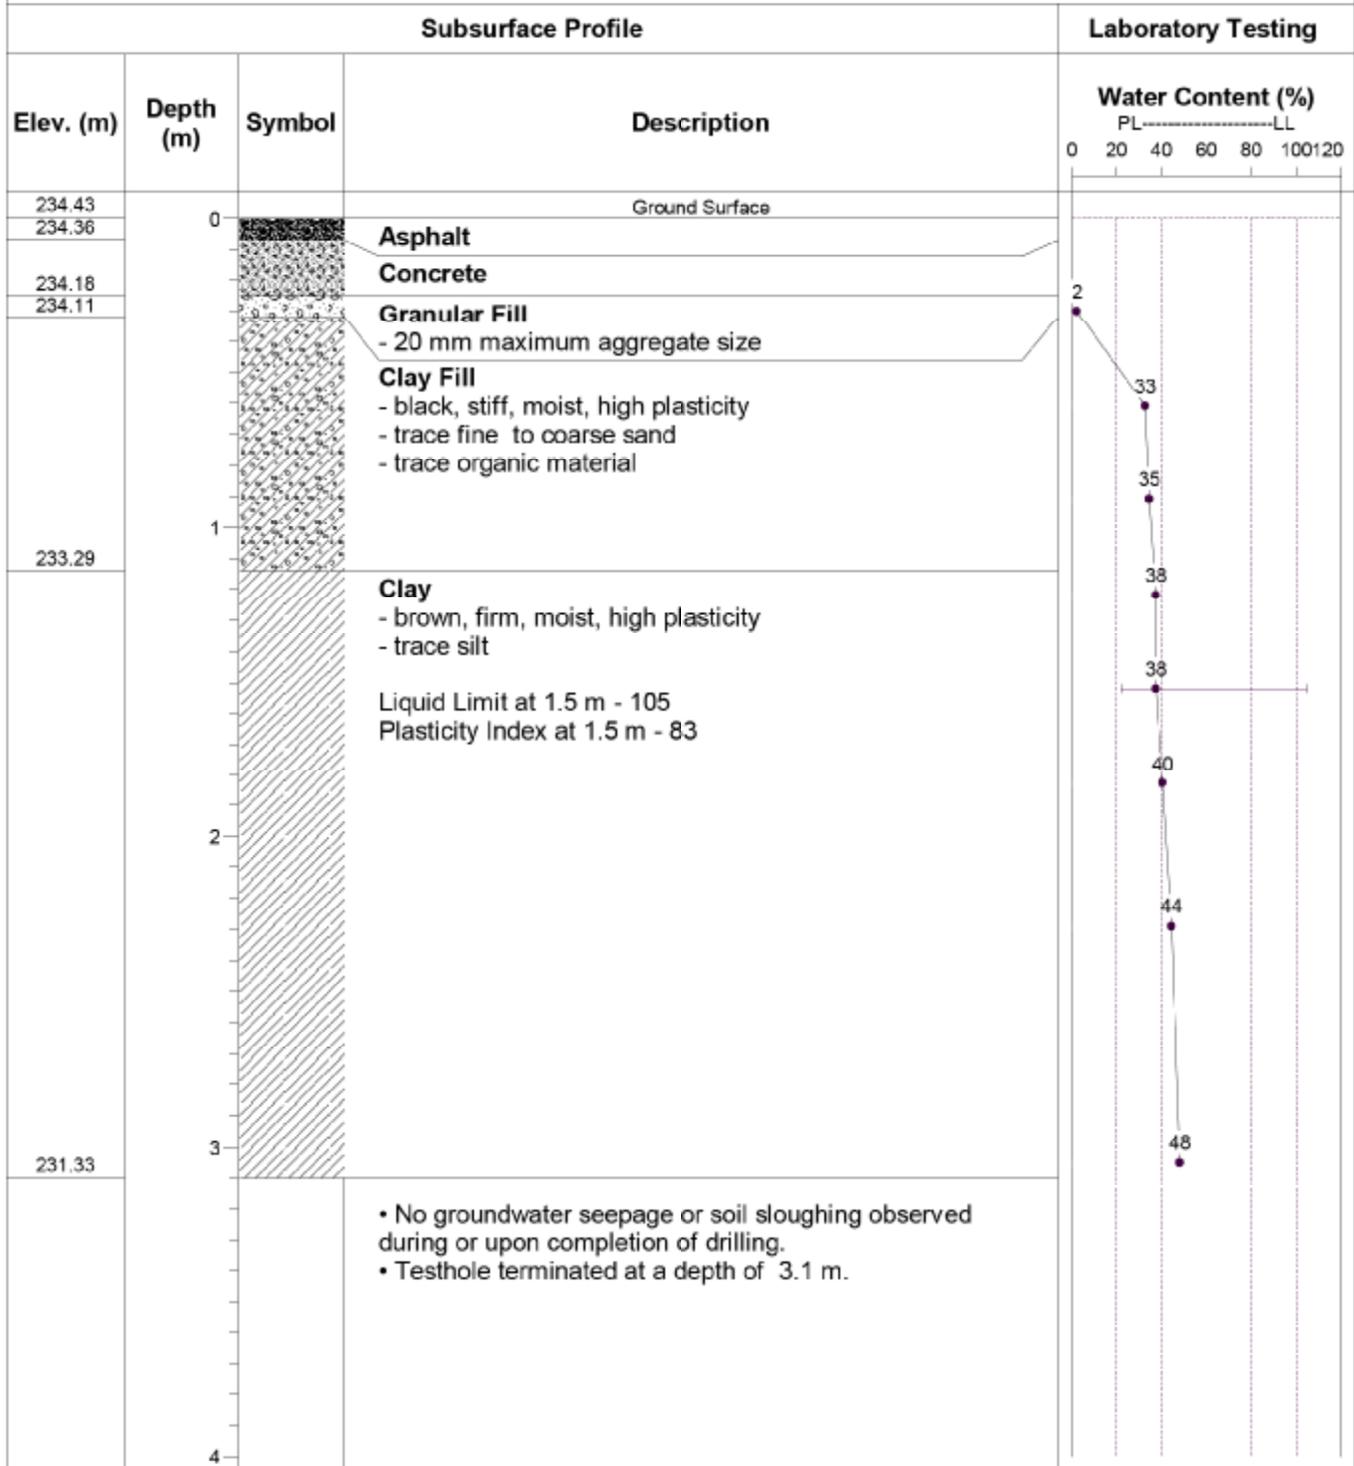
TESTHOLE TH7

Project Name: Replacement of Sturgeon Creek Bridge
Client: Stantec Consulting Ltd.
Drilling Contractor: Paddock Drilling Ltd.
Drilling Method: 125 mm Auger

Date Drilled: July 16, 2010
Depth of Testhole: 3.1 m
Testhole Elevation: 234.43 m
Logged By: Larry Presado

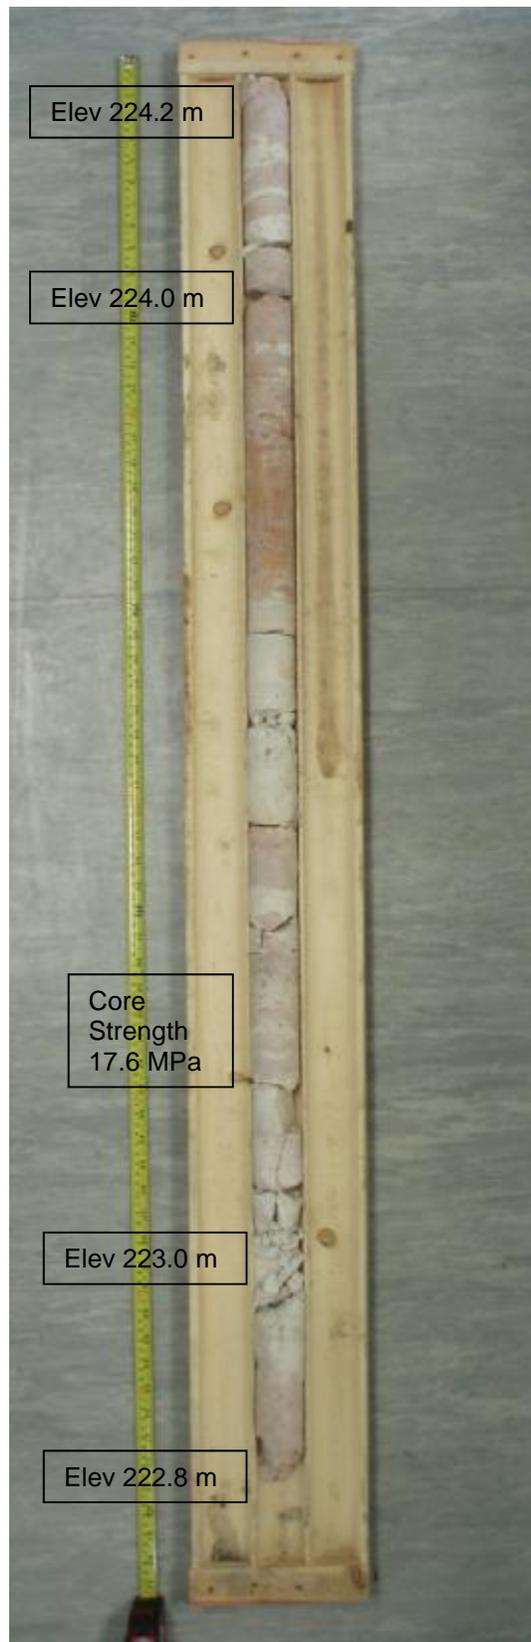
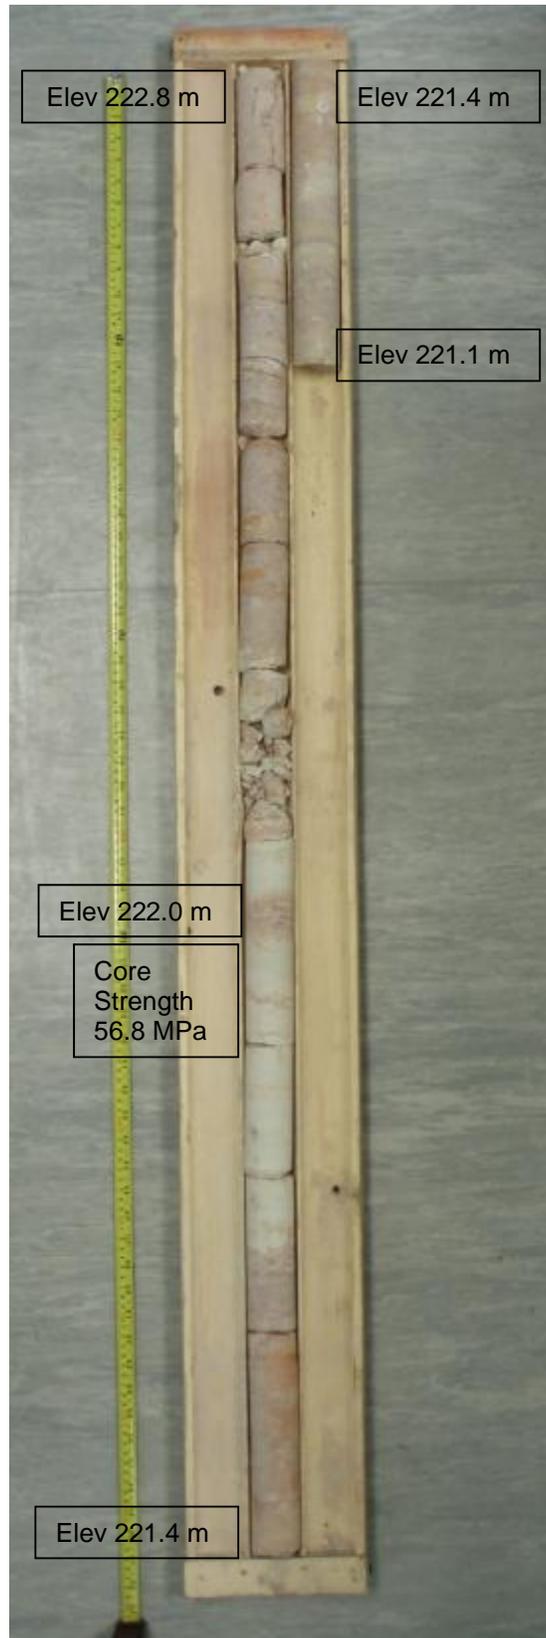
TESTHOLE TH3

CARBONATE BEDROCK CORE PHOTOGRAPHS

Testhole TH3			Testhole TH5		
Elevation (m)	RQD	Rock Quality	Elevation (m)	RQD	Rock Quality
224.2 to 222.6	59%	fair	224.7 to 223.2	45%	poor
222.6 to 221.5	83%	good	223.2 to 221.6	93%	excellent

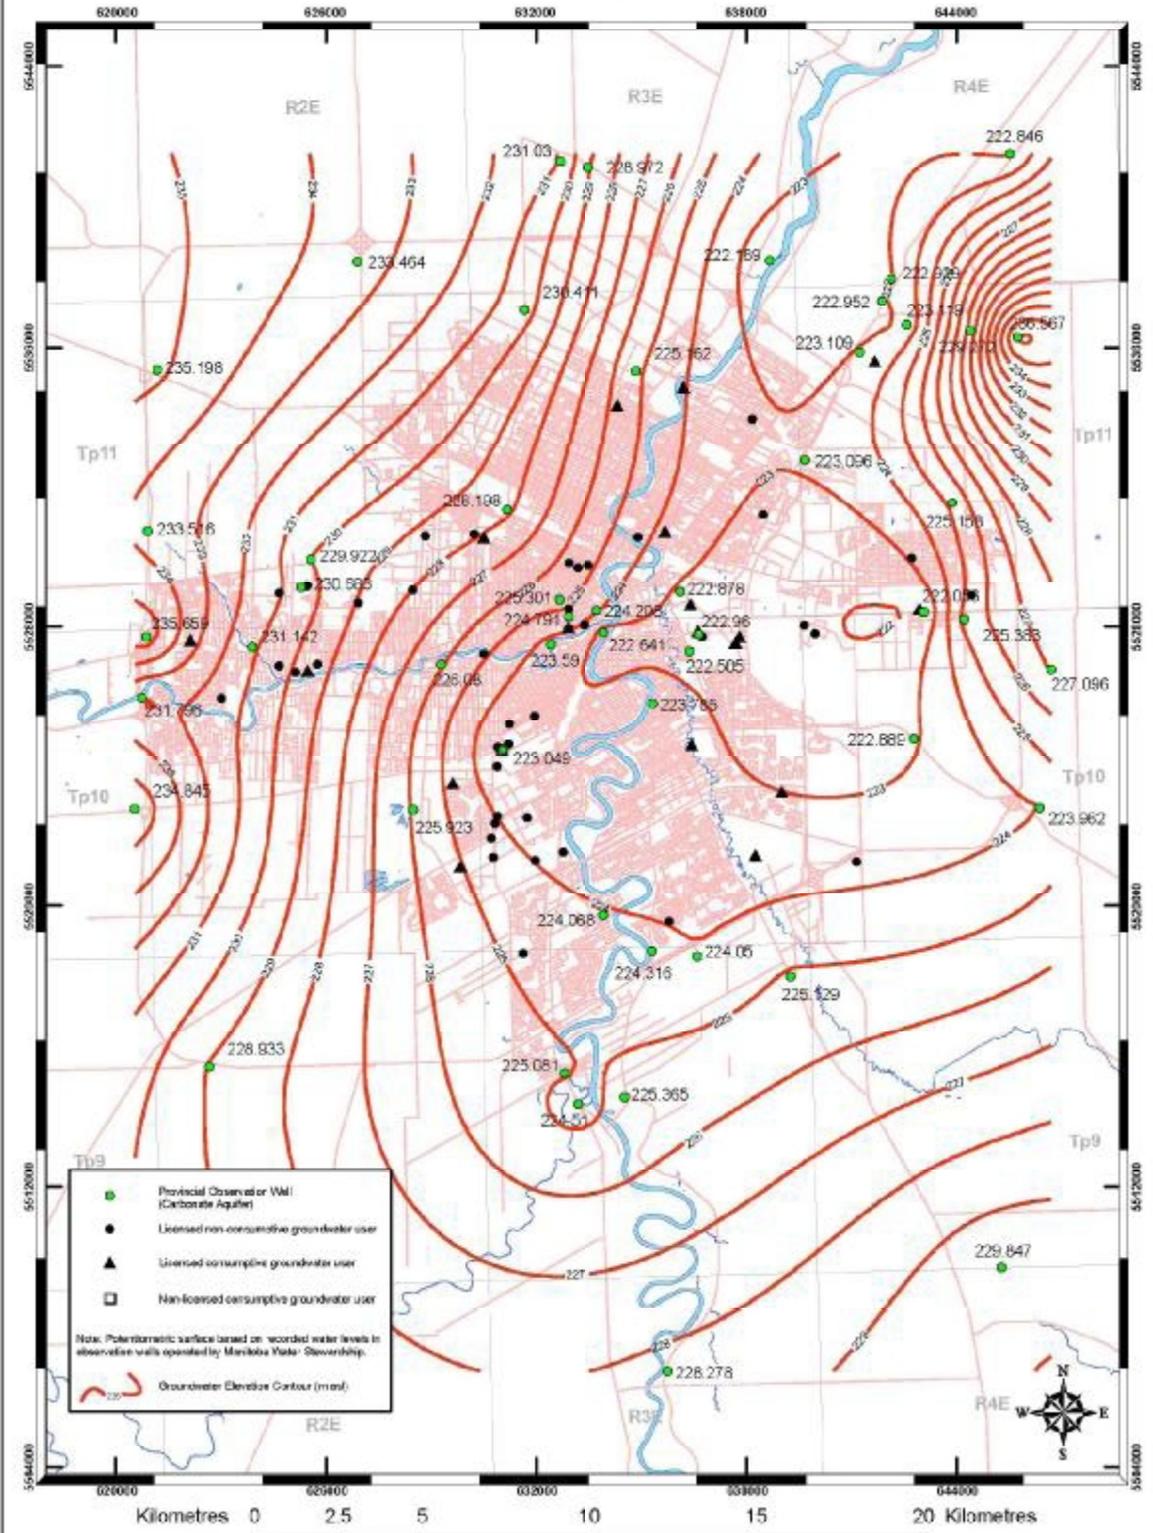
CARBONATE AQUIFER POTENTIOMETRIC SURFACE

Carbonate Aquifer Potentiometric Surface Winnipeg Area December 15, 2006

Heavy groundwater seepage was observed from the silt till in the testholes. The groundwater level was between an elevation of 228.7 and 229.5 m upon completion of drilling. Information obtained from Manitoba Water Stewardship indicates the potentiometric surface within the carbonate bedrock aquifer have been as high as 232.5 m near the project site. A hydrograph from an observation well at the Grace Hospital and a contour map for the carbonate aquifer potentiometric surface are provided in Appendix D. Soil sloughing was typically observed within the silt till. It should be noted that only short-term seepage and sloughing conditions were observed in the testholes and groundwater levels will normally fluctuate during the year. Based upon the hydrograph for the observation well at the Grace Hospital, the seasonal variation in the carbonate aquifer potentiometric surface is approximately 2 m.

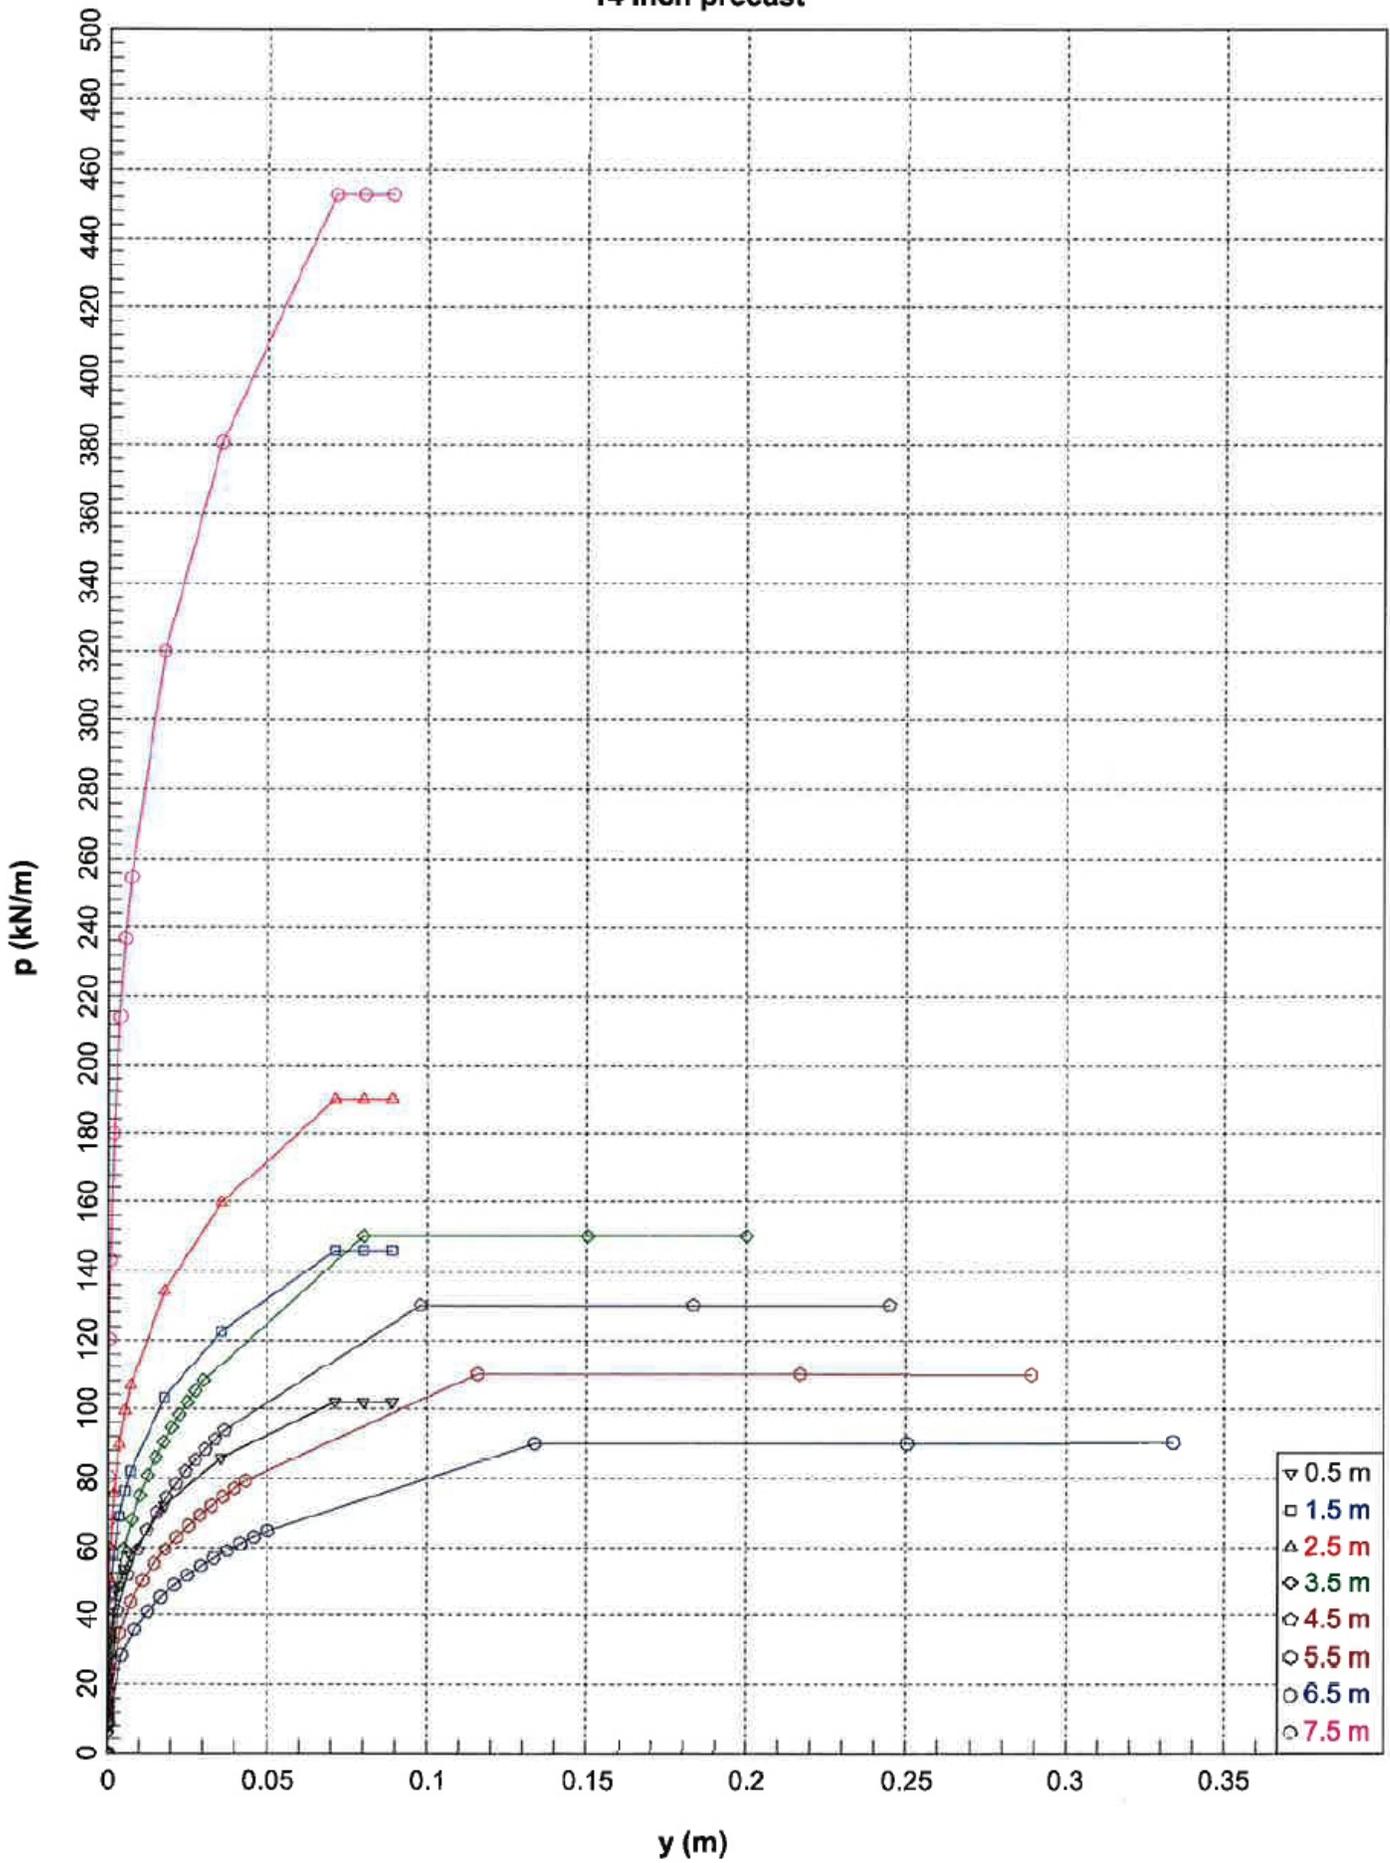
FIGURE 1

14 inch precast

Analyses were undertaken for both fixed and pinned pile head conditions for precast concrete piles. The lateral resistance provided by a pile cap was neglected. The output of the lateral analysis is provided in Appendix D. Incorporating the pile cap into the analysis may reduce the associated lateral deflections by approximately 50%. It is recommended that the lateral load capacity of precast concrete piles be confirmed when the foundation design has been completed.
