**FINAL REPORT
GEOTECHNICAL INVESTIGATION AND
FOUNDATION ENGINEERING FOR
STURGEON CREEK BRIDGE REPLACEMENT**

Prepared for
STANTEC
905 WAVERLEY STREET
WINNIPEG, MANITOBA
R3T 5P4

Prepared by
THE NATIONAL TESTING LABORATORIES LIMITED
199 HENLOW BAY
WINNIPEG, MANITOBA
R3Y 1G4

October 28, 2011

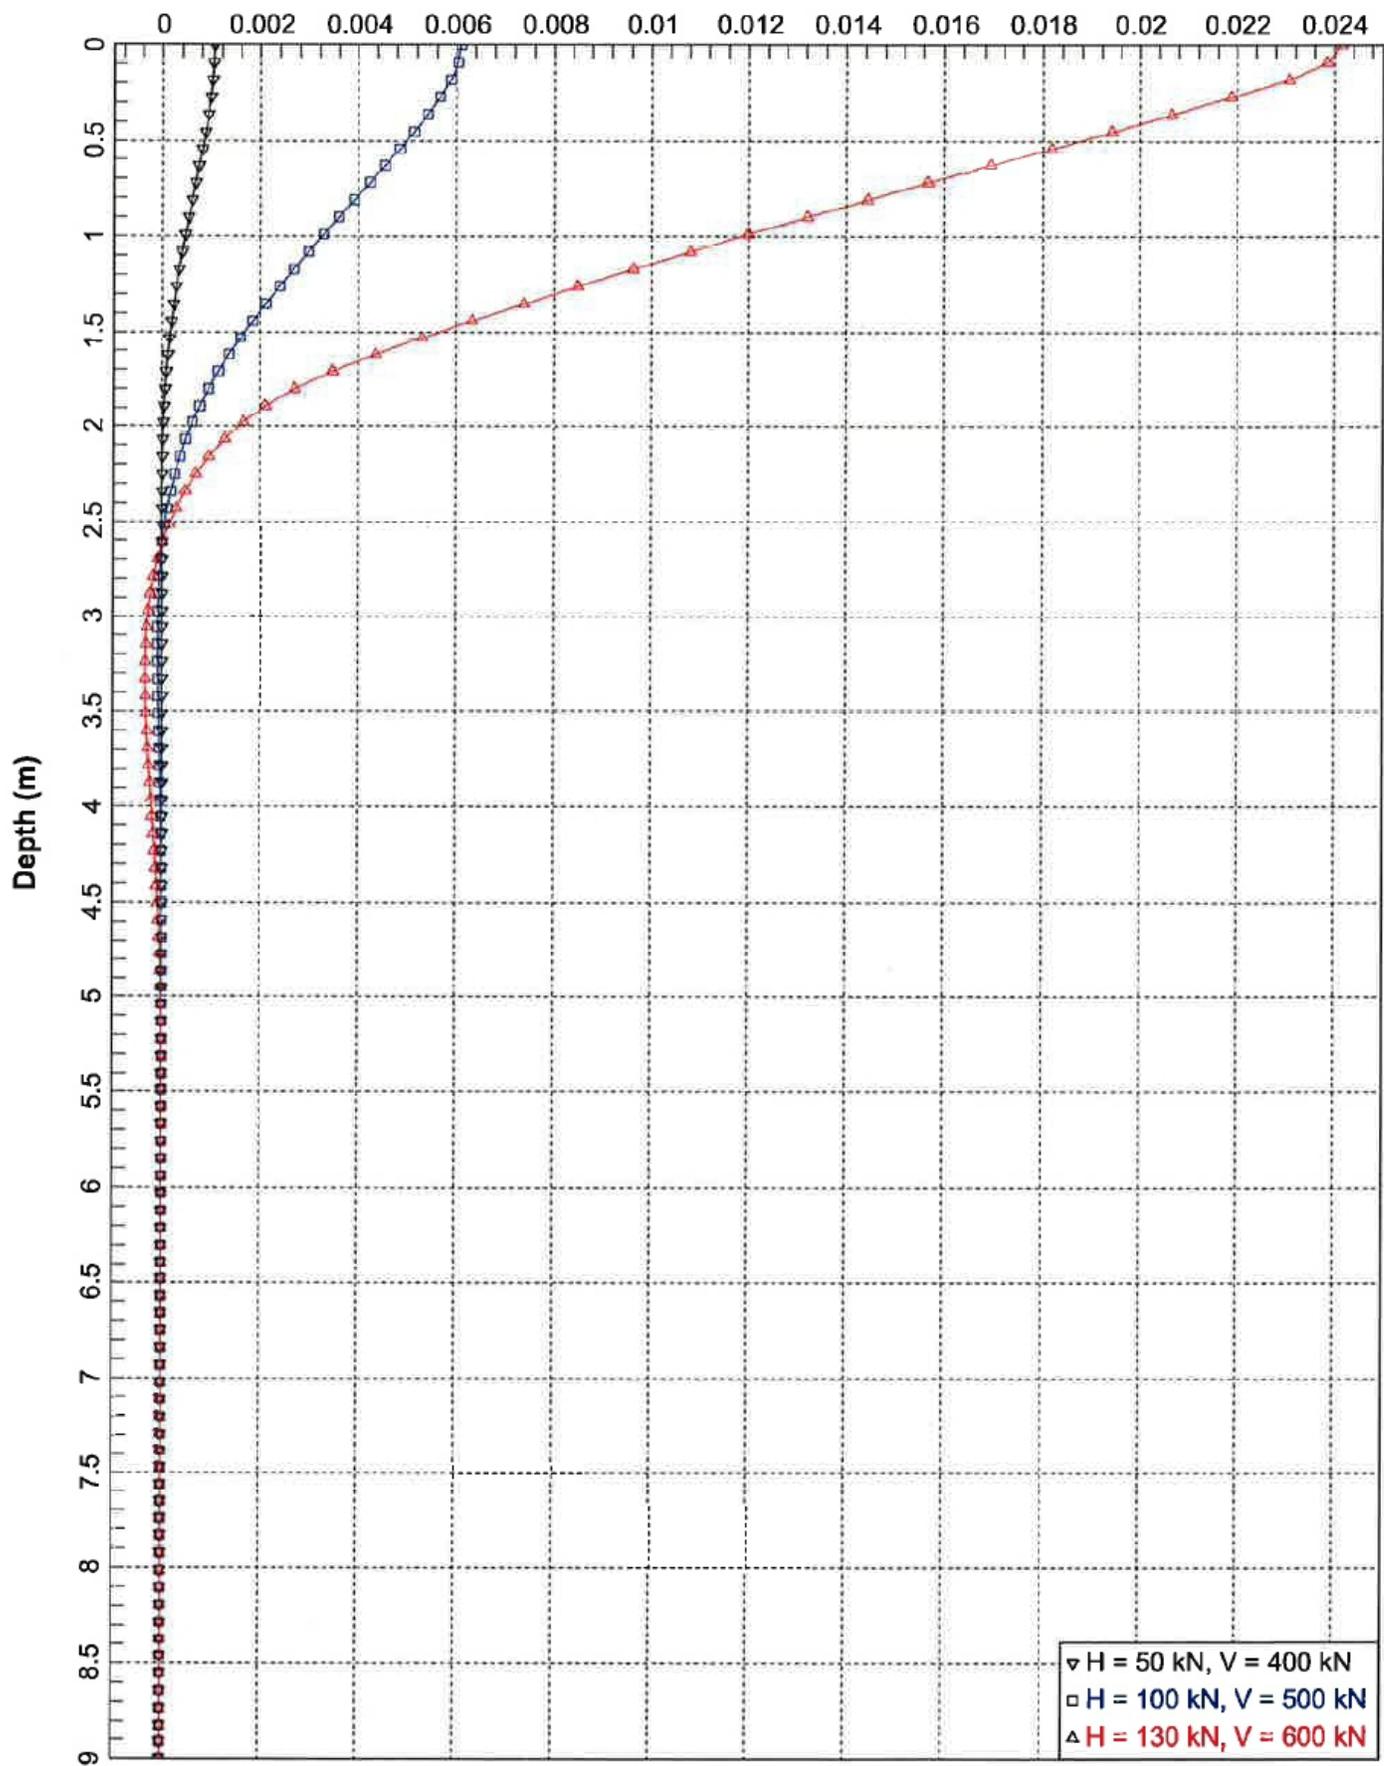
FIGURE 2

14 inch precast - fixed

Lateral Deflection (m)

Analyses were undertaken for both fixed and pinned pile head conditions for precast concrete piles. The lateral resistance provided by a pile cap was neglected. The output of the lateral analysis is provided in Appendix D. Incorporating the pile cap into the analysis may reduce the associated lateral deflections by approximately 50%. It is recommended that the lateral load capacity of precast concrete piles be confirmed when the foundation design has been completed.

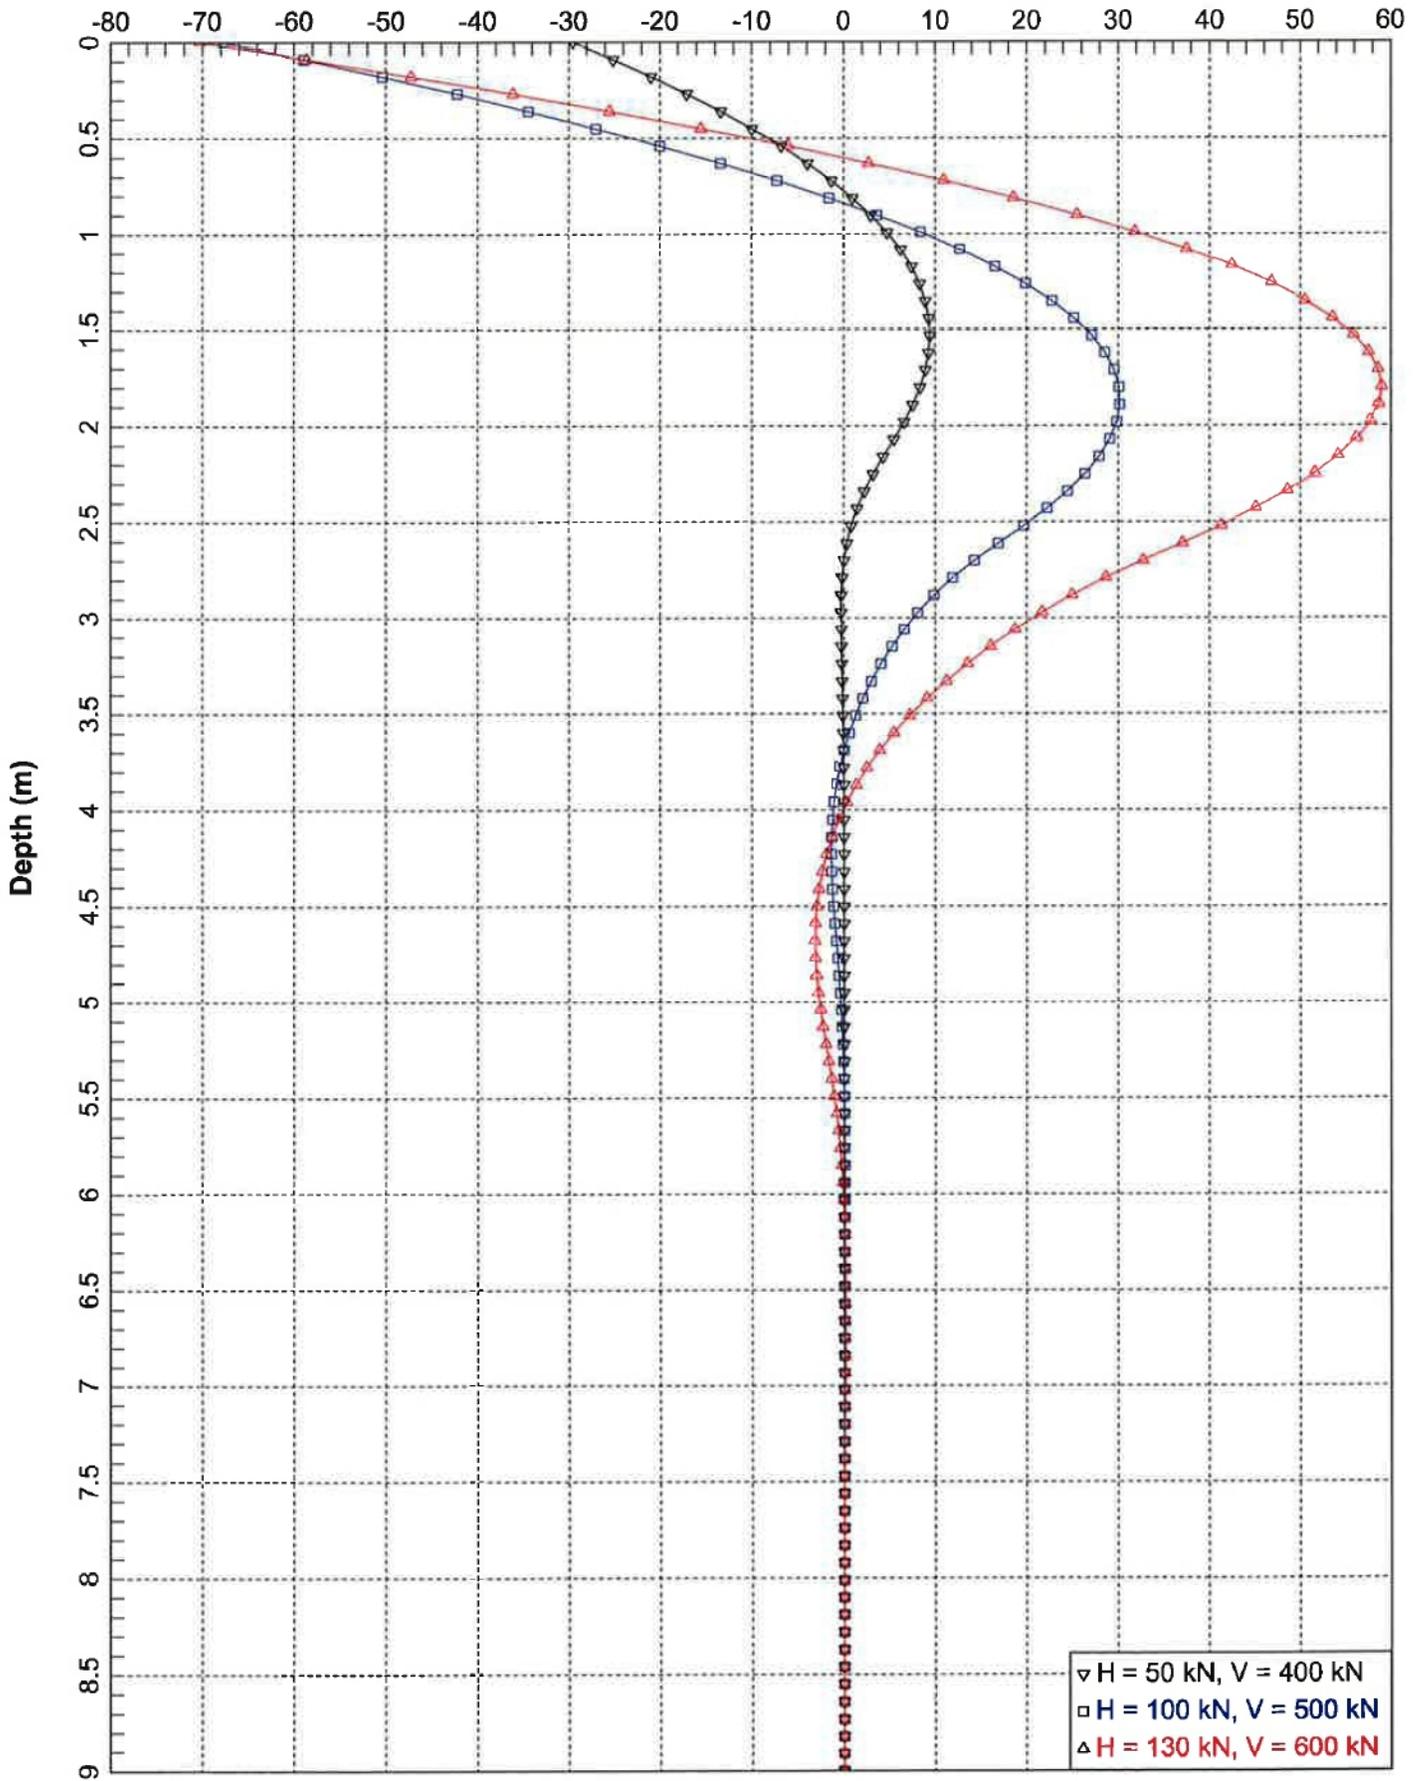
FIGURE 3

14 inch precast - fixed
Bending Moment (kN-m)

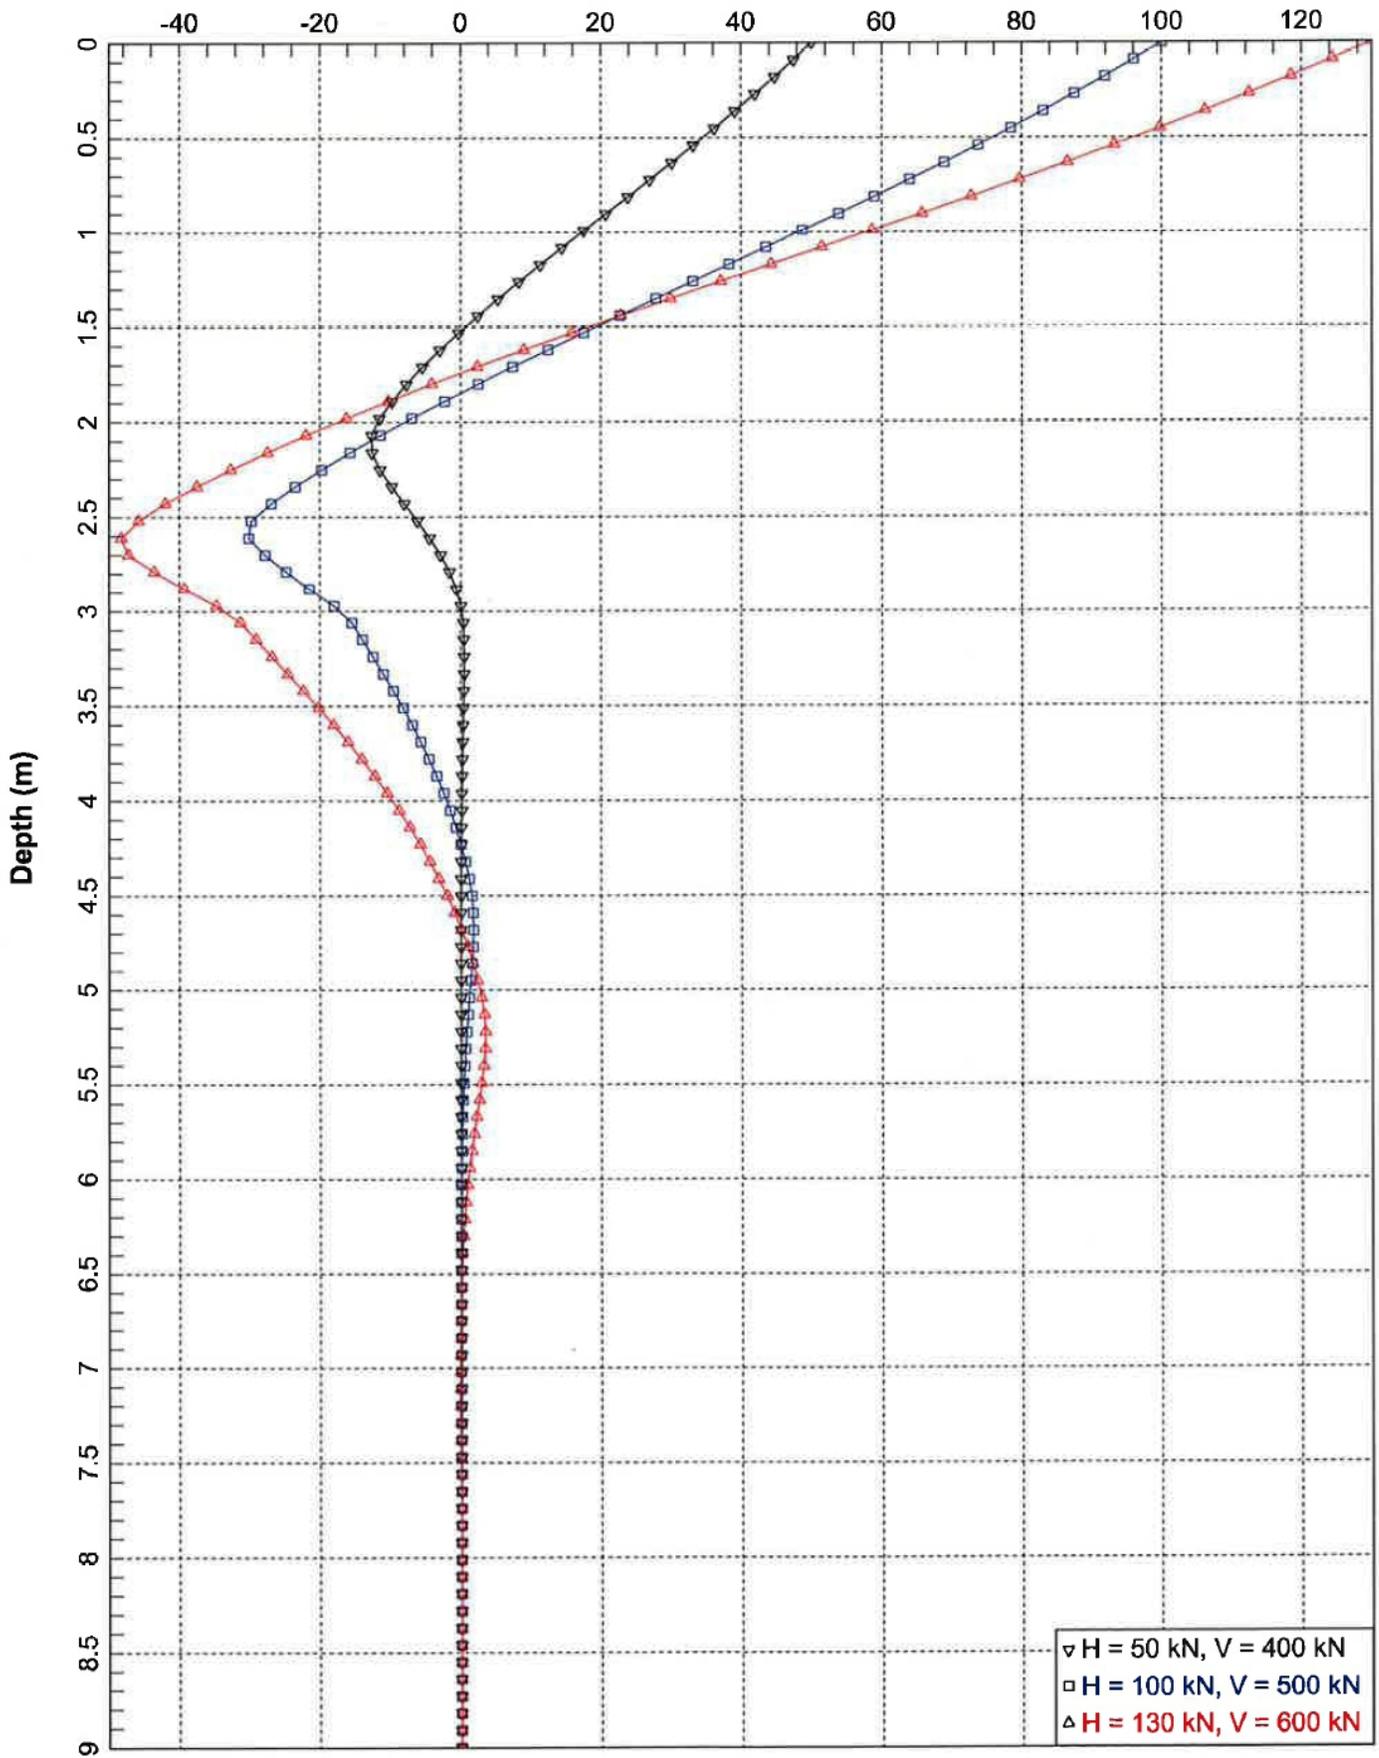
FIGURE 4

14 inch precast - fixed

Shear Force (kN)

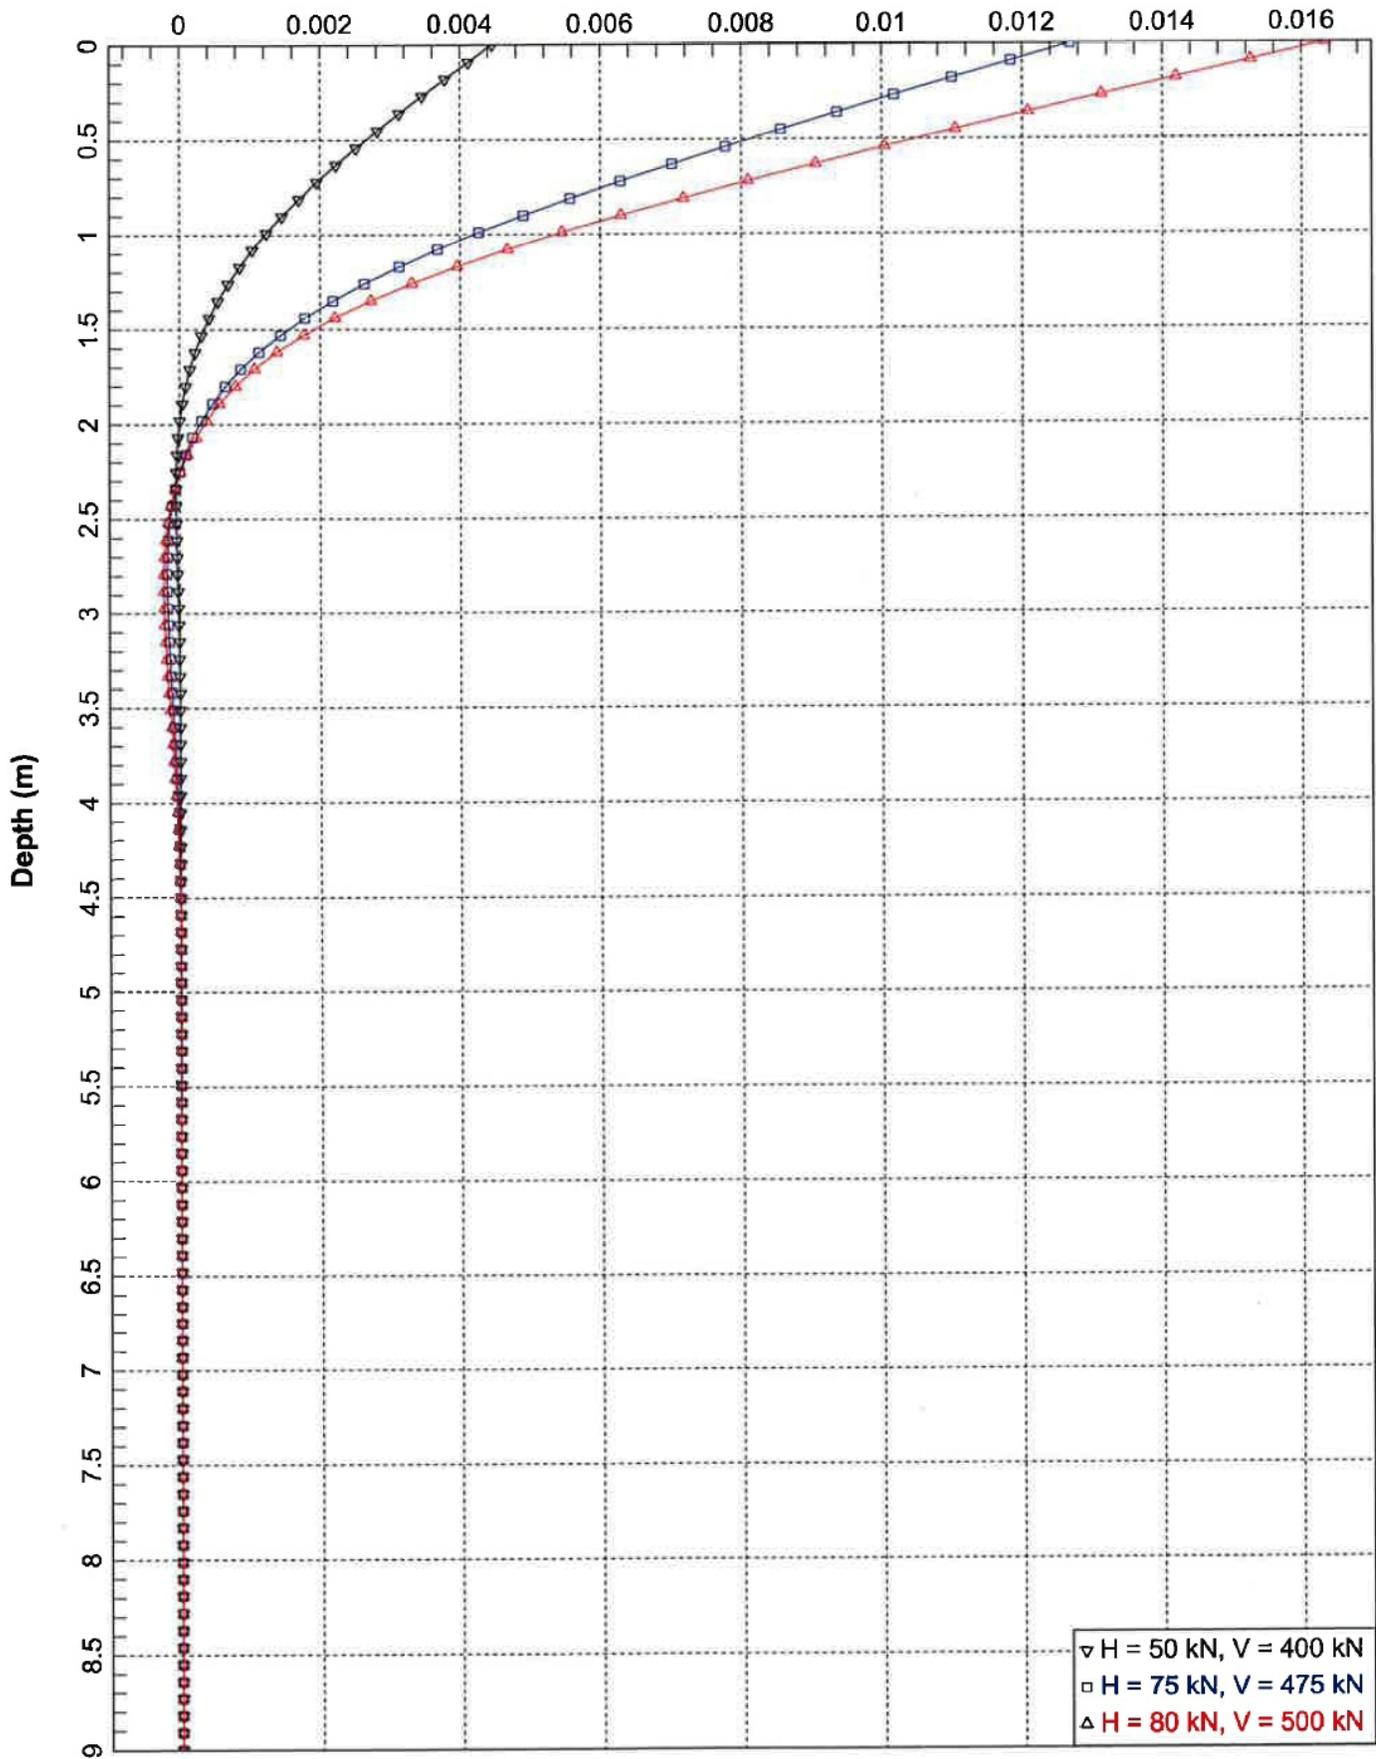
FIGURE 5

14 inch precast - pinned
Lateral Deflection (m)

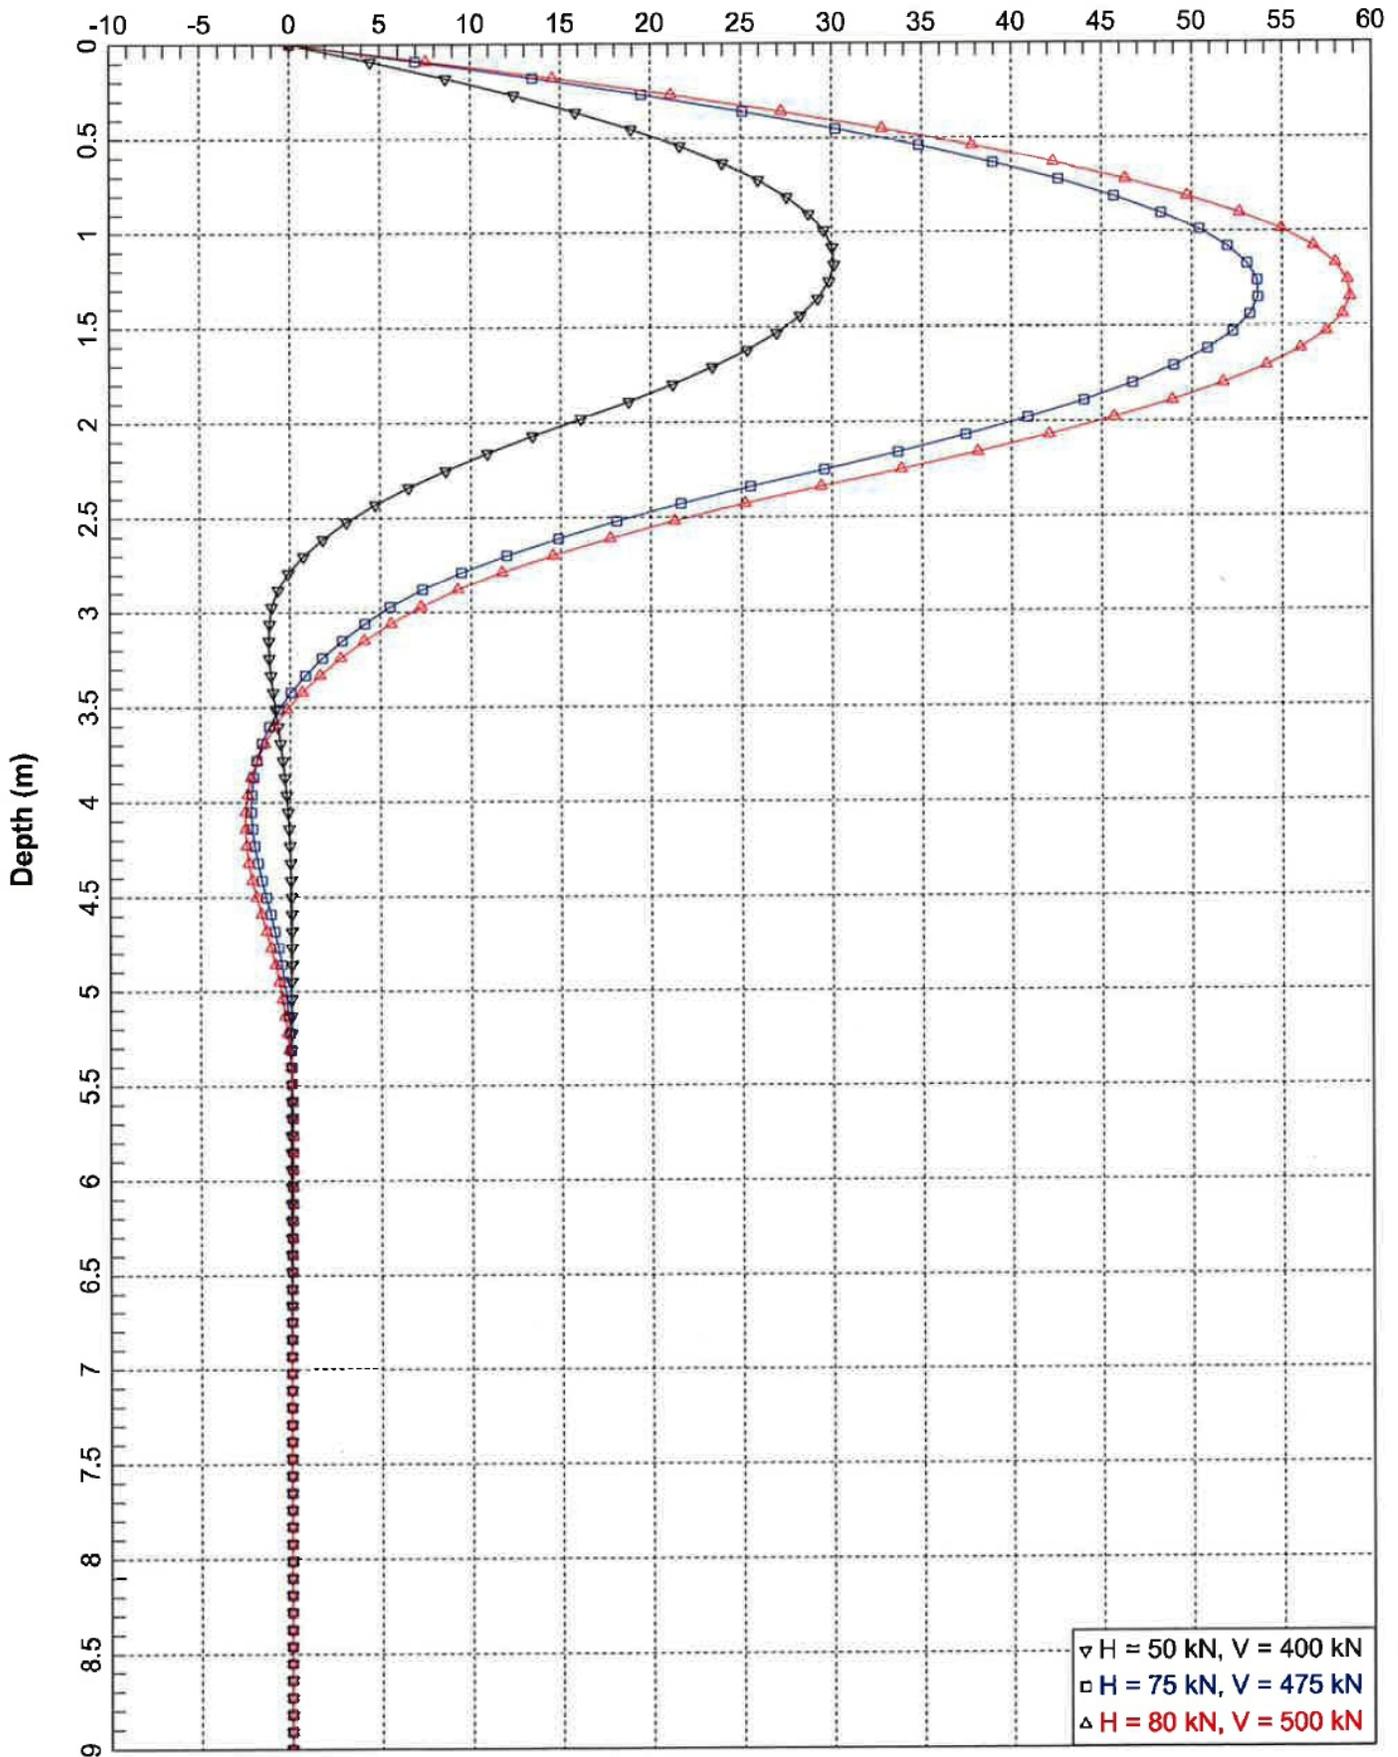
FIGURE 6

14 inch precast - pinned
Bending Moment (kN-m)

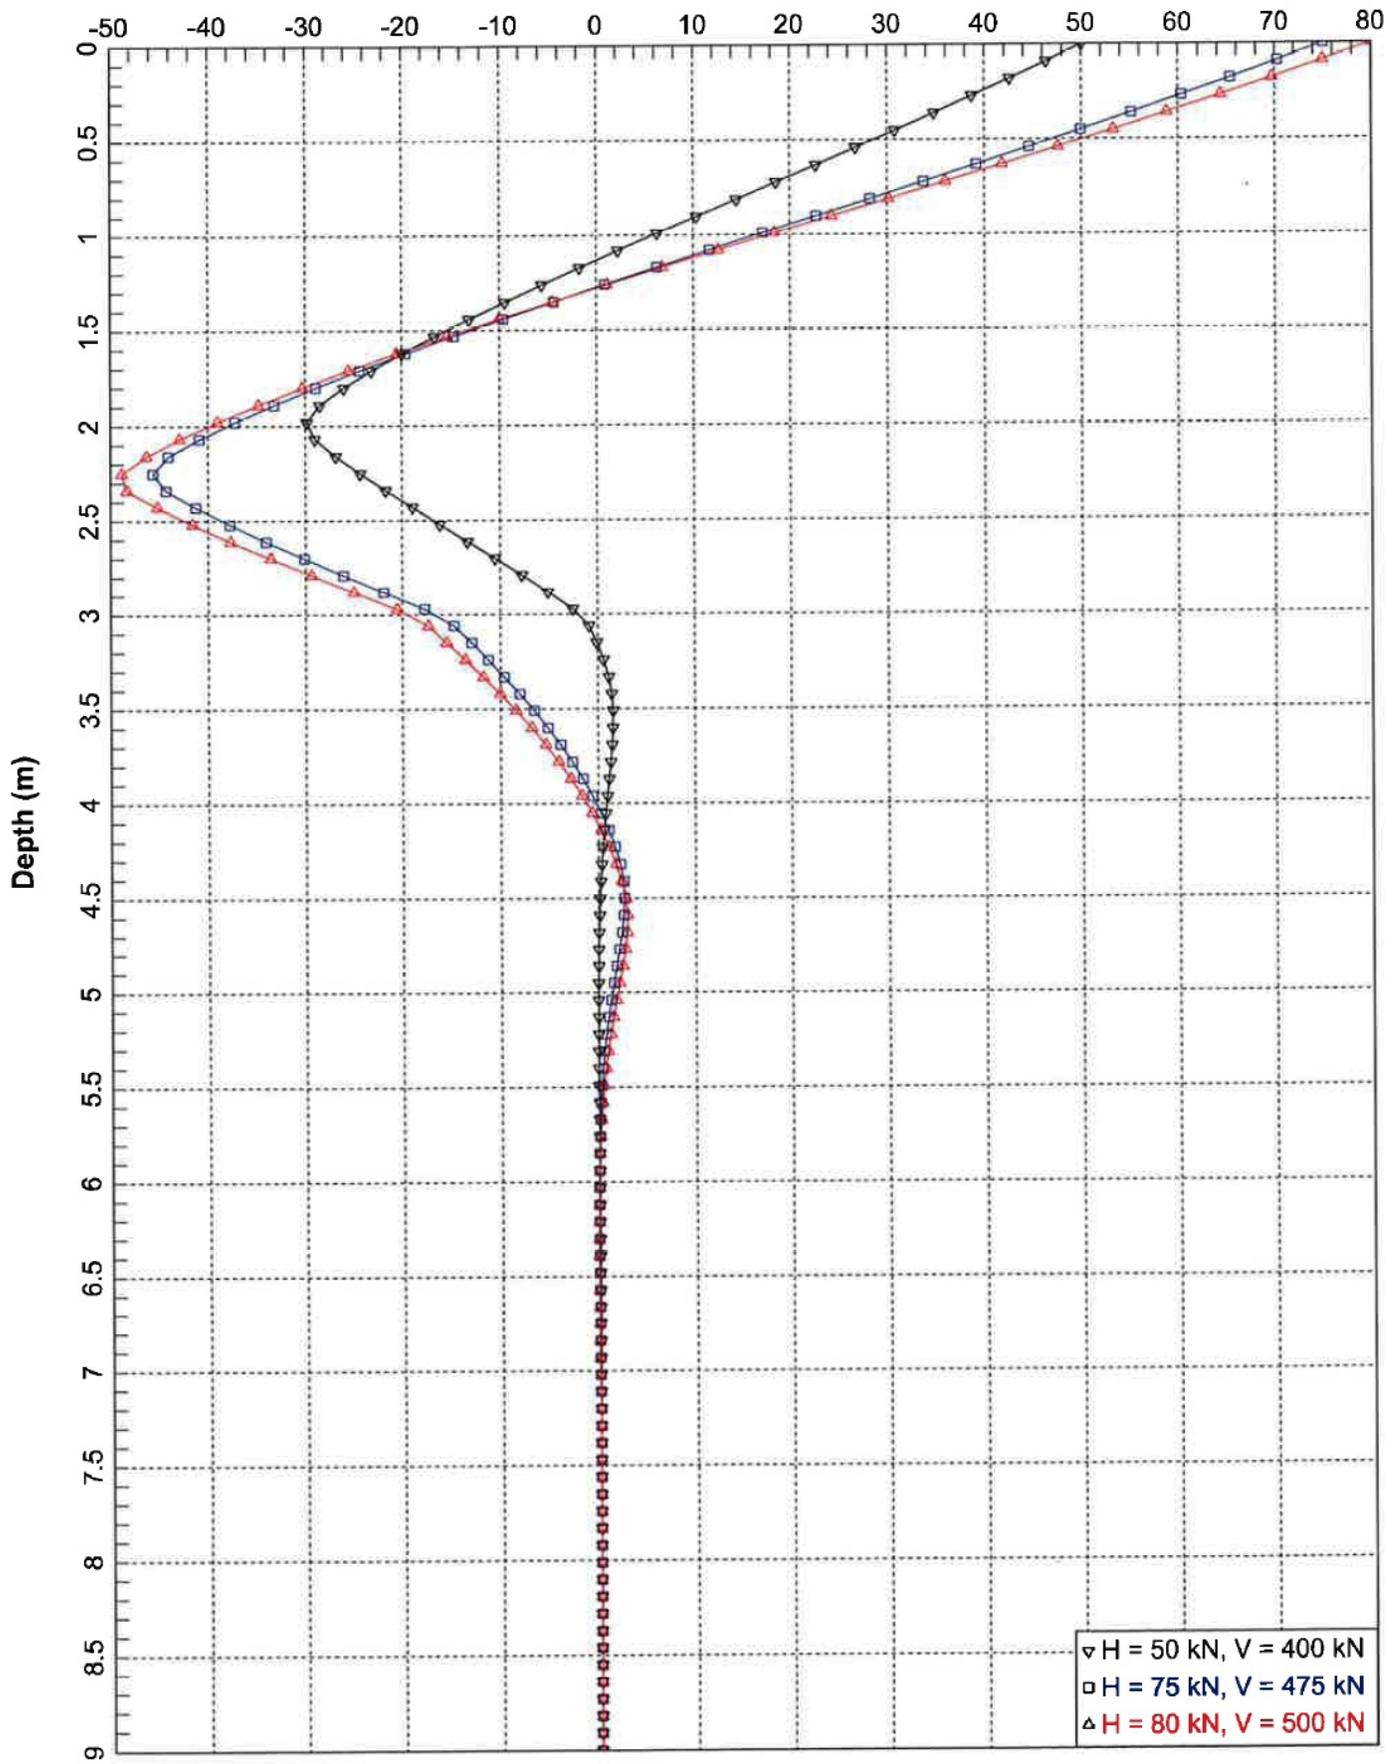
FIGURE 7

14 inch precast - pinned

Shear Force (kN)

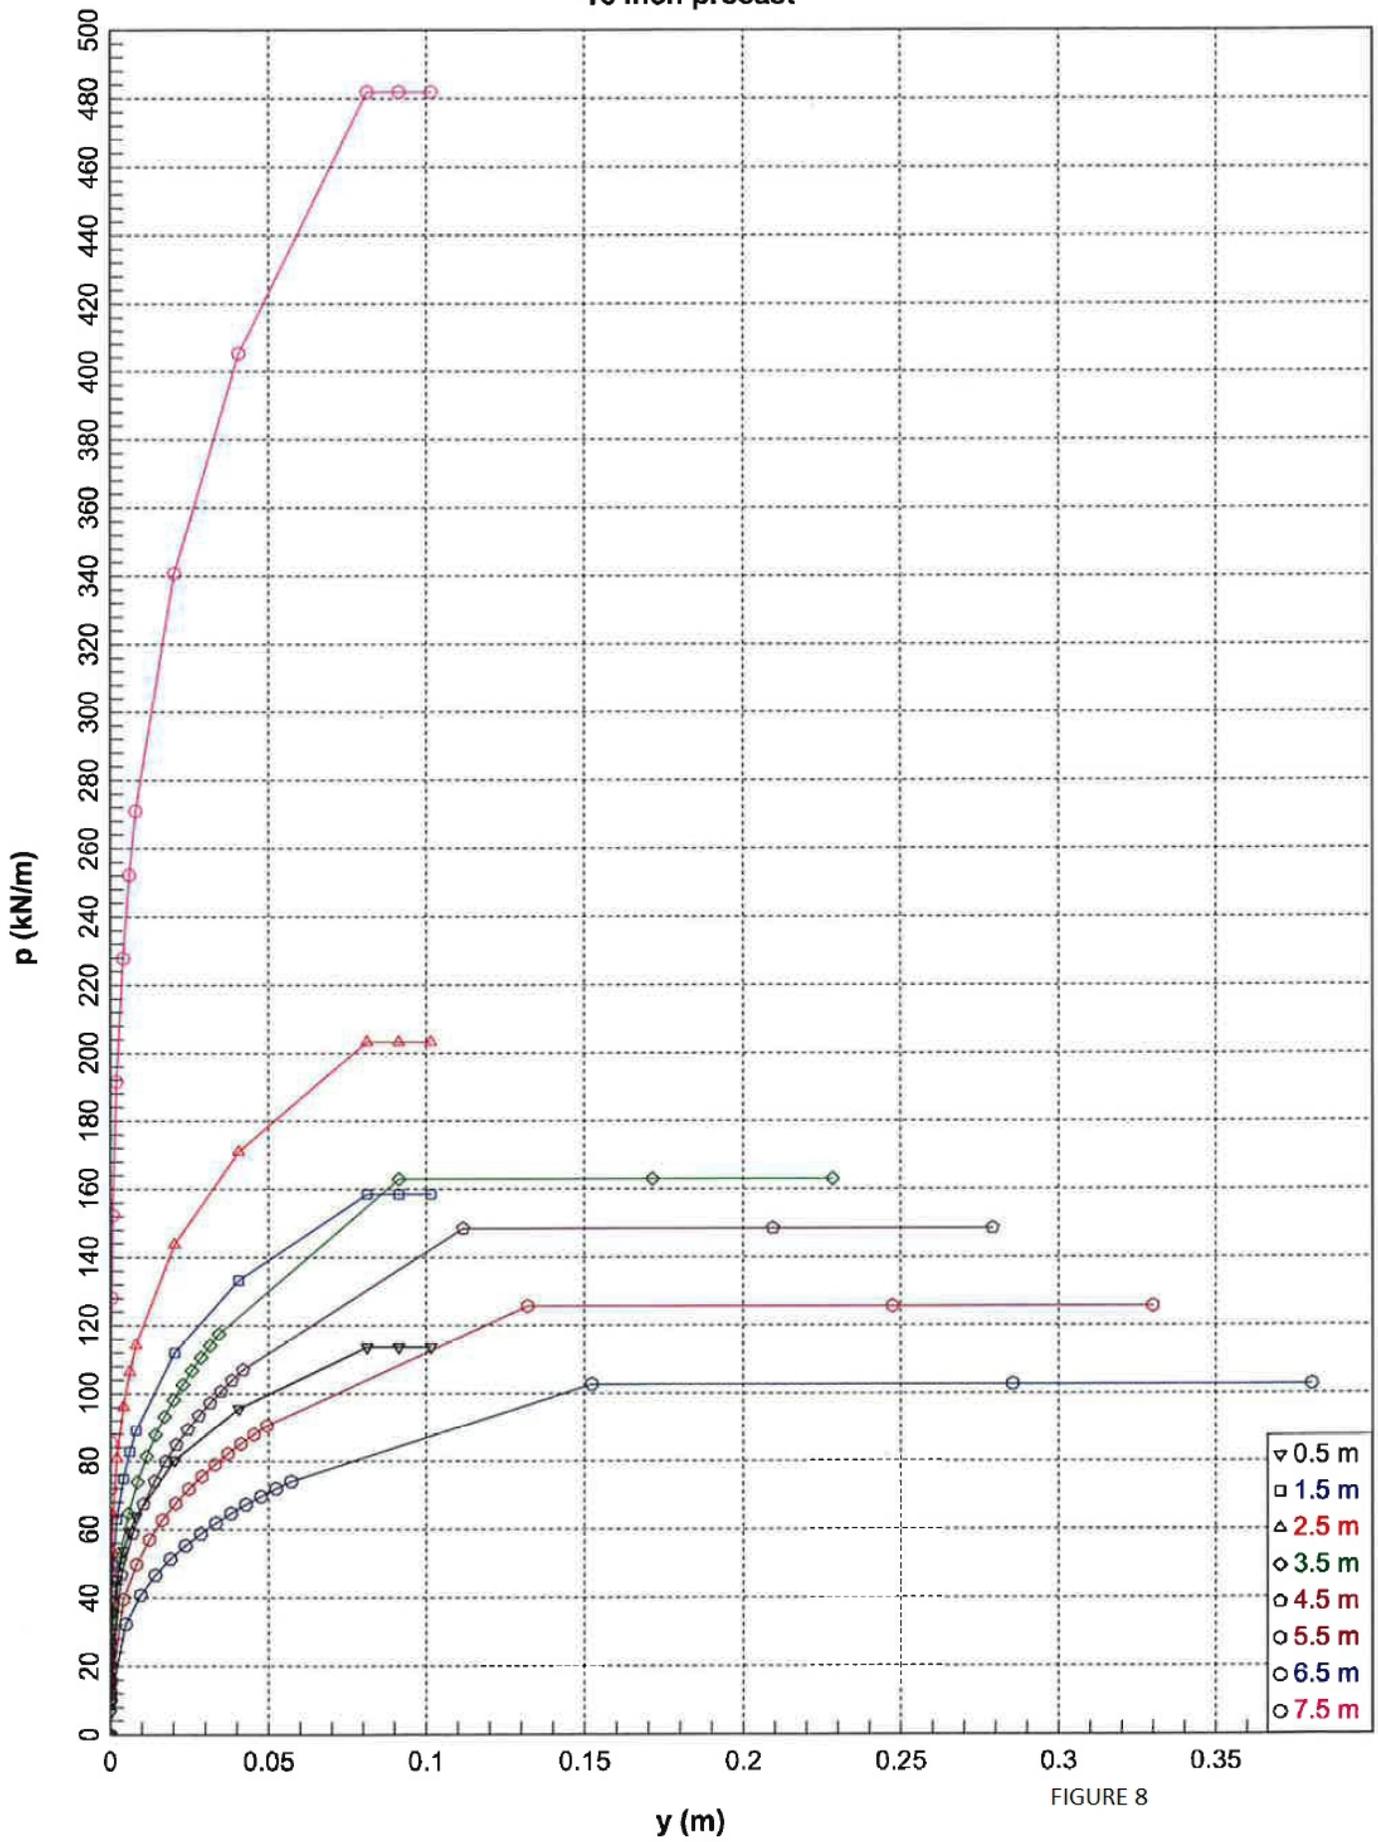
FIGURE 8

16 inch precast

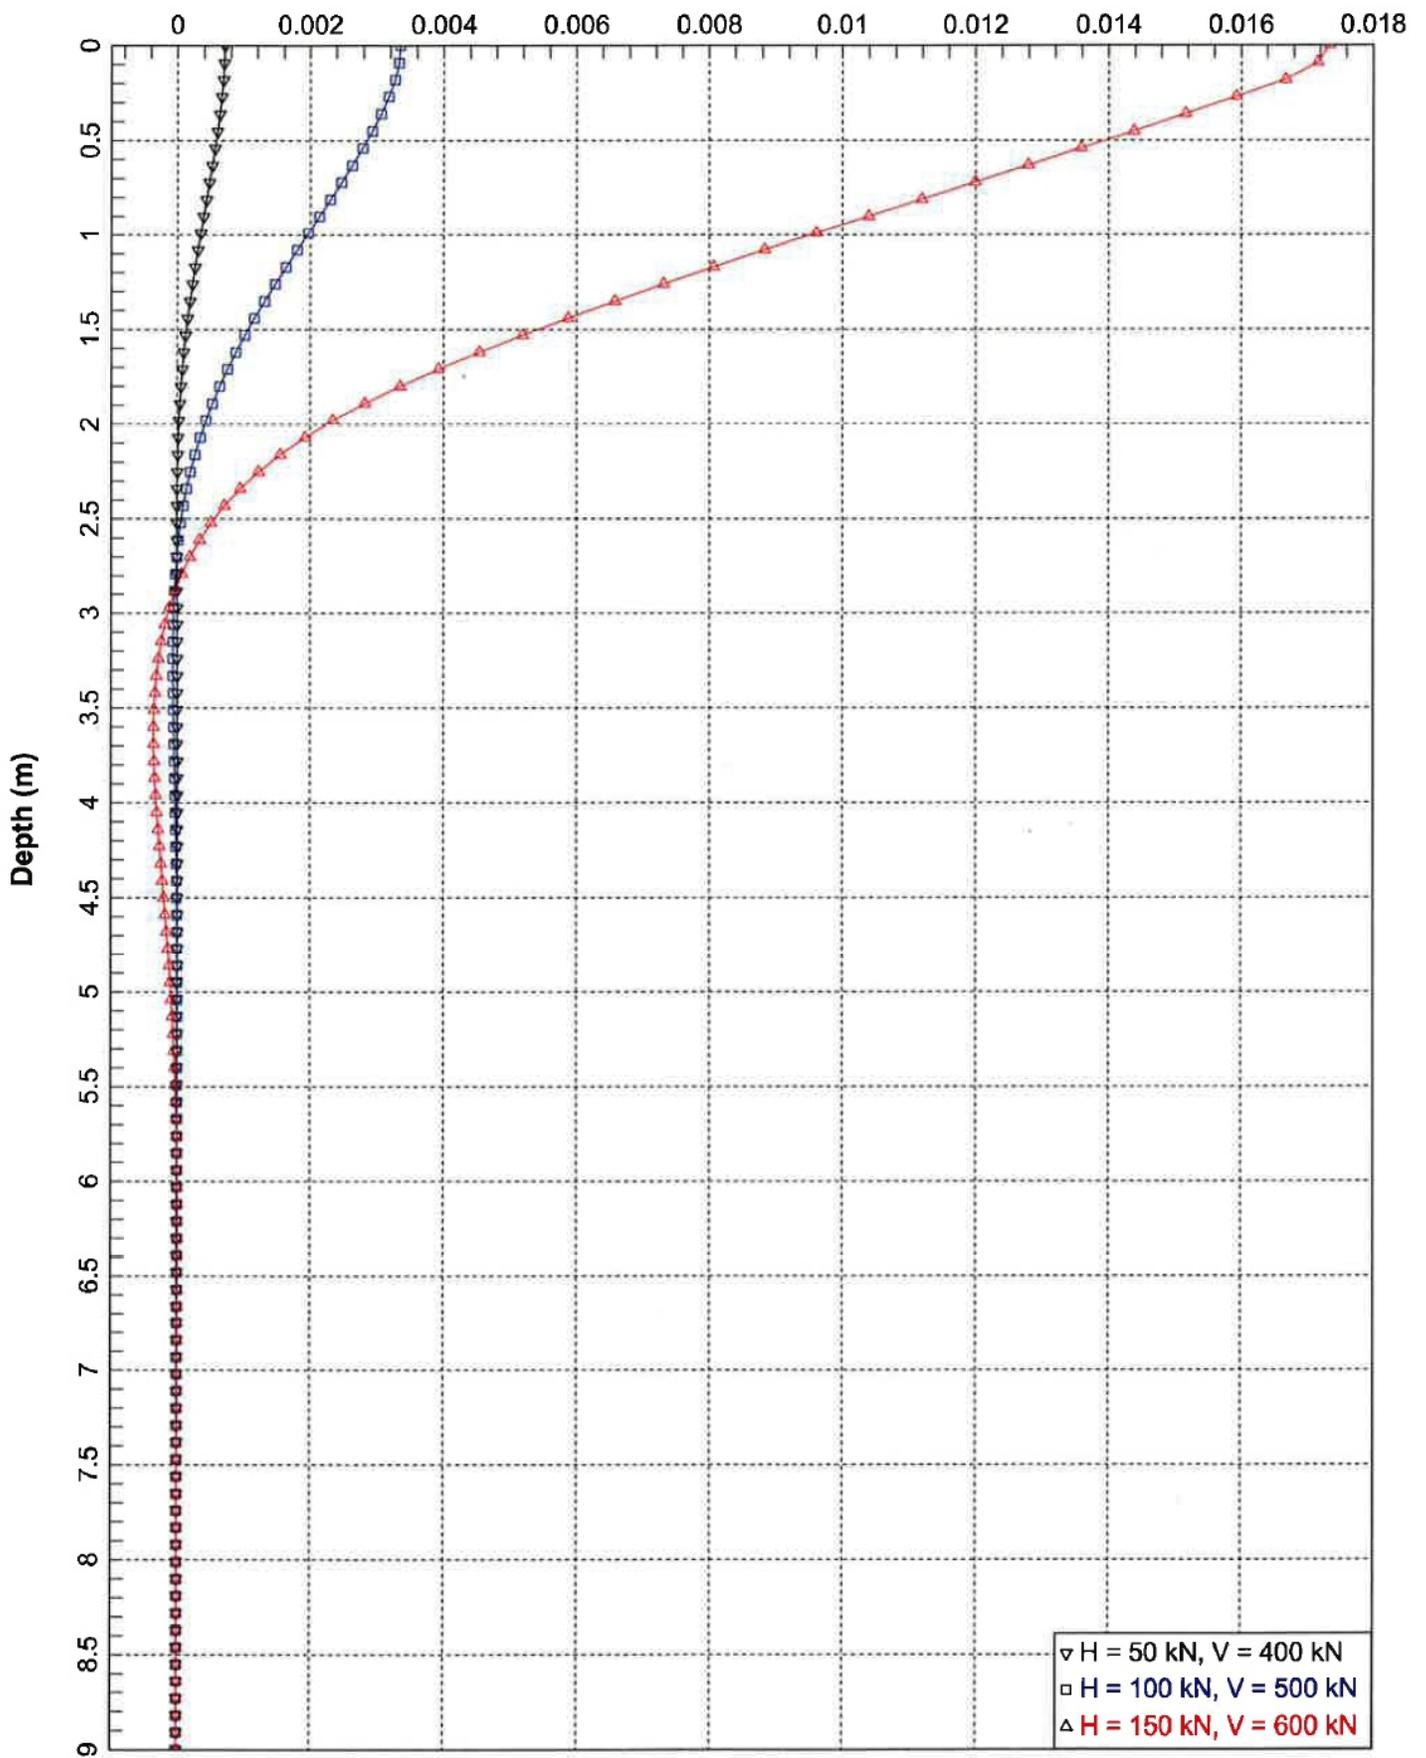
FIGURE 9

16 inch precast - fixed

Lateral Deflection (m)

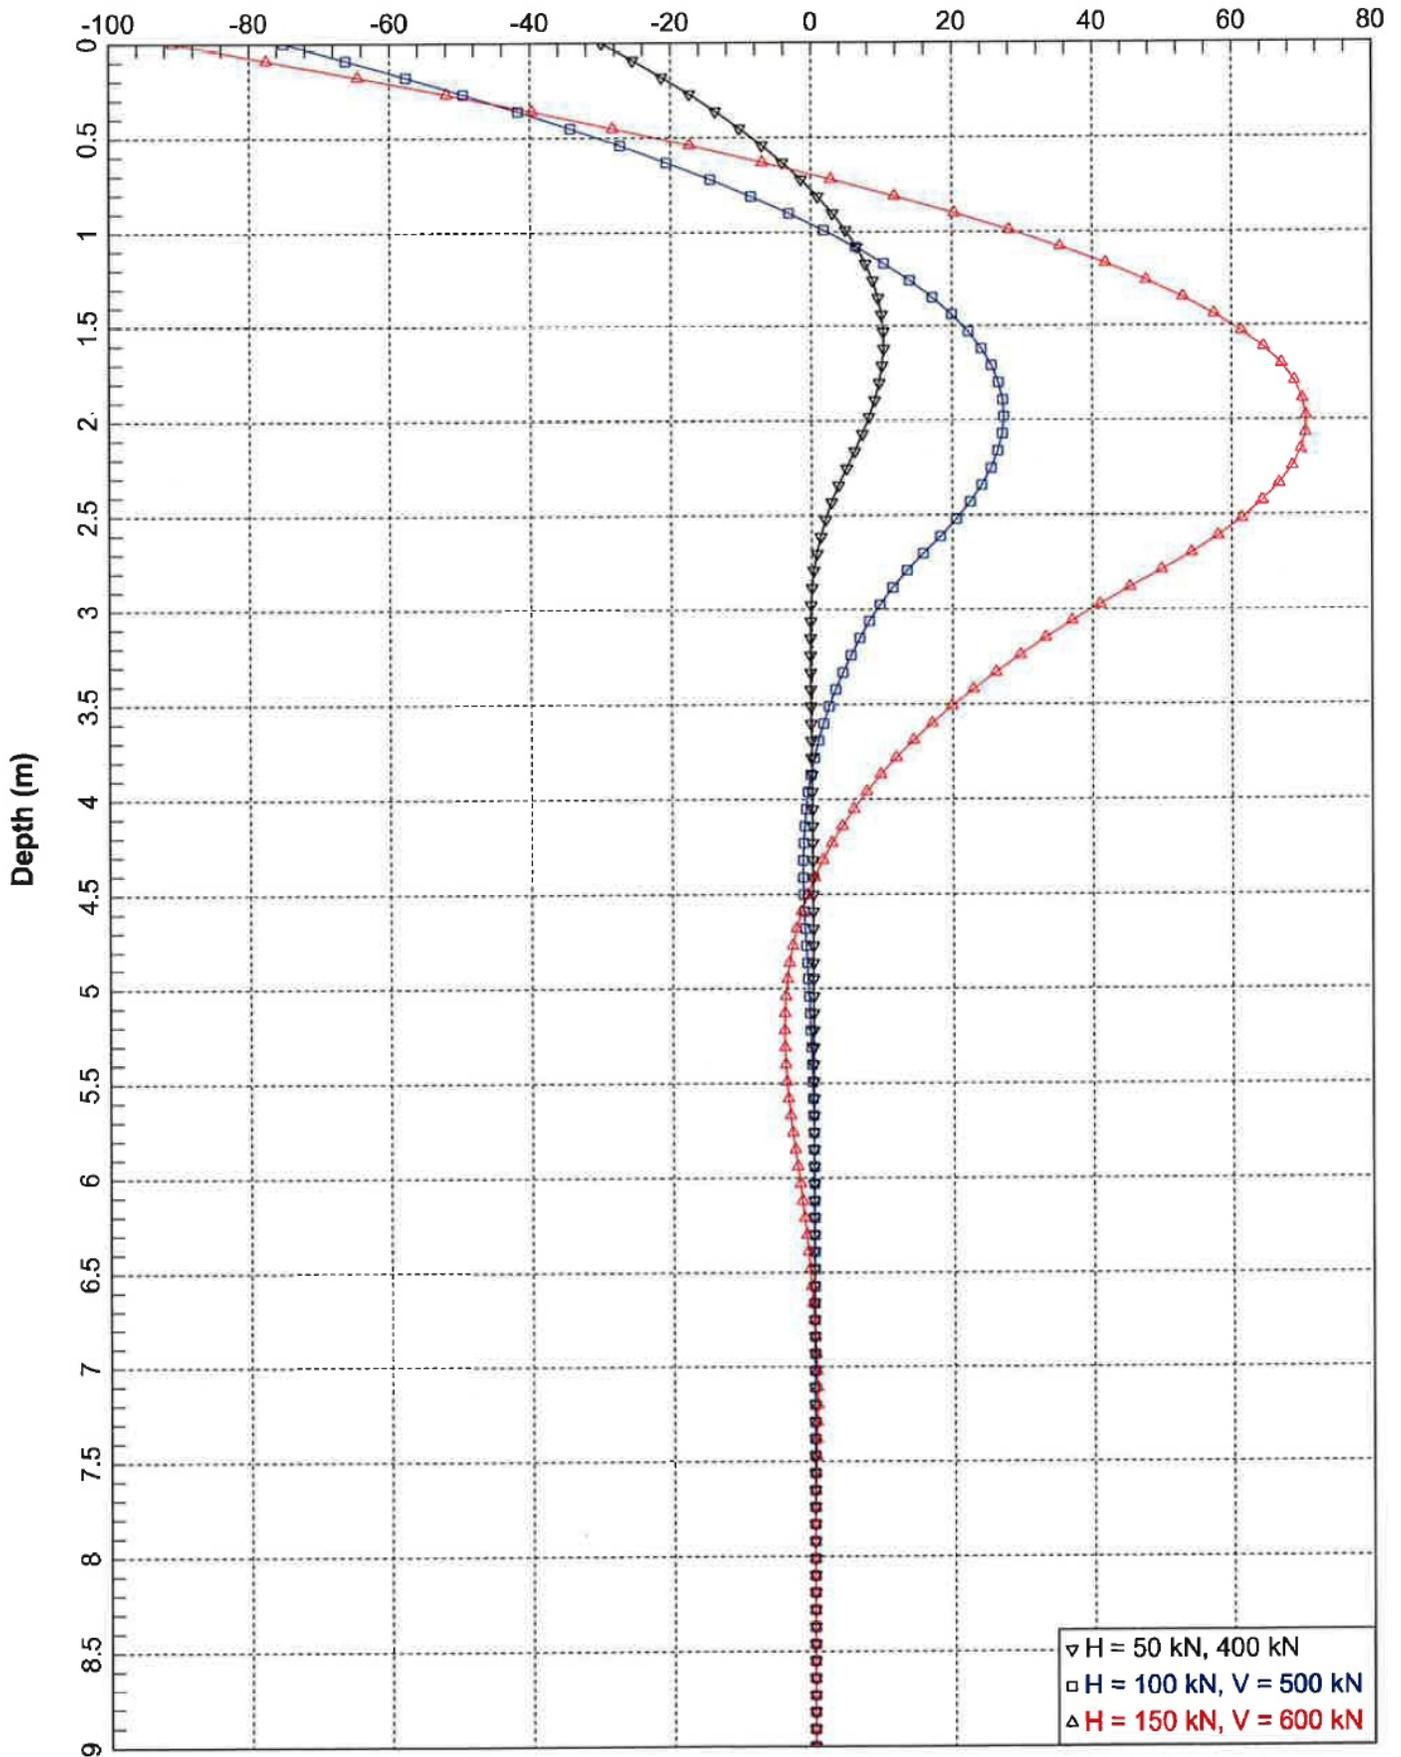
FIGURE 10

16 inch precast - fixed
Bending Moment (kN-m)
