**FINAL REPORT
GEOTECHNICAL INVESTIGATION AND
FOUNDATION ENGINEERING FOR
STURGEON CREEK BRIDGE REPLACEMENT**

Prepared for
STANTEC
905 WAVERLEY STREET
WINNIPEG, MANITOBA
R3T 5P4

Prepared by
THE NATIONAL TESTING LABORATORIES LIMITED
199 HENLOW BAY
WINNIPEG, MANITOBA
R3Y 1G4

October 28, 2011

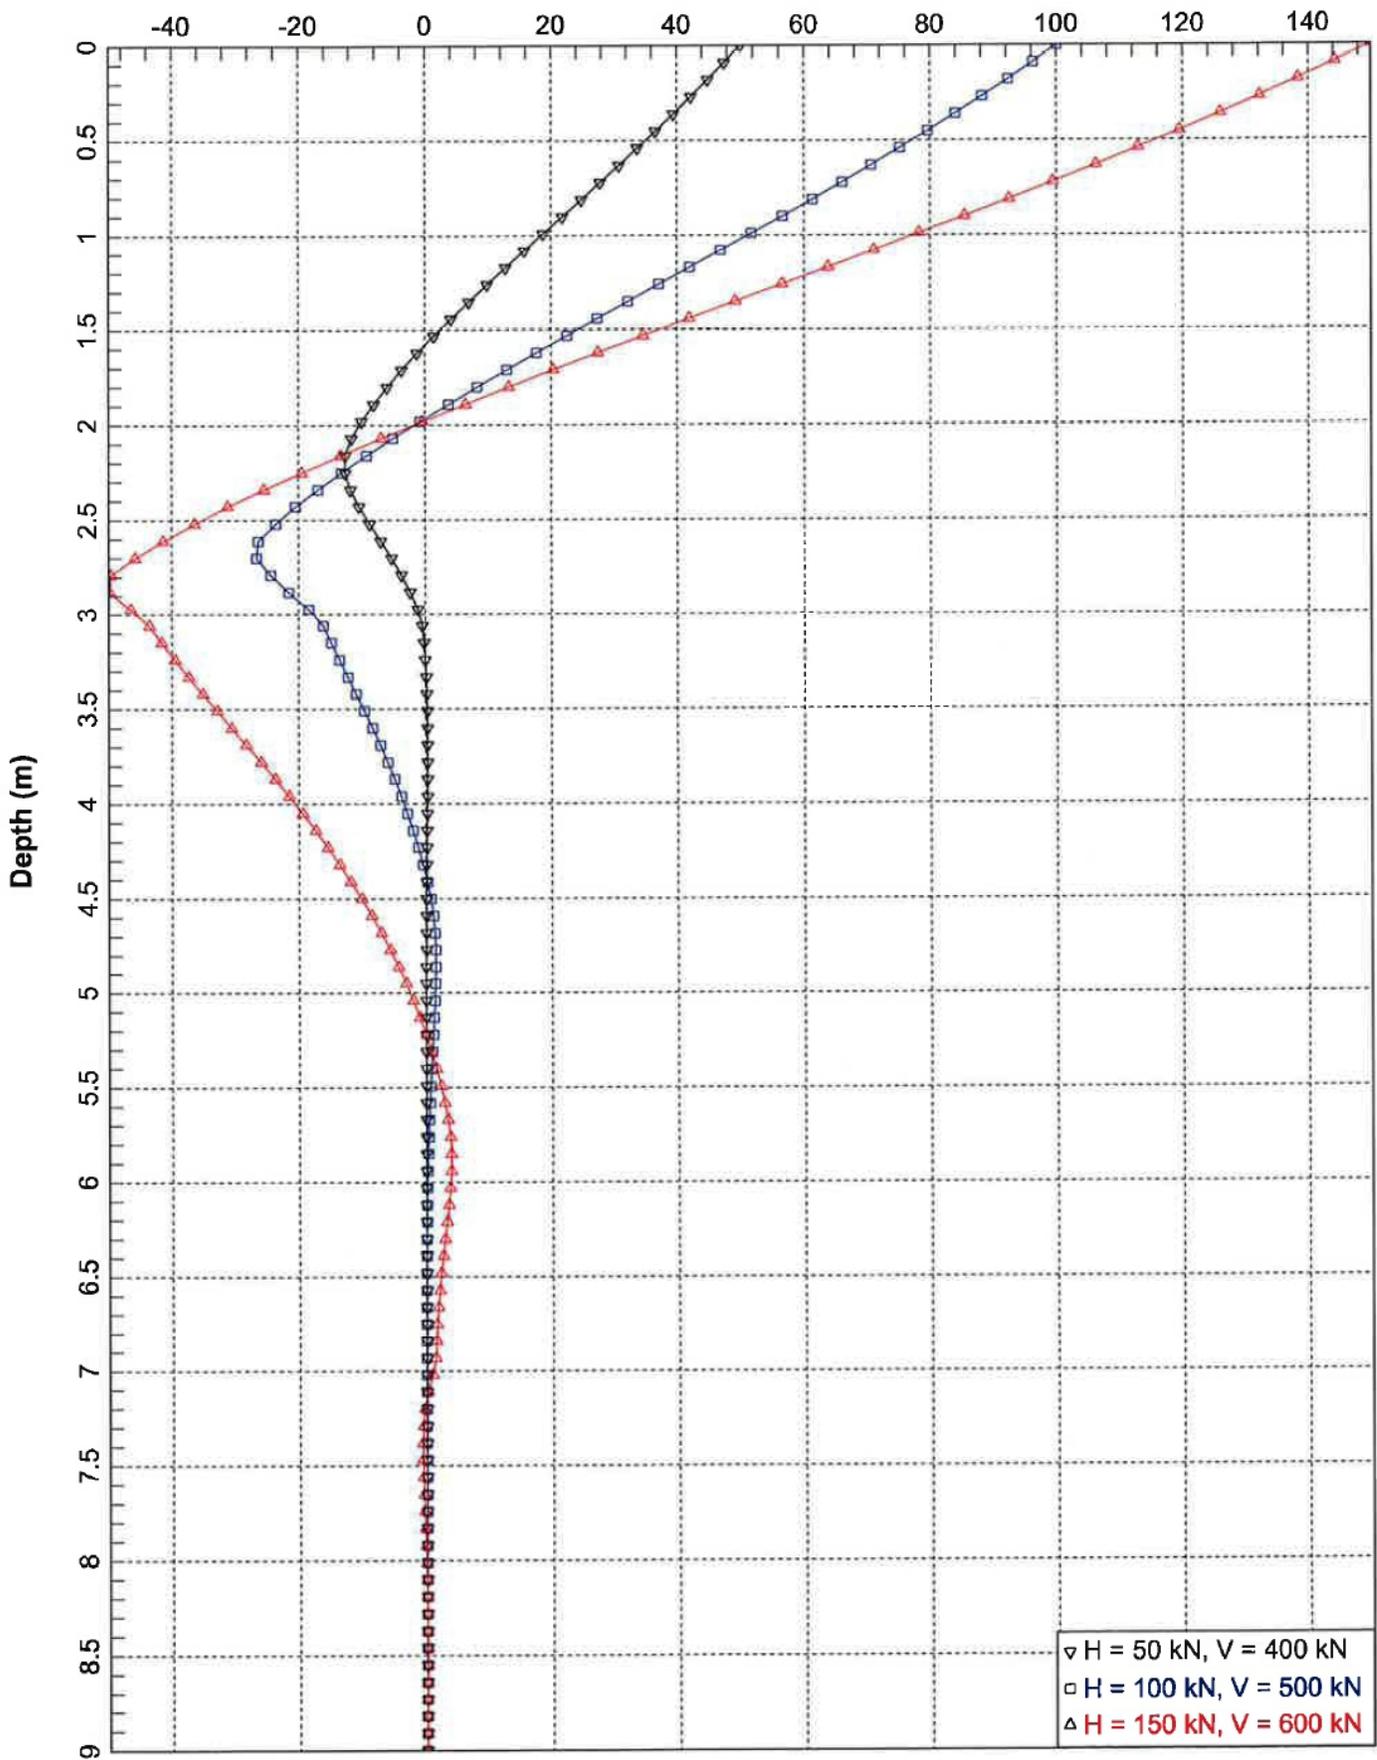
FIGURE 11

16 inch precast - fixed

Shear Force (kN)

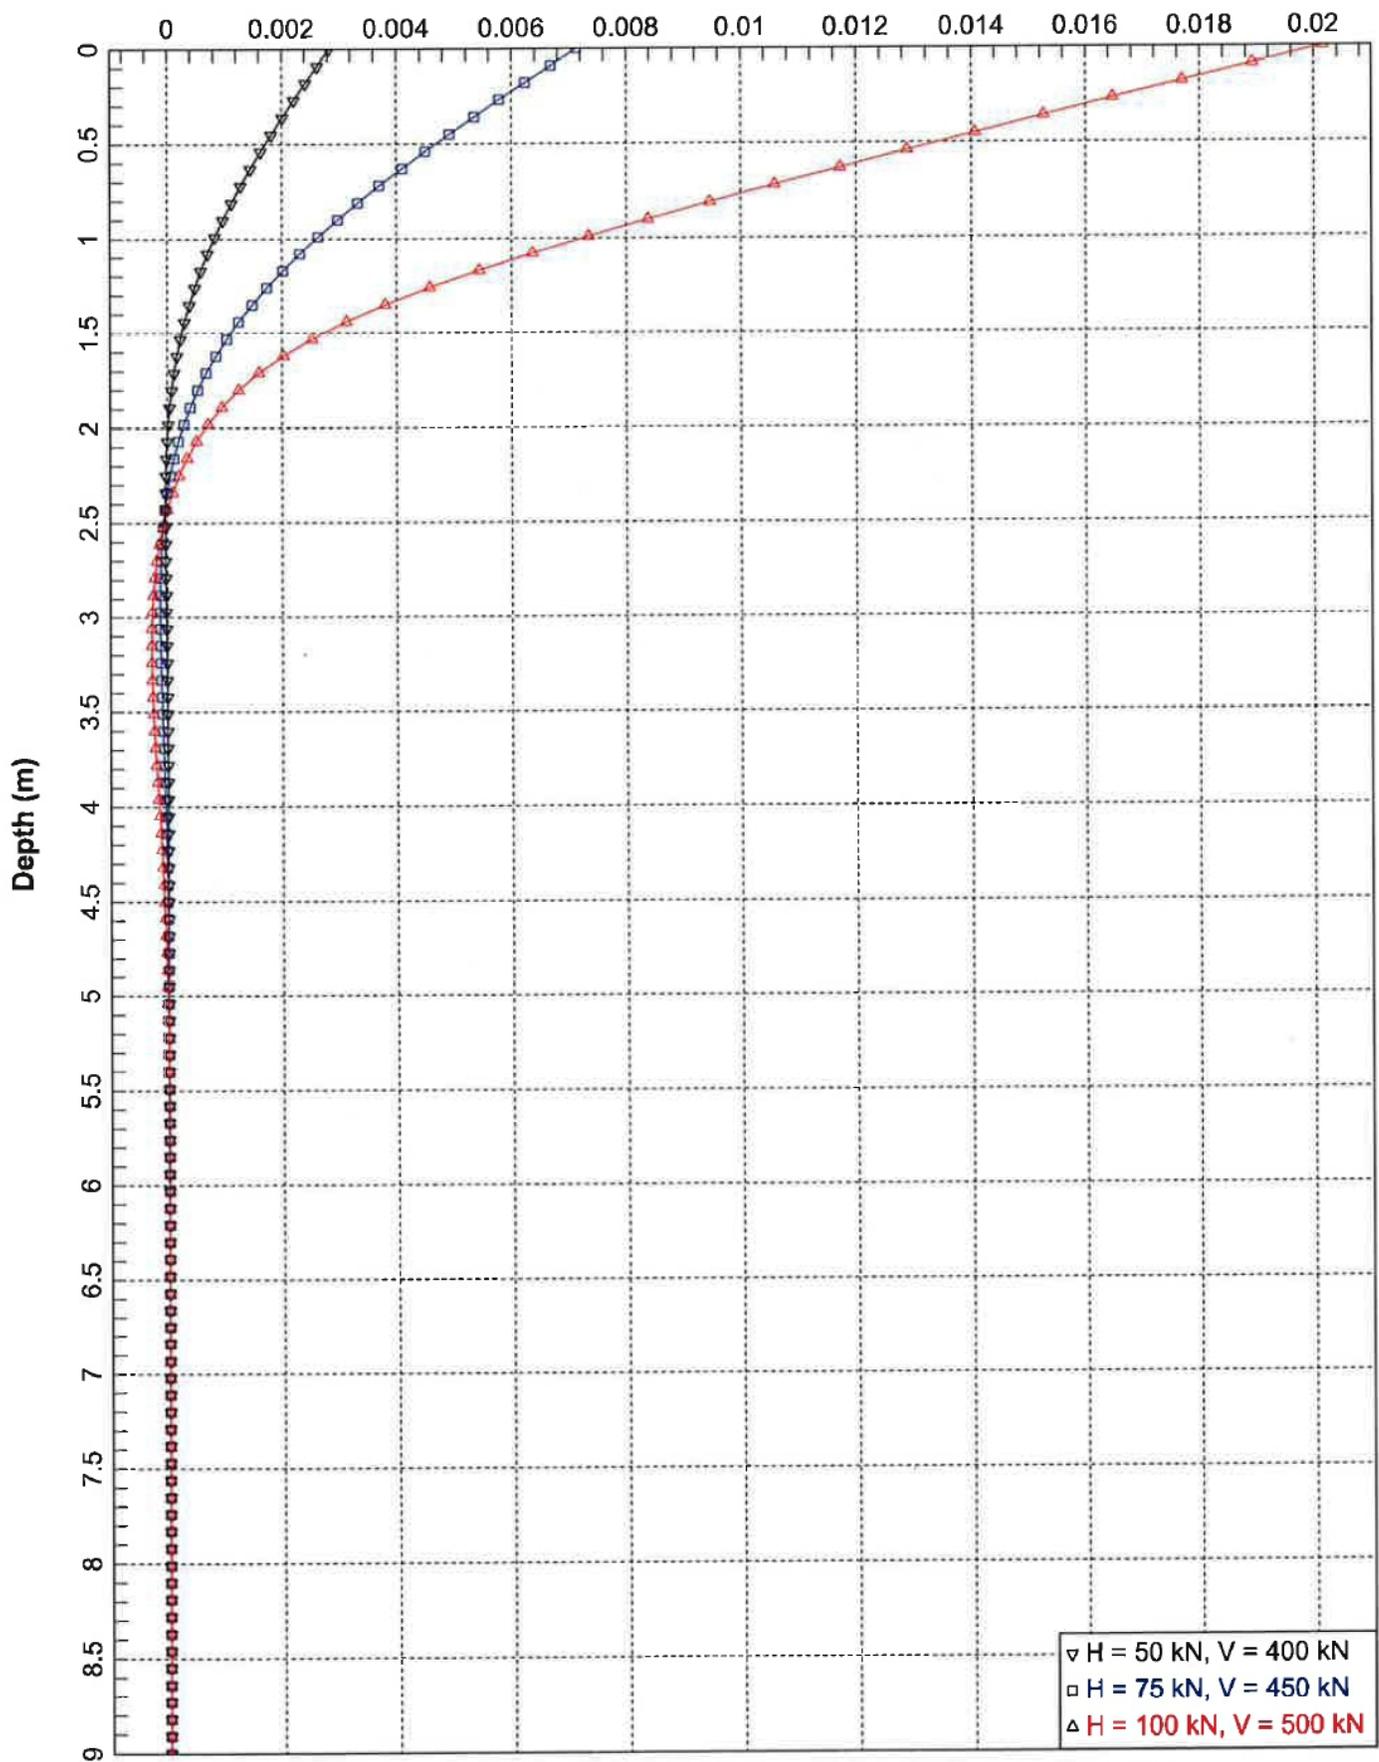
FIGURE 12

16 inch precast - pinned

Lateral Deflection (m)

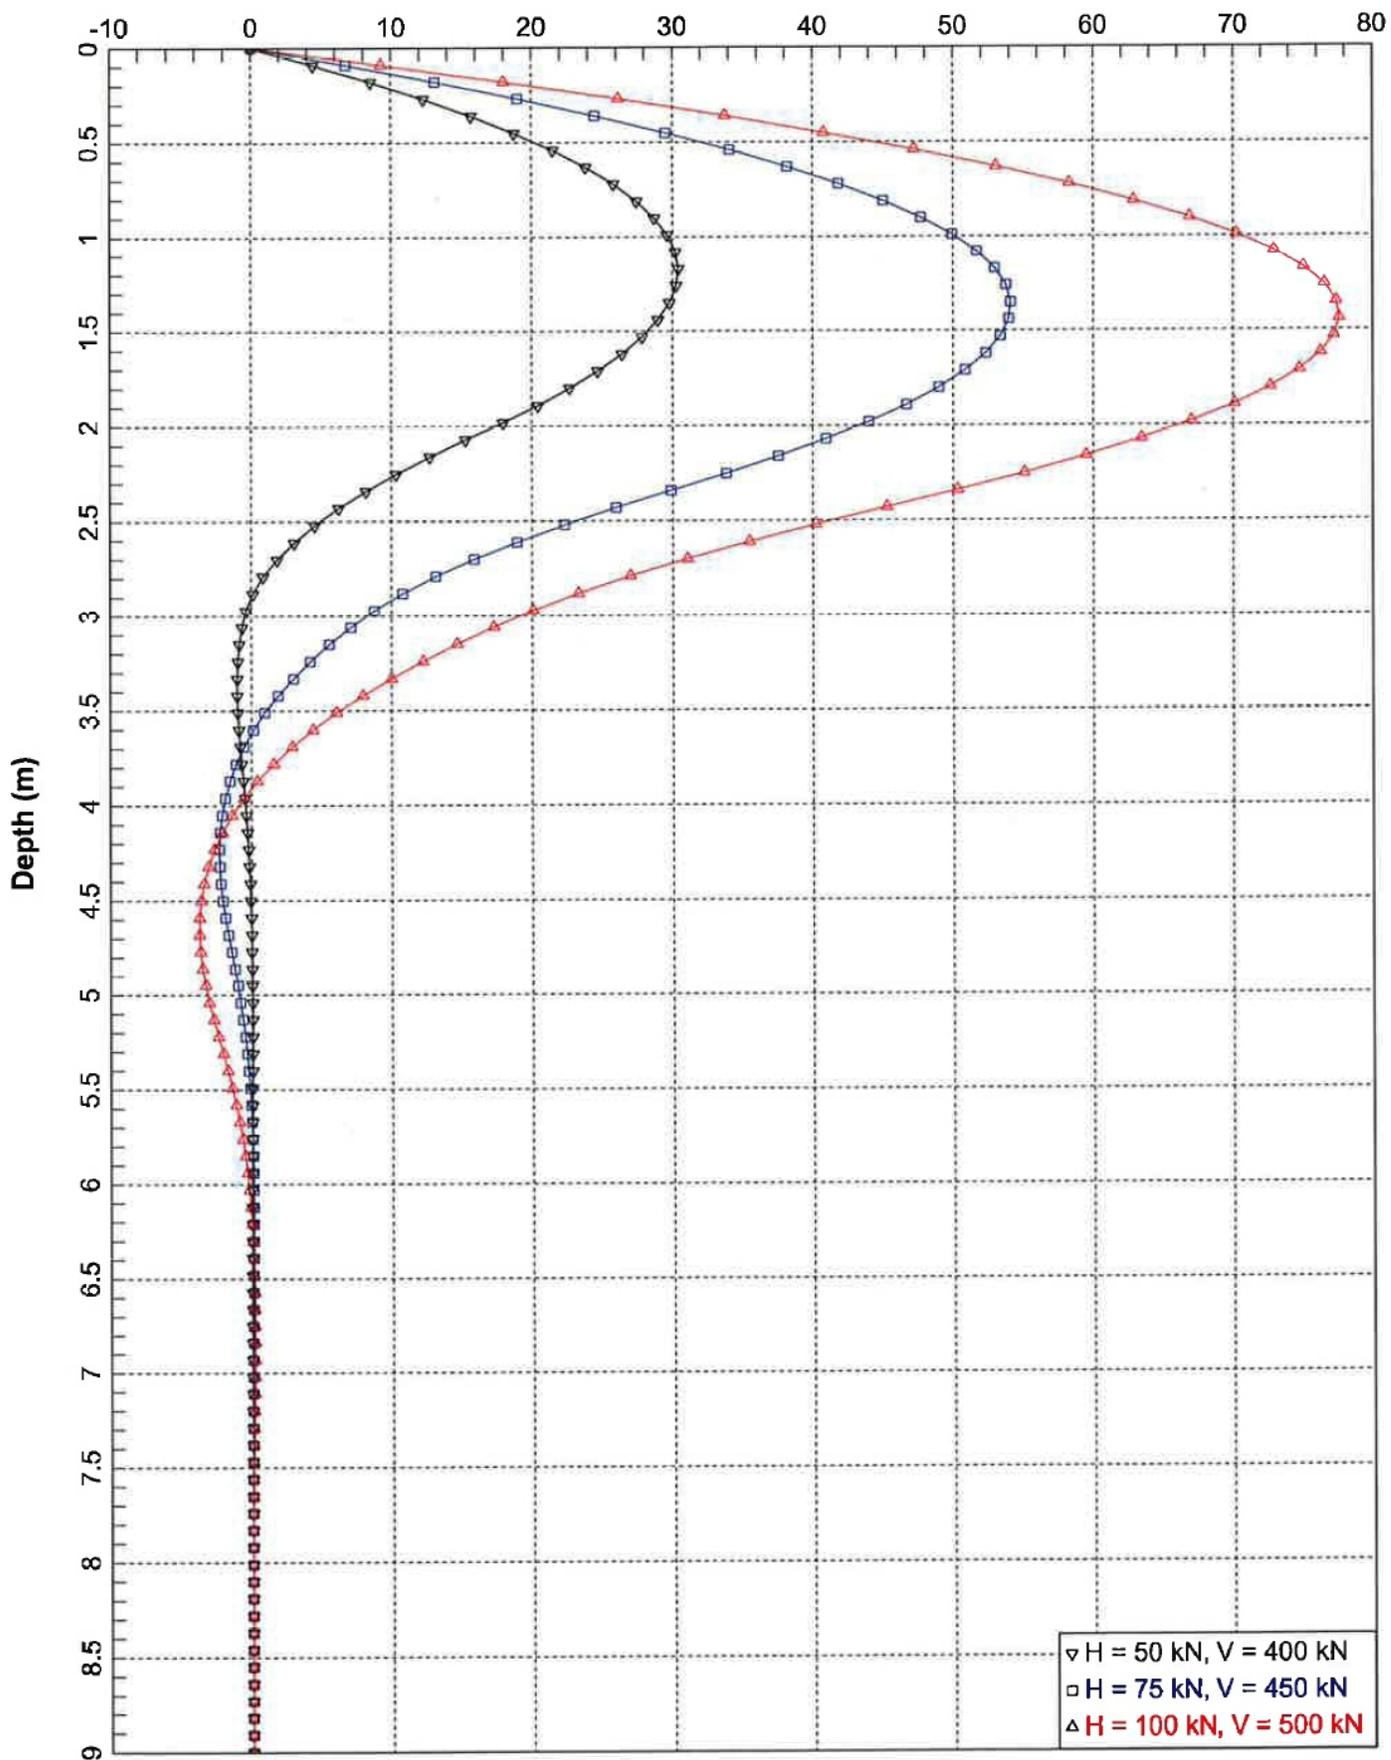
FIGURE 13

16 inch precast - pinned

Bending Moment (kN-m)

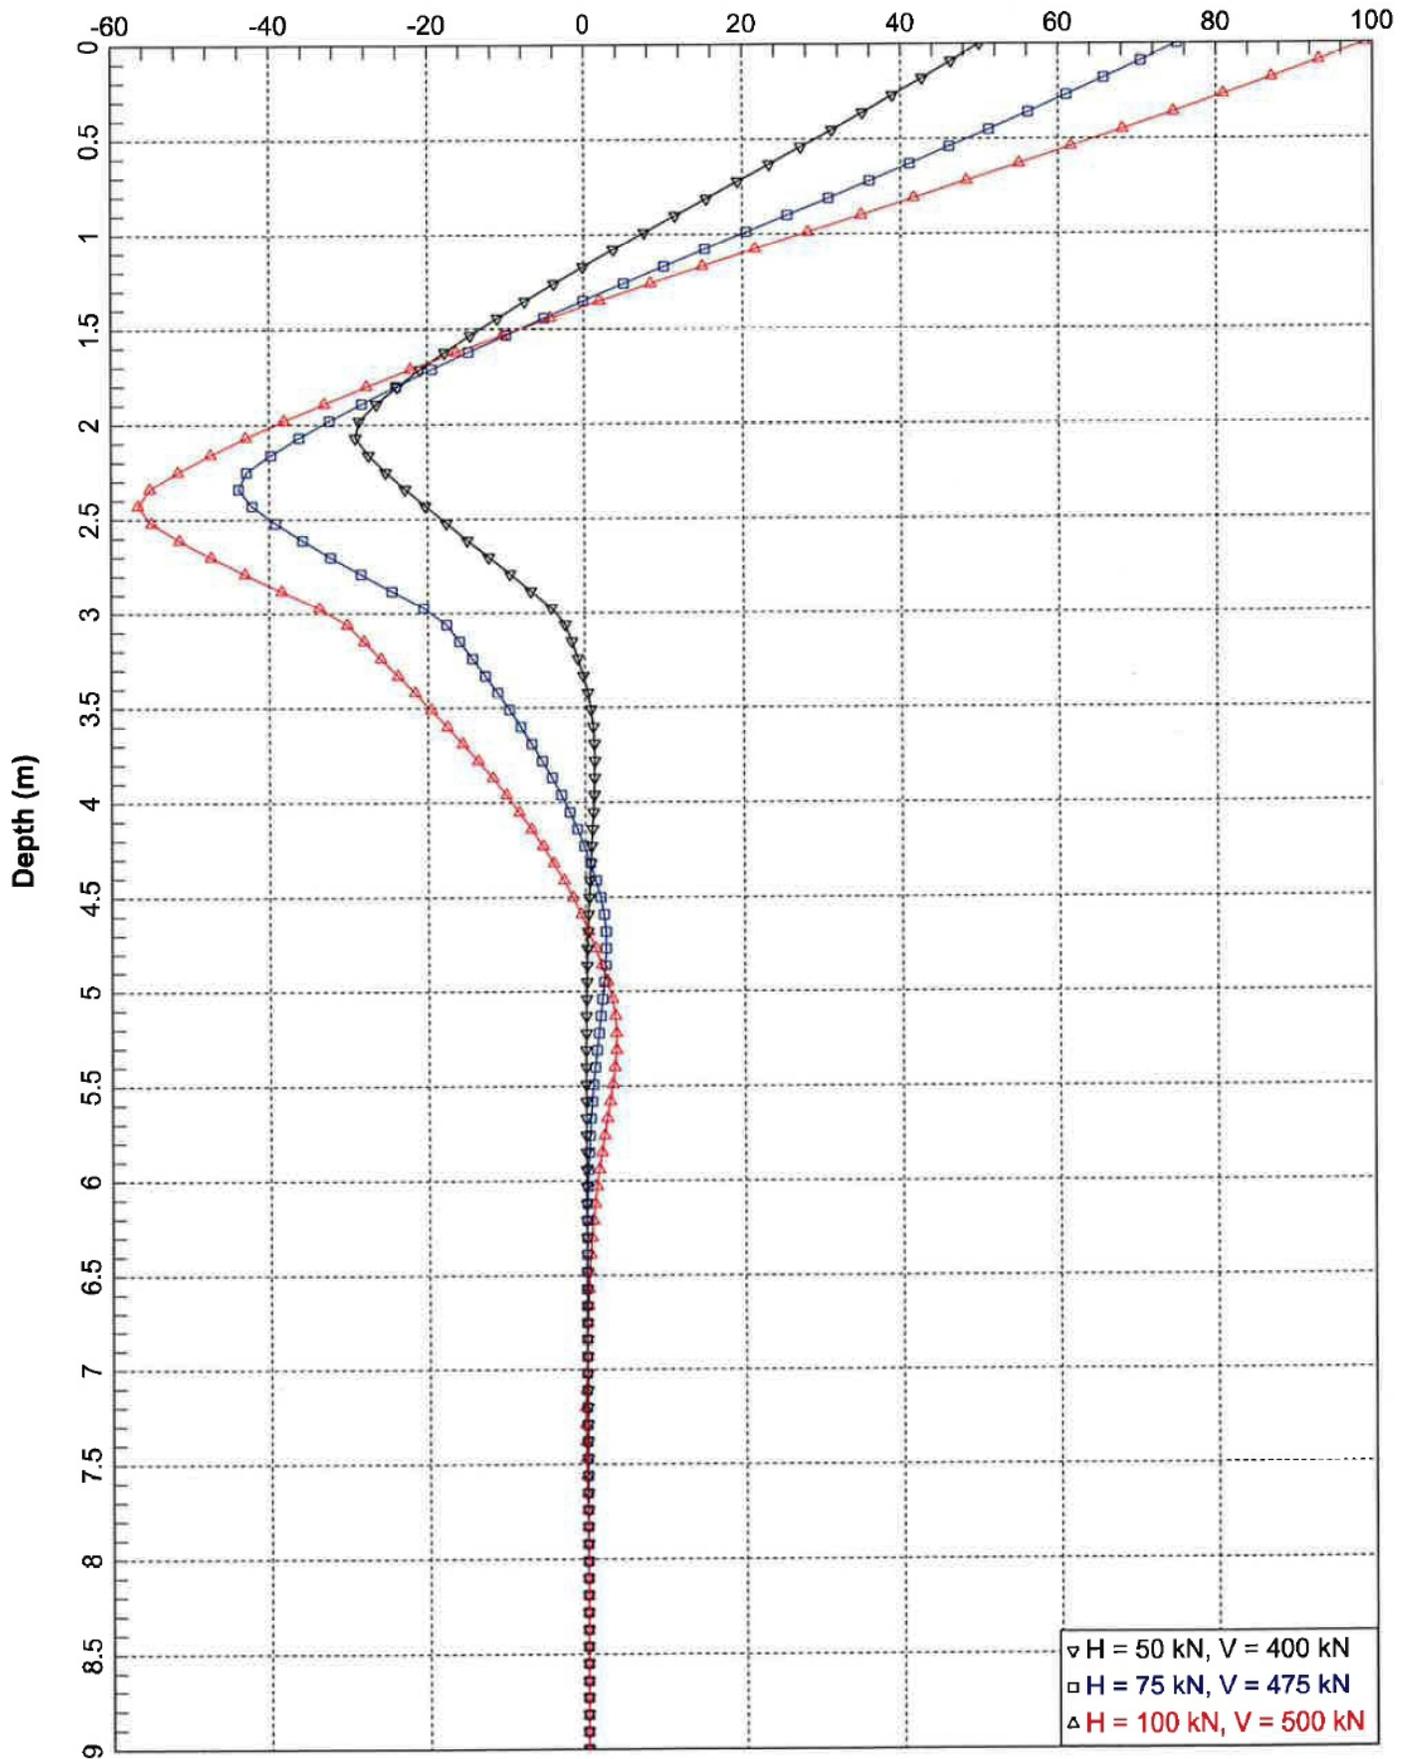
FIGURE 14

16 inch precast - pinned
Shear Force (kN)

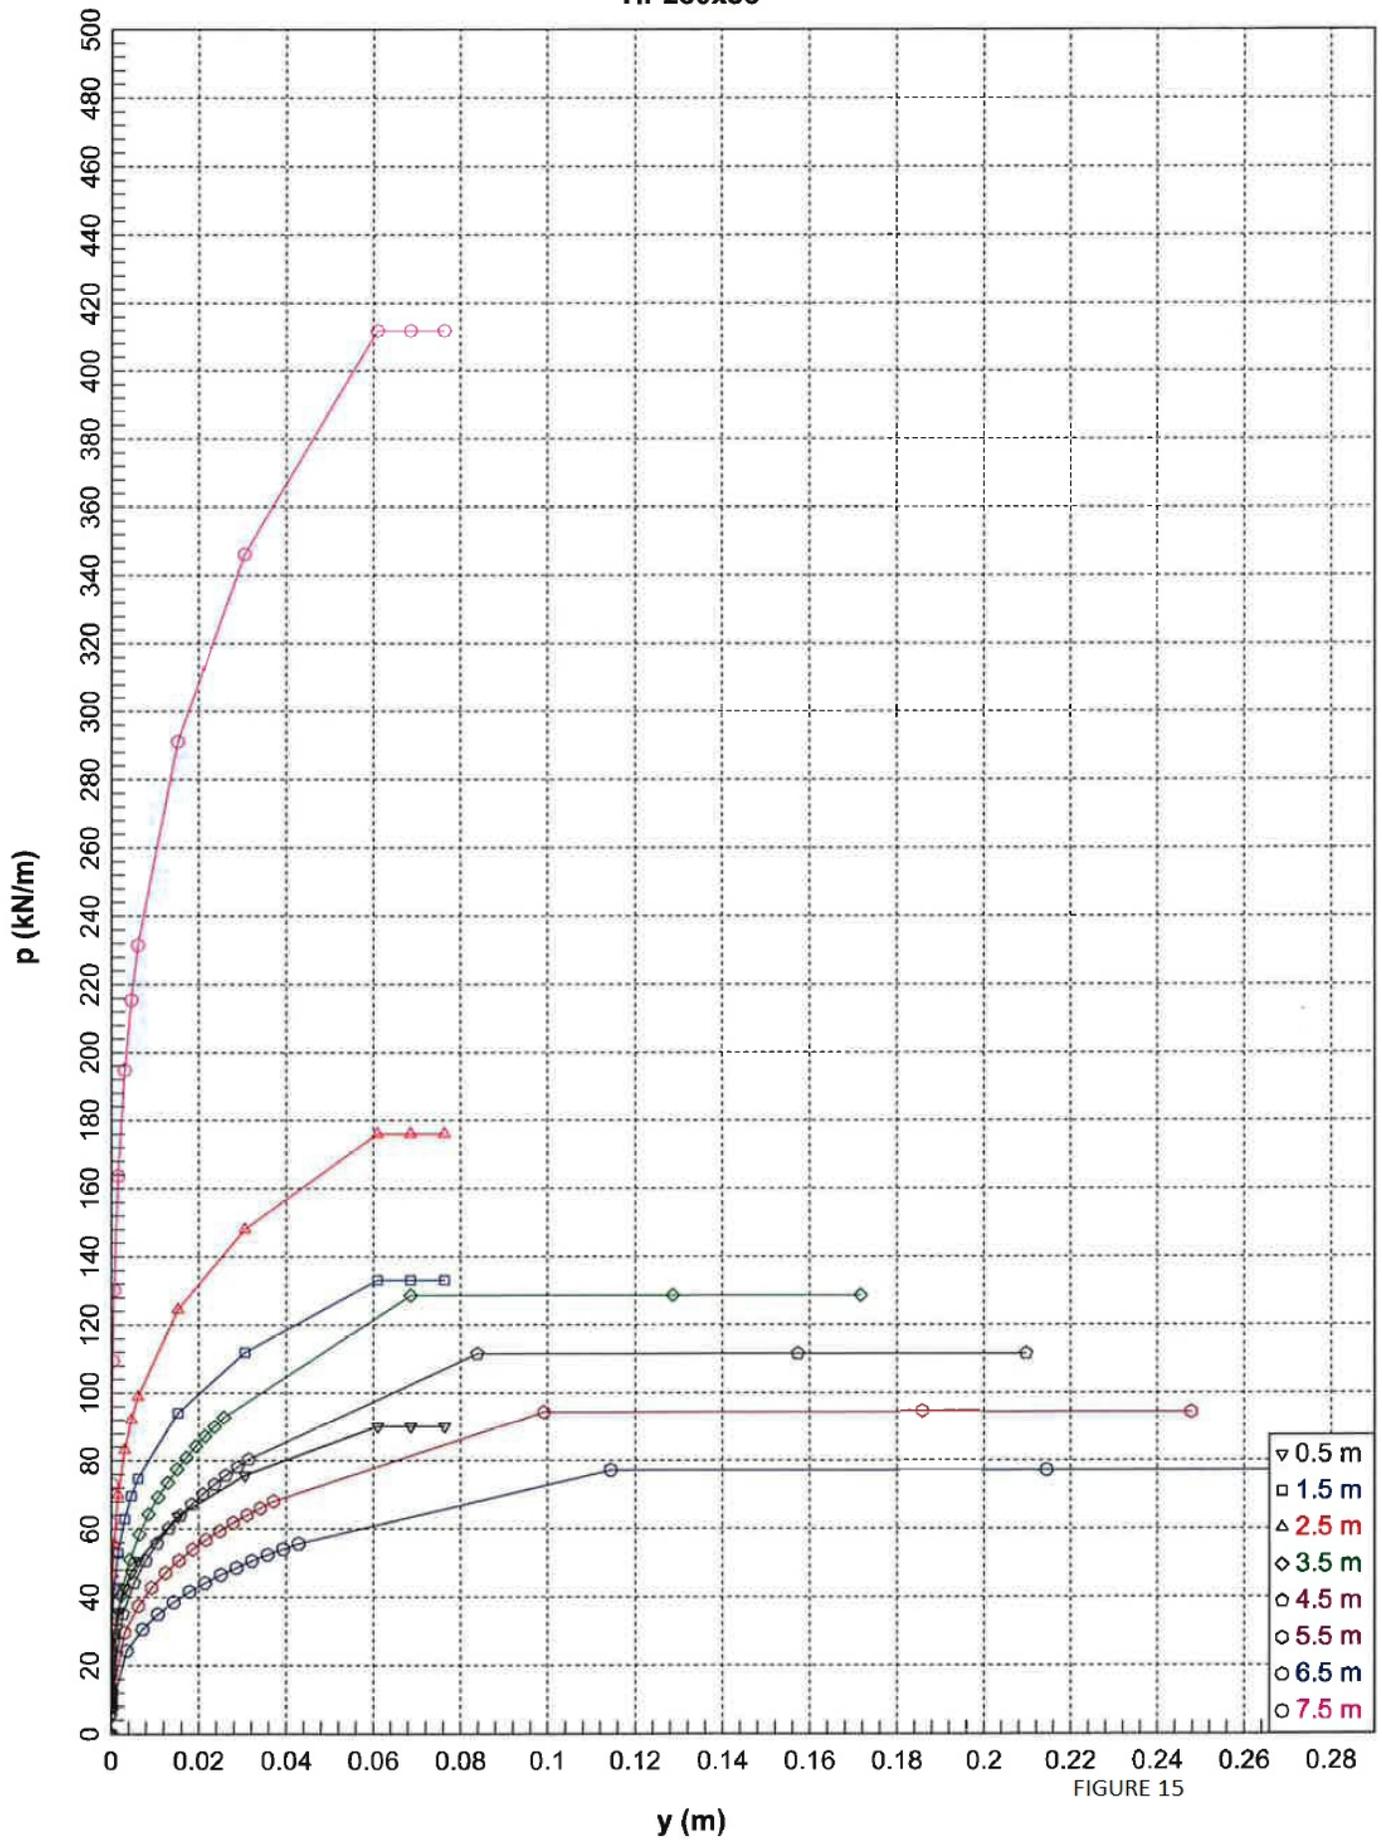
FIGURE 15

HP250x85

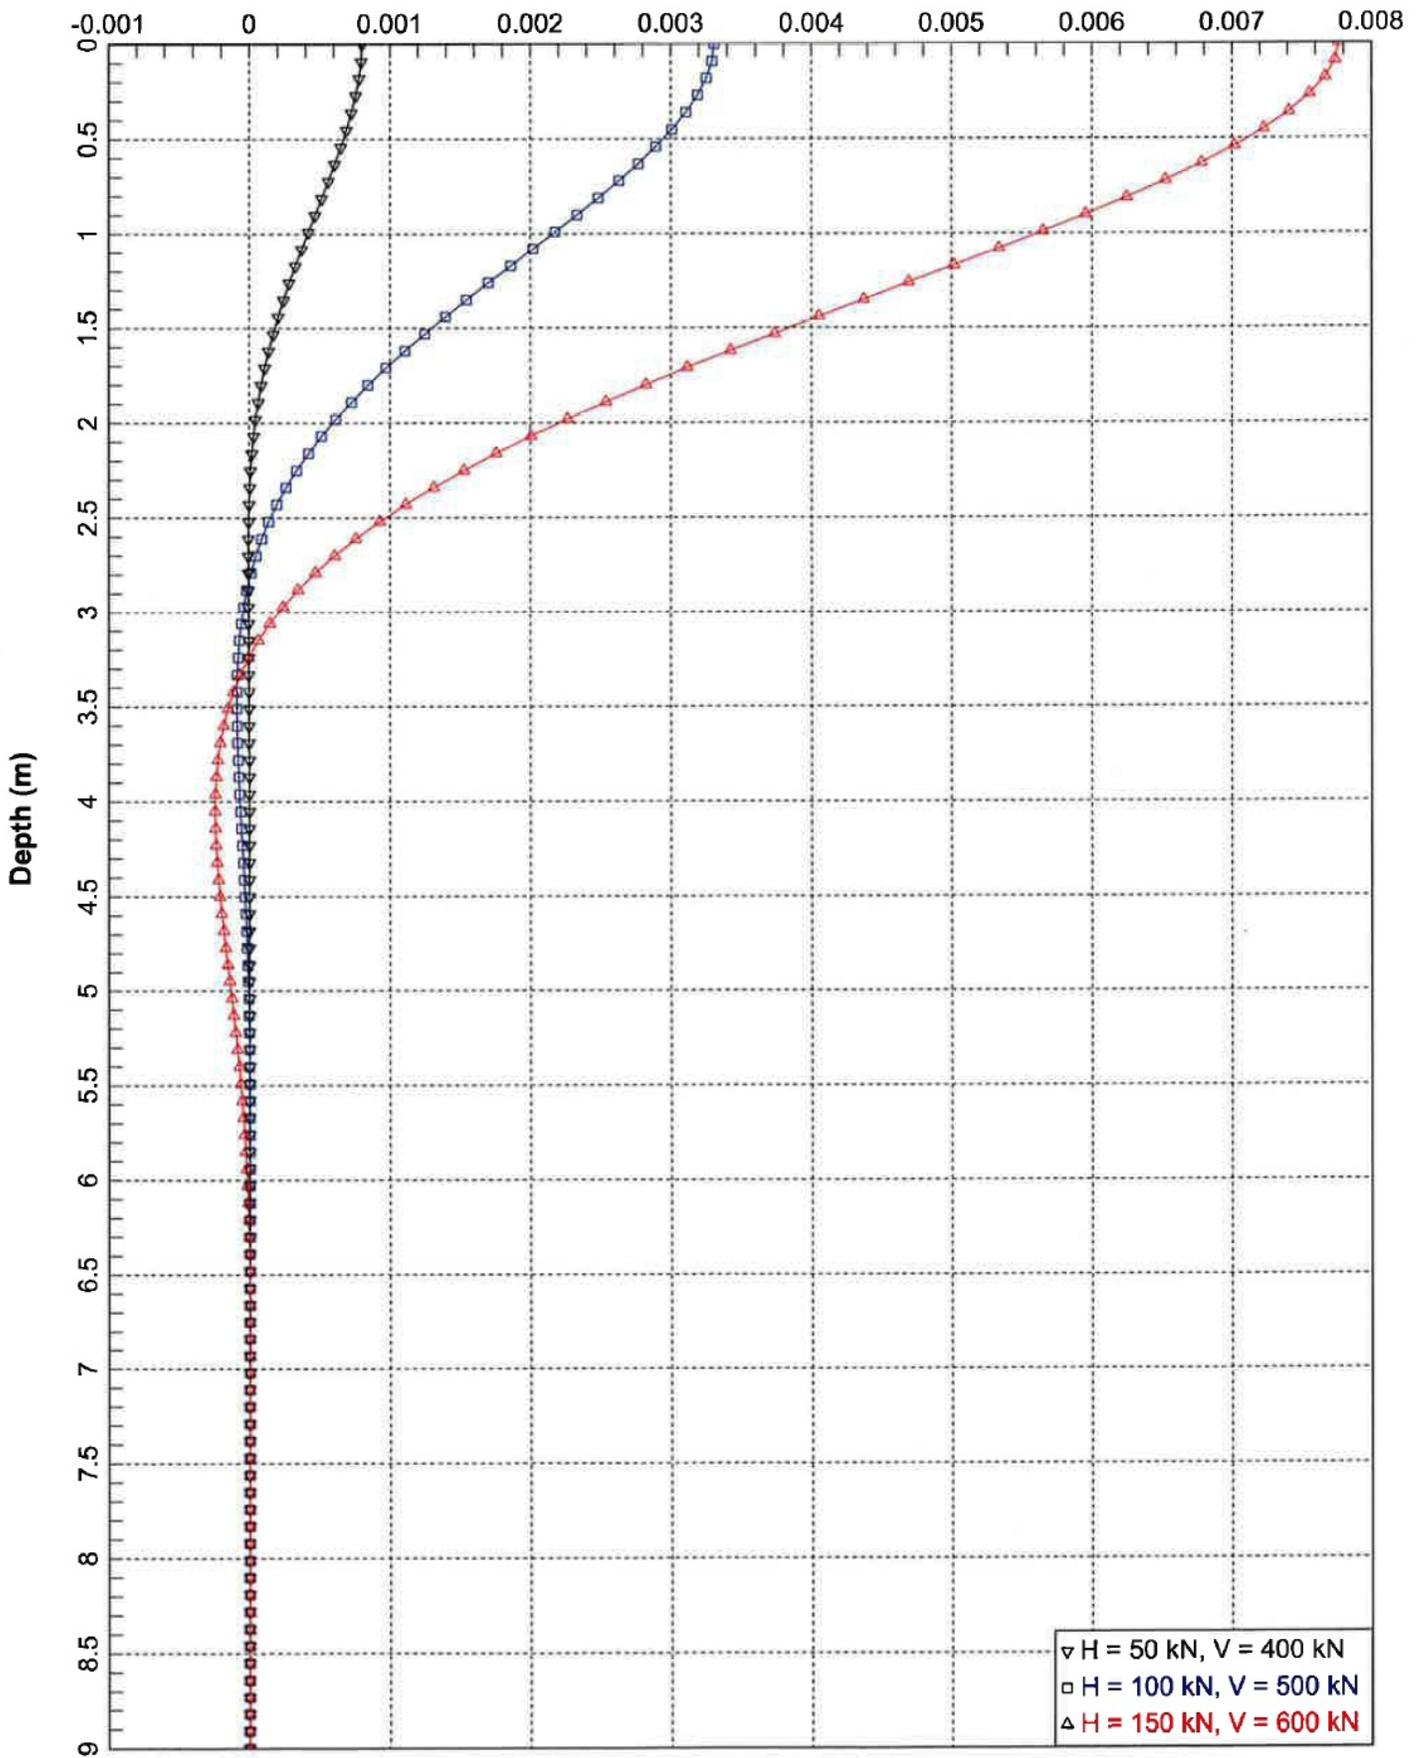
FIGURE 16

HP250x85 - fixed
Lateral Deflection (m)

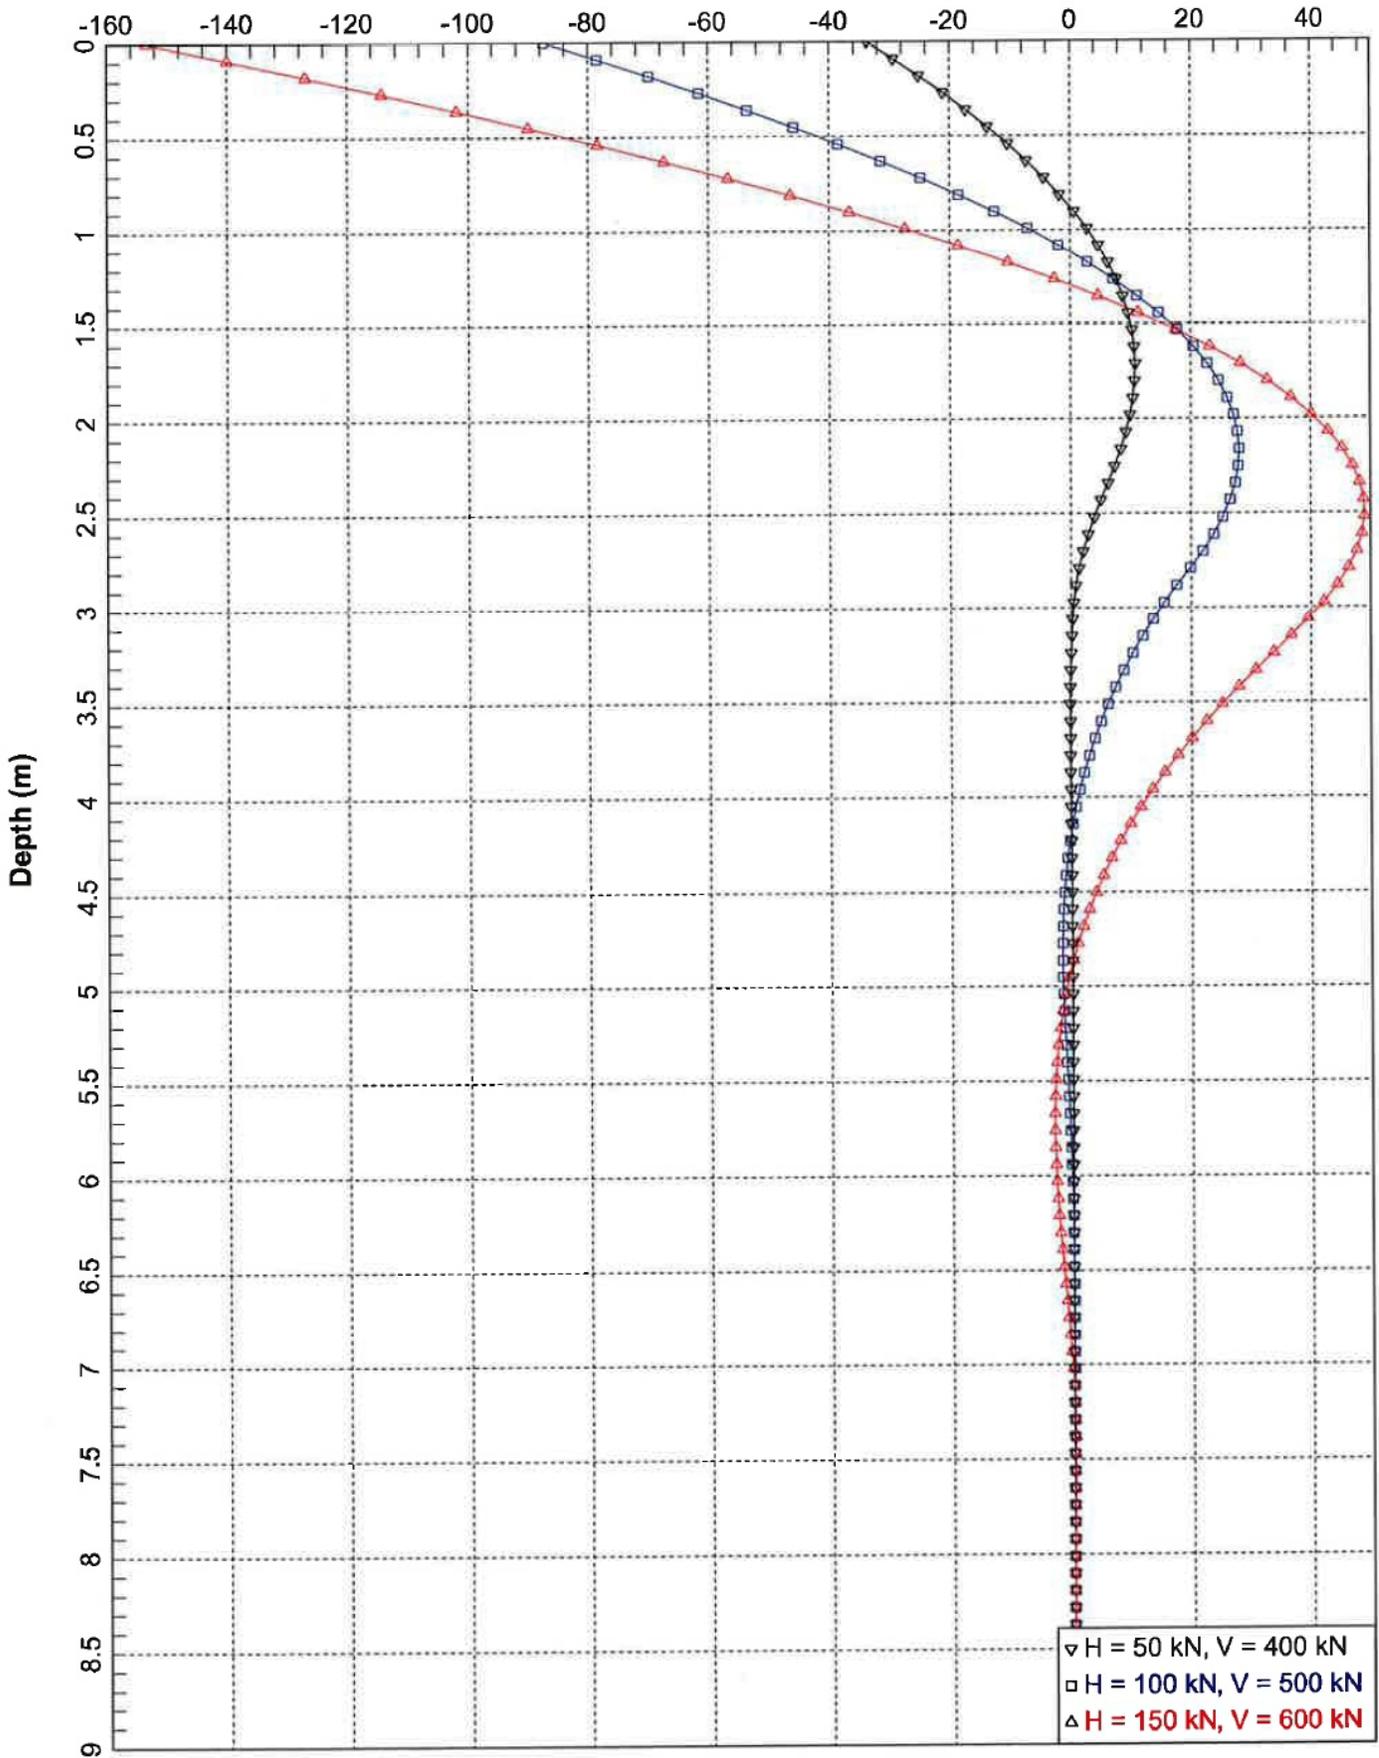
FIGURE 17

HP250x85 - fixed
Bending Moment (kN-m)

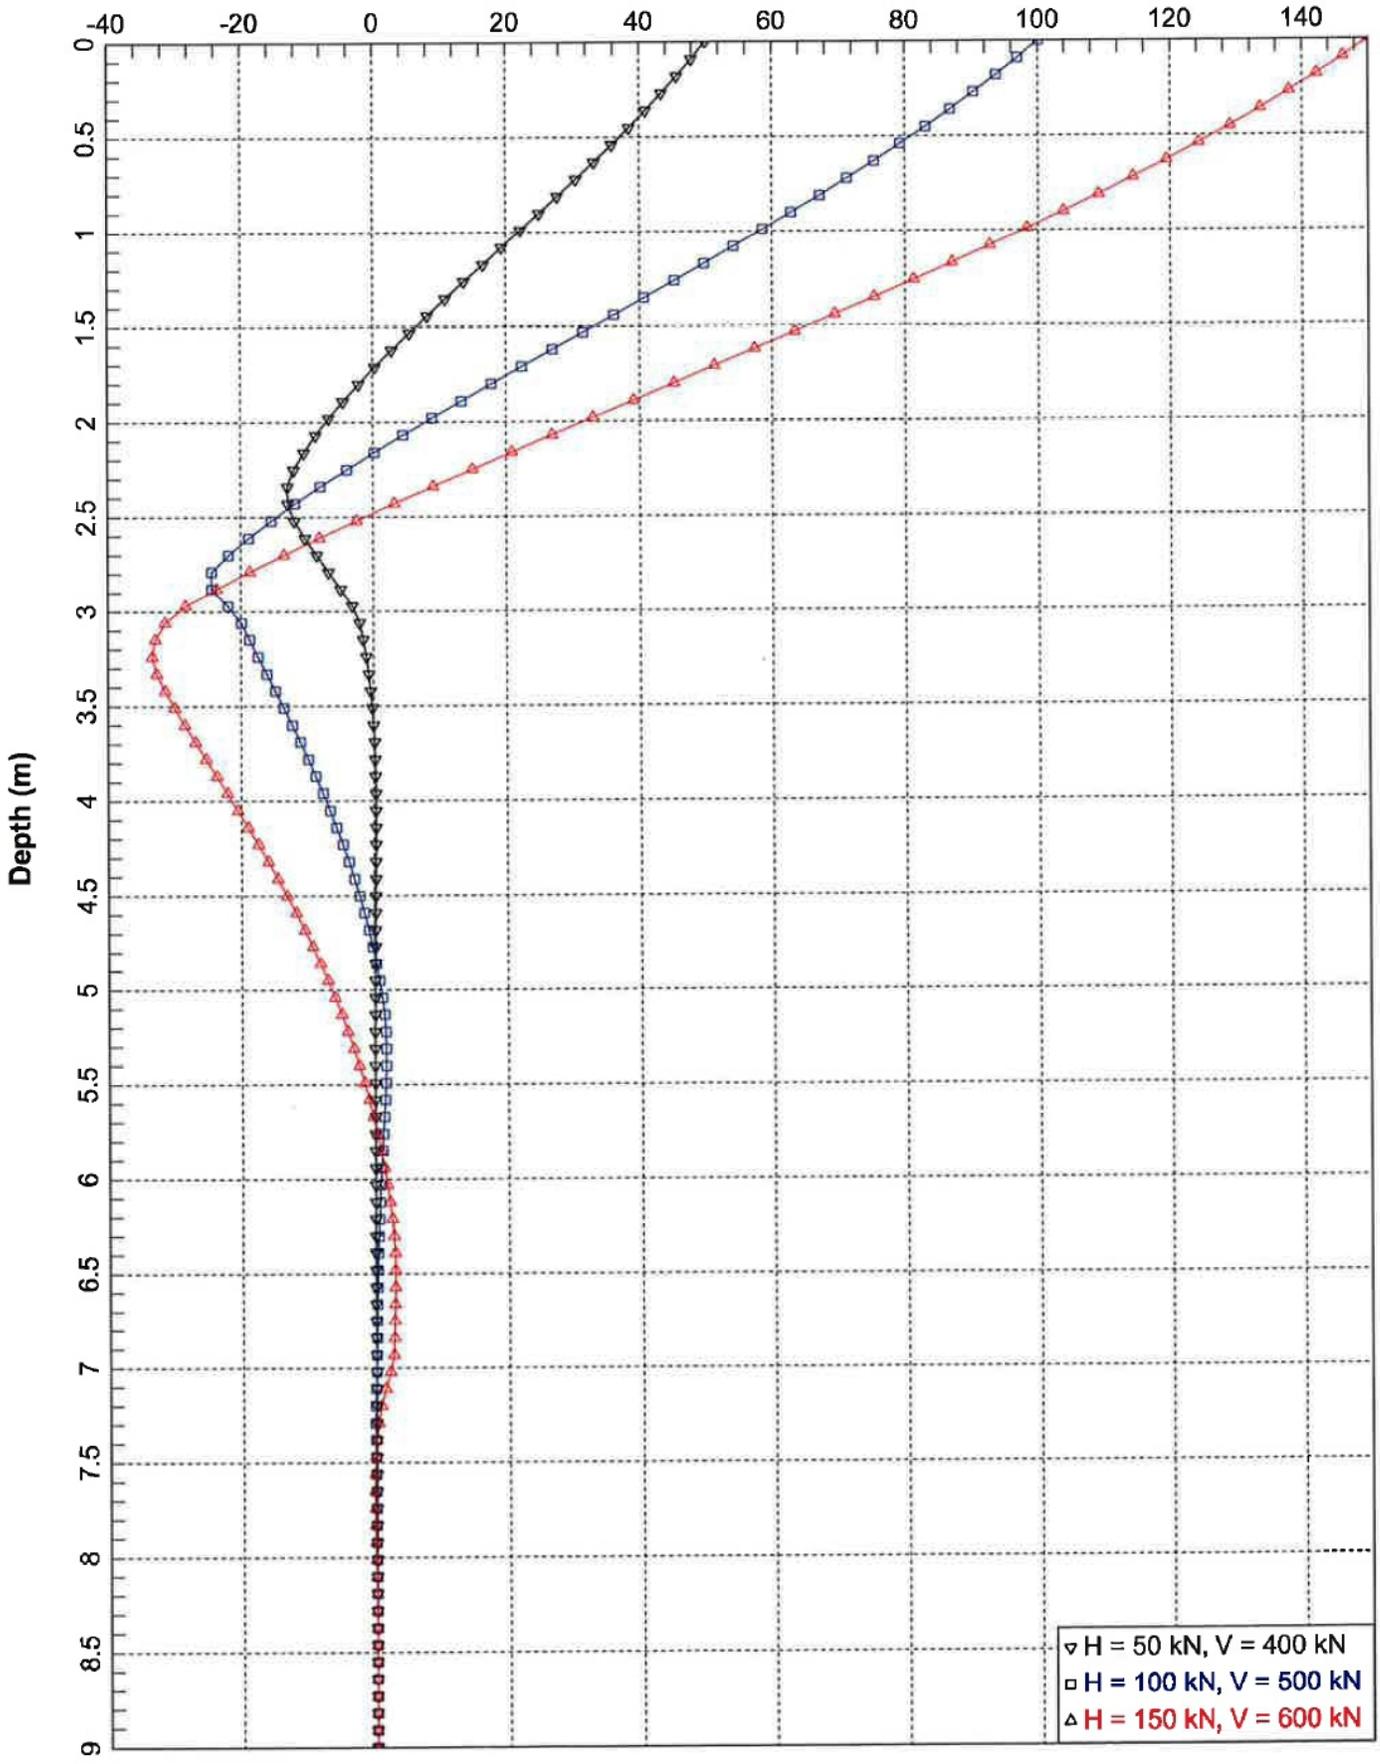
FIGURE 18

HP250x85 - fixed
Shear Force (kN)

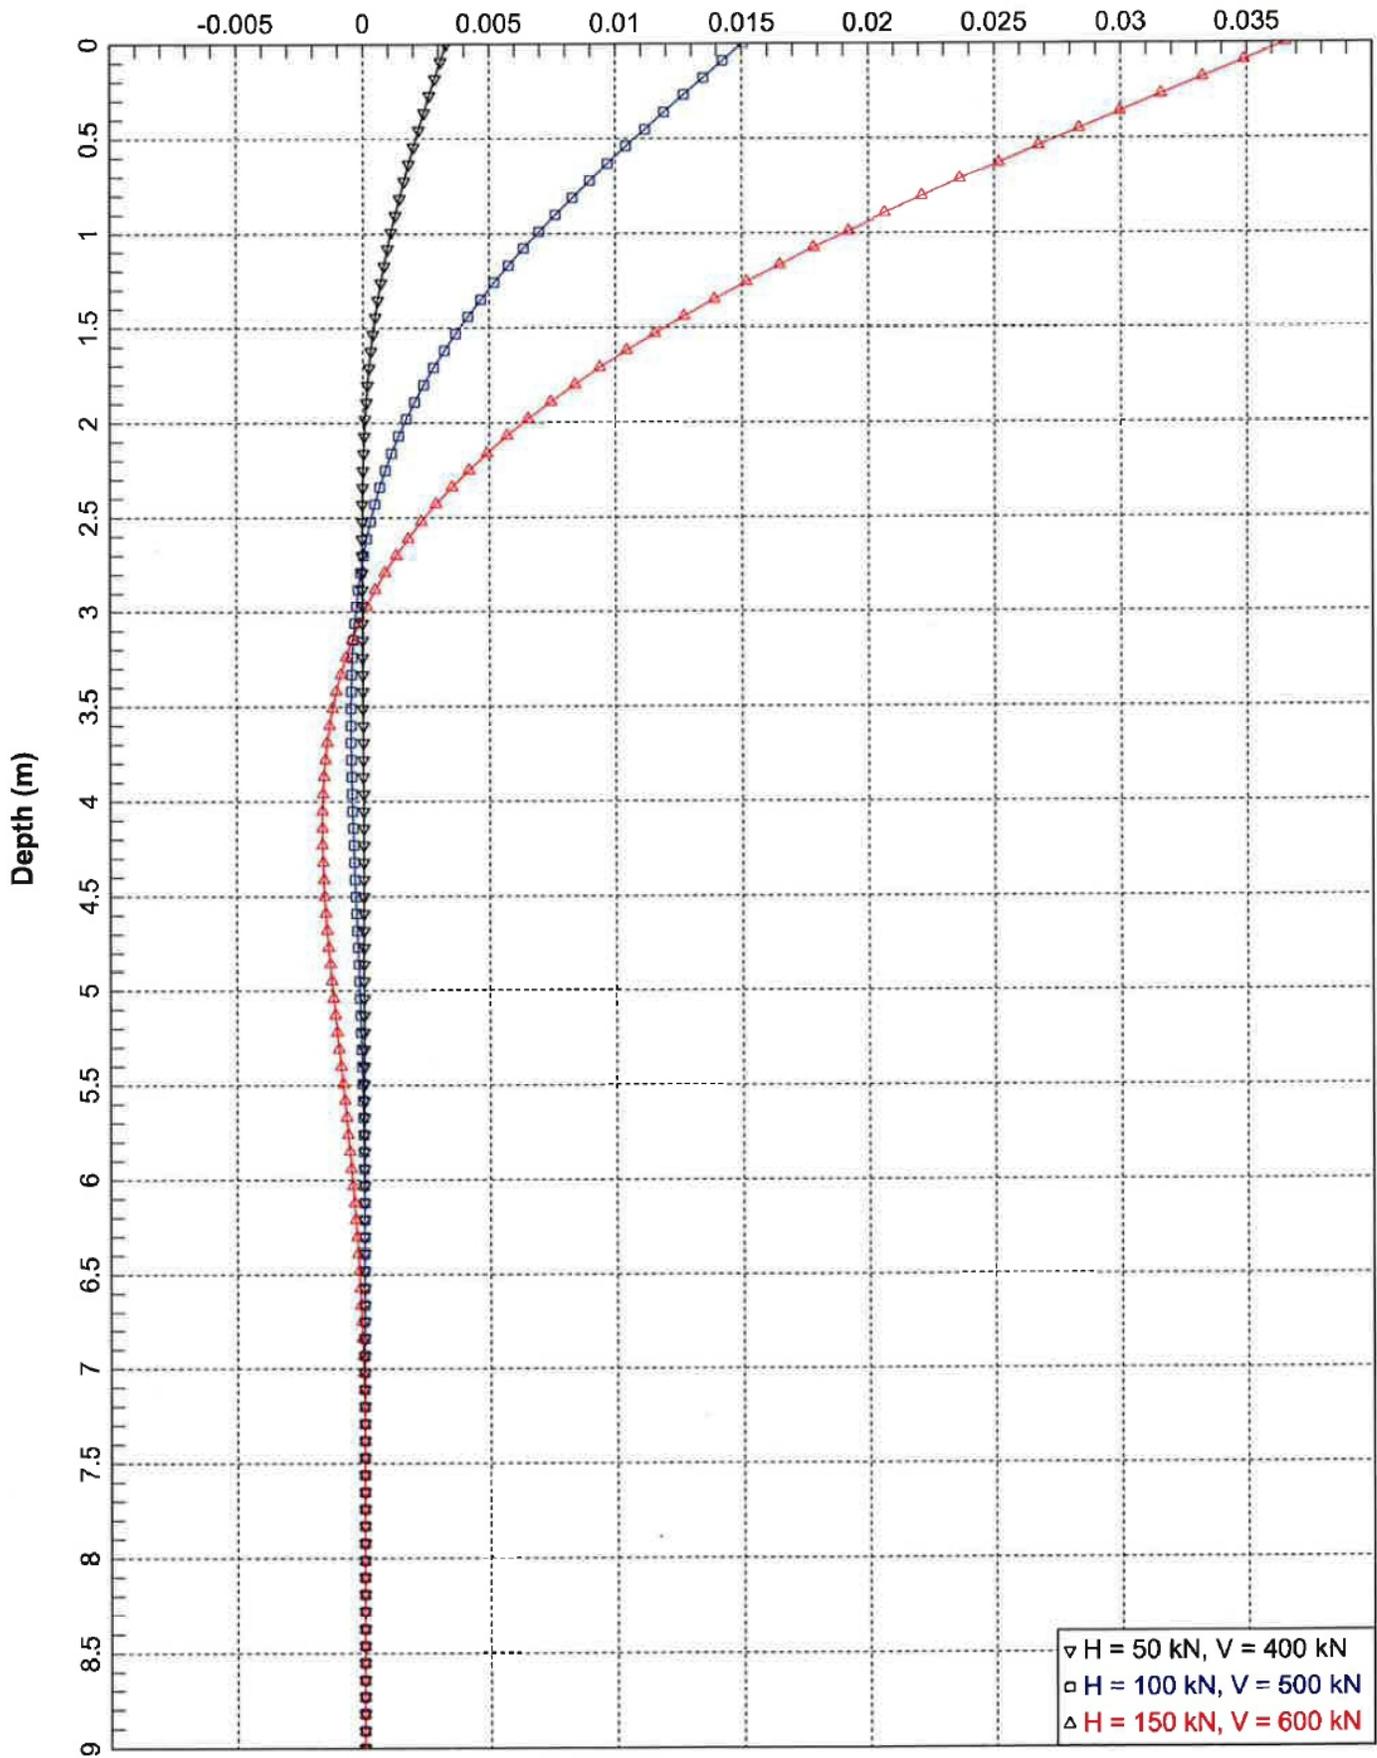
FIGURE 19

HP250x85 - pinned
Lateral Deflection (m)
