**FINAL REPORT
GEOTECHNICAL INVESTIGATION AND
FOUNDATION ENGINEERING FOR
STURGEON CREEK BRIDGE REPLACEMENT**

Prepared for
STANTEC
905 WAVERLEY STREET
WINNIPEG, MANITOBA
R3T 5P4

Prepared by
THE NATIONAL TESTING LABORATORIES LIMITED
199 HENLOW BAY
WINNIPEG, MANITOBA
R3Y 1G4

October 28, 2011

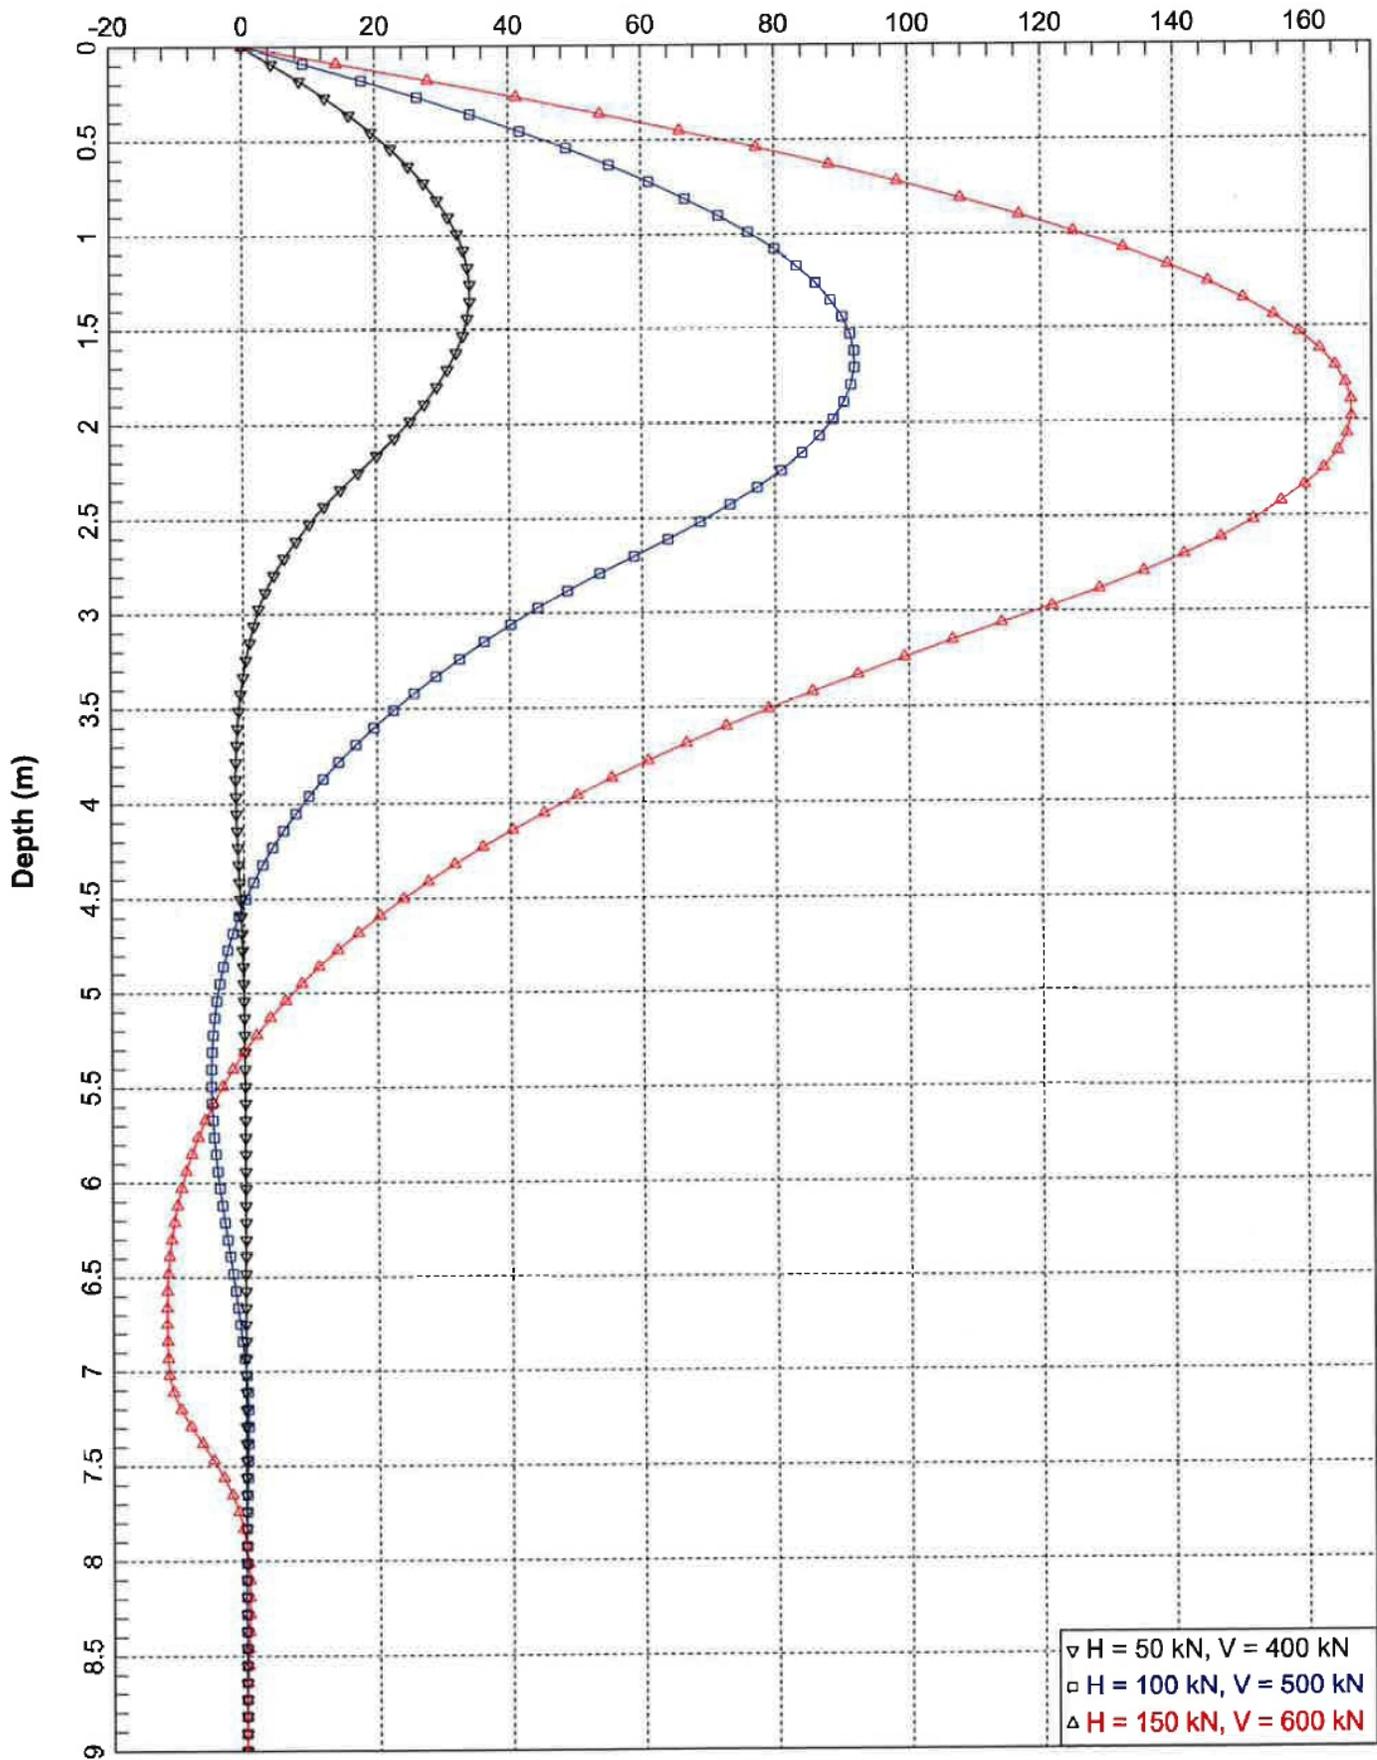
FIGURE 20

HP250x85 - pinned
Bending Moment (kN-m)

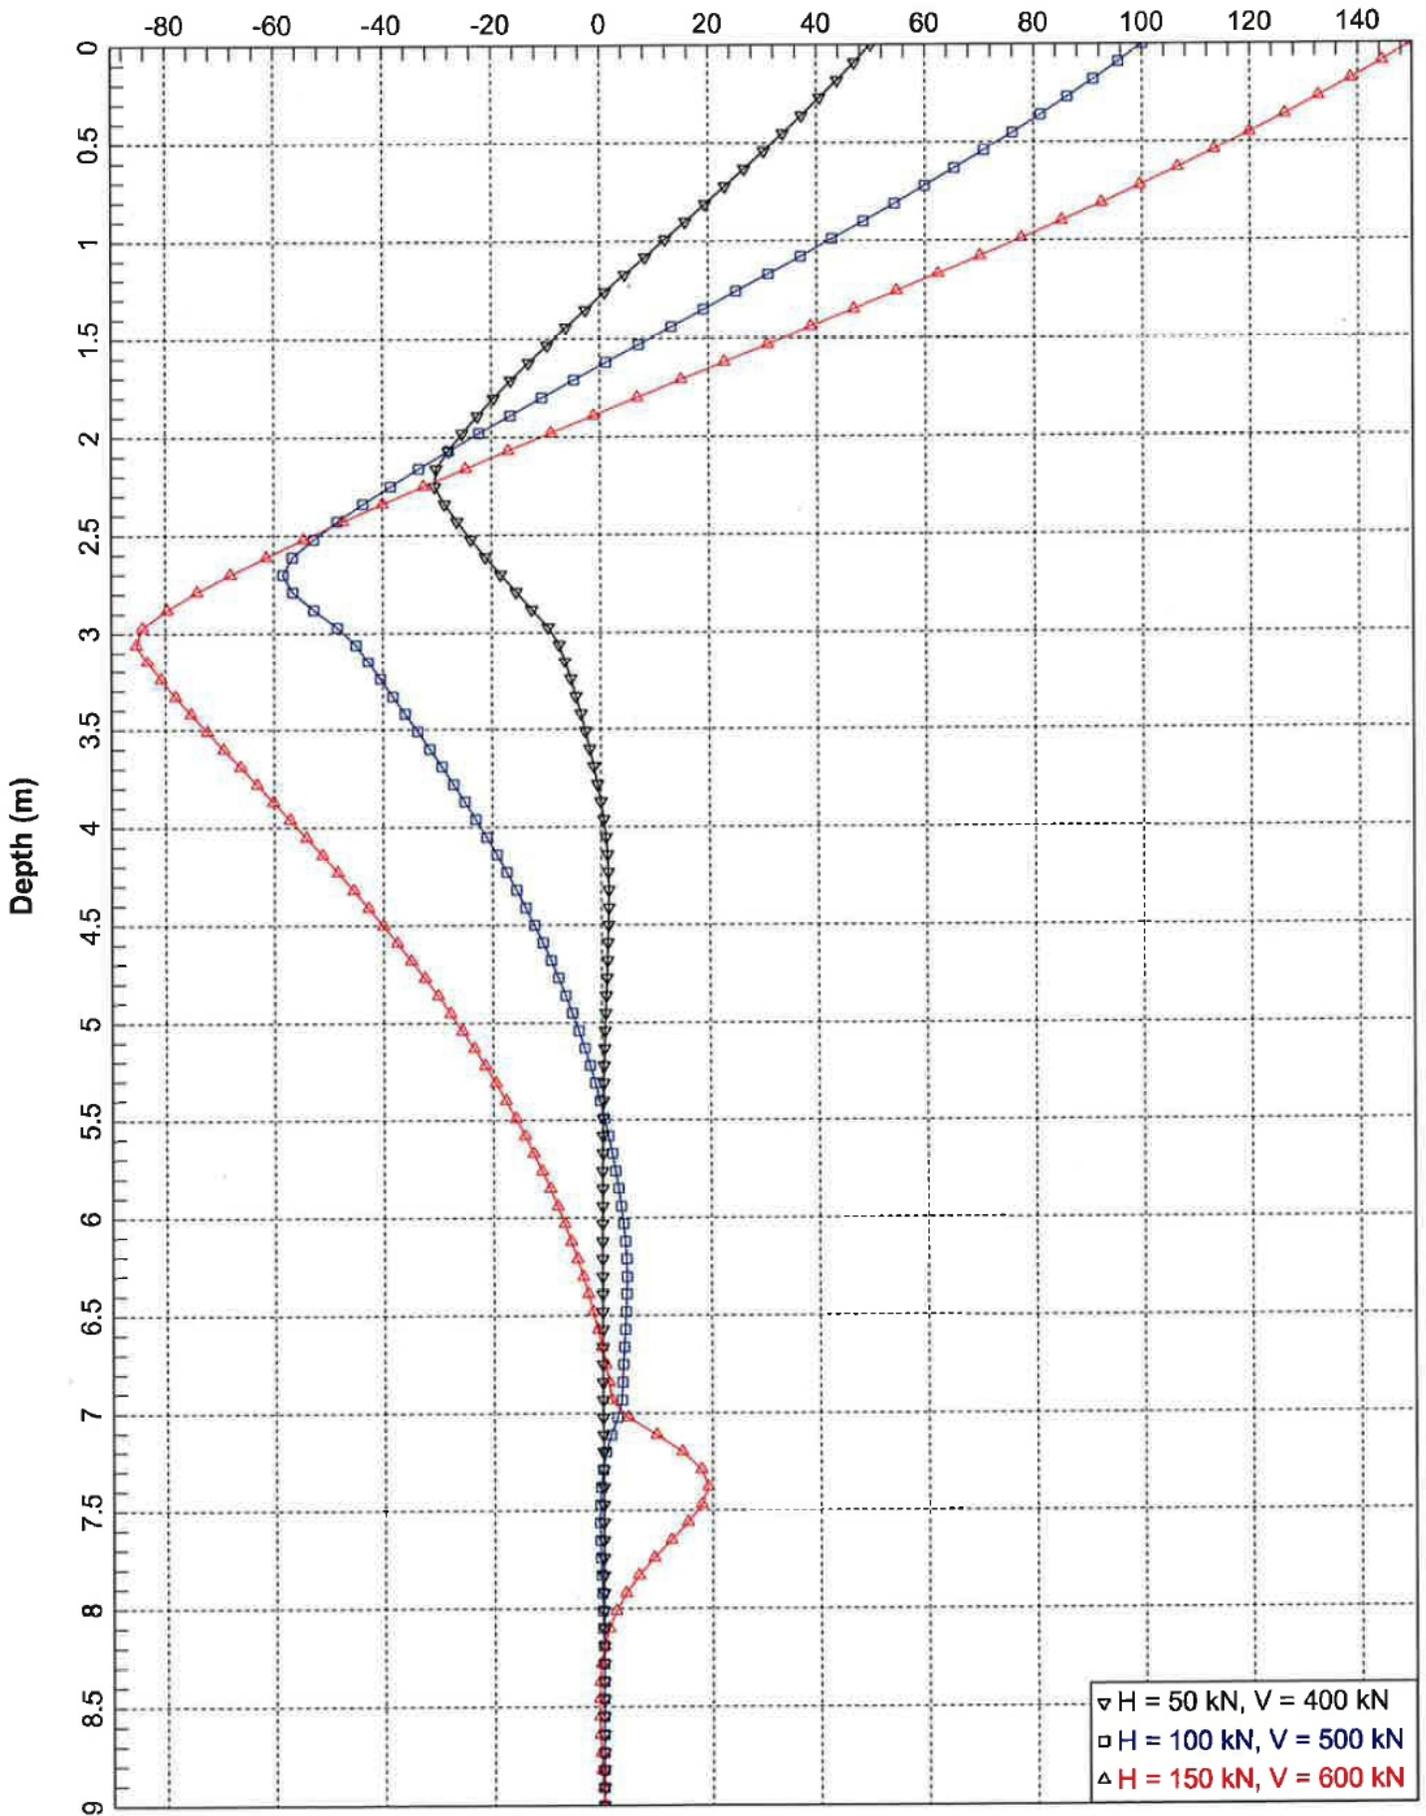
FIGURE 21

HP250x85 - pinned

Shear Force (kN)

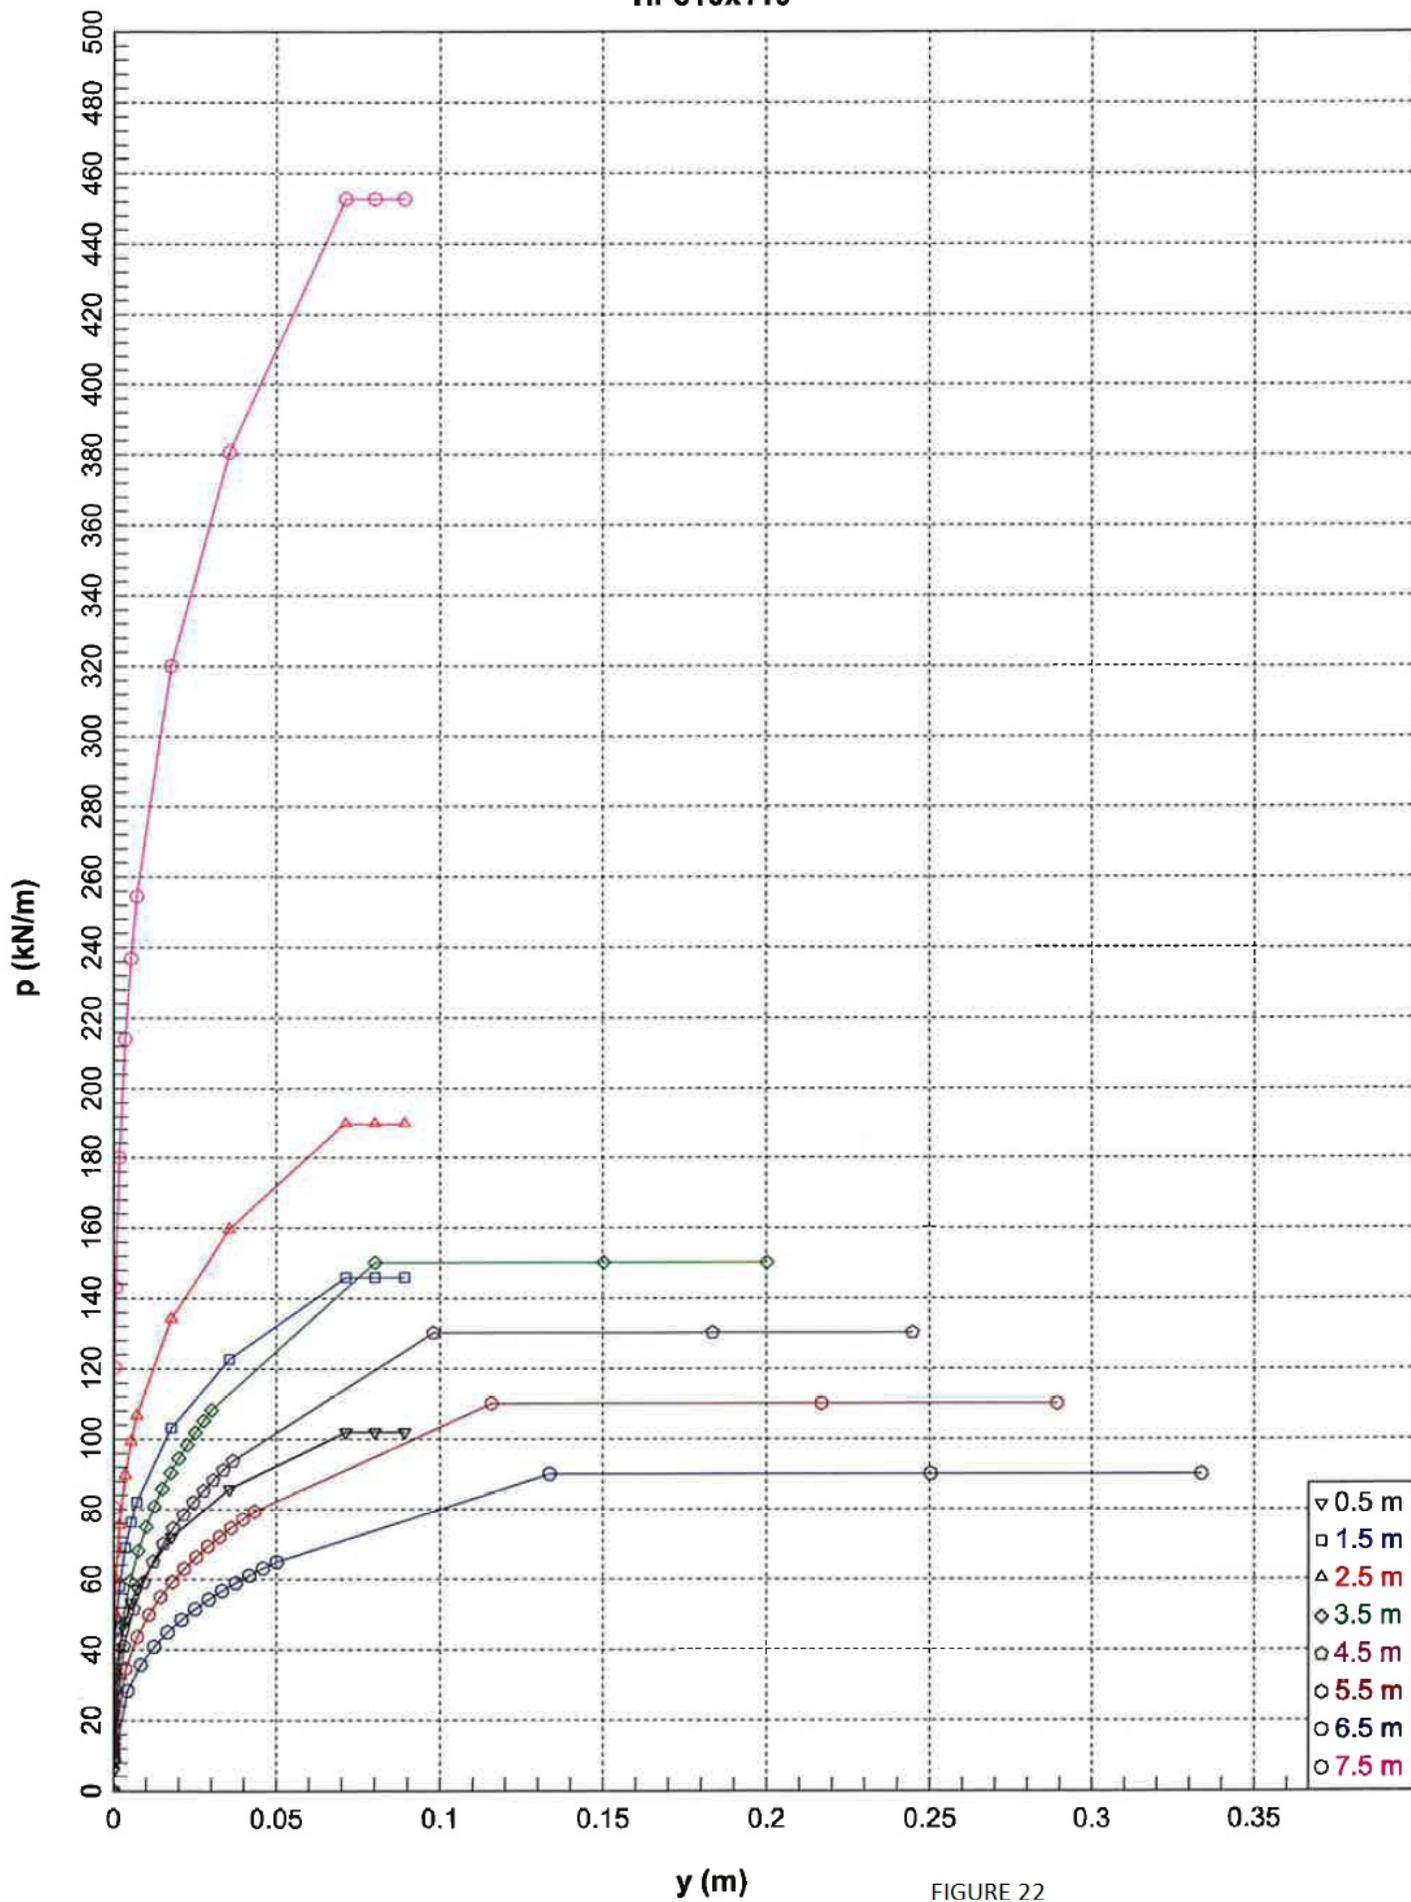
FIGURE 22

HP310x110

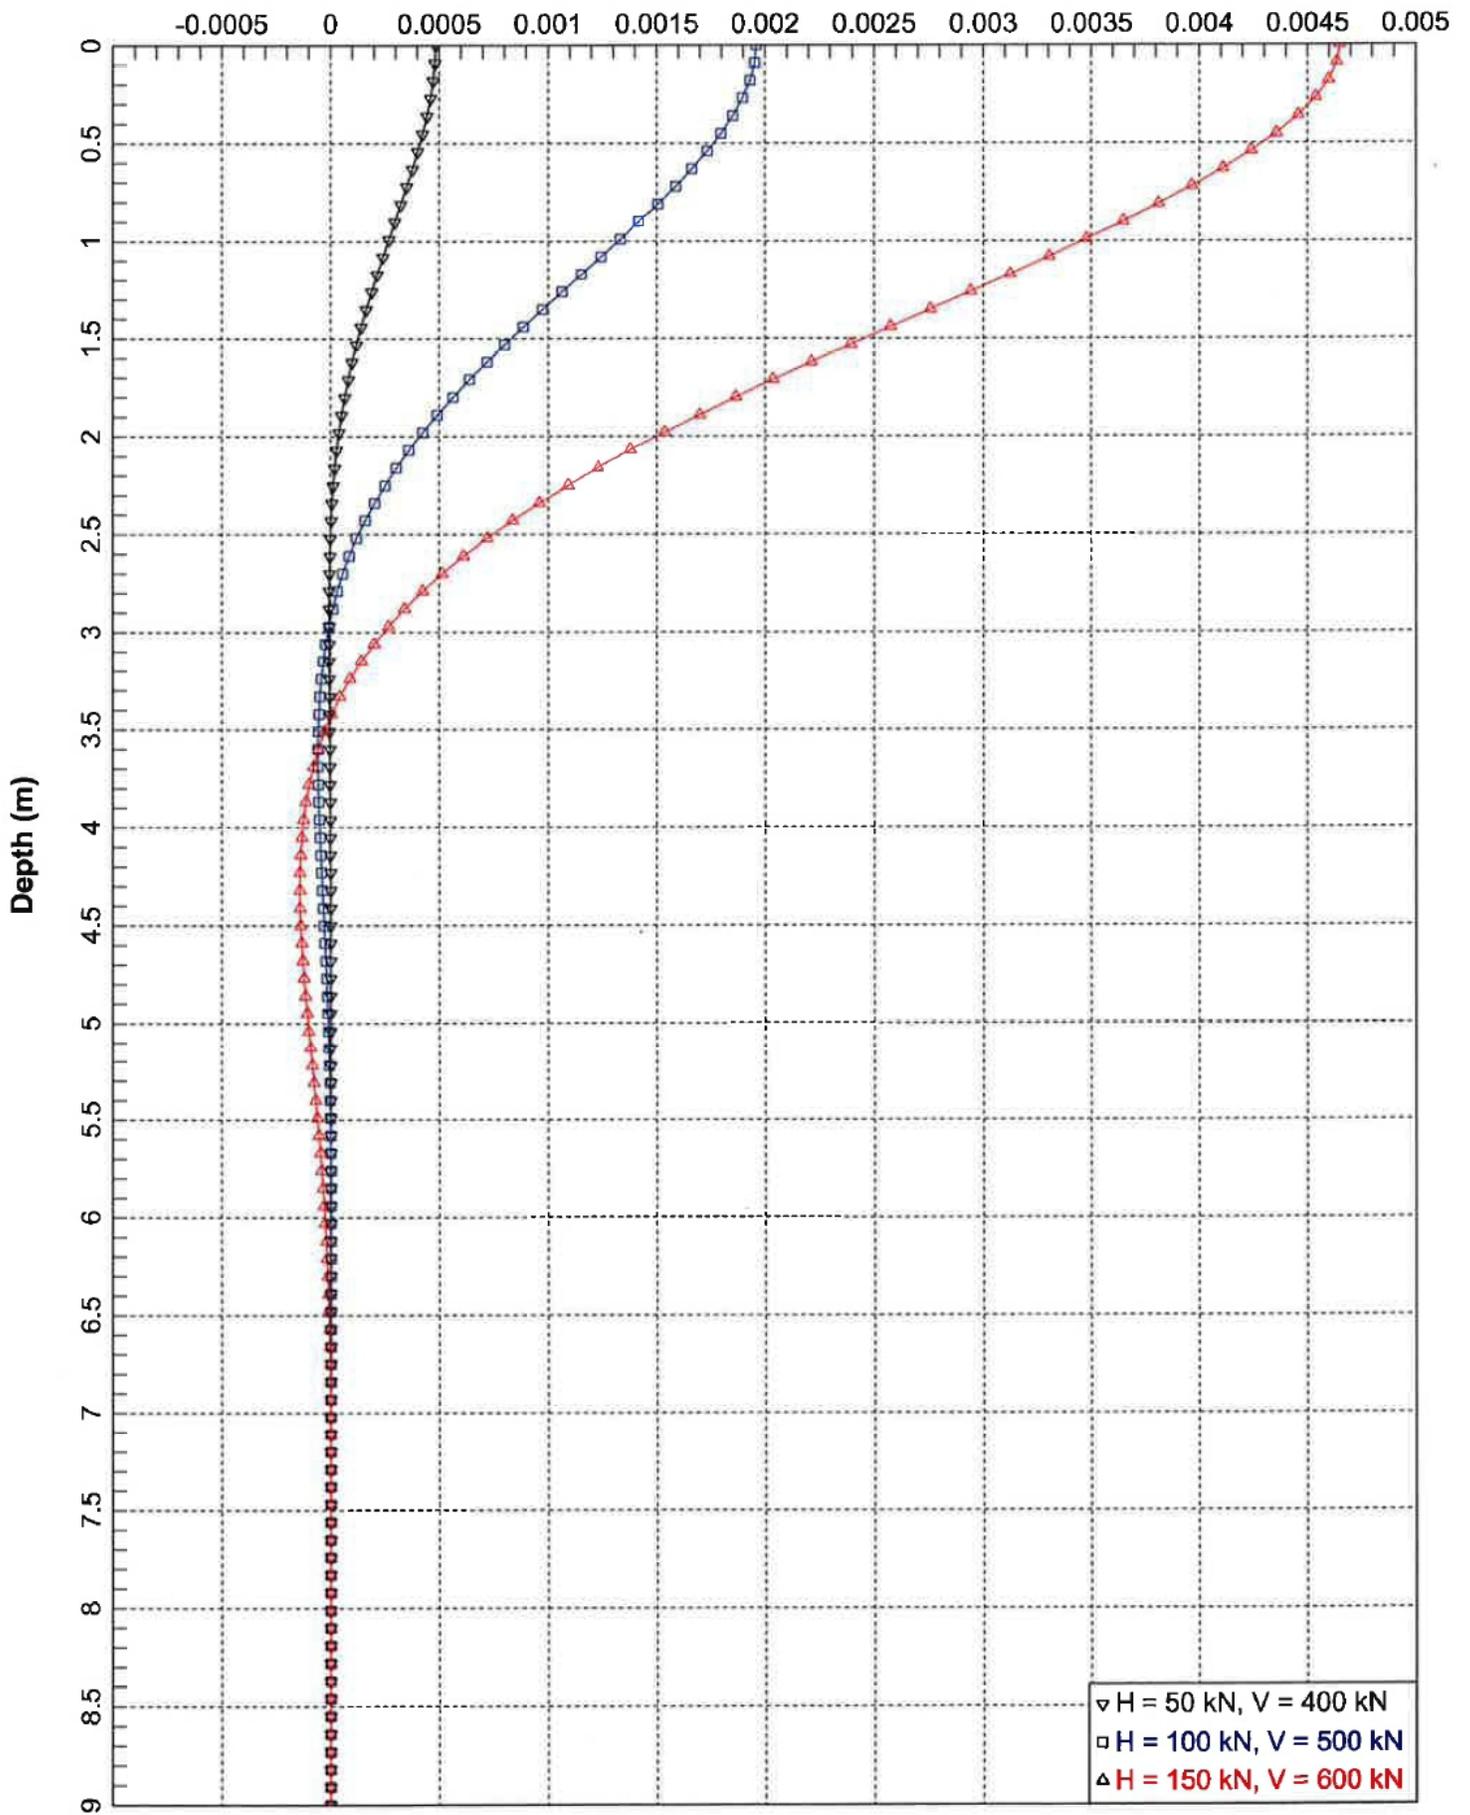
FIGURE 23

HP310x110 - fixed
Lateral Deflection (m)

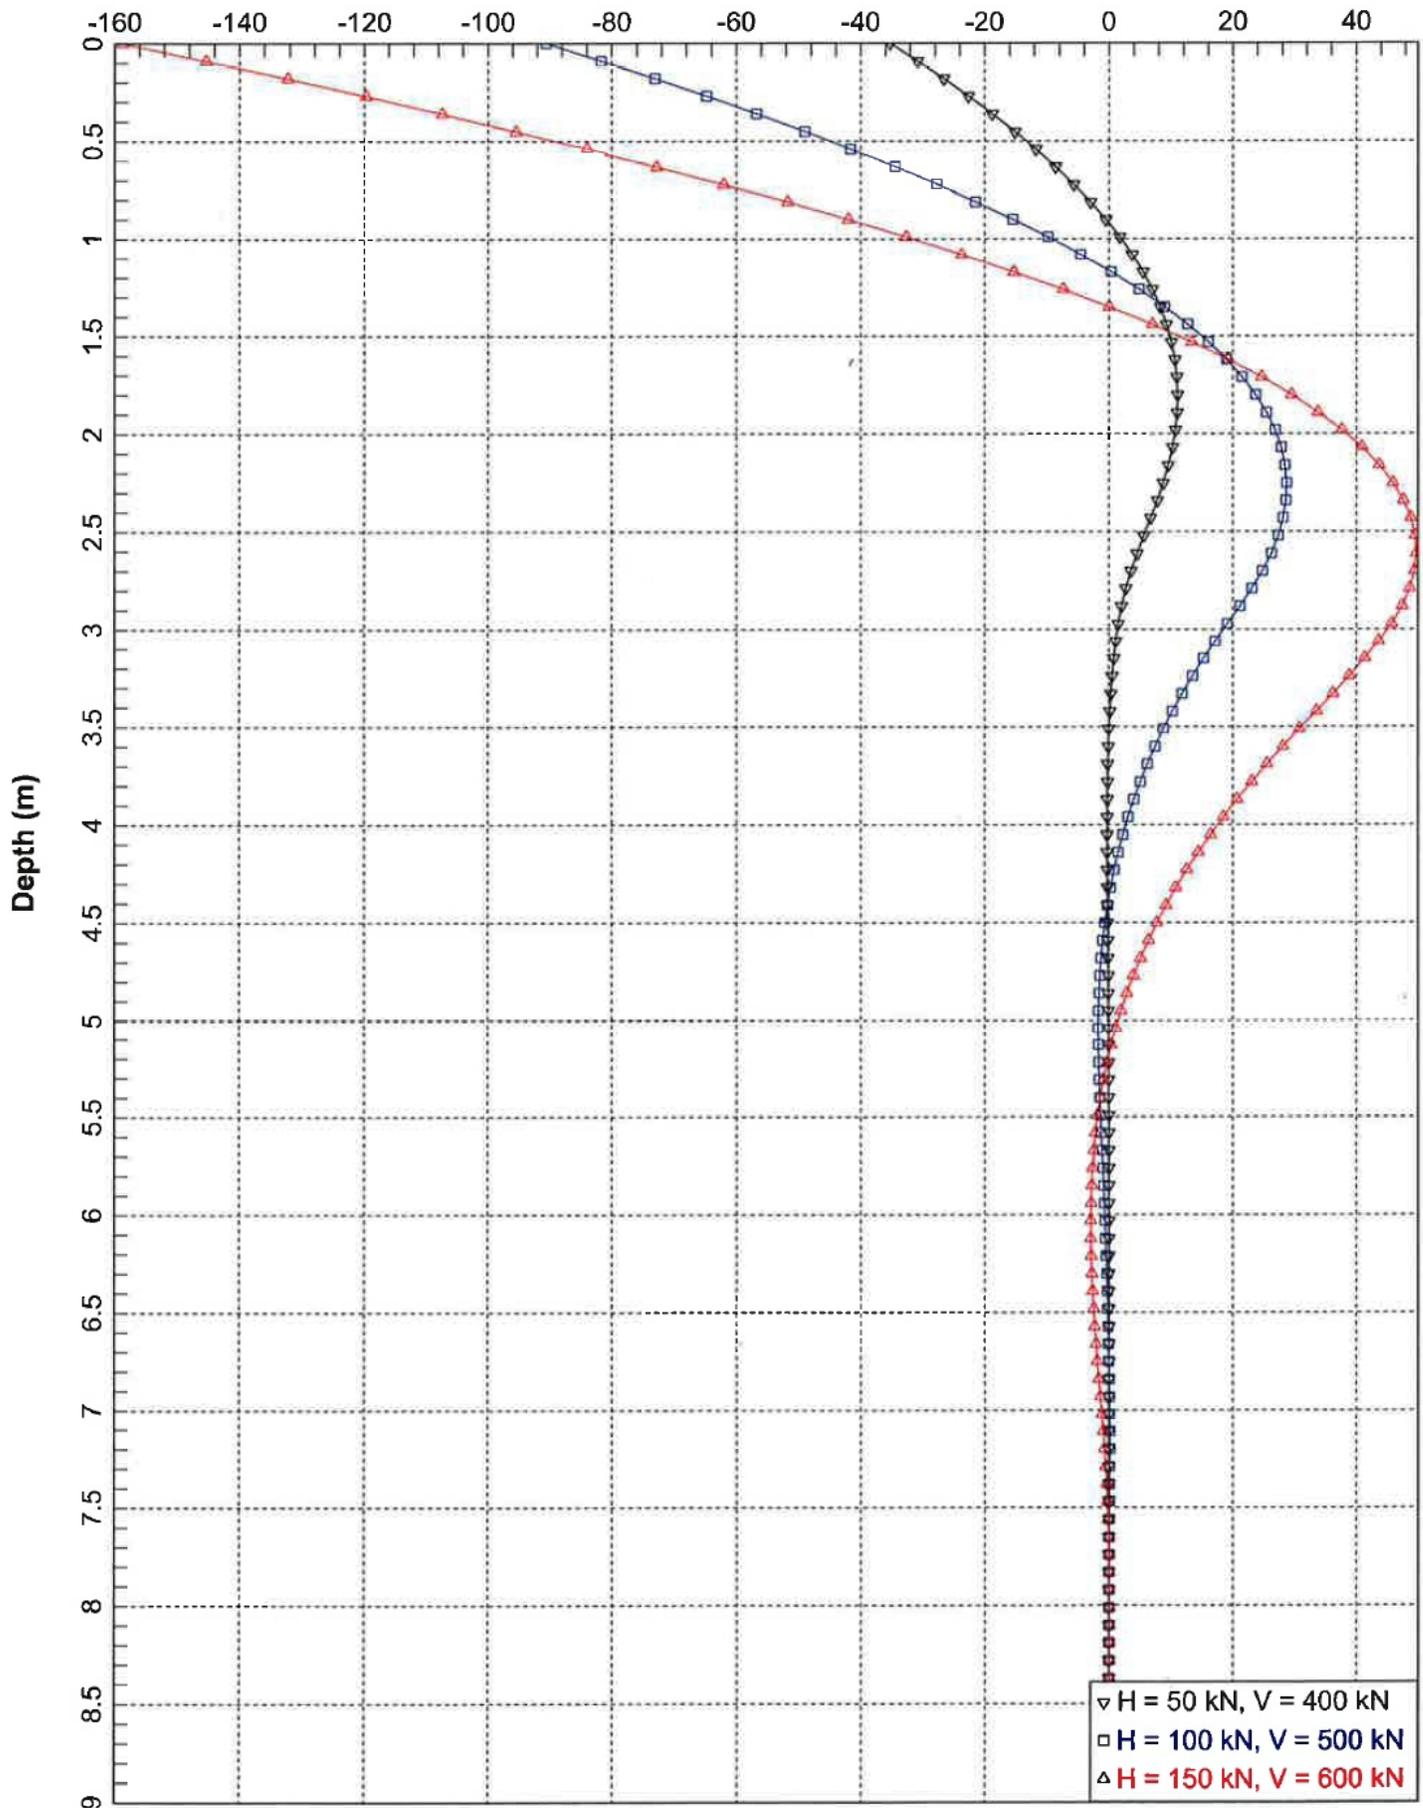
FIGURE 24

HP310x110 - fixed
Bending Moment (kN-m)

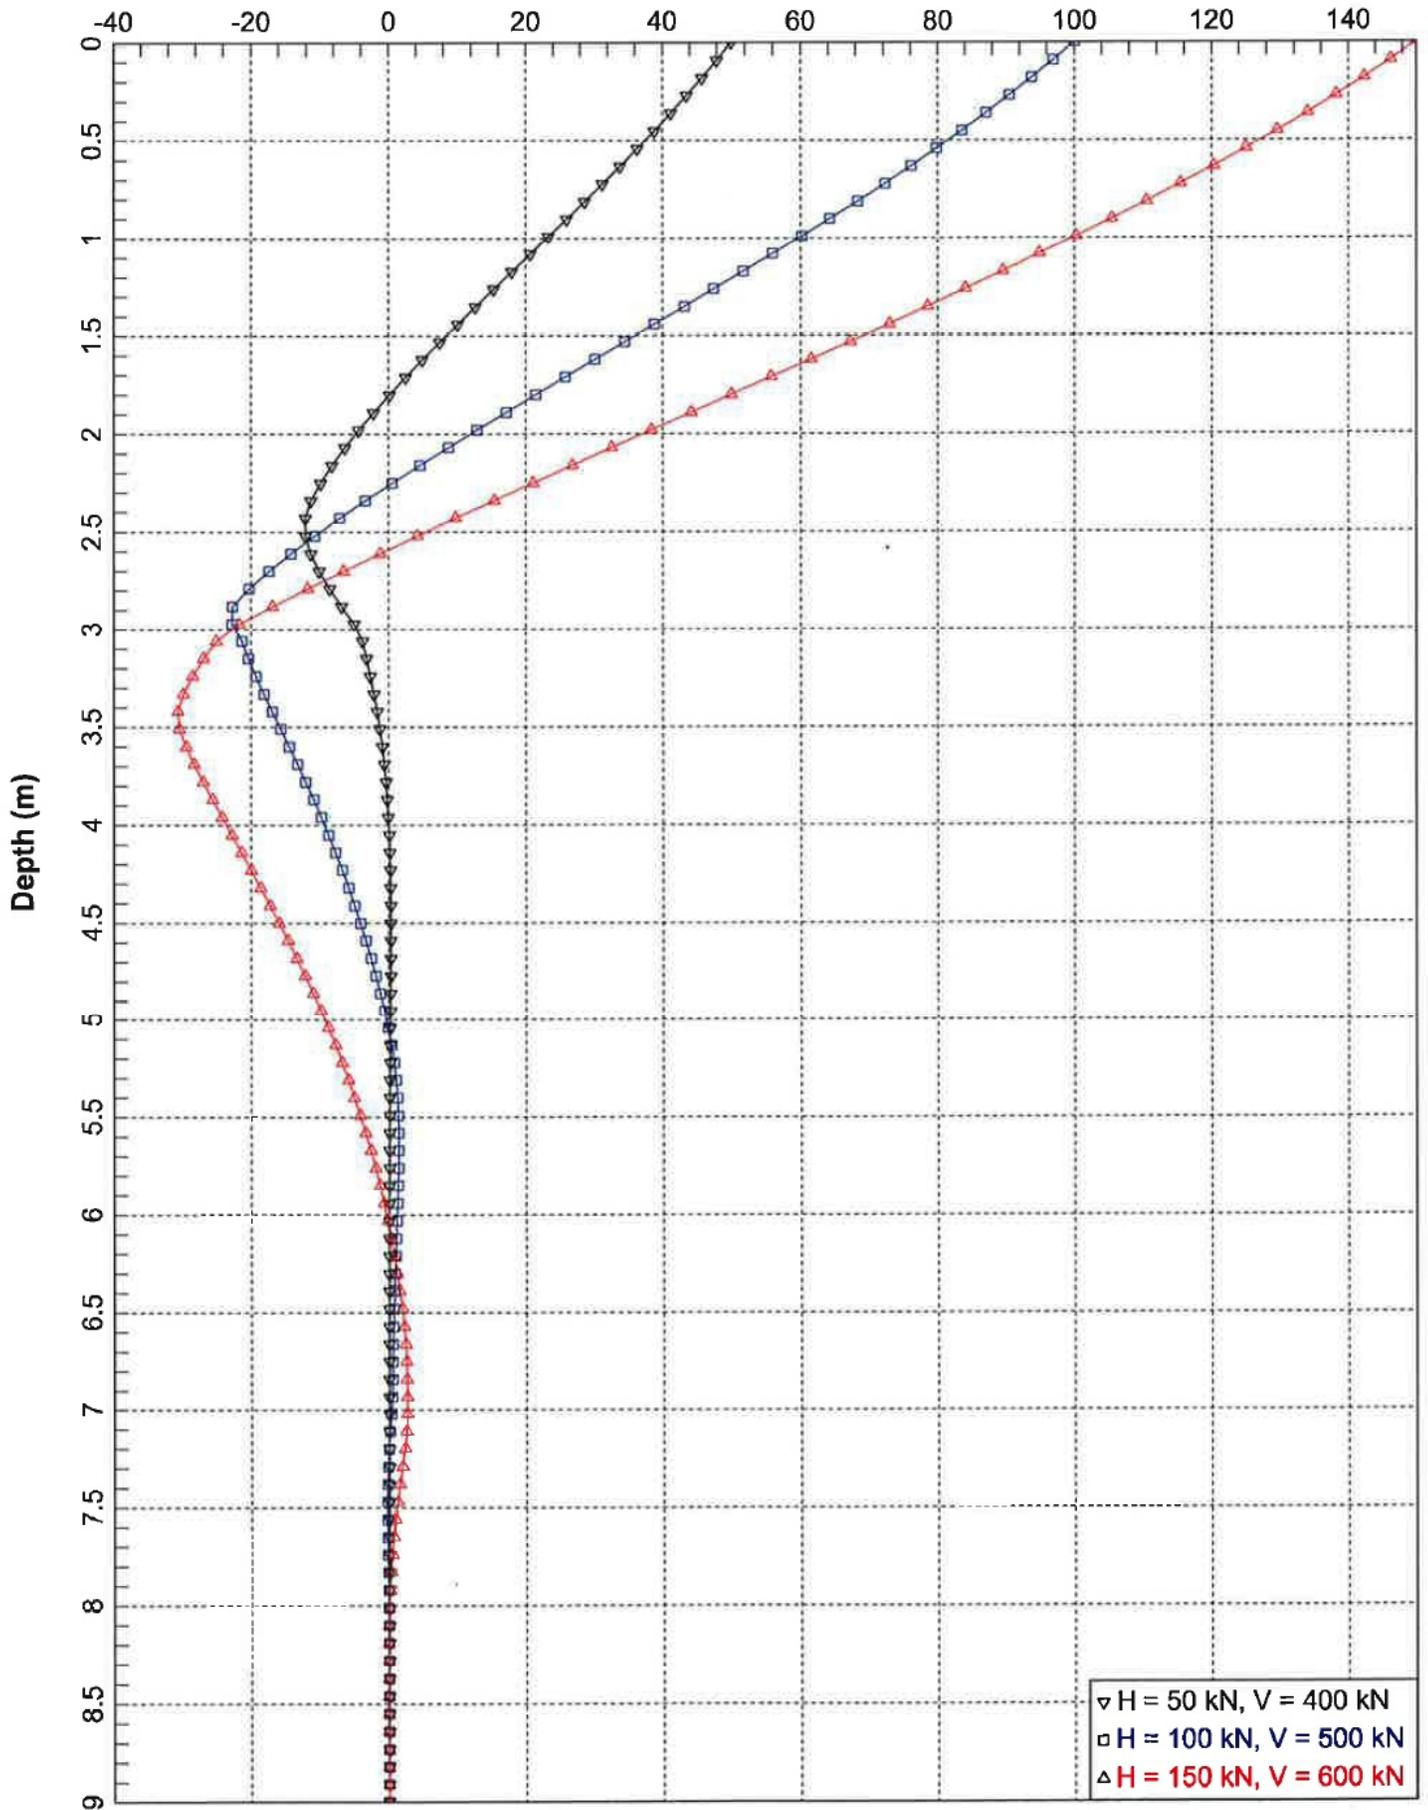
FIGURE 25

HP310x110 - fixed

Shear Force (kN)

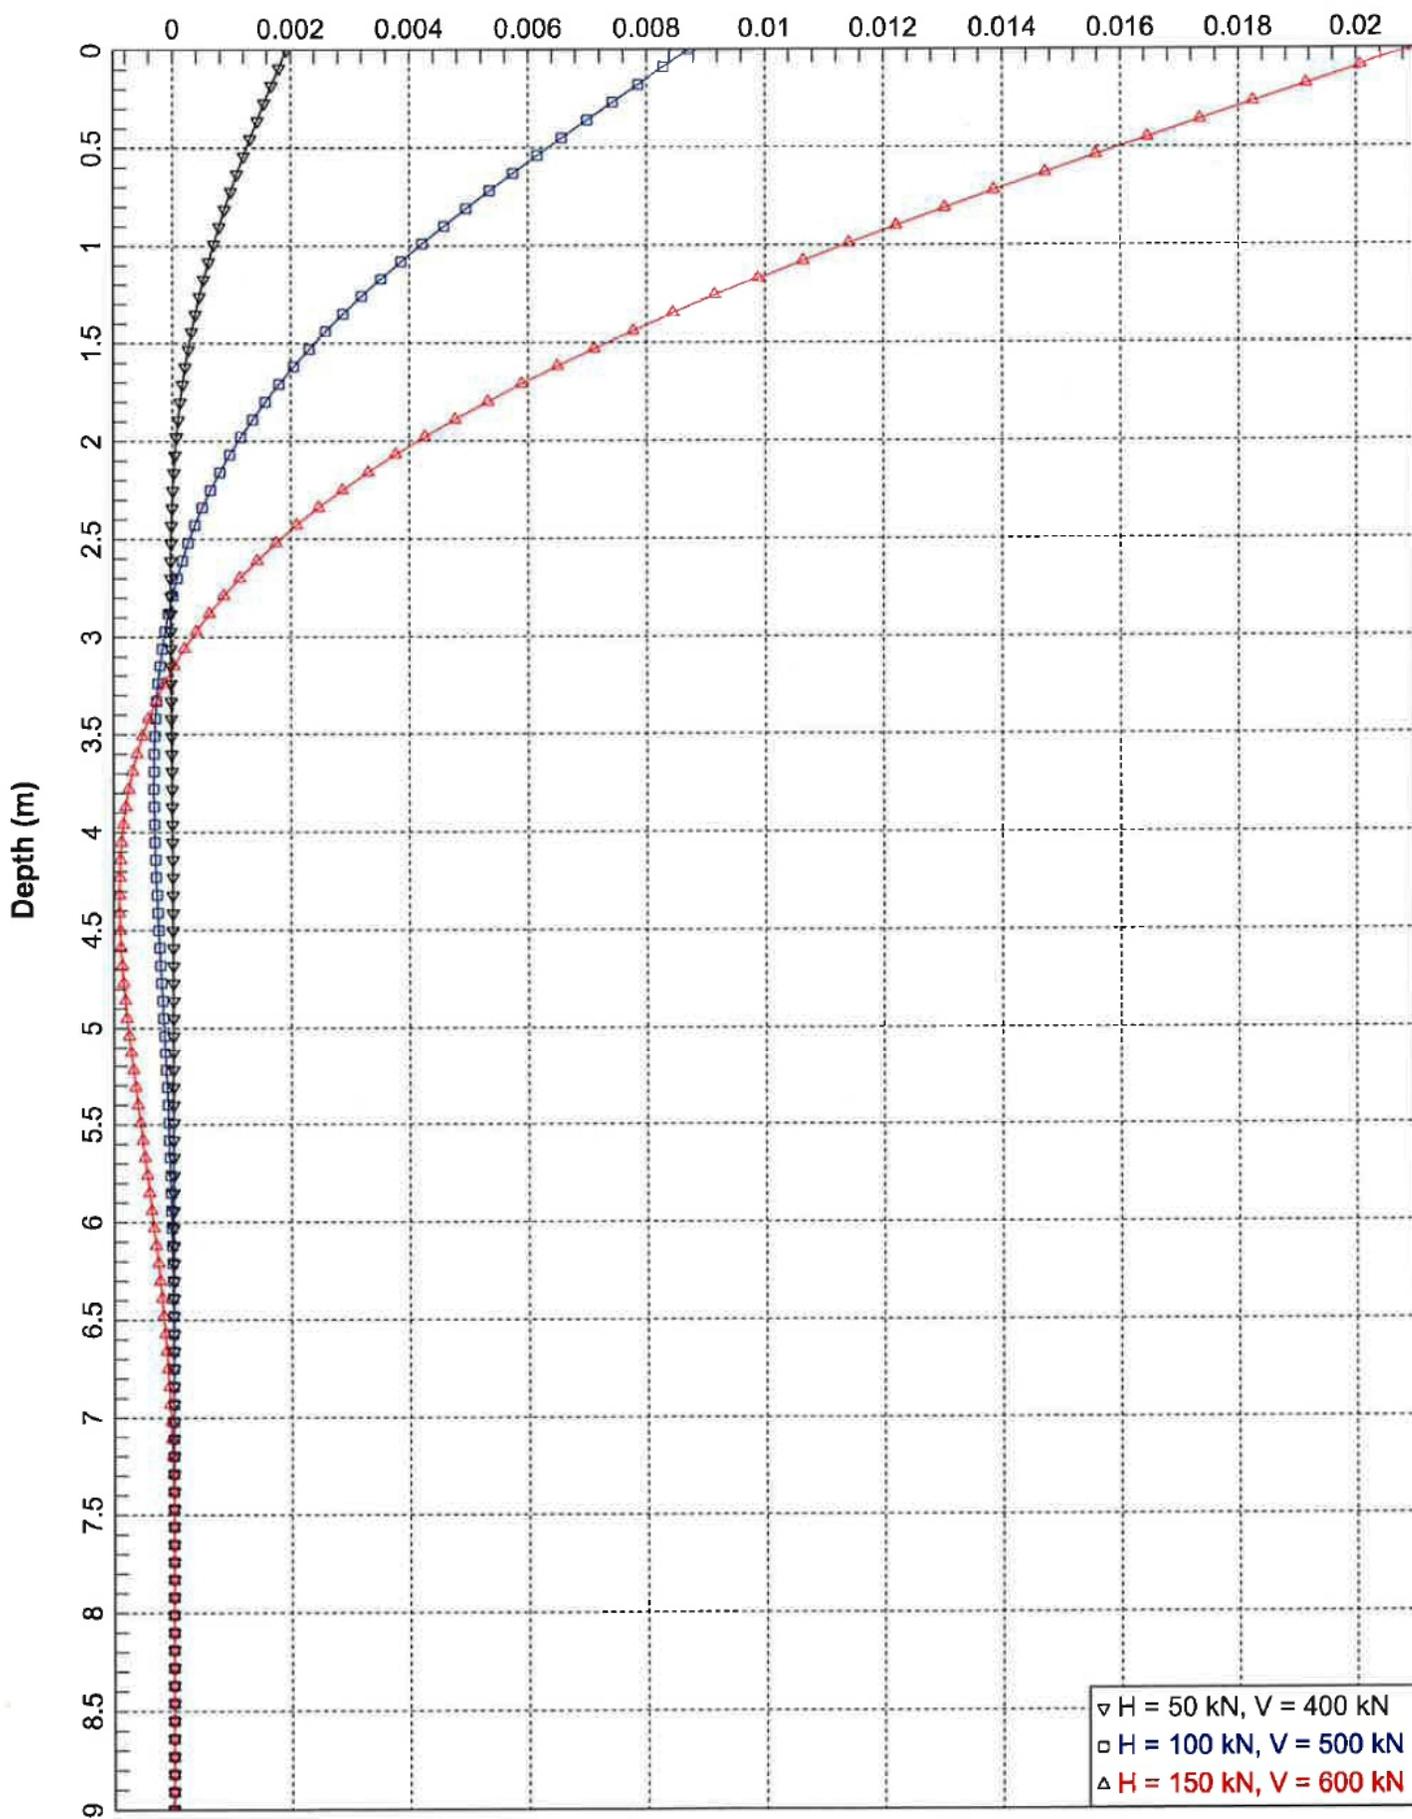
FIGURE 26

HP310x110 - pinned

Lateral Deflection (m)

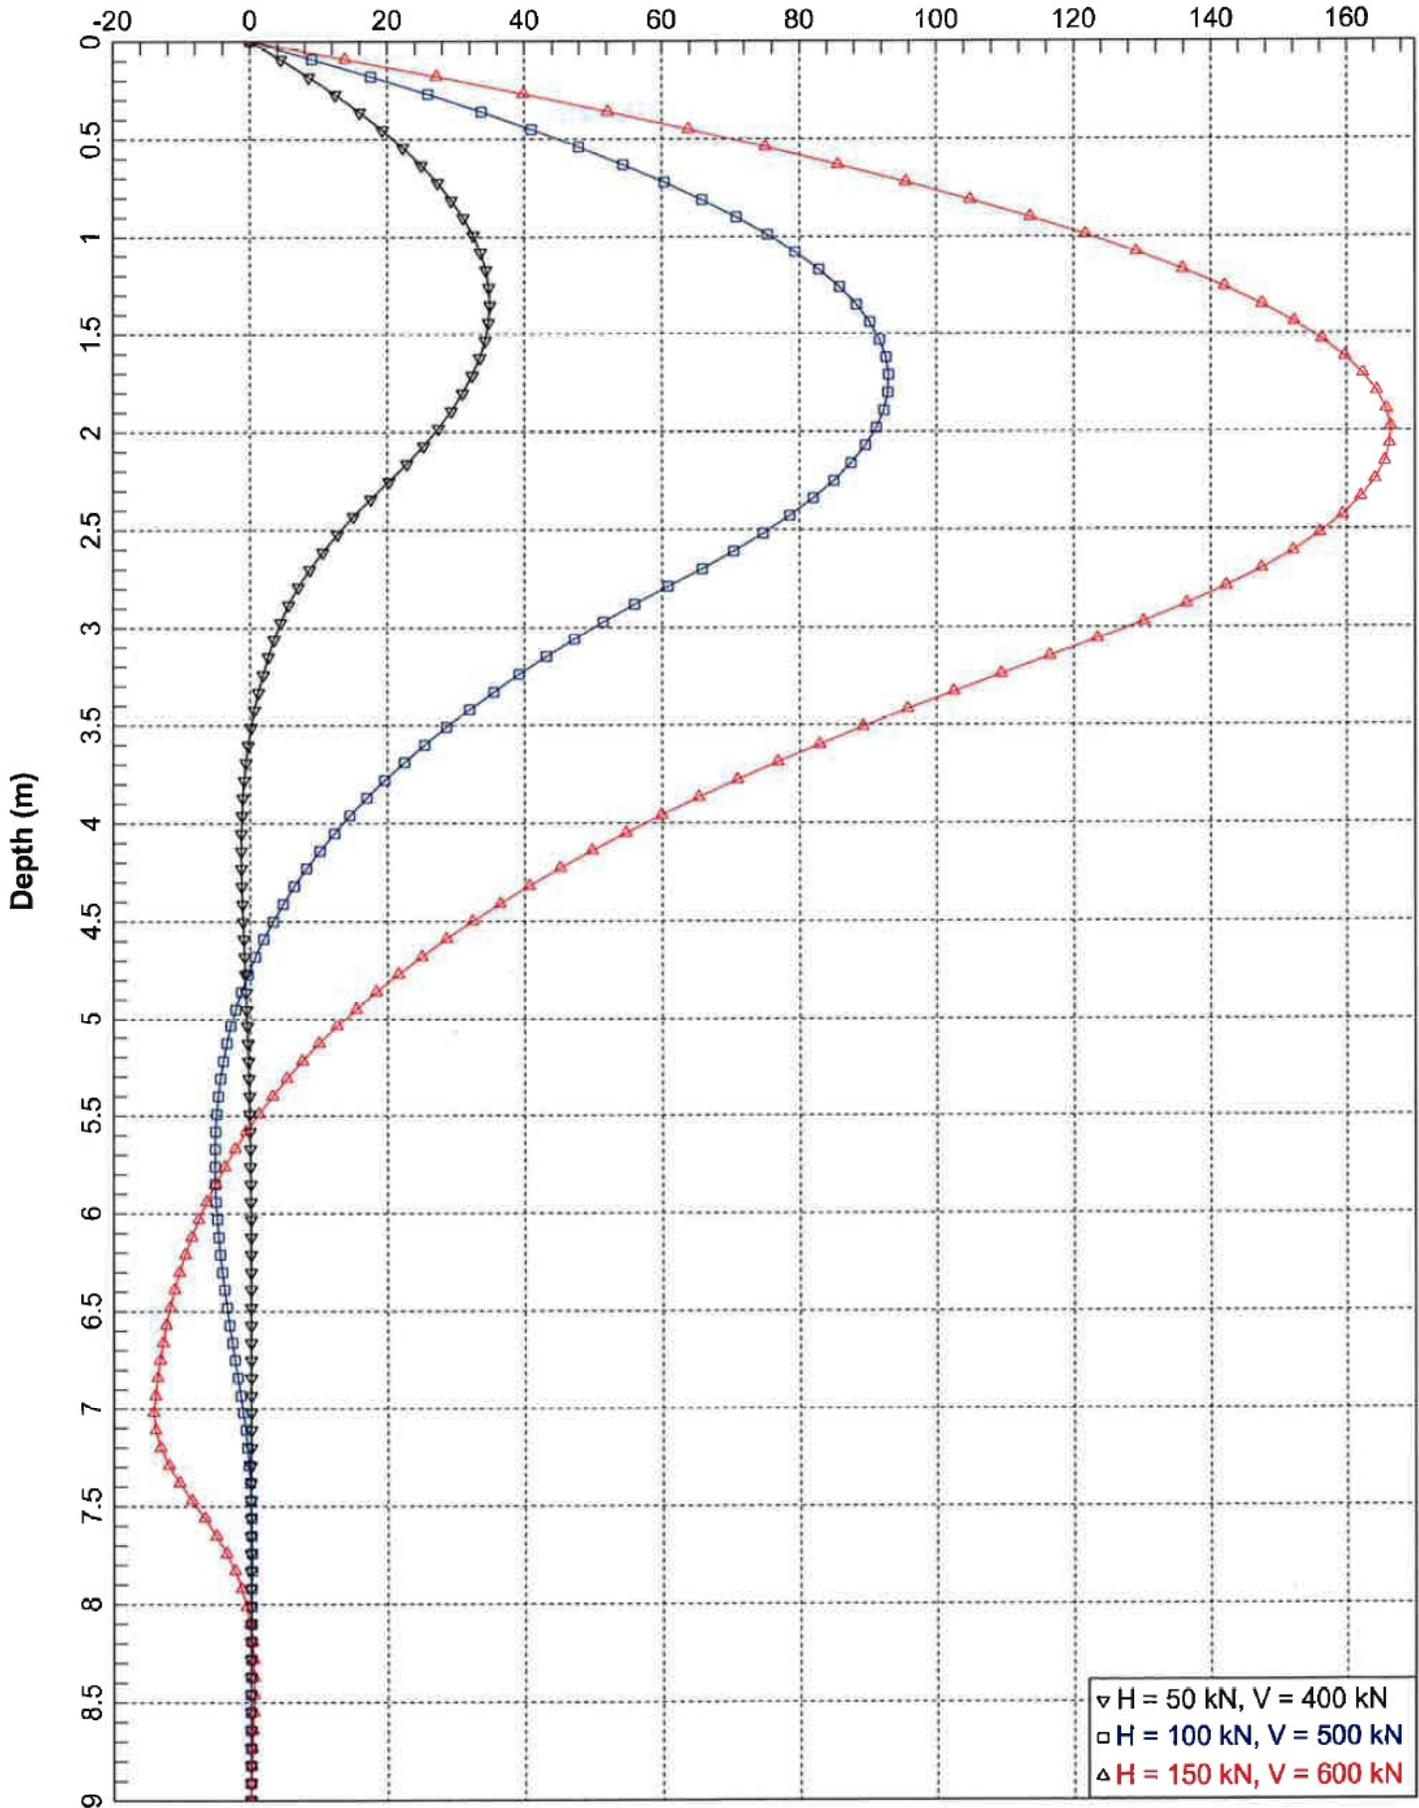
FIGURE 27

HP310x110 - pinned
Bending Moment (kN-m)

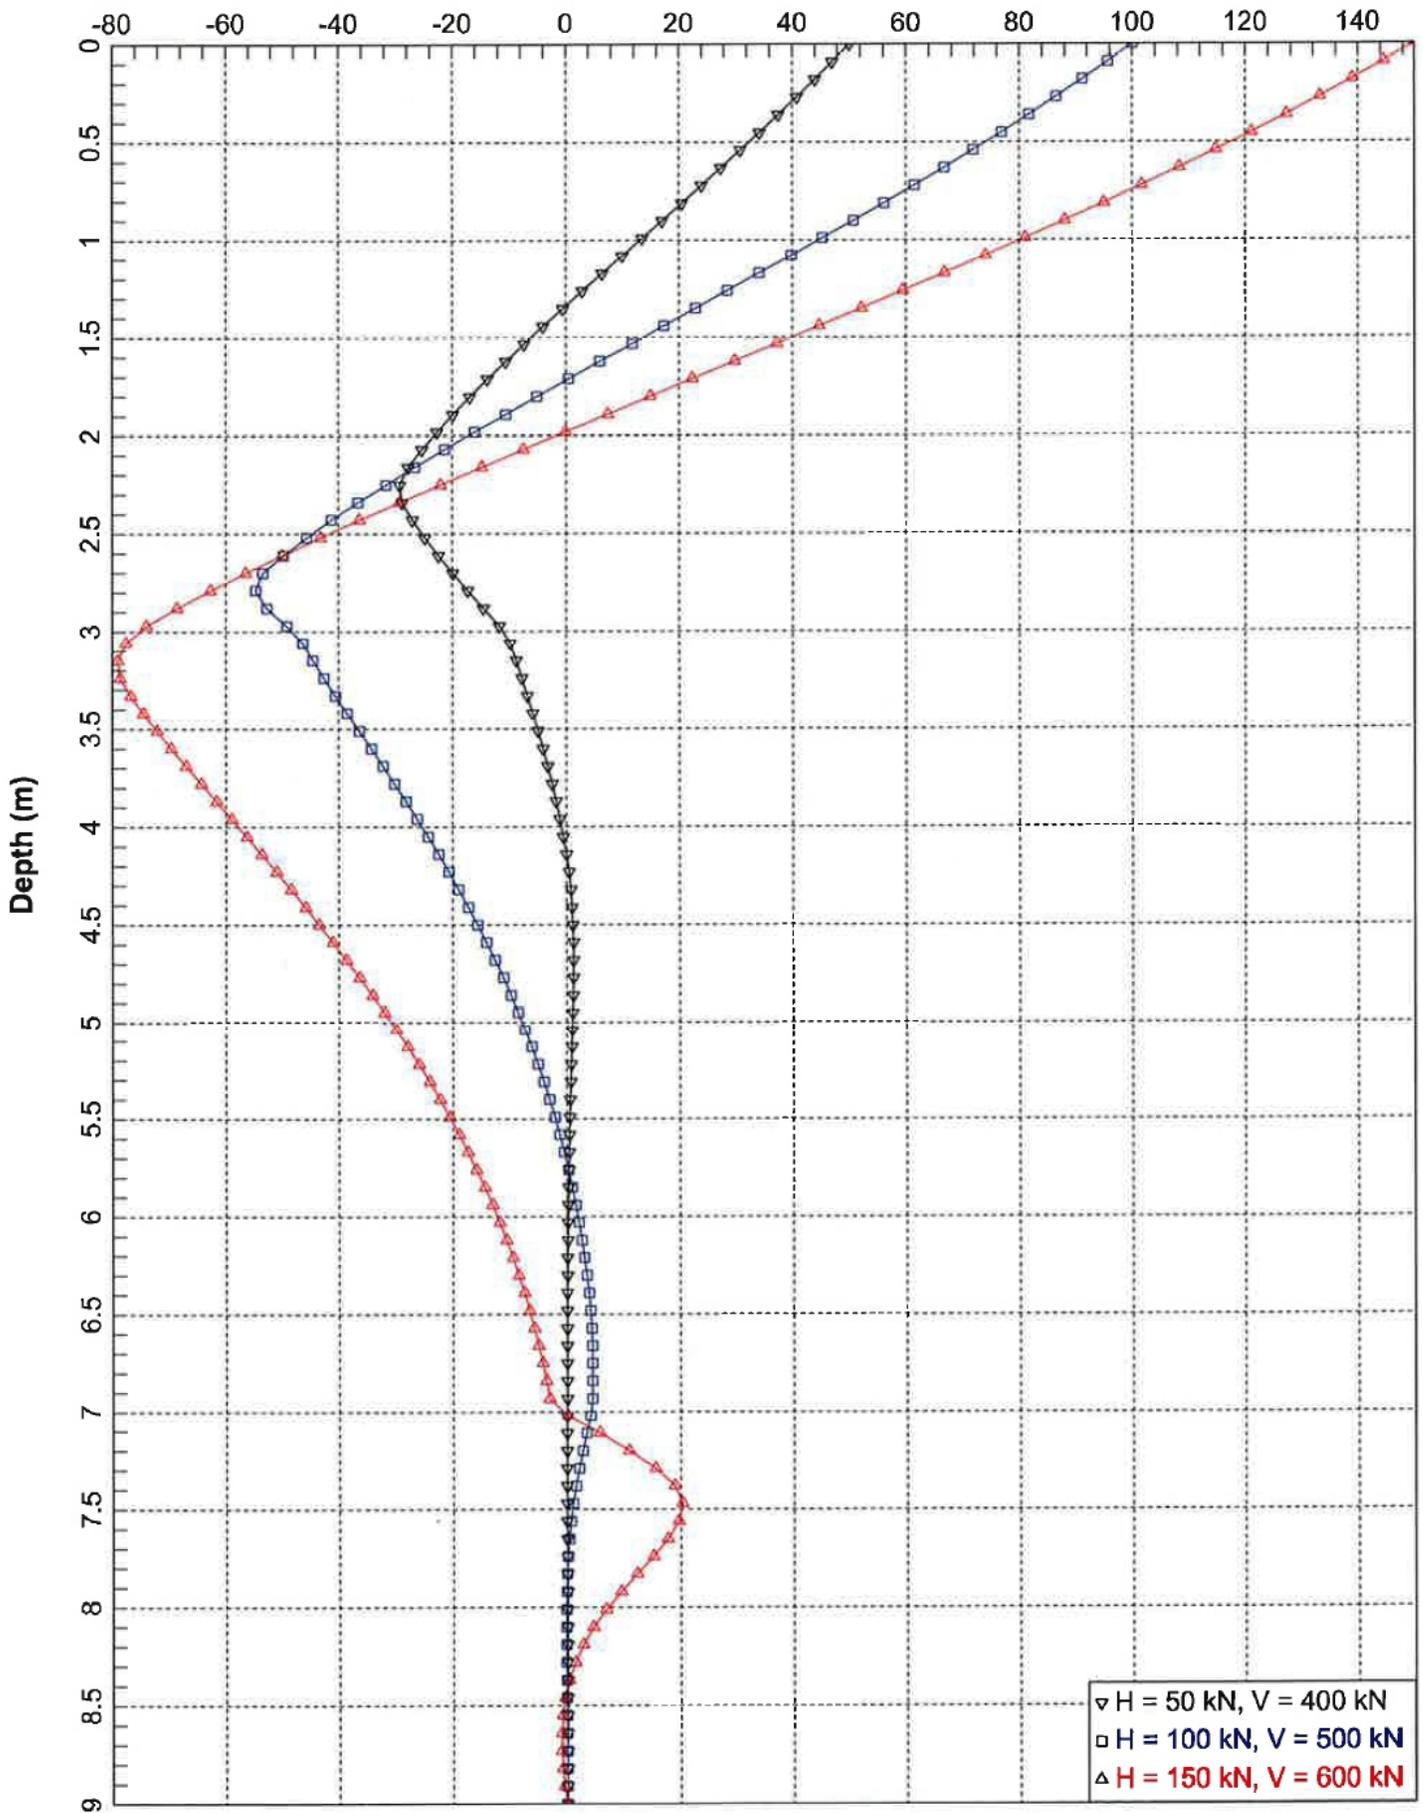
FIGURE 28

HP310x110 - pinned

Shear Force (kN)
