**FINAL REPORT
GEOTECHNICAL INVESTIGATION AND
FOUNDATION ENGINEERING FOR
STURGEON CREEK BRIDGE REPLACEMENT**

Prepared for
STANTEC
905 WAVERLEY STREET
WINNIPEG, MANITOBA
R3T 5P4

Prepared by
THE NATIONAL TESTING LABORATORIES LIMITED
199 HENLOW BAY
WINNIPEG, MANITOBA
R3Y 1G4

October 28, 2011

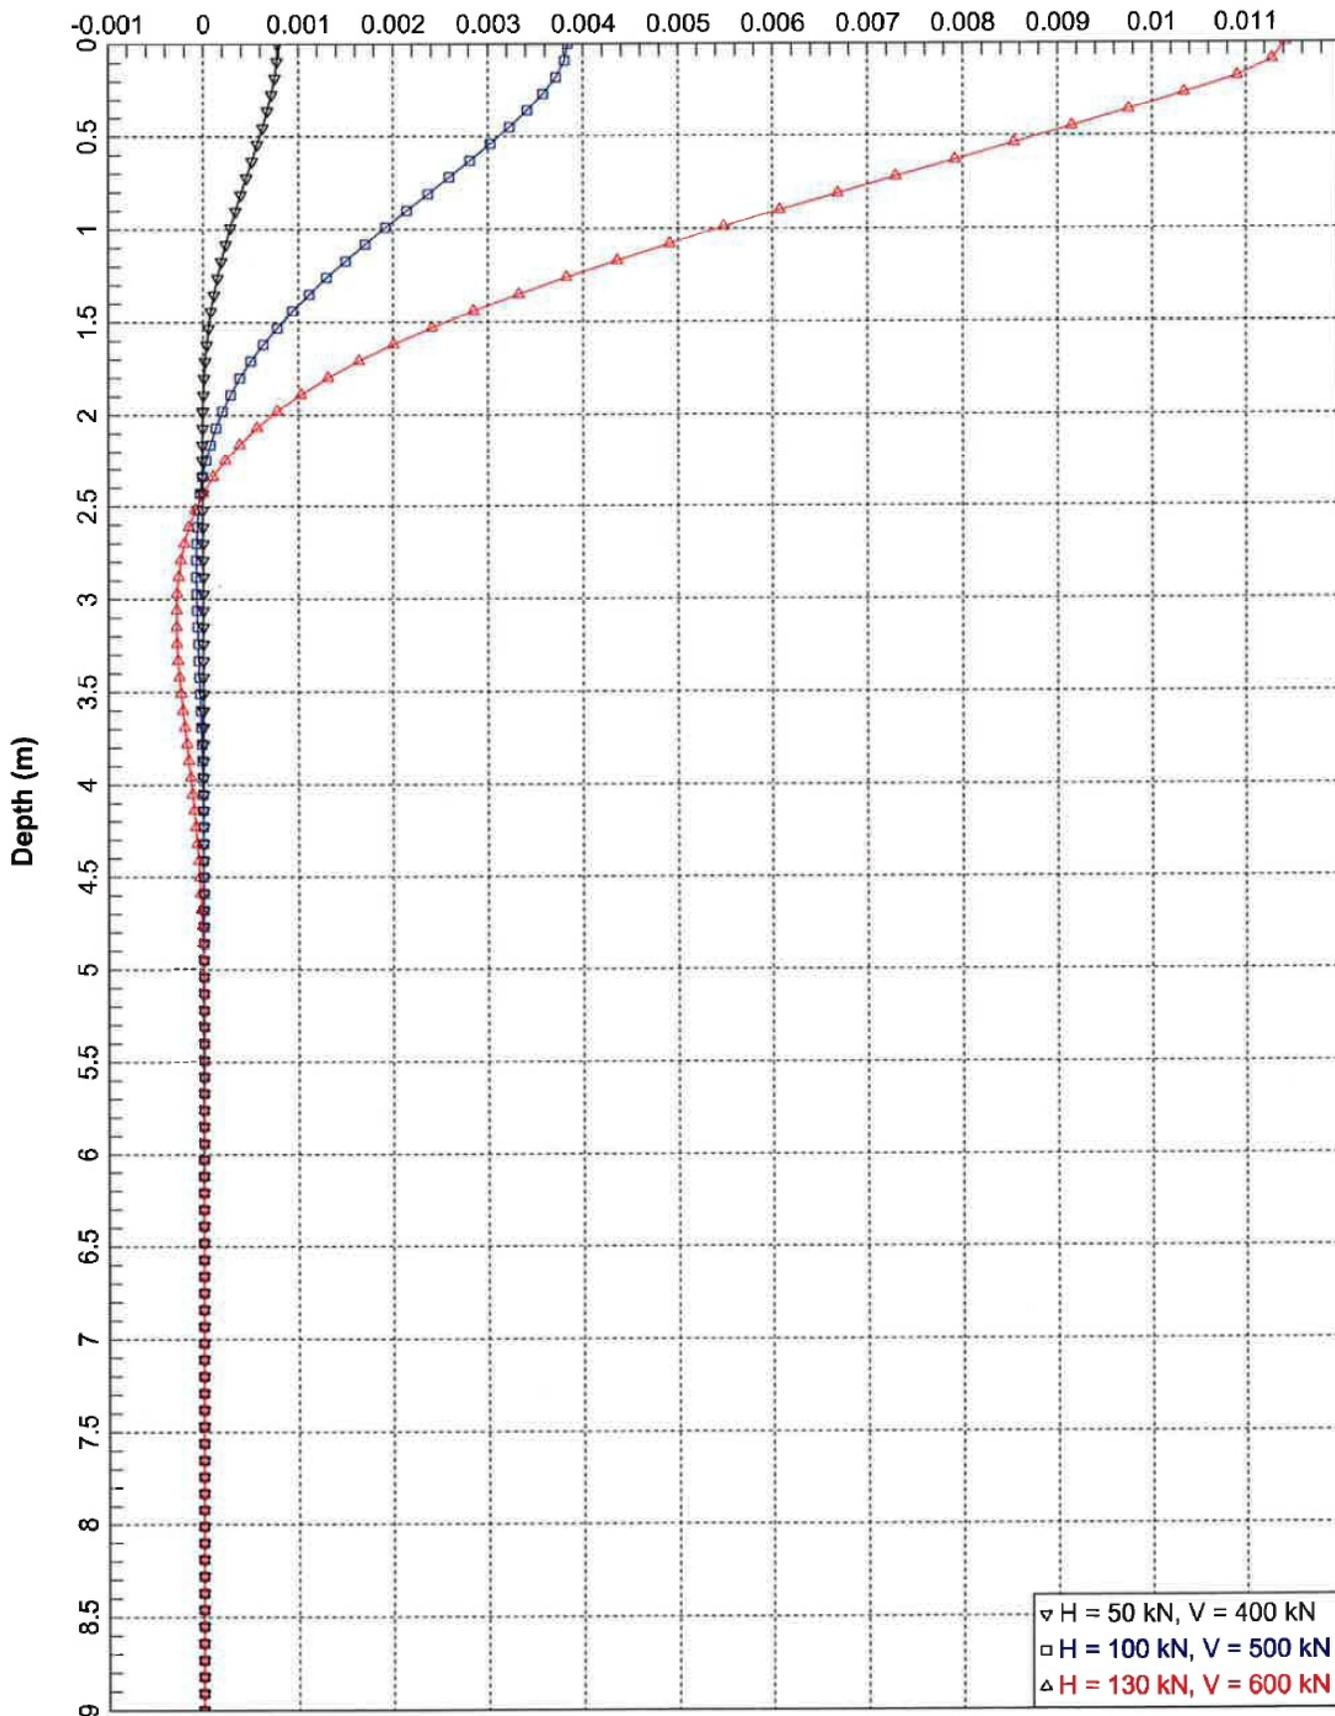
FIGURE 29

14 inch precast - fixed + 5:1 batter
Lateral Deflection (m)

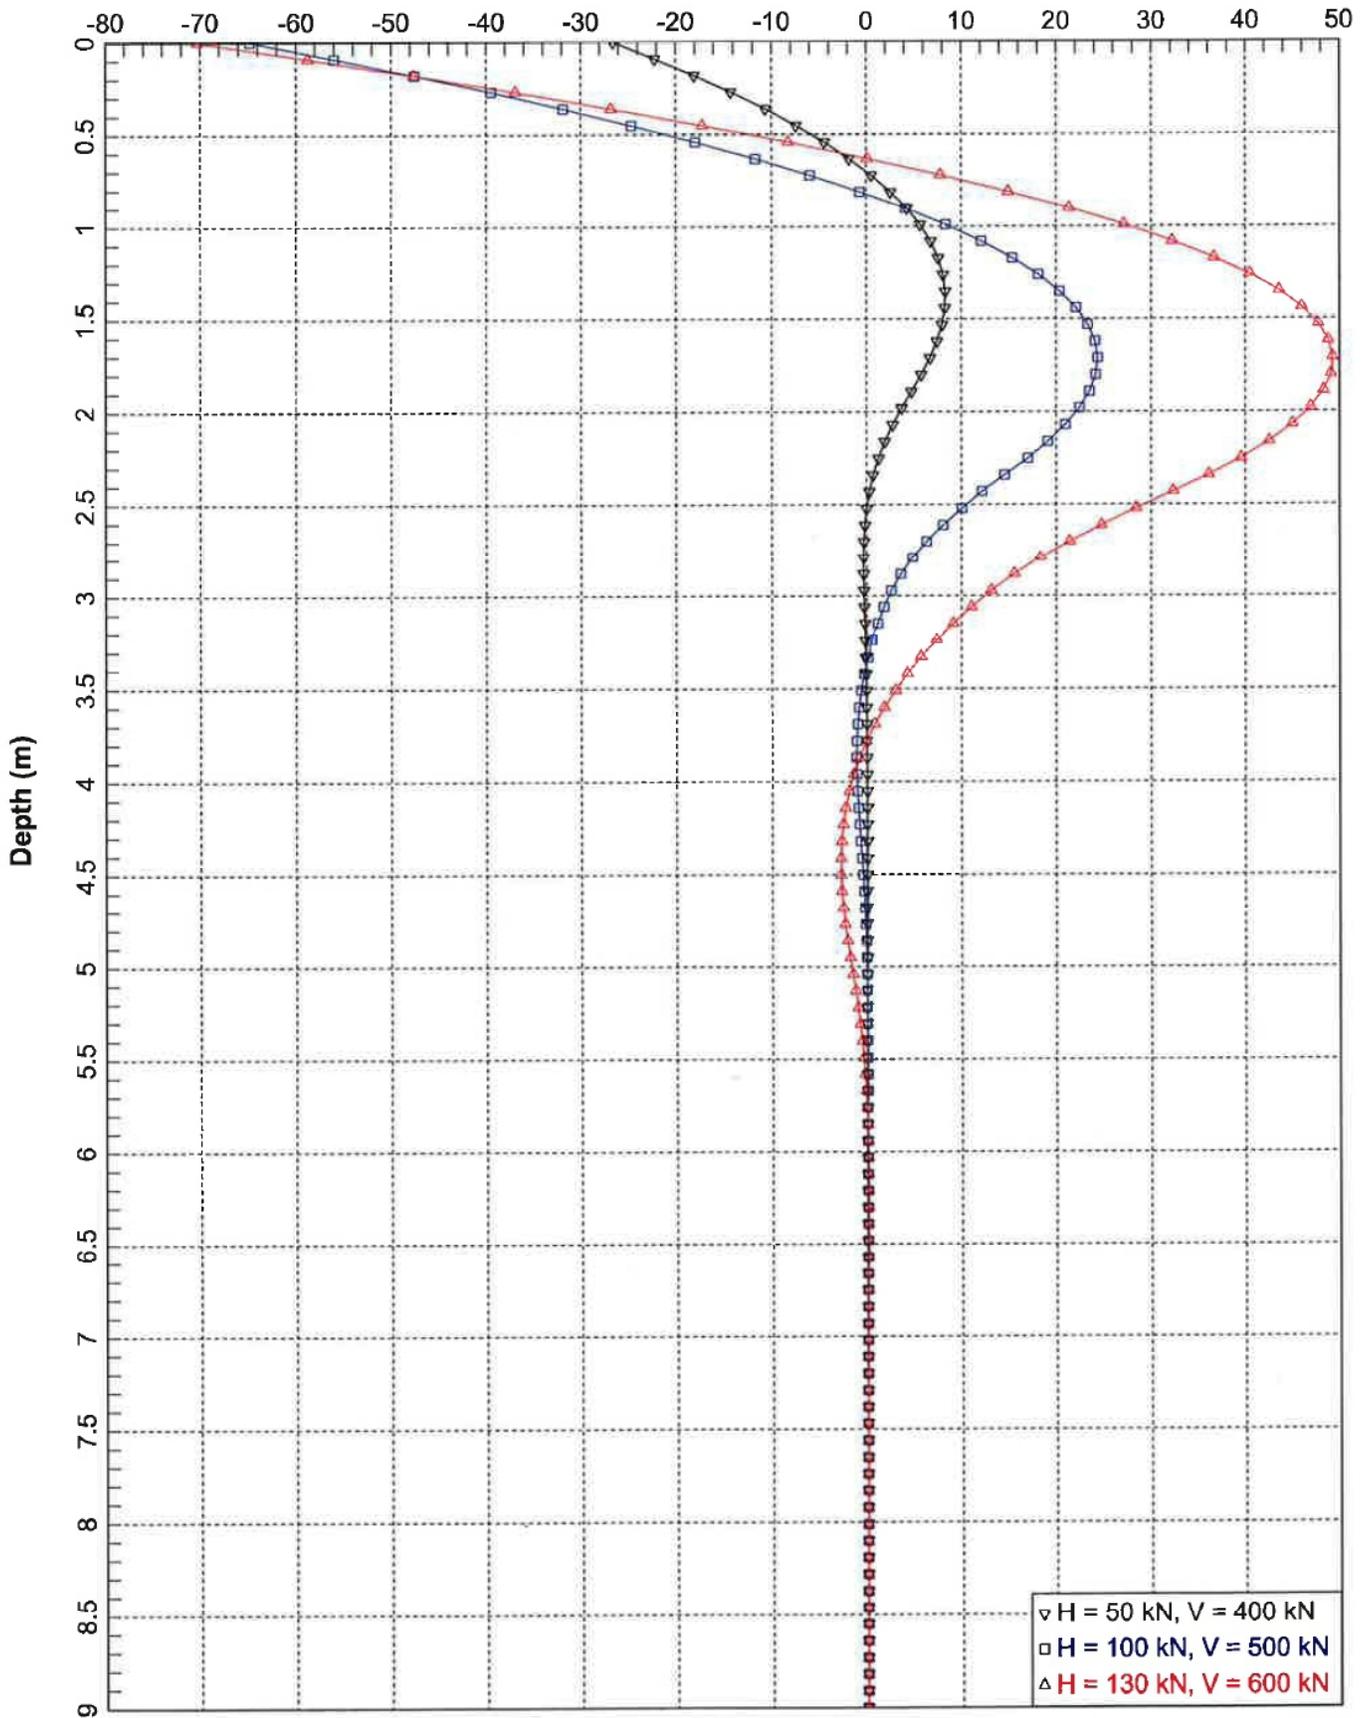
FIGURE 30

14 inch precast - fixed + 5:1 batter

Bending Moment (kN-m)

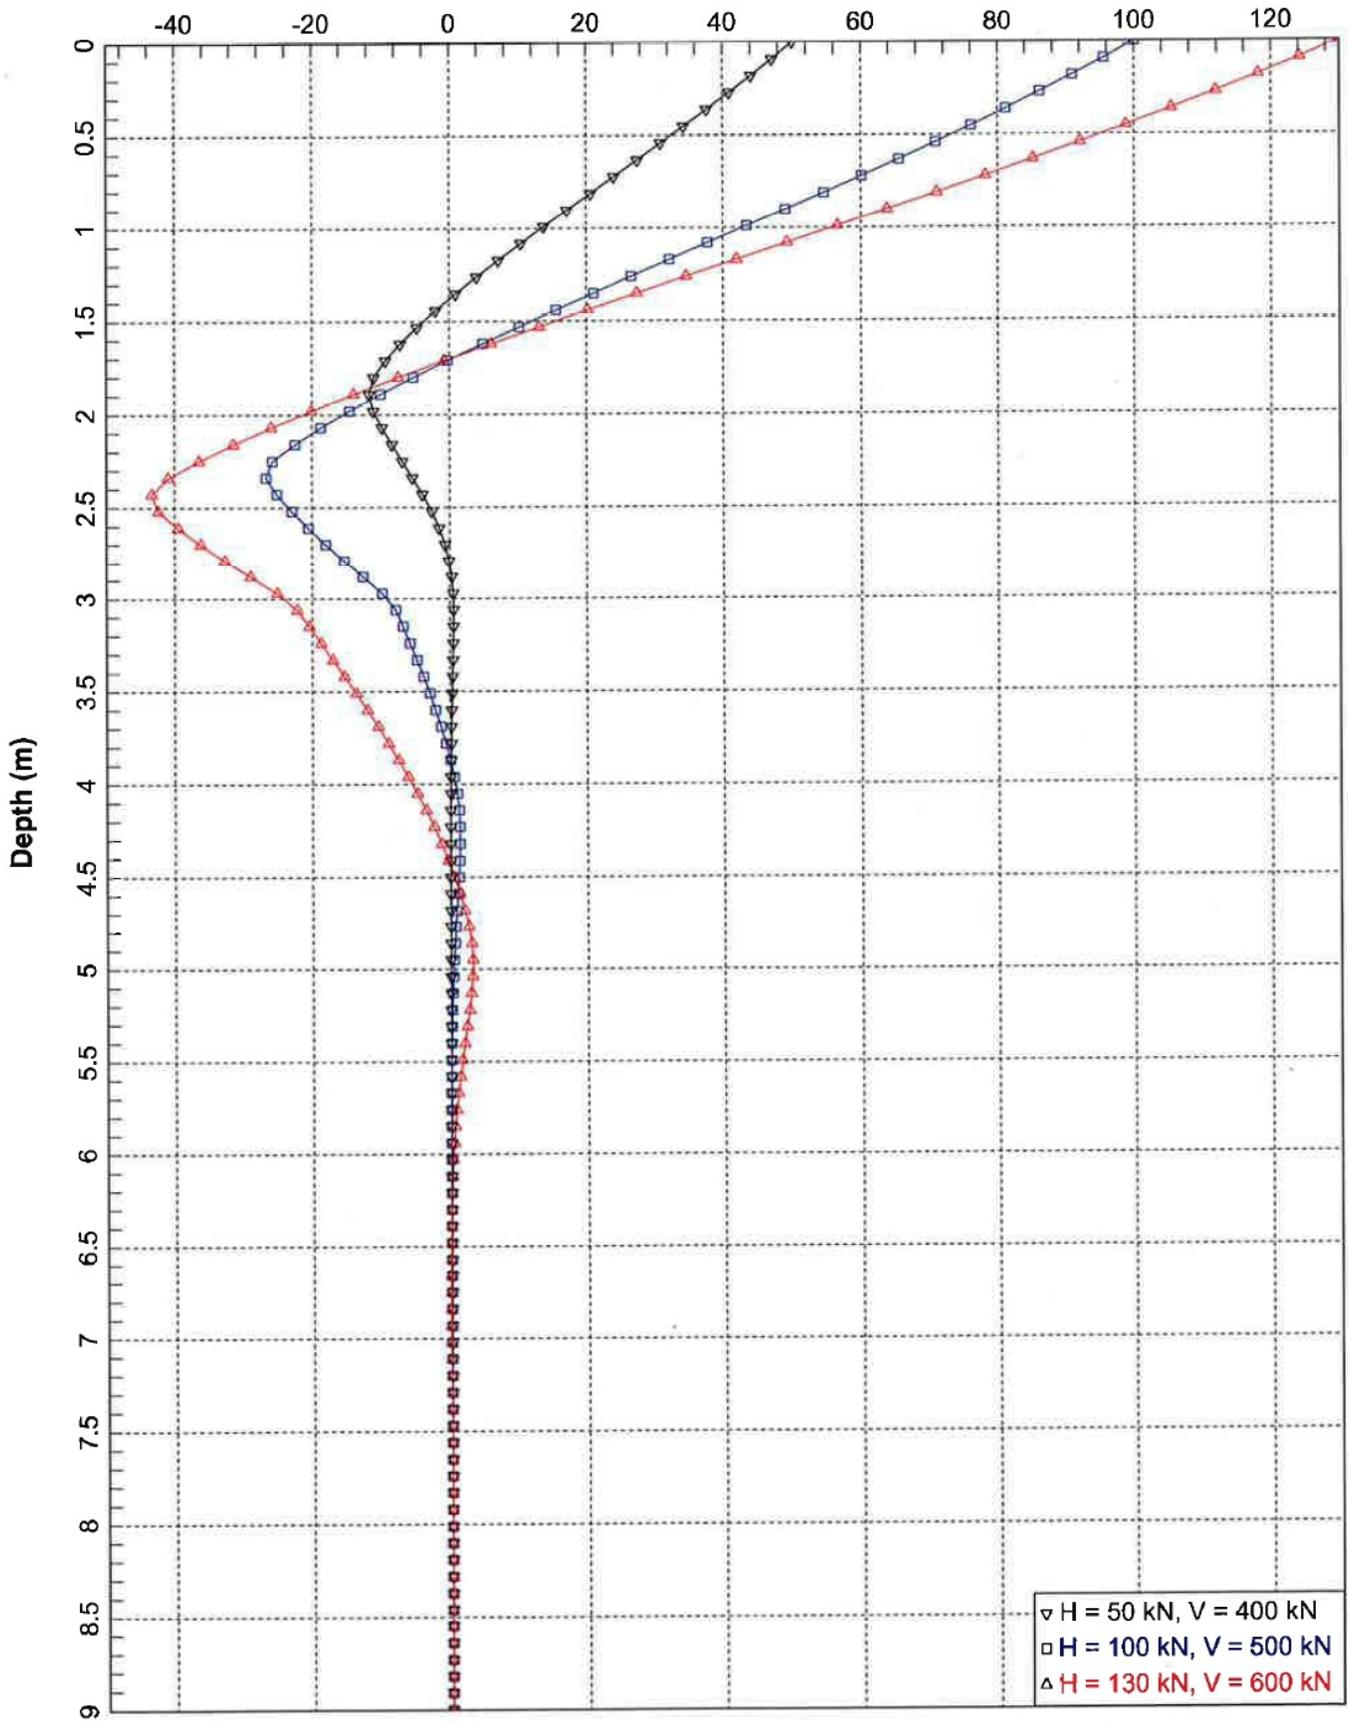
FIGURE 31

14 inch precast - fixed + 5:1 batter

Shear Force (kN)
