Plan and Profile of Shoal Lake Aqueduct

GREATER WINNIPEG WATER DISTRICT.
 BRIDGE OVER AQUEDUCT AT DEACON.

October 23, 2008
Stantec File: 113731470

**Reference: City of Winnipeg GWWD Bridge Inspections
Deacon Railway Bridge (buried) – Initial Inspection Results**

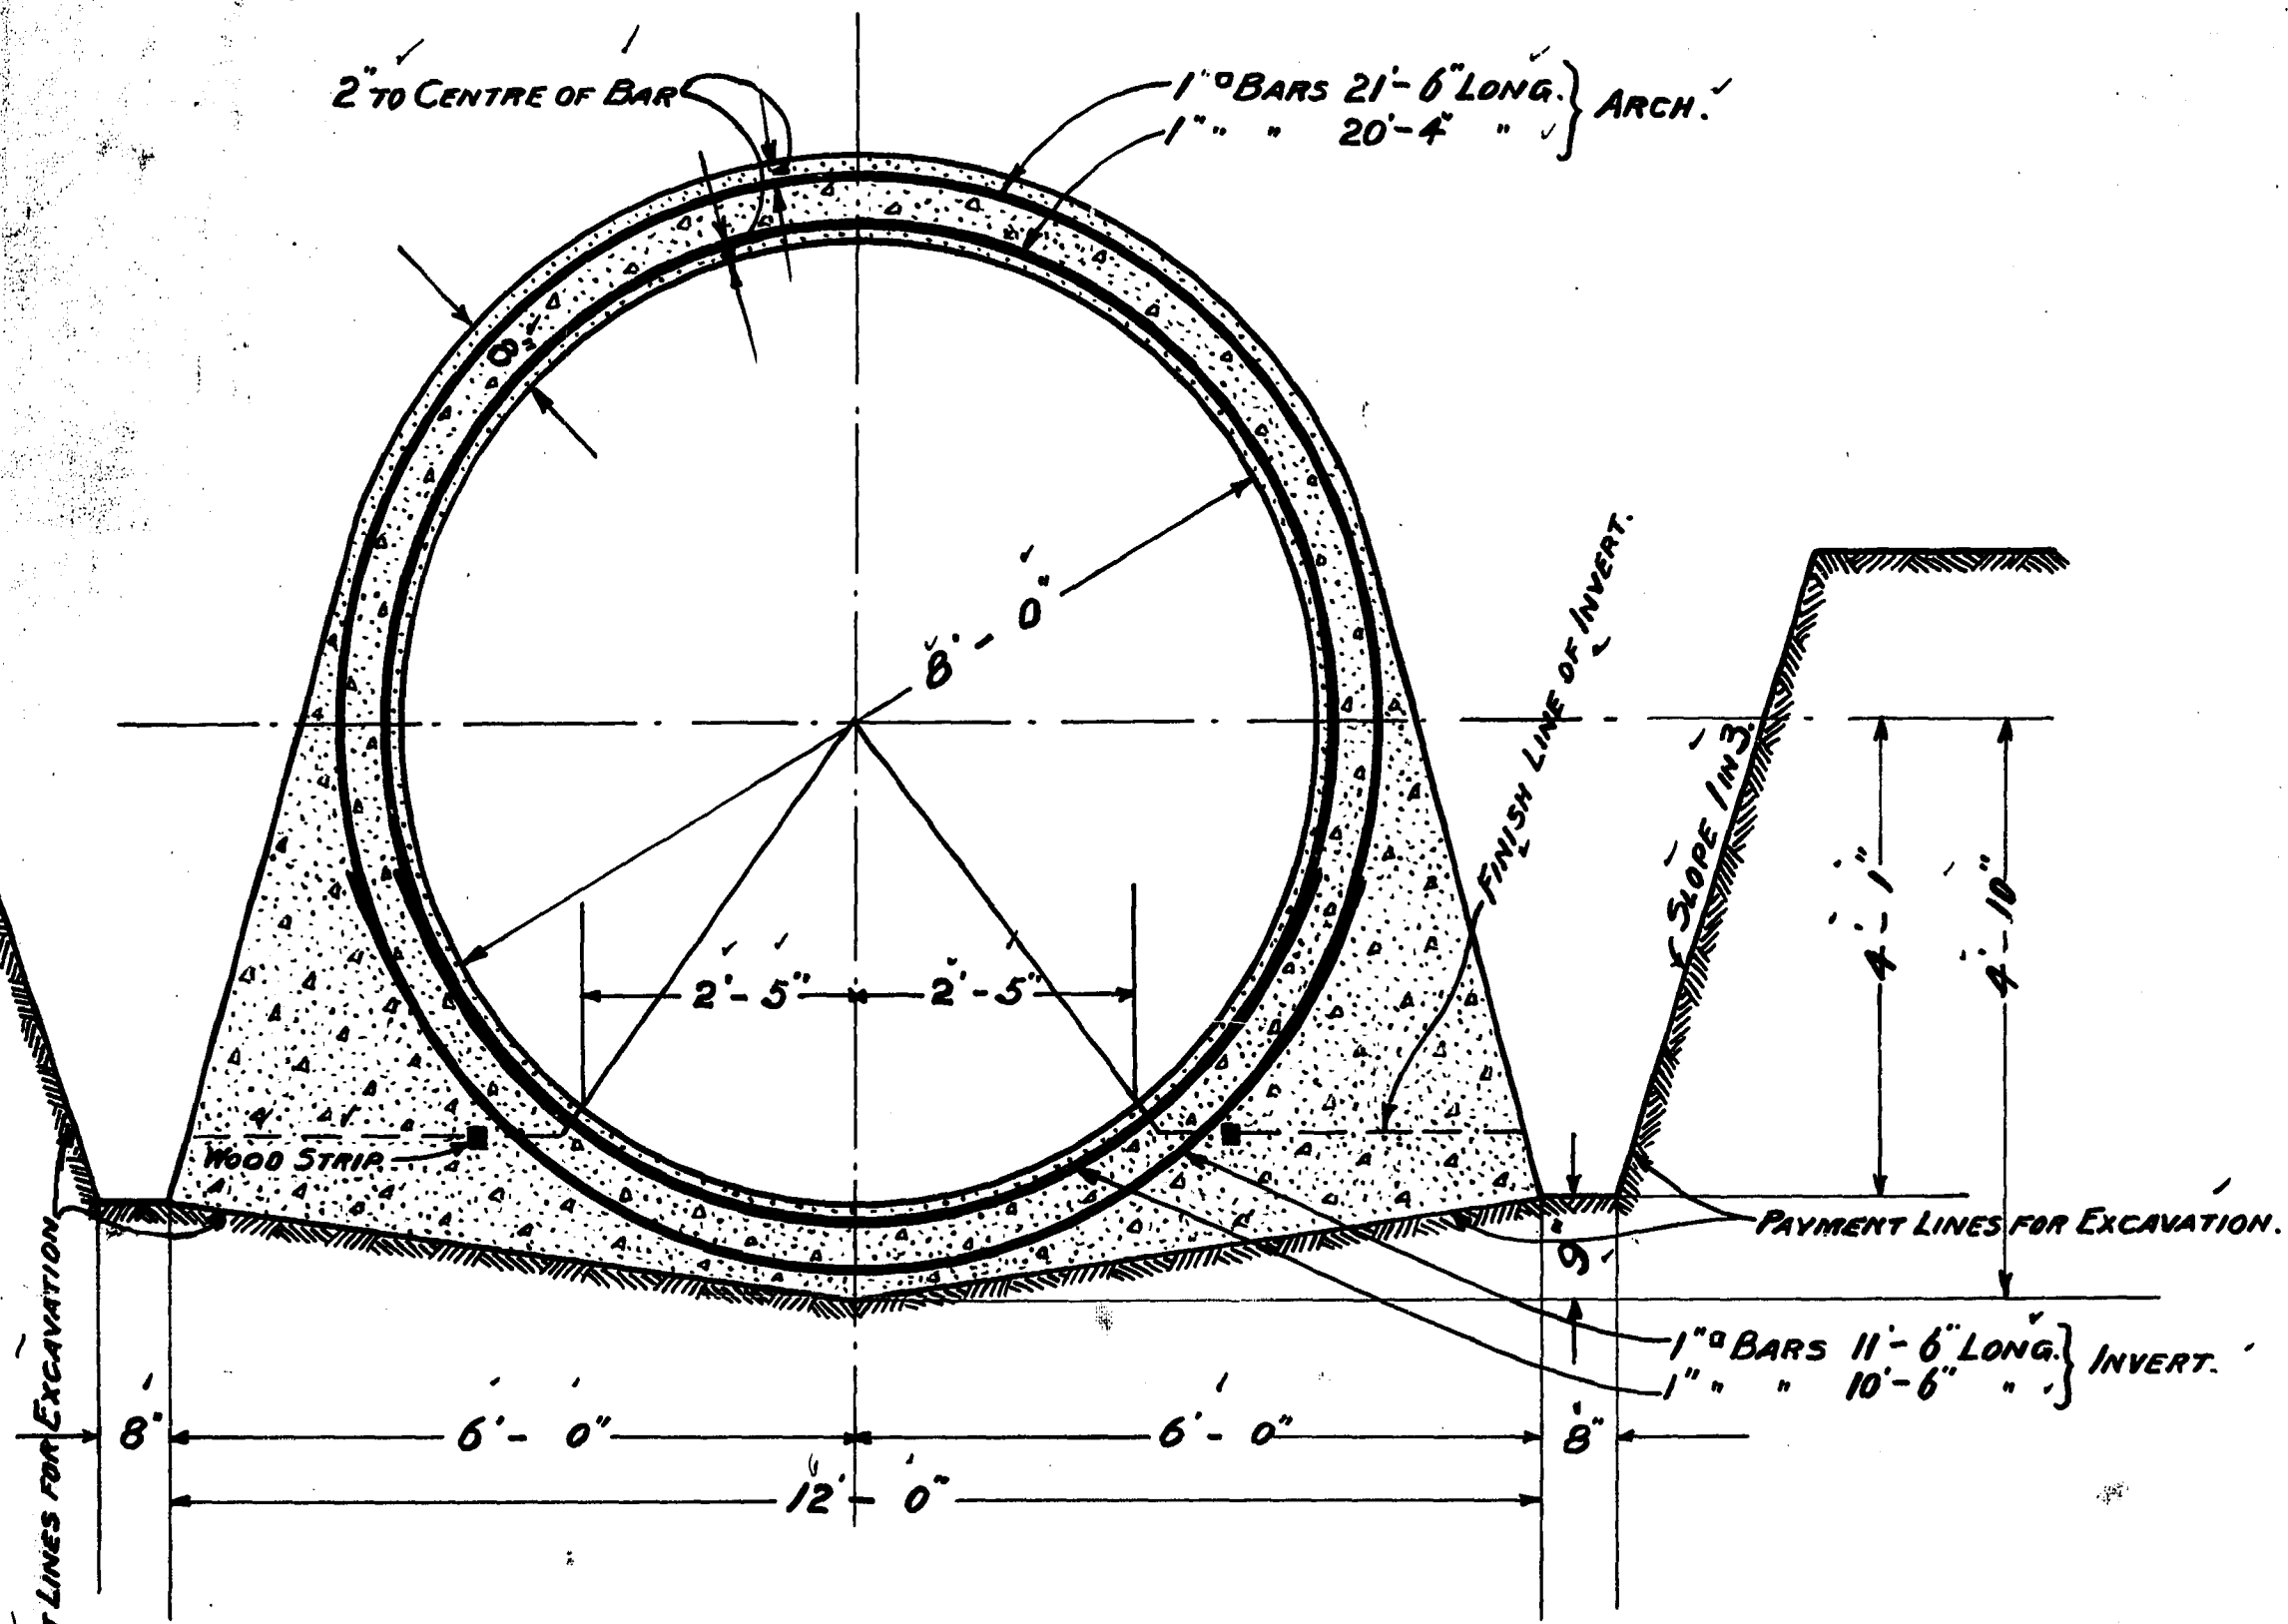
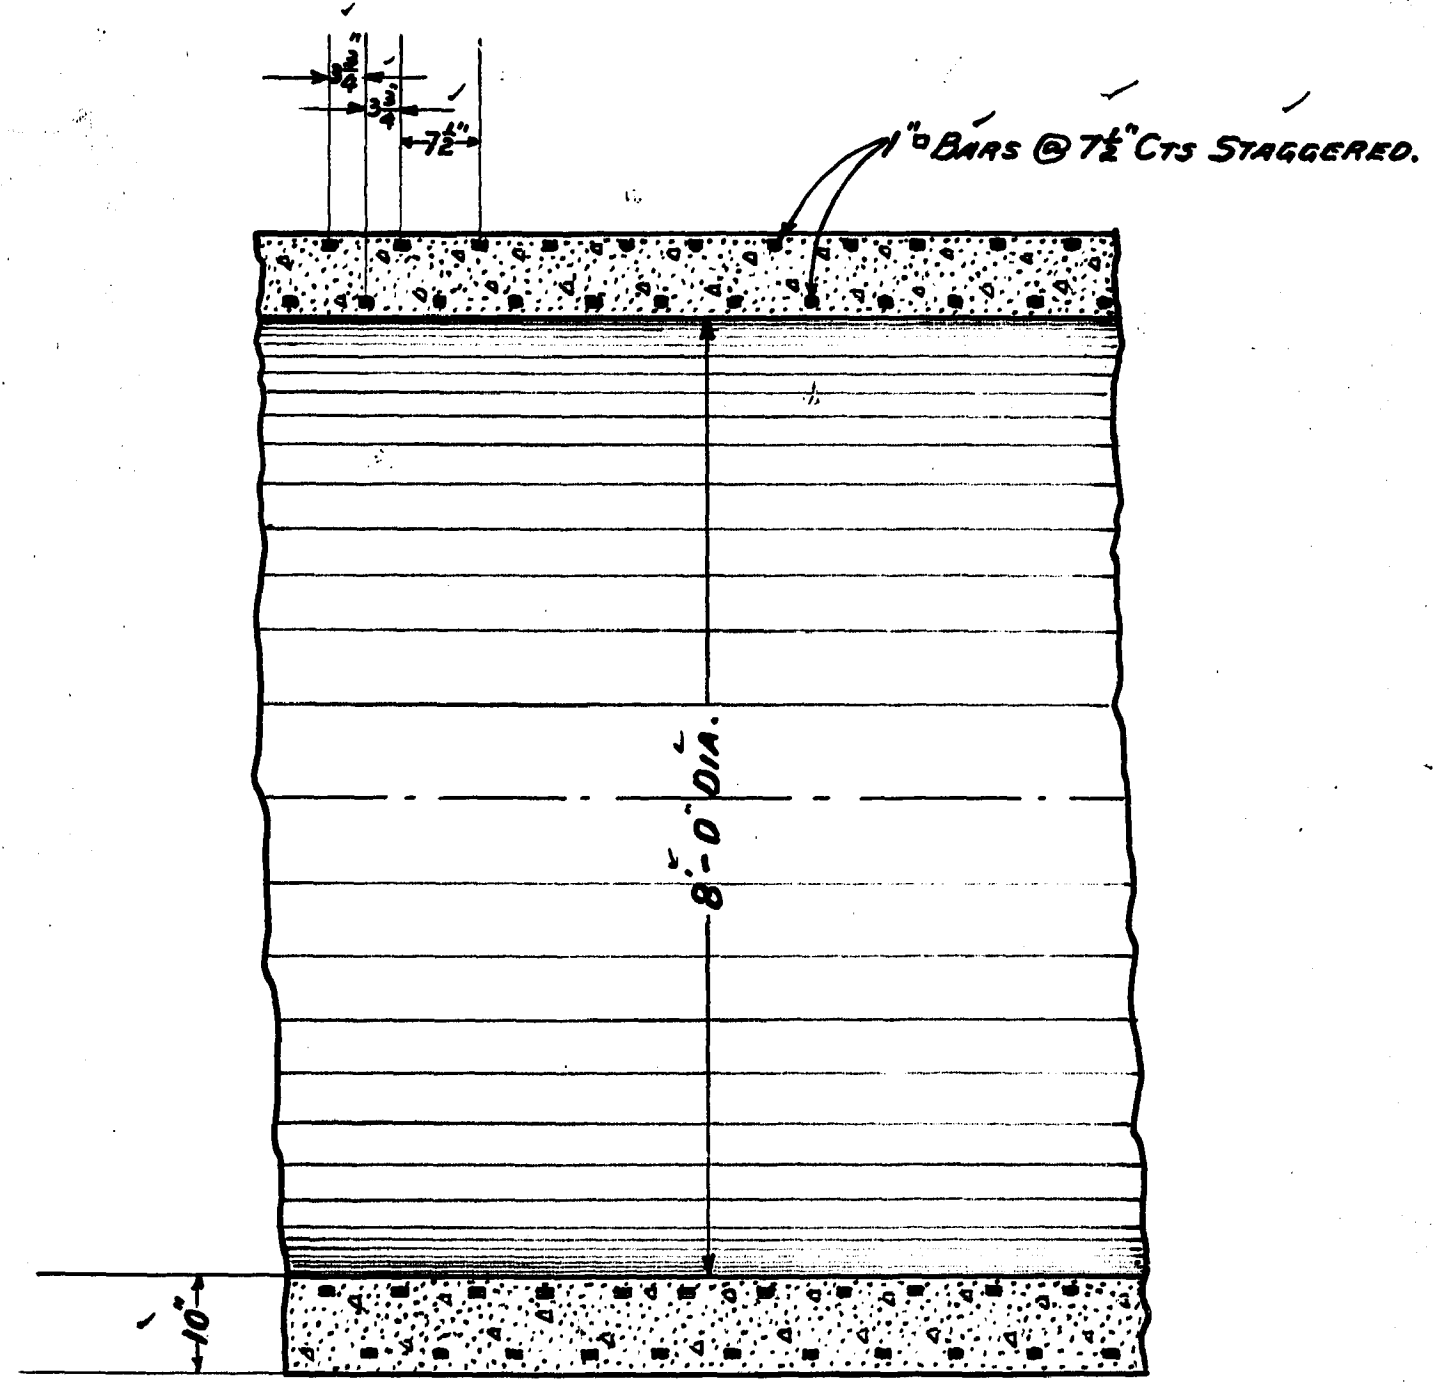
LONGITUDINAL SECTION OF PIPE.

CONCRETE IN ARCH = 0.829 CU YDS PER LINEAR FOOT.	STEEL IN ARCH = 982.5 = 3340.5 Lbs.
" " INVERT = 0.397 " " " " " "	" " INVERT = 516.5 = 1756.1 " "
TOTAL = 1.226 " " " " " "	TOTAL 1499.0 = 5096.6 " PER 15'-0" SECTION.

GREATER WINNIPEG WATER DISTRICT.
 8'-0" CIRCULAR REINFORCED AQUEDUCT.
 DOUBLE REINFORCED FOR RAILWAY CROSSING.
 JUNE 5TH 1918. SCALE 1/2" = 1 FT.

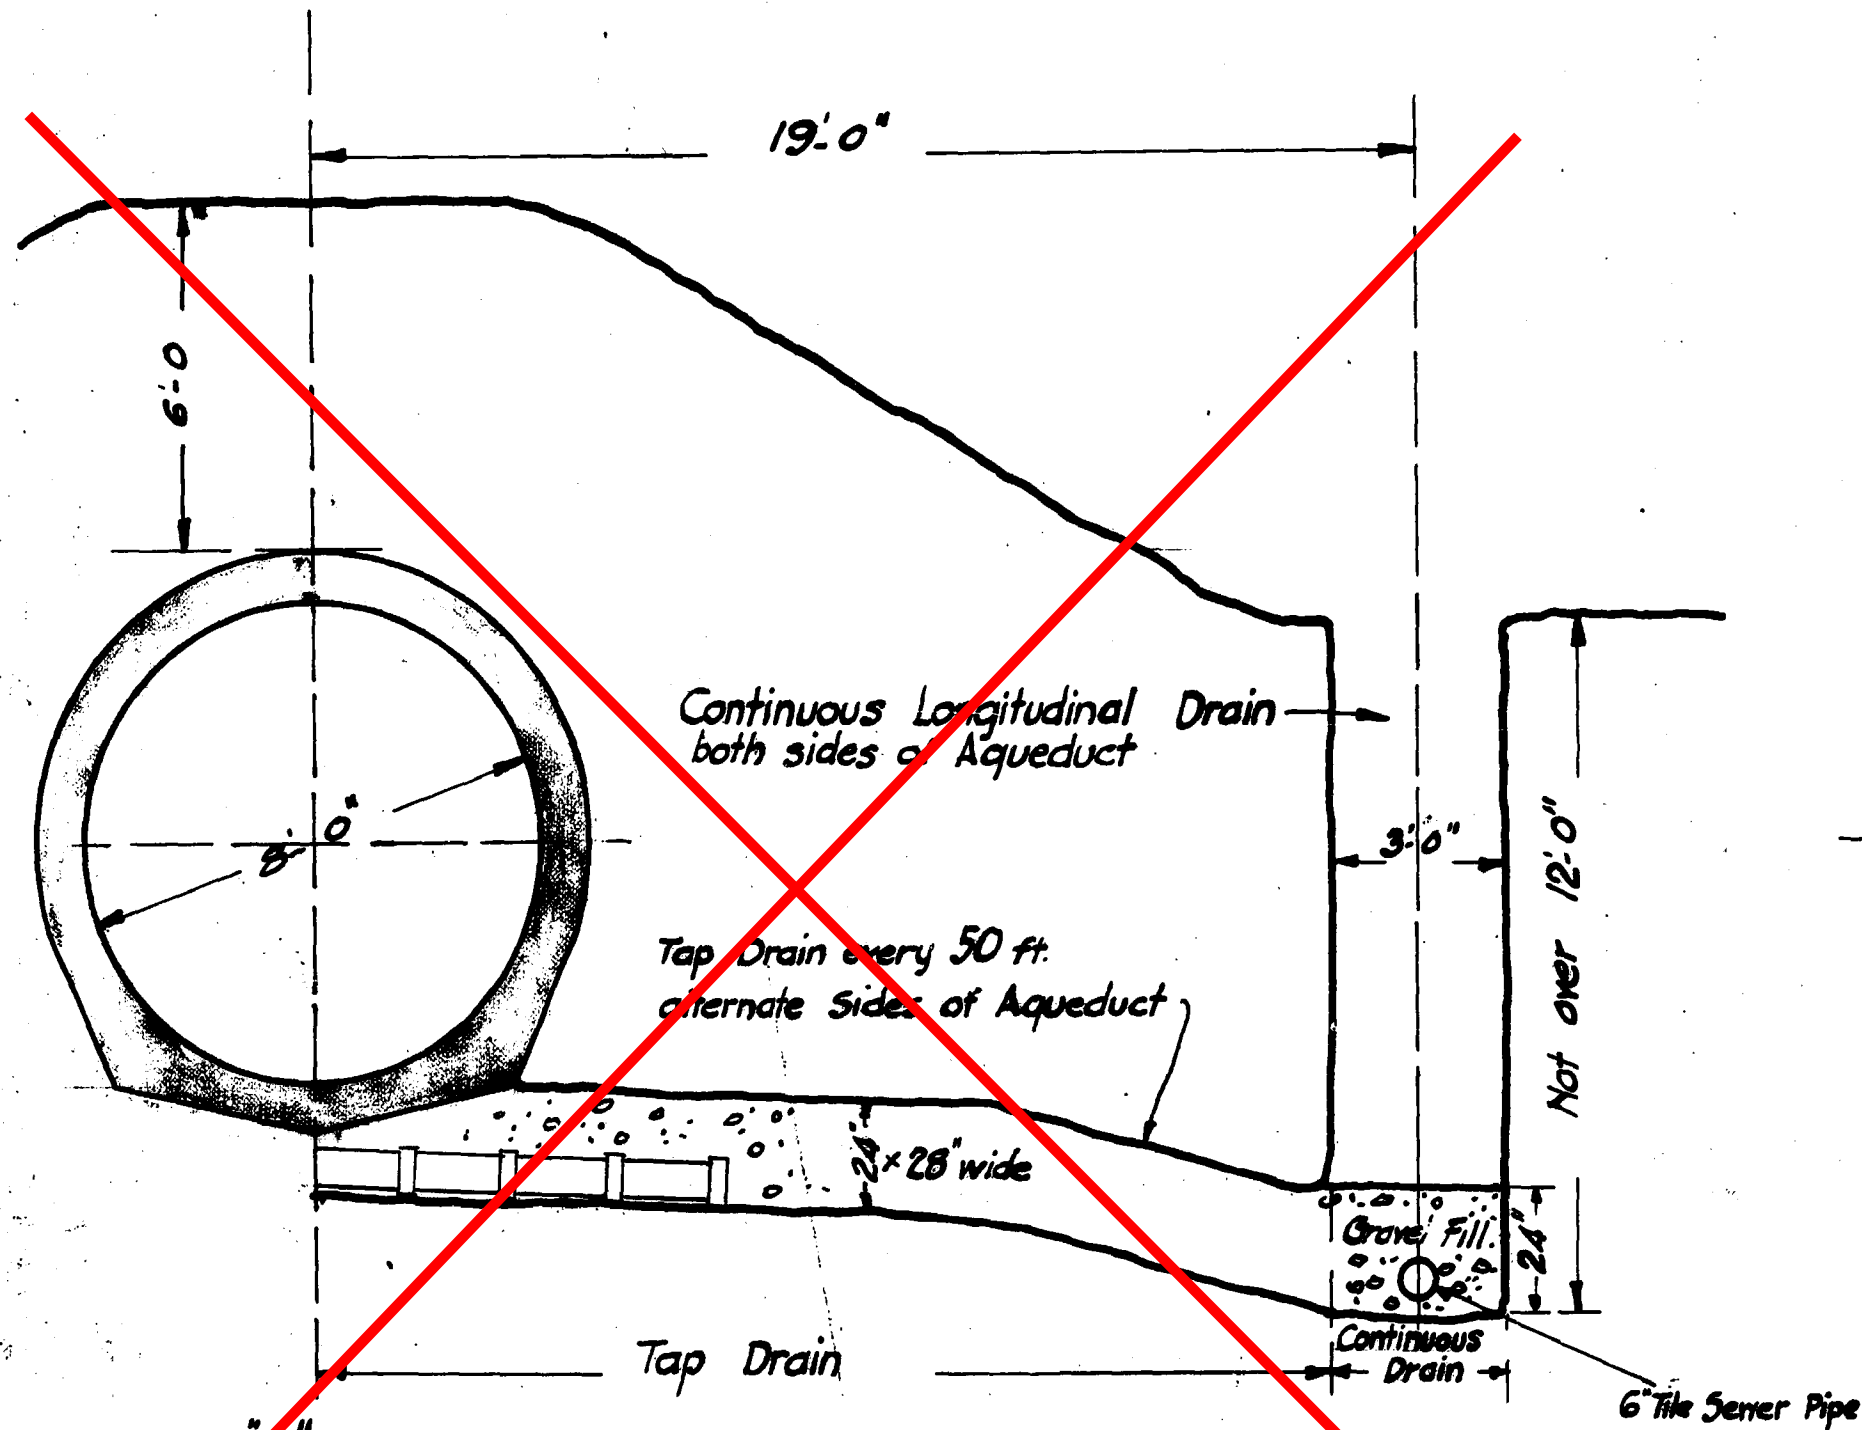
Method "A" of underdrainage which is the basis of payment to Fowler & Young and estimated to cost \$26,000.00 per Mile

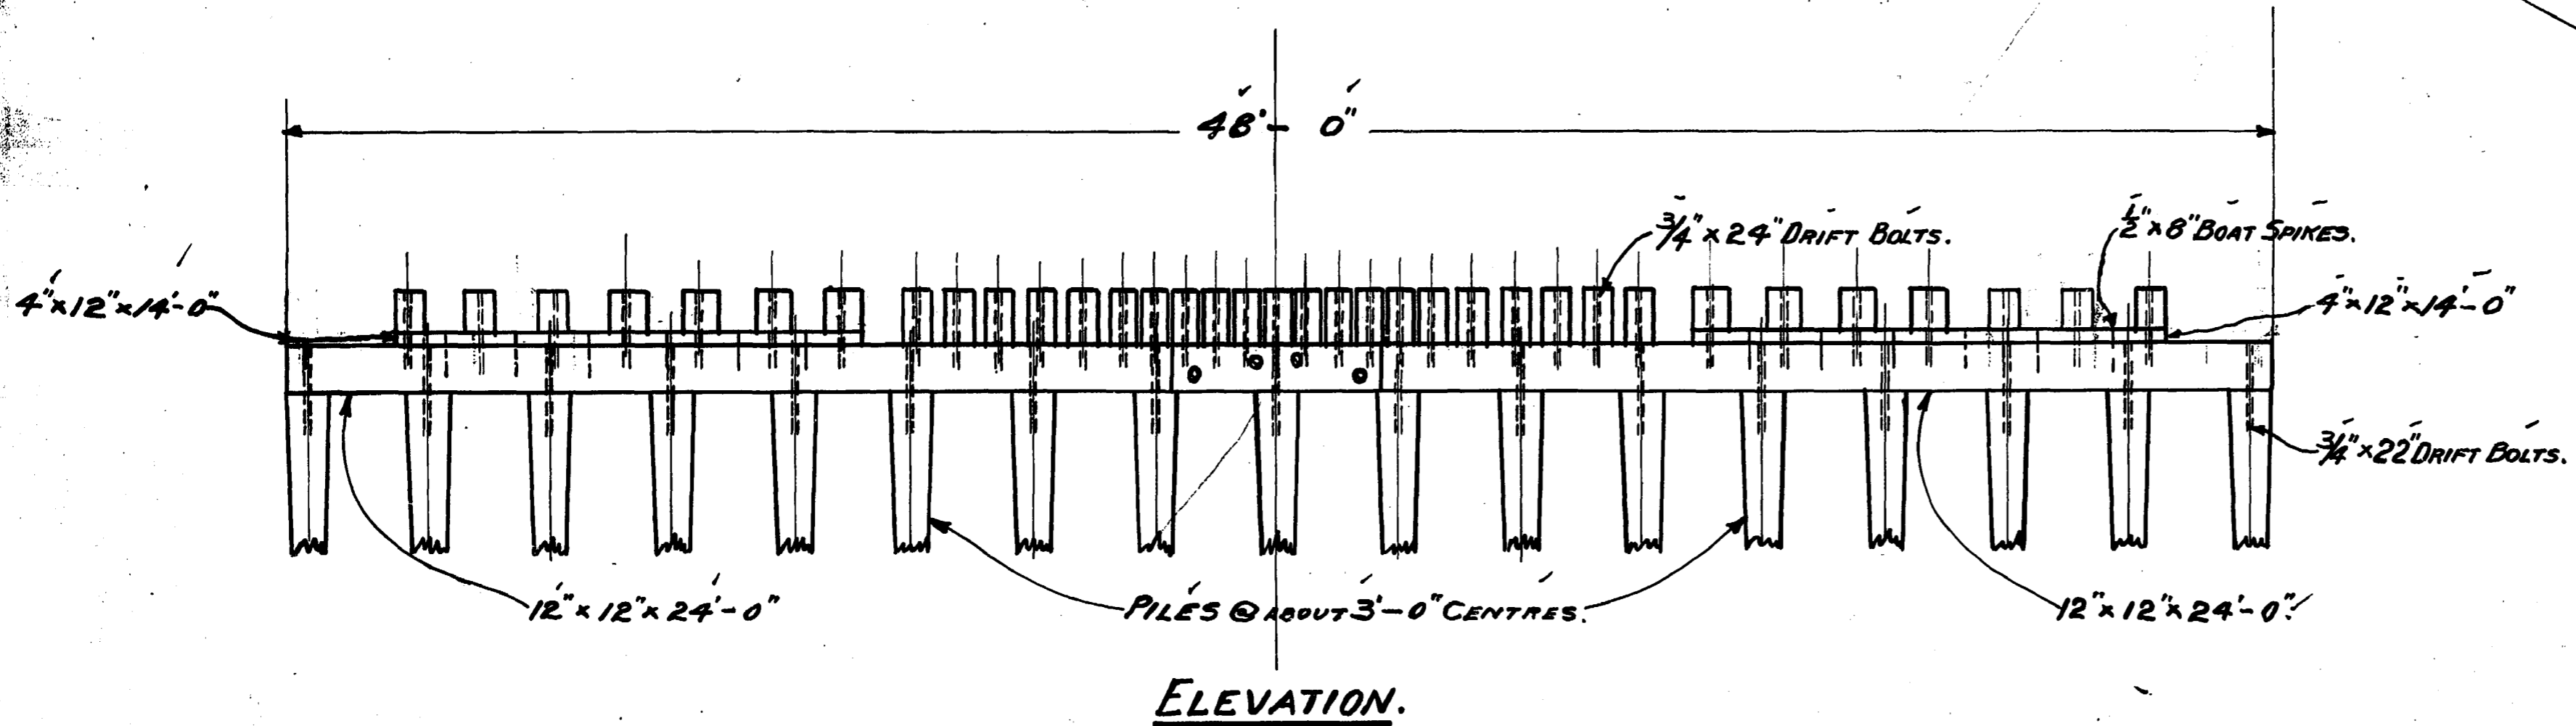
LUMBER					IRON.			
DESCRIPTION					DESCRIPTION.			
	KIND.	SIZE.	LENGTH.	NO OF Pcs.		SIZE.	NO OF Pcs.	
✓	CAPS.	DOUGLAS FIR	12' x 12'	24'-0"	4	DRIFT BOLTS	3/4" x 22"	38.
✓	TIES.	"	8' x 16'	16'-0"	21	"	3/4" x 24"	70.
✓	"	"	10' x 12'	16'-0"	8	BOAT SPIRES	2" x 8"	24.
✓	"	"	8' x 18'	16'-0"	6			
✓	FACING STRIPS	"	4' x 12'	12'-0"	4	BOLTS	3/4" x 22"	8
✓	SPLICES	"	4' x 12'	5'-0"	4	CAST WASHERS	3/4" x 3 1/2" P.P.	10.

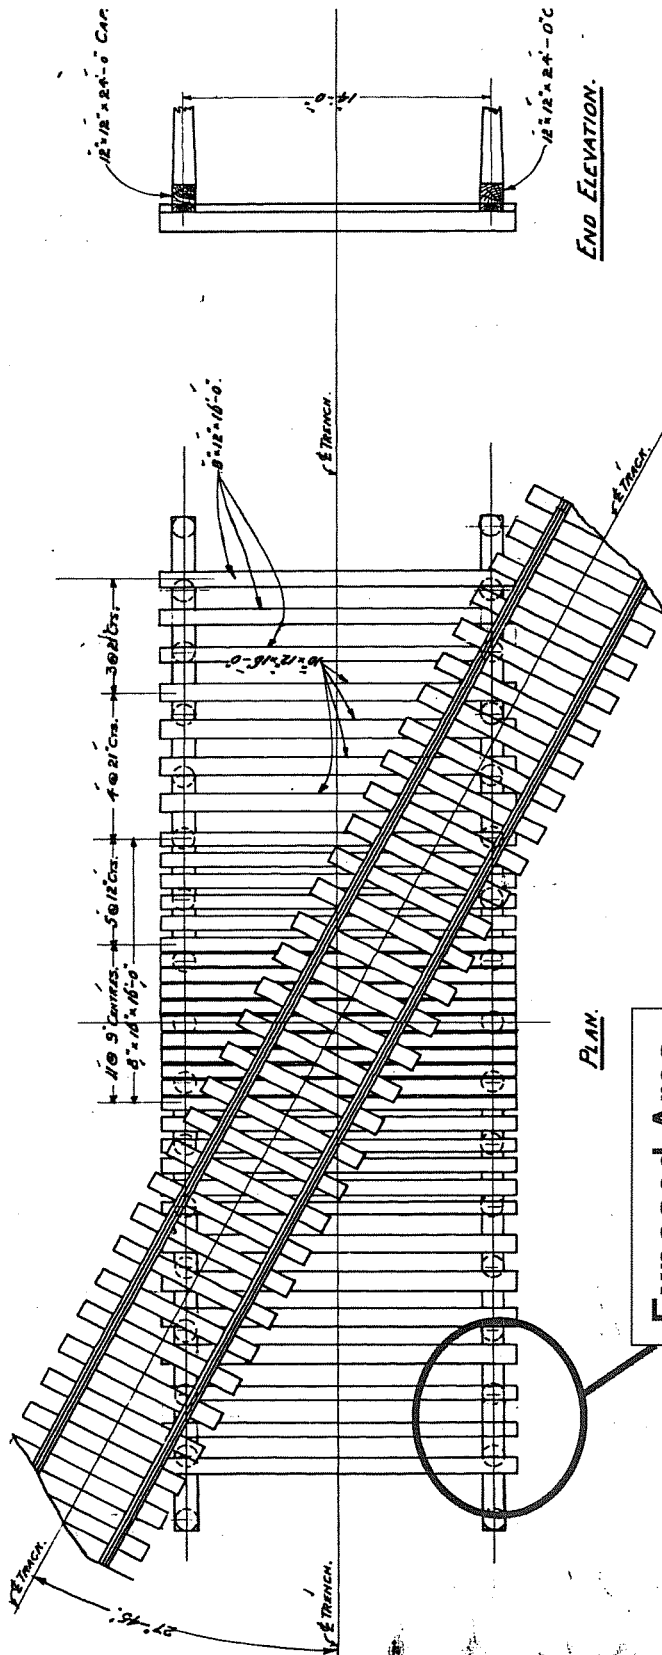
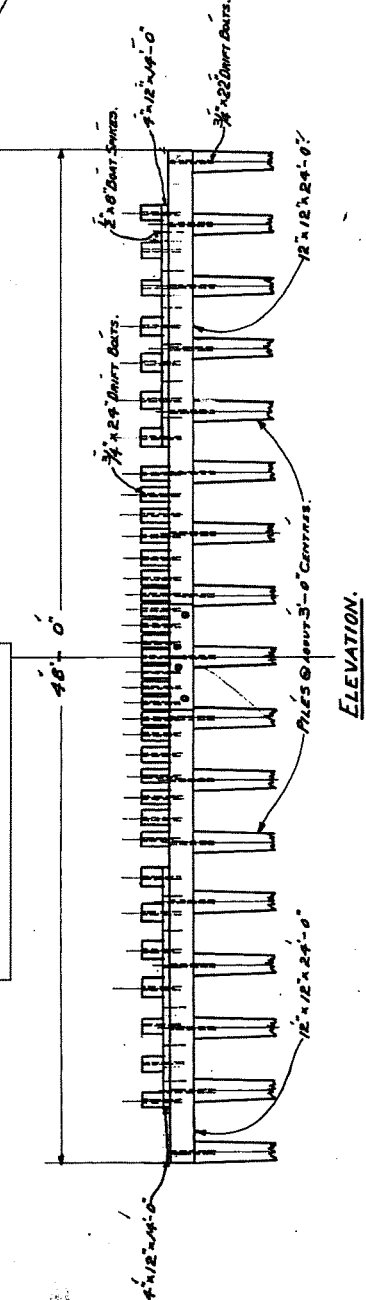
Figure 1

END ELEVATION.

PLAN.

Exposed Area

ELEVATION.
