***Phase 1 Environmental Site Assessment
Proposed East District Police Station***

PHASE I ENVIRONMENTAL SITE ASSESSMENT

1. LOCATION: ST. BONIFACE INDUSTRIAL PARK WINNIPEG MANITOBA
 2. CLIENT: NUMBER 10 ARCHITECTURAL GROUP / CITY OF WINNIPEG .
 3. PREPARED BY. D. OLEKSIUK P. ENG.
D. OLEKSIUK AND ASSOCIATES INC.
#3-434 ARCHIBALD ST. WINNIPEG, MB.
-

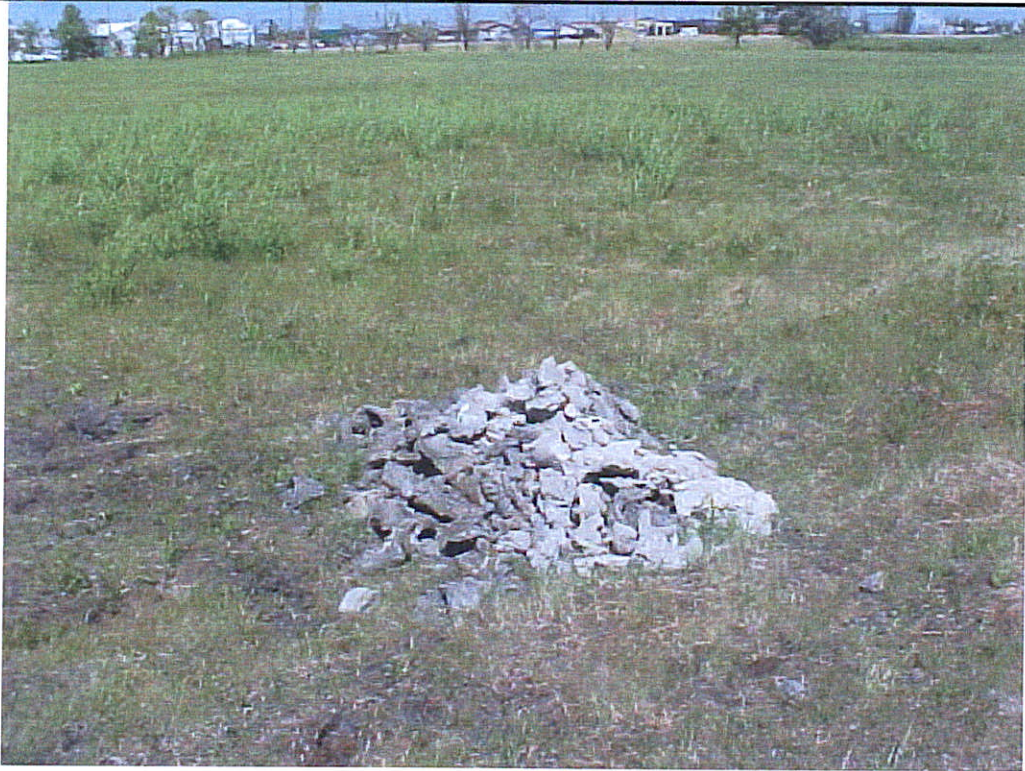
PHOTO #3- GEOTECHNICAL TEST HOLE CUTTINGS

Evidence of recent subsurface drilling soil cuttings were noted at three locations (Photo #3). These are presumed to be associated with a geotechnical survey of the site. The cuttings did not indicate any staining or unusual odours.
