# **APPENDIX 'A'**

# **GEOTECHNICAL REPORT**

The geotechnical report is provided to aid in the Contractor's evaluation of the existing pavement structure and/or soil conditions. The information presented is considered accurate at the locations shown on the Drawings and at the time of drilling. However, variations in pavement structure and/or soil conditions may exist between test holes and fluctuations in groundwater levels can be expected seasonally and may occur as a result of construction activities. The nature and extent of variations may not become evident until construction commences.

## Geotechnical Report for Waverley Street Southbound

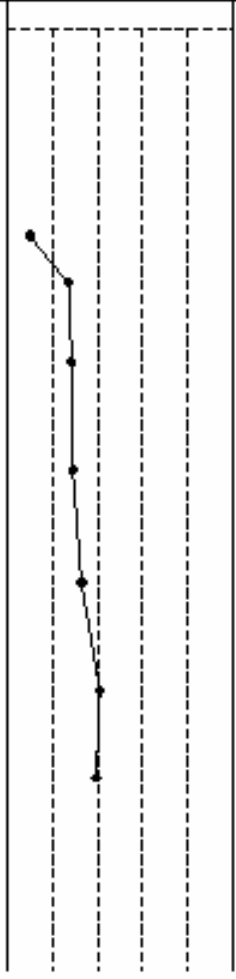
TESTHOLE TH10

Project Name: 2007 Regional and Residential Streets Program Client: Stantec Consulting Ltd. Site: Waverley Street, Bishop Grandin Boulevard to Bison Drive Testhole Location: SB, approximately Sta. 1+050, acceleration lane, 1.6 m E of W side of lane		Date Drilled: January 17, 2007 Depth of Testhole: 2.1 m Logged by: Kurtis Kulchyski	
Subsurface Profile		Laboratory Testing	
Depth	Symbol	Description	Water Content (%)
			0    20    40    60    80    100
Ground Surface

Asphalt

Concrete	
0.5

Limestone Fill - 20 mm maximum aggregate size	
1.0

Clay Fill - grey/brown, moist, firm, high plasticity, trace fine grained gravel, trace fine to coarse grained sand

Clay - brown, moist, firm, high plasticity - light brown below 2.0 m, some silt	
2.0			
2.5		End of testhole at 2.1 m below grade.	
		No water seepage or soil sloughing were observed during or after the completion of drilling.
