# JESSIE AVENUE GUELPH STREET TO HARROW STREET 2008 CITY OF WINNIPEG LOCAL STREETS RENEWALS PROGRAM

### Jessie Avenue Guelph Street to Harrow Street 2008 Local Street Renewals Program Geotechnical Investigation

## YALE AVENUE WILTON STREET TO GUELPH STREET 2008 CITY OF WINNIPEG LOCAL STREETS RENEWALS PROGRAM

# ROSEDALE AVENUE NASSAU STREET TO OSBORNE STREET 2008 CITY OF WINNIPEG LOCAL STREETS RENEWALS PROGRAM

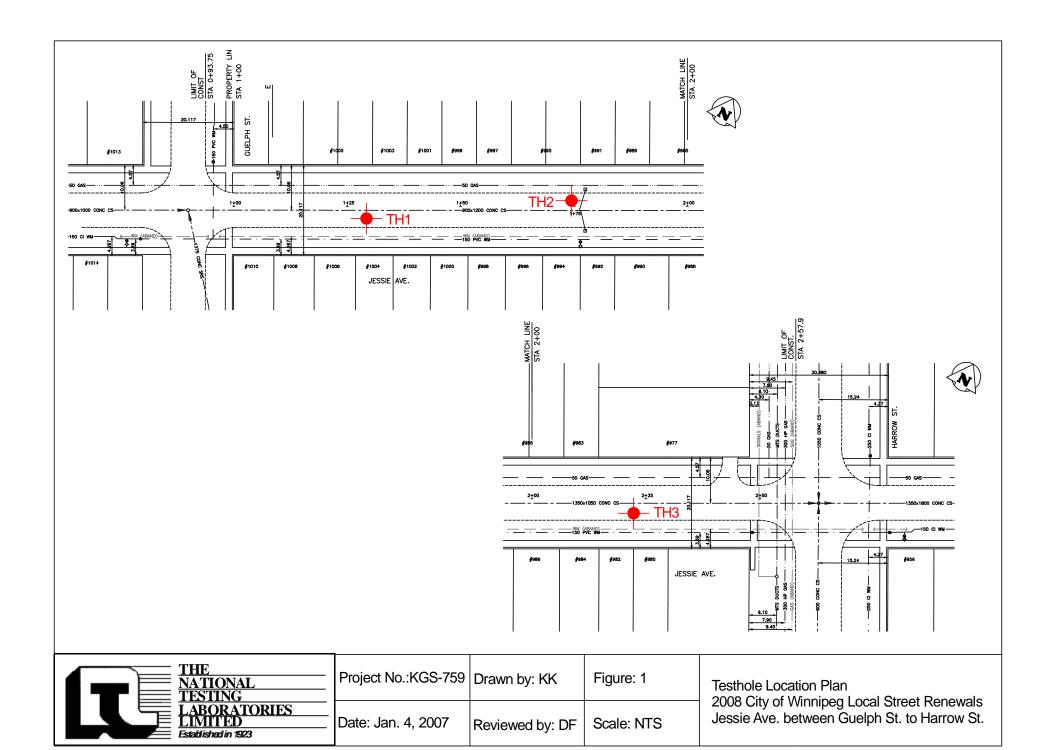
Taathal		Pavement S	Surface	Pavement Structure Material		Cample	Sample	Moisture	Particle Size Analysis			Atterberg Limits			
Testhol e ID	Testhole Location	Туре	Thickness (mm)	Туре	Thickness (mm)	Sample Description	Depth (m)	Content (%)	Gravel (%)	Sand (%)	Silt (%)	Clay (%)	Liquid Limit	Plastic Limit	Plasticity Index
	EB Lane, 2 m E of property line between 1006 / 1004 Jessie St., 1.5 m away from curb	Asphalt/Concrete	60/180	N/A	-	-	ı	-	-	-	ı	-	-	•	-
TH2	WB Lane, 2.4 m W of property line of 995 /	Asphalt/Concrete	15/190	N/A	-	Clay	0.6	33.7	0.0	2.5	10.3	87.2	84	30	54
1112	991 Jessie St., 1.5 m away from curb	AsphalivConcrete	e 15/190	IN/A	-	Clayey Silt	1.2	10.7	0.0	5	68.4	26.6	25	18	7
	EB Lane, In line with property line between 982 / 980 Jessie St., 1.5 m away from curb	Asphalt/Concrete	27/213	N/A	-	-	-	-	-	-	-	-	-	-	-

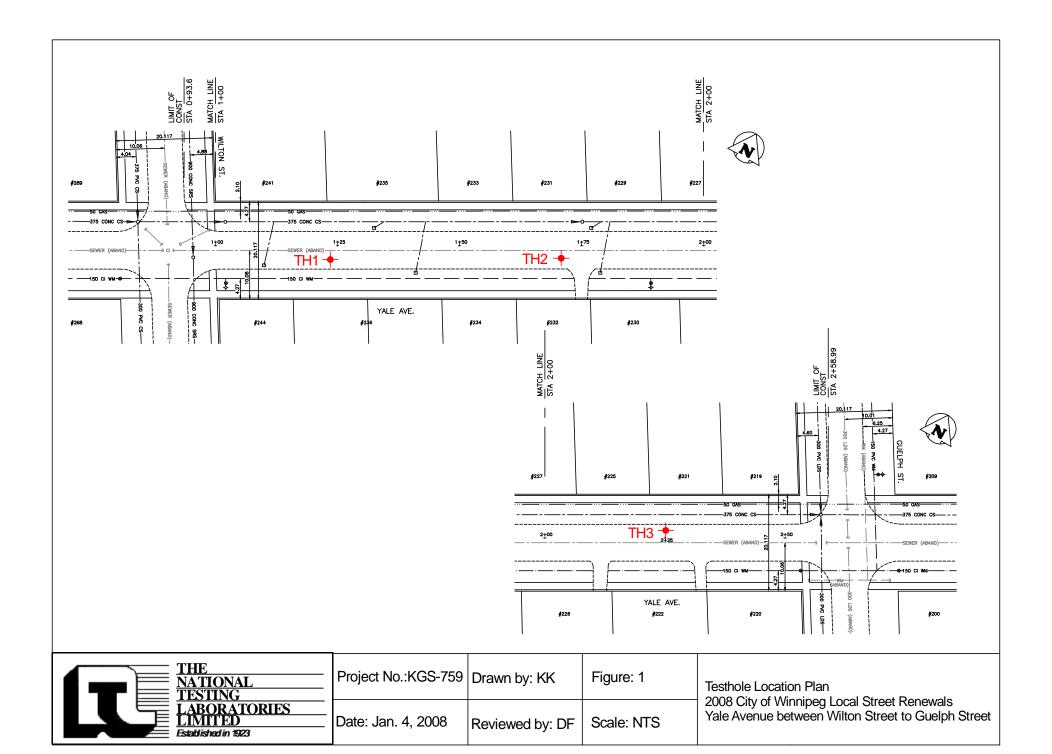
Tootholo		Paveme	nt Surface	Pavement Stru	ucture Material	Commis	Sample	Moisture	Par	ticle Size	e Analy	sis	Att	erberg L	.imits
Testhole ID	Testhole Location	Туре	Thickness (mm)	Туре	Thickness (mm)	Sample Description	Depth (m)	Content (%)	Gravel (%)	Sand (%)	Silt (%)	Clay (%)	Liquid Limit	Plastic Limit	Plasticity Index
TH1	EB lane, In line with the east property line of 241 Yale Ave., 1.8 m away from curb	Asphalt	80	Granular	220	N/A	N/A	-	-	-	-	-	-	-	-
TH2	EB lane, 7.5 m east of property line of 234 / 232 Yale Ave., 1.8 m away from curb	Asphalt	100	Granular	225	Clayey Silt	0.9	21.4	0.0	6.2	64.2	29.6	29	16	13
ТН3	WB lane, 3.5 m east of property line of 225 / 221 Yale Ave., 1.8 m away from curb	Asphalt	95	Granular	205	Silty Clay	0.3	28.4	0.8	16	31.8	51.4	55	22	33

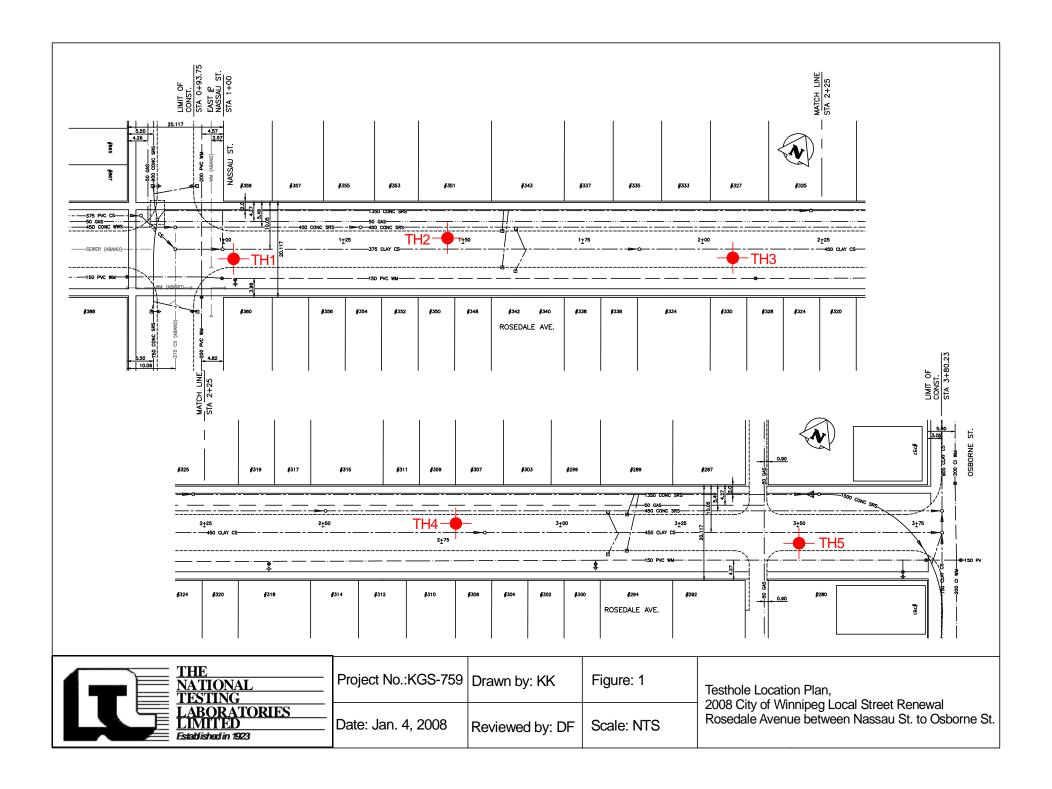
Taathala		Pavement S	urface	Pavement S	tructure Material	Commis	Sample	Moisture	Part	ticle Size	Analys	sis	Atterberg Limits		
Testhole ID	Testhole Location	Туре	Thickness (mm)	Туре	Thickness (mm)	Sample Description	Depth (m)	Content (%)	Gravel (%)	Sand (%)	Silt (%)	Clay (%)	Liquid Limit	Plastic Limit	Plasticity Index
	EB lane, 3.3 m east of the west propery line of 360 Rosedale Avenue, 1.8 m away from curb	Asphalt/Concrete	125/175	N/A	-	N/A	N/A	•	1	-		-	-	-	-
TH2	WB lane, 5.9 m east of the property line of 353 / 351 Rosedale Avenue, 1.8 m away from curb	Asphalt/Concrete	25/195	N/A	-	Clay	0.6	37.5	0.0	1.8	15.3	82.9	98	29	69
	EB lane, 2.7 m west of the propery line of 330 / 328 Rosedale Avenue, 1.8 m away from curb	Asphalt/Concrete	27/213	N/A	-	Clayey Silt	1.2	28.6	0.0	2.3	58.2	39.5	37	17	20
TH4	WB lane, 0.1 m east of the property line of 309 / 307 Rosedale Avenue, 1.8 m away from curb	Asphalt/Concrete	25/205	N/A	-	N/A	N/A	-	-	-	-	-	-	-	-

EB lane, 6.6 m east of the west propery line of 280 Rosedale Avenue, 1.8 m away from curb	Asphalt/Concrete	35/190	N/A	-	N/A	N/A	-	-	1	-	1	-	-	-

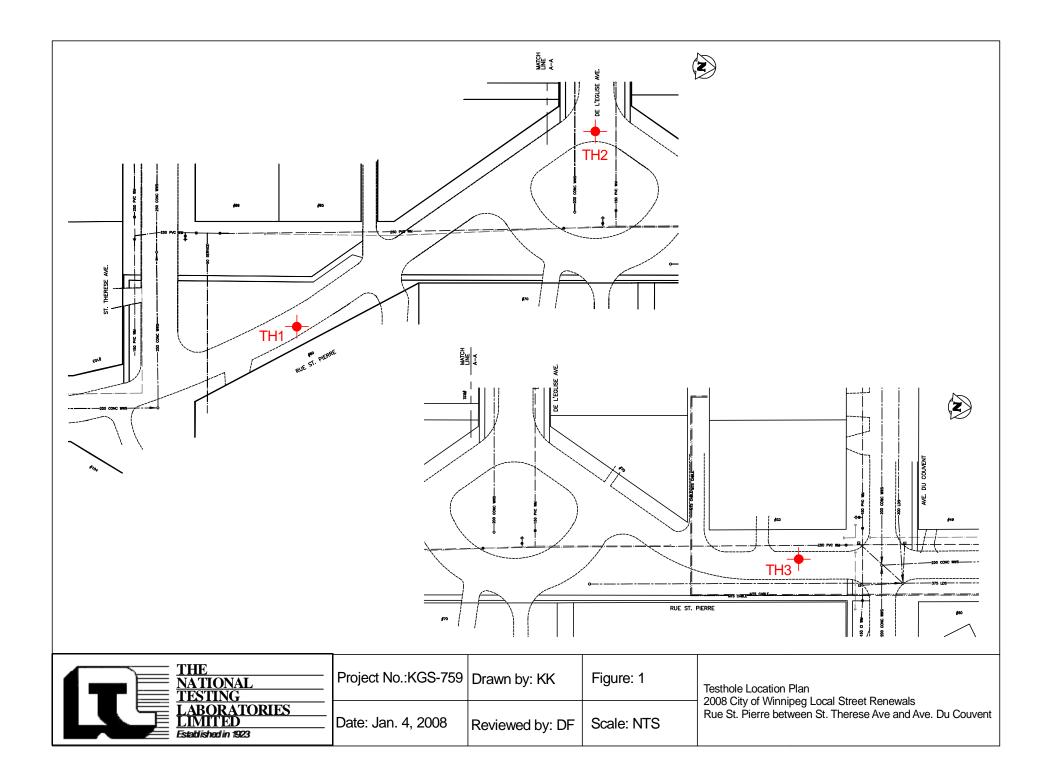
Testhole		Pavement Surface		Pavement Structure Material		Commis	Sample	Moisture	Pai	rticle Size	Analy	sis	At	terberg Li	mits
ID	Testhole Location	Туре	Thickness (mm)	Туре	Thickness (mm)	Sample Description	Depth (m)	Content (%)	Gravel (%)	Sand (%)	Silt (%)	Clay (%)	Liquid Limit	Plastic Limit	Plasticity Index
TH1	NB Lane, 40 m N of the intersection with St. Therese Avenue, 1.5 m away from curb	Asphalt	130	Granular	320	Clay	0.6	32	0.1	8.8	24.8	66.3	65	23	42
I IH2	2.5 m west of the westerley edge of the traffic circle	Asphalt	95	Granular	205	Clayey Silt	1.2	23.8	0.0	6.6	62.2	31.2	29	17	12
	SB Lane, 6.5 m N of the driveway of 53 Rue St. Pierre, 1.8 m away from curb	Asphalt	130	Granular	327	N/A	N/A	-	-	•	-	-	-	ı	-

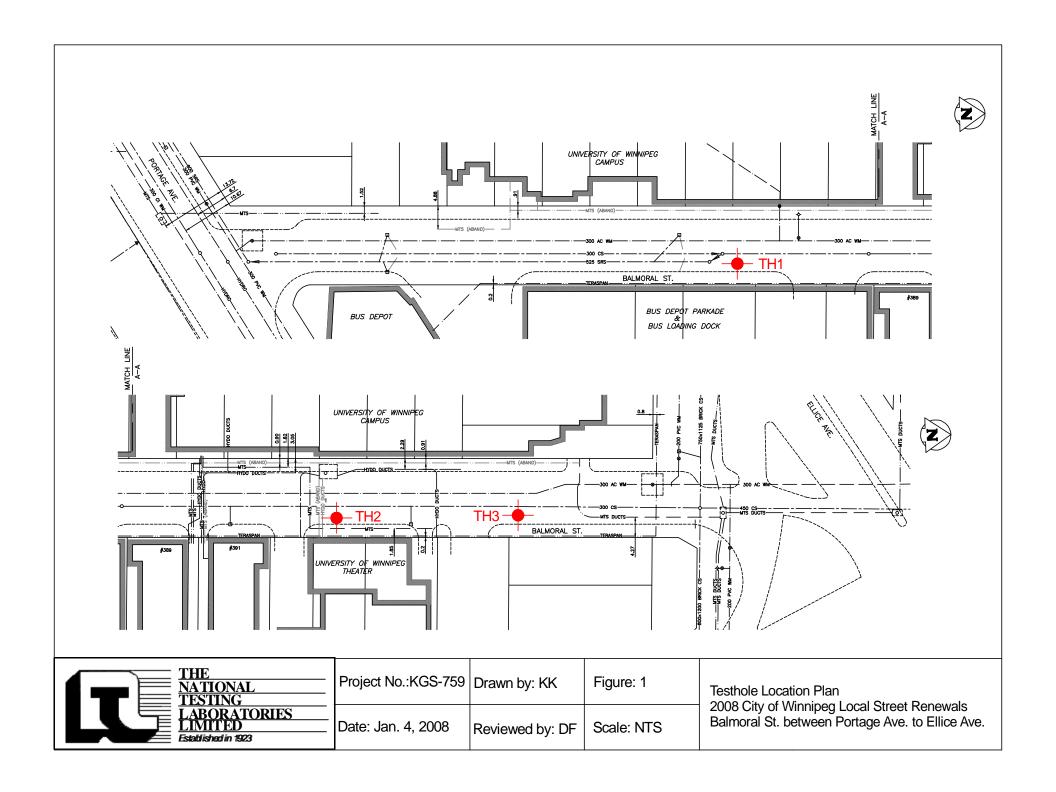
Tablesia		Pavement Surface		Pavement Structure Material		la	Sample	Moisture	Particle Size Analysis				Atterberg Limits		
Testhole ID	Testhole Location	Туре	Thickness (mm)	Туре	Thickness (mm)	Sample Description	Depth (m)	Content (%)	Gravel (%)	Sand (%)	Silt (%)	Clay (%)	Liquid Limit	Plastic Limit	Plasticity Index
I H1	E. Curb Lane, 28 m N of the NW corner of the Bus Depot Parkade, 1.7 m away from curb	Concrete	190	Granular	710	N/A	N/A	1	-	-	-	ı	-	-	-
TH2	E. Curb Lane, 6.5 m N of the SW corner of the U of W Theater, 1.7 m away from curb	Concrete	230	Granular	670	Silty Clay	1.2	24.6	0.0	6.5	35.2	58.3	46	18	28
TH3	E. Curb Lane, 20 m N of the NW corner of the U of W Theater, 2.0 m away from curb	Concrete	200	Granular	867	N/A	N/A	-	-	-	-	1	-	-	-
