**ASHBURN STREET
SARGENT AVENUE TO WELLINGTON AVENUE
CITY OF WINNIPEG 2009 STREET RENEWAL PROGRAM**

Prepared for
KGS GROUP INC.
3rd FLOOR - 865 WAVERLEY STREET
WINNIPEG, MANITOBA
R3T 5P4

Prepared by
THE NATIONAL TESTING LABORATORIES LIMITED
199 HENLOW BAY
WINNIPEG, MANITOBA
R3Y 1G4

**LARK STREET
BANNATYNE AVENUE TO WILLIAM AVENUE
CITY OF WINNIPEG 2009 STREET RENEWAL PROGRAM**

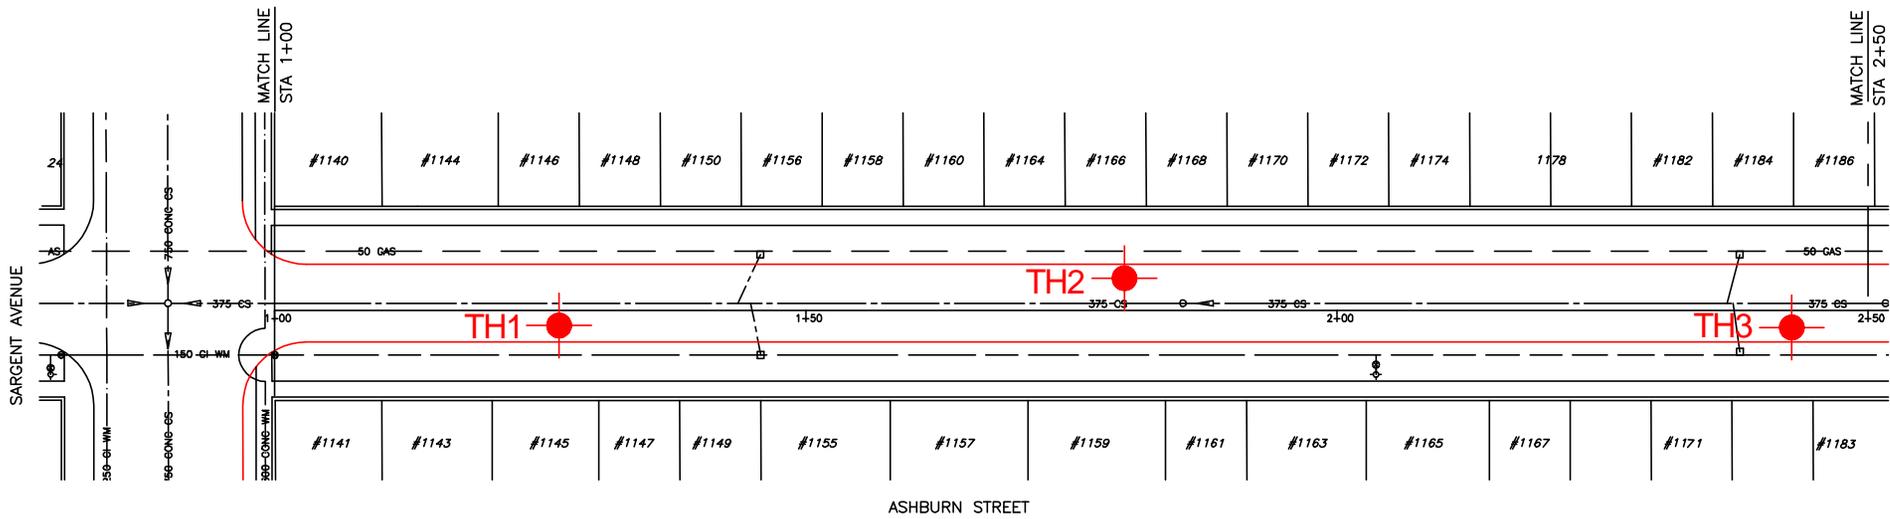
Figure: 1

Testhole Location Plan
Ashburn Street
Sargent Avenue to Wellington Avenue
City of Winnipeg 2009 Street Renewal Program

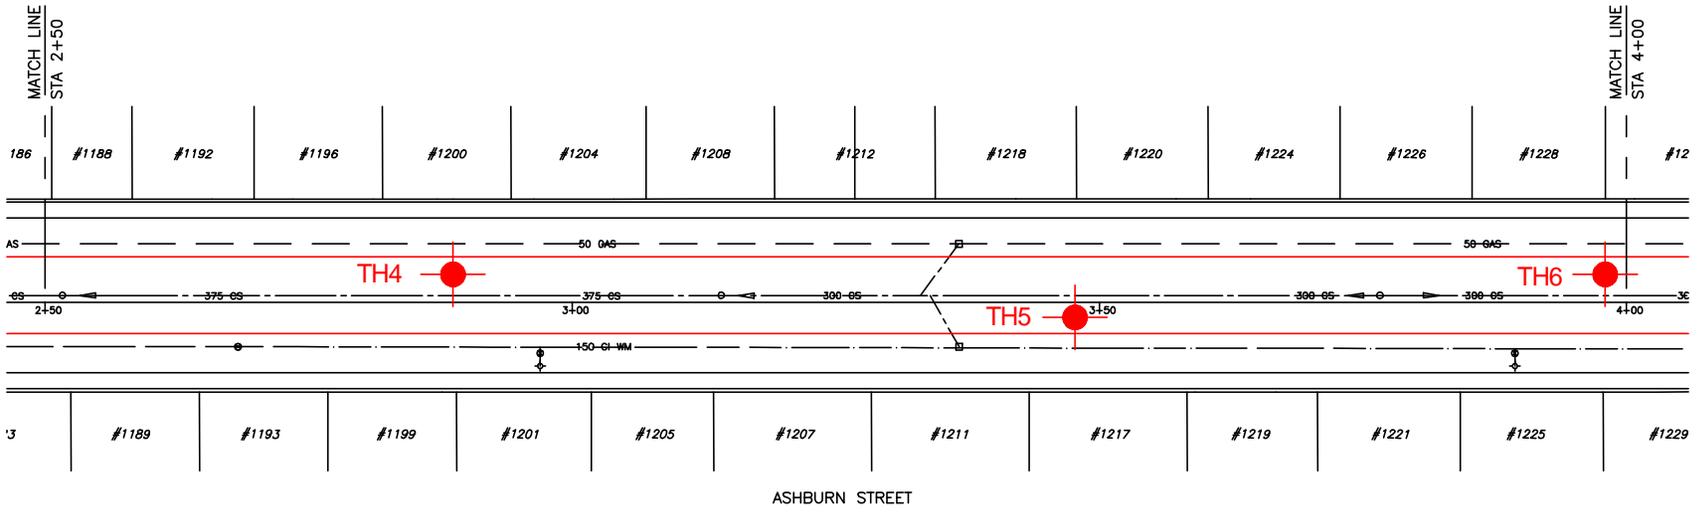
Figure: 2

Testhole Location Plan
Ashburn Street
Sargent Avenue to Wellington Avenue
City of Winnipeg 2009 Street Renewal Program

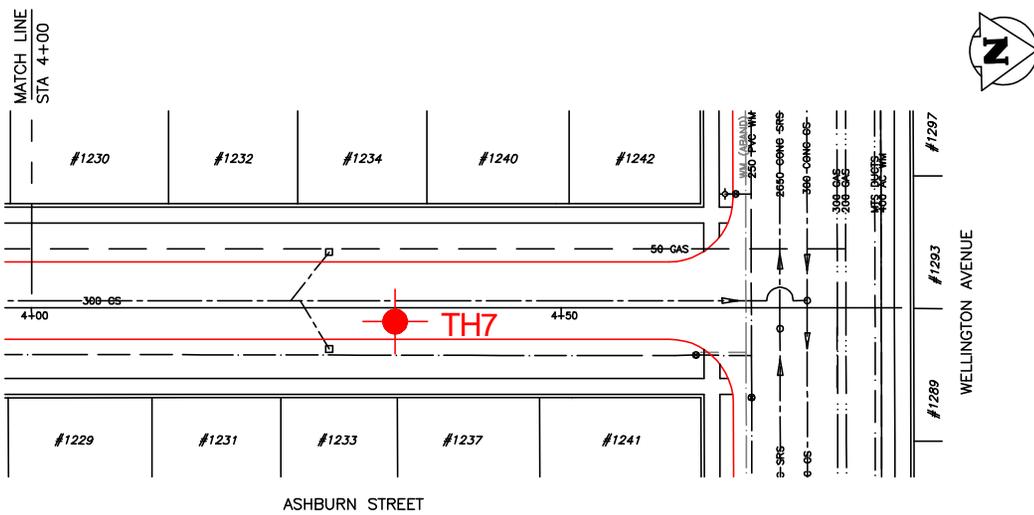
Figure: 3

Testhole Location Plan
Ashburn Street
Sargent Avenue and Wellington Avenue
City of Winnipeg 2009 Street Renewal Program

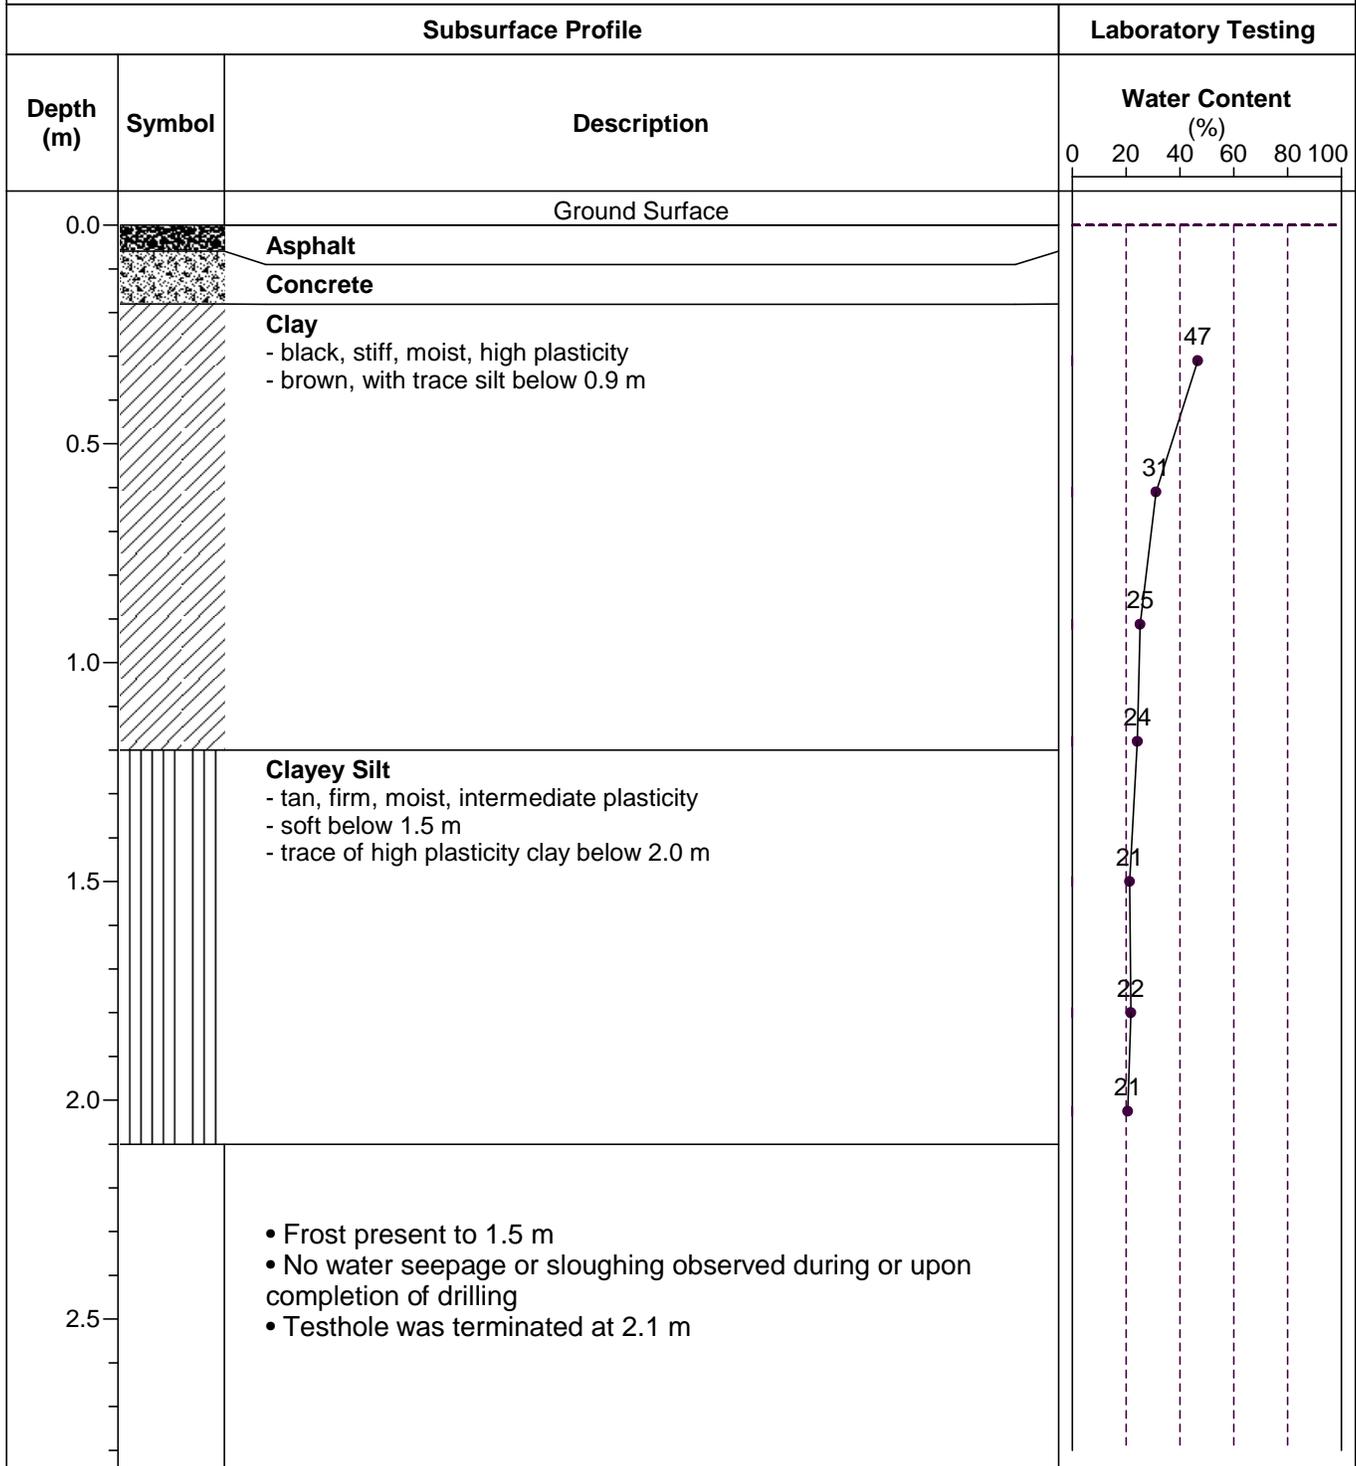
TESTHOLE TH1

Project Name: City of Winnipeg 2009 Street Renewal Program
Client: KGS Group
Site: Ashburn Street, Sargent Ave to Wellington Ave
Testhole Location: Northbound lane, 4 m south of the property line of 1145 / 1143 Ashburn St.

Date Drilled: January 21, 2009
Depth of Testhole: 2.1 m
Logged by: Jeff Brant

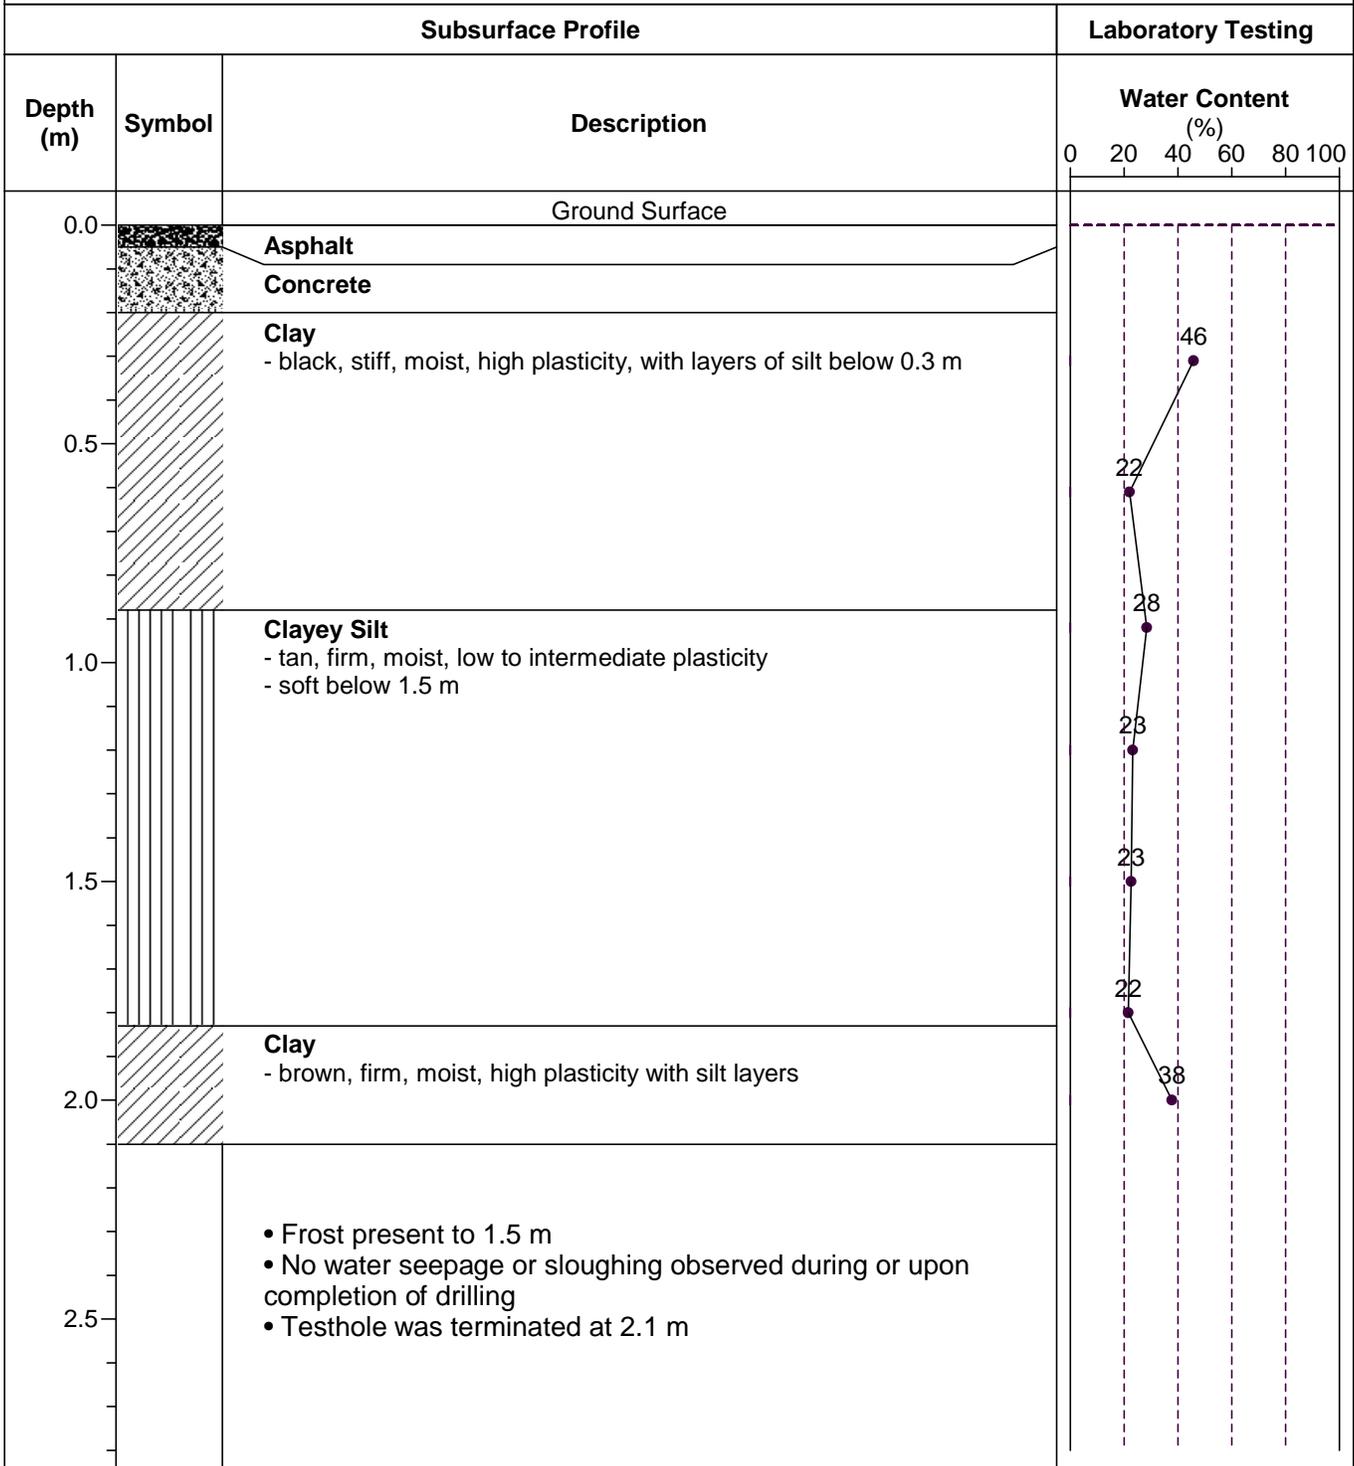
TESTHOLE TH2

Project Name: City of Winnipeg 2009 Street Renewal Program
Client: KGS Group
Site: Ashburn Street, Sargent Ave to Wellington Ave
Testhole Location: Southbound lane, 2 m south of the property line of 1166 / 1168 Ashburn St.

Date Drilled: January 21, 2009
Depth of Testhole: 2.1 m
Logged by: Jeff Brant

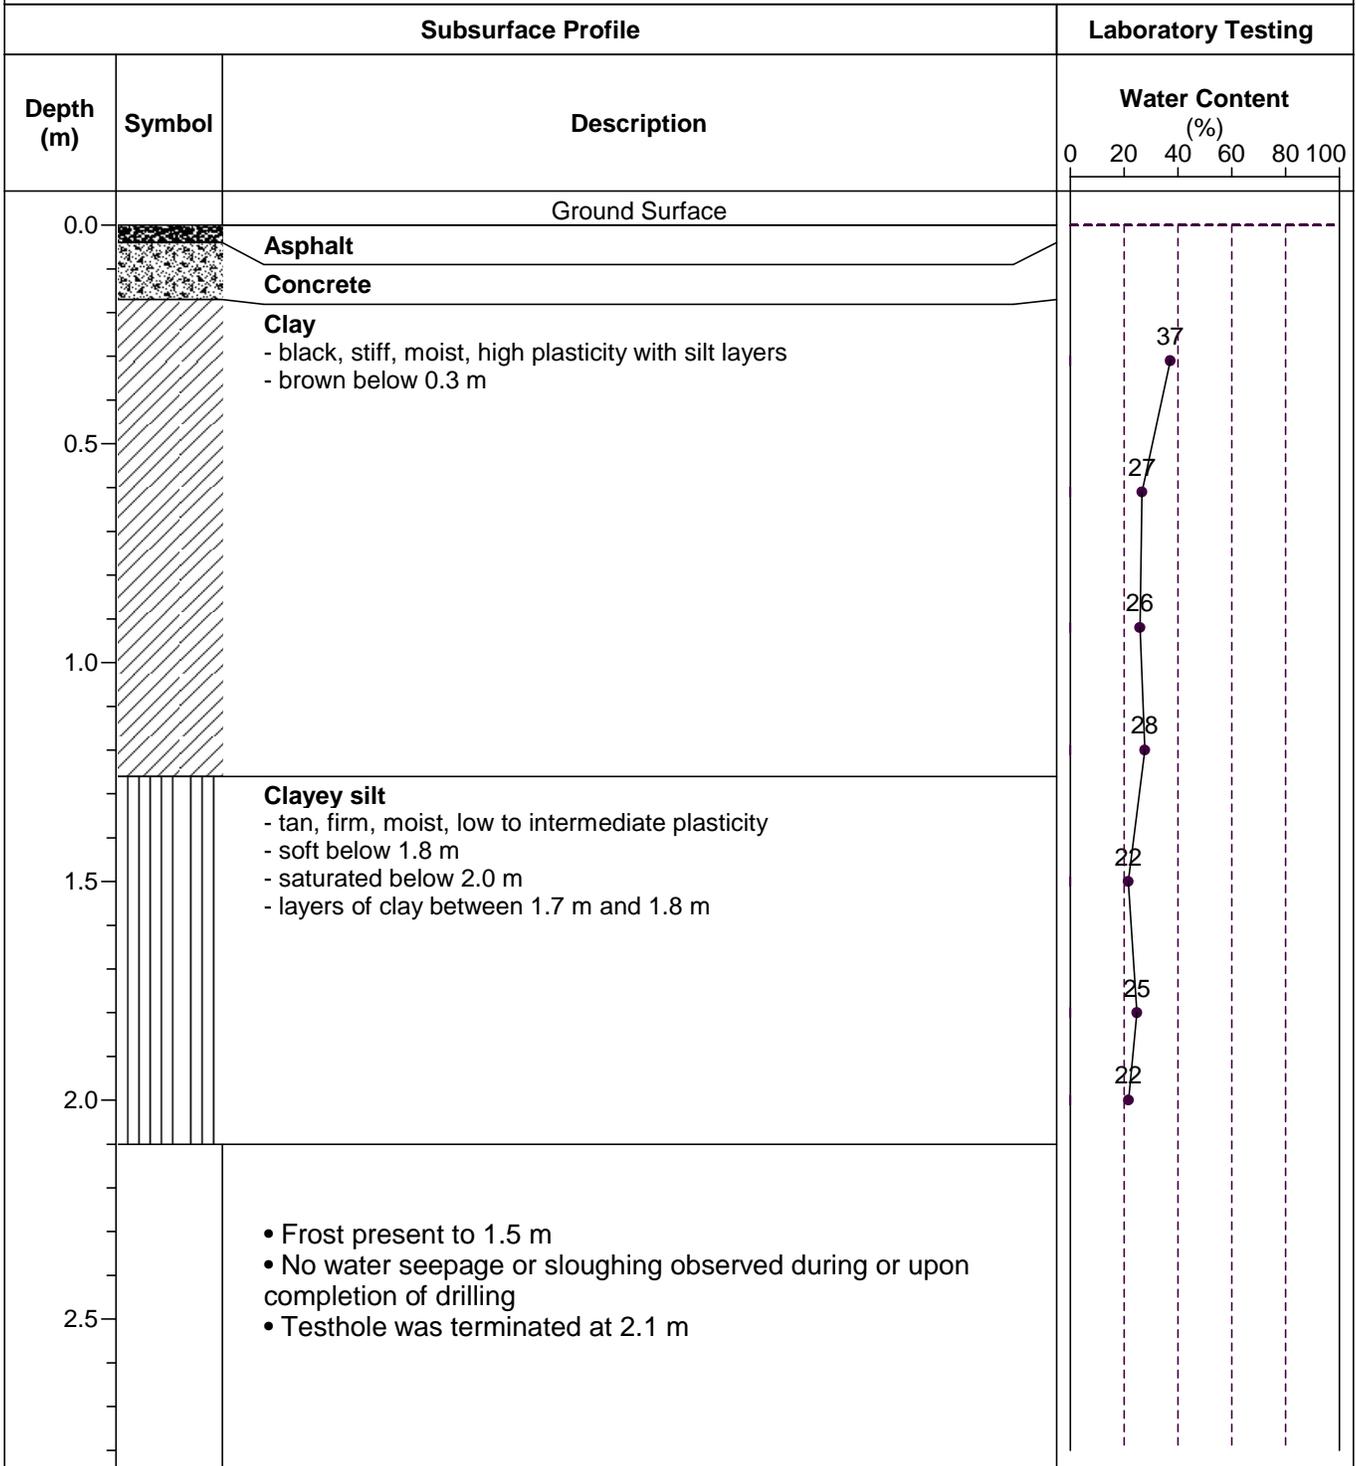
TESTHOLE TH3

Project Name: City of Winnipeg 2009 Street Renewal Program
Client: KGS Group
Site: Ashburn Street, Sargent Ave to Wellington Ave
Testhole Location: Northbound lane, 3 m north of property line of 1183 / 1171 Ashburn St.

Date Drilled: January 21, 2009
Depth of Testhole: 2.1 m
Logged by: Jeff Brant

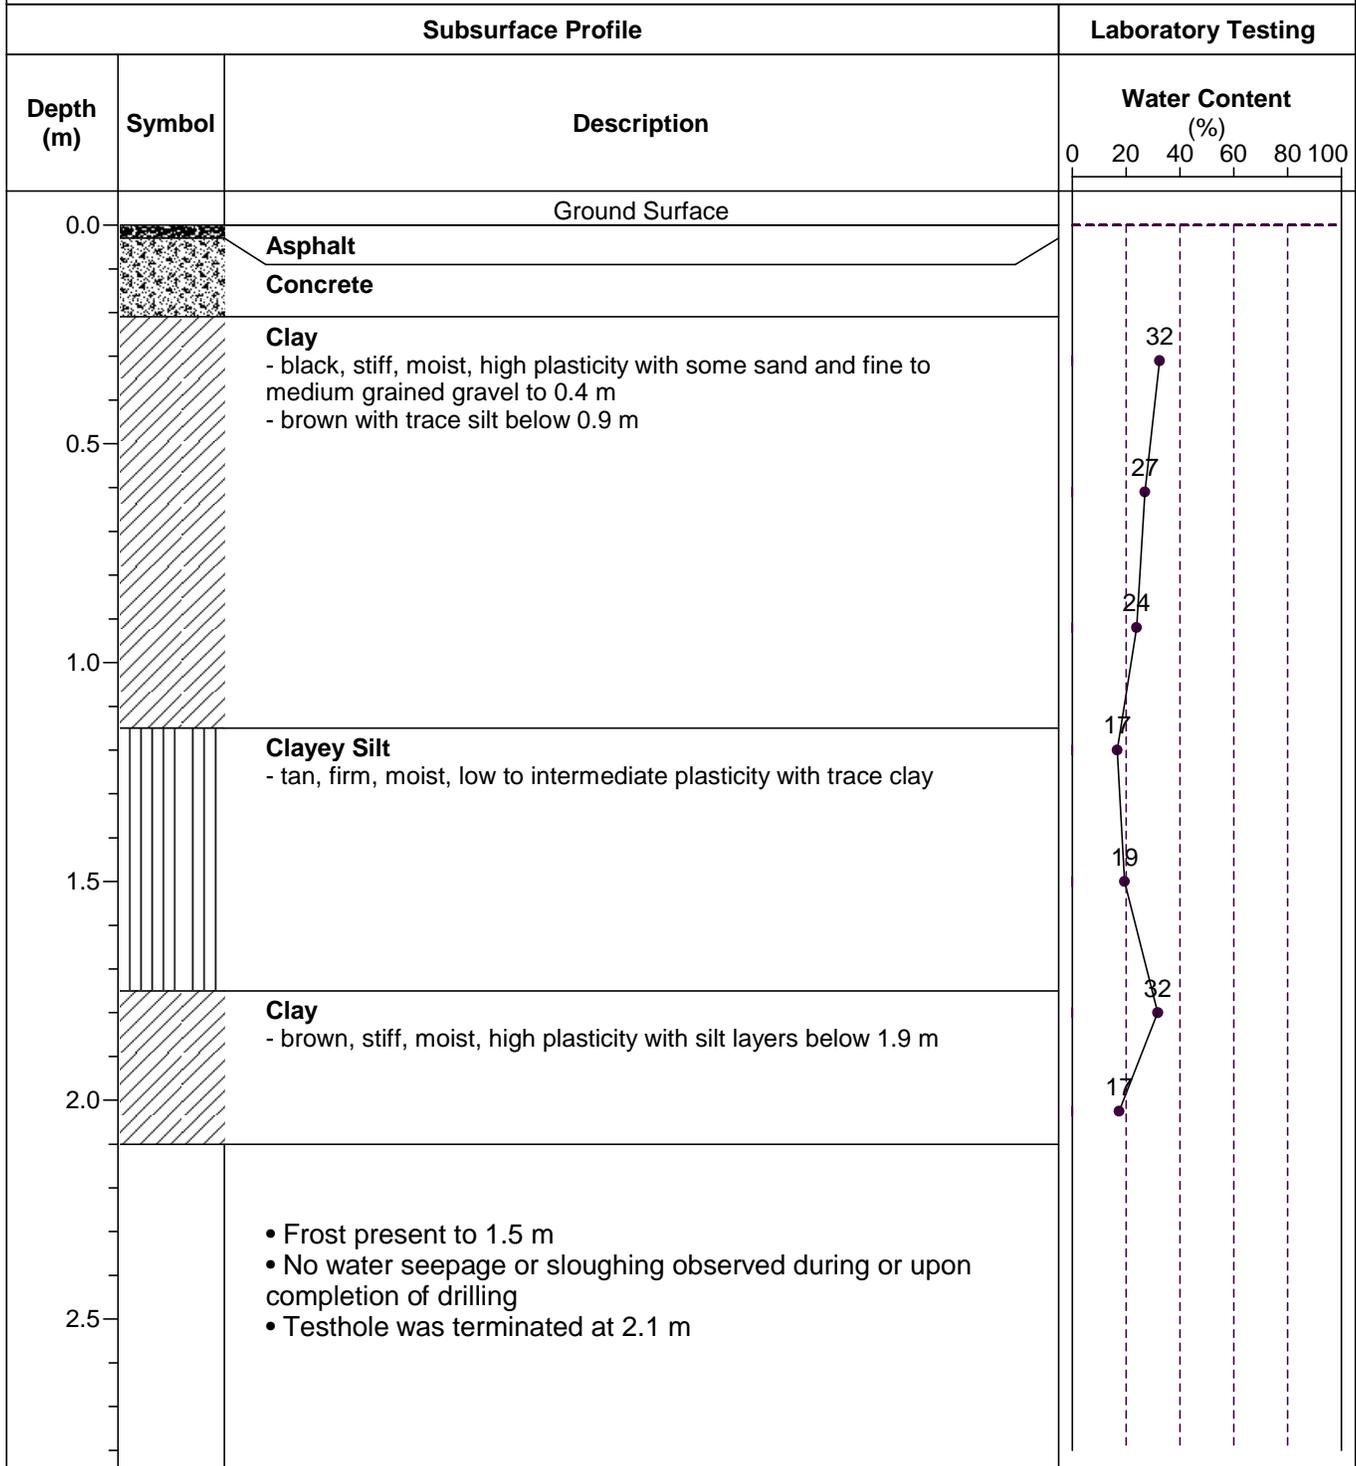
TESTHOLE TH6

Project Name: City of Winnipeg 2009 Street Renewal Program
Client: KGS Group
Site: Ashburn Street, Sargent Ave to Wellington Ave
Testhole Location: Southbound lane, In line with property line of 1228 / 1230 Ashburn St.

Date Drilled: January 21, 2009
Depth of Testhole: 2.1 m
Logged by: Jeff Brant

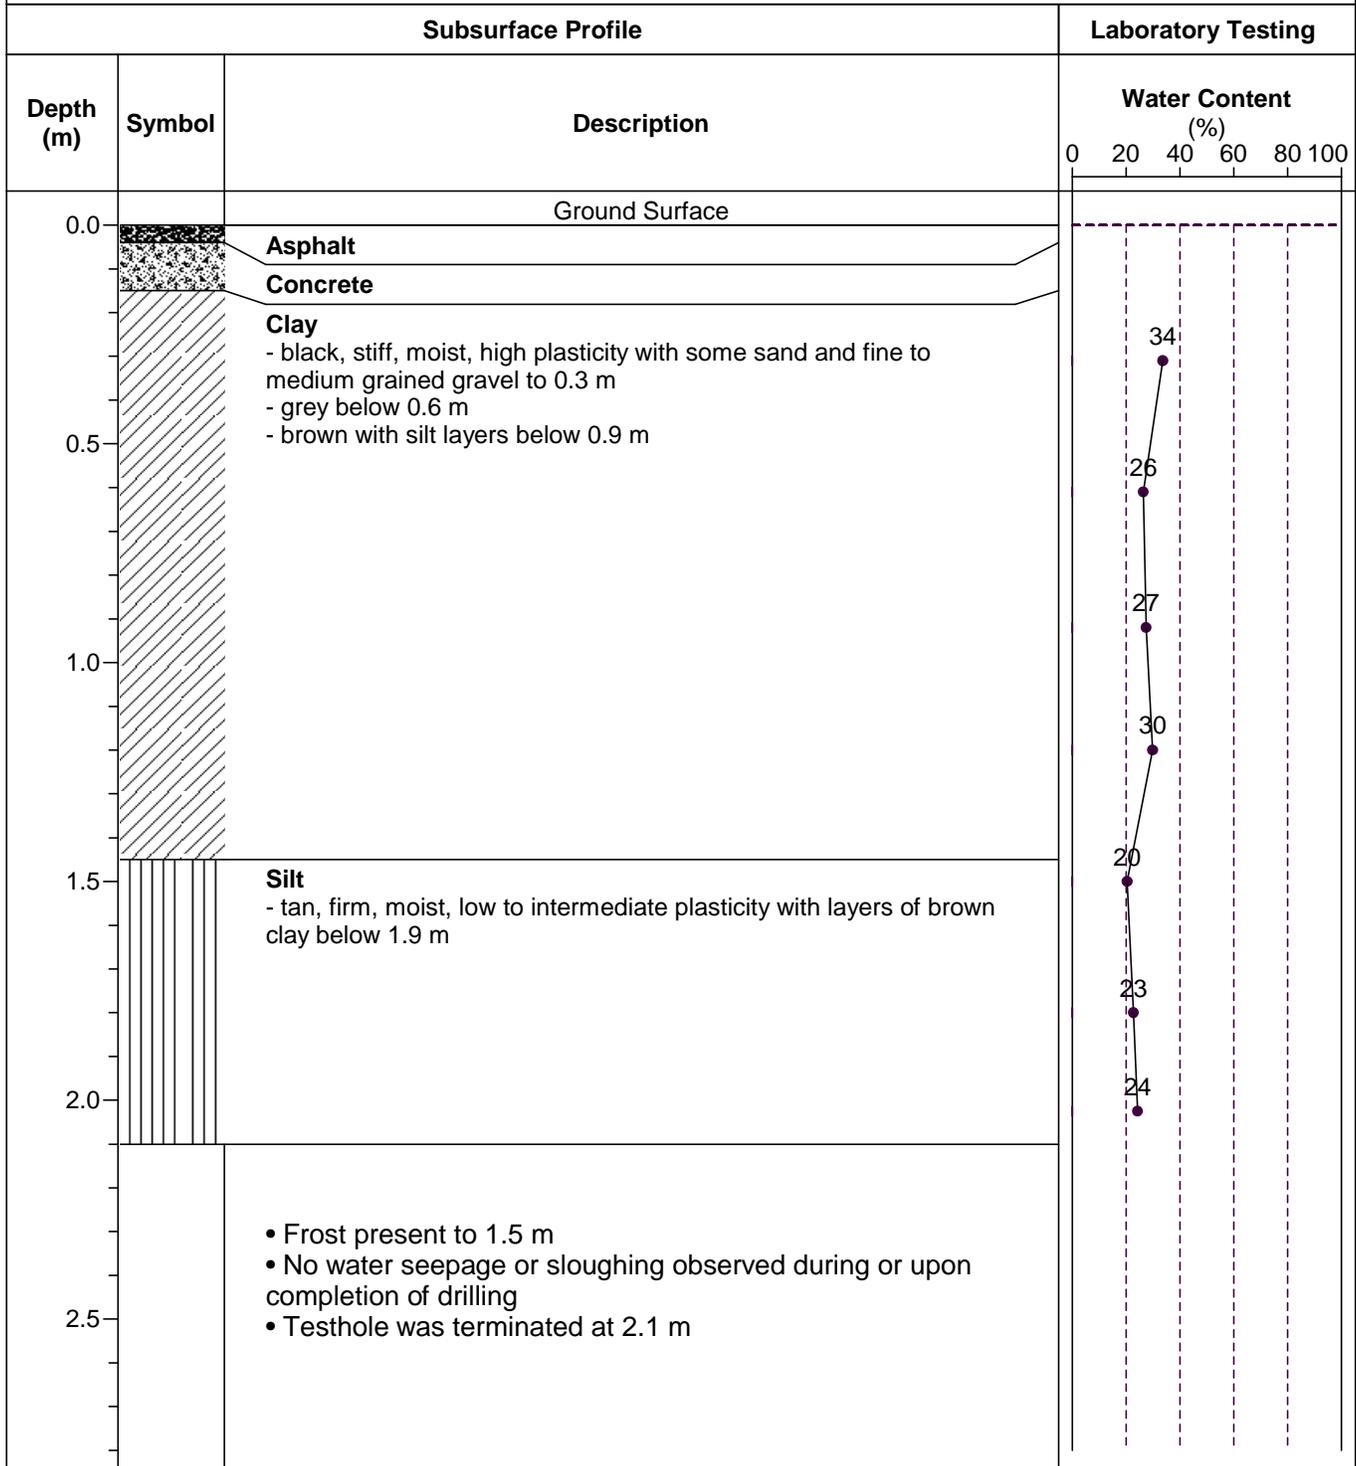
TESTHOLE TH7

Project Name: City of Winnipeg 2009 Street Renewal Program
 Client: KGS Group
 Site: Ashburn Street, Sargent Ave to Wellington Ave
 Testhole Location: Northbound lane, In line with property line of 1233 / 1237 Ashburn St.

Date Drilled: January 21, 2009
 Depth of Testhole: 2.1 m
 Logged by: Jeff Brant

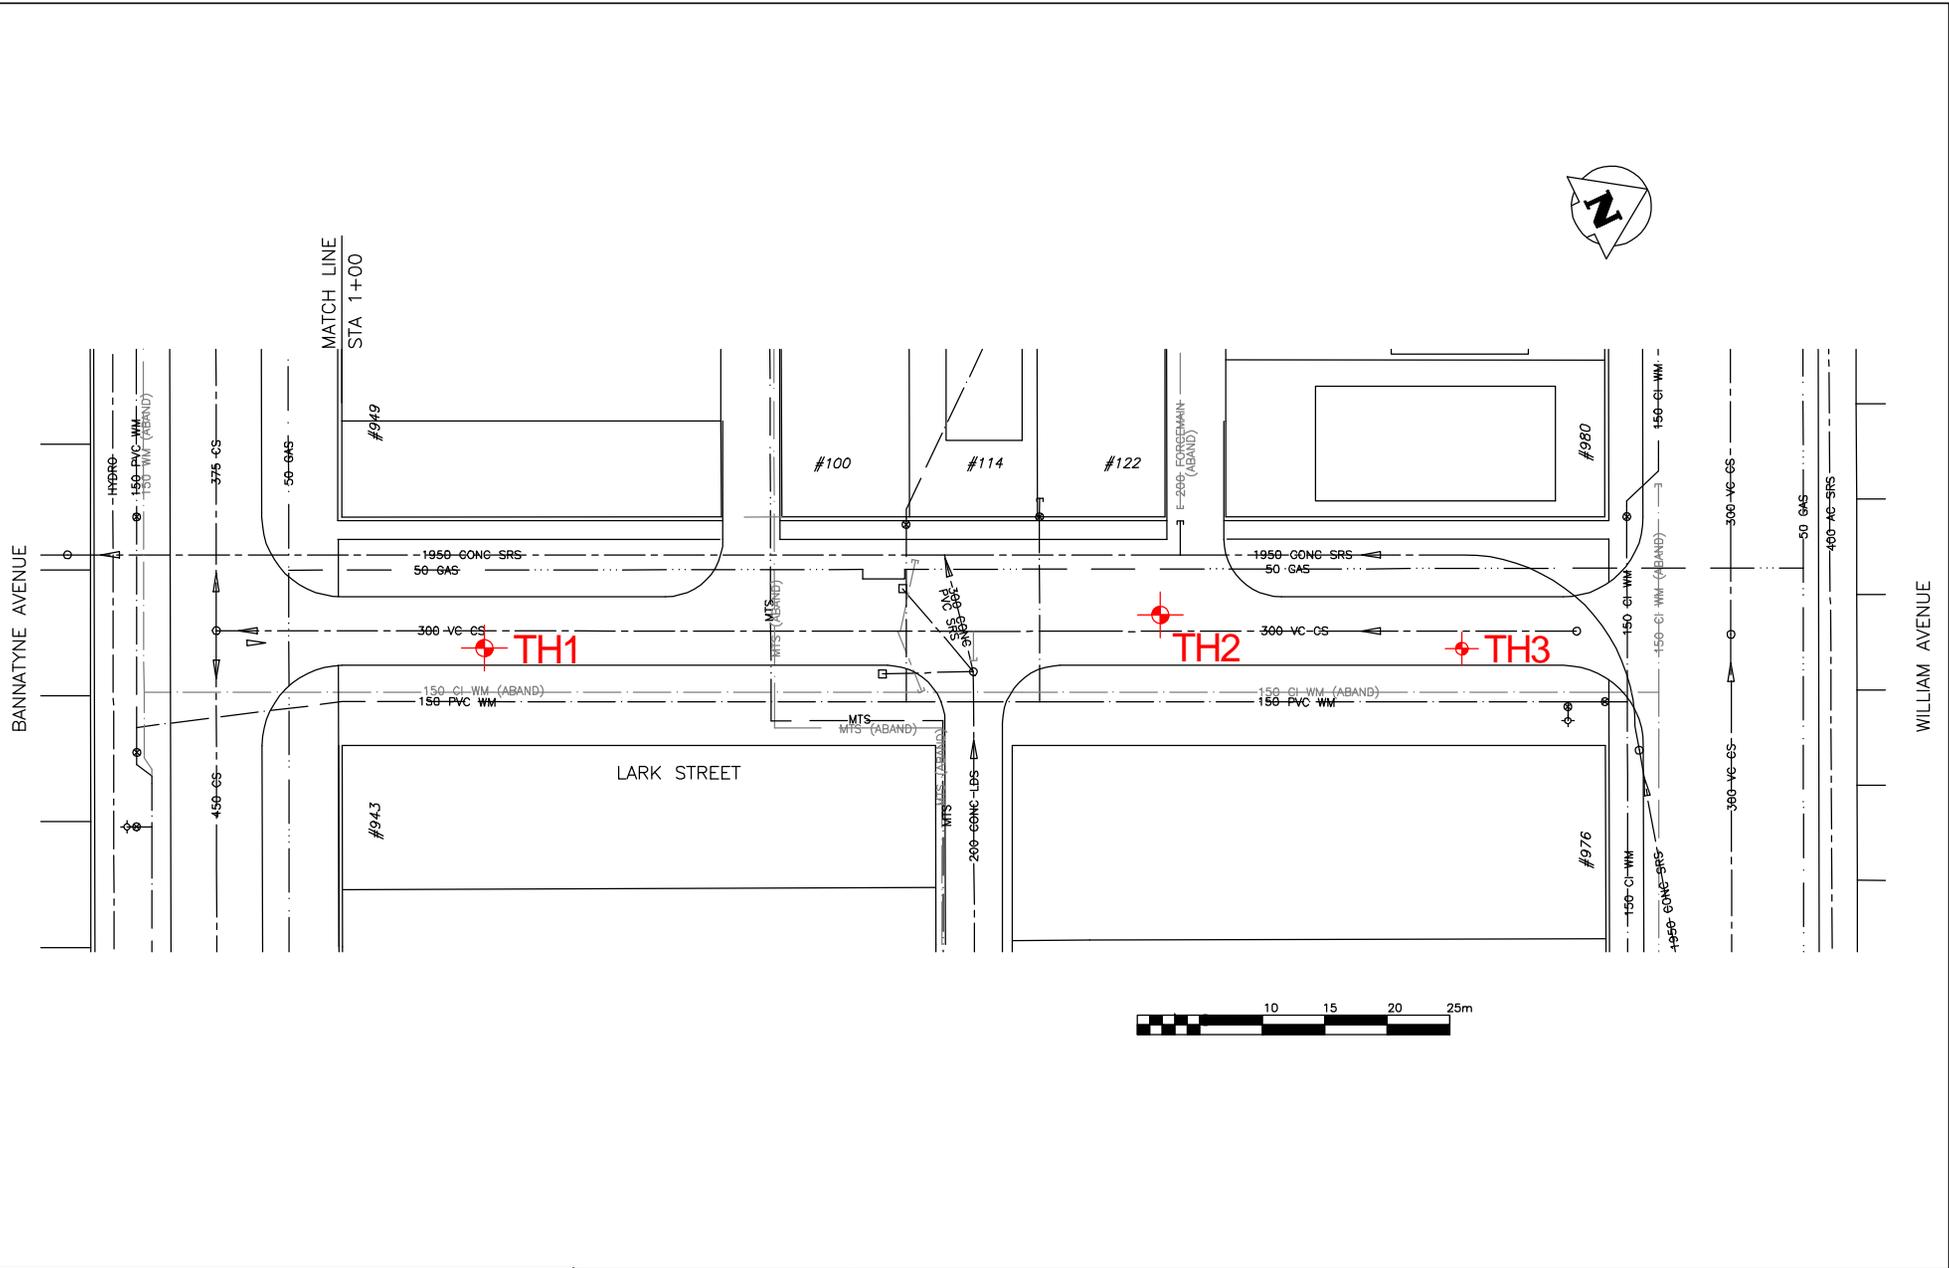
Figure: 1

Testhole Location Plan
Lark Street

Bannatyne Avenue to William Avenue
2009 City of Winnipeg Street Renewal

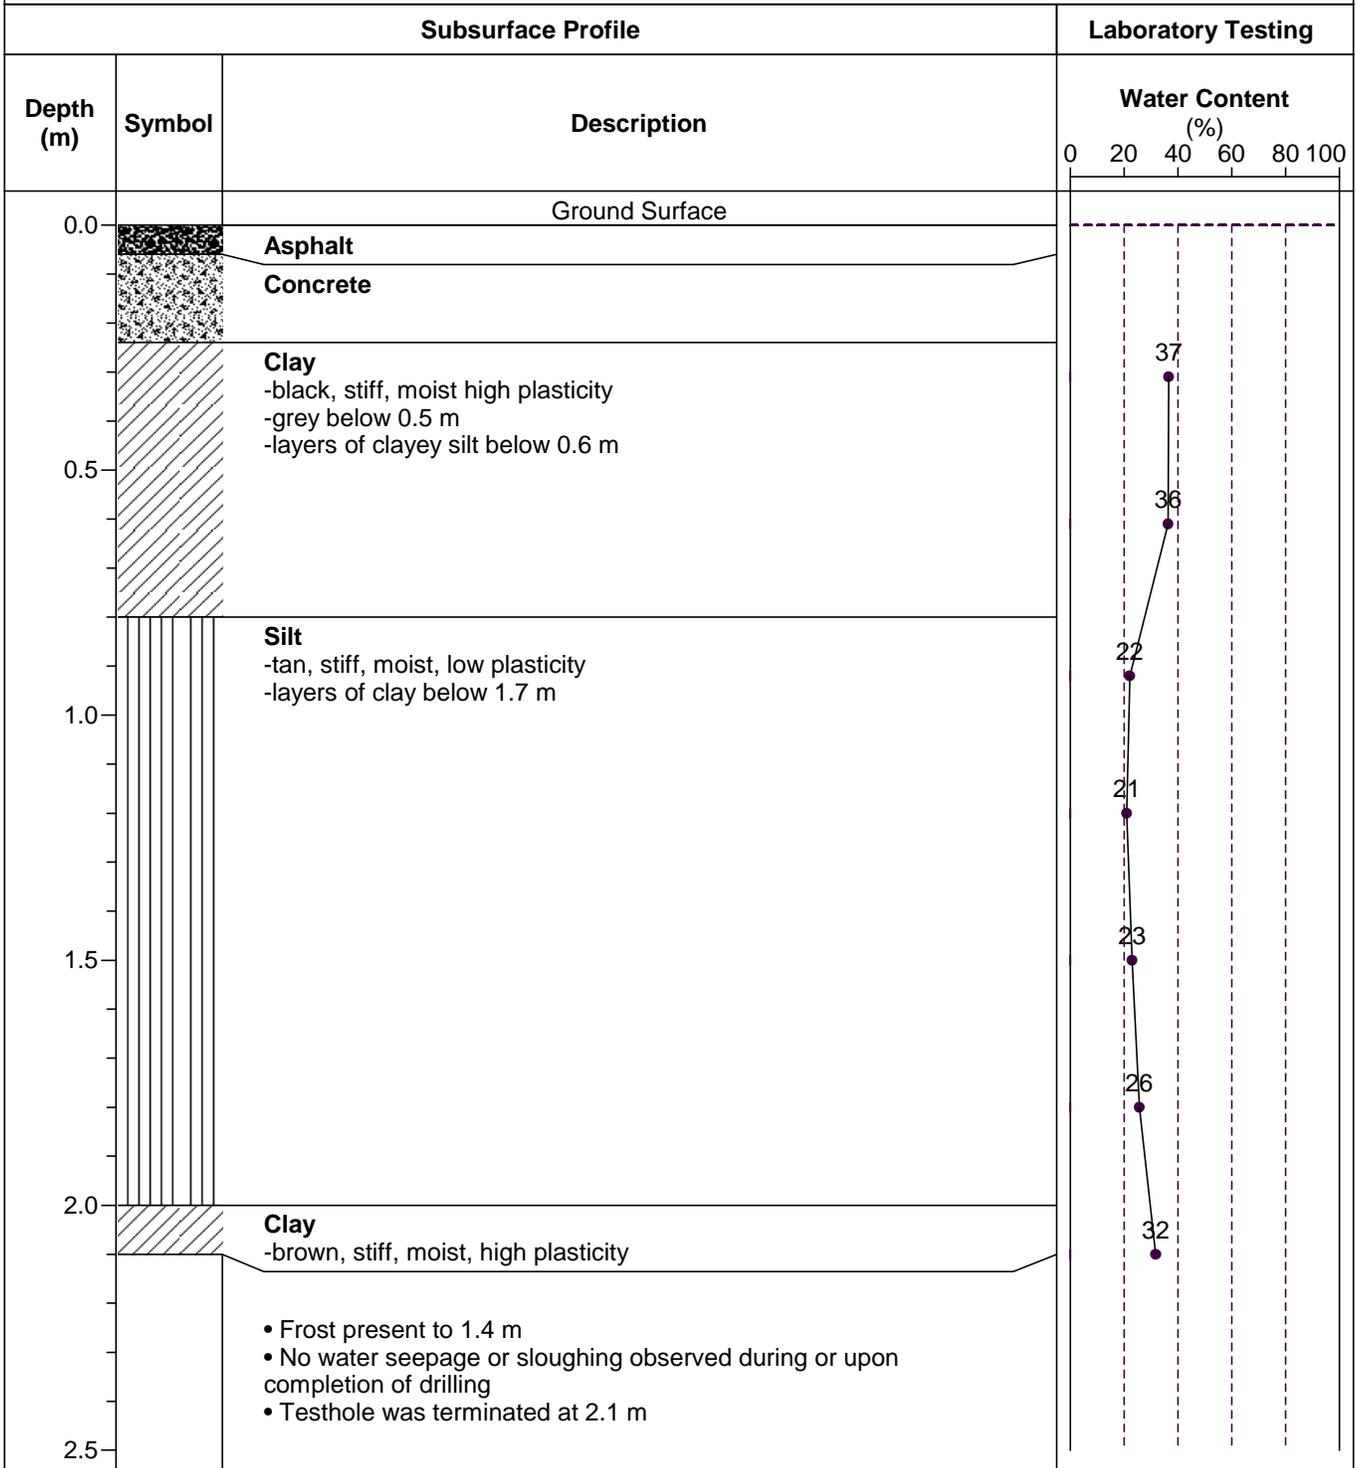
TESTHOLE TH3

Project Name: City of Winnipeg 2009 Street Renewal Program
 Client: KGS Group Inc.
 Site: Lark Street, Bannatyne Ave. to William Ave.
 Testhole Location: Northbound lane, 11 m S of the N property line of 976 William Ave., 1.3 m from curb

Date Drilled: January 27, 2009
 Depth of Testhole: 2.1 m
 Logged by: Kurtis Kulchyski

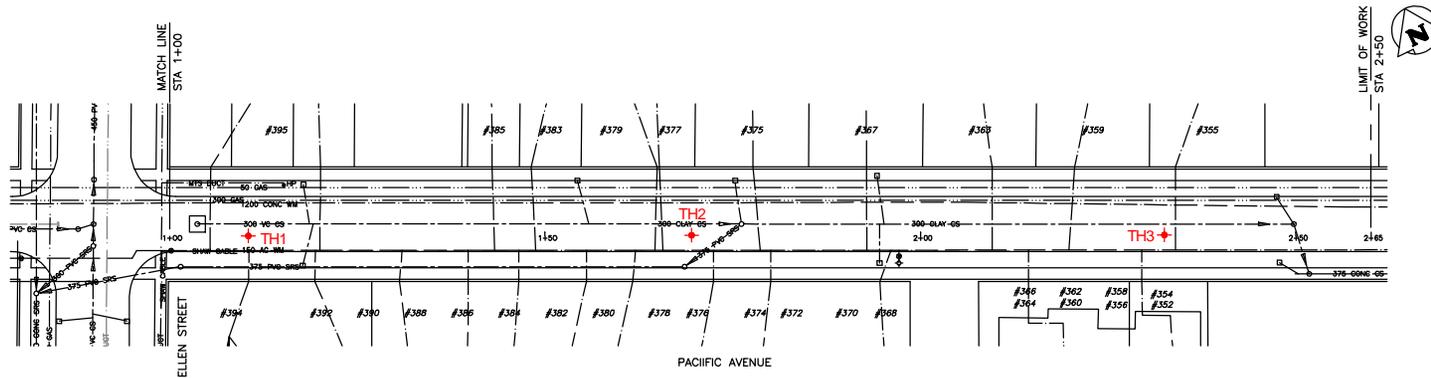
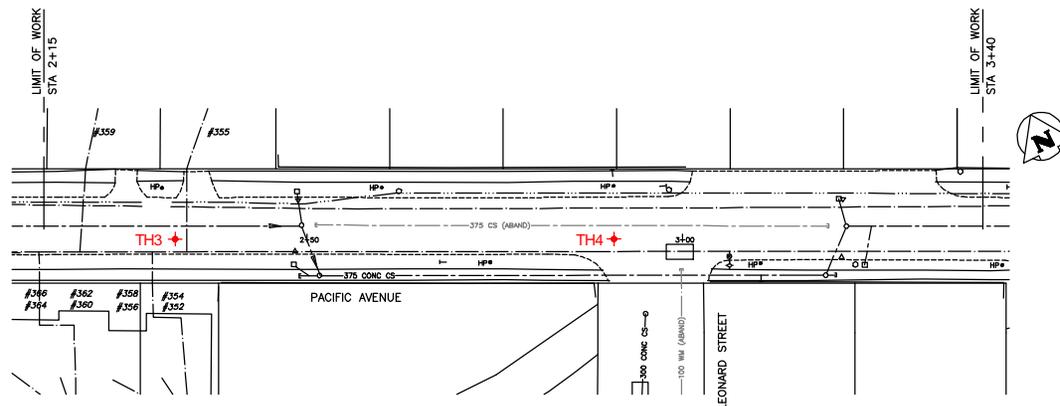
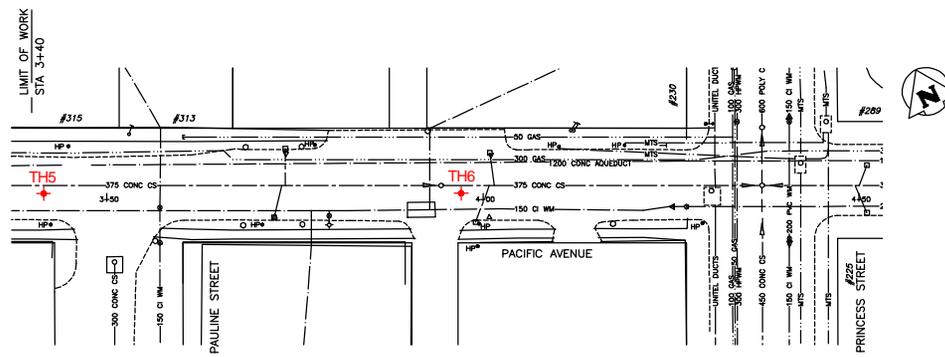
Figure: 1

Testhole Location Plan
Pacific Avenue

Ellen Street to Princess Street
City of Winnipeg 2009 Street Renewal Program

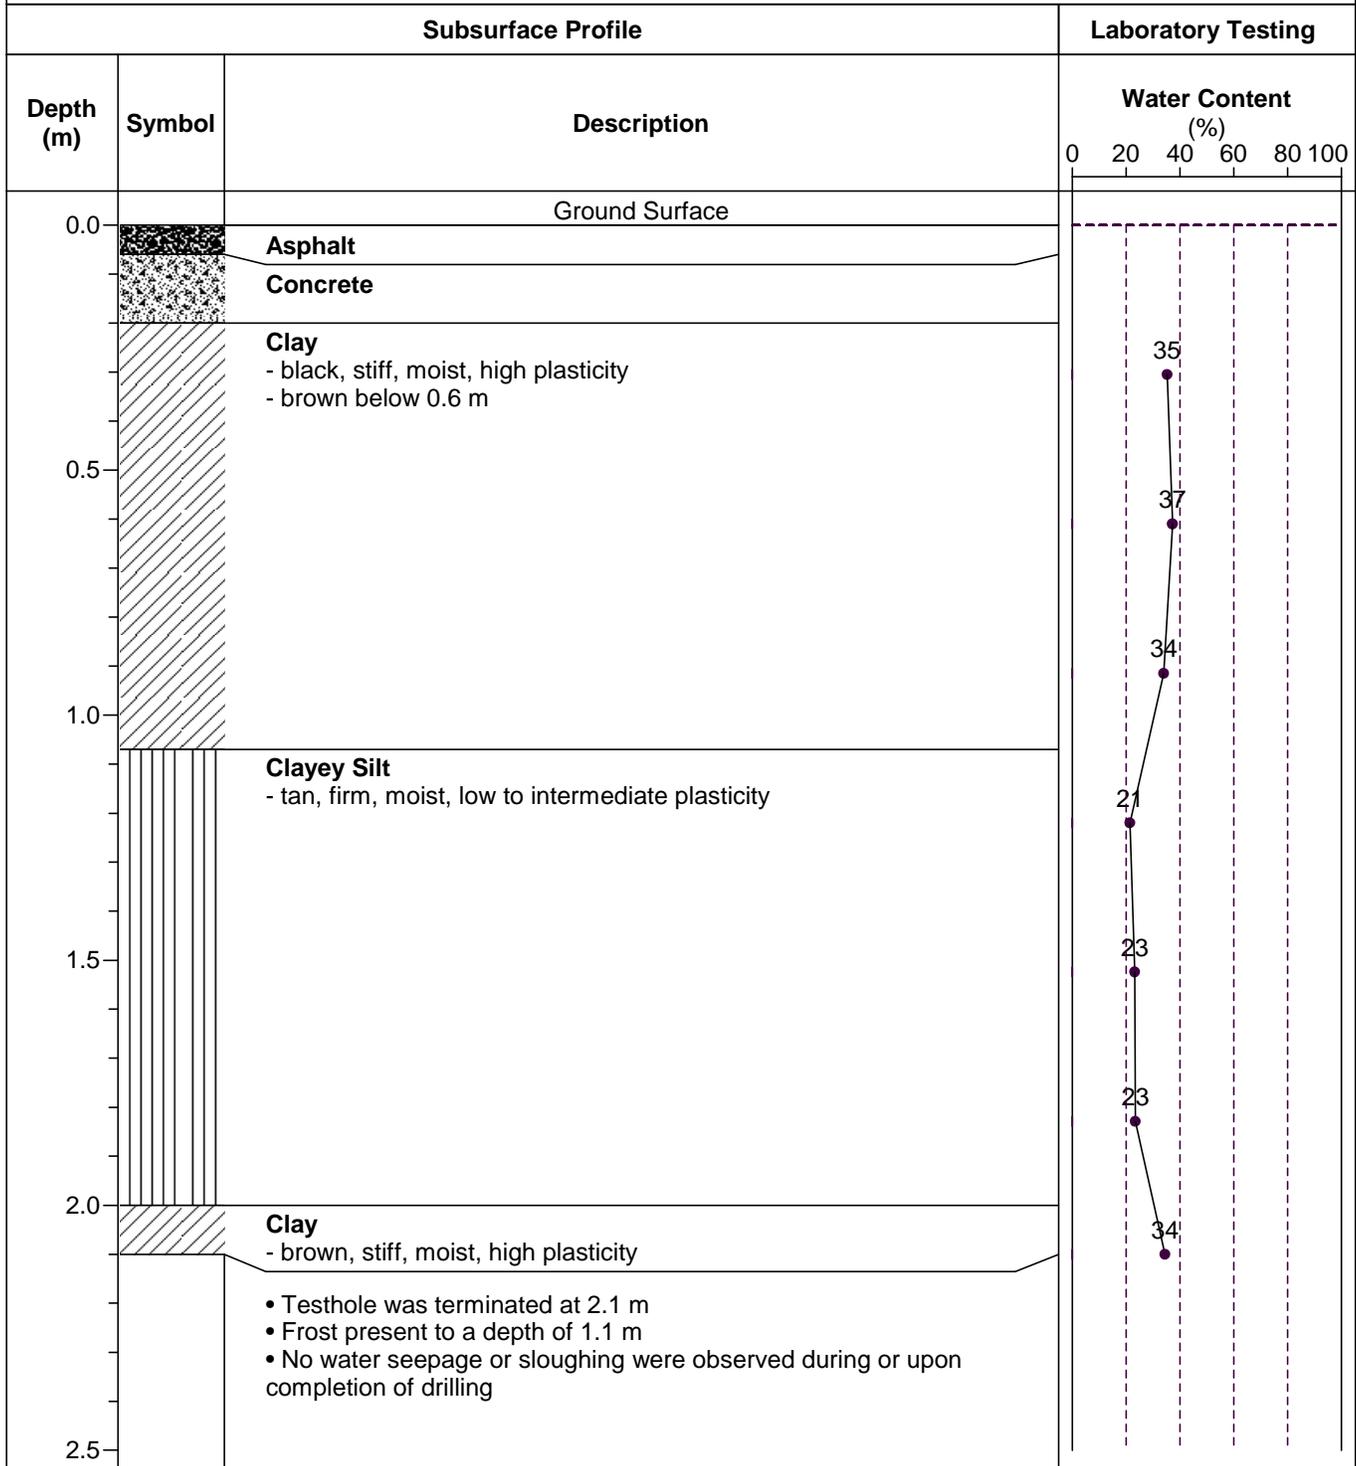
TESTHOLE TH1

Project Name: City of Winnipeg 2009 Street Renewal Program
Client: KGS Group Inc.
Site: Pacific Avenue, Ellen Street to Princess Street
Testhole Location: Eastbound lane, In line with prop. line of 392 / 394 Pacific Ave., 2.0 m from curb

Date Drilled: January 27, 2009
Depth of Testhole: 2.1 m
Logged by: Kurtis Kulchyski

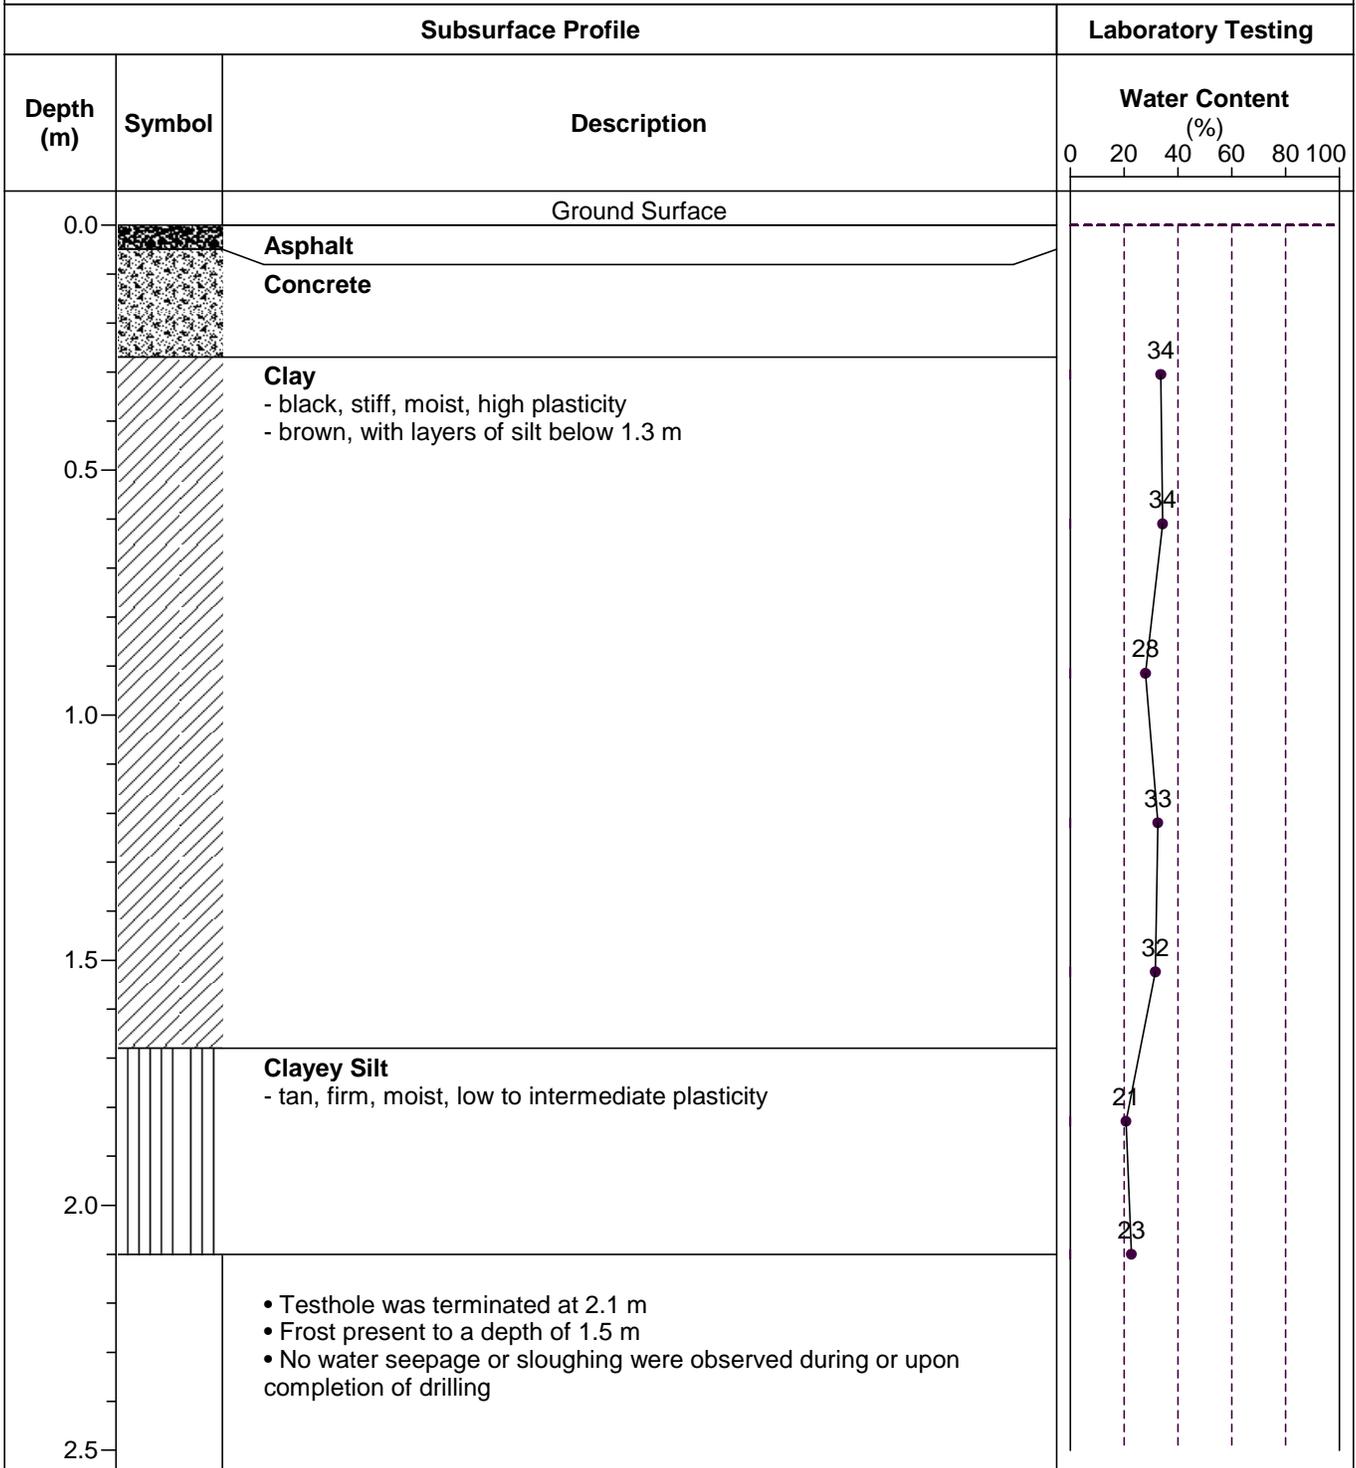
TESTHOLE TH3

Project Name: City of Winnipeg 2009 Street Renewal Program
 Client: KGS Group Inc.
 Site: Pacific Avenue, Ellen Street to Princess Street
 Testhole Location: Eastbound lane, 2 m east of prop. line of 355 / 359 Pacific Ave., 2.0 m from curb

Date Drilled: January 27, 2009
 Depth of Testhole: 2.1 m
 Logged by: Kurtis Kulchyski
