**ASHBURN STREET
SARGENT AVENUE TO WELLINGTON AVENUE
CITY OF WINNIPEG 2009 STREET RENEWAL PROGRAM**

Prepared for
KGS GROUP INC.
3rd FLOOR - 865 WAVERLEY STREET
WINNIPEG, MANITOBA
R3T 5P4

Prepared by
THE NATIONAL TESTING LABORATORIES LIMITED
199 HENLOW BAY
WINNIPEG, MANITOBA
R3Y 1G4

**LARK STREET
BANNATYNE AVENUE TO WILLIAM AVENUE
CITY OF WINNIPEG 2009 STREET RENEWAL PROGRAM**

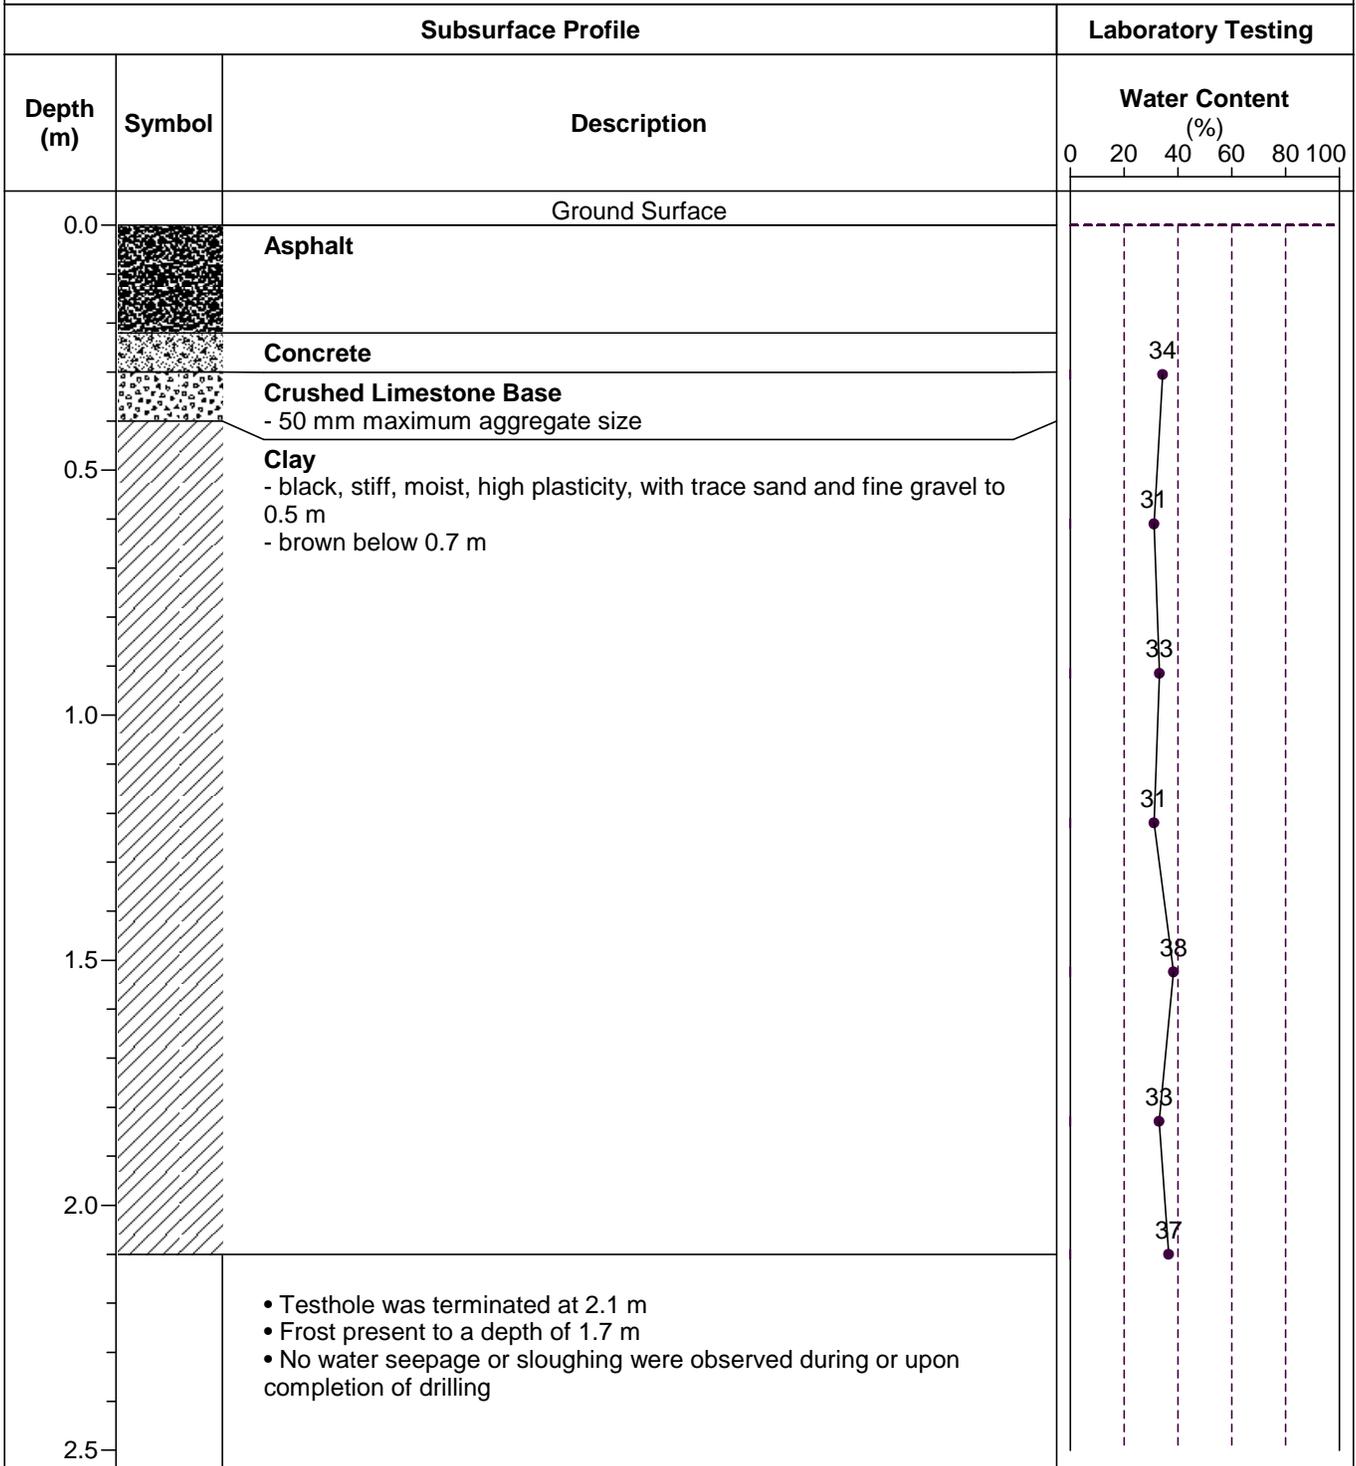
TESTHOLE TH4

Project Name: City of Winnipeg 2009 Street Renewal Program
 Client: KGS Group Inc.
 Site: Pacific Avenue, Ellen Street to Princess Street
 Testhole Location: Eastbound lane, 45 m east of east prop. line of 355 Pacific Ave., 2.0 m from curb

Date Drilled: January 27, 2009
 Depth of Testhole: 2.1 m
 Logged by: Kurtis Kulchyski

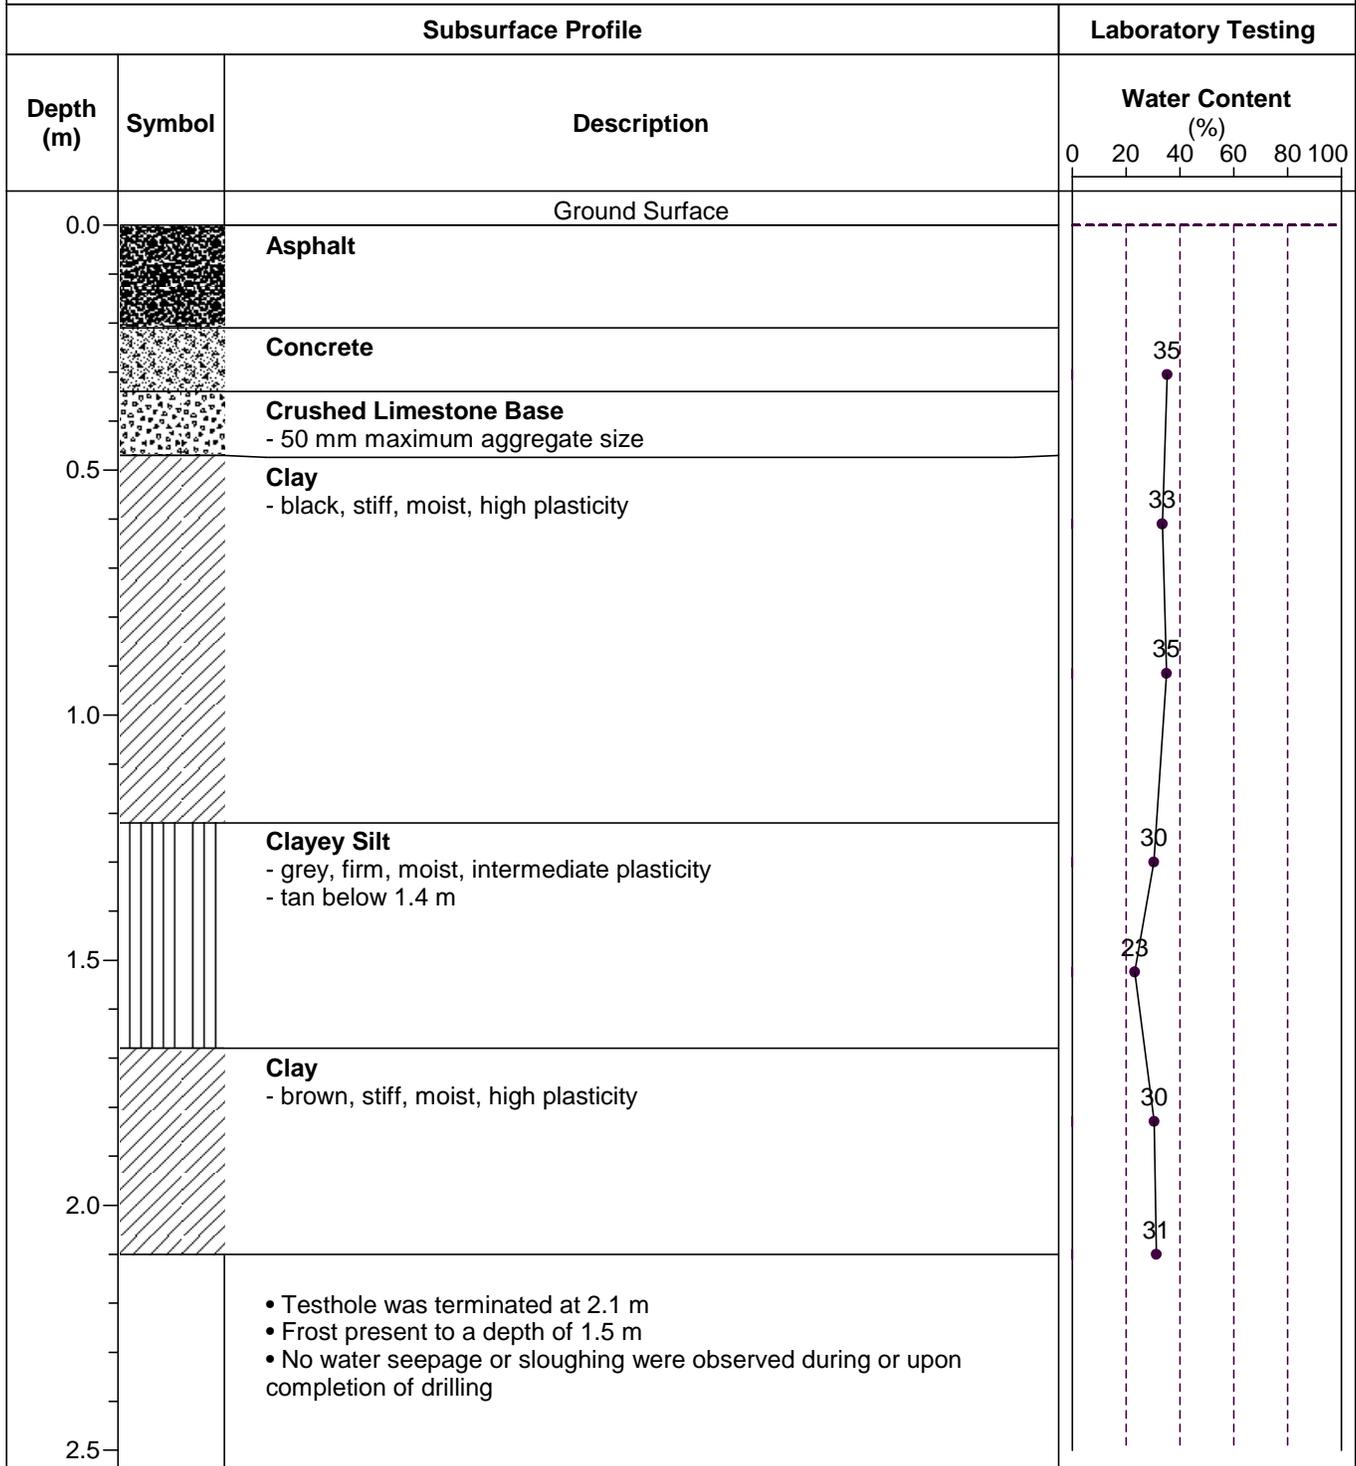
TESTHOLE TH5

Project Name: City of Winnipeg 2009 Street Renewal Program
 Client: KGS Group Inc.
 Site: Pacific Avenue, Ellen Street to Princess Street
 Testhole Location: Eastbound lane, 4 m west of west curb of Paulin St., 3.5 m from curb

Date Drilled: January 27, 2009
 Depth of Testhole: 2.1 m
 Logged by: Kurtis Kulchyski
