Subject: FW: Sturgeon Road Bridge Replacement (DFO file WI-11-1776)

Reference: Sturgeon Bridge Replacement, Winnipeg, Manitoba

Stantec
STURGEON ROAD BRIDGE REPLACEMENT AND ROADWORKS

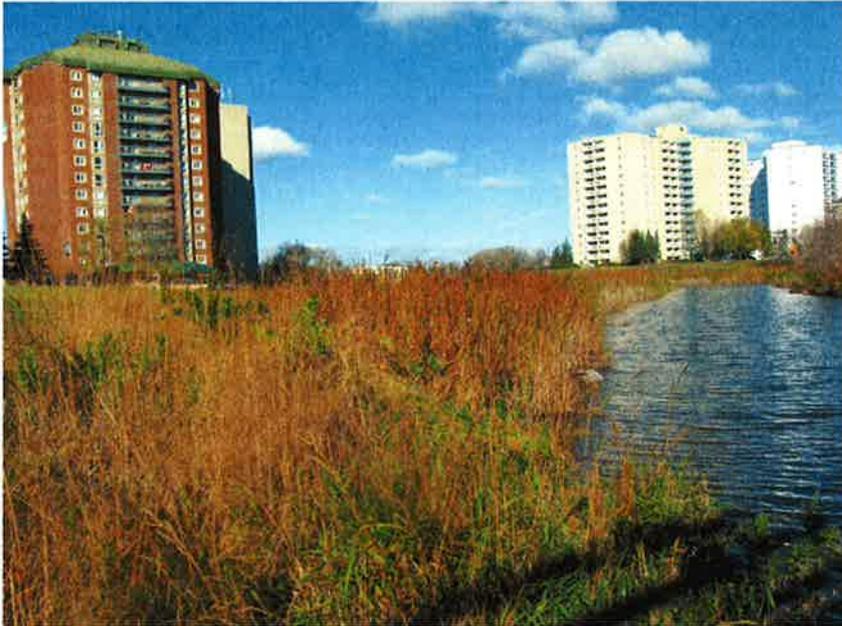
Photo #1: Sturgeon Creek, river right - looking upstream from Sturgeon Bridge, October 14, 2010.

Immediately beneath the Sturgeon Bridge, and within 20 meters of the development site, there is minimal in-stream vegetation. Sedges and grasses line the edge of the wetted channel and may provide a slight degree of cover for fish. No large woody debris is present at the proposed development site. No shrubs or trees create overhanging riparian vegetation within 20 meters of the (Photos 1-5).

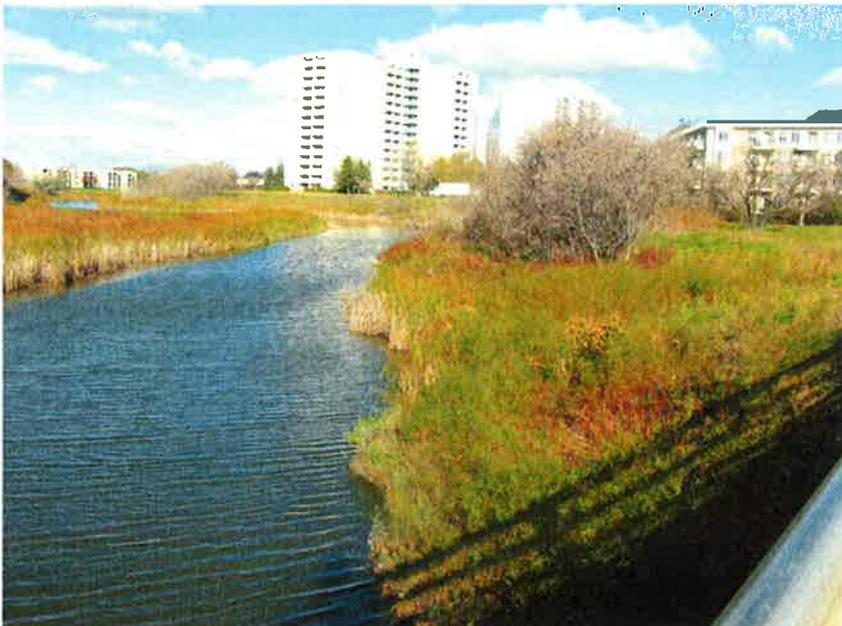
Photo #2: Sturgeon Creek, river left - looking upstream from Sturgeon Bridge, October 14, 2010.

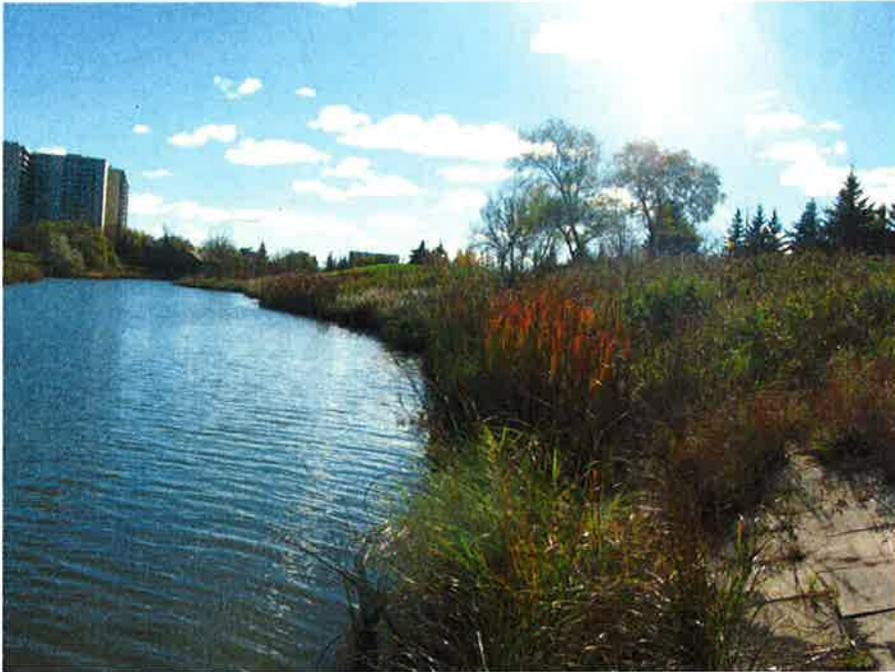
Photo #3: Sturgeon Creek, river right - looking downstream from Sturgeon Bridge, October 14, 2010.

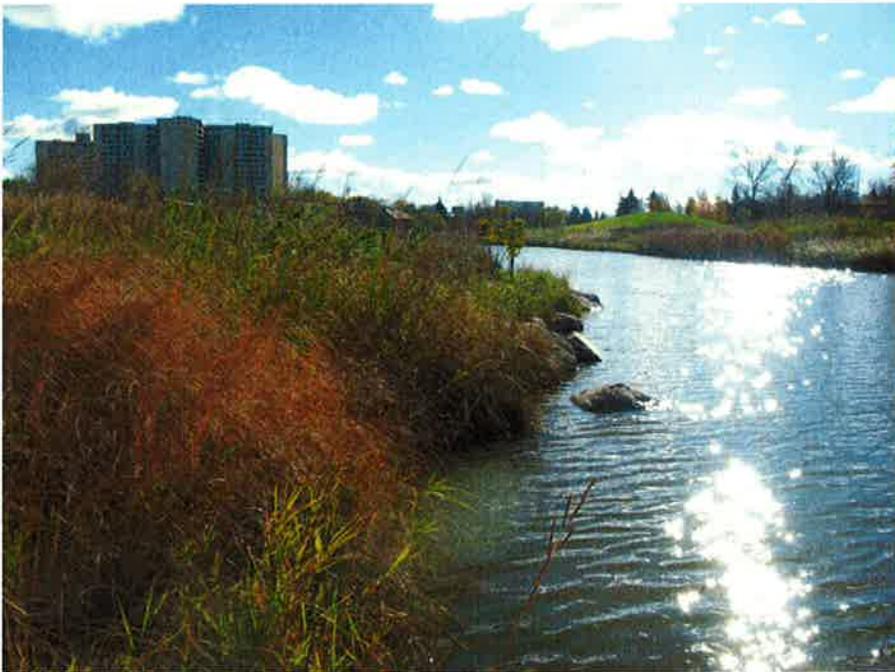
Photo #4: Sturgeon Creek, river left - looking downstream from Sturgeon Bridge, October 14, 2010.

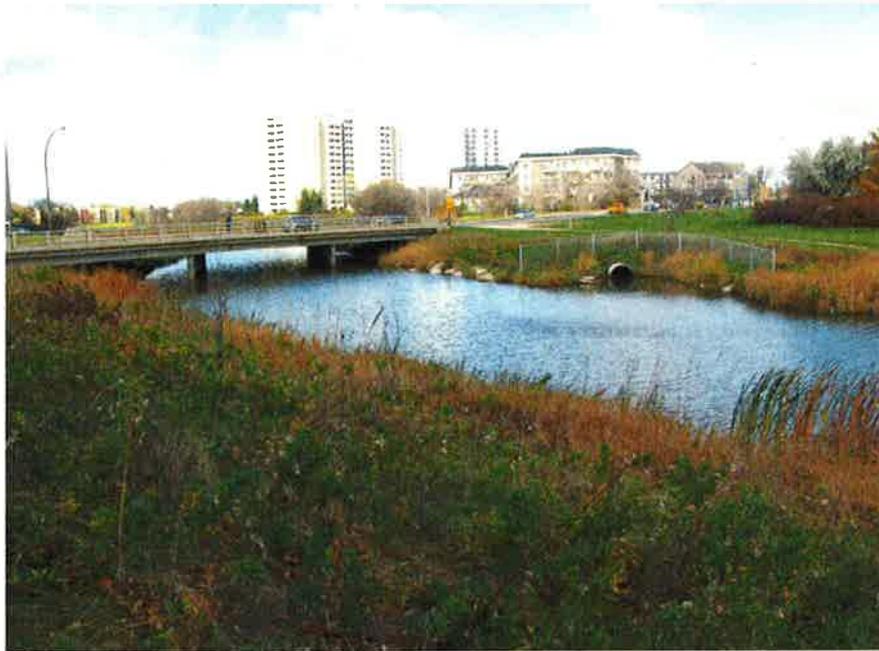
Photo #5: Sturgeon Creek, river right - looking downstream from Sturgeon Bridge, October 14, 2010.

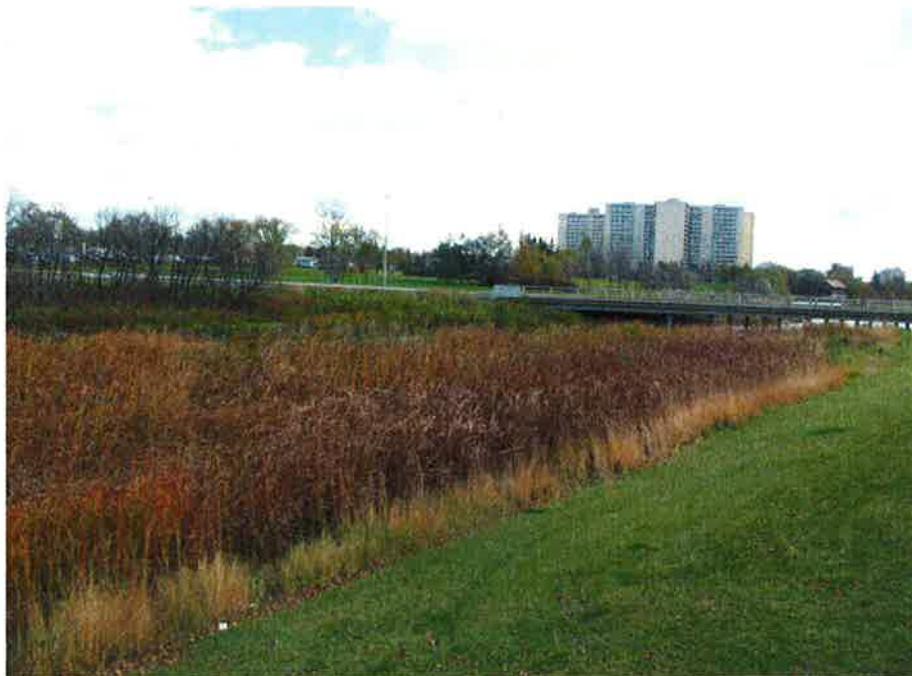
Photo #6: Sturgeon Creek, large cattail patch upstream river right of Sturgeon Bridge, October 14, 2010.

A relatively large cattail patch lies approximately 25 meters upstream of the Sturgeon Bridge development site. This cattail patch extends 53 meters into the stream channel and spans approximately 100 meters, at river right within the bankfull channel (Photo 6).

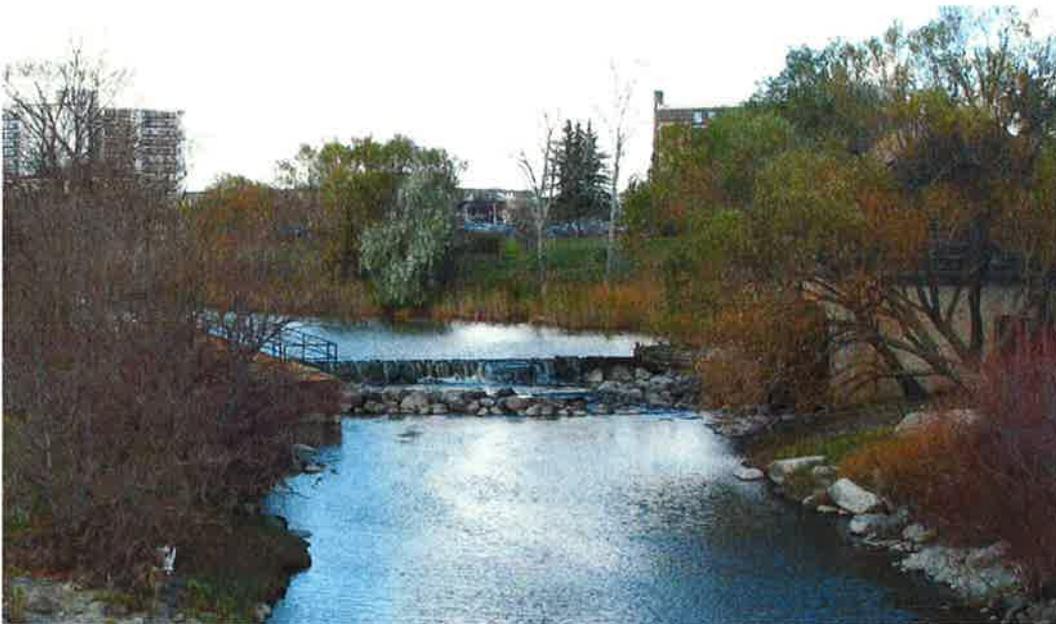
Photo #8: Sturgeon Creek, Old Grant's Mill, looking upstream from Portage Bridge, October 14, 2010.

A seasonally operating grain mill and water wheel lie approximately 350 meters downstream of Sturgeon Bridge (Photo 8). The construction of a water diverting dam associated with this mill would obstruct fish passage except for the operation of a fish ladder (Photo 9-10). The fish ladder is maintained on a seasonal basis by the Naturalist Services Branch of the Winnipeg Public Works Department. Fish species using the ladder are periodically enumerated through the use of a fish trap and gill nets (Tuchscherer pers. comm.).

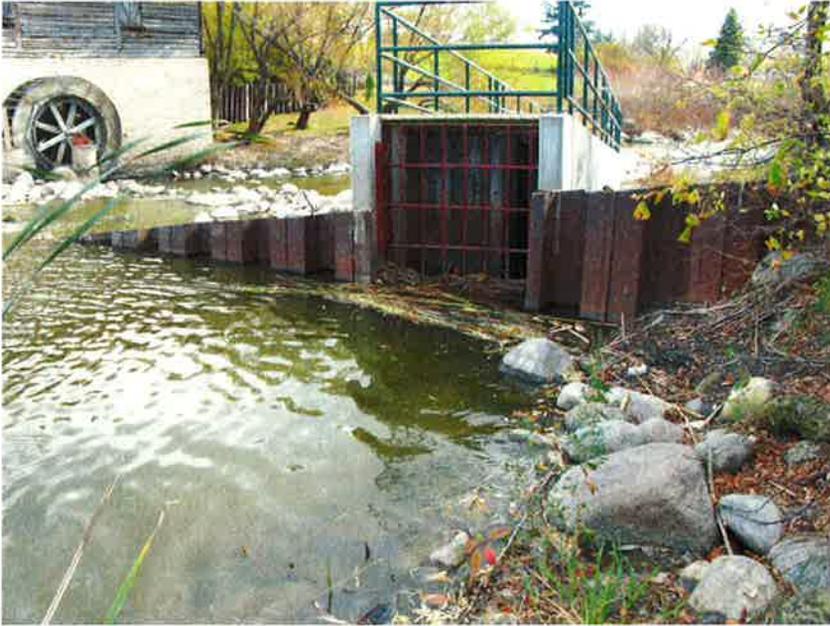
Photo # 9: Sturgeon Creek, upstream entrance to fish ladder at Old Grant's Mill, October 14, 2010.

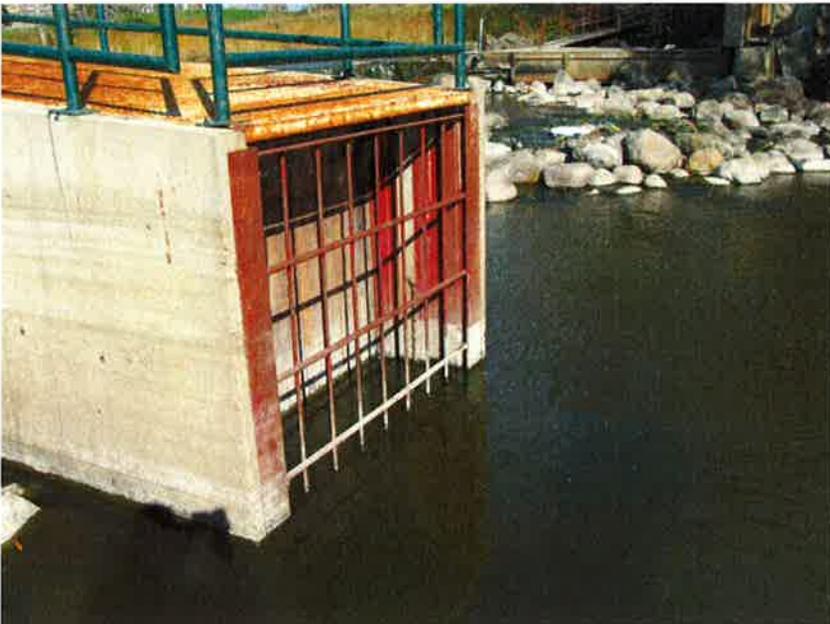
Photo # 10: Sturgeon Creek, downstream exit to fish ladder at Old Grant's Mill, October 14, 2010.

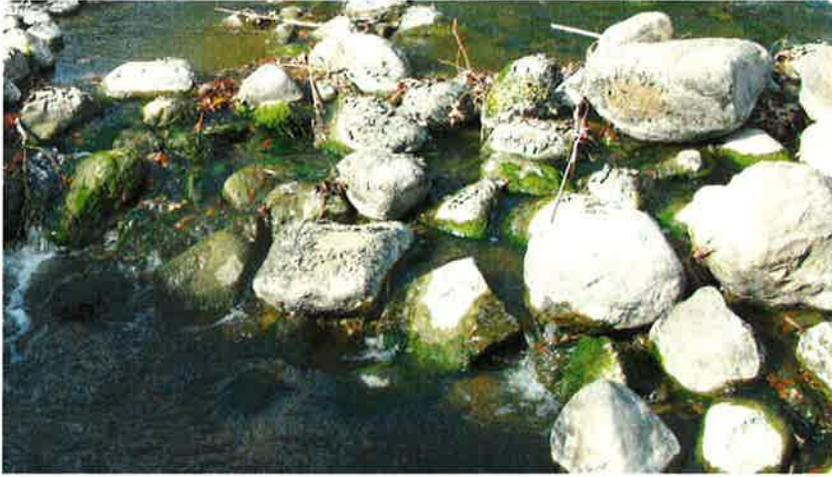
Photo # 15: Sturgeon Creek, algae on riffle rocks, October 14, 2010.

Portage Avenue crosses Sturgeon Creek approximately 375 meters downstream of the development site. Downstream of the Portage Bridge, the riparian zone associated with Woodhaven Park includes many more mature trees, with vegetation overhanging the wetted width of Sturgeon Creek. Downstream of the Portage Avenue Bridge, five riffles occur within Woodhaven Park (Photos 11-14) breaking the otherwise consistent run of Sturgeon Creek to the Assiniboine River. These riffles are composed of rocks and boulders ranging from 10-60 cm in diameter. In each riffle, 10-80% of the under-water surfaces of cobble, rocks and boulders were covered with green-brown filamentous algae (Photo 15).
