## **APPENDIX 'A' - GEOTECHNICAL REPORT**

# GEOTECHNICAL INVESTIGATION FURBY PLACE RECONSTRUCTION WINNIPEG, MANITOBA

AMEC File No. WX10364.5001

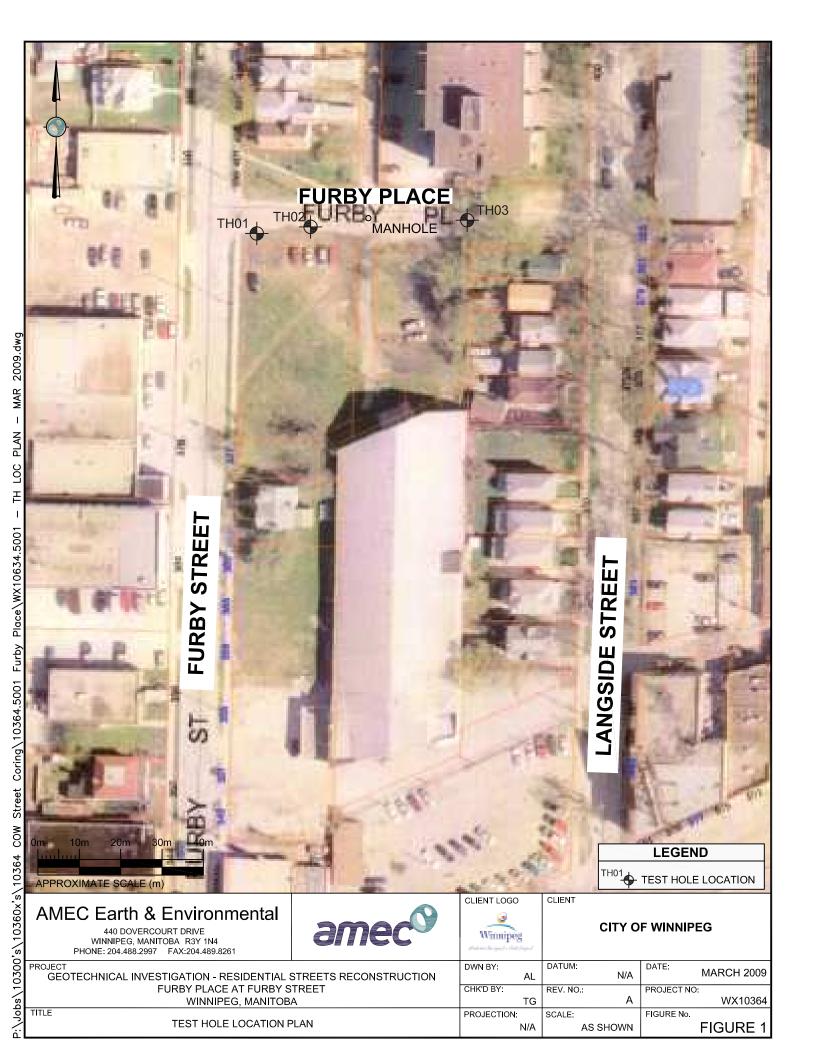
On 12 February 2009, following utility clearances, all test holes were drilled on the roadway, using a truck mounted Mobile B40LX drill rig operated by Maple Leaf Drilling Ltd. of Winnipeg, and equipped with 125 mm continuous flight solid stem augers. Typically the asphalt encountered would have been cored prior to test hole drilling however the COW informed AMEC that the street was gravel surfaced. Therefore in order to avoid costs associated with drill rig mobilization and standby charges, drilling proceeded without coring. The test hole locations are shown on Figure 1 in Appendix A.

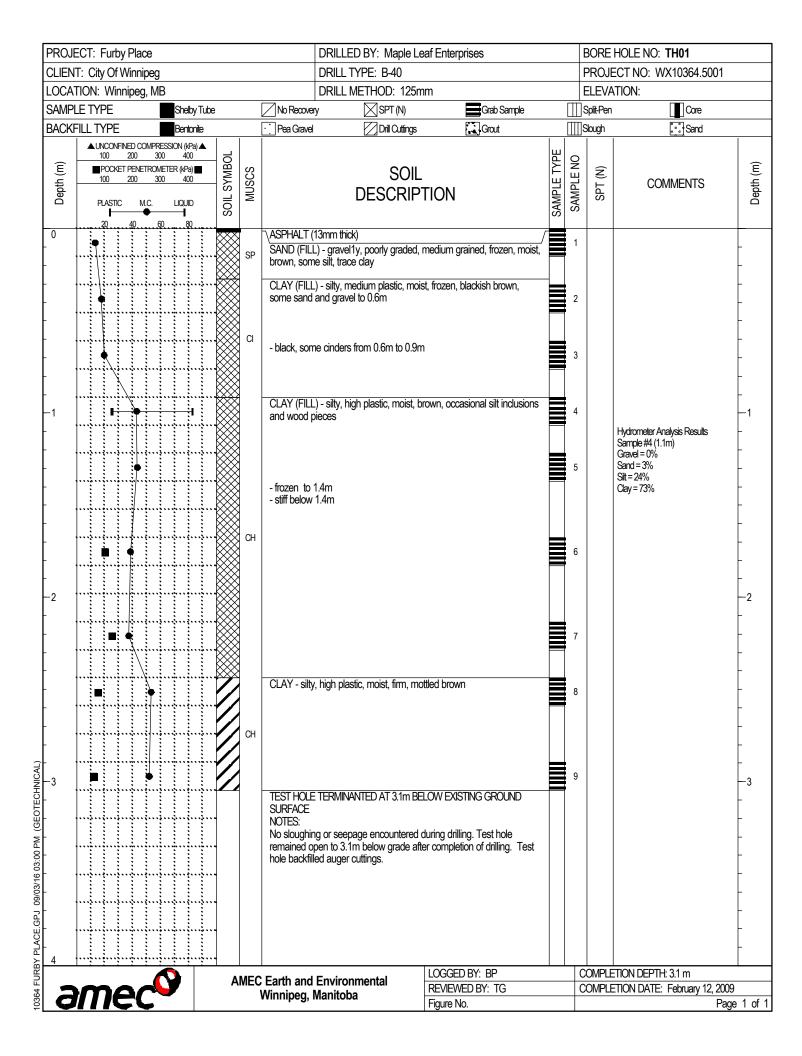
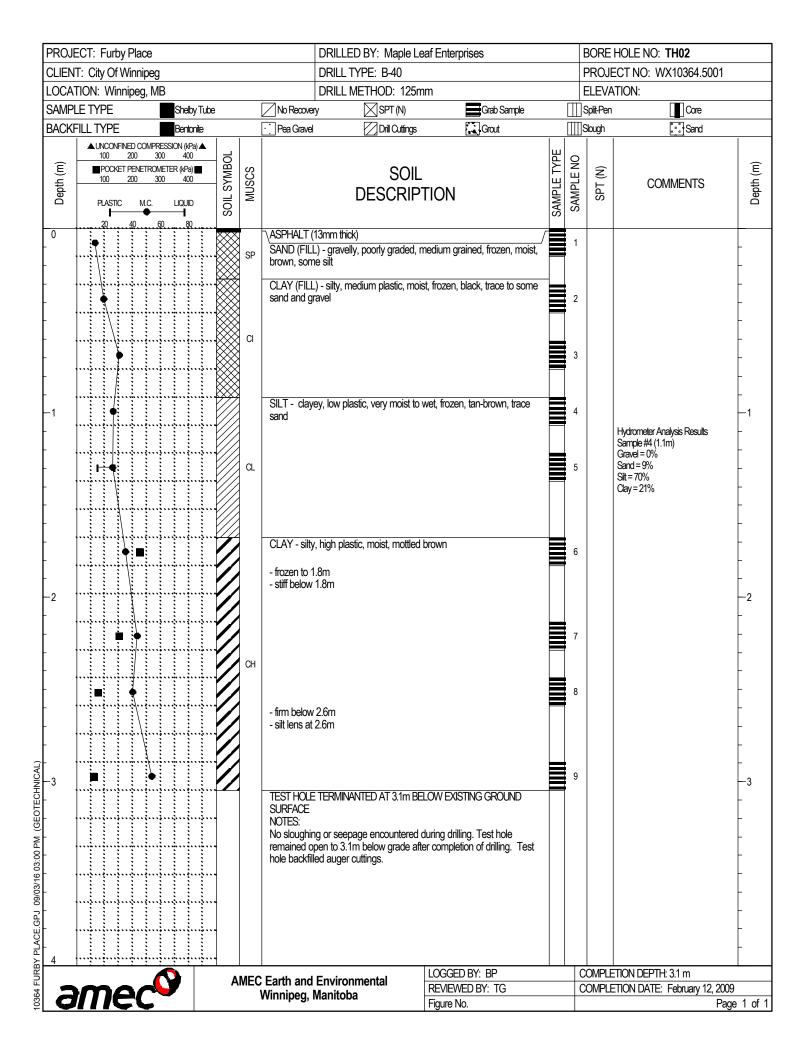
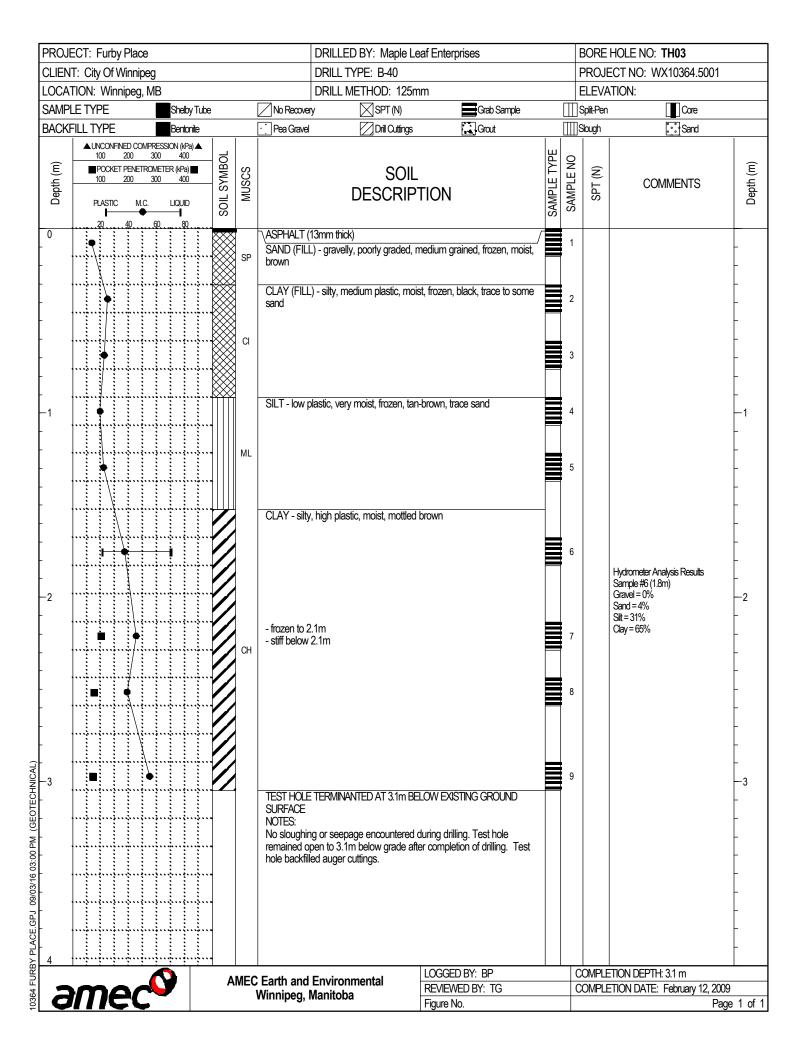
Asphalt pavement was present at each test hole location and was about 13 mm thick. The asphalt was underlain by variable fill materials that generally consisted of gravel fill underlain by clay fill. The sand fill noted below the asphalt pavement ranged from 270 mm (TH01 & TH02) to 305 mm (TH03) thick. Generally the sand fill was frozen, gravelly, poorly graded, medium grained, brown and moist. The clay fill was about 610 mm (TH02 and TH03) to 2100 mm (TH01) thick. The clay fill was typically silty, medium plastic however was high plastic below about 0.9 m in test hole TH01, moist, stiff (where not frozen) and black to brown and contained trace to some amounts of sand and gravel.

Low plastic silt was present directly below the clay fill in test holes TH02 and TH03, and was about 610 to 760 mm thick. The silt was generally low plastic, very moist to wet, tan-brown with trace amounts of sand. Native high plastic clay was noted under the clay fill or silt and extended to the depths explored in all test holes. The clay was generally silty, moist, firm to stiff, and mottled brown.

Table 1, below, summarizes the thickness and types of pavements and soils encountered at each of the test hole locations. Atterberg limit and hydrometer analysis results are summarized in Table 2. Detailed soil stratigraphy is illustrated in the attached test hole logs in Appendix A.
