## Memorandum

To	Eric Loewen	Page	1
CC			
Subject	Elm Park Pedestrian Bridge – Geotechnical Investigation		
From	Faris Khalil		
Date	December 11, 2009	Project Number	60119229 2940 394 00 (4.6.1)

The City of Winnipeg is planning condition improvements to the existing Elm Park pedestrian bridge. It is understood that the proposed improvements will include the abandonment of the last south span and the south abutment by extending the approach fill towards the south bent-pier. A soil retention structure will be required to provide adequate lateral support and containment of the approach fill. The existing bent-piers will be maintained and no additional foundation elements will be introduced. A new approach slab is to be constructed between the bridge and the proposed approach fill to accommodate the potential for differential displacement.

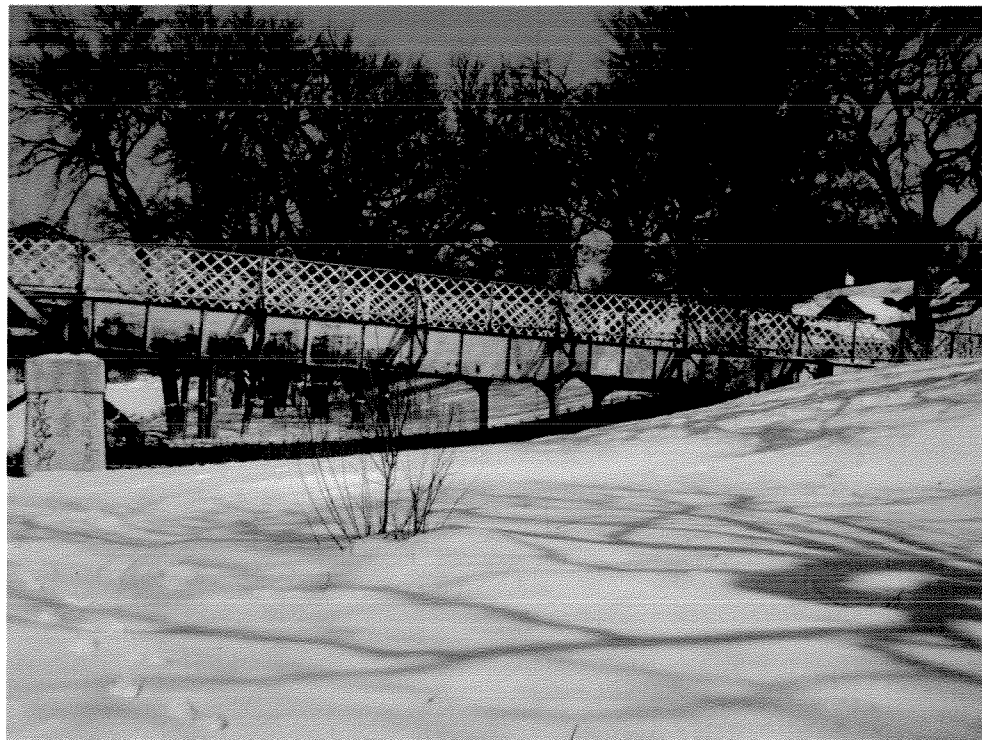
**Photo 01: South End of the Existing Bridge, Looking East**

The south end of the bridge is supported by a concrete abutment, two bent-piers and a concrete pier (Pier No. 4). The bent-pier structures are shown on Photo 01, these structures are not shown on the drawing B-5986-2, attached, made available by the City of Winnipeg. The south abutment is mostly buried and only the upper 0.5 m is visible, Photo 02. The drawing B-5986-2 illustrates the general arrangement of the bridge and test holes data from the 1964 drilling. AECOM reviewed this drawing and completed a site inspection on October 1<sup>st</sup> 2009 to assess the site condition, define the scope of the geotechnical work and develop the field investigation program. A second site inspection was completed by AECOM's structural group on October 30<sup>th</sup> 2009 to investigate the foundation type and condition of the existing bent-piers. Further discussion of the inspection details and foundation assessment is provided below.
