Project: Floor Slab Investigation
644 Parkdale Street

On April 27, 2012 the National Testing Laboratories Ltd. conducted an investigation of the floor slab at the St. James Centennial Pool & Recreation Centre located 644 Parkdale Street in Winnipeg, Manitoba. It was reported that the flooring in the fitness centre is lifting from the floor slab due to high relative humidity levels within the concrete. Recent measurements performed by another firm indicated the relative humidity of the floor slab was 99%. The purpose of the investigation was to determine the thickness of the concrete slab, presence of vapour barrier below slab, and the subsurface conditions below the slab.

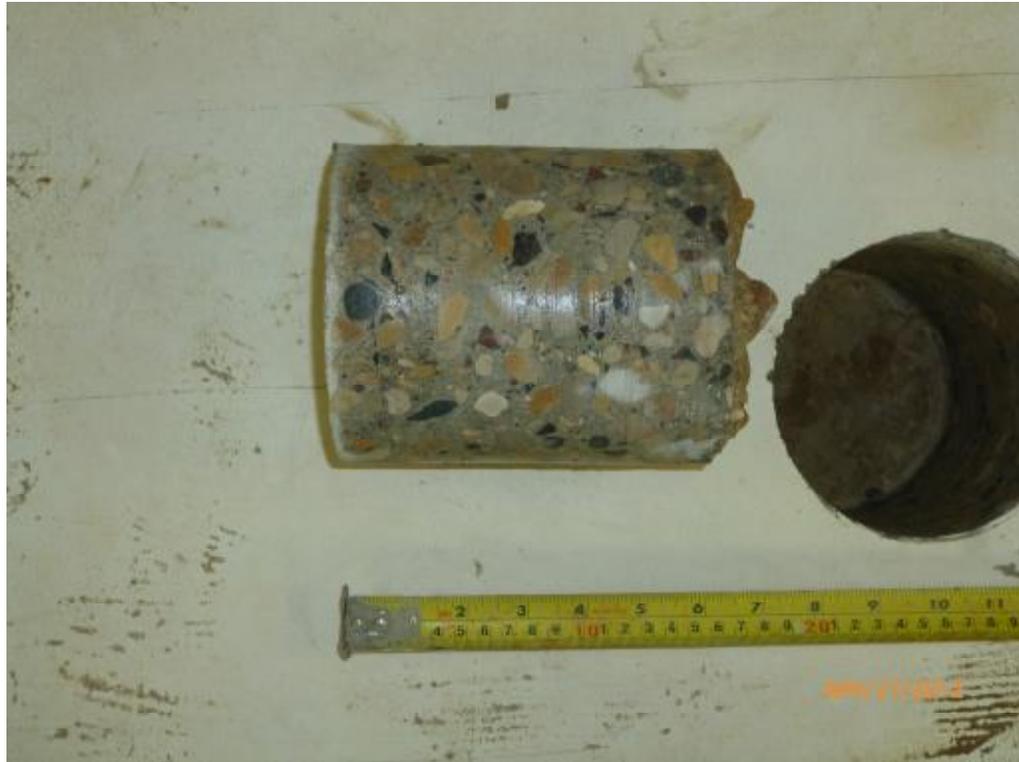
Figure 1 - Concrete core adjacent to core location

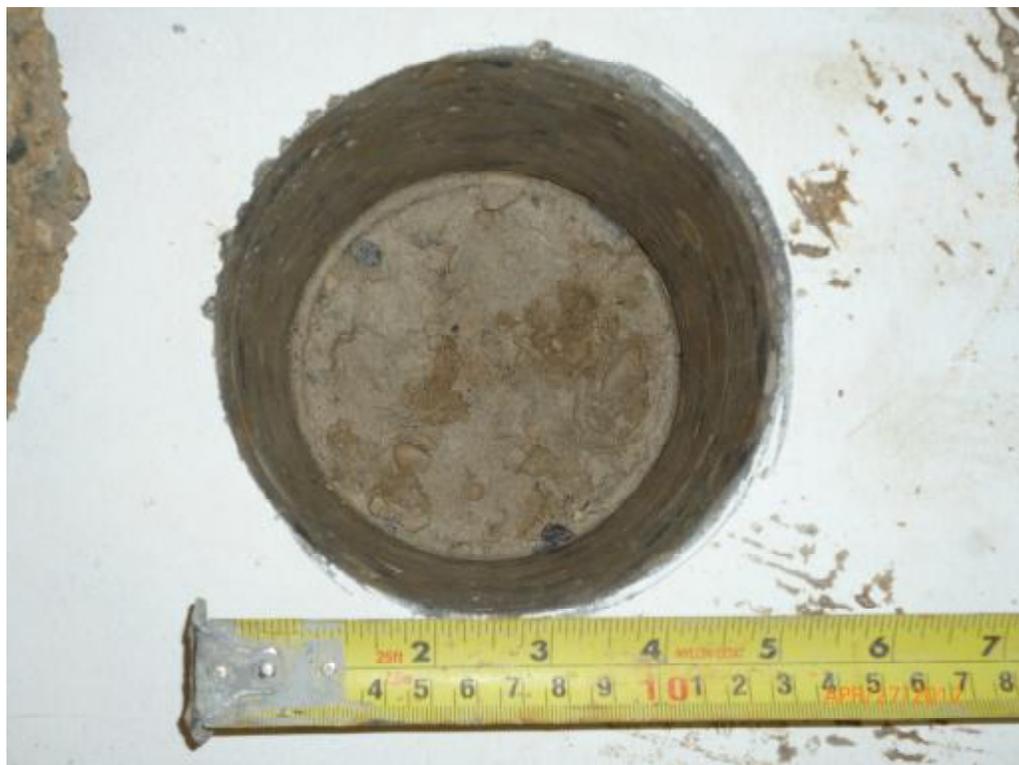
Figure 2 - Granular base course at underside of concrete slab

Based upon our investigation, it was not evident why there are high relative humidity results in the concrete slab. It may be possible that the concrete slab is drawing moisture from the granular base immediately below the slab above the vapour barrier. Typically the vapour barrier is directly below the concrete slab, however, at times it is used with some base material above it. Having granular base material above the vapour barrier allows for the concrete slab to draw moisture in an attempt to prevent curling of the slab as it cures. This practice may be the root cause of the high RH% readings.

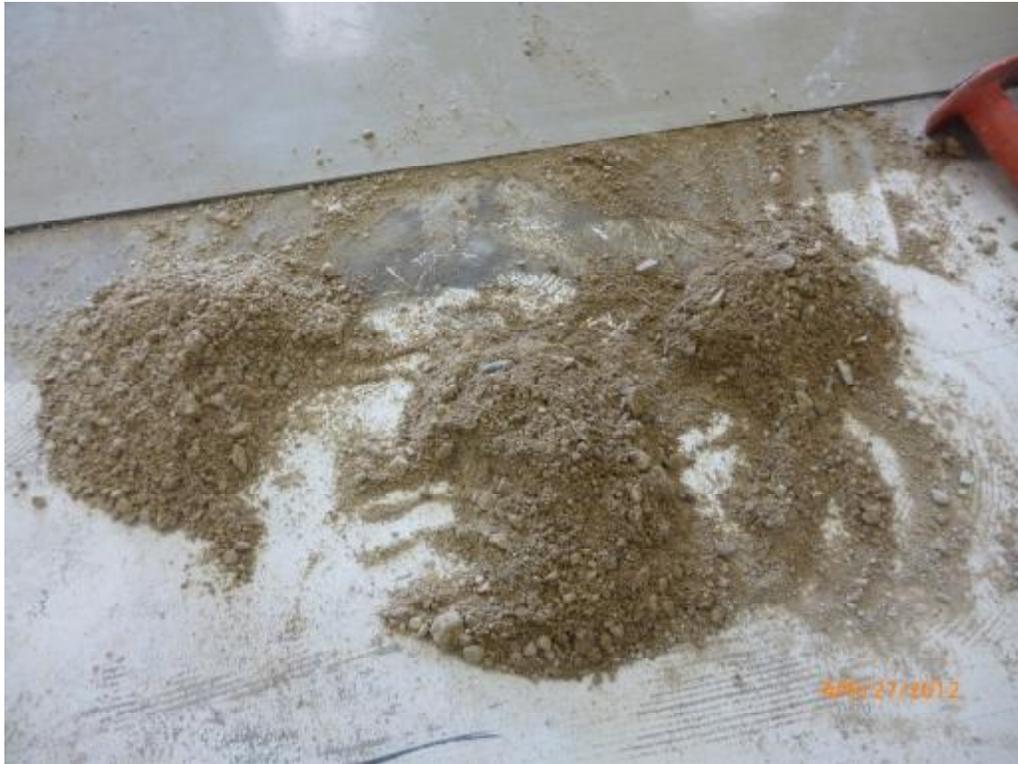
Figure 3 – Granular base obtained from test hole

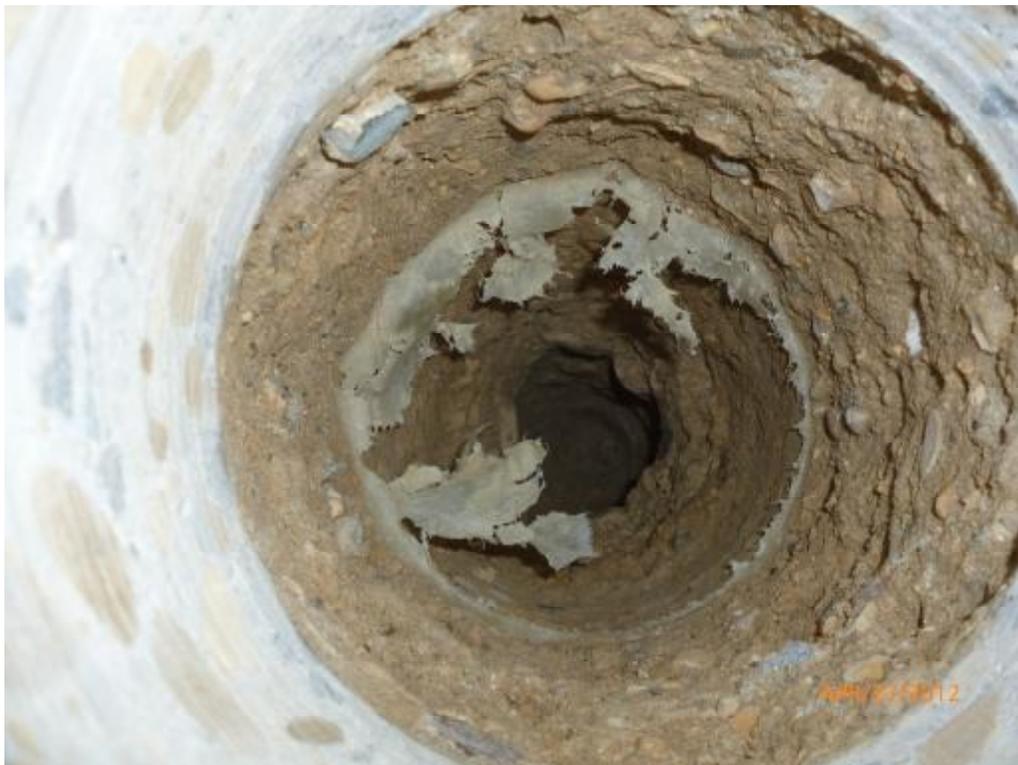
Figure 4 – Poly vapour barrier present 100 mm below underside of concrete

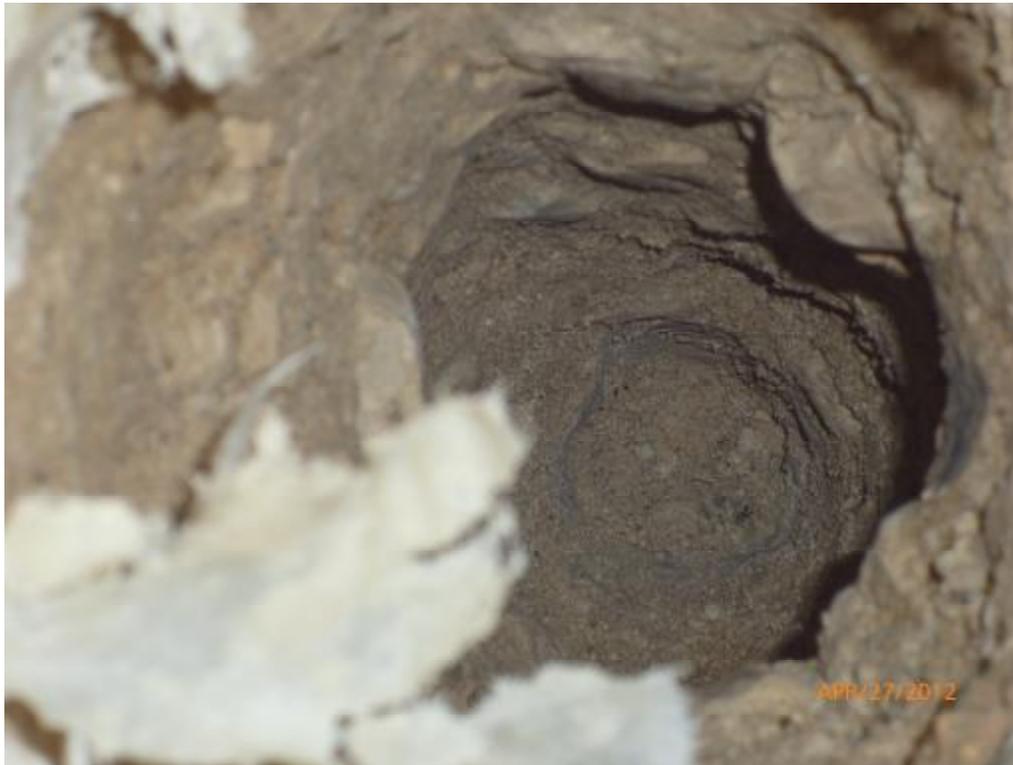
Figure 5 – Granular base at a depth of 0.75 m below top of concrete slab

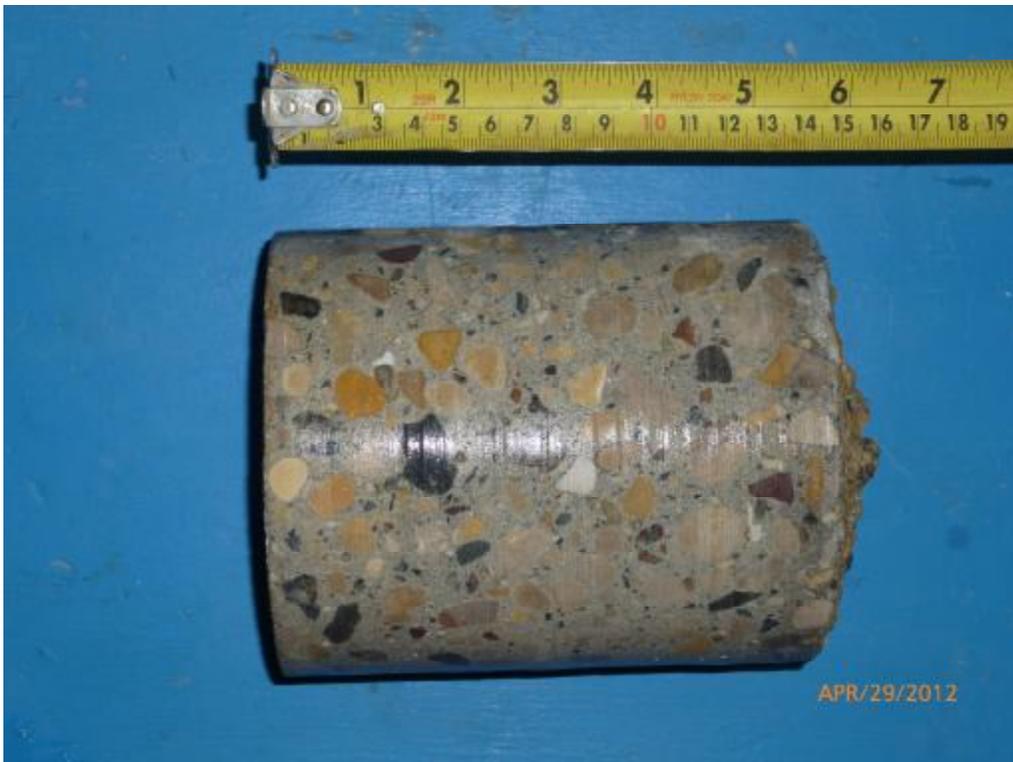
Figure 6 – Core sample obtained from concrete slab
