**PHASE I ENVIRONMENTAL SITE ASSESSMENT  
480 KEENLEYSIDE STREET  
WINNIPEG, MANITOBA**

22 March 2013

AMEC Project No: WX17105

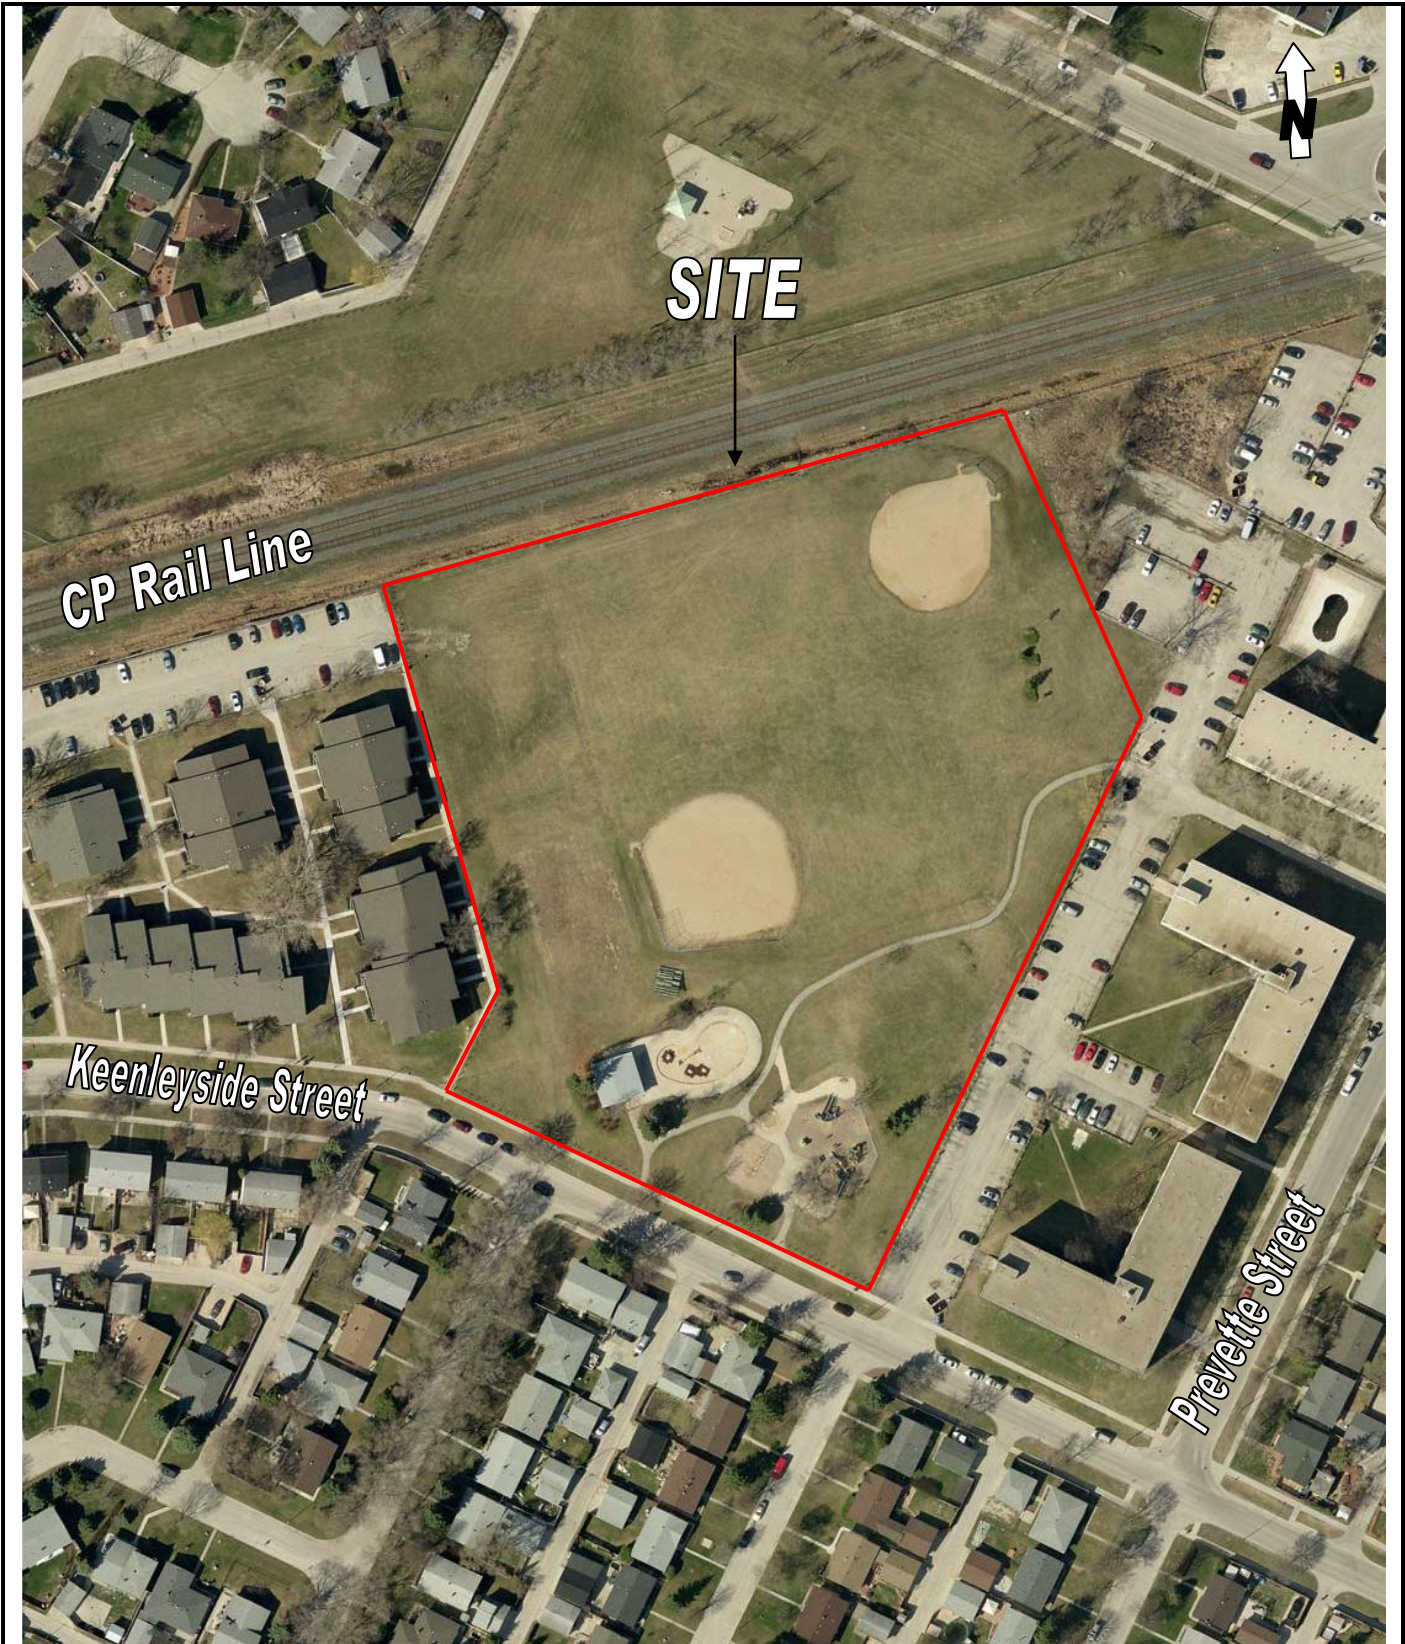
A map showing the location of the Site in relation to Winnipeg is shown in Figure A1, Appendix A. A plan showing the layout of the Site and the neighbouring properties is provided in Figure A2, Appendix A.

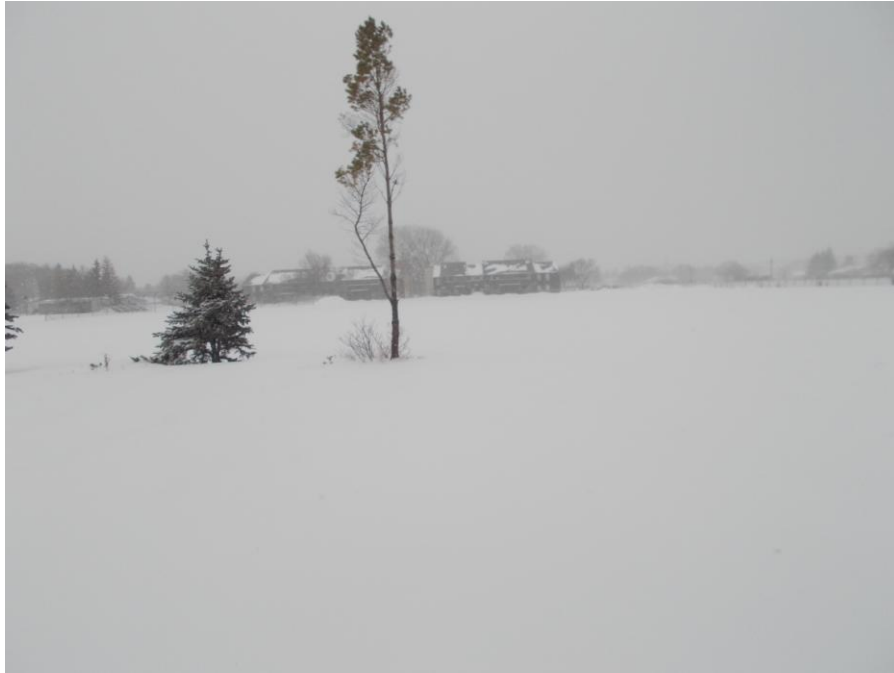
**PHOTOGRAPH 1:** Looking southwest across the Site from the northeast corner of the Site.

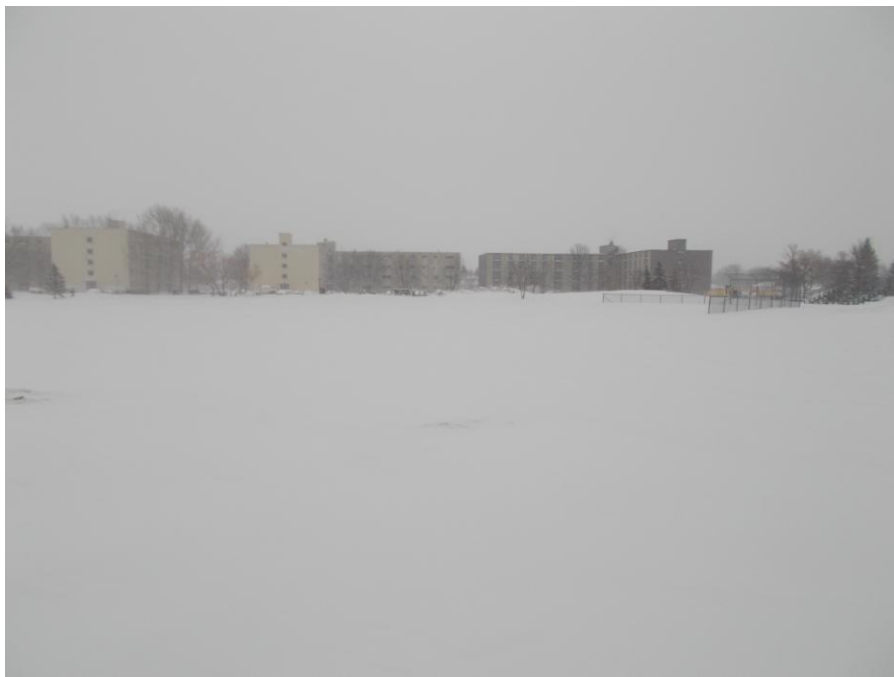
**PHOTOGRAPH 2:** Looking northeast across the Site from the southwest corner of the Site.

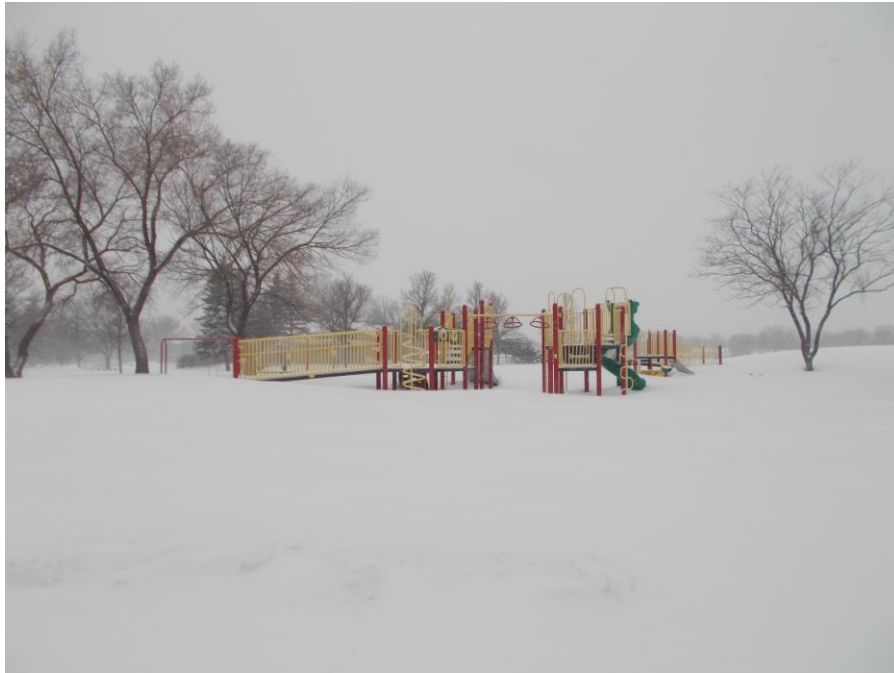
**PHOTOGRAPH 3:** Looking northwest showing the playground located in the southeast corner of the Site.

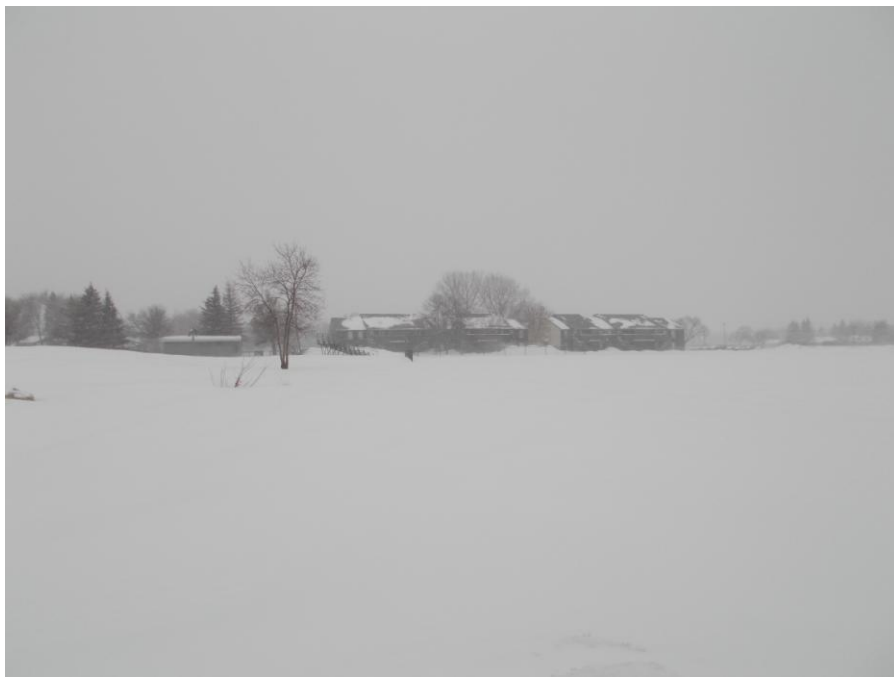
**PHOTOGRAPH 4:** Looking west across the Site from the approximate centre of the eastern Site boundary.

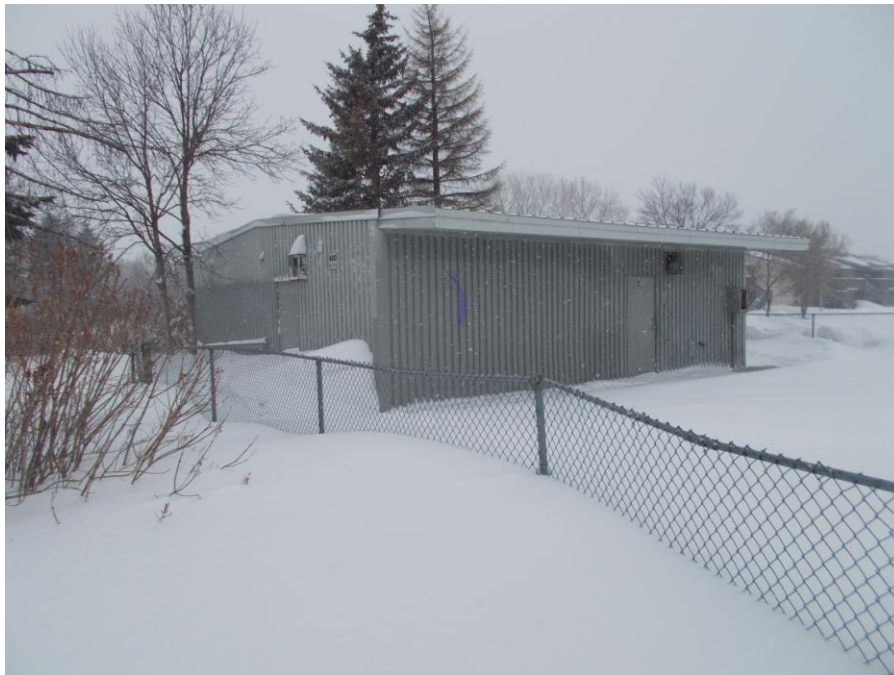
According to the City of Winnipeg Assessment and Taxation Department the wading pool building was constructed in 1973. The Site building was constructed on a concrete slab with a steel frame. The interior walls throughout the building were observed to consist of a mixture of wood panelling, stained plywood, and exposed exterior metal siding. Ceilings throughout the building were observed to consist of exposed steel beams and insulation. Additionally, it appeared that suspended ceiling tiles were formally installed within the Site building as tracking associated with suspended ceiling tiles was observed. Flooring throughout the building was observed to consist of exposed and finished concrete. Lighting was provided to the building by fluorescent tube lighting. The roof and exterior walls of the building were observed to consist of corrugated metal. No heating or cooling sources were observed within the Site buildings as the building is only used during the summer months when the wading pool is operational.

**PHOTOGRAPH 5:** Showing the exterior of the Wading Pool building.

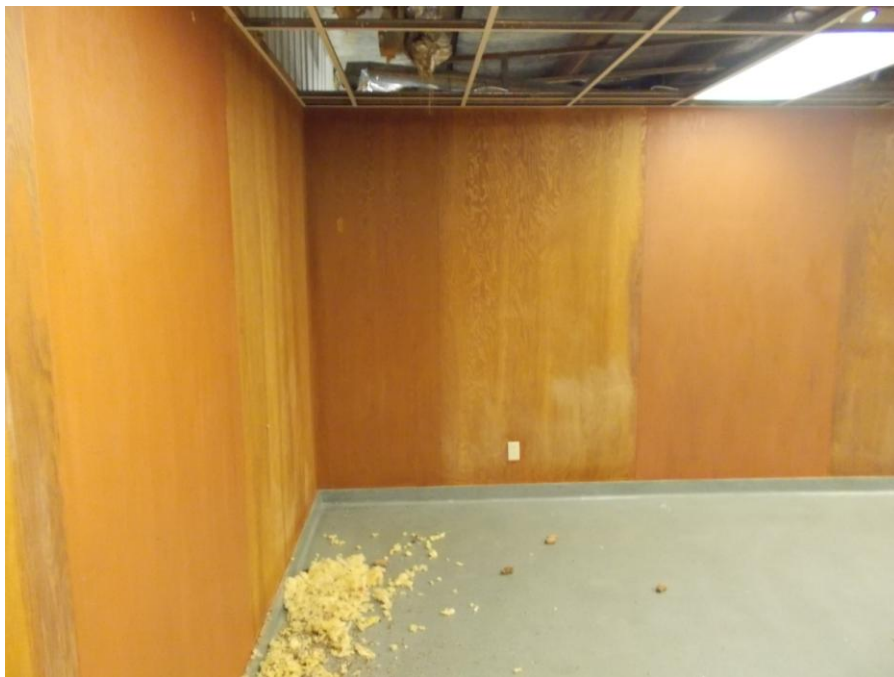
The Site building was also observed to house the mechanical equipment associated with the wading pool. A small amount of chemicals associated with pool maintenance were observed to be stored above a concrete floor in the mechanical room of the Site building. Further, at the time of the Site inspection it appeared that an animal had entered the Site building at one point through an opening in the northwest corner near the top of the wall. Pieces of fiberglass insulation and pine cones were observed to be scattered in various areas of the northern portion of the building.

As the Site was developed in 1973, there is a potential for asbestos containing materials to be present within the Site building, however, were not observed at the time of the Site inspection. ACMs which may be present within the building, but which were not observed or reported during the Site inspection, may include roofing materials and mastics, joint compounds associated with various types of concrete block, vermiculite insulation within wall cavities, and thermal insulating materials such as fire door insulation, and gaskets associated with mechanical equipment.

**PHOTOGRAPH 6:** Showing interior building materials, also showing insulation and pine cones observed on the floor of the Site building.

Based on the findings of the assessment, AMEC recommends that a designated substances survey (DSS) be conducted prior to any renovation or demolition given the potential for disturbance of these materials during renovation / demolition activities.

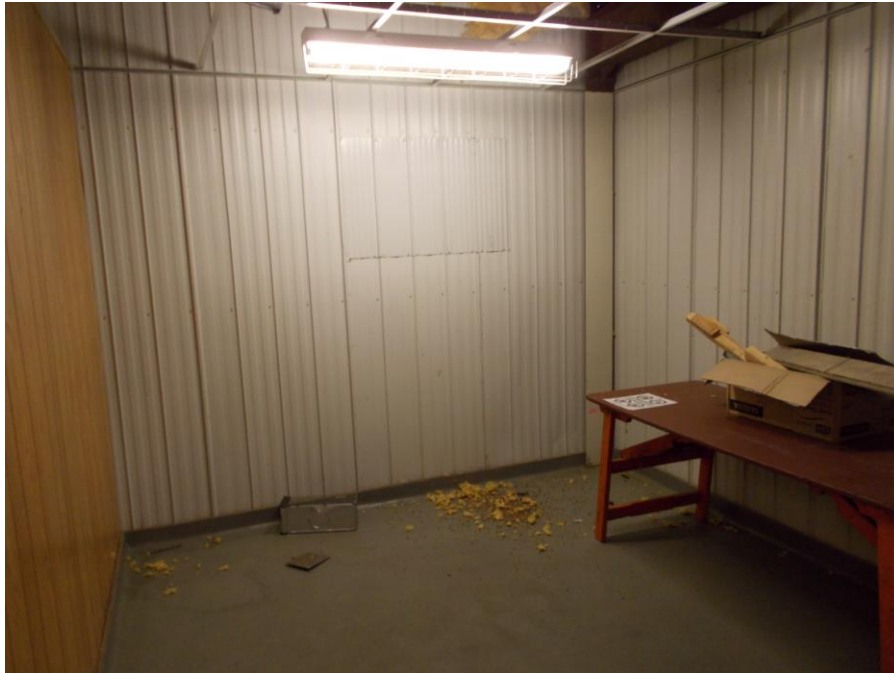
**PHOTOGRAPH 7:** Showing interior building materials, also showing insulation observed on the floor of the Site building.

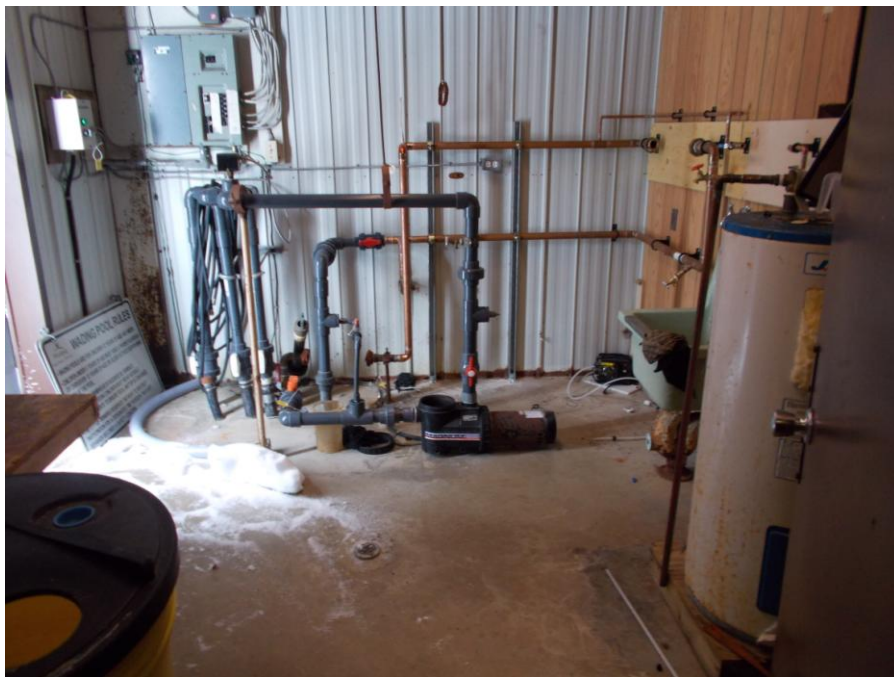
Apart from a small quantity of cleaning products and pool chemicals, there was no chemical use or storage observed on-site at the time of the Site assessment.

**PHOTOGRAPH 8:** Showing the wading pool mechanical room.

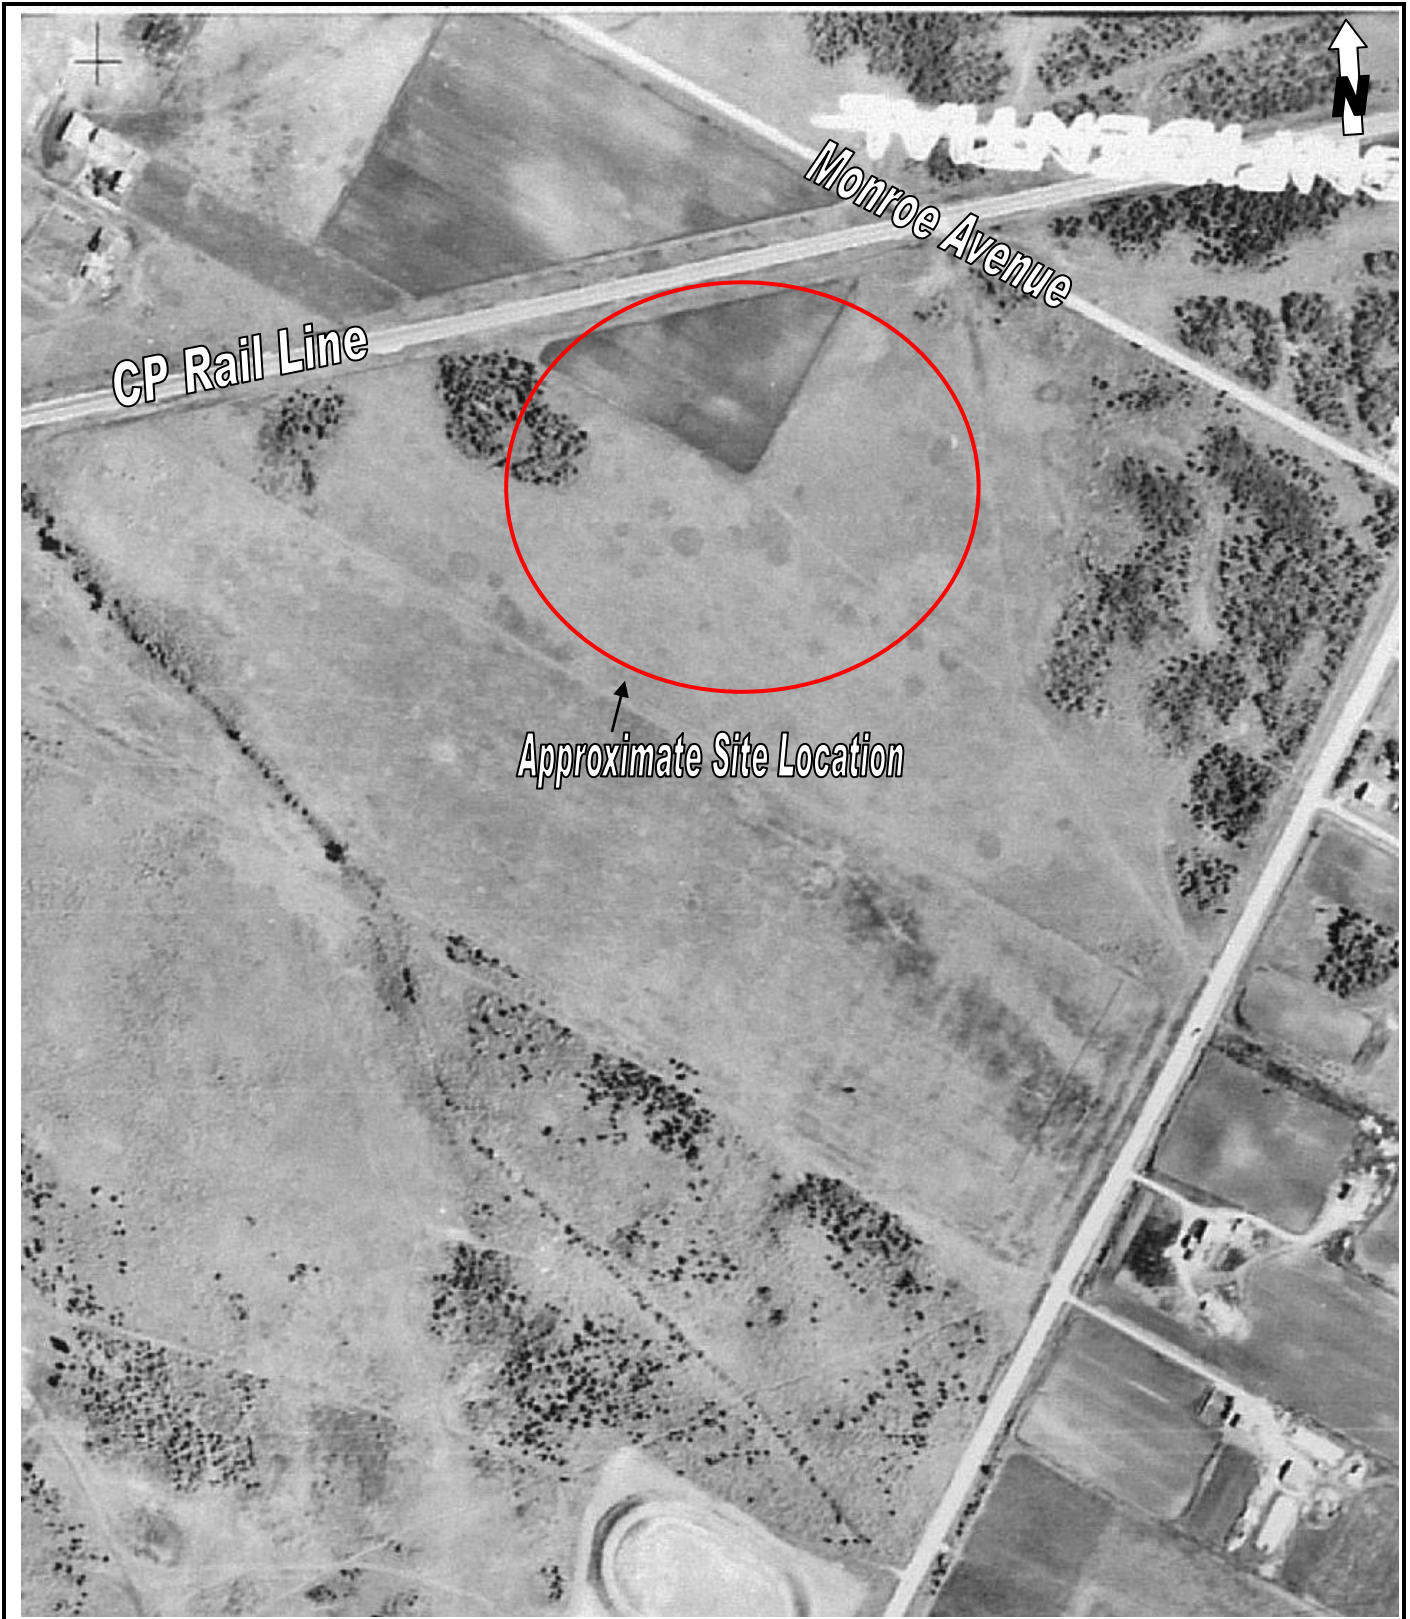
Figure: E1

The Site consisted of agricultural and grass covered land prior to 1950 until the early 1970s when it was developed as Keenleyside Park with a maintenance building, wading pool, playground, and footpath. Sometime between 1997 and 2012 the baseball diamonds were developed. It was reported to AMEC that the playground in the southeast corner of the Site was updated sometime between 2007 and 2008. There have been no further changes at the Site since 2008.

1950 AERIAL PHOTOGRAPH  
PHASE I ENVIRONMENTAL SITE ASSESSMENT  
480 KEENLEYSIDE STREET  
WINNIPEG, MANITOBA

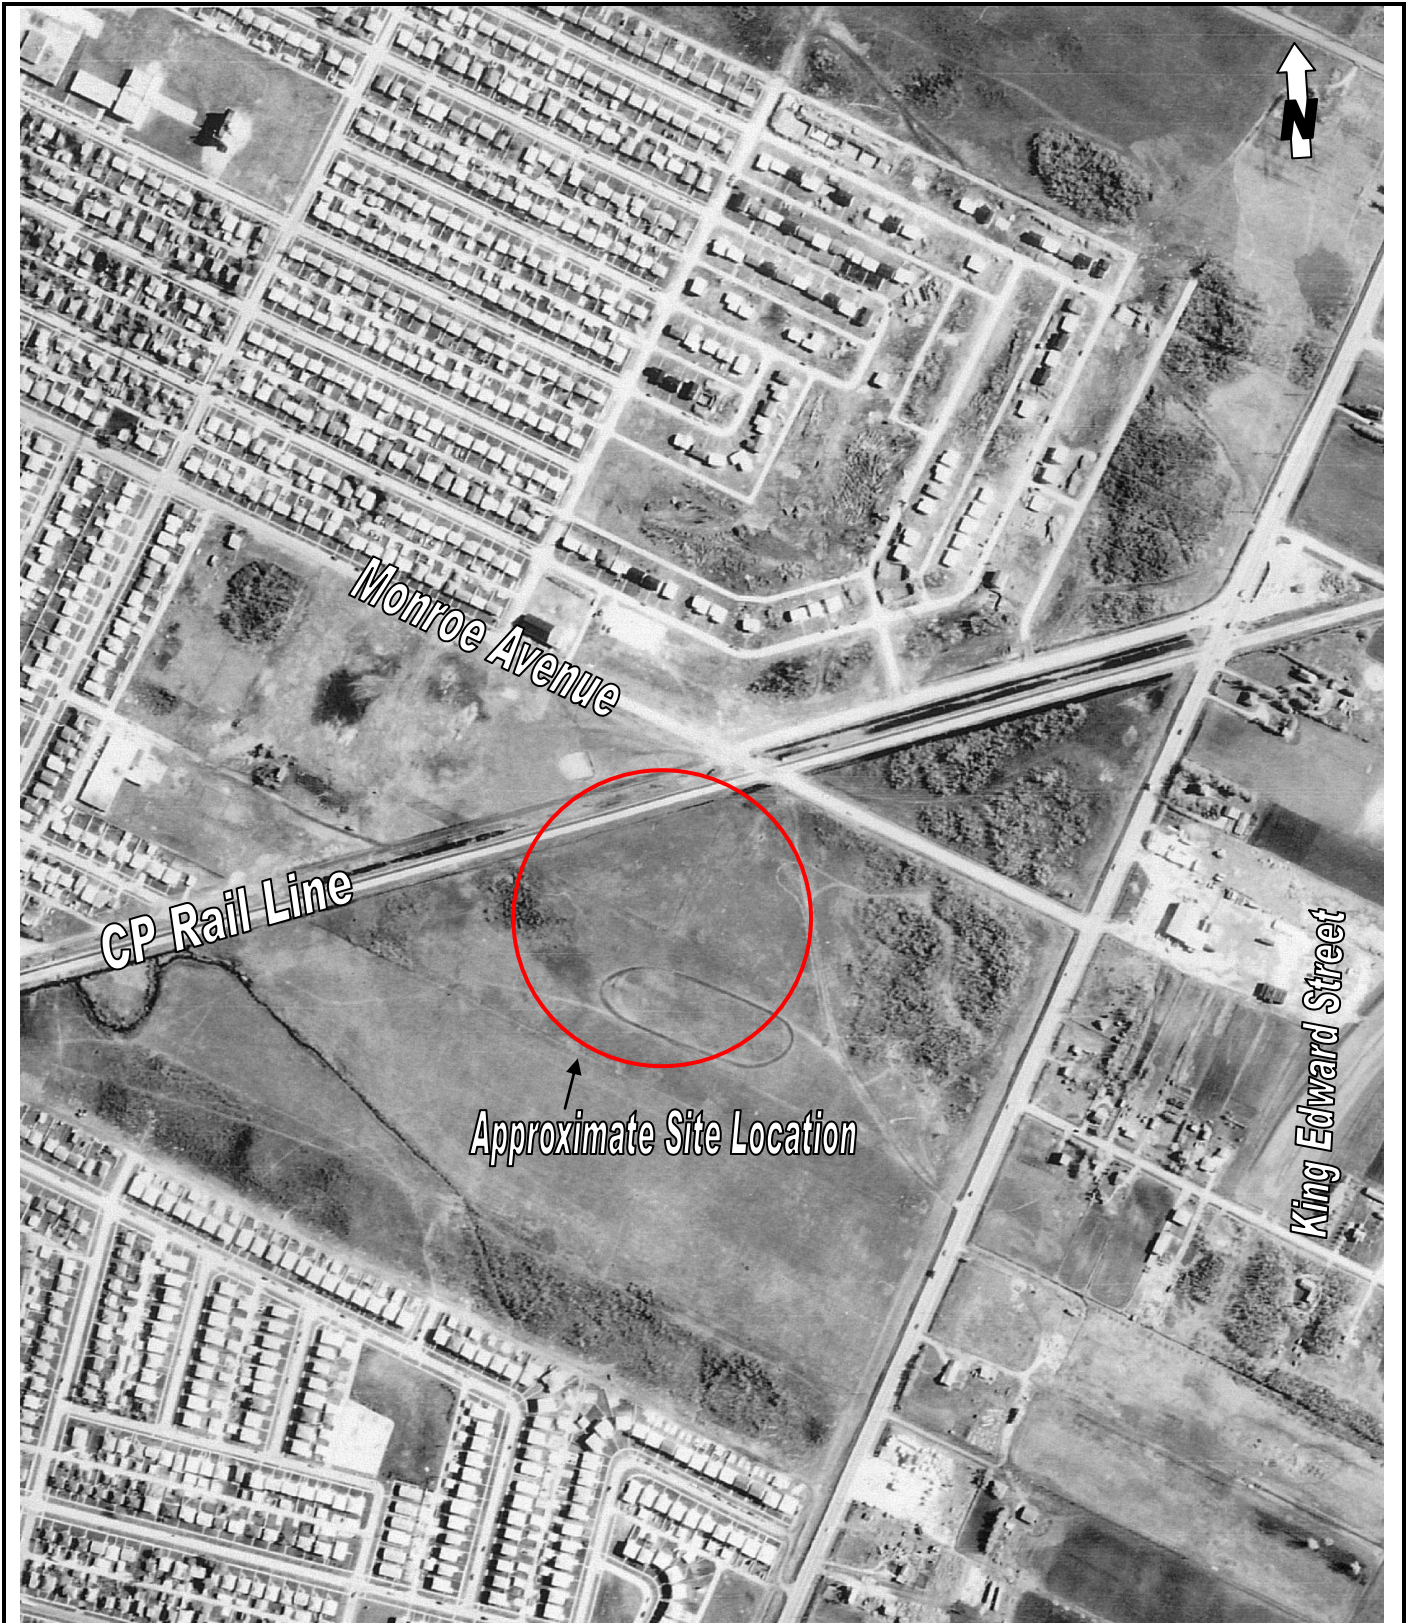
Figure: E2

1968 AERIAL PHOTOGRAPH  
PHASE I ENVIRONMENTAL SITE ASSESSMENT  
480 KEENLEYSIDE STREET  
WINNIPEG, MANITOBA

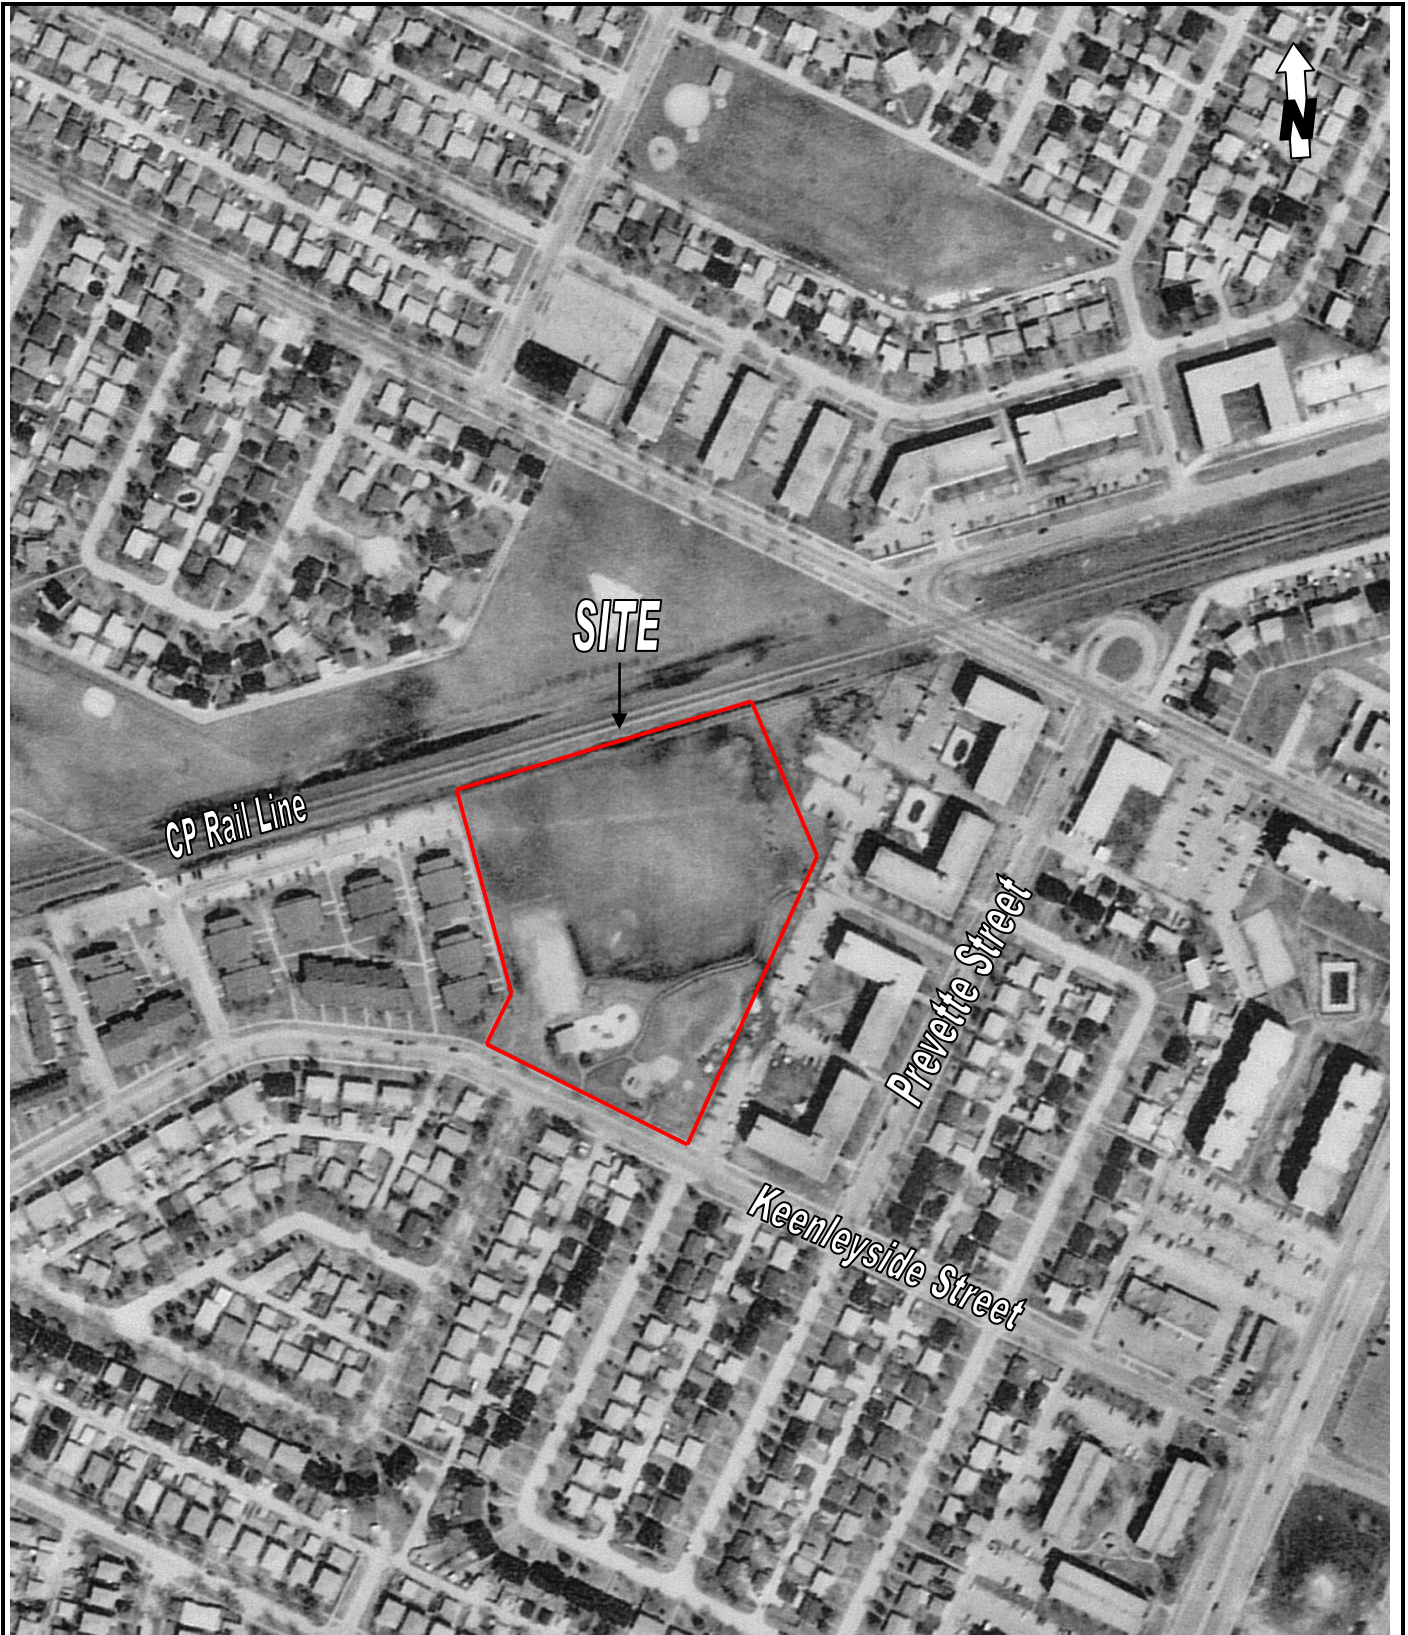
1997 AERIAL PHOTOGRAPH  
PHASE I ENVIRONMENTAL SITE ASSESSMENT  
480 KEENLEYSIDE STREET  
WINNIPEG, MANITOBA
