GEOTECHNICAL REPORT

**GEOTECHNICAL INVESTIGATION
RESIDENTIAL STREETS RECONSTRUCTION
WINNIPEG, MANITOBA**

21 January 2015

Amec Foster Wheeler File No. WX17565R1

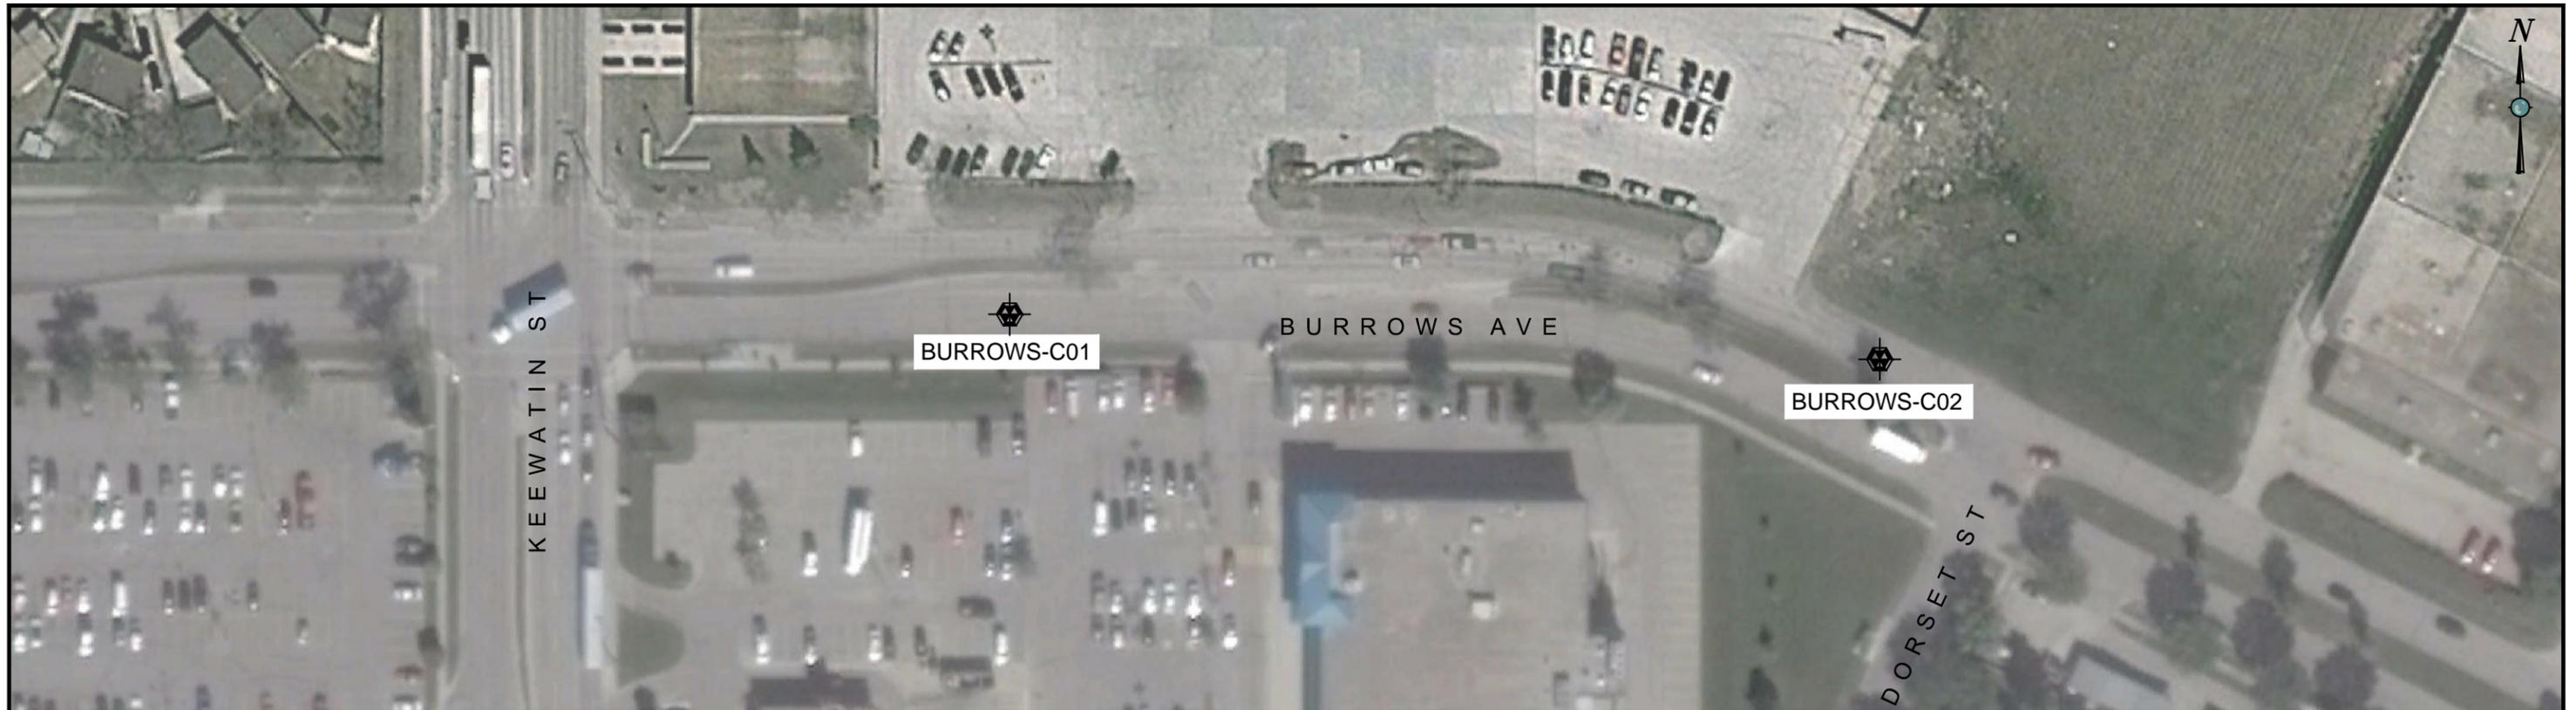
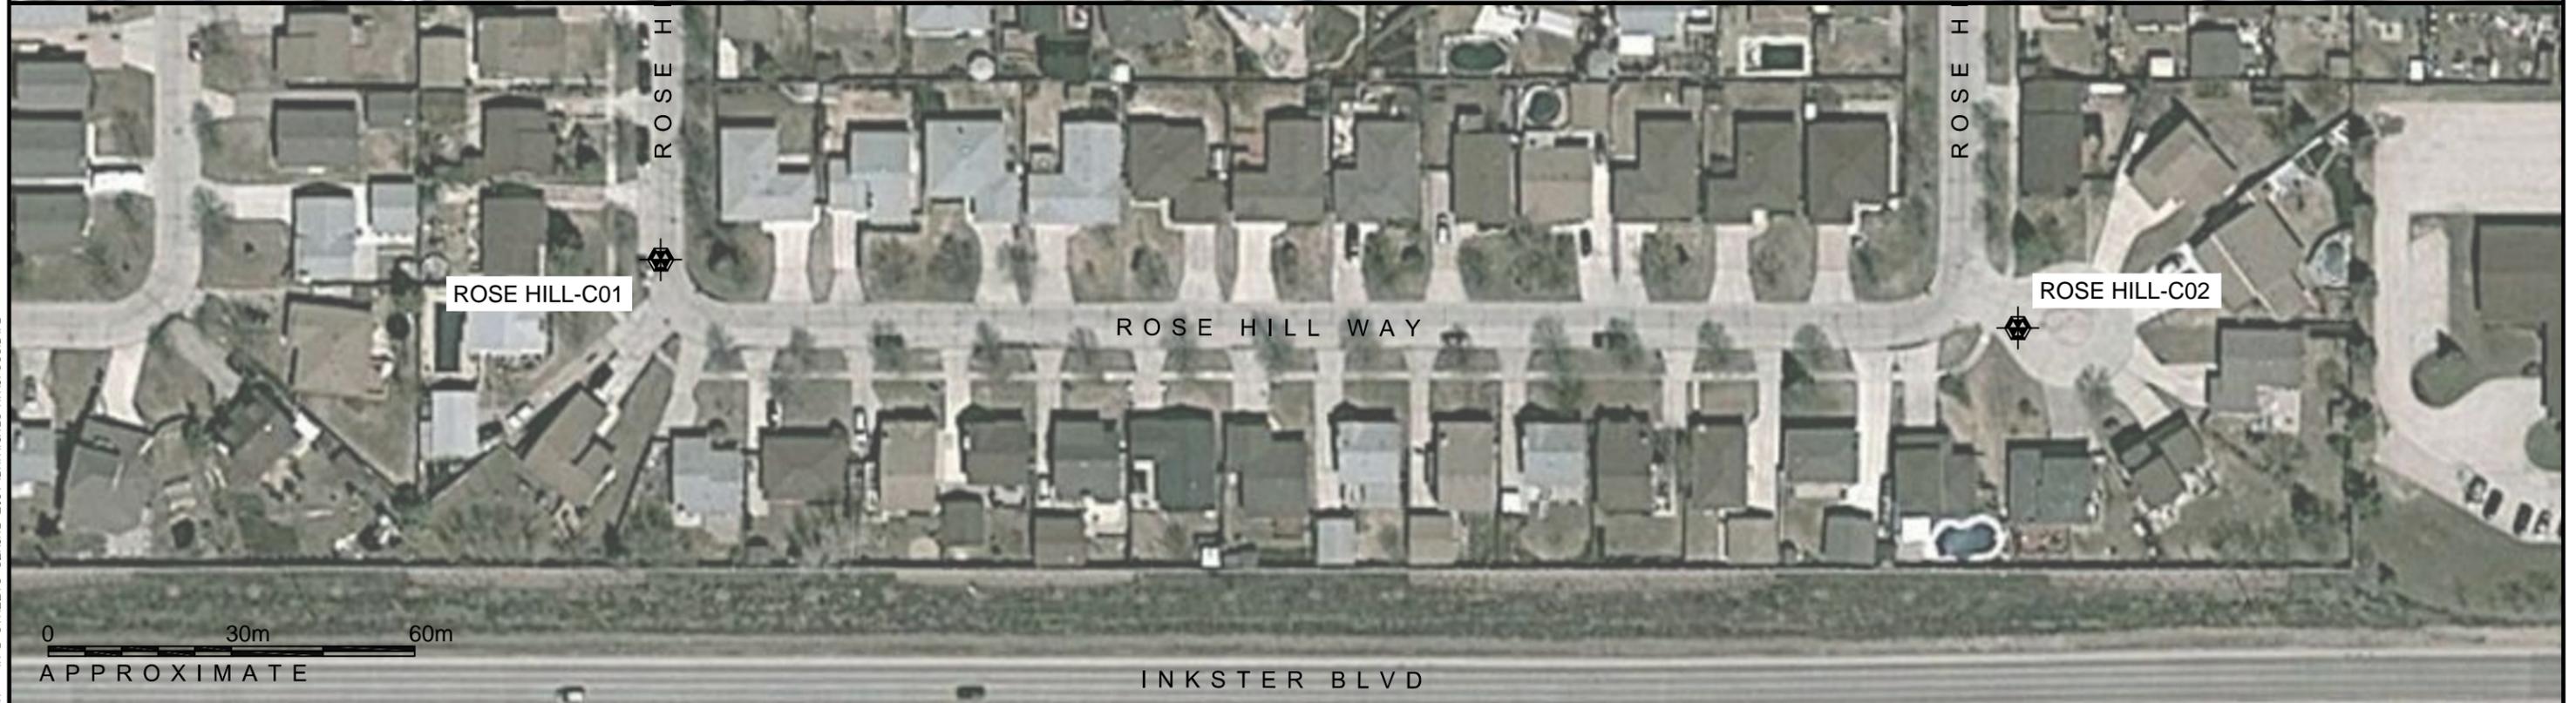
LEGEND: CORE HOLE LOCATION	CLIENT LOGO	CLIENT:	DWN BY:	STREET CORING PROGRAM VARIOUS STREET LOCATIONS WINNIPEG, MANITOBA	DATE:
		MMM GROUP LIMITED	MD AJ NAD83		DECEMBER 2014 PROJECT NO: WX17565
		AMEC Environment & Infrastructure 440 DOVERCOURT DRIVE WINNIPEG, MANITOBA R3Y 1N4 PHONE: 204.488.2997 FAX:204.489.8261		CORE/TEST HOLE LOCATIONS (BURROWS AVE/ROSE HILL WAY)	REV. NO.: A
			PROJECTION: UTM Zone 14 U SCALE: AS SHOWN		FIGURE NO: FIGURE 6
