THE CITY OF WINNIPEG
PUBLIC WORKS DEPARTMENT
ENGINEERING DIVISION

NAIRN AVENUE OVERPASS
CONCRETE GIRDER AND PIER REPAIRS

PIER CAP, GIRDER & BEARING REPAIRS - SHEET 1

CITY DRAWING NUMBER B121-2015-05
SHEET 5 OF 7
DRAWING No. REV 05 C

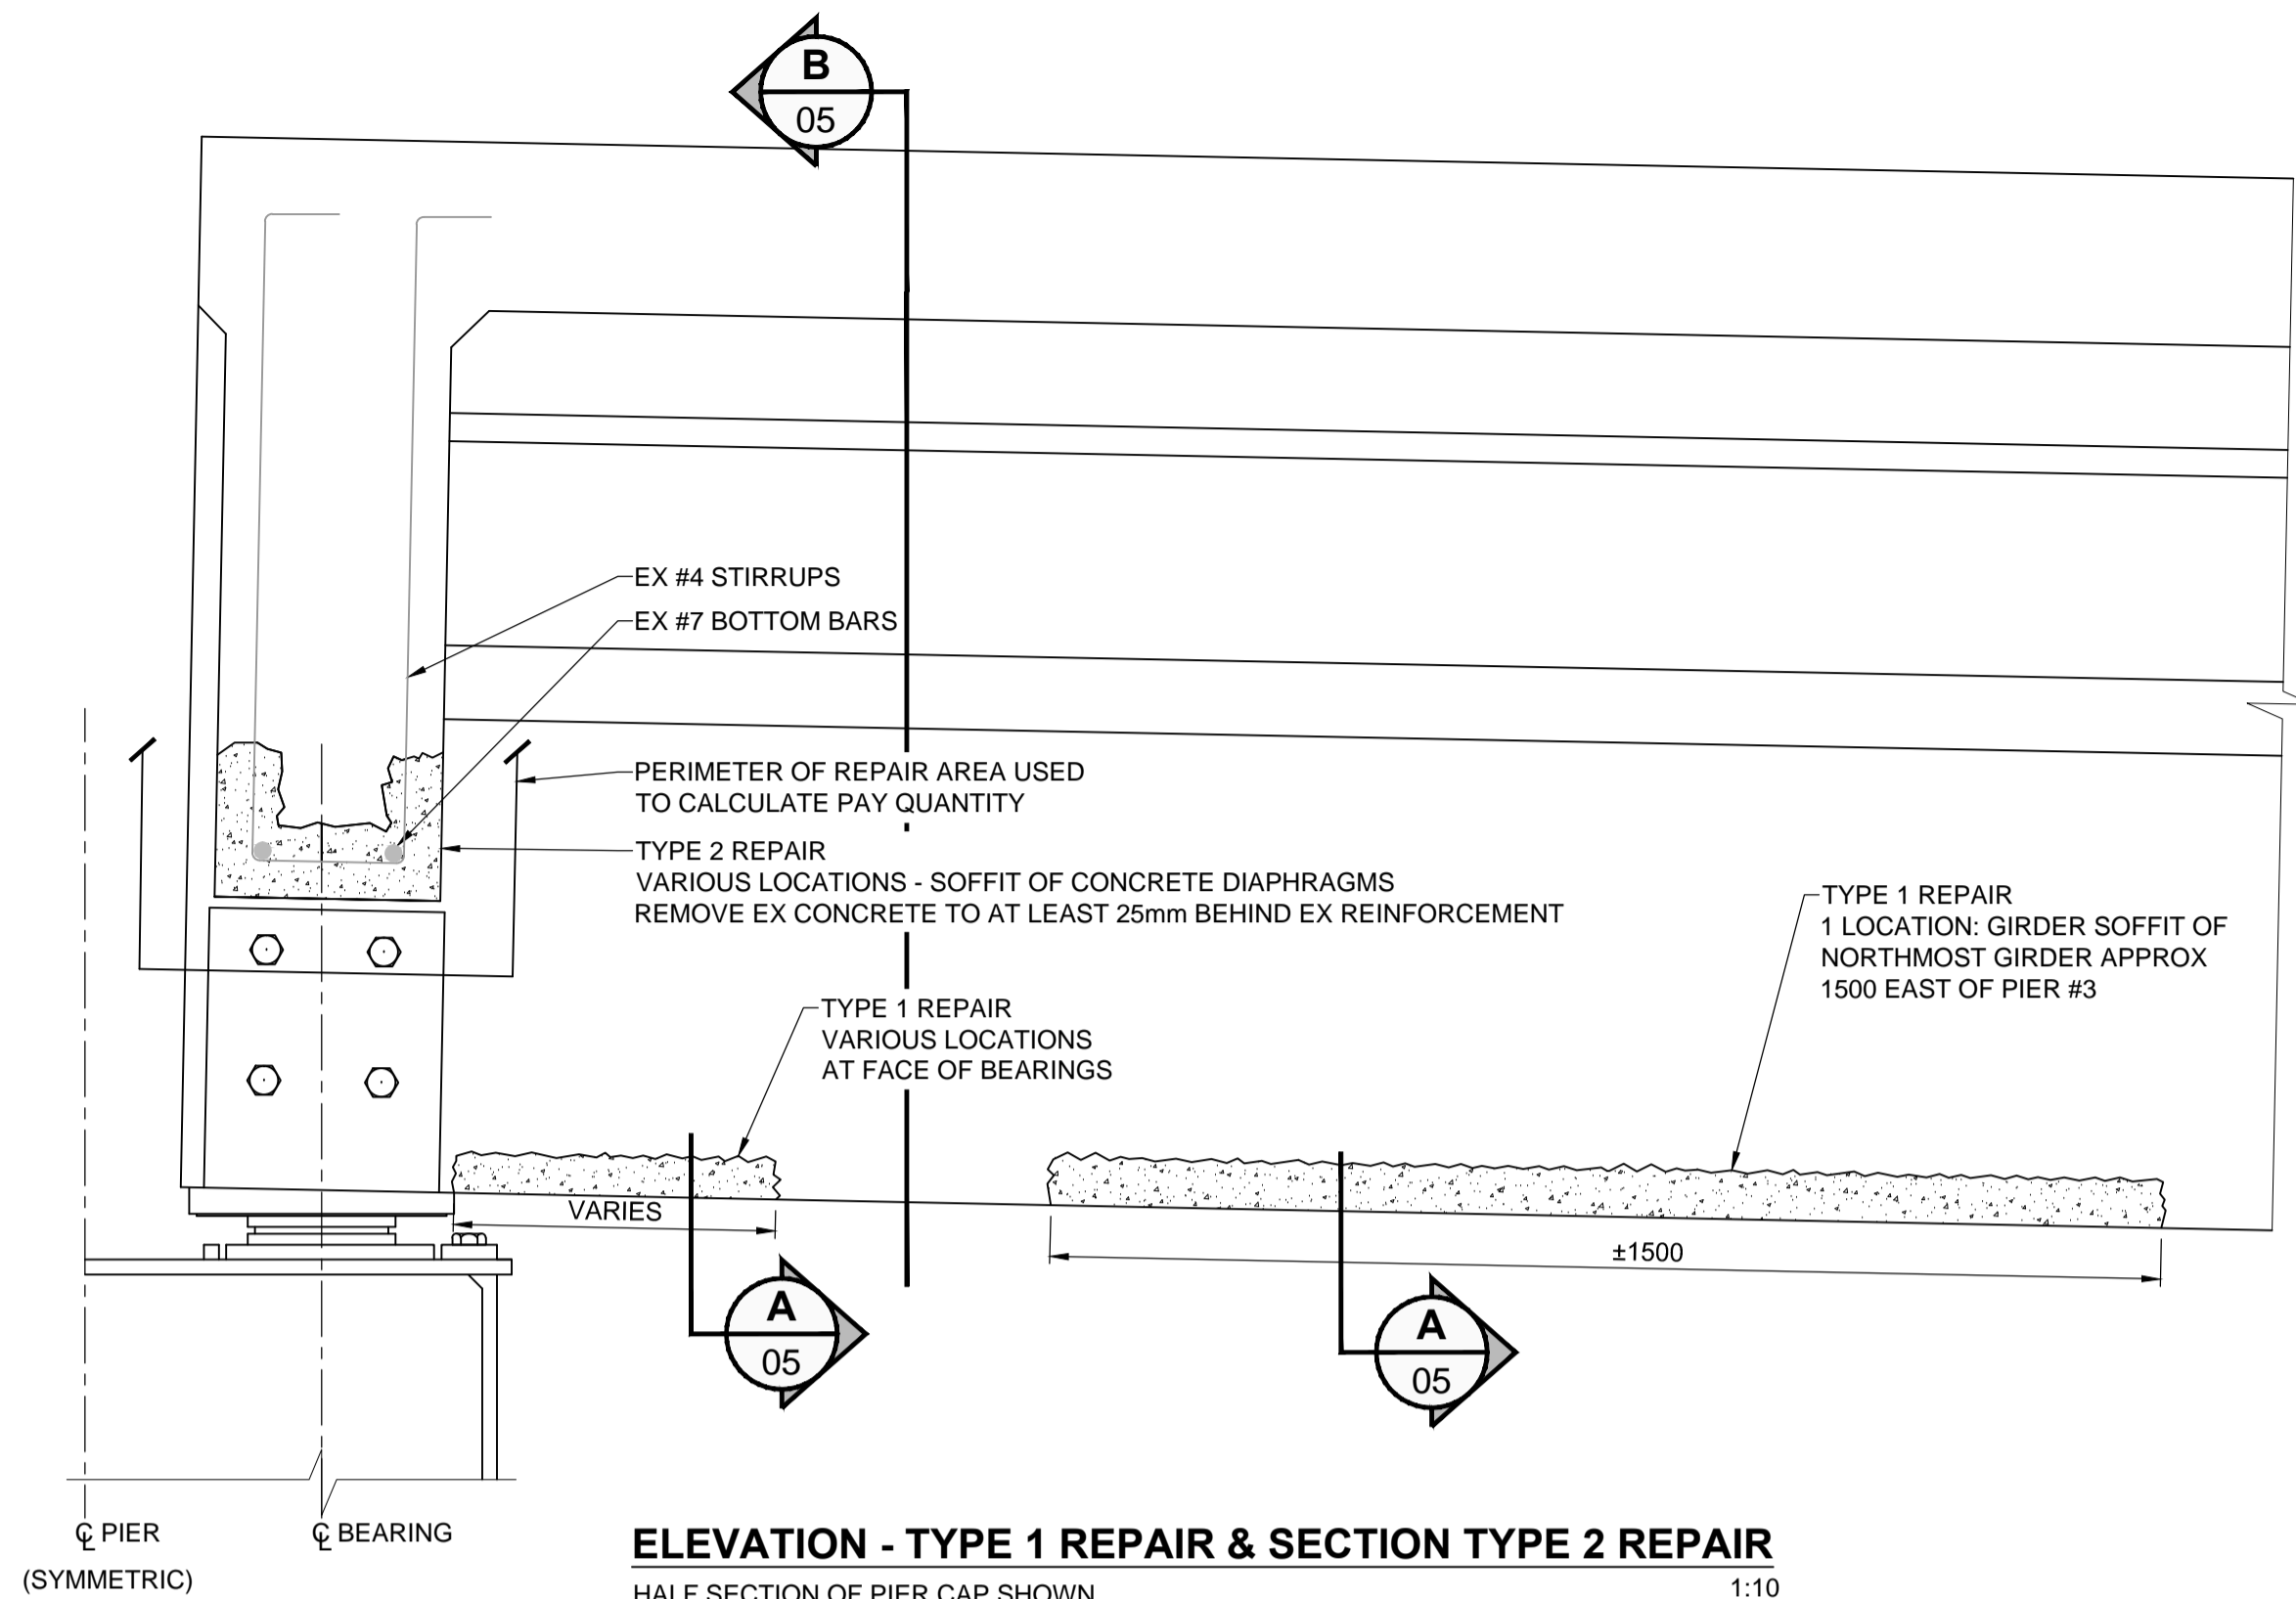
ELEVATION - TYPE 1 REPAIR & SECTION TYPE 2 REPAIR
 HALF SECTION OF PIER CAP SHOWN
 SIMILAR WORK OPPOSITE SIDE
 1:10

- PERFORM A 20mm DEEP SAWCUT AT REPAIR LIMITS TO LIMIT THE EXTENTS OF CONCRETE DEMOLITION.
 - REMOVE CONCRETE TO THE DEPTHS SHOWN.
 - SANDBLAST CONCRETE SURFACE AGAINST WHICH REPAIR MATERIAL SHALL BE PLACED TO STANDARD SSPC NO.6 COMMERCIAL BLAST CLEANING.

- INSTALL STEEL REINFORCEMENT (TYPE 1 REPAIR ONLY).
 - COMPLETE CONCRETE REPAIR BY USE OF A CONCRETE REPAIR MATERIAL COMPATIBLE WITH THE CONCRETE SUBSTRATE AND THE CONTRACTOR'S METHOD OF PLACEMENT. THE CONTRACTOR MAY CHOOSE TO USE A PROPRIETARY REPAIR MORTAR SUBJECT TO THE REVIEW AND ACCEPTANCE OF THE CONTRACT ADMINISTRATOR.

- MAINTAIN FORMS IN PLACE FOR A MINIMUM OF 3 DAYS.

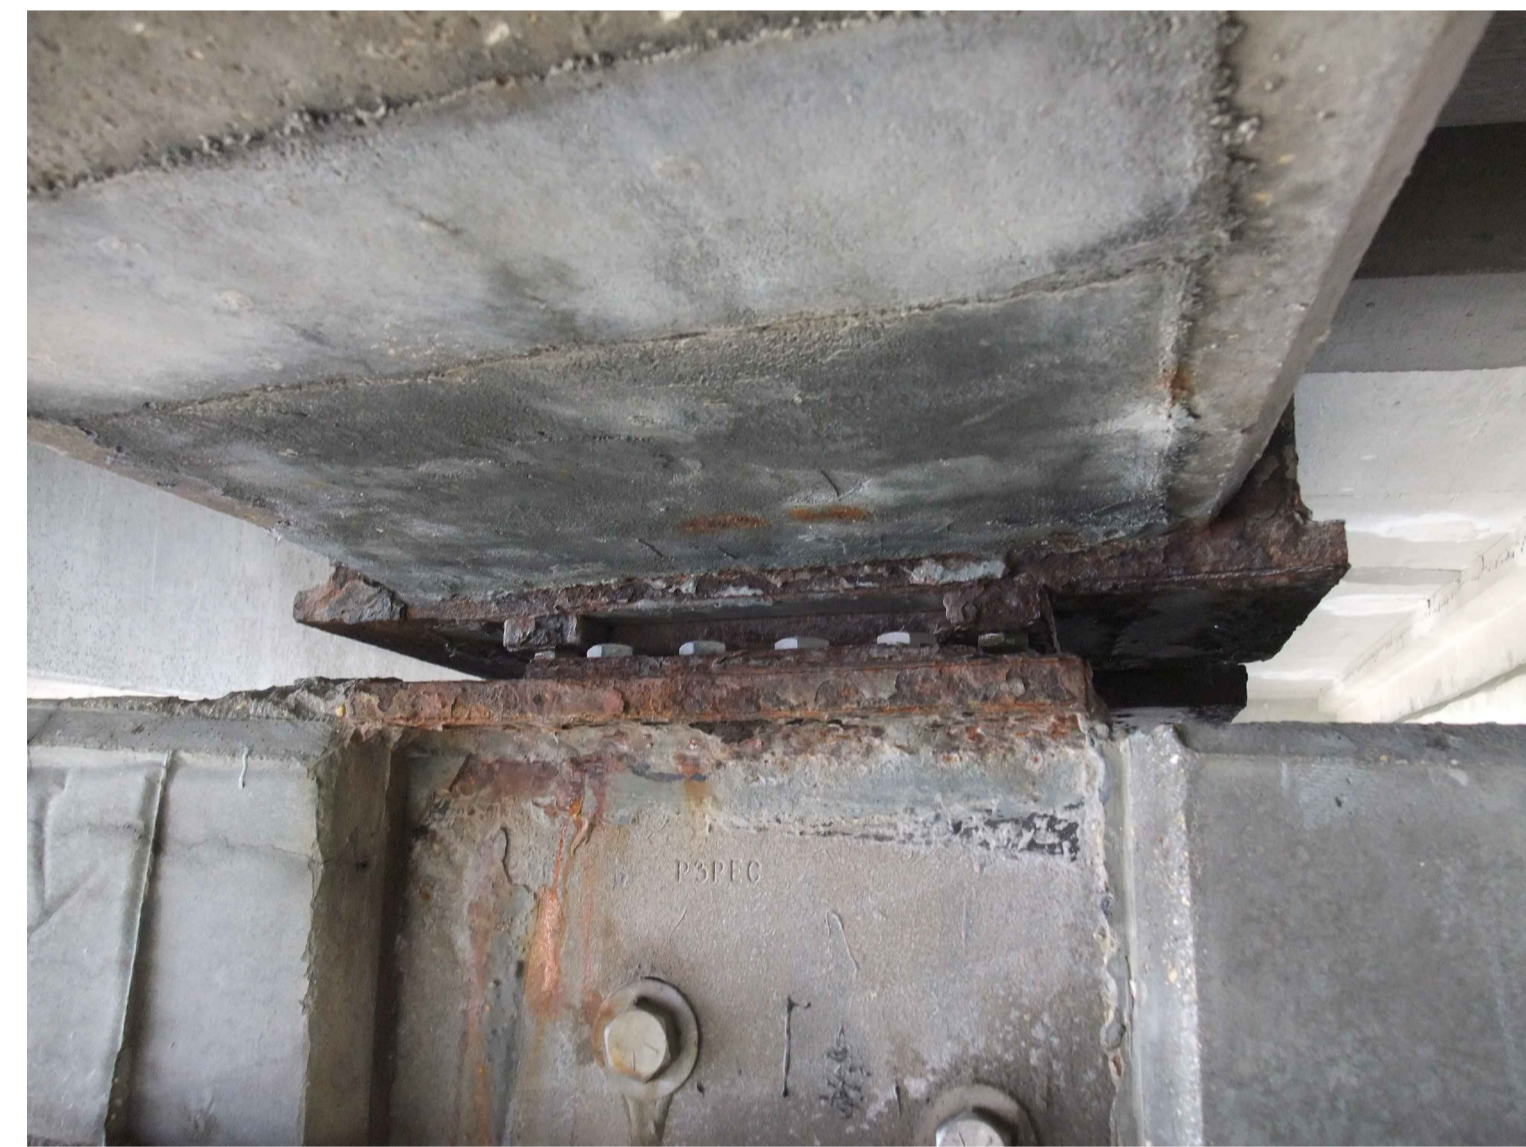
PHOTO - TYPICAL GUIDE BEARING EXISTING CONDITIONS

- CONTRACTOR TO SUBMIT BEARING REPAIR PROCEDURE TO CONTRACT ADMINISTRATOR FOR REVIEW AND ACCEPTANCE PRIOR TO PERFORMING THE WORK.
- BEARING REPAIR PROCEDURE - BASIS OF DESIGN:
 - TEMPORARILY PROTECT BEARING PAD AND SOLE PLATE STAINLESS STEEL SLIDING SURFACE BY USE OF MASTIC TAPE OR OTHER APPROPRIATE MEANS.
 - SANDBLAST EXPOSED STEEL SURFACES WITHIN BEARING REPAIR EXTENTS TO SSPC-SP 10/ NACE NO.2, NEAR-WHITE BLAST CLEANING.
 - METALLIZE EXPOSED STEEL SURFACES WITHIN BEARING REPAIR EXTENTS WITH 20 mil THICK LAYER OF ACTIVATED ARC SPRAY ZINC. TOUCH-UP DIFFICULT-TO-REACH SURFACES WITH 2 x 60 mil THICK COATS COLD-APPLIED ZINC PAINT INSTALLED ACCORDING TO MANUFACTURER'S INSTRUCTIONS.

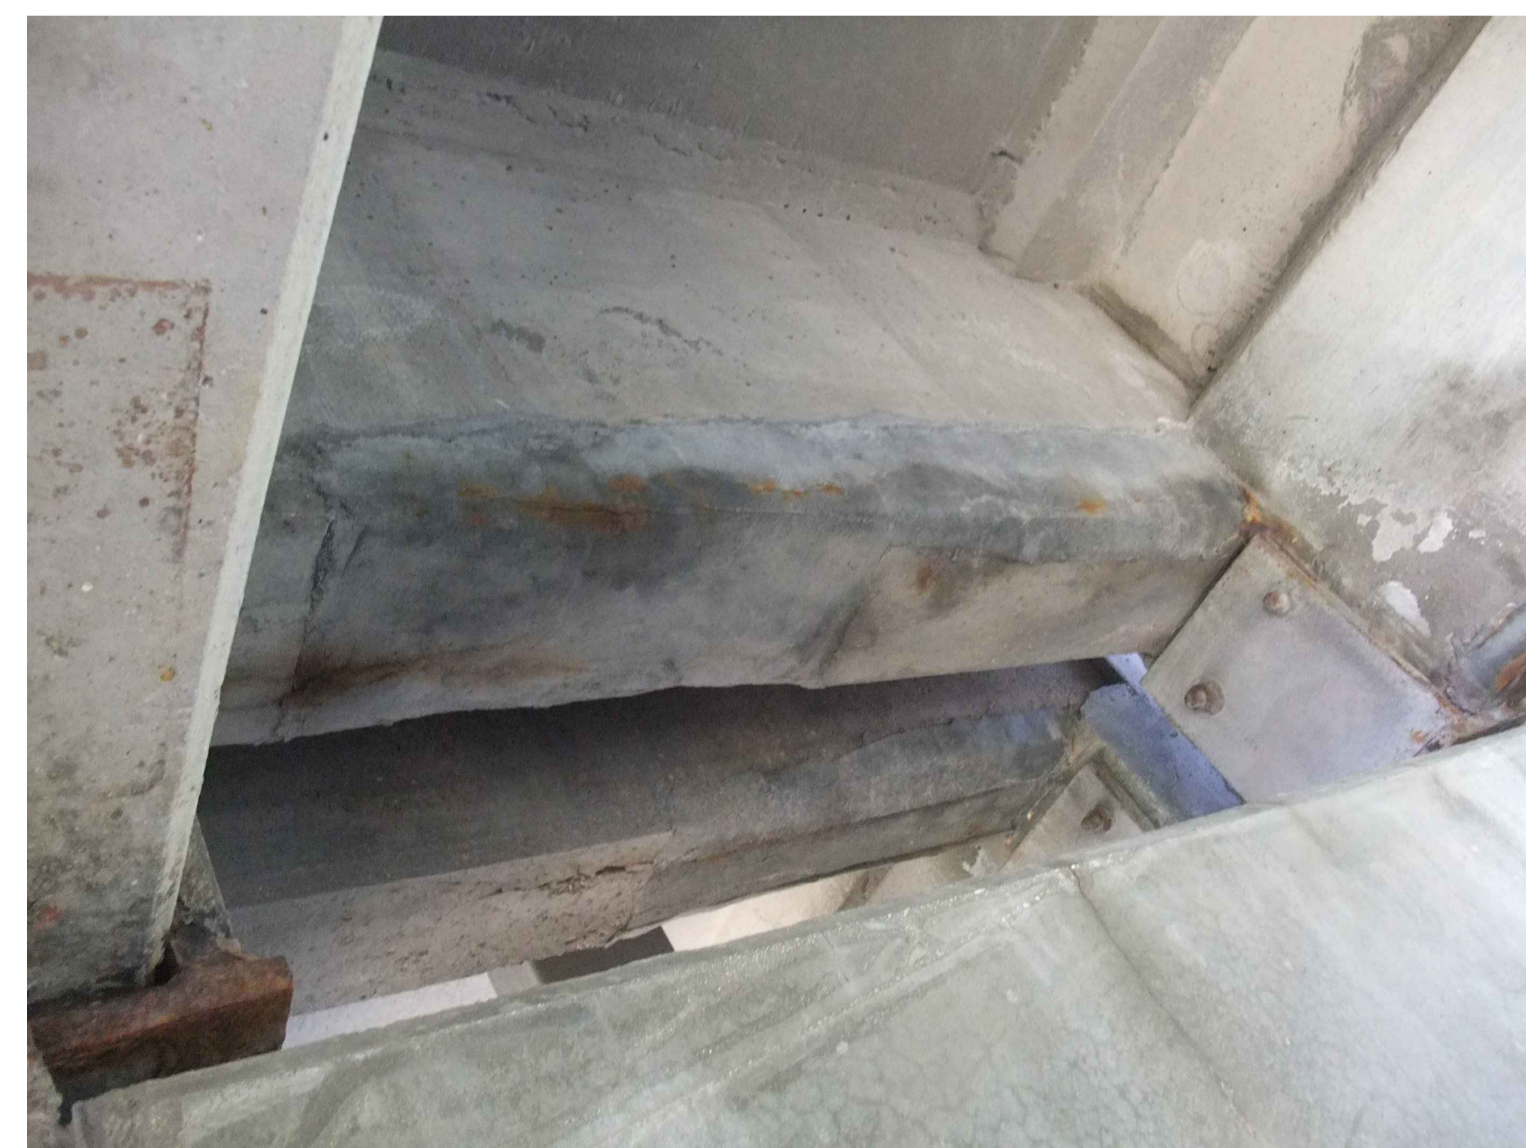
PHOTO - TYPICAL EXISTING CONDITIONS - TYPE 2 REPAIR LOCATION

- PERFORM TYPE 1 AND TYPE 2 REPAIRS AT LOCATIONS MARKED OUT BY THE CONTRACT ADMINISTRATOR IN THE FIELD.
- CONCRETE GIRDER AND END DIAPHRAGM REPAIR PROCEDURE - BASIS OF DESIGN :
