The City of Winnipeg  
Water and Waste Department  
Engineering Division

# Wilkes Reservoir North Cell Rehabilitation

Bid Opportunity 930-2015

## Mandatory Bidder's Conference

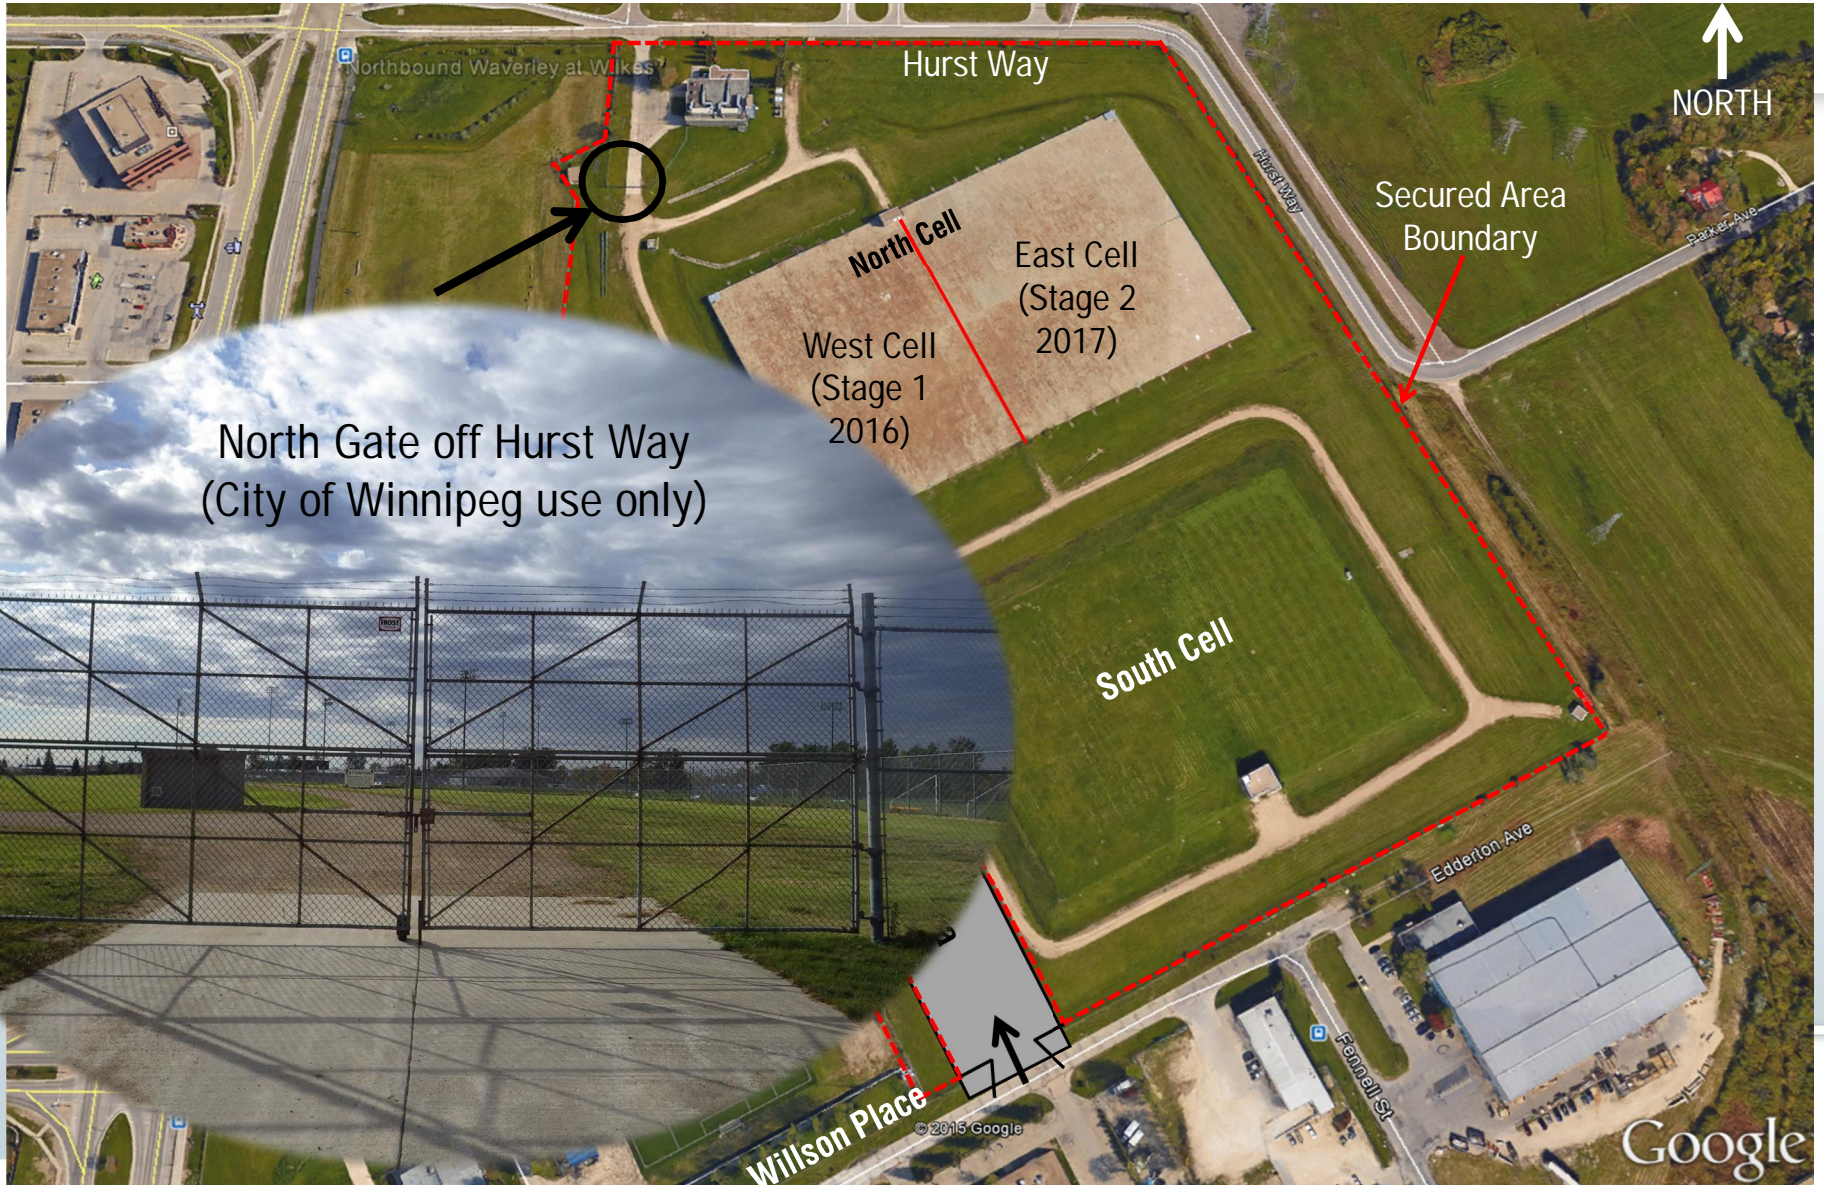
Secured Area Boundary

North Cell

East Cell  
(Stage 2  
2017)

West Cell  
(Stage 1  
2016)

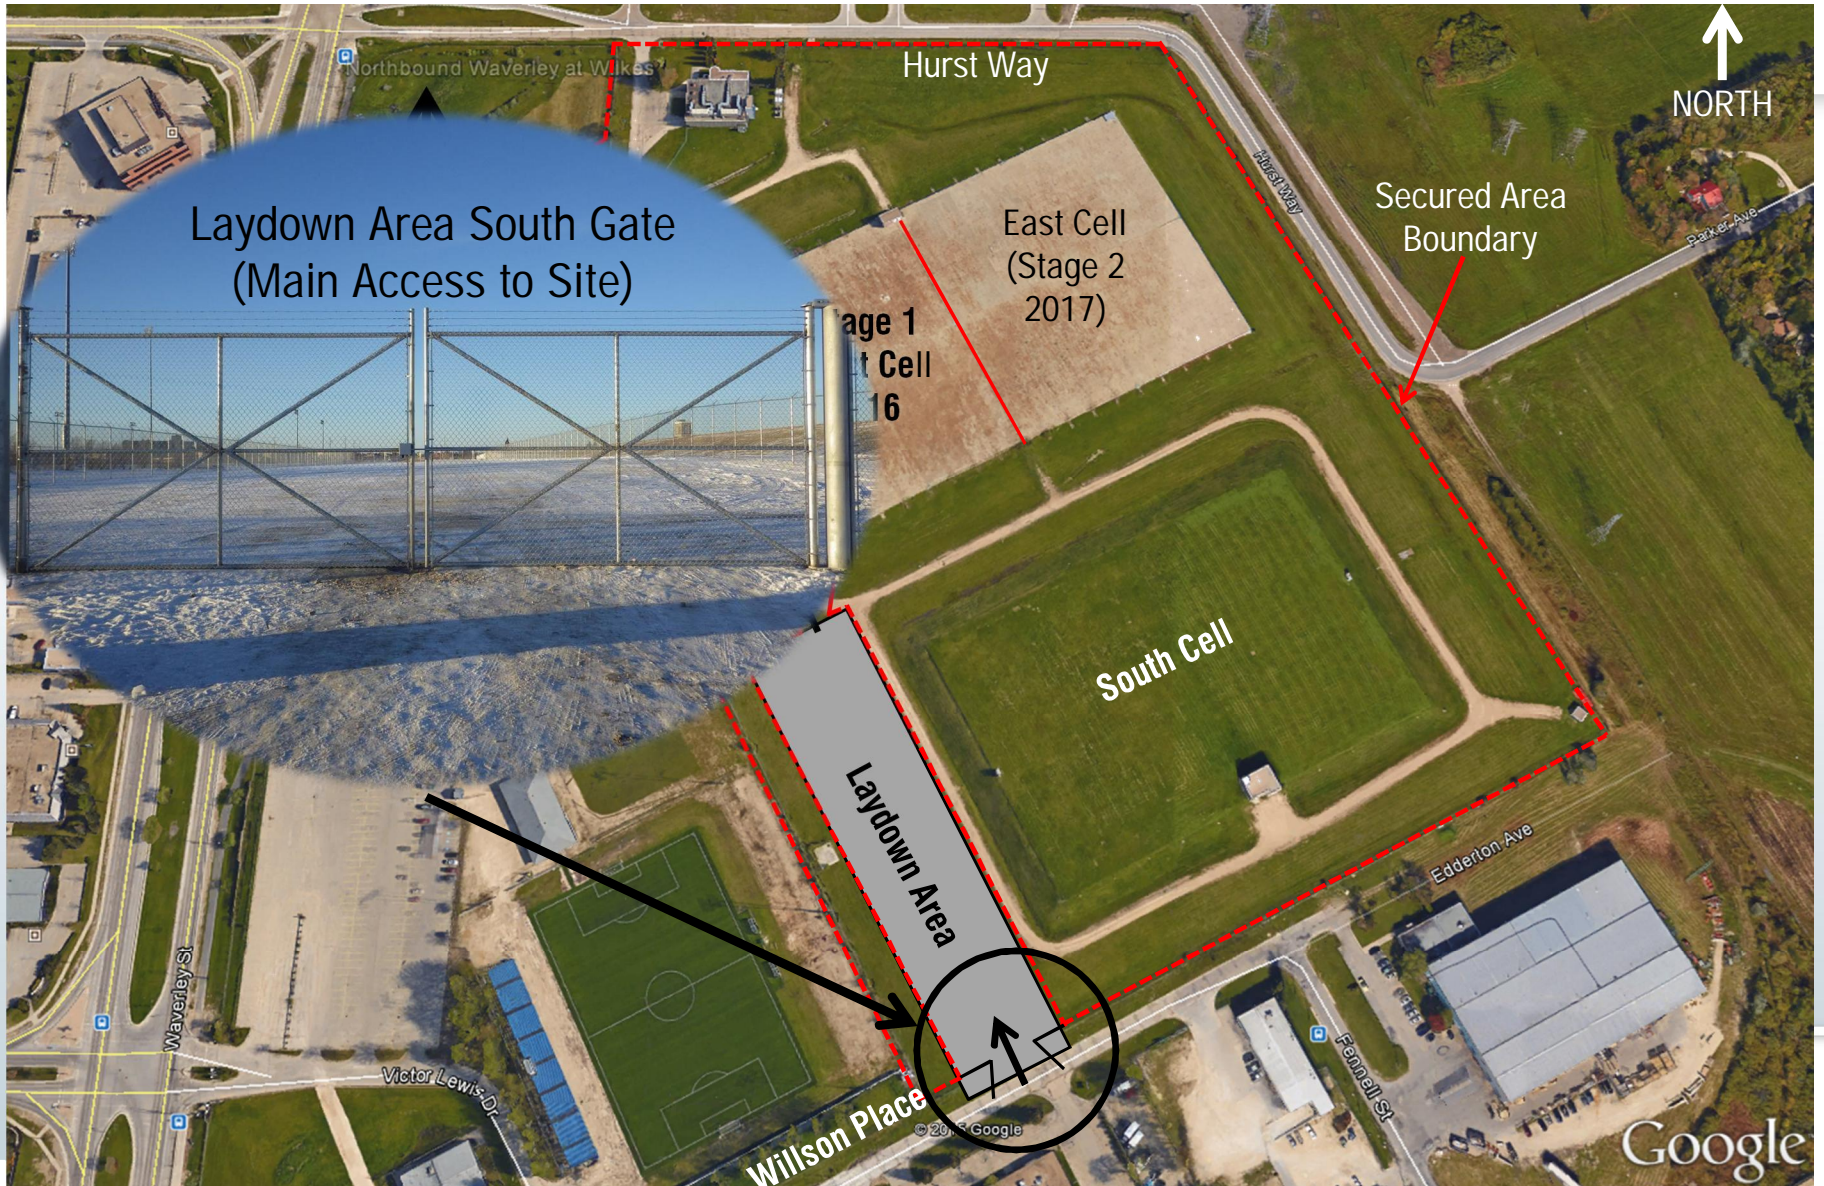
Laydown Area South Gate  
(Main Access to Site)

East Cell  
(Stage 2  
2017)

Stage 1  
West Cell  
16

Laydown Area

- Constructed by others (City of Winnipeg Bid Opportunity 711-2015).
- Approximately 35 m x 150 m granular pad enclosed with 3.0 m high barbed wire fencing.
- Will be main storage area for materials, deliveries, site offices, parking, etc.
- Security clearances not required within laydown area (see Security Requirements).
- South gate of laydown area to be locked when Contractor not on site.

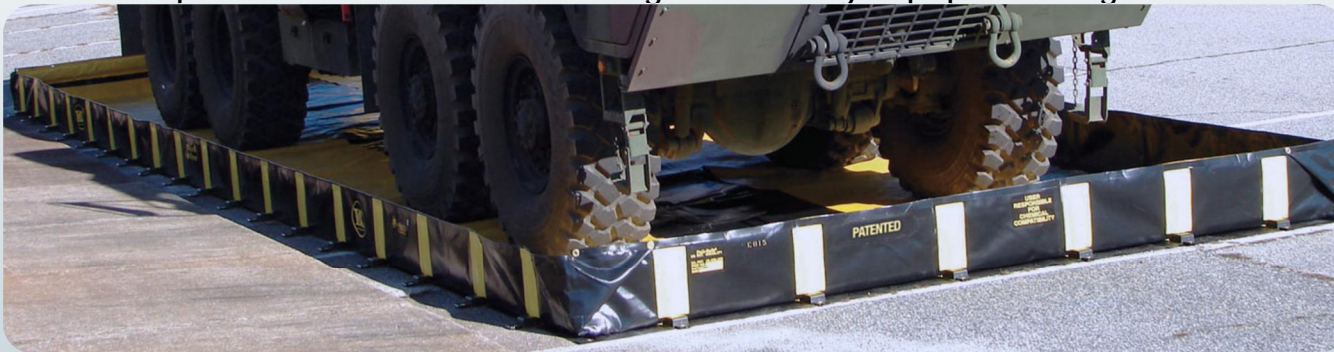
Example of vehicle berm for fuel containment during refueling (Basic Concepts Inc.)

- E3 Environmental Plan
- Need to submit Environmental Protection Plan.
  - Includes a Fuel Handling and Storage Plan
  - Contractor to propose refueling procedures/location for approval
  - Requires some form of fuel containment
  - Requires membranes under large stationary equipment e.g. cranes

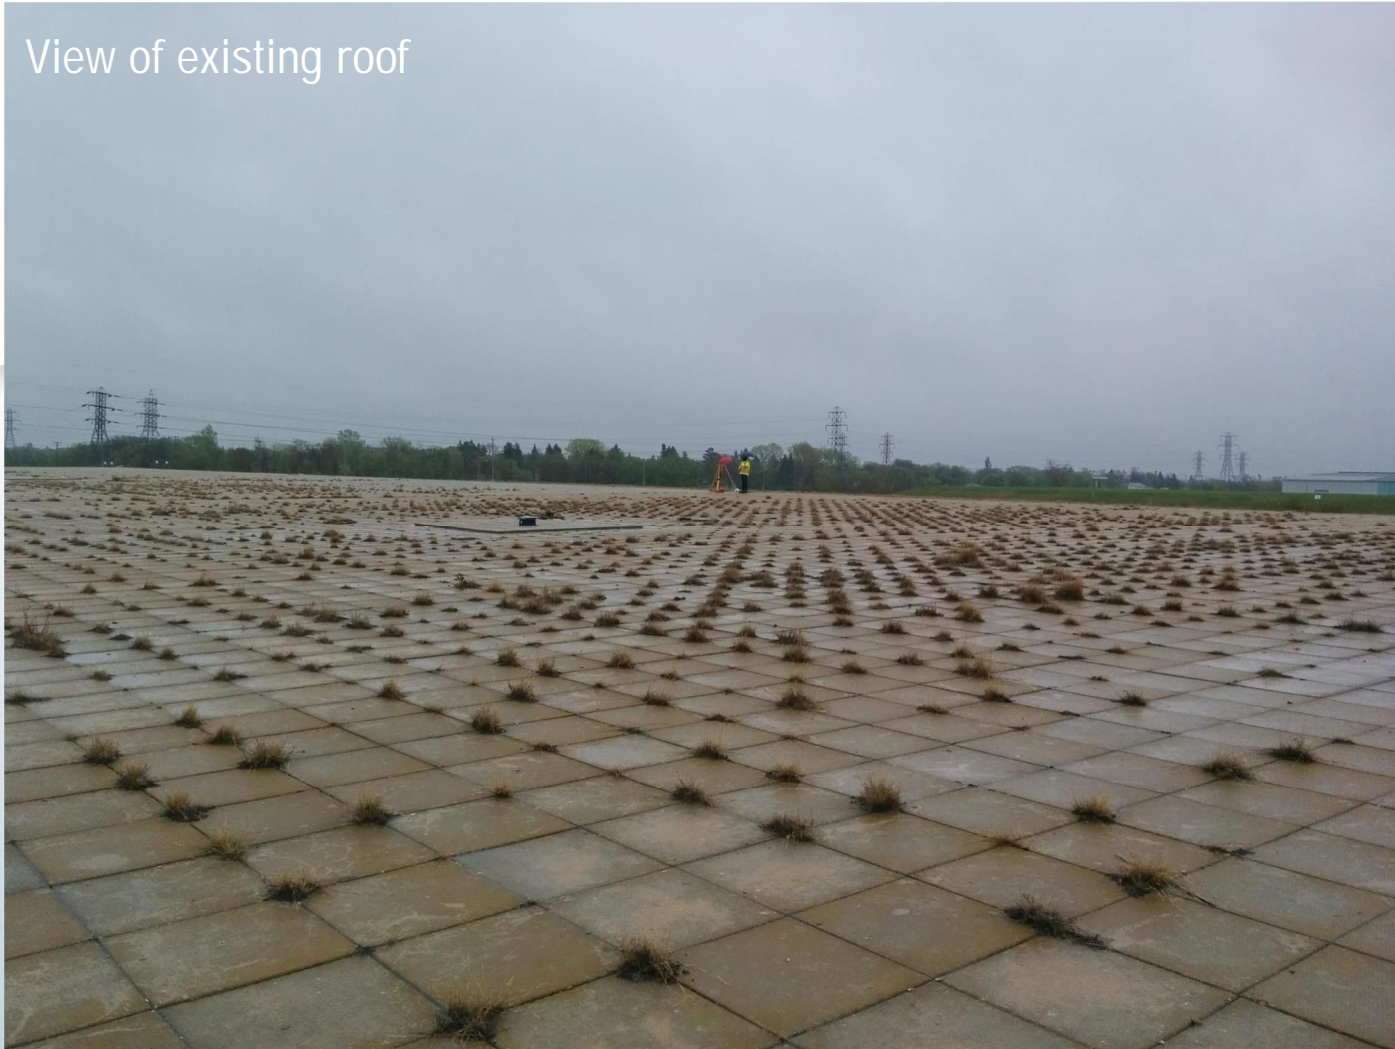
View of existing roof

- Remove existing building envelope
- Salvage steel grid line marker plates

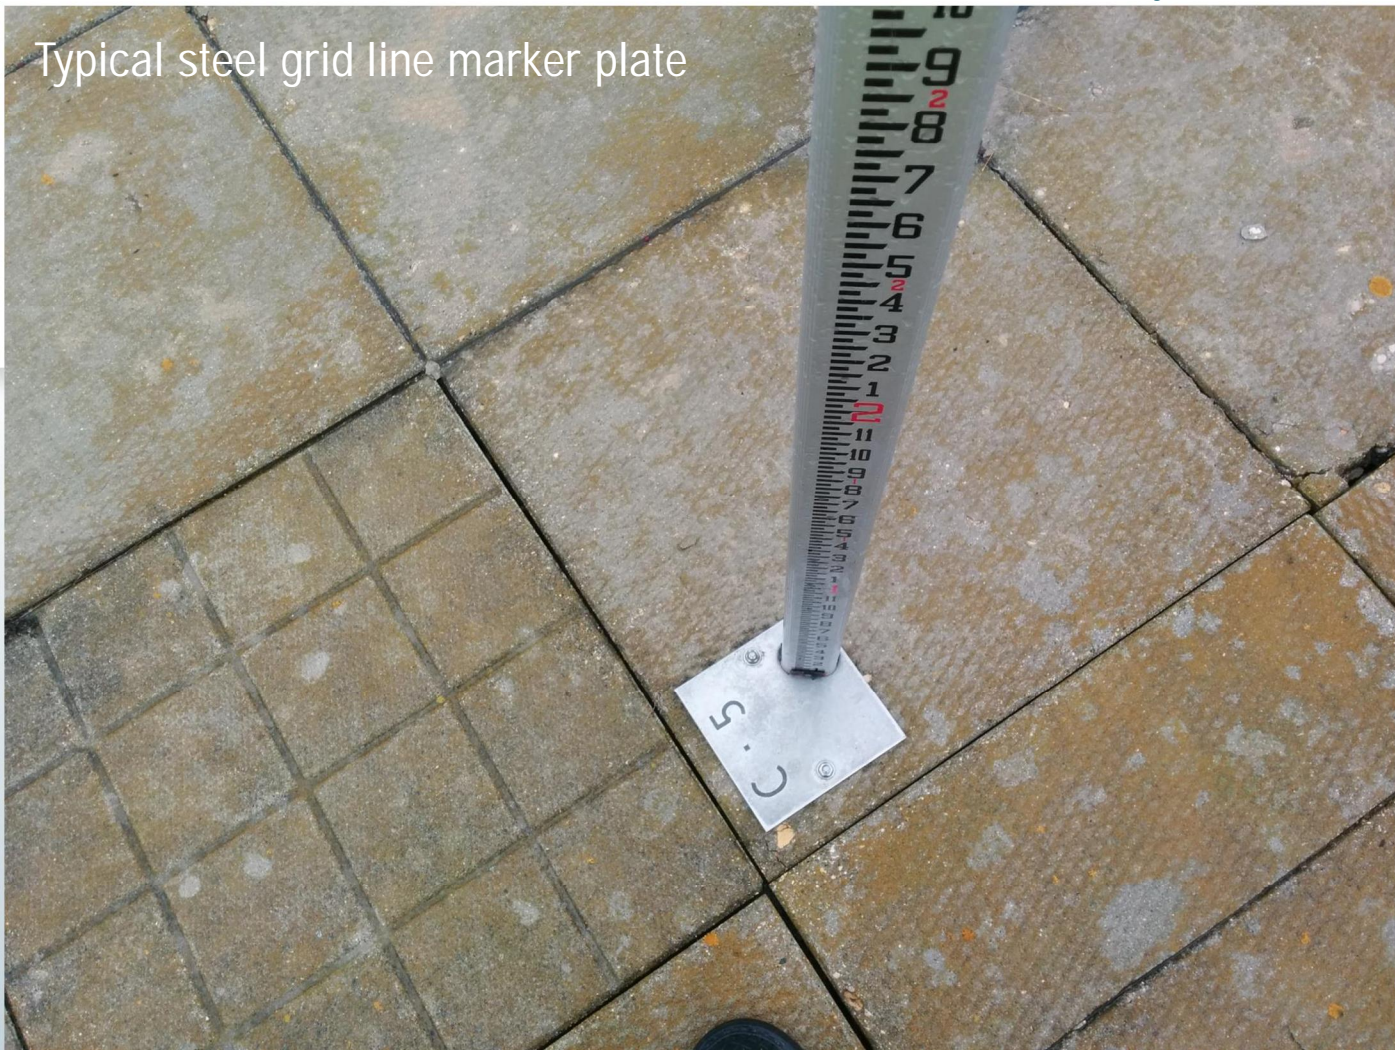
Typical steel grid line marker plate

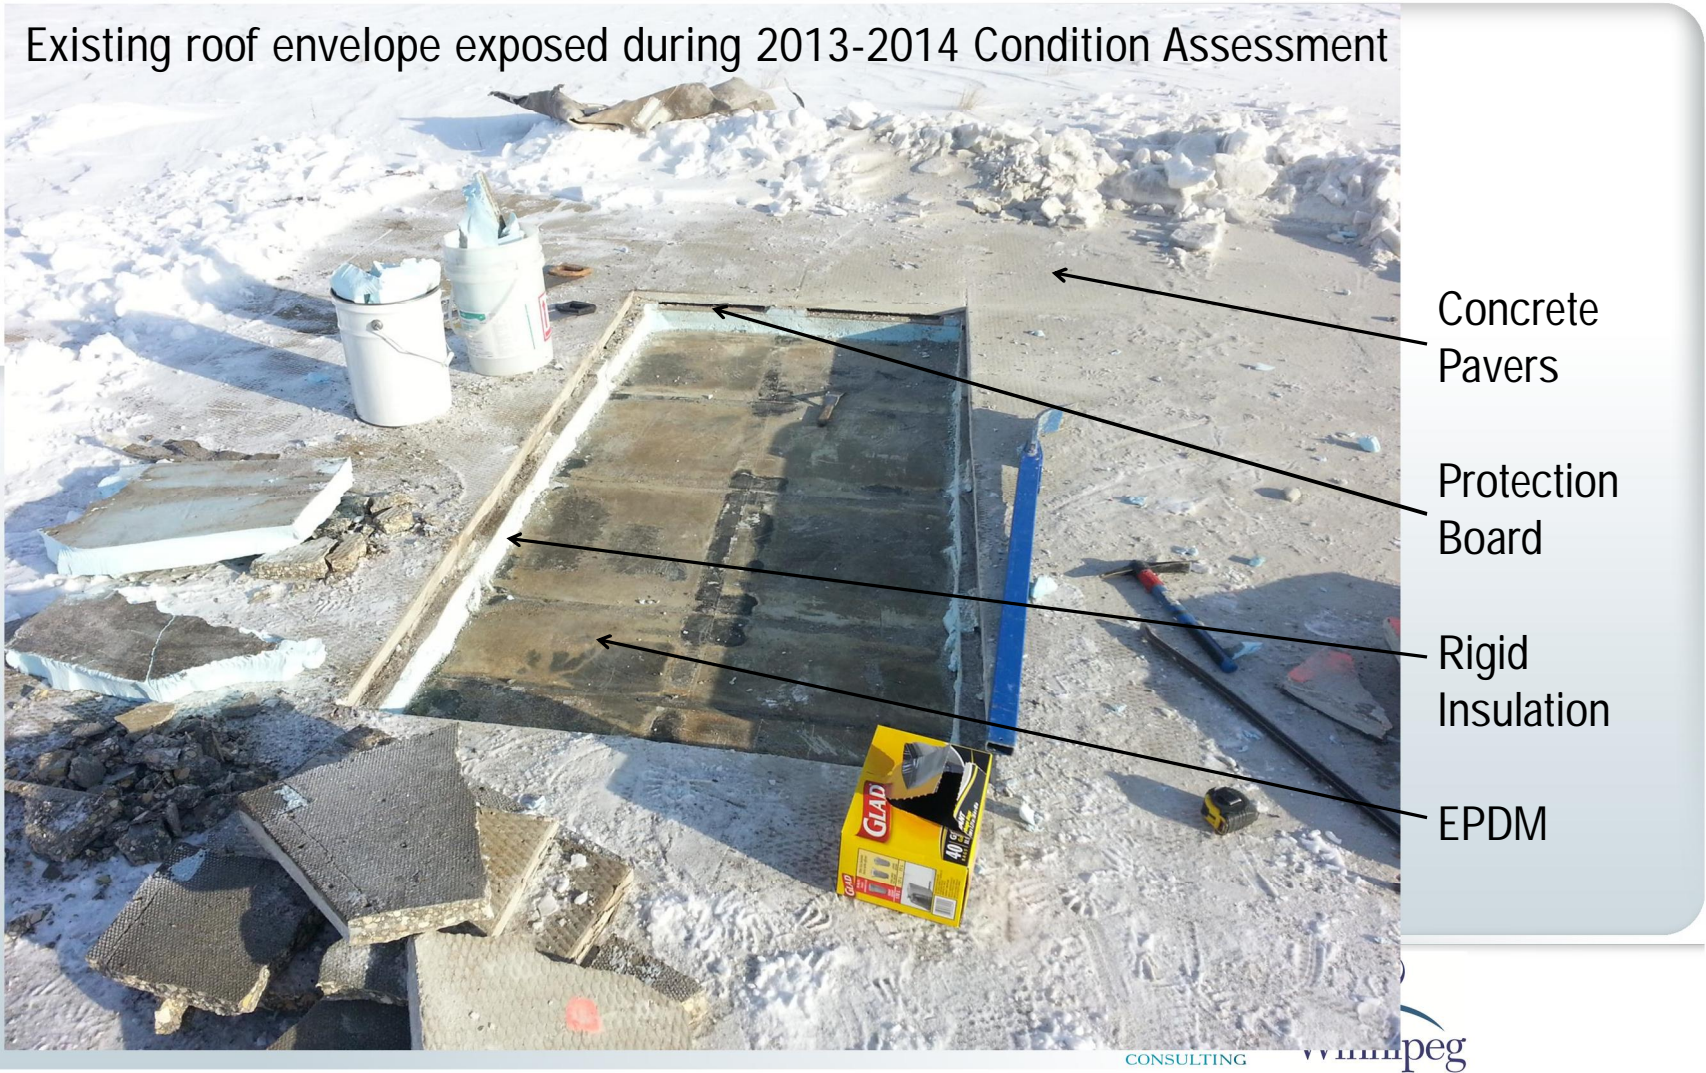
## Existing roof envelope exposed during 2013-2014 Condition Assessment

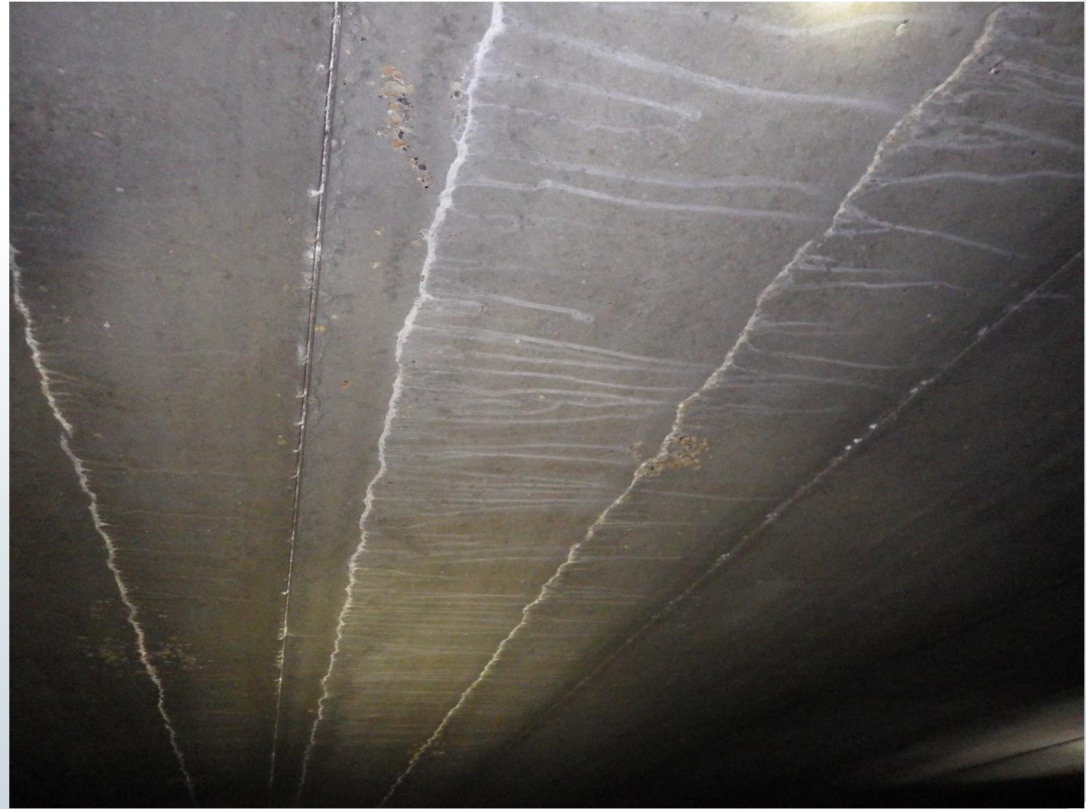
## Replacement/Repair of Hollowcore Slabs

Replace designated hollowcore slabs with new slabs

Repair designated hollowcore slabs

- Cut slots into each void from above
- Place rebar
- Fill voids solid with SCC

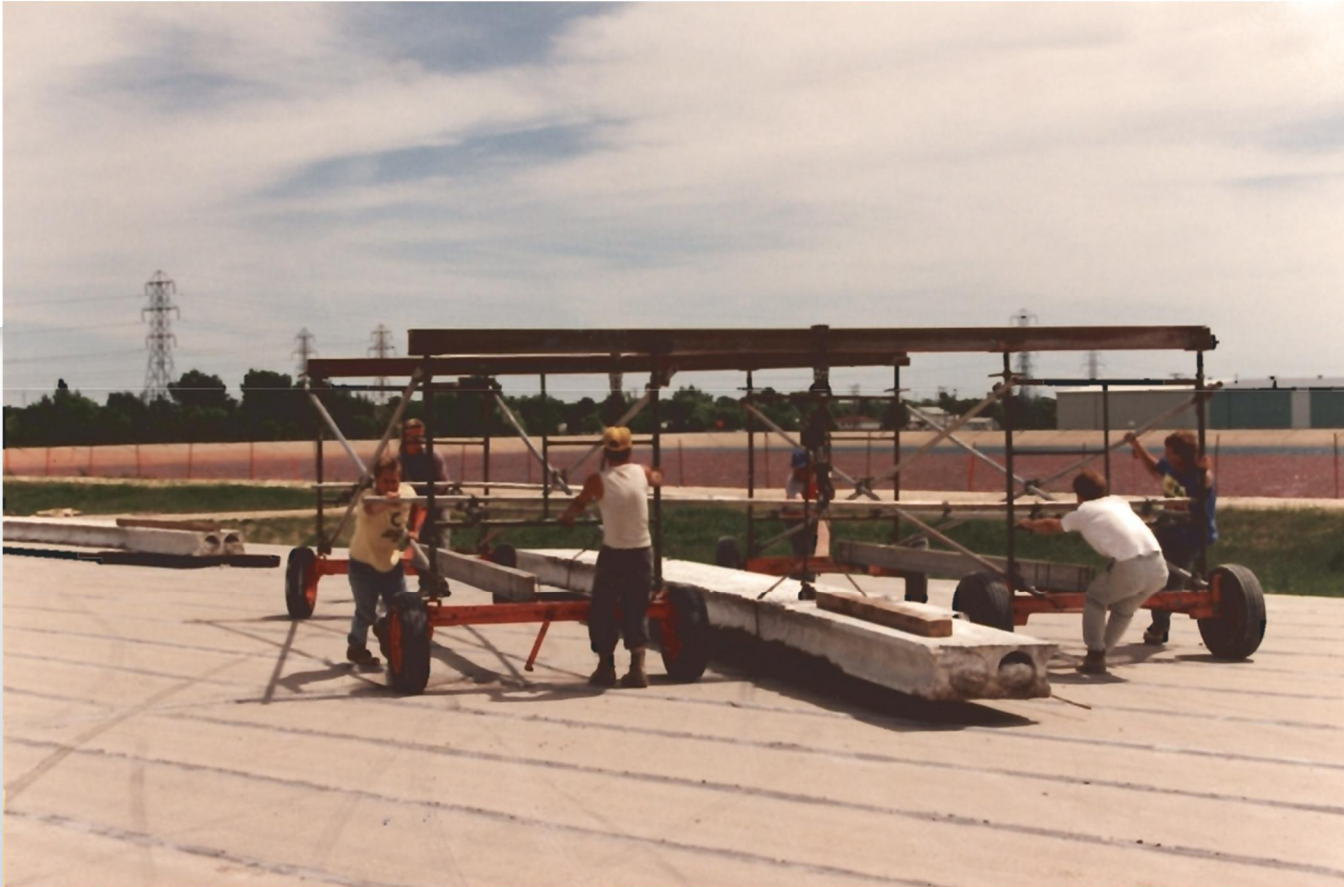
## Hollowcore Slab Replacement

- Note: See drawings for load restrictions for equipment operating on the roof.
- Picture shows a system used to install hollowcore slabs during the 1991 rehabilitation.
- Contractor to submit proposed hollowcore replacement method for review and approval.

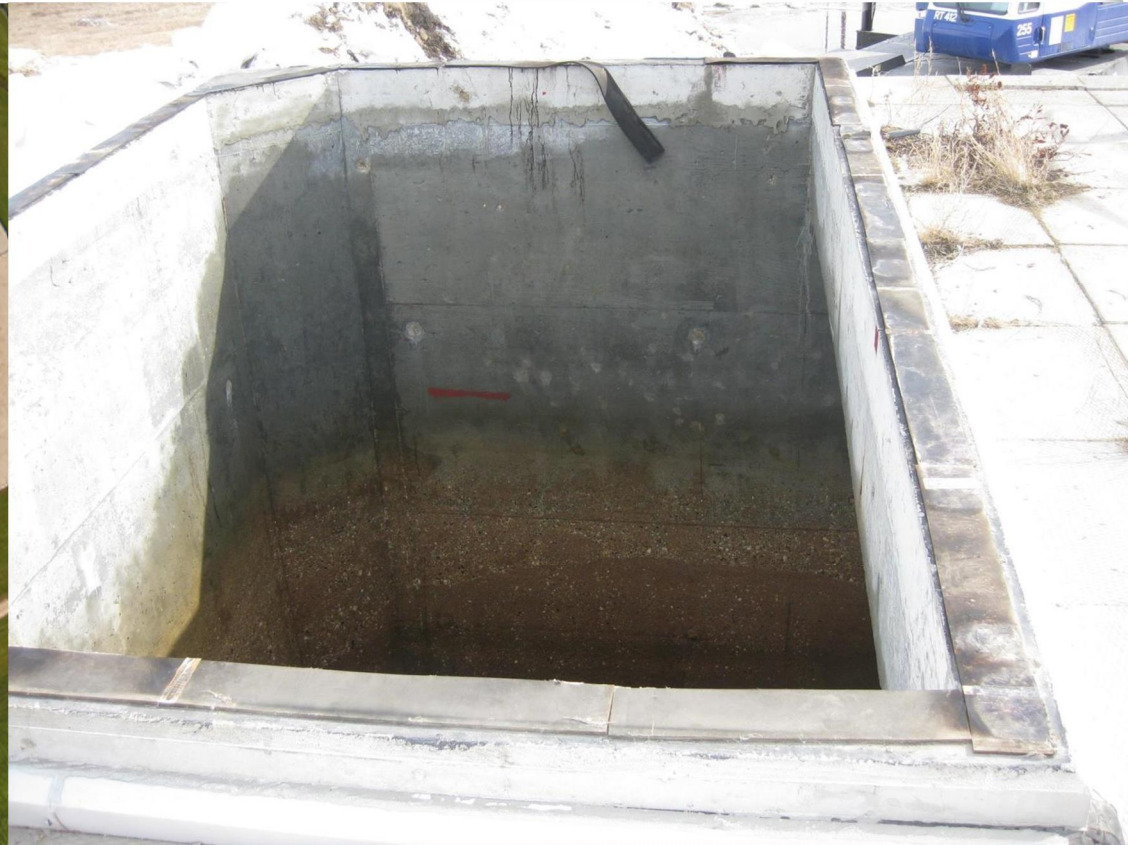
Note: Access into Cells will be via scaffolding stairway at designated hollowcore removal locations (shown on Drawings). Access building not to be used for access unless approved

Existing equipment access hatches  
(2.6 m x 4.1 m)

Approximate locations  
of temporary access  
(scaffolding/stairway)

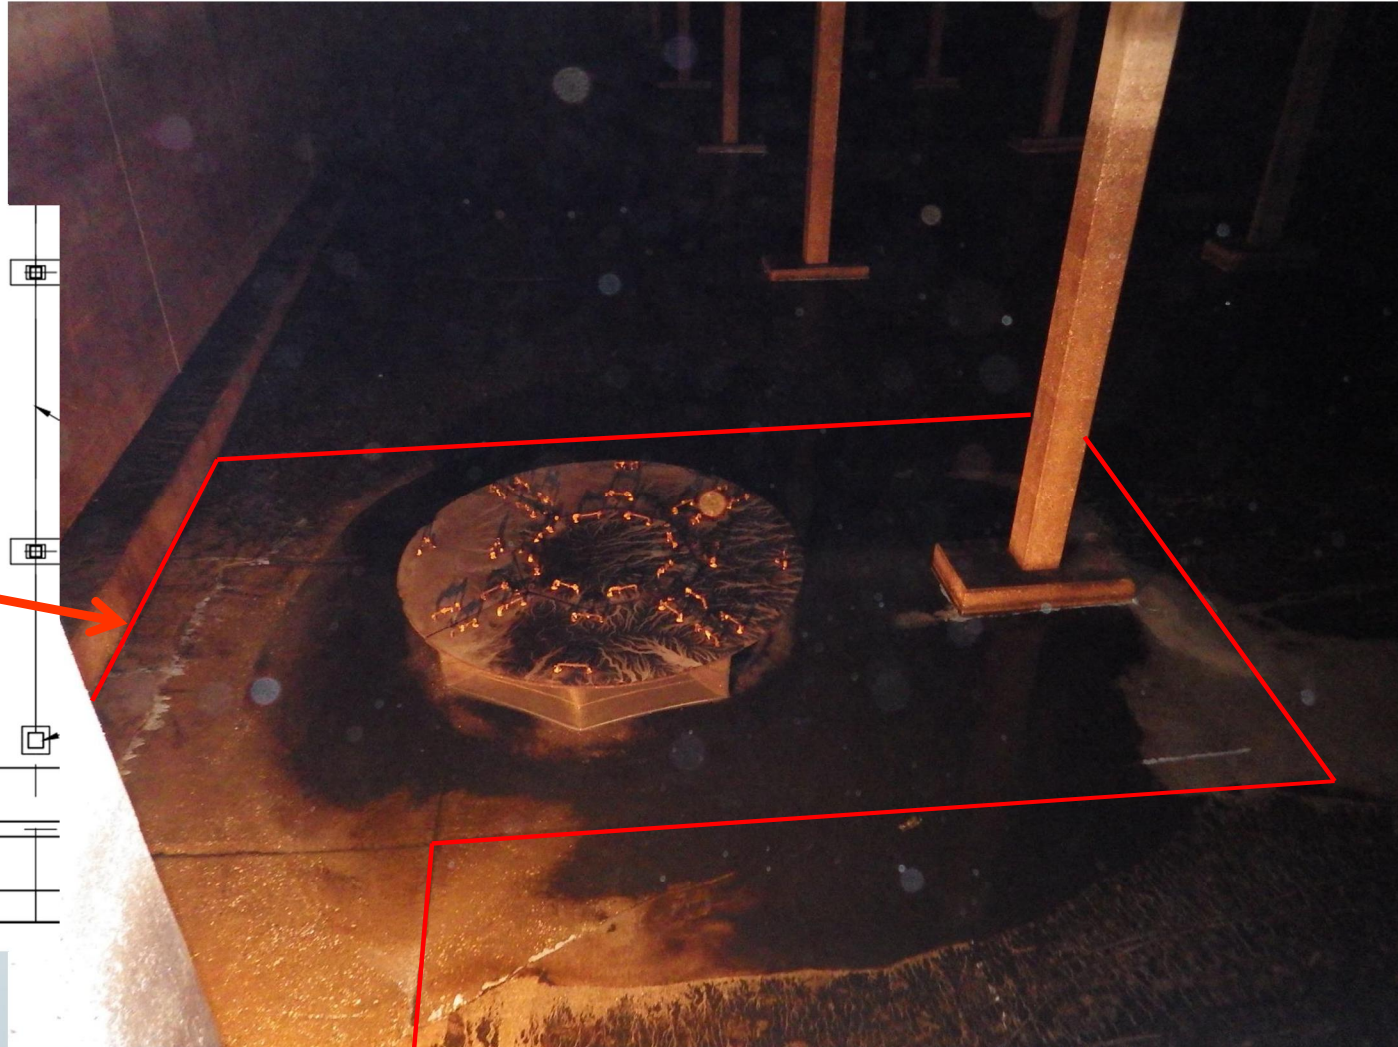
## Gel Injection at Suction Pits

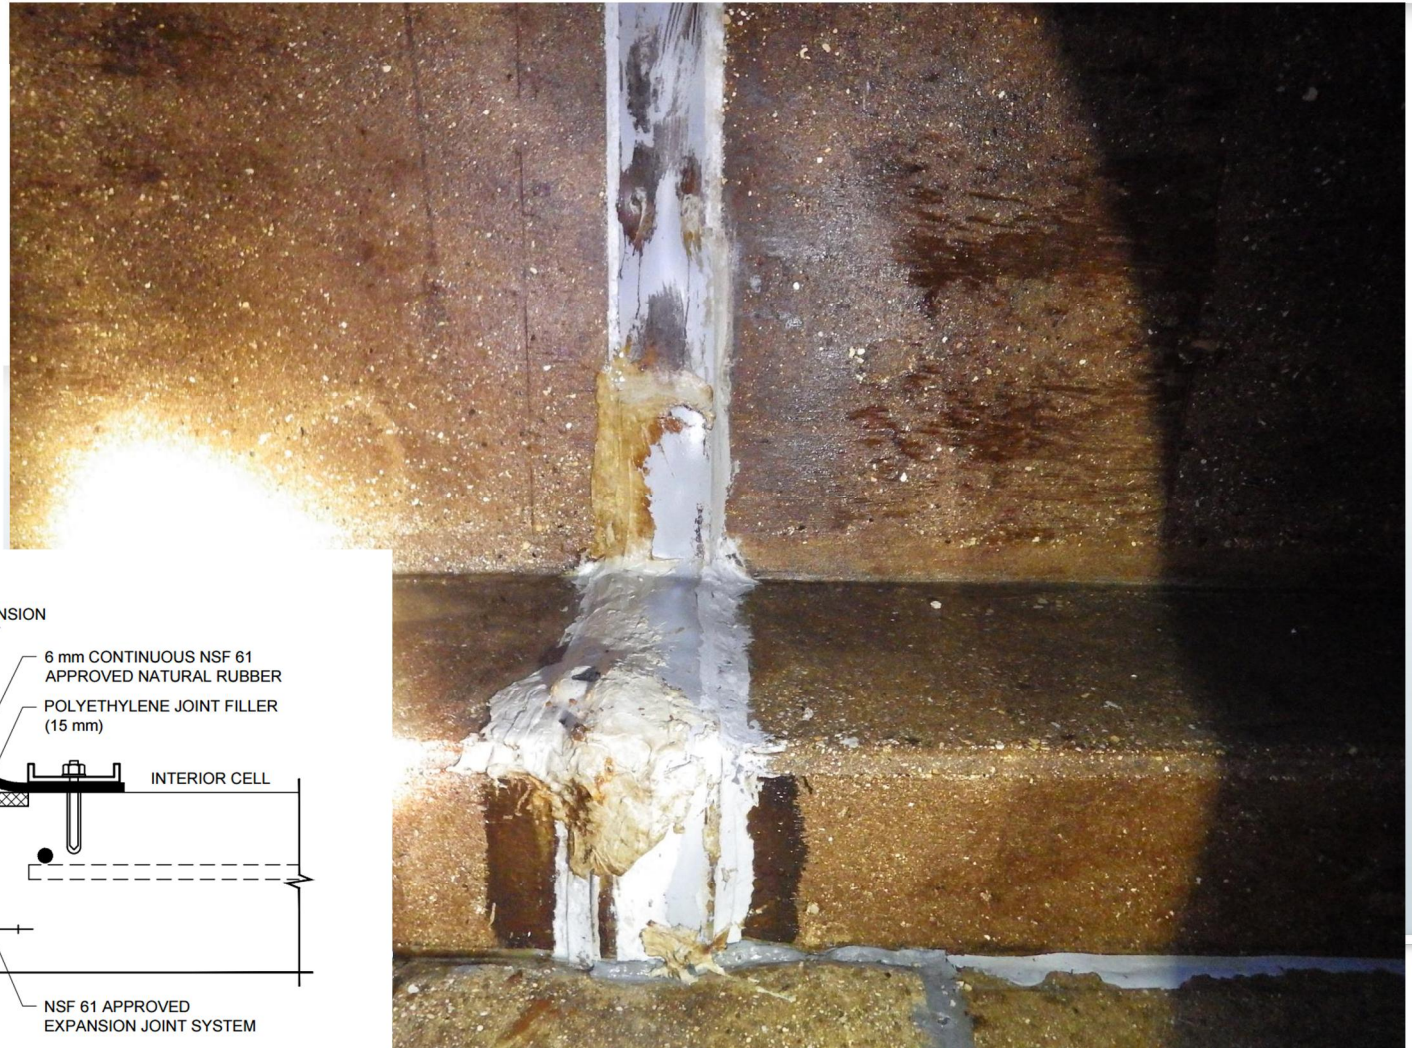
# Wall Expansion Joint Replacement

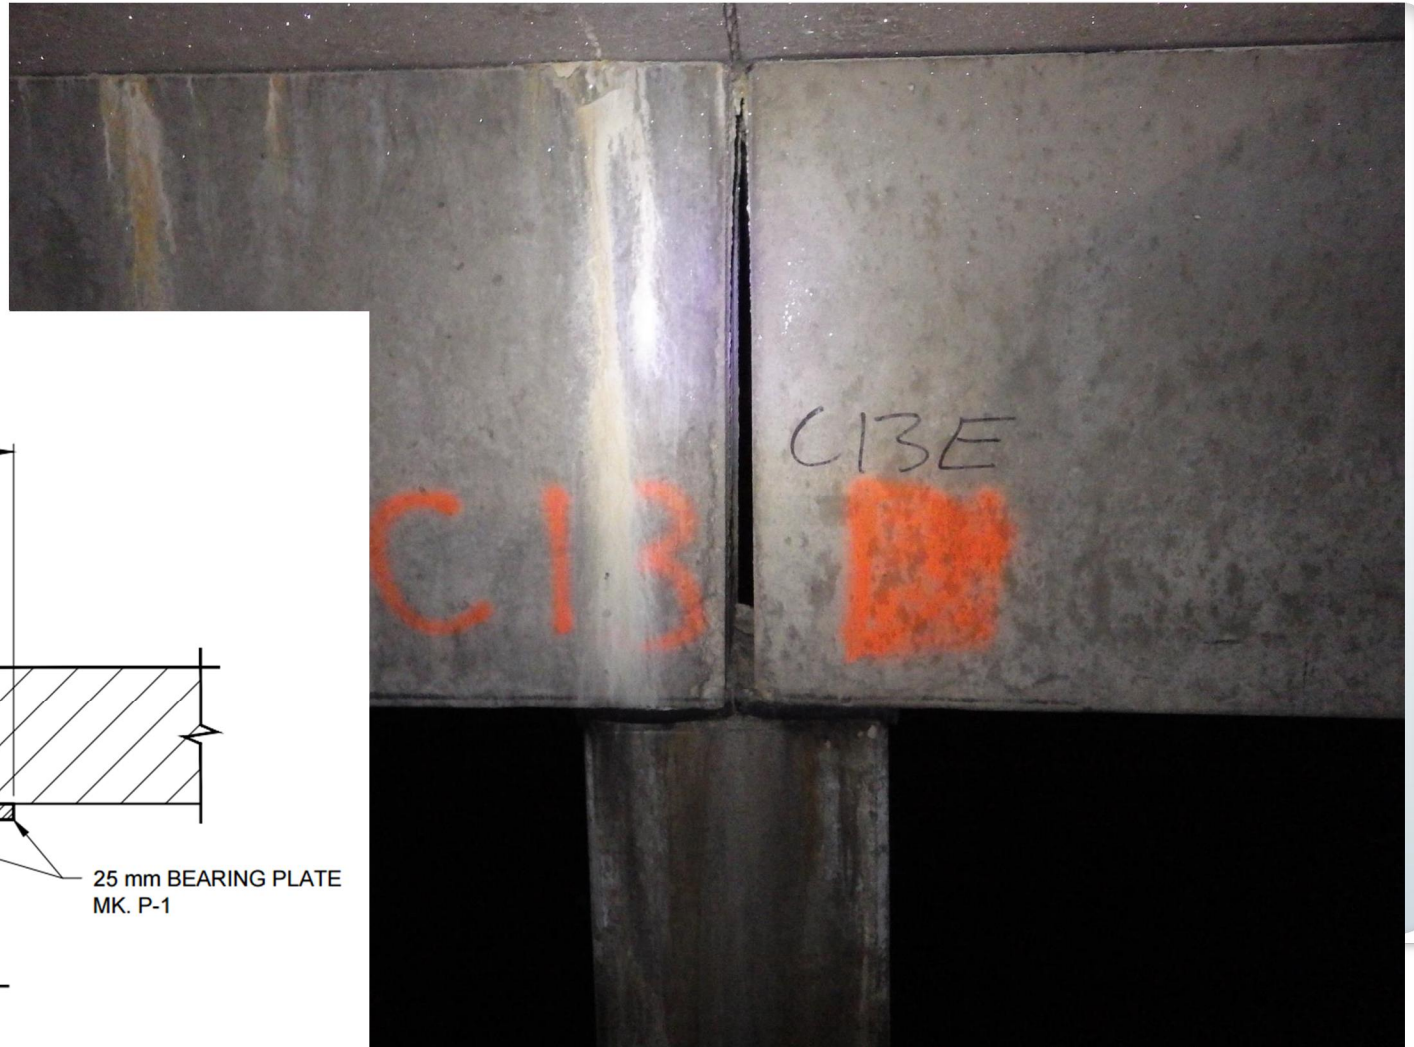
## Type 2 – Interior Column Plates

- At good beam ends

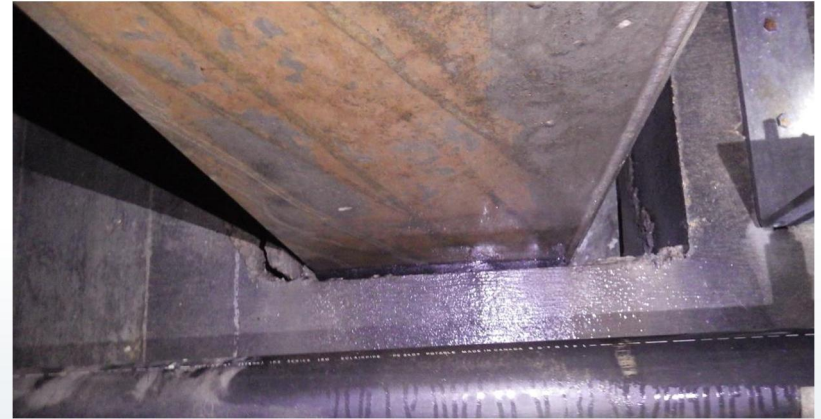
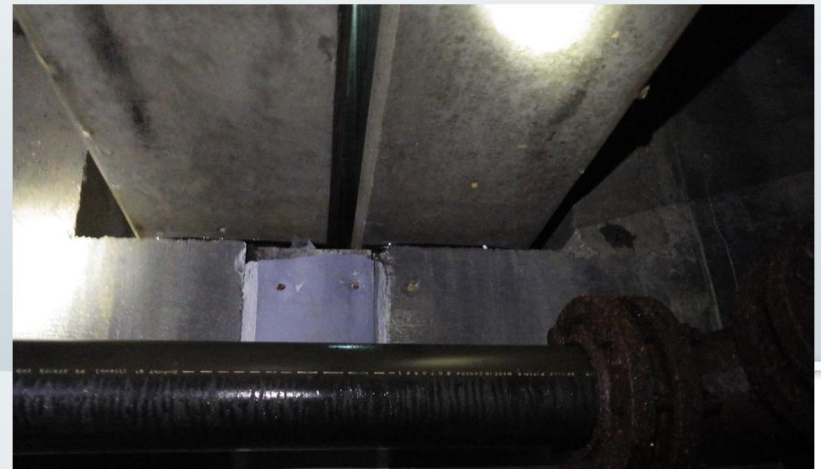
# Type 3 – Wall Seat Plates

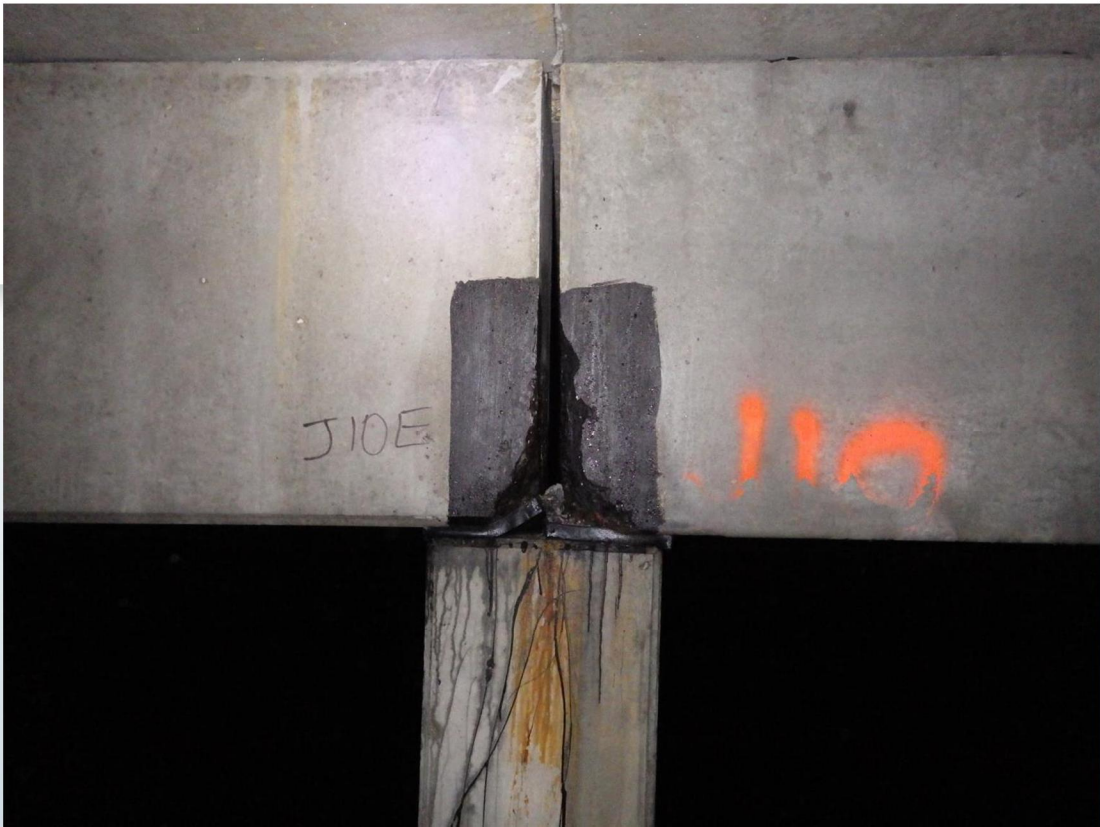
# Concrete Spall Repairs Beam Ends

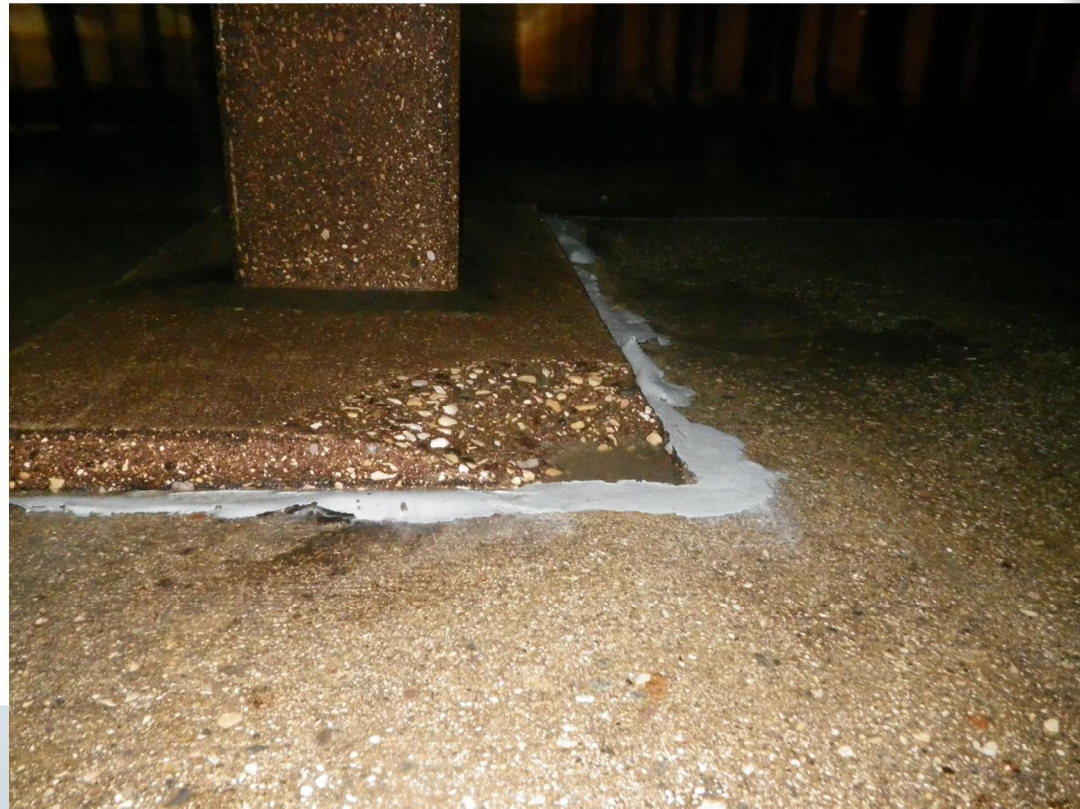
## Concrete Spall Repairs Pile Caps

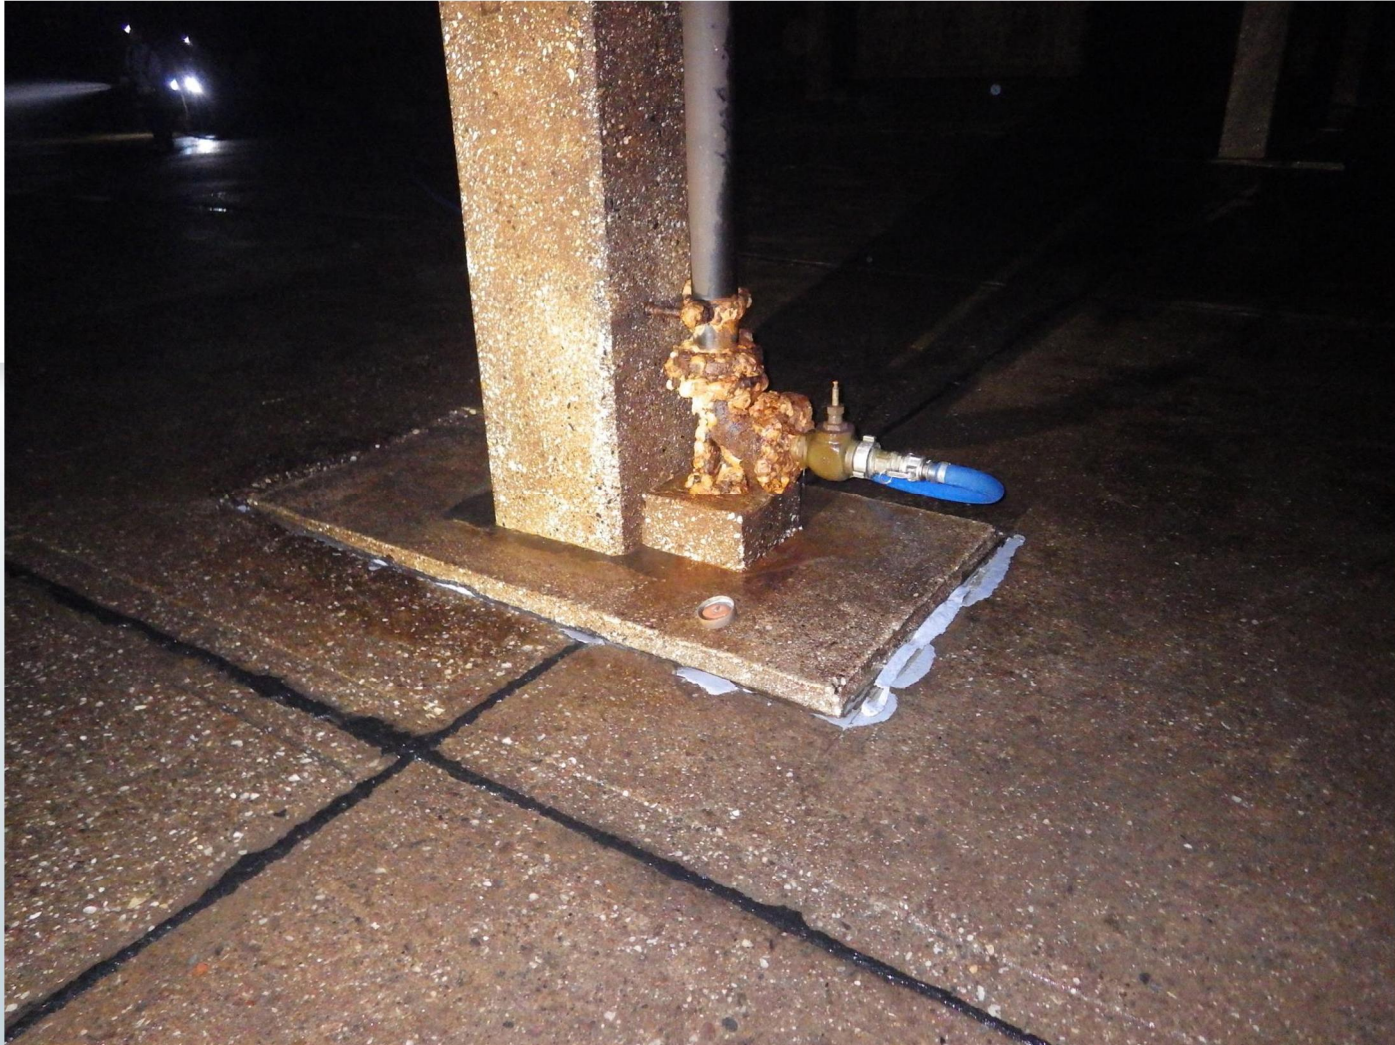
Water Supply  
For Cell Clean-up
