2017 BRIDGE MAINTENANCE - MIDTOWN  
BRIDGE & ST. VITAL BRIDGE REPAIRS

MIDTOWN BARRIER REPAIR LAYOUT 3

CITY DRAWING NUMBER: B114-17-05  
SHEET 05 OF 17  
CONSULTANT DRAWING NUMBER: --

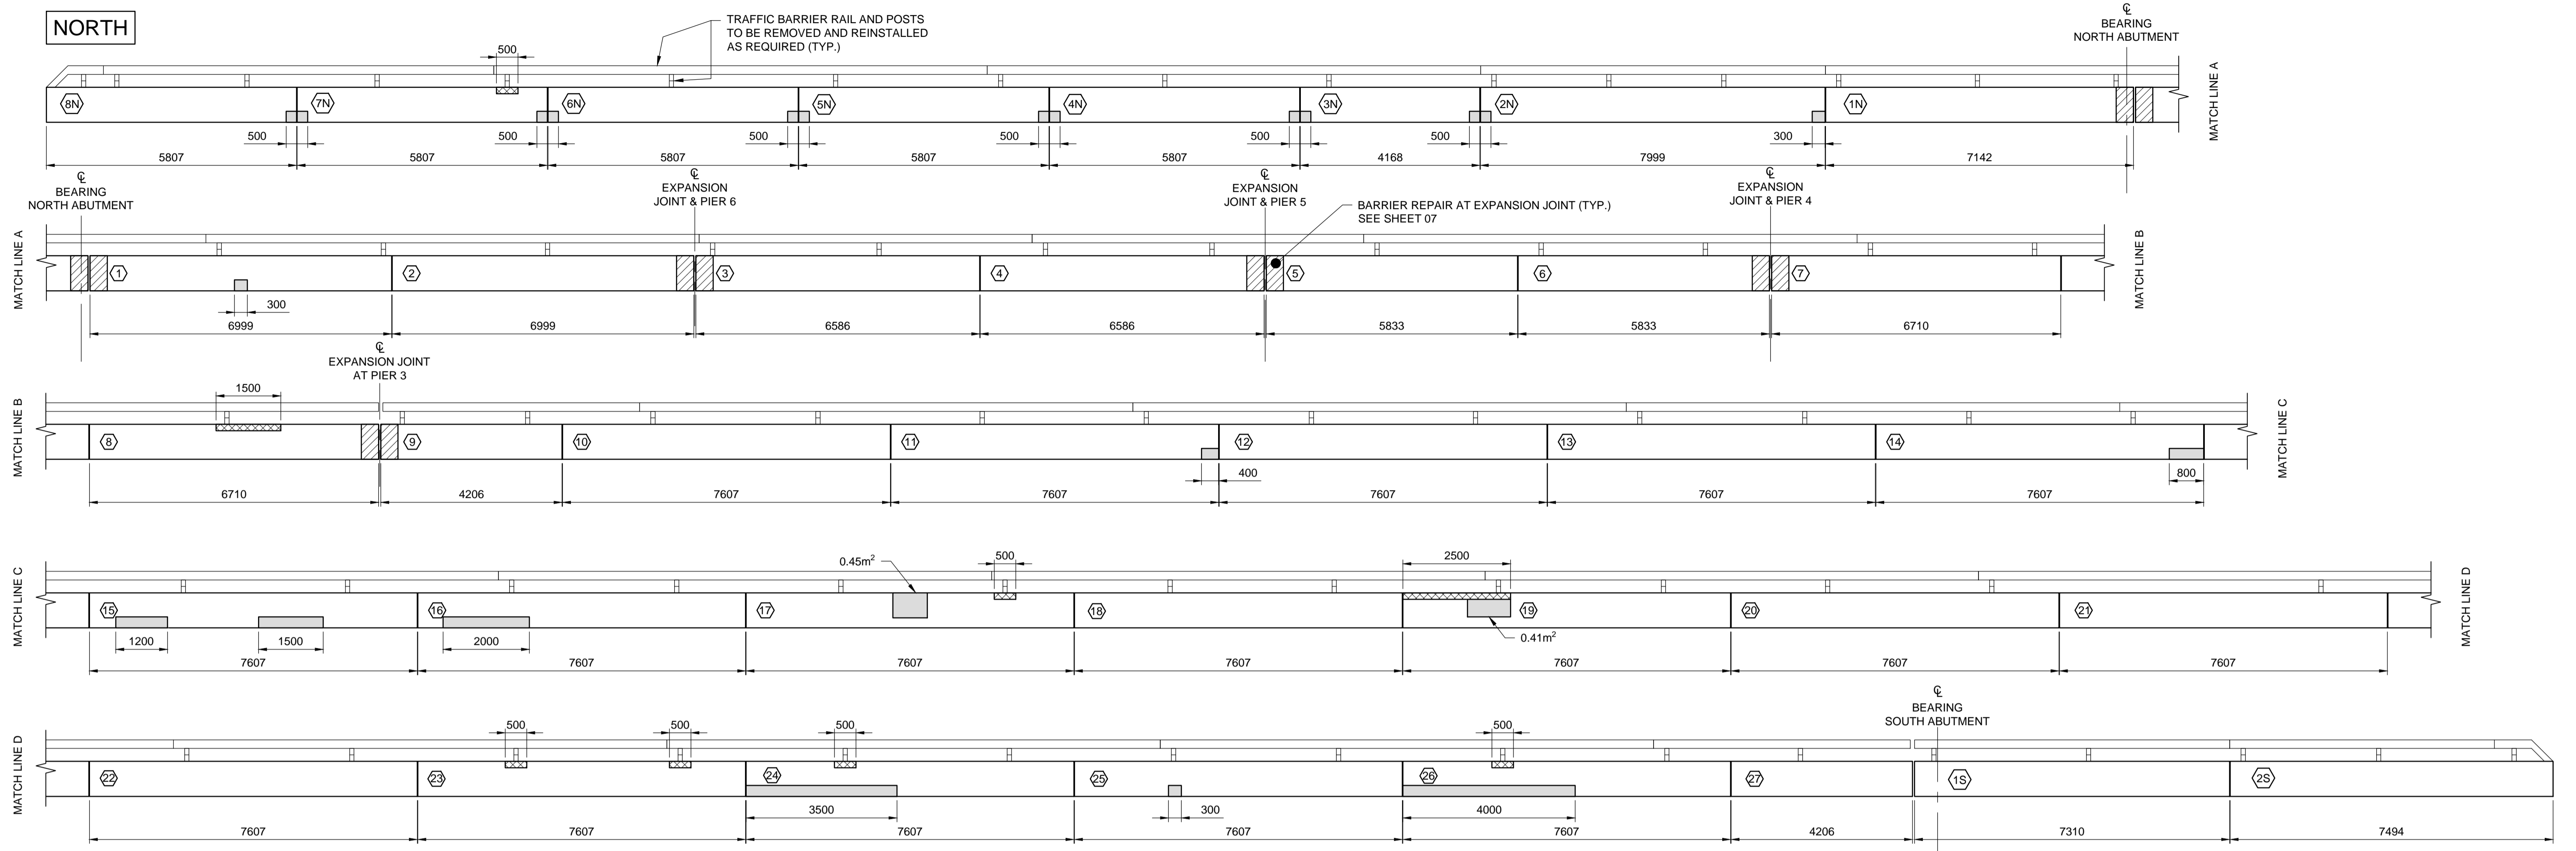
### NORTHBOUND CURB LANE BARRIER ELEVATION

1:75  
LOOKING EAST

TYPE 1 CONCRETE BARRIER REPAIR
-

TYPE 2 CONCRETE BARRIER REPAIR
- CONCRETE BARRIER JOINT REPAIR
-

- 7.0 m
- 5.26 m²
- 30

1. DIMENSIONS SHOWN OF EXISTING BARRIERS ARE APPROXIMATE.
2. DIMENSIONS SHOWN OF REPAIR AREAS ARE APPROXIMATE. LAYOUT ACTUAL REPAIR AREAS WITH CONTRACT ADMINISTRATOR ON SITE.
3. SEE SPECIFICATION FOR REPAIR PREPARATION & CONCRETE REPLACEMENT DETAILS.
4. REPLACE ALL BARRIER JOINT SEALS WITH EMSEAL BEJS-ON-A-REEL
