TYPICAL WATERPROOFING DETAILS – TRAFFIC BEARING MEMBRANE

Project
**FIRE PARAMEDIC SERVICE
STATION No. 5**
STRUCTURAL REPAIRS TO APPARATUS ROOM FLOORS
845 SARGENT AVENUE
WINNIPEG, MANITOBA

Sheet Title
**WATERPROOFING MEMBRANE
SECTIONS AND DETAILS**

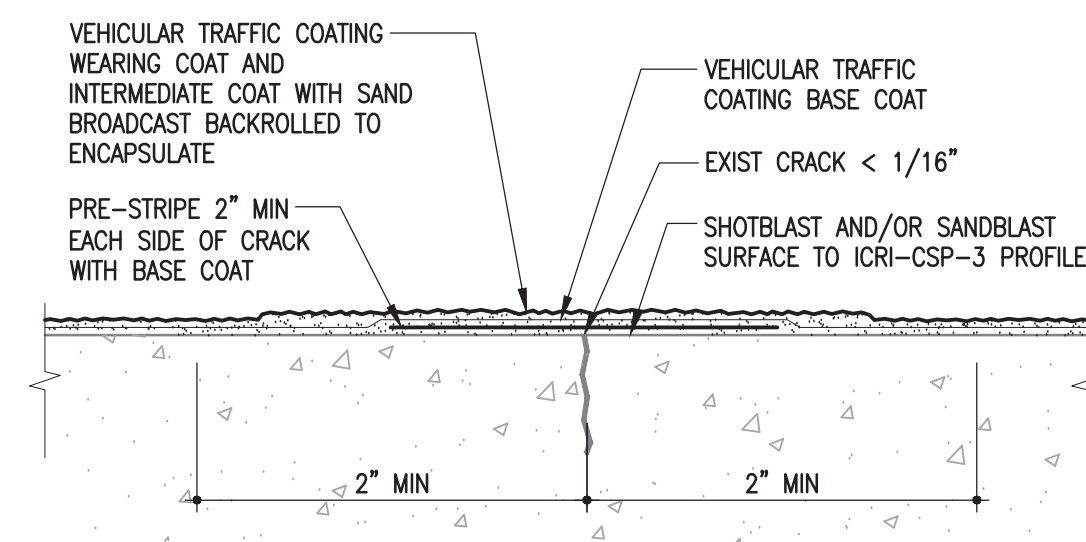
1 DETAIL AT CRACKS (< 1/16")
- S6.1 N.T.S. (VEHICULAR TRAFFIC COATING)

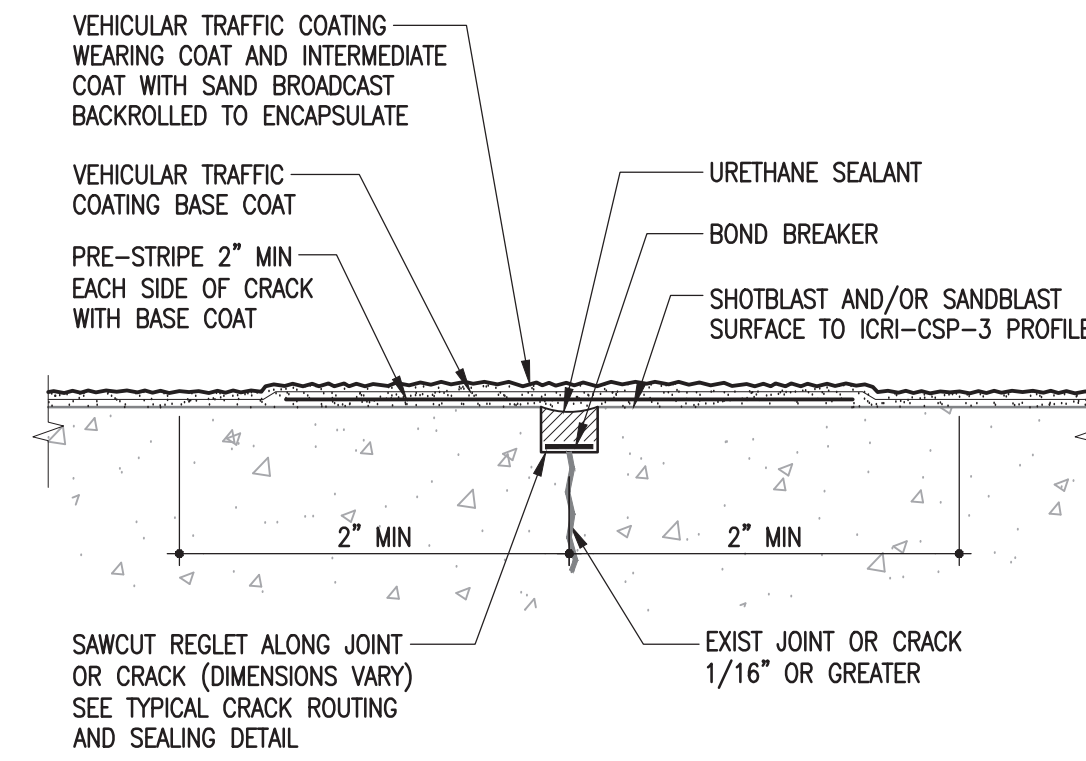
2 DETAIL AT JOINT OR CRACKS (1/16" OR GREATER)
- S6.1 N.T.S. (VEHICULAR TRAFFIC COATING)

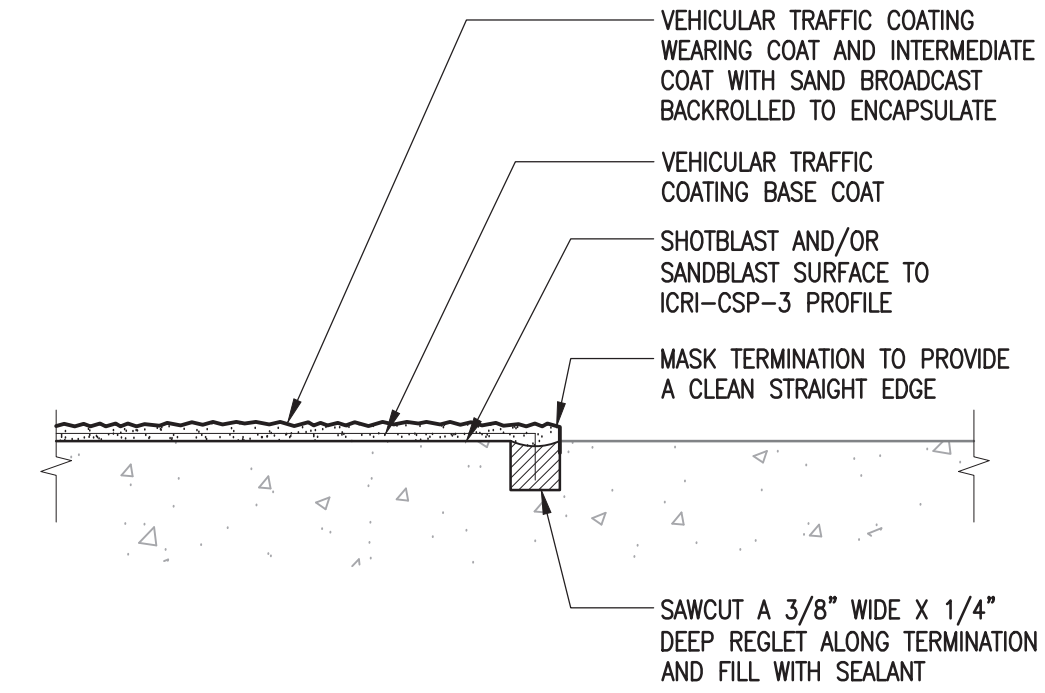
3 DETAIL AT HORIZONTAL TERMINATION
- S6.1 N.T.S. (VEHICULAR TRAFFIC COATING)

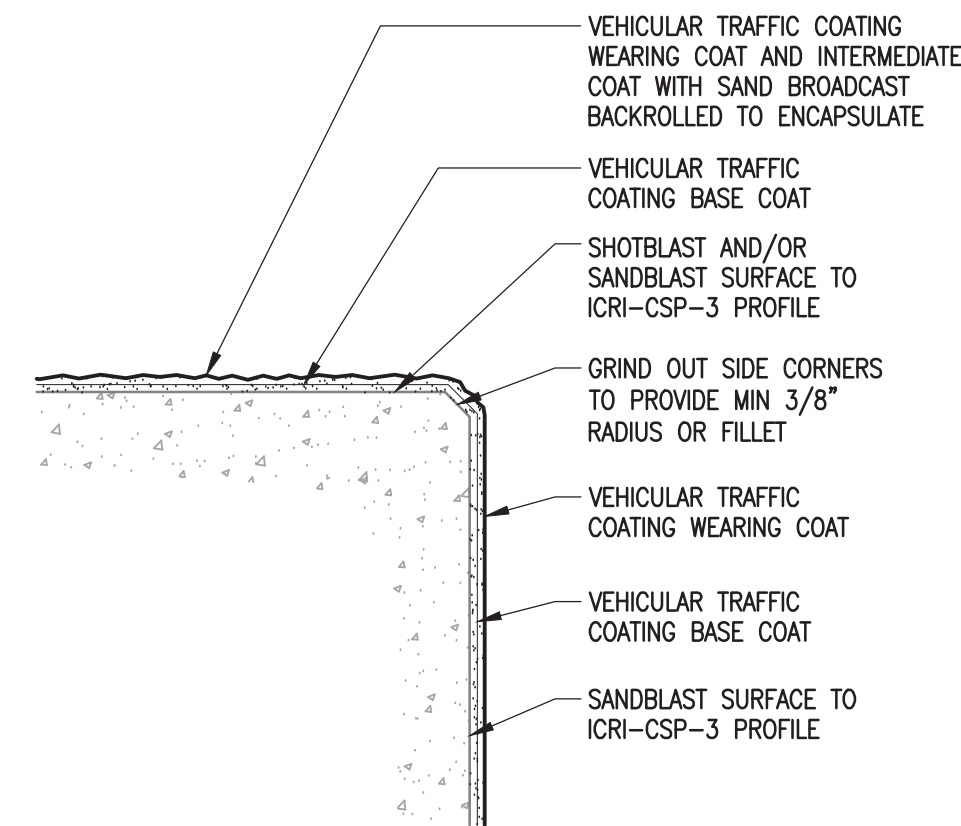
4 DETAIL AT OUTSIDE CORNER
- S6.1 N.T.S. (VEHICULAR TRAFFIC COATING)

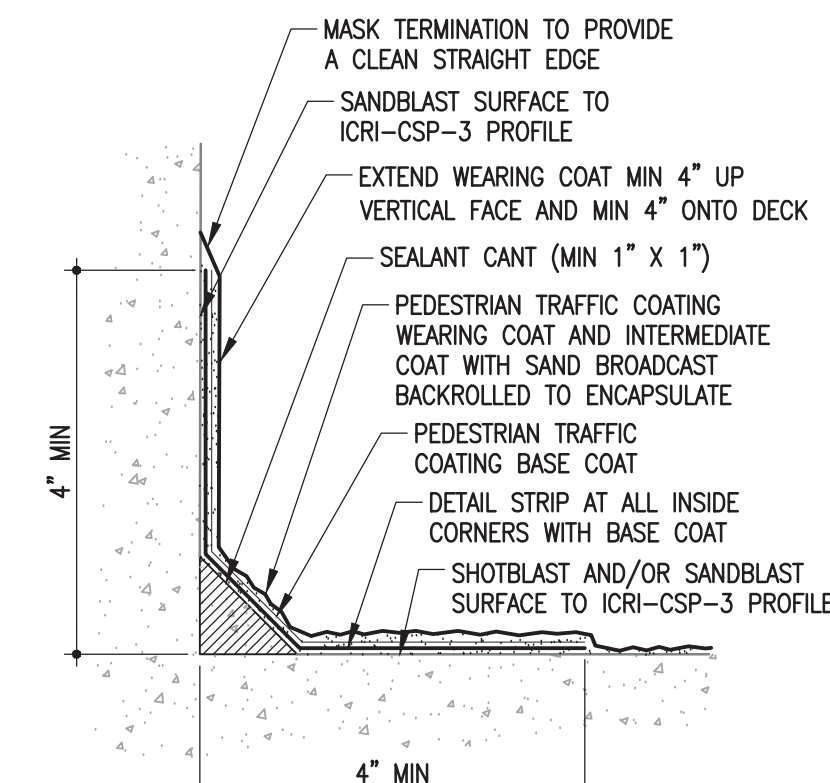
5 DETAIL AT INSIDE CORNER
- S6.1 N.T.S. (VEHICULAR TRAFFIC COATING)

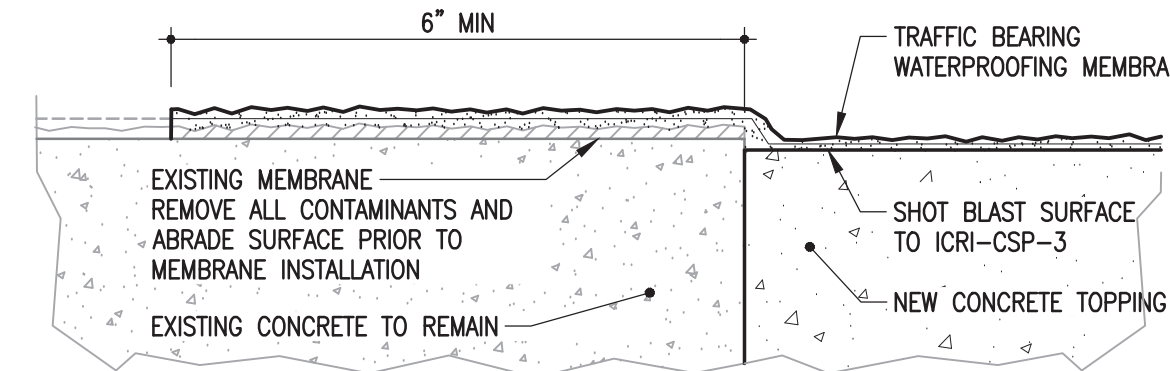
6 TYPICAL MEMBRANE REPAIR DETAIL
- S6.1 N.T.S. (VEHICULAR TRAFFIC COATING)

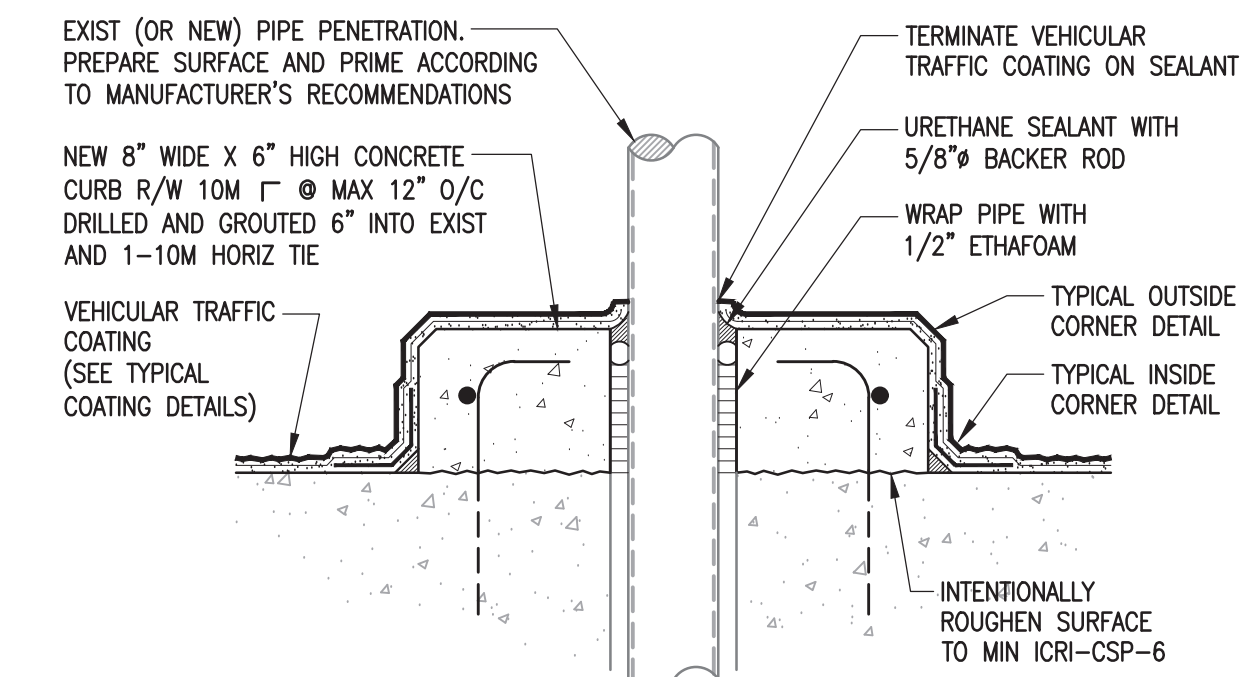
7 DETAIL AT PIPE PENETRATION
- S6.1 N.T.S. (VEHICULAR TRAFFIC COATING)
