Project
St. John's Library Renovation

Drawing
Details

Reviewed By
PS
Drawing No.
A-601

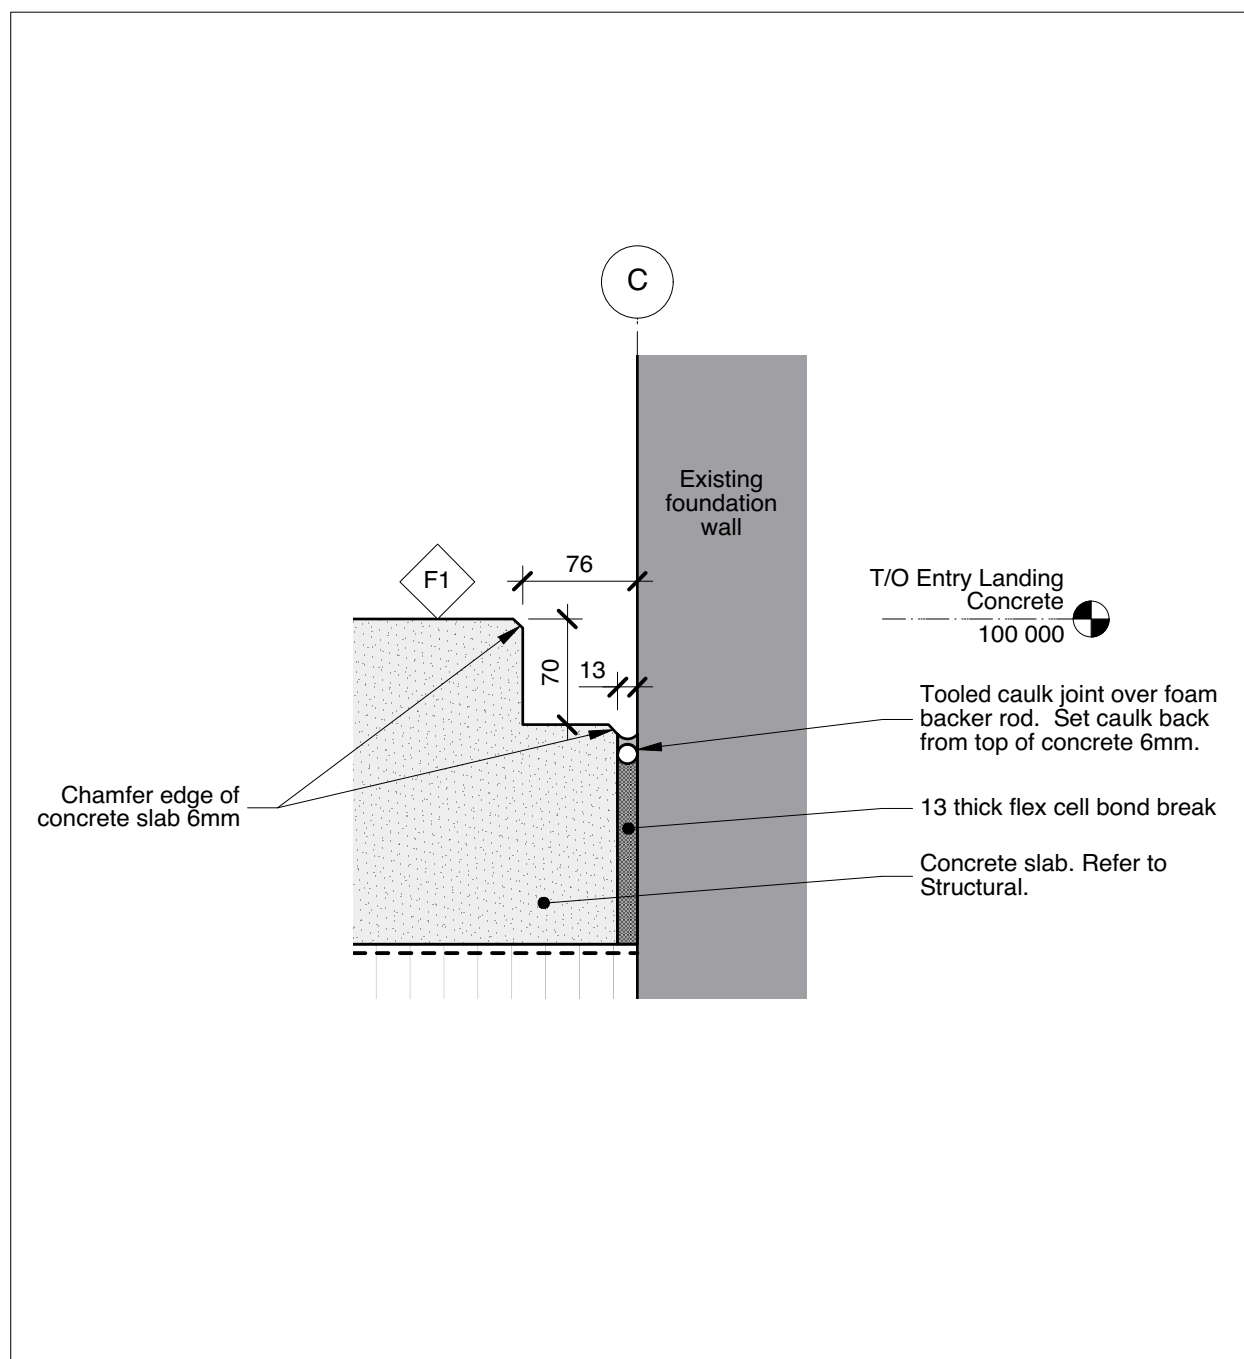
11 A-601 1:5
Typical Section Detail - Concrete Floor Juncture to Existing Exterior Foundation Wall

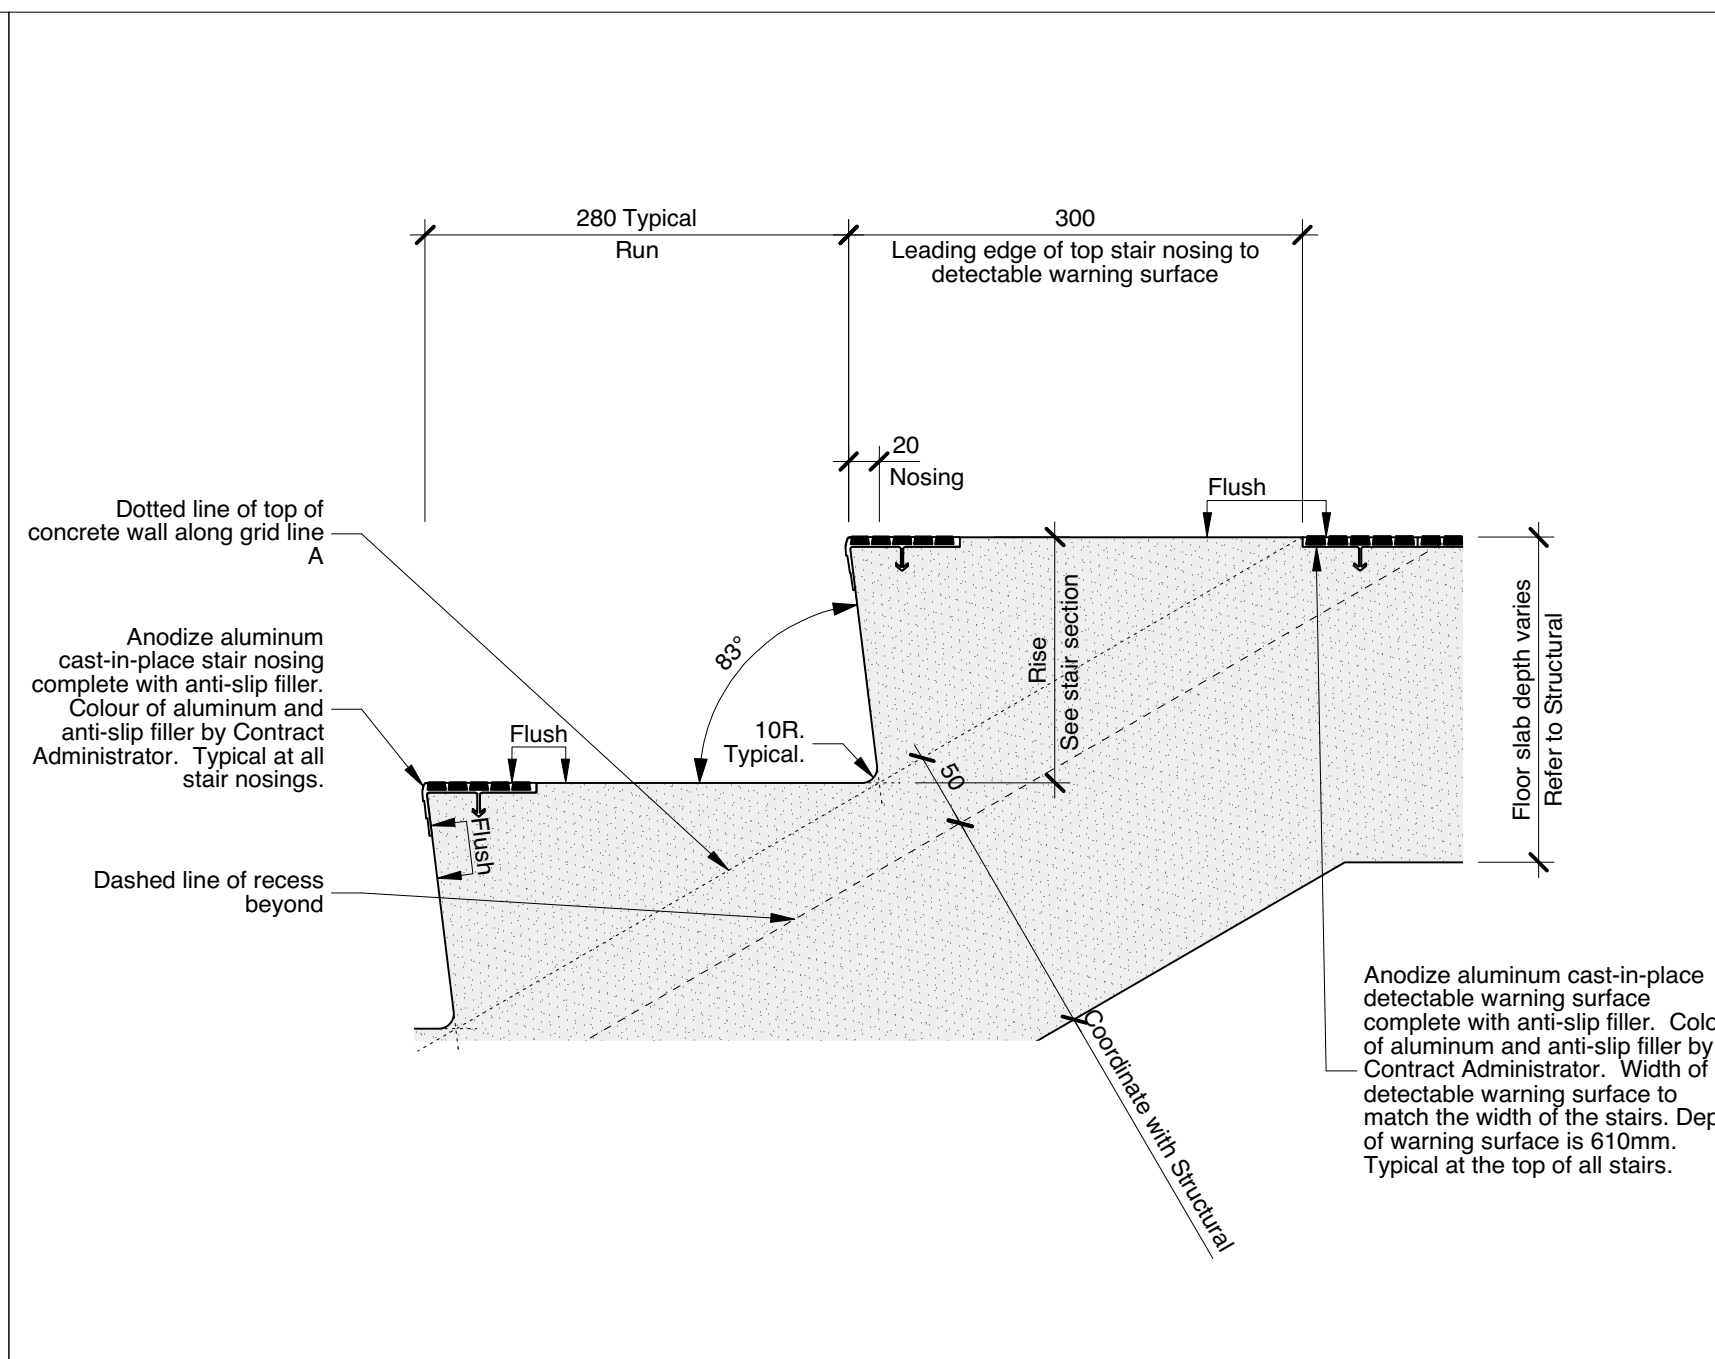
9 A-601 1:20
Section Detail - Typical Stair Tread

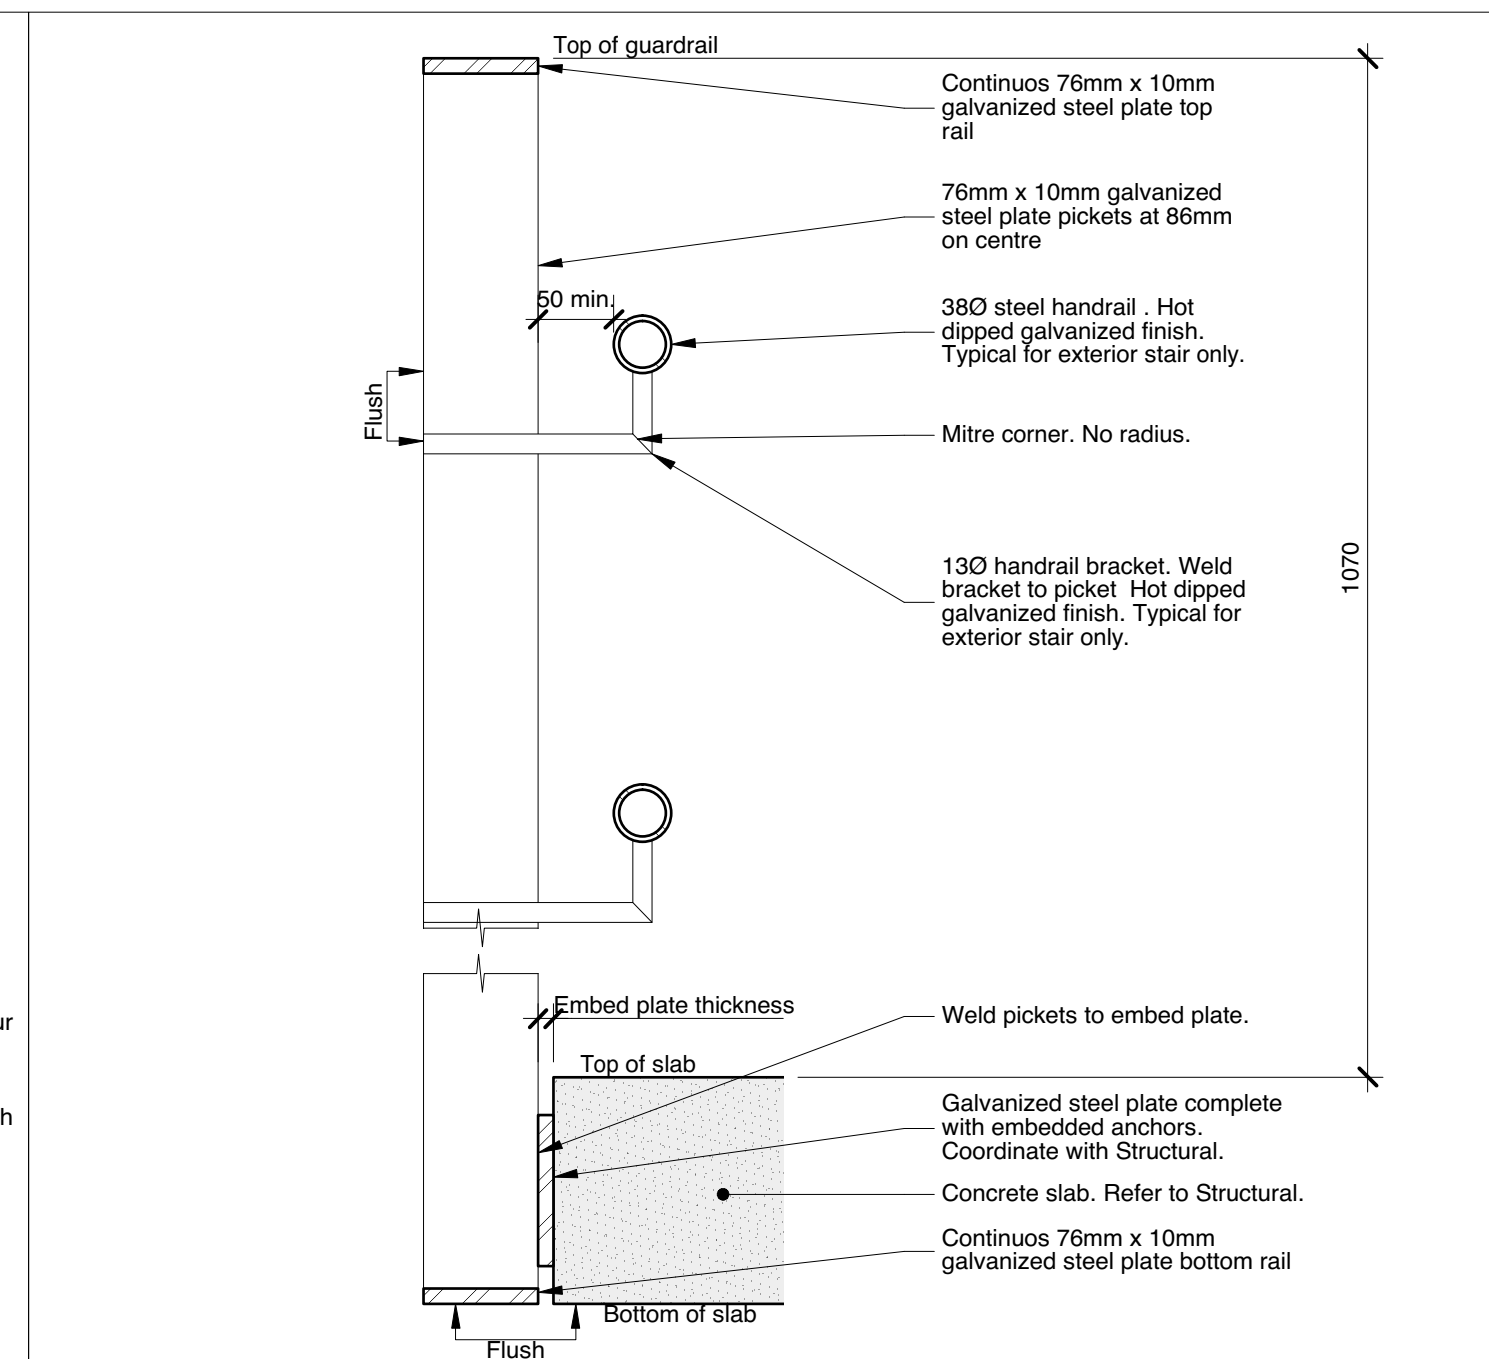
6 A-601 1:5
Section Detail - Exit Stair Guardrail/ Handrail

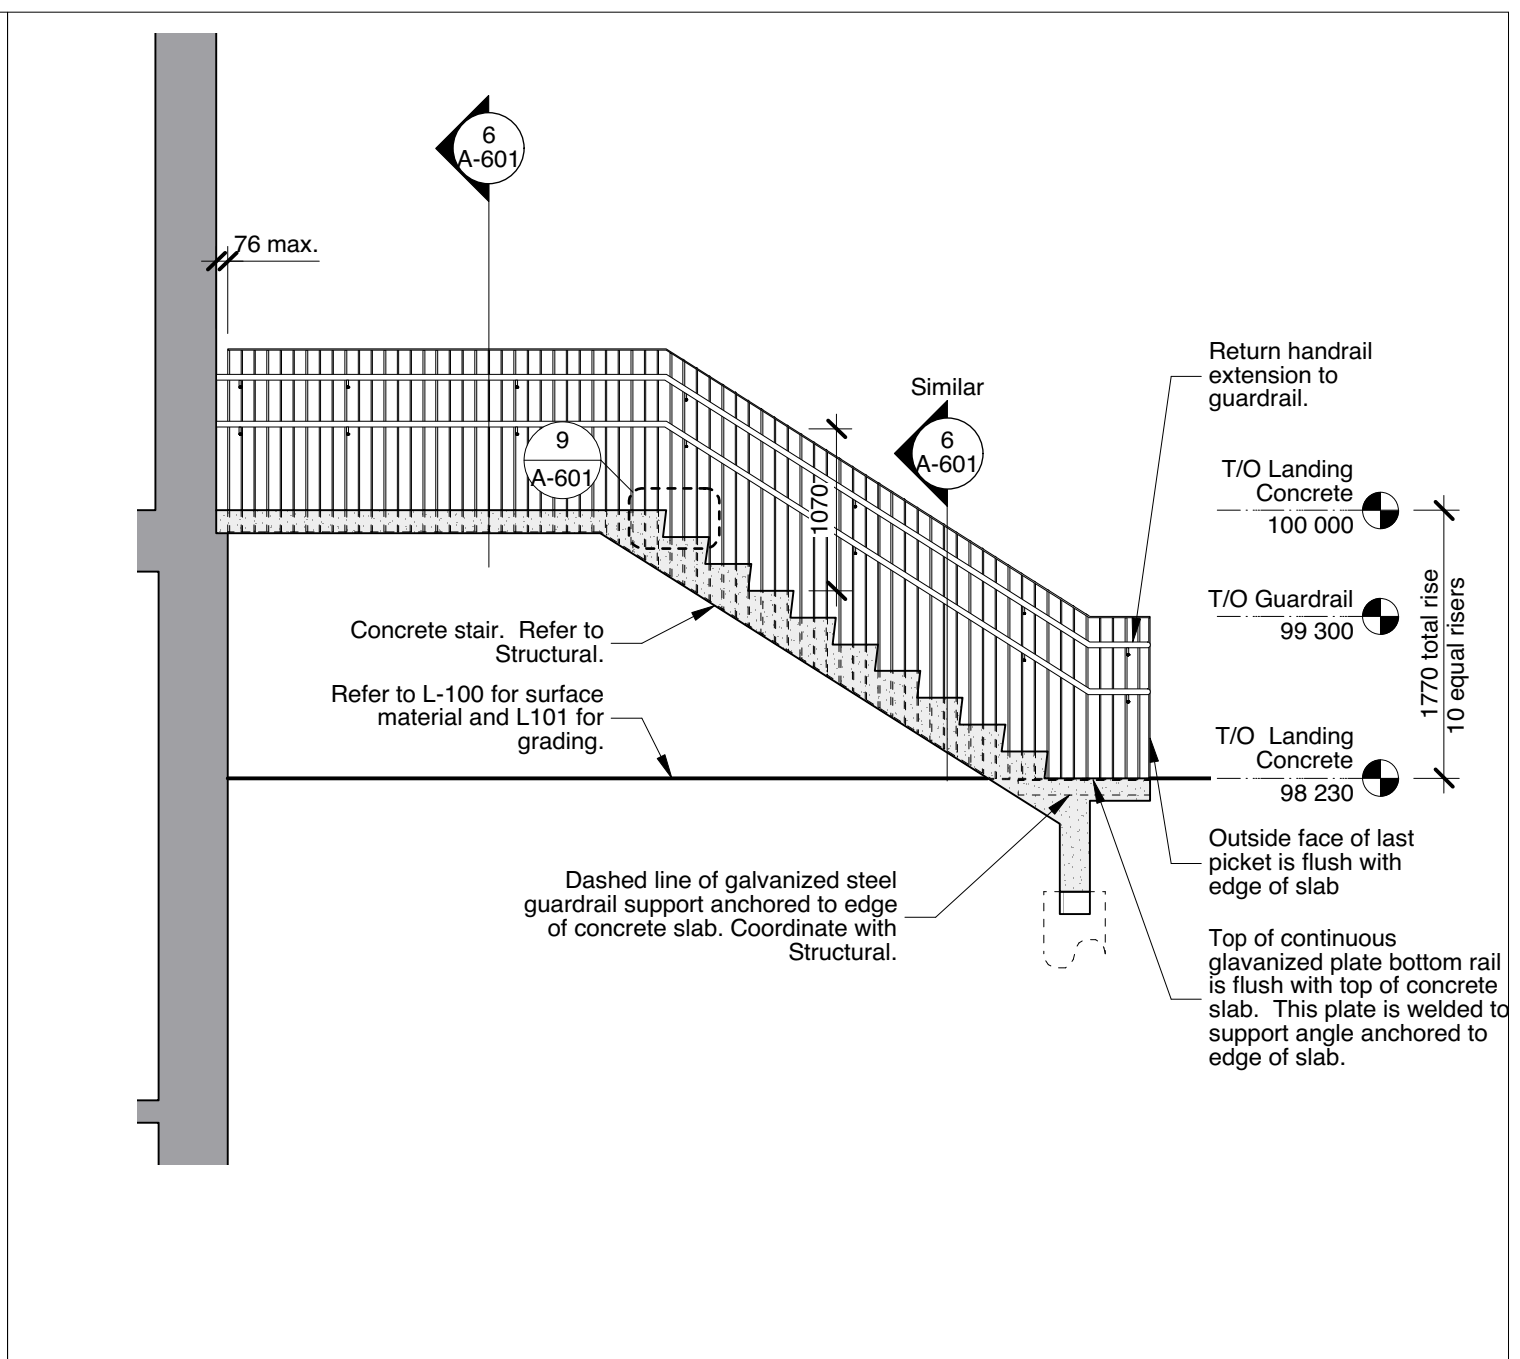
3 A-601 1:50
Stair Section - Exterior Exit Stair from Main Floor

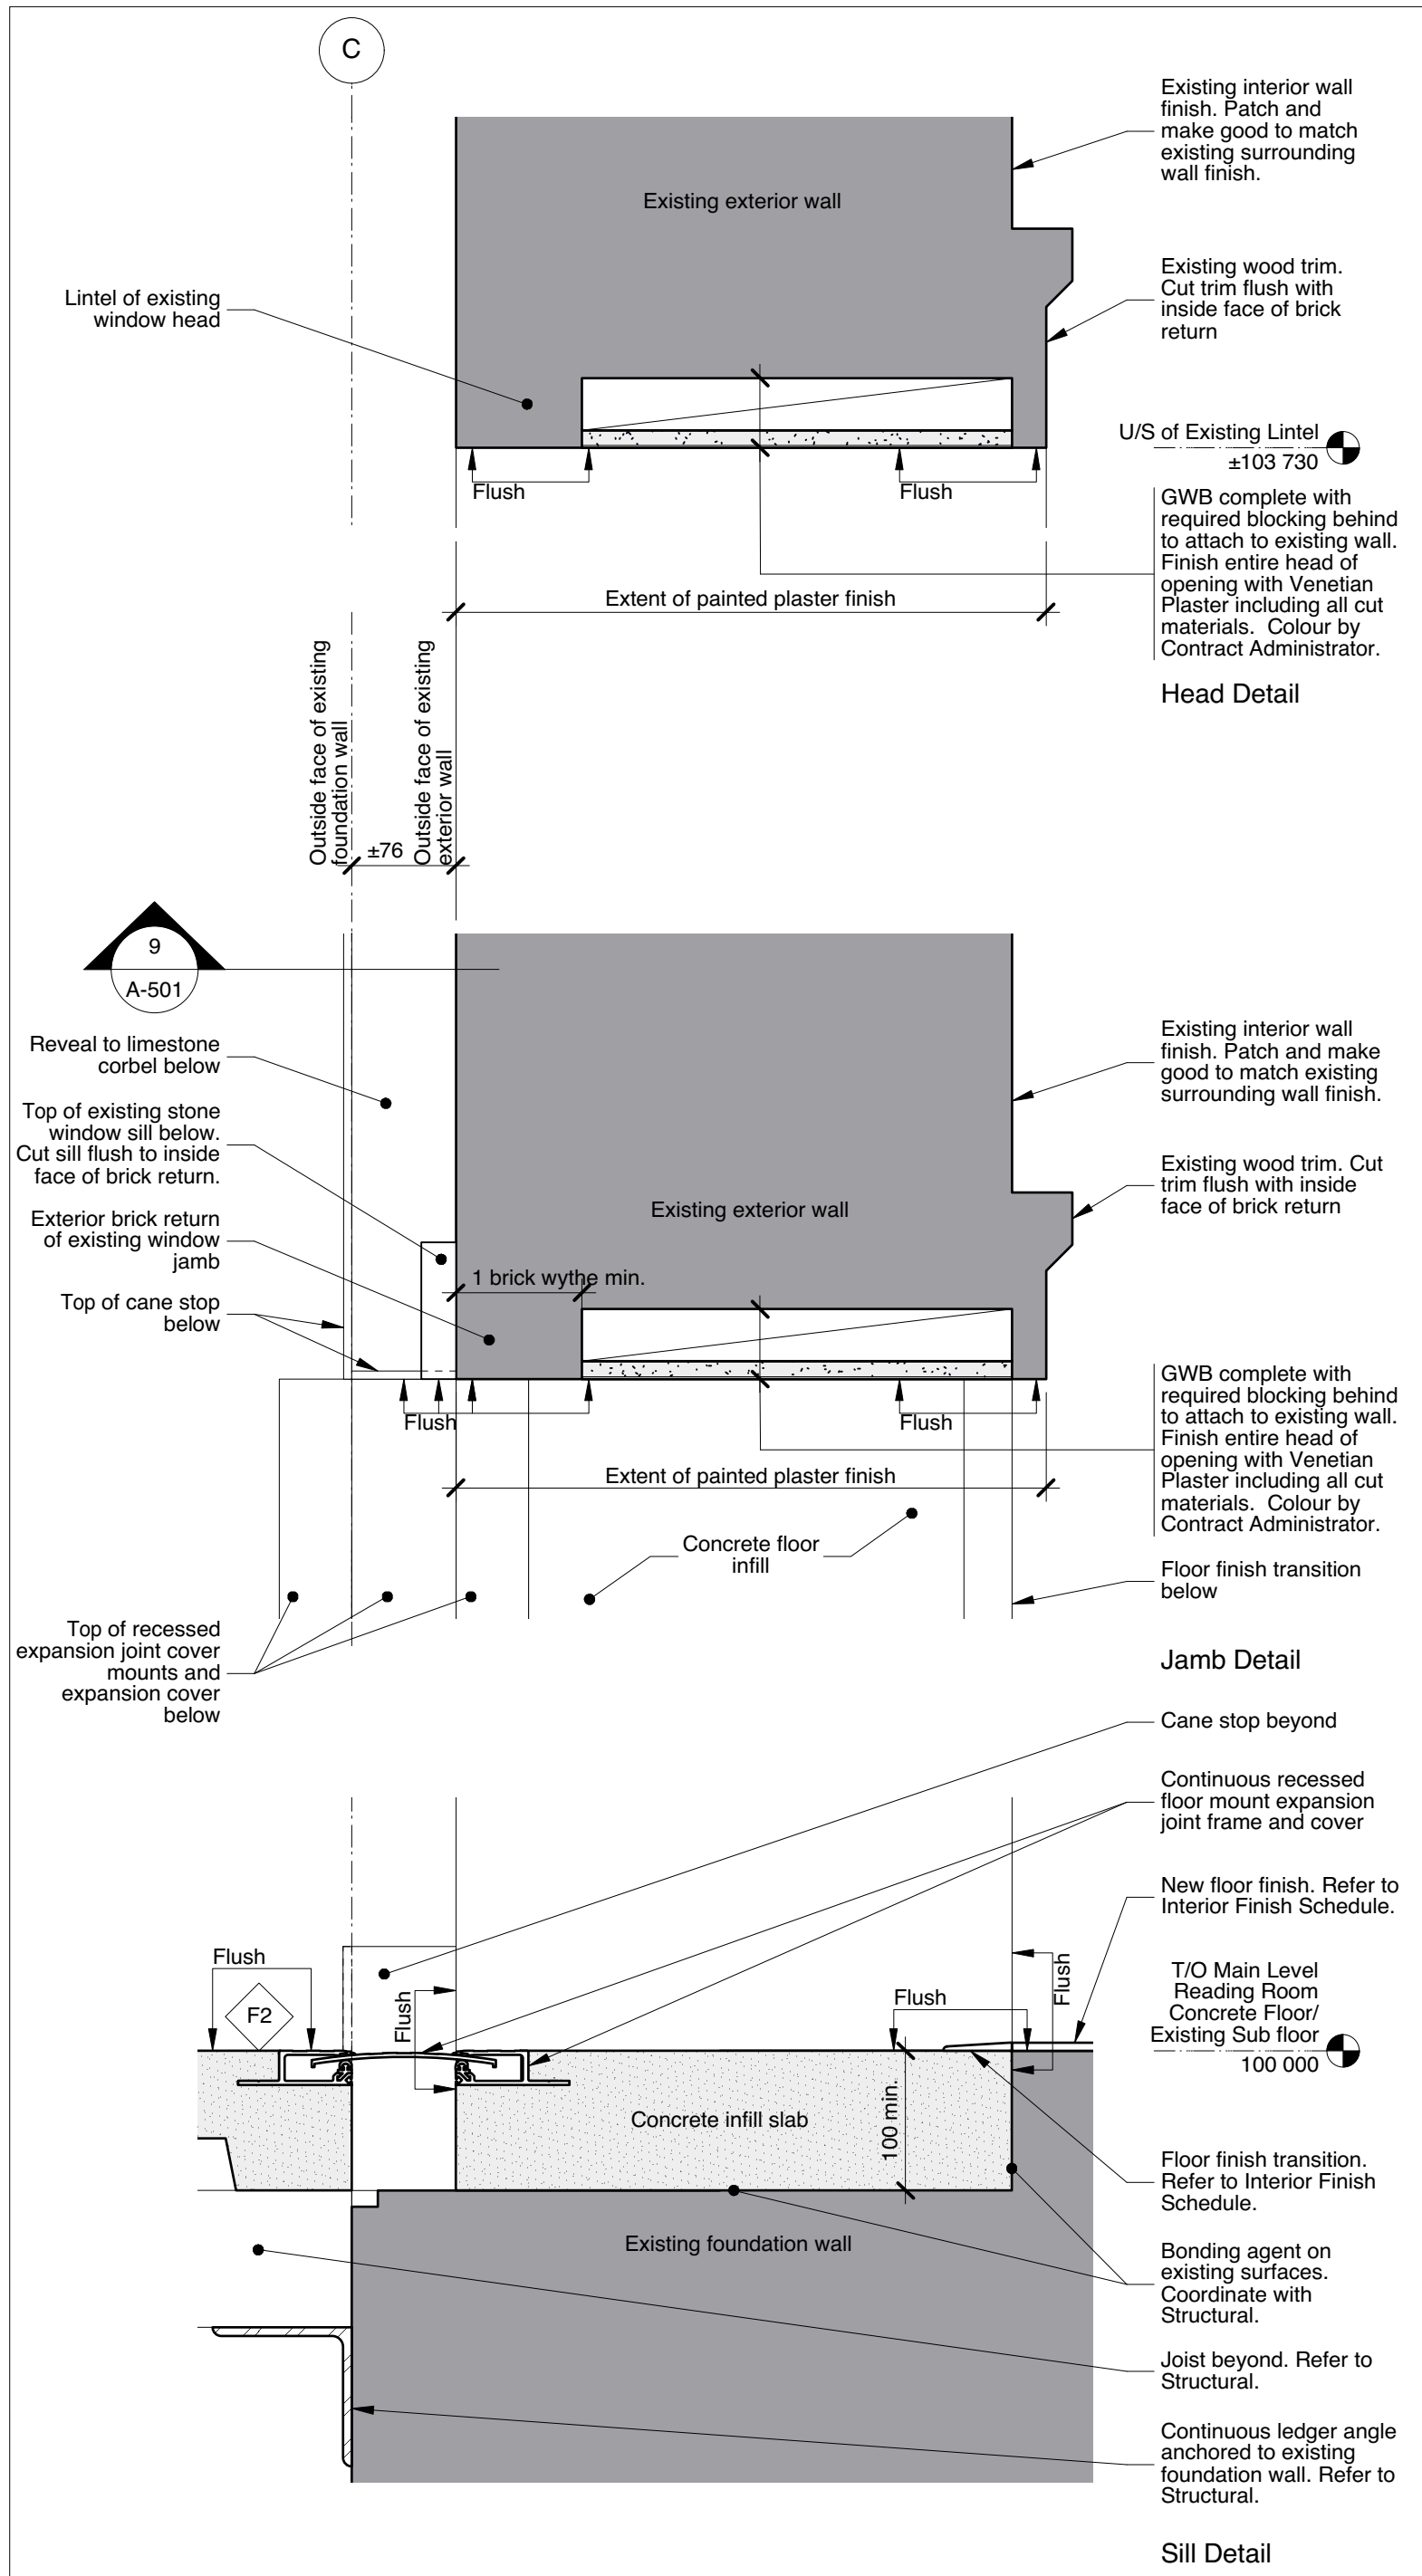
10 A-601 1:5
Detail - Link Between Main Level Reading Room and Existing Stacks Through Existing Window Opening

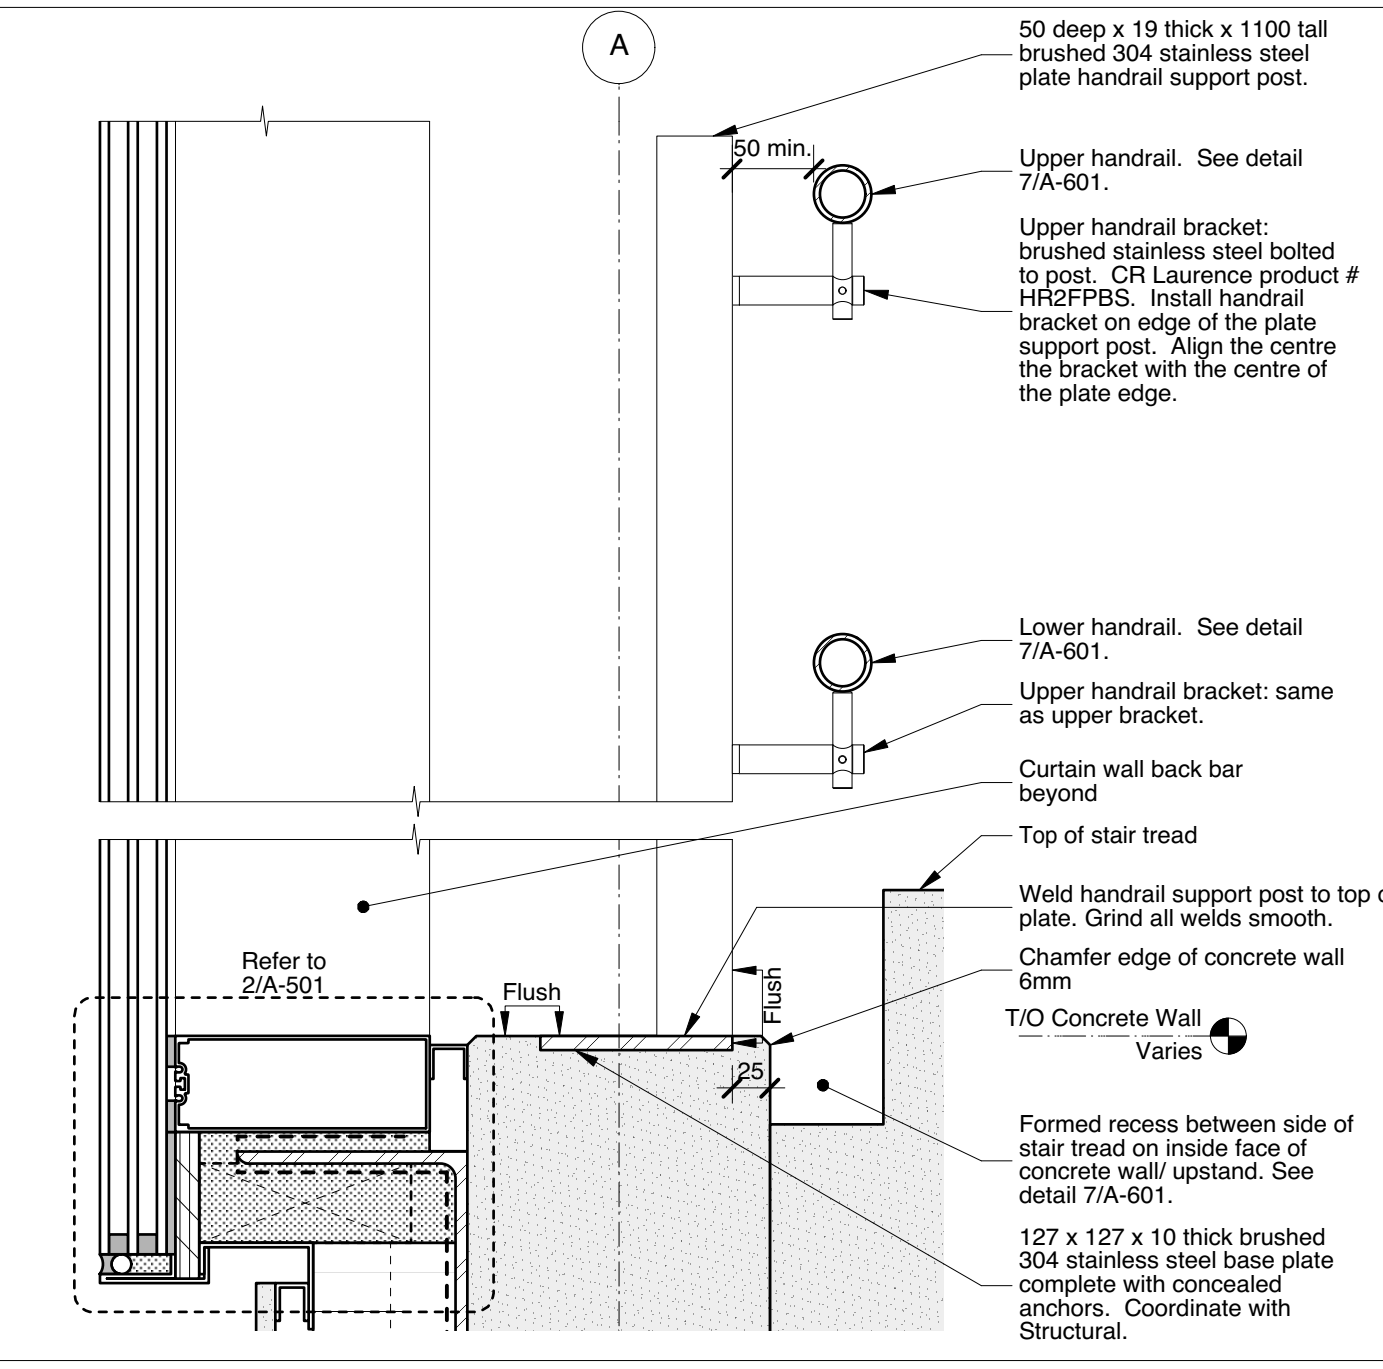
8 A-601 1:5
Section Detail - Handrail Parallel to Curtain Wall on Grid A

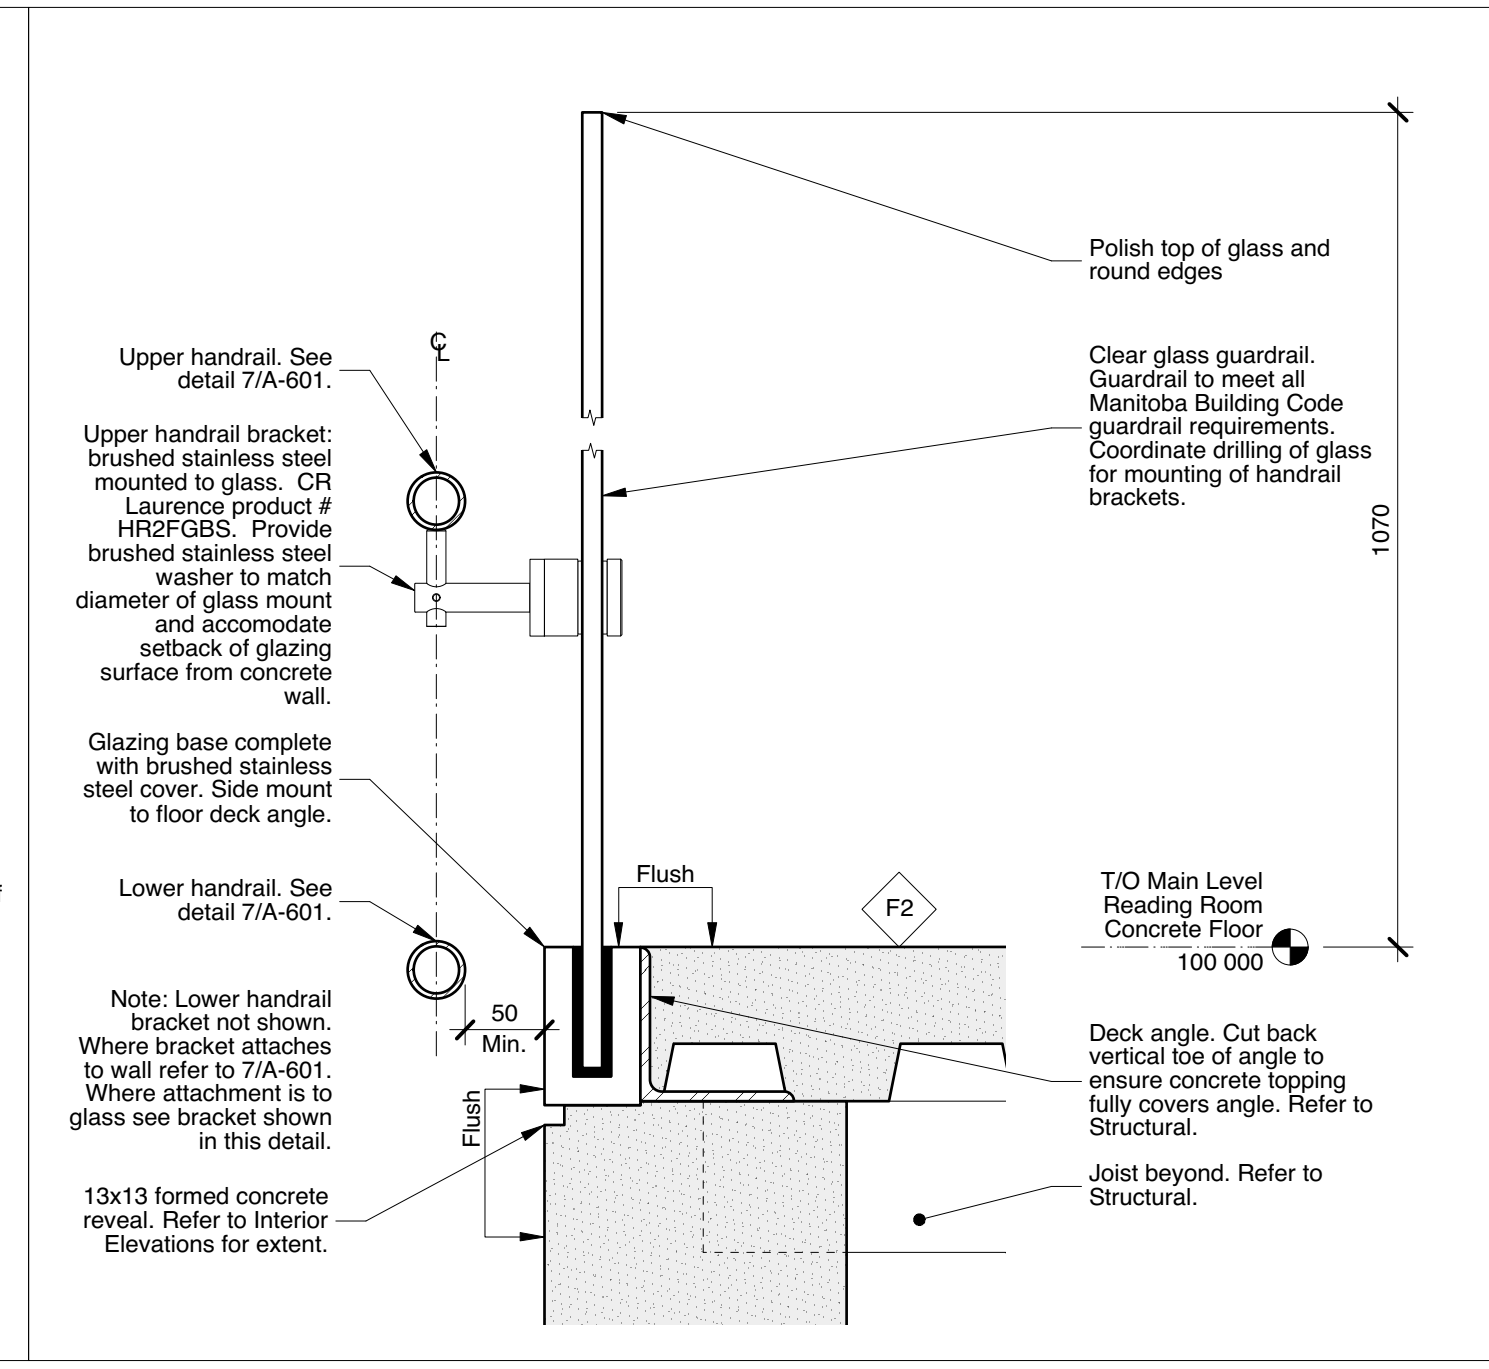
5 A-601 1:5
Section Detail - Guardrail at Head of Main Level Reading Room Stairs

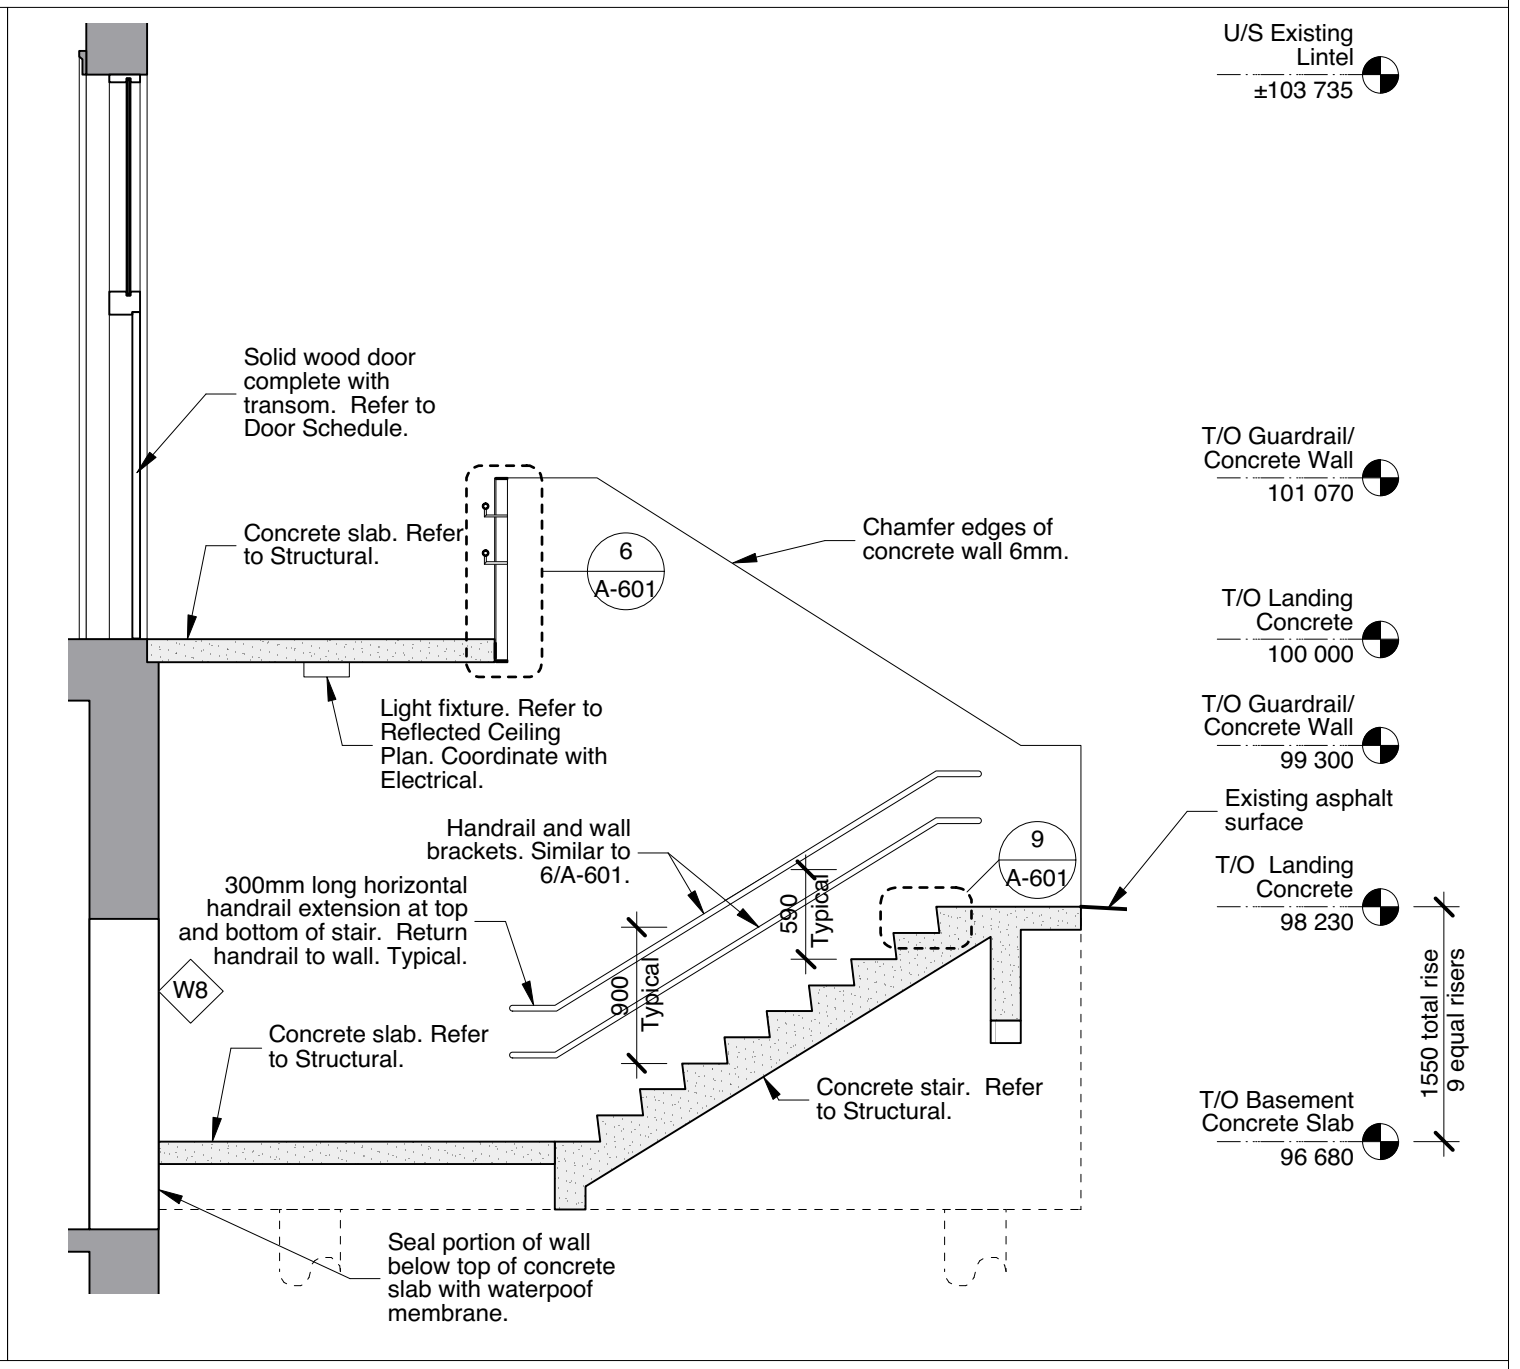
2 A-601 1:50
Stair Section - Exterior Exit Stair from Basement

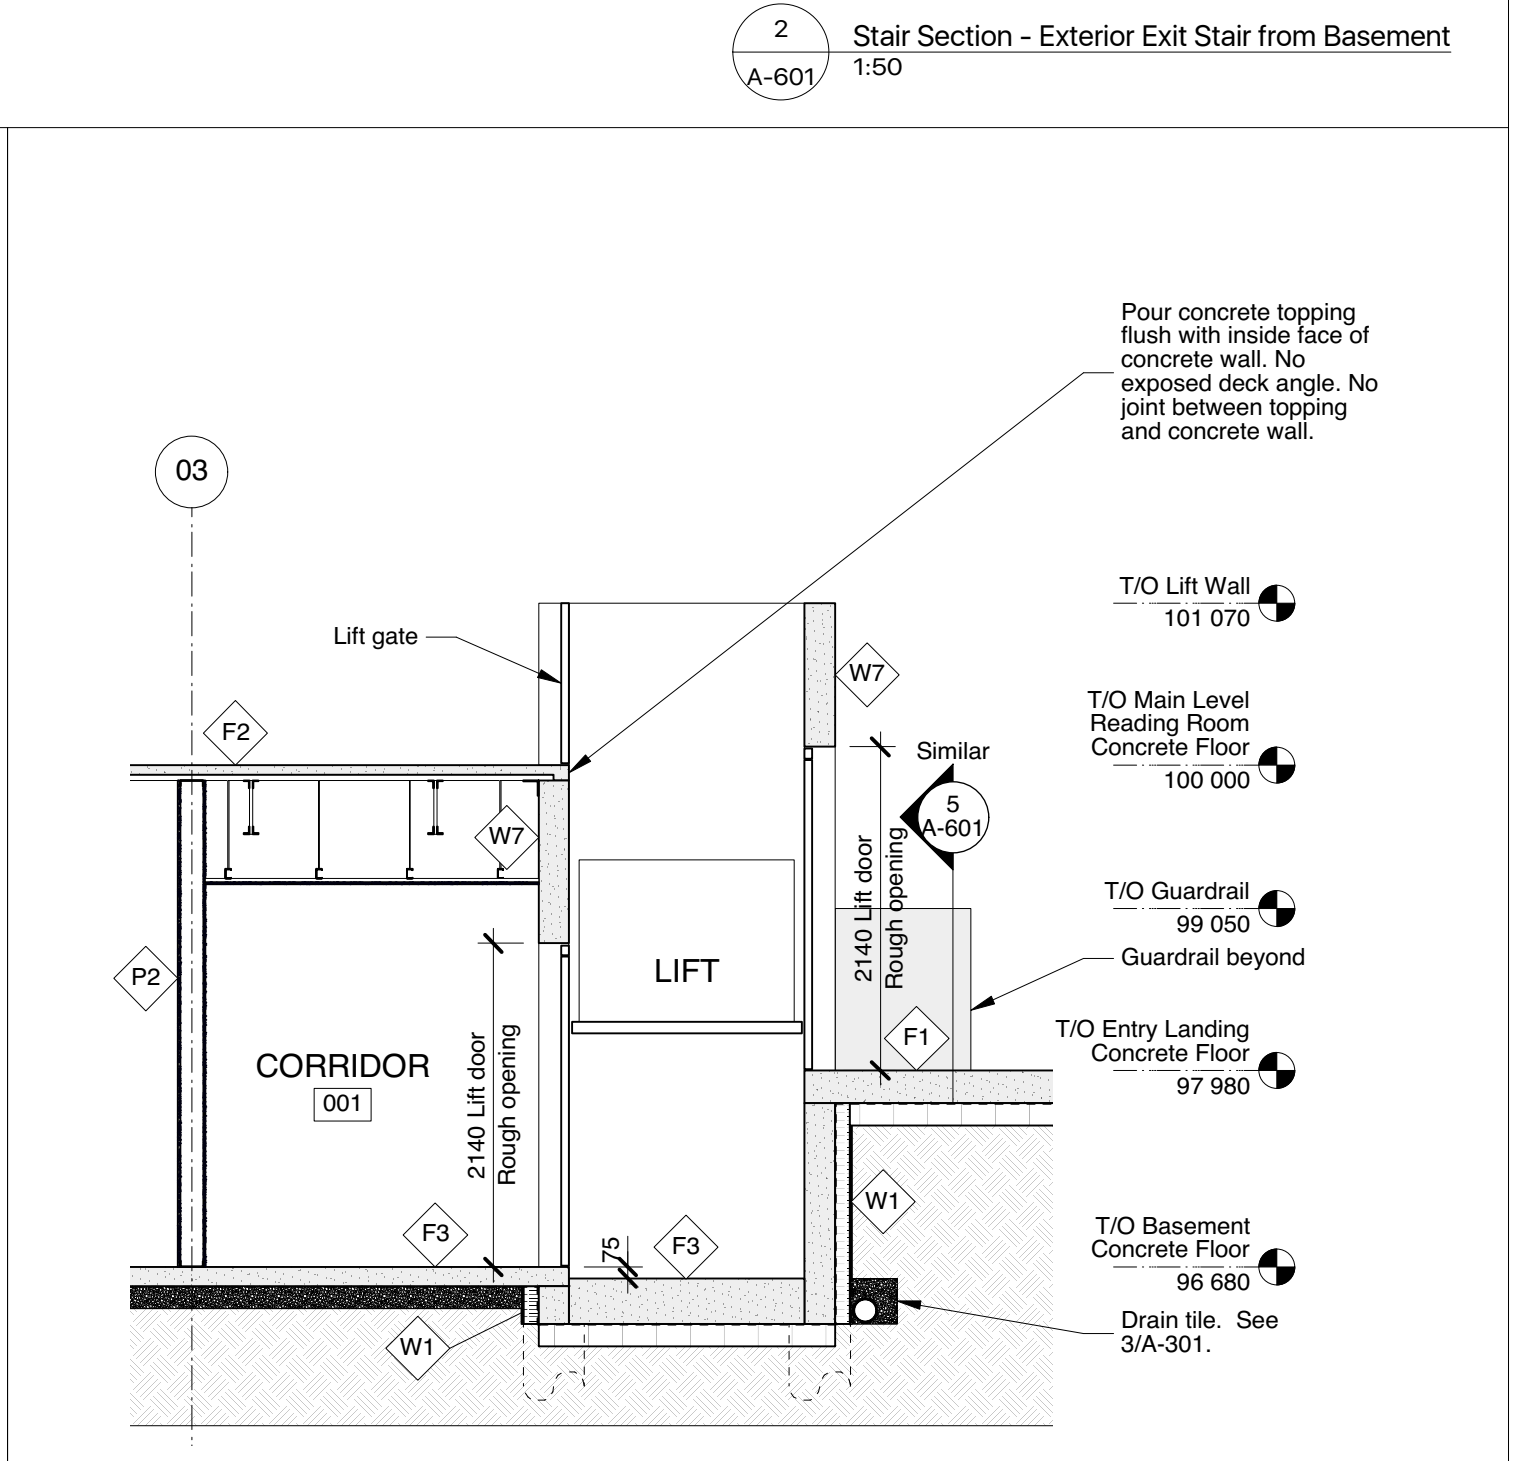
1 A-601 1:50
Lift Section - East West Section Through Lift
