Project  
**CENTURY ARENA**  
GLULAM REPAIRS  
1377 CLARENCE AVENUE  
WINNIPEG, MANITOBA

Sheet Title  
CLADDING REPAIR DETAILS

File	2017-0007	Date	2017-04-19
Design	SMC	Drawn	RJM
Revision	Sheet No.		
<b>A</b>	<b>S5.1</b>

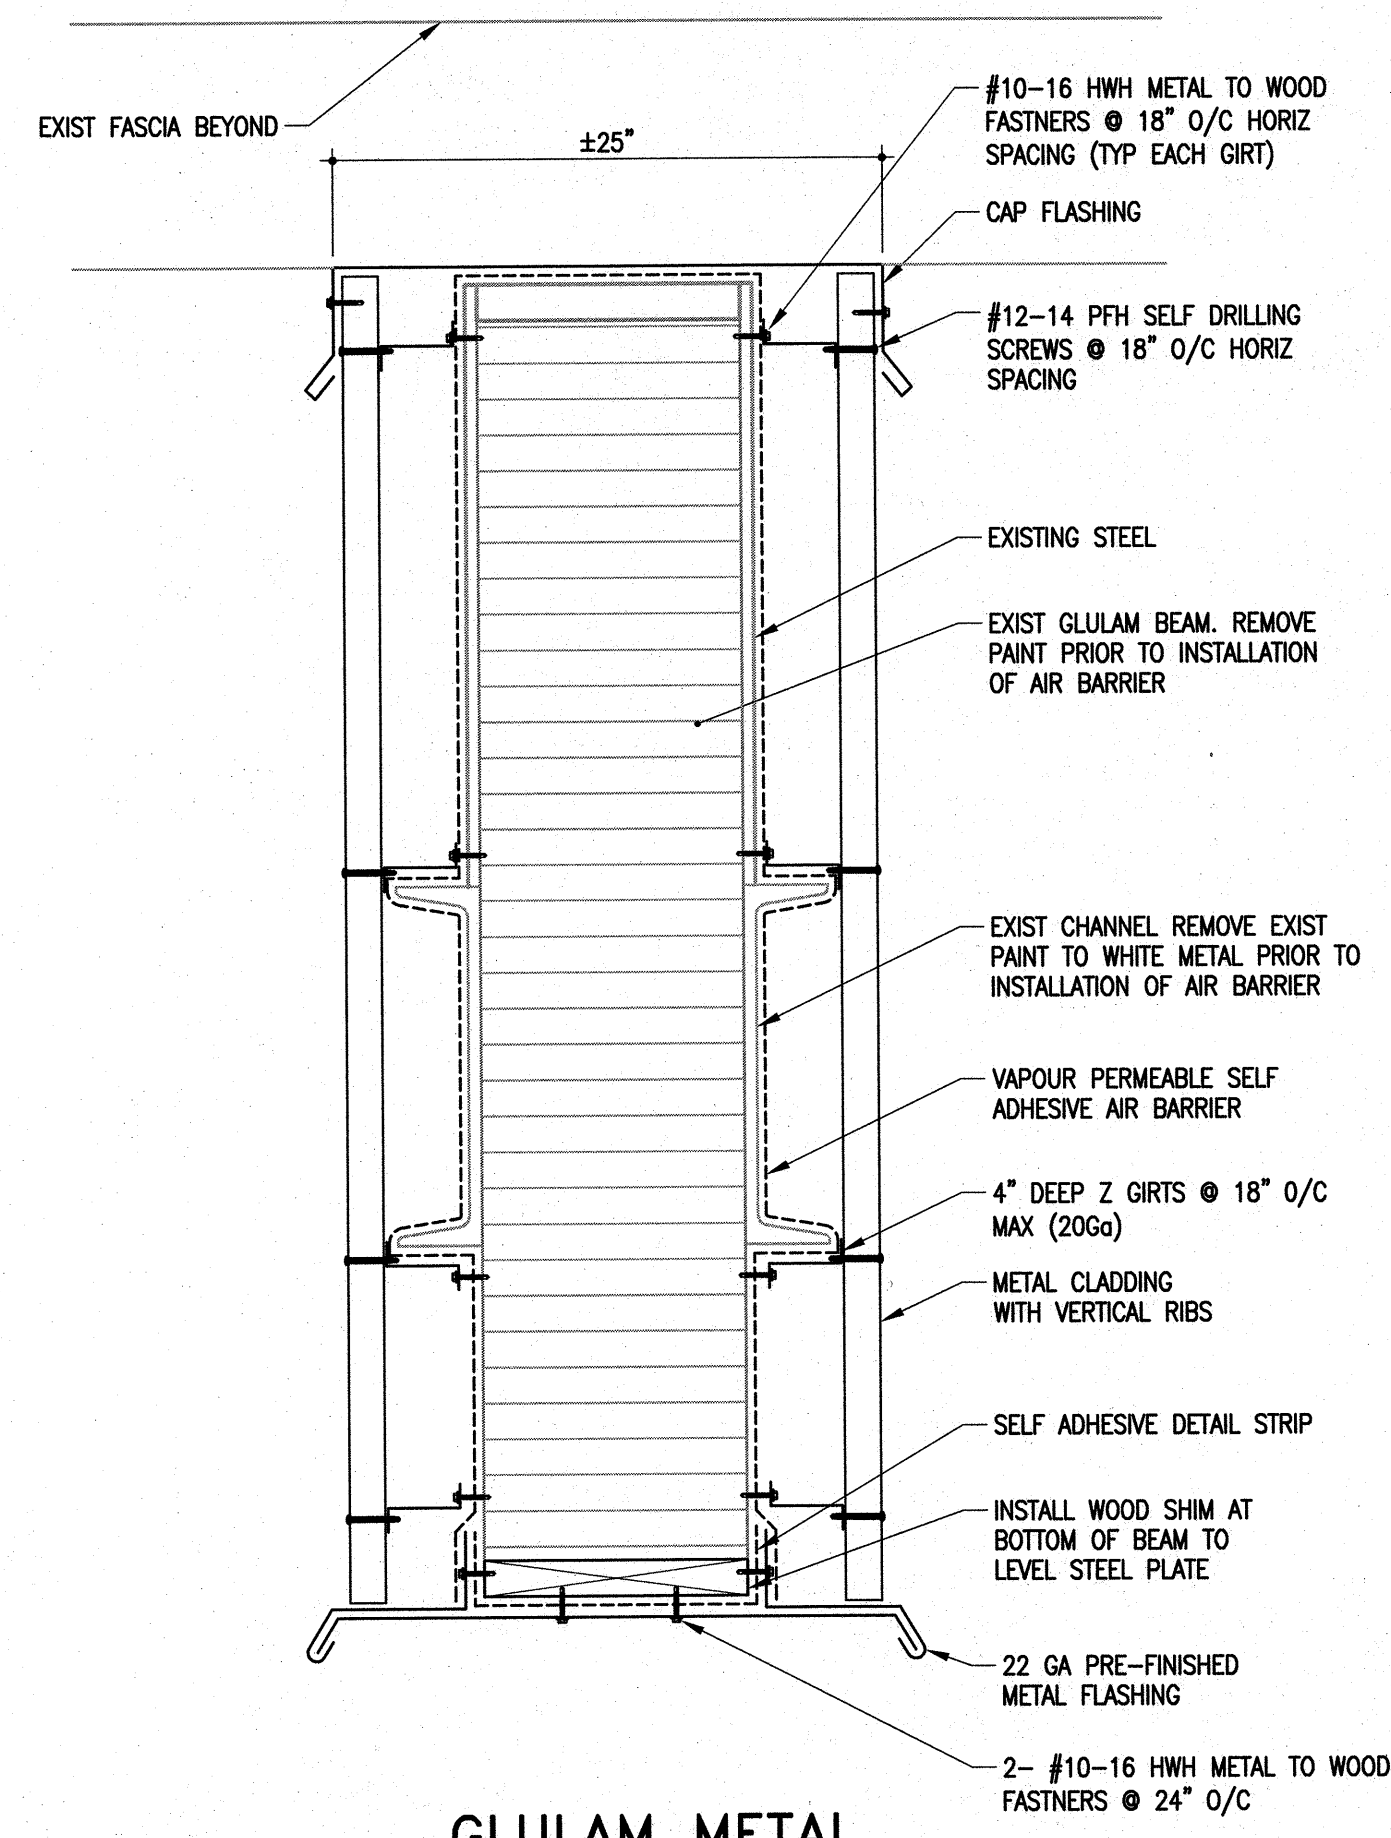
**A** GLULAM METAL CLADDING REPAIR  
S4.2 | S5.1 1-1/2" = 1'-0"
