## **APPENDIX 'C'**

# PAVEMENT CORES BRIDGE DECK AND SUBSTRUCTURE

Reference: Fermor Avenue Bridge Over Seine River

On May 18<sup>th</sup> and 25<sup>th</sup>, 2016, Stantec Consulting Ltd. was retained to recover a total of twenty-eight (28) core samples from the Fermor Avenue Bridge over the Seine River in Winnipeg, Manitoba. Twelve (12) core samples were obtained from the bridge deck, which the remaining sixteen (16) core samples were recovered from the substructure. The purpose of the coring program was to determine the compressive strength, air-void parameters, and chloride content of the concrete. As instructed by Dillon Consulting, all testing conducted on the deck concrete was performed below the high density concrete overlay. Photographs of the core samples are attached to this report. The testing performed and the corresponding results for each core sample are identified below.

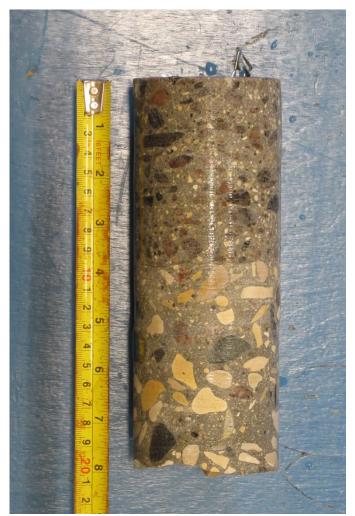
Figure 2 - Core no. D2, eastbound curb lane

The air-void parameter results for core nos. D2, D4, and D6 (as highlighted in Table 3) do not meet CSA A23.1 specification limits for frost resistant concrete. It should be noted that the concrete represented by these three core samples was obtained from the original construction of the bridge deck.

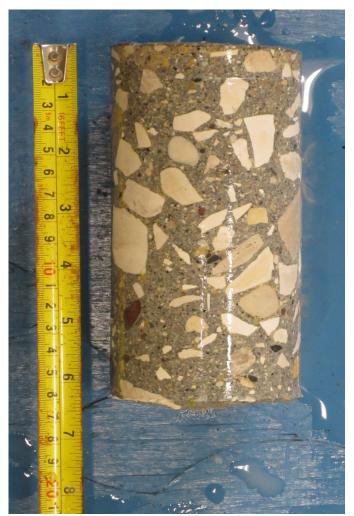
Figure 27 - Core no. A7, west abutment

Core No.	Core Identification		Depth from	Chloride Content	
	Structure	Location	Surface (mm)	(% by mass of concrete)	
A7	West Abutment	East face of abutment, 1.1 m south of 6 <sup>th</sup> girder from north side, 0.4 m from bearing seat	50 to 60	0.292
