**RED RIVER – NORTH DRIVE**

**AQUATIC HABITAT ASSESSMENT**

October 2018

**North/South Consultants Inc.**  
Aquatic Environment Specialists

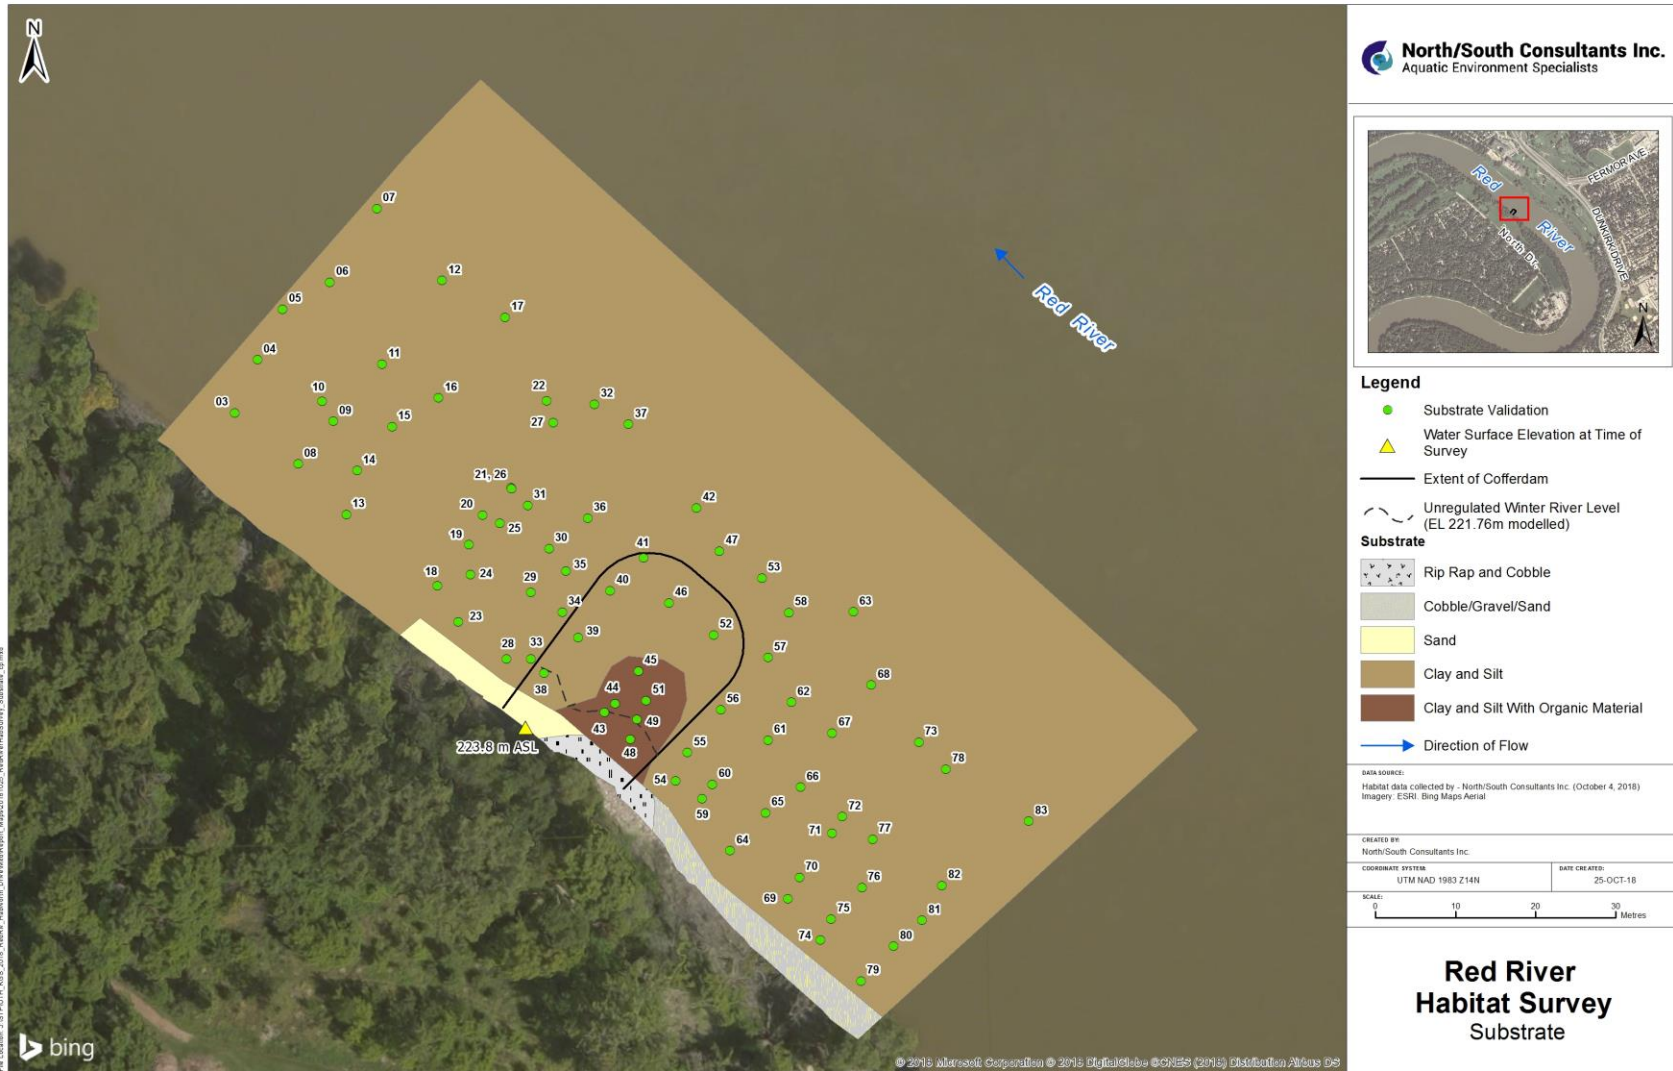
Figure 3. Substrate map of the Red River North Drive outfall study site.

Substrate classes were divided up into five different classes based on primary, secondary and tertiary substrates. Substrate in the entire Study Area reach was largely comprised of clay and silt (Photo 13); clay and silt accounted for 94% of the substrate composition in the Study Area. Clay and silt with organics accounted for 2% of the substrate and in the near-shore area cobble/gravel/sand, rip rap and cobble, and sand accounted for 2%, 1% and 1% respectively. In the area where there was clay and silt with organics there was harder substrate (cobble/gravel) beneath the fine sediments but was not captured in the acoustic data and was not seen in the side-scan imagery of the data collection. A substrate map is presented in Figure 3. Substrate validation results are presented in Table 1. Locations of grabs, photos, and survey transects are presented in Figure 4.

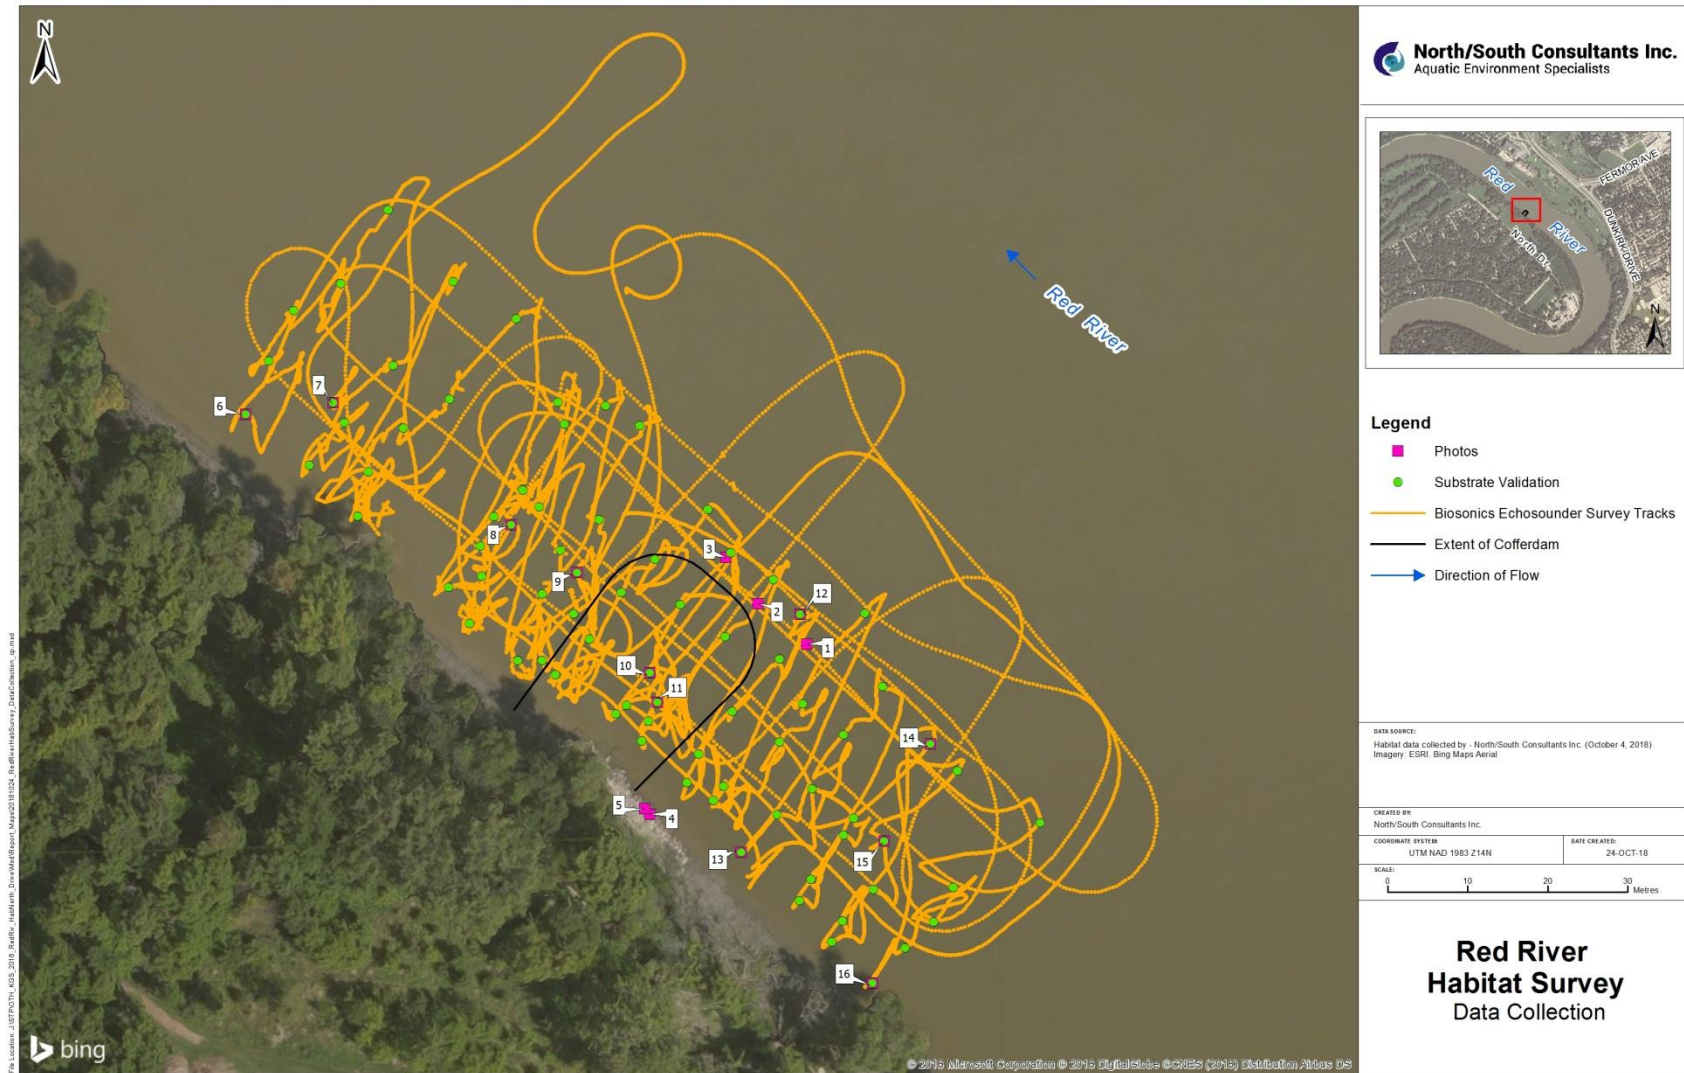
Figure 4. Substrate validation results showing ponar locations and GPS tracks at the Red River North Drive outfall study site.

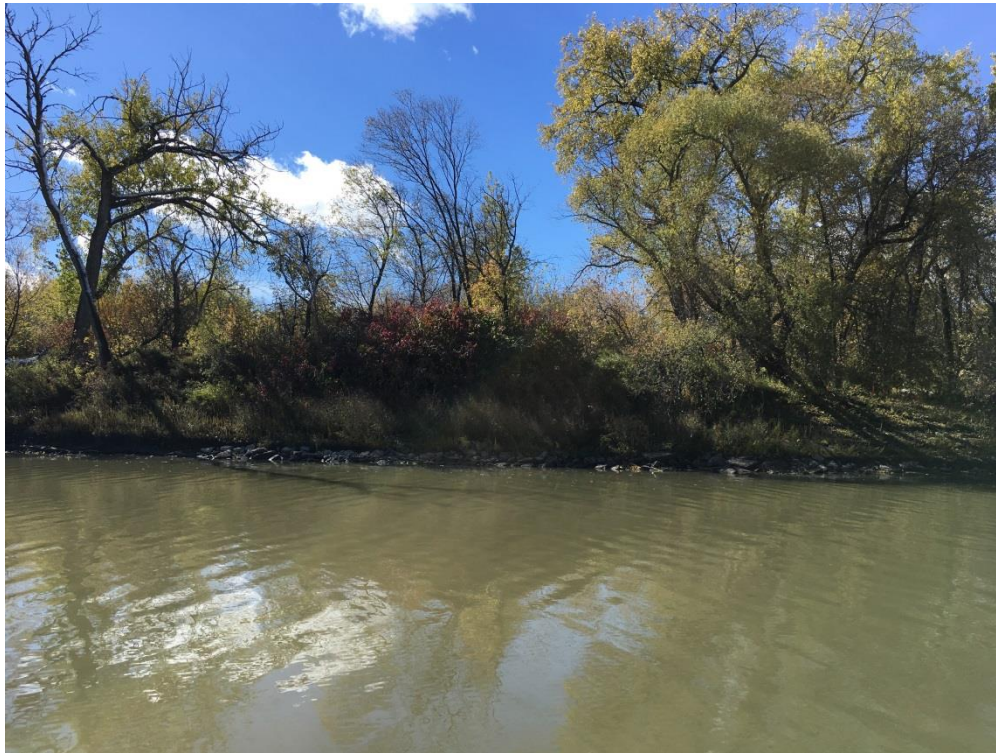
Photo 1. Site photo at the Red River – North Drive outfall site.

The banks of the Red River in the Study Area were well vegetated and gently sloped in most areas (Photos 1-5). Riparian vegetation consisted primarily of deciduous grasses, shrubs and trees. Flow conditions were low with some observable current. Instream substrate consisted mostly of a mix of clay and silt (Photos 6-15) with a small area of clay and silt with organic material (Photo 16), and near-shore areas of sand (Photo 17), cobble/gravel/sand (Photo 18) and rip rap and cobble (Photo 4).

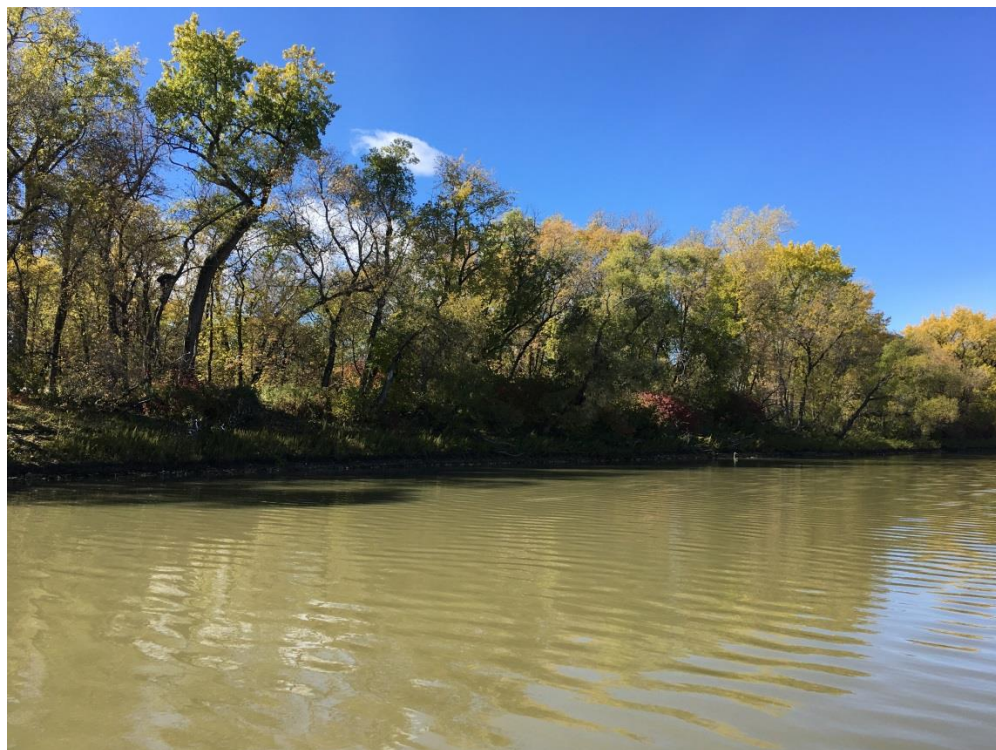
Photo 2. North Drive outfall site showing the downstream extent of the study site.

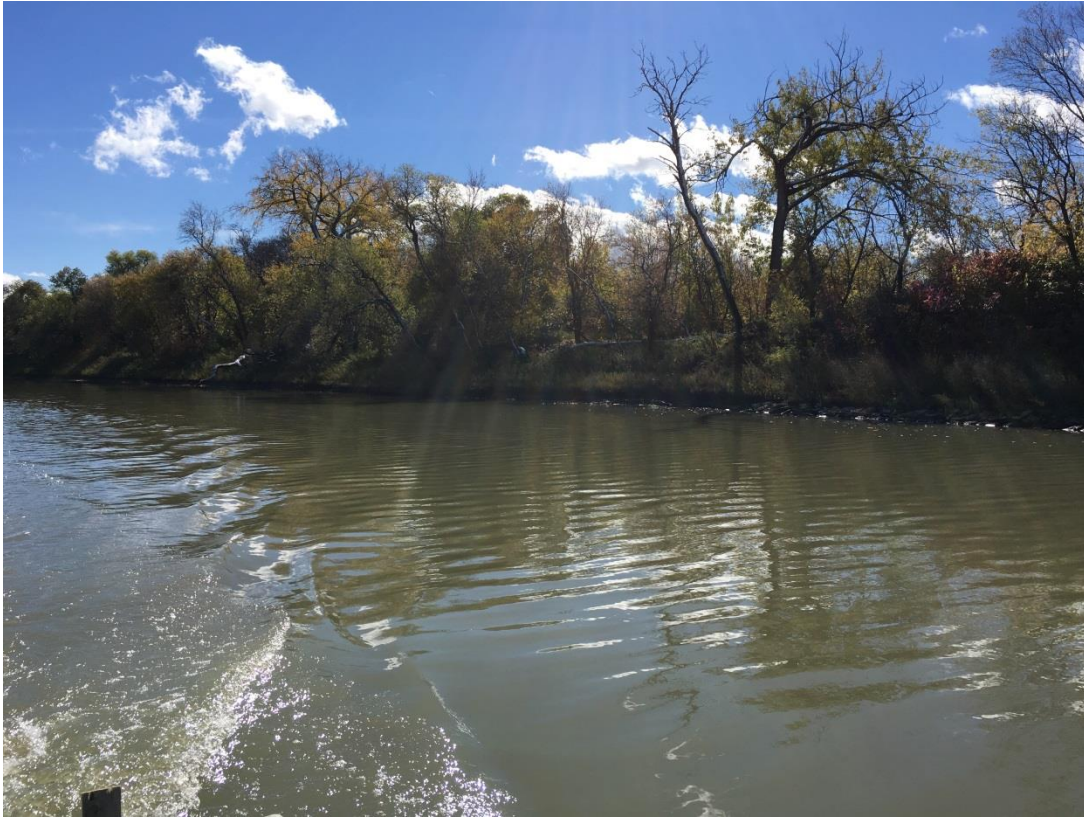
Photo 3. North Drive outfall site showing the upstream extent of the study site.

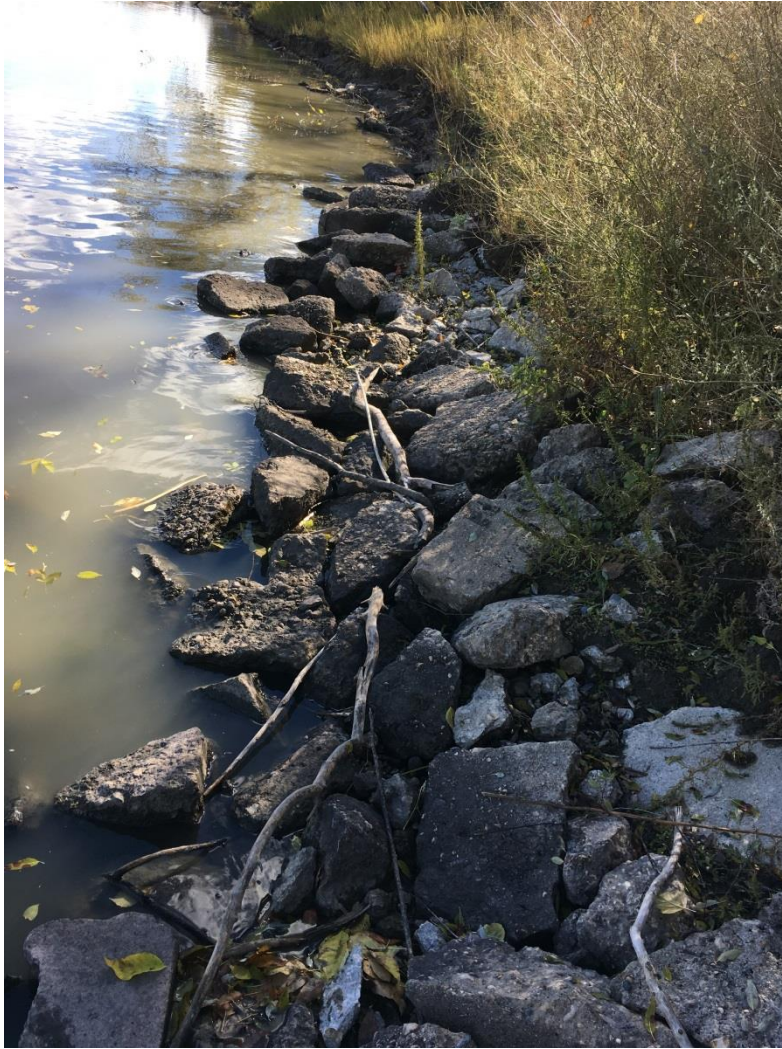
Photo 4. North Drive outfall site showing shoreline around the outfall (photo taken looking upstream).

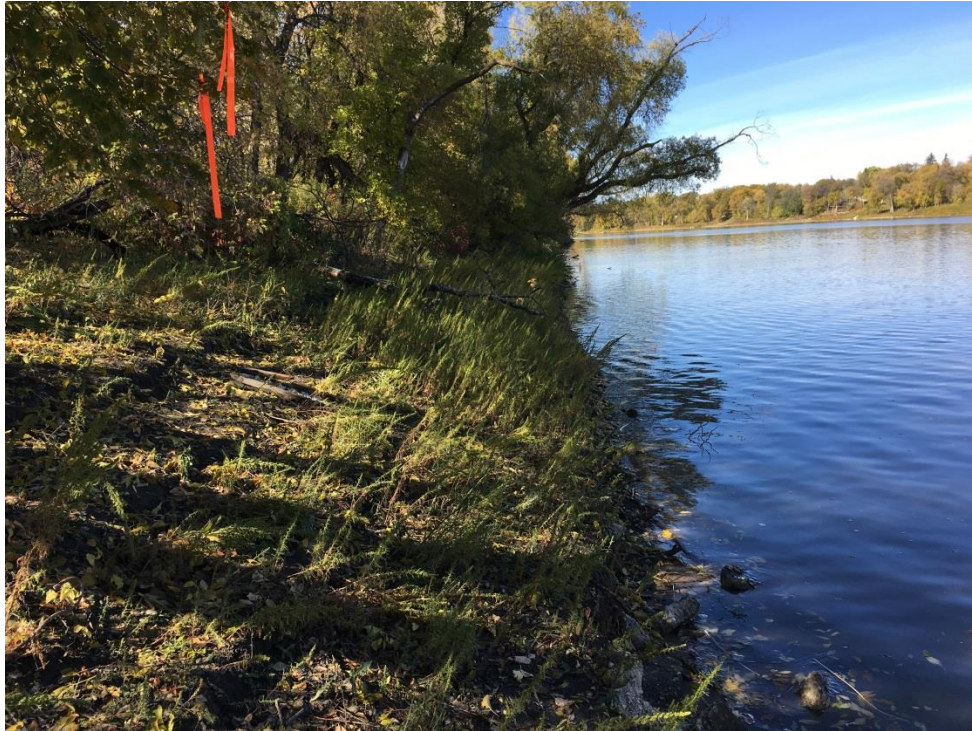
Photo 5. North Drive outfall site showing shoreline around the outfall (photo taken looking downstream).

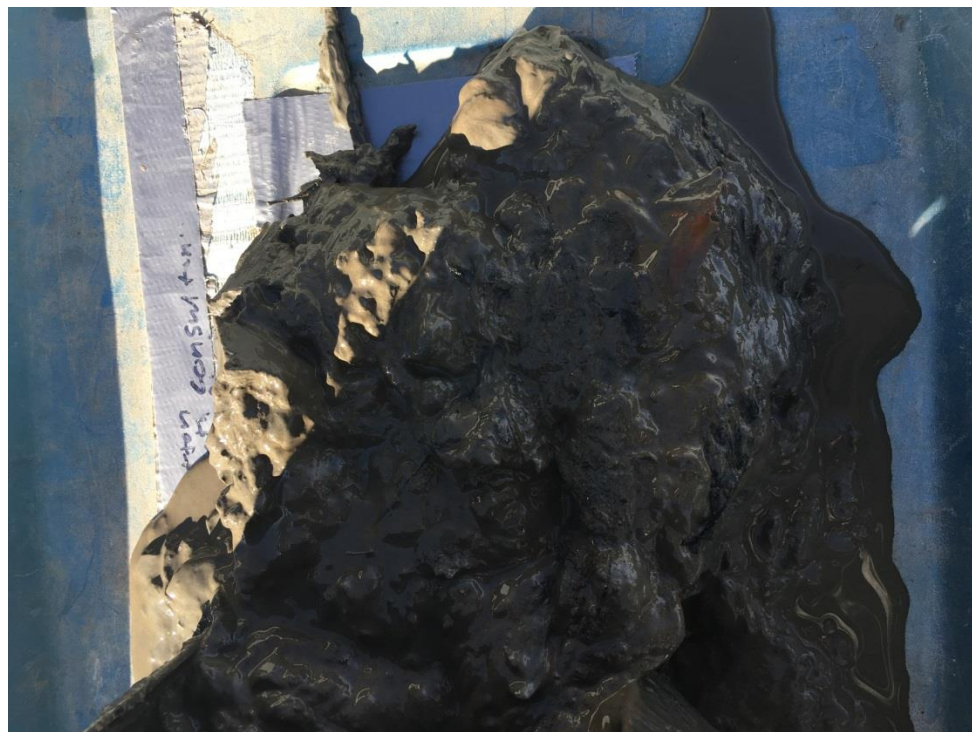
Photo 6. Substrate validation from site T1-5m showing a mix of soft clay/silt.

| Transect | Distance from Shore (m) | Substrate | | | Photo # | Waypoint ID | UTM (14U) | | Comments |
|---|---|---|---|---|---|---|---|---|---|
| T1 | 5 | Clay | Silt | - | Photo 6 | RrW003 | 634726 | 5523537 | - |

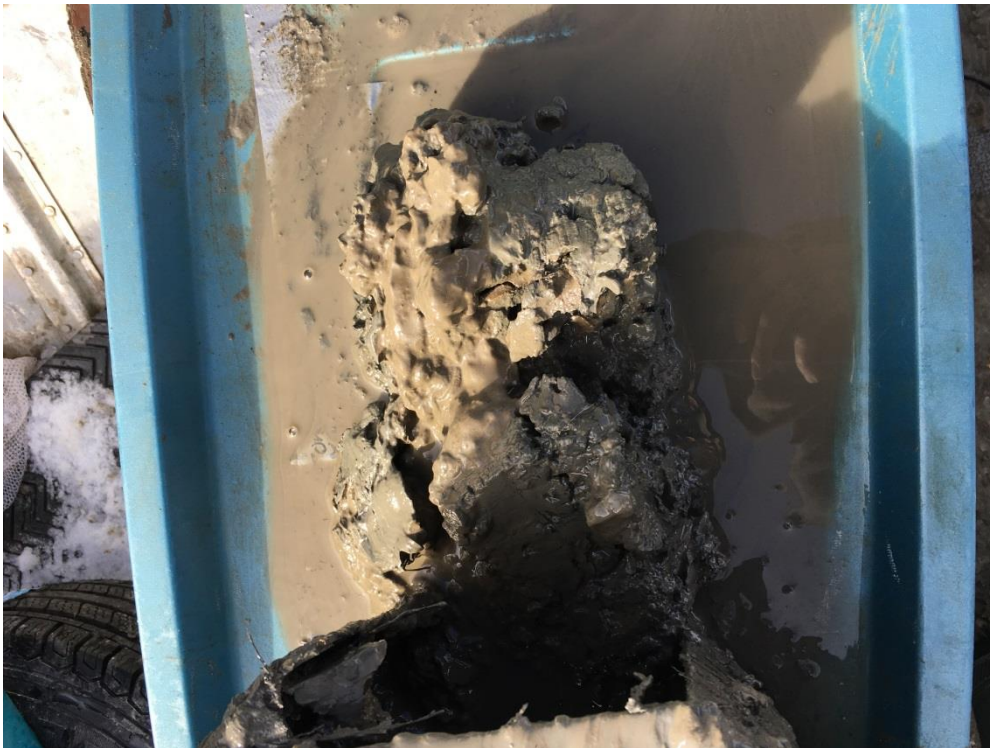
Photo 8. Substrate validation from site T5-15m showing a mix of soft clay/silt.

| Transect | Distance from Shore (m) | Substrate | | | Photo # | Waypoint ID | UTM (14U) | | Comments |
|---|---|---|---|---|---|---|---|---|---|
| T5 | 15 | Clay | Silt | - | Photo 8 | RrW025 | 634759 | 5523523 | - |

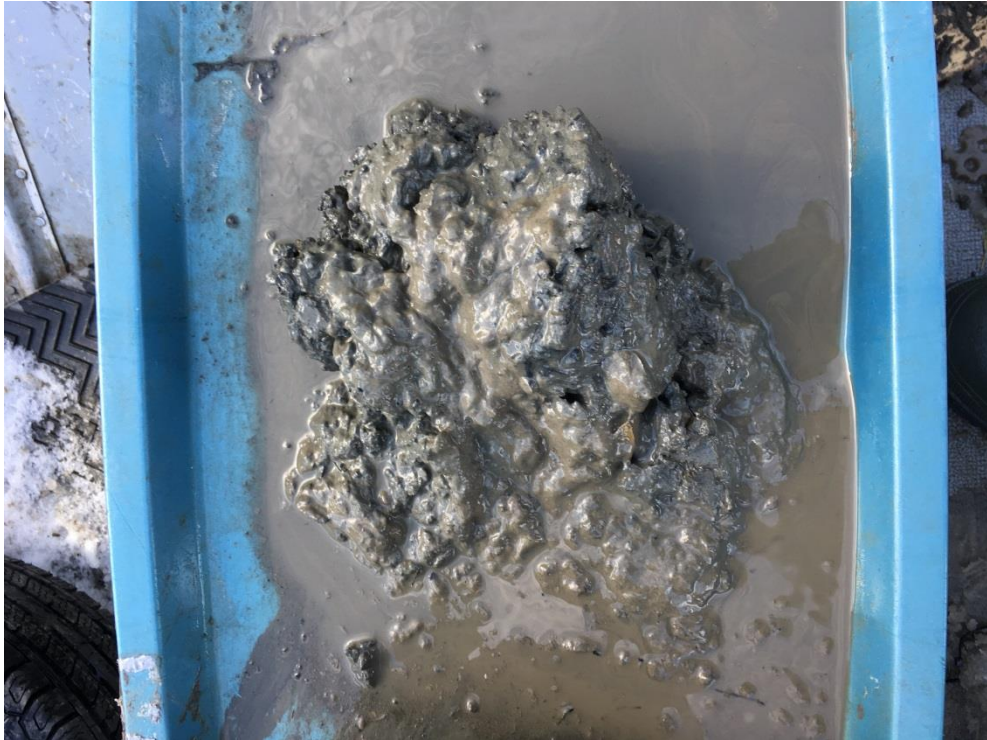
Photo 9. Substrate validation from site T7-15m showing a mix of soft clay/silt.

| T7 | 15 | Clay | Silt | - | Photo 9 | RrW035 | 634767 | 5523517 | - |

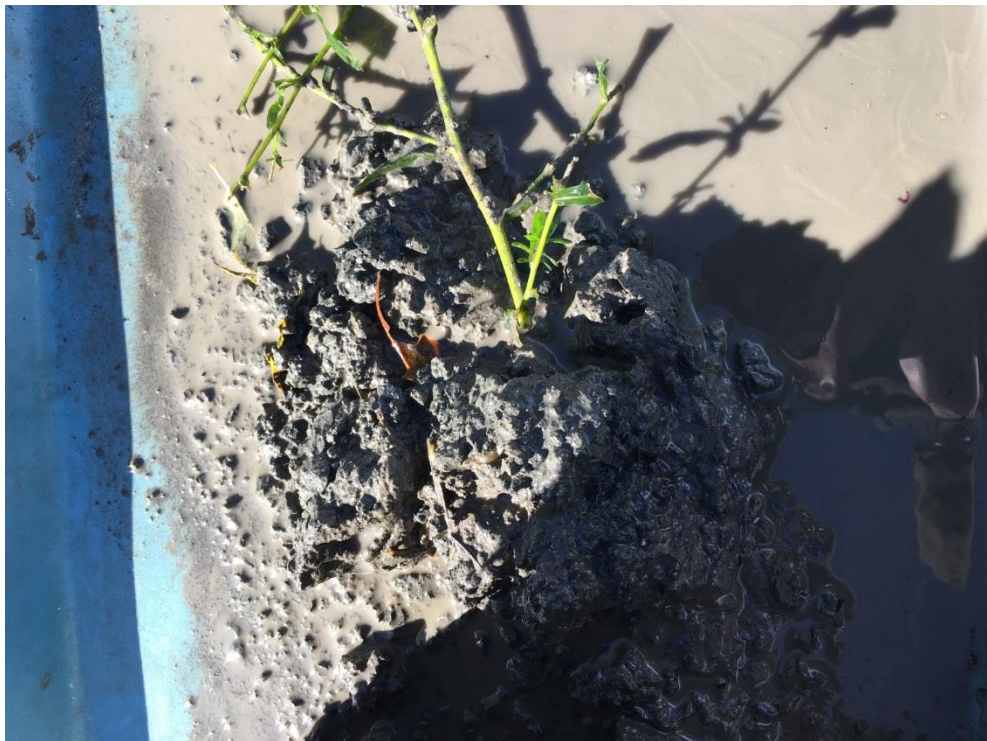
Photo 10. Substrate validation from site T9-15m showing a mix of soft clay/silt and organic material.

| T9 | 15 | Clay | Silt | OM | Photo 10 | RrW045 | 634776 | 5523505 | - |

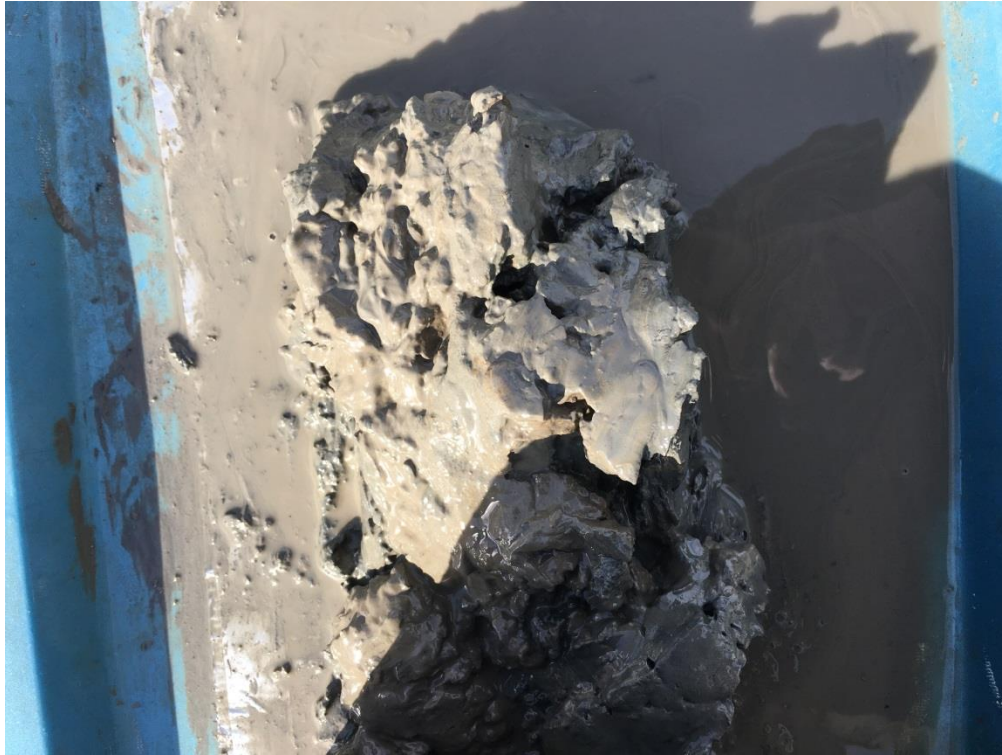
Photo 11. Substrate validation from site T11-30m showing a mix of soft clay/silt.

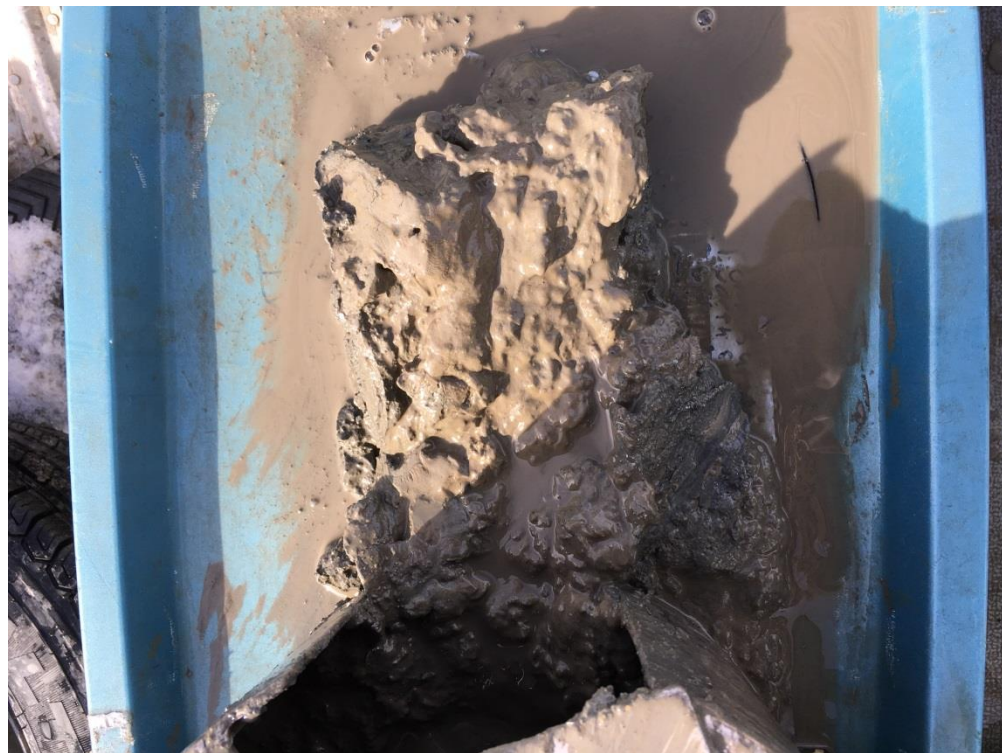
Photo 12. Substrate validation from site T13-5 showing a mix of soft clay/silt

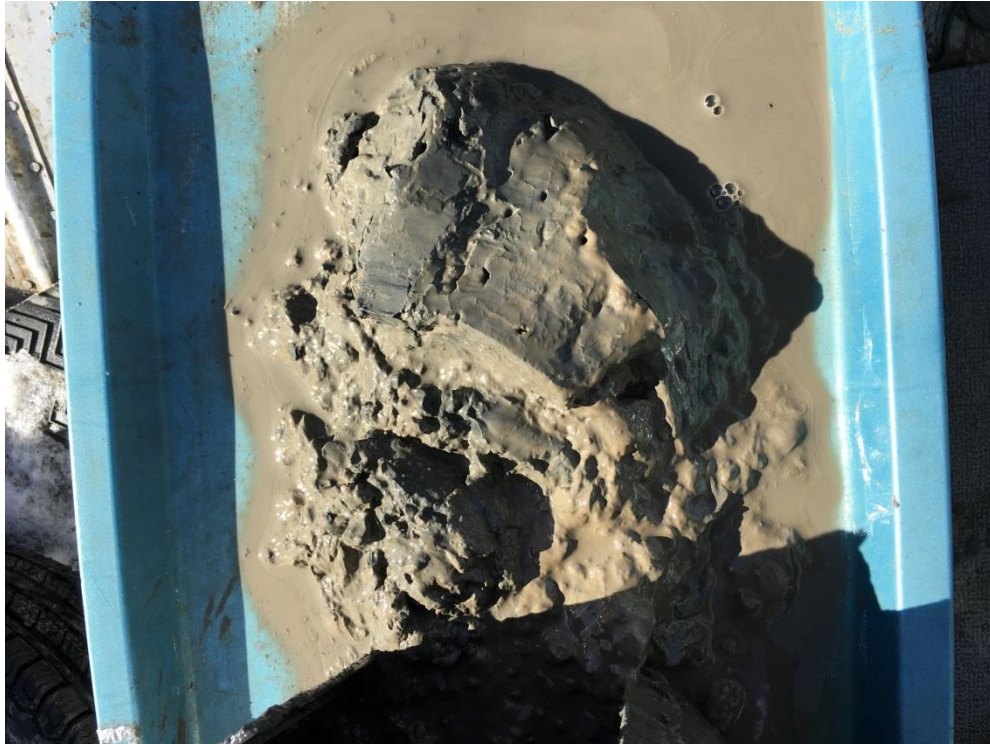
Photo 13. Substrate validation from site T14-30 showing a mix of soft clay/silt.

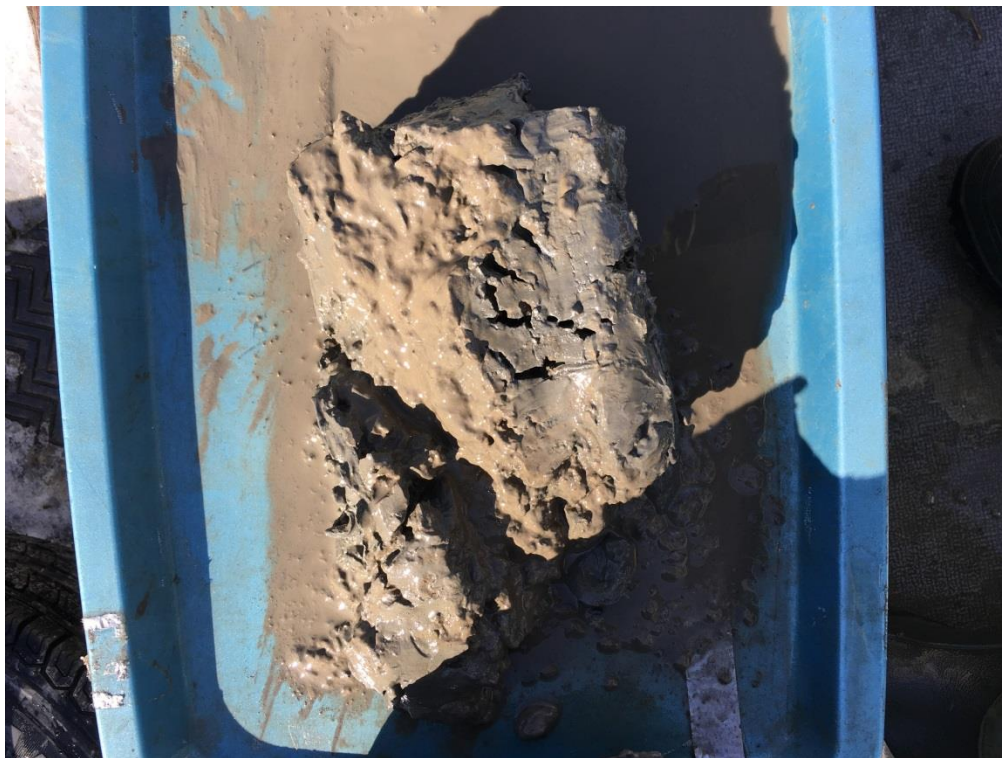
Photo 14. Substrate validation at site T15-20m showing a mix of soft clay/silt.

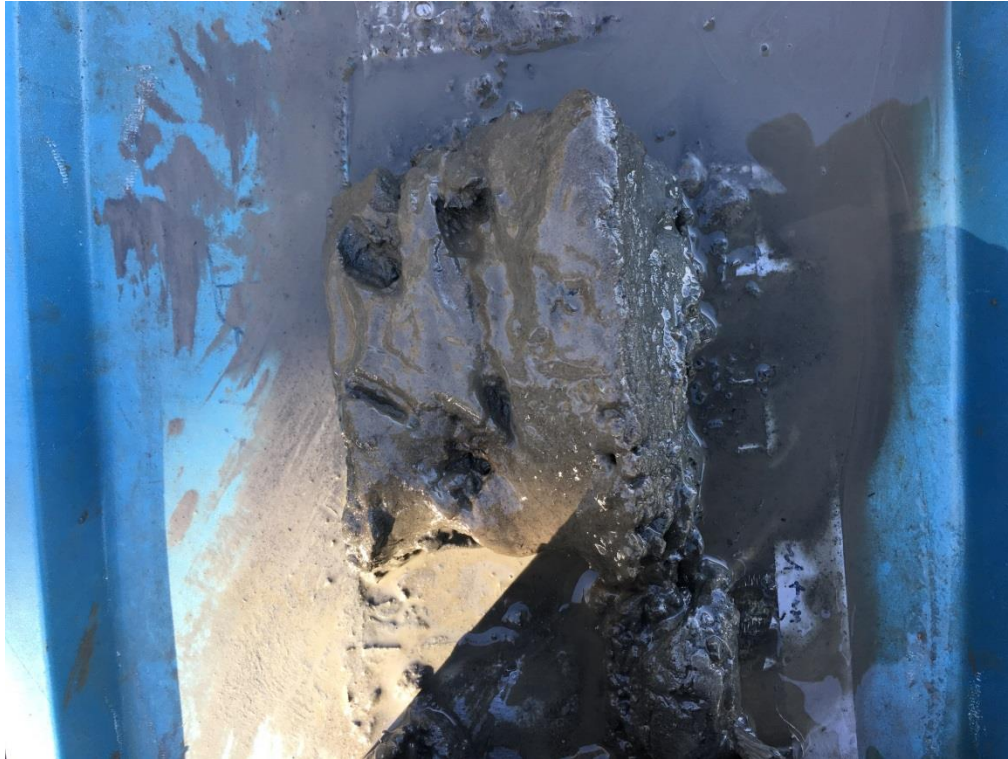
Photo 15. Substrate validation at site T16-5m showing a mix of soft clay/silt.

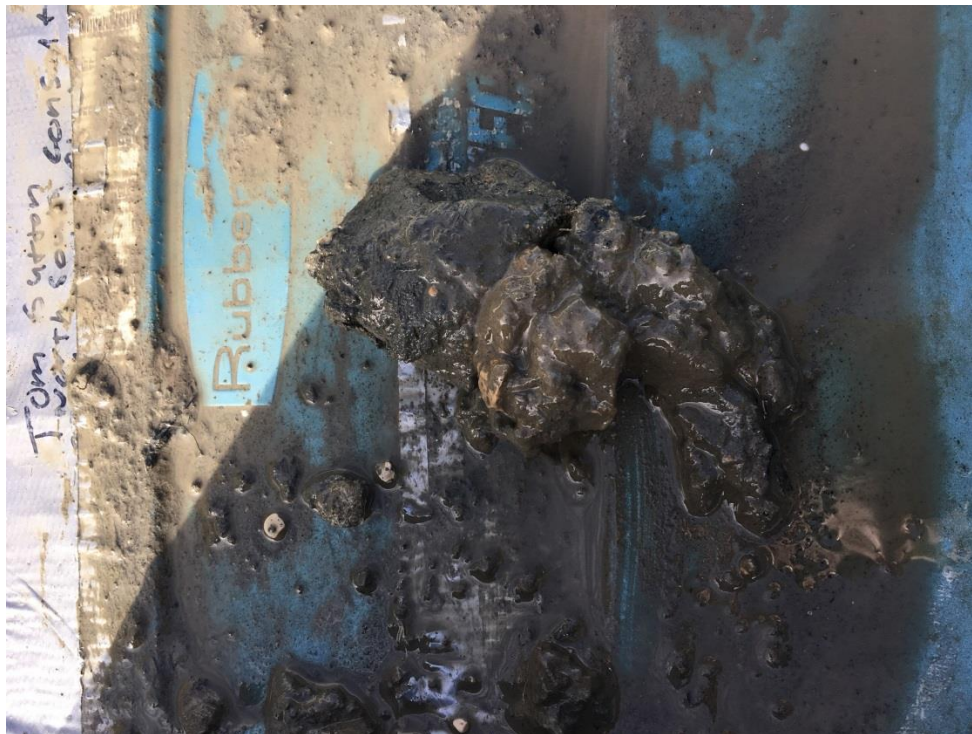
Photo 16. Substrate validation from site T10-15m showing a mix of clay, cobble, gravel.

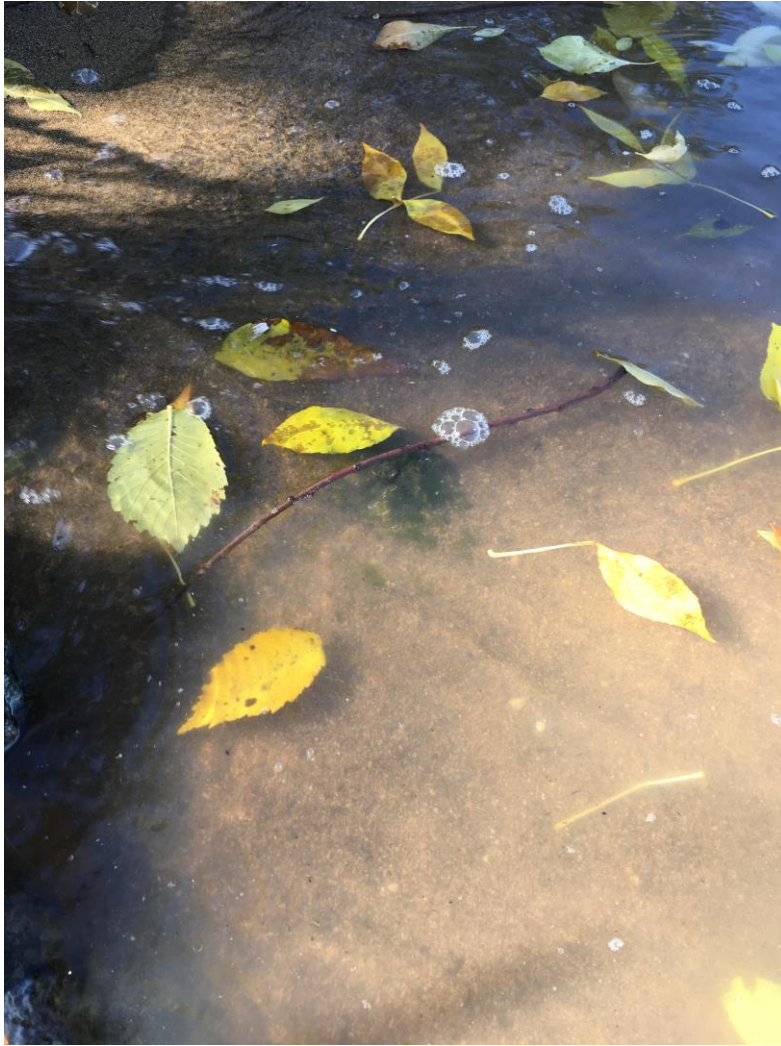
Photo 17. Substrate in the near-shore area consisting of sand.

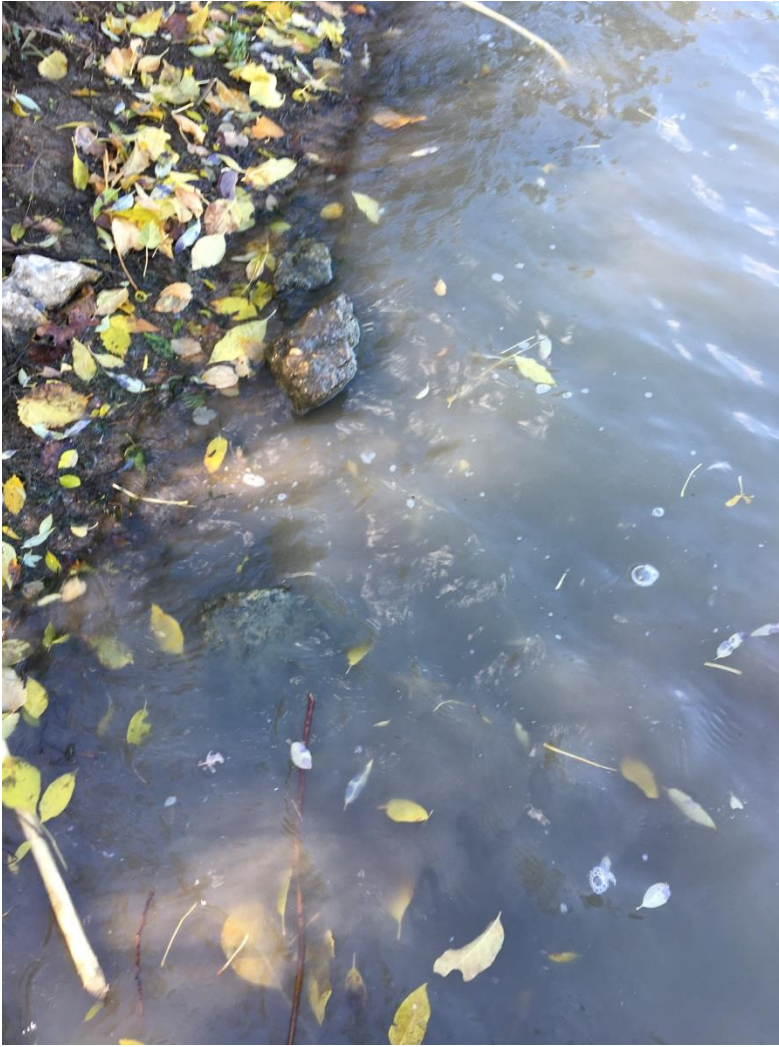
Photo 18. Substrate in the near-shore area consisting of cobble/gravel/sand.
