Figure 1: Metro Route 90 Underpass Pumping Station – Pump 1 Motor with Oil Lubricator (Top Left)

Figure 2: Metro Route 90 Underpass Pumping Station – Pump 2 Motor and Gear Drive

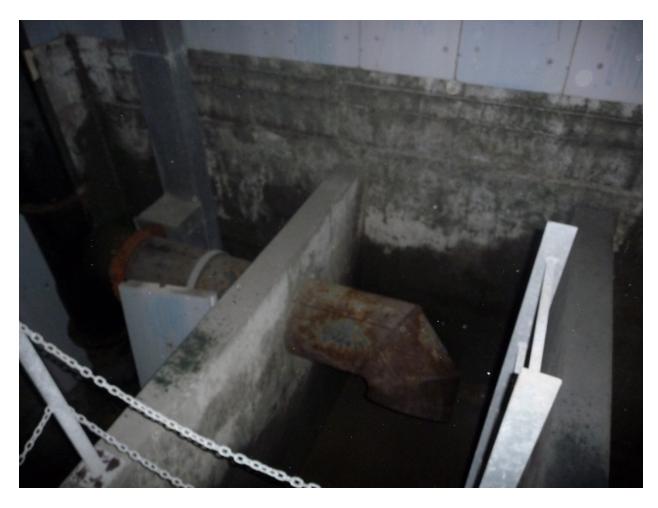
Figure 12: Metro Route 90 Underpass Pumping Station – Pump 2 Discharge Elbow

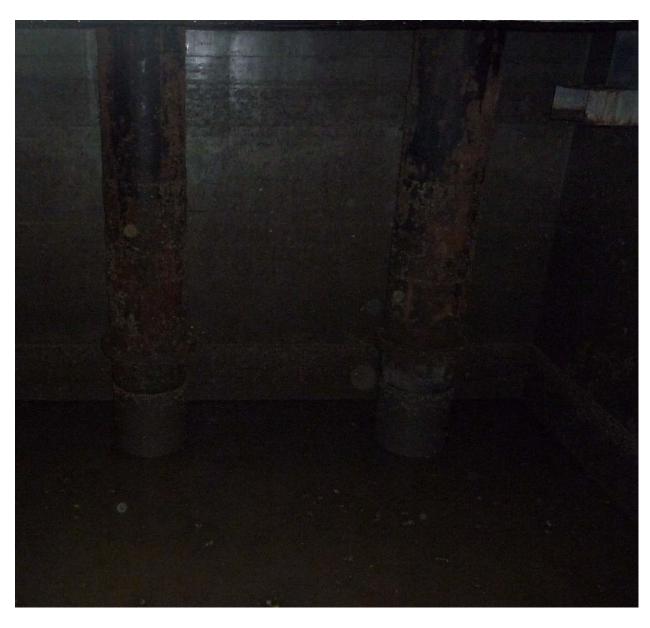
Figure 13: Metro Route 90 Underpass Pumping Station – Pump 1 and 2 Lower Columns
