# Asbestos Assessment

Council Building – Print Shop  
510 Main Street, Winnipeg, Manitoba

March 17, 2016

Pinchin File: 111454.038

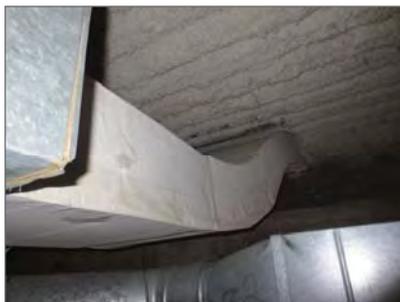
Ducts in the assessed area are insulated with fibreglass. Parging cement containing chrysotile asbestos is present over the fibreglass at edges, seams and pins. Parging cement is a friable insulation, jacketed with canvas and is in good condition (Samples 0006 A-C).

Duct Insulation

Material and Quantity	Location	Recommended Procedure
Duct Insulation	Above Ceilings	Type III
Black Mastic Sealant on HVAC Insulation	Above Ceilings	Type I
Pipe Insulation	Above Ceilings and Pipe Chases	Type II
Cementitious Firestopping	Pipe Chases	Type II
Spray-on Insulation	Structural Beams and Cellular Steel Floor Deck	Type III

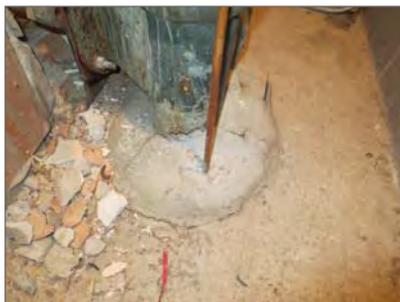
Firestopping, cross contaminated with asbestos, is present at pipe penetrations in women's washroom pipe chase (Samples 0008 A-C).

The firestopping is a non-friable material and is in good condition.

Asbestos Contaminated Firestopping

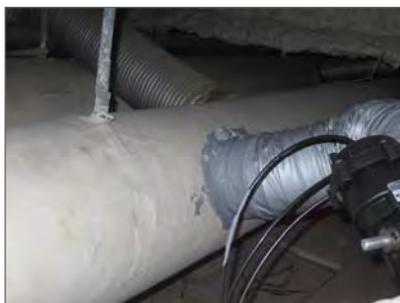
Grey Mastic applied to HVAC insulation within ceiling spaces was determined not to contain asbestos (Samples 0009 A-C).

Grey Mastic, Non-asbestos Containing

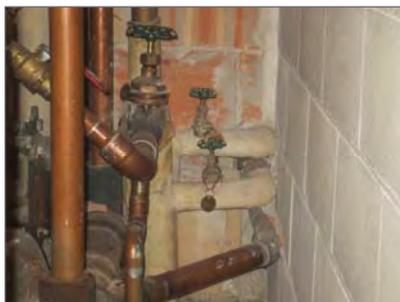
Fire brick within pipe chase was determined not to contain asbestos (Sample S0007).

Non-Asbestos Firebrick

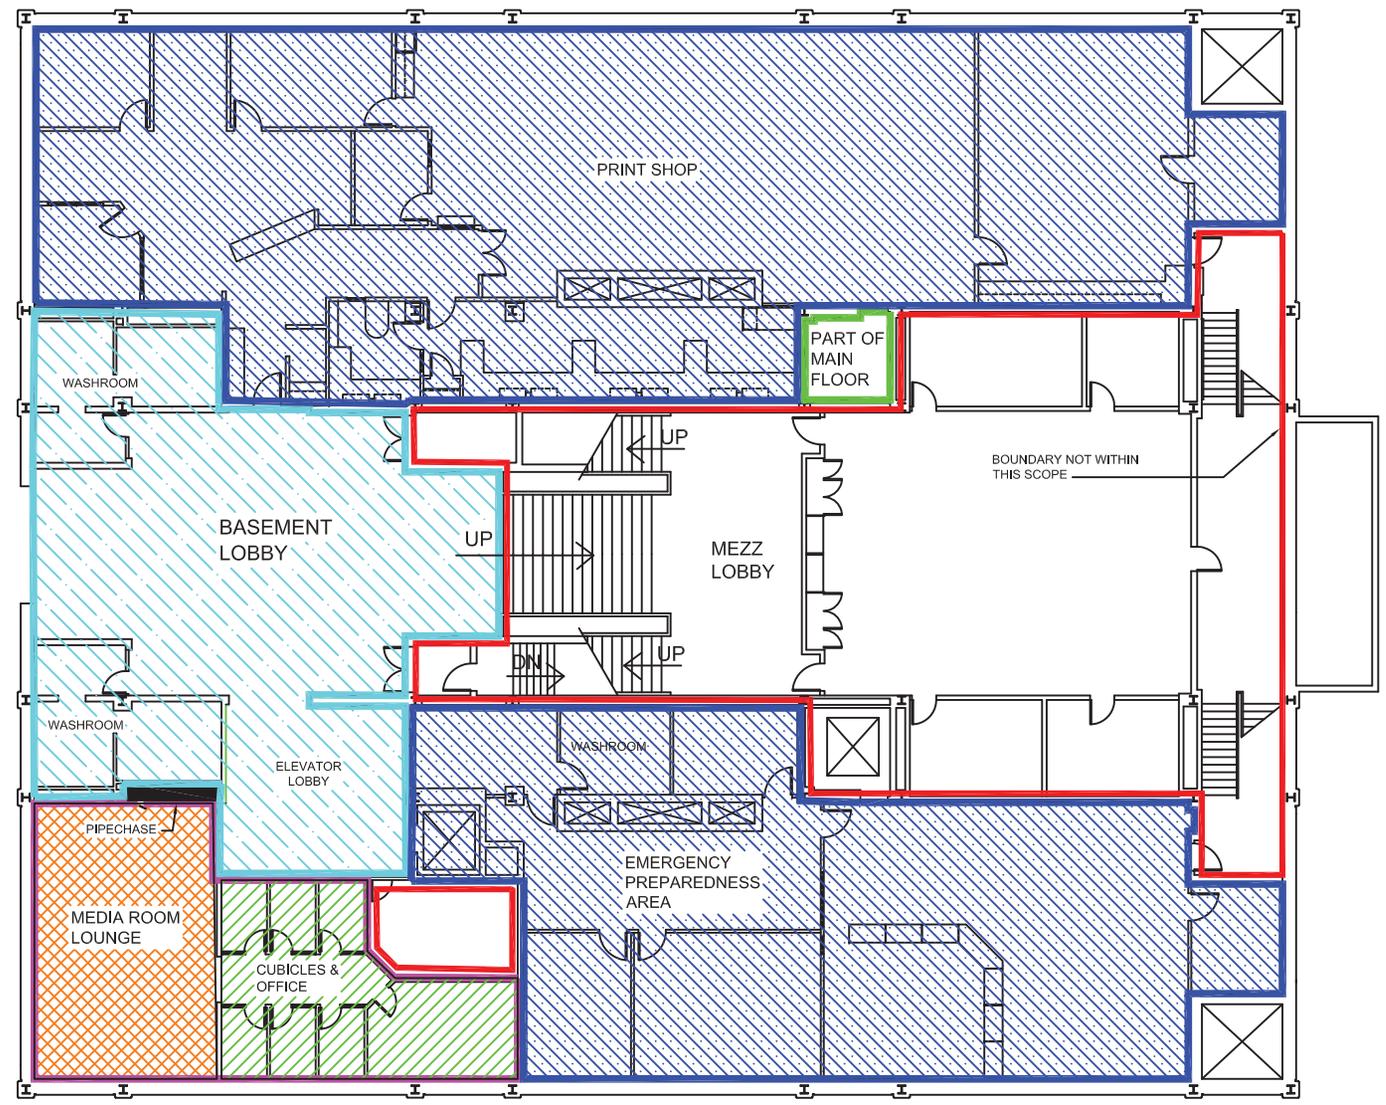
ASBESTOS INVENTORY			
BUILDING:		CB-60 COUNCIL BUILDING 510 MAIN STREET WINNIPEG, MANITOBA	
REVISED BY:	DATE:	SCALE:	SHEET #:
AB	March 17, 2016	N.T.S.

NOTE: PROCEED WITH CAUTION THRU/IN ALL PIPECHASE/PLBG WALLS, ASBESTOS CONTAINING MATERIAL MAY BE PRESENT
