**TYPE 3 REPAIR**

**TYPE 5 REPAIR**

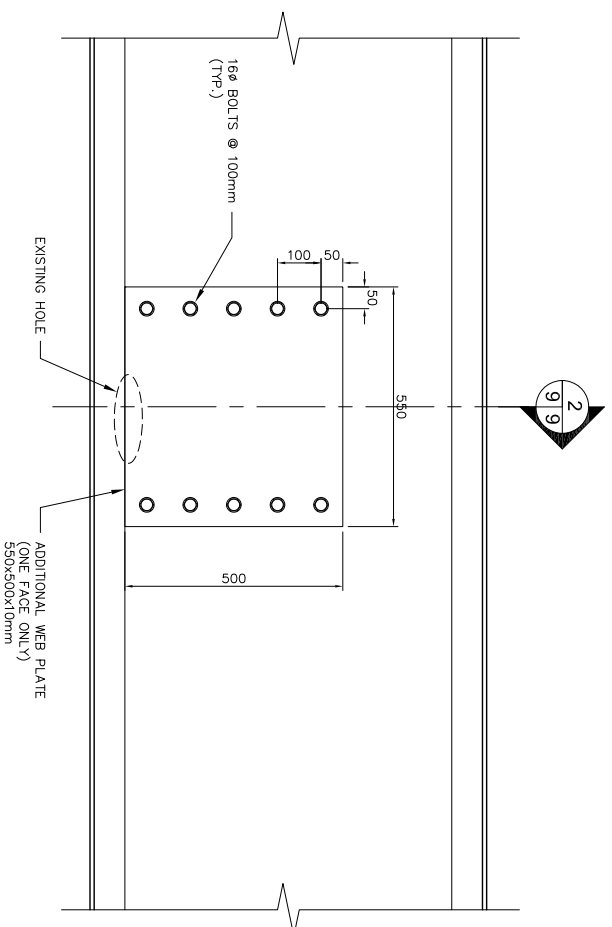
EXISTING CONDITION OF EXTERIOR GIRDER WEB ON SPAN 37

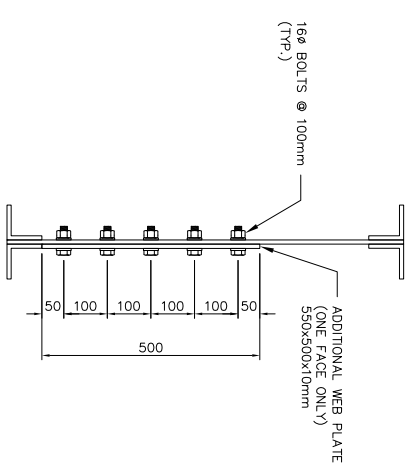
2 CROSS-SECTION OF PROPOSED REPAIR

1 SECTION @ EXTERIOR GIRDER SHOWING WEB REPAIR

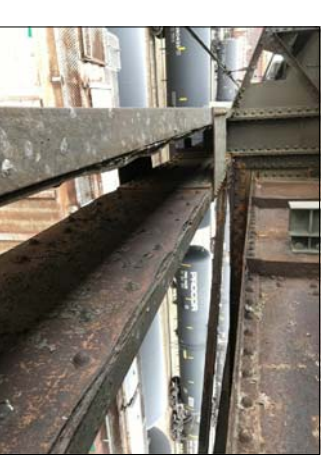
EXISTING CONDITION OF TRUSS BOTTOM CHORD AT SPAN 19 - BAY 4
