City of Winnipeg – Planning, Property and Development

**Riverbank Stabilization along Lyndale Drive–  
Birchdale Ave. to Claremont Ave.  
Preliminary Design Report**

**Project Number:** 0015-038-00

**Date:** November 5, 2020

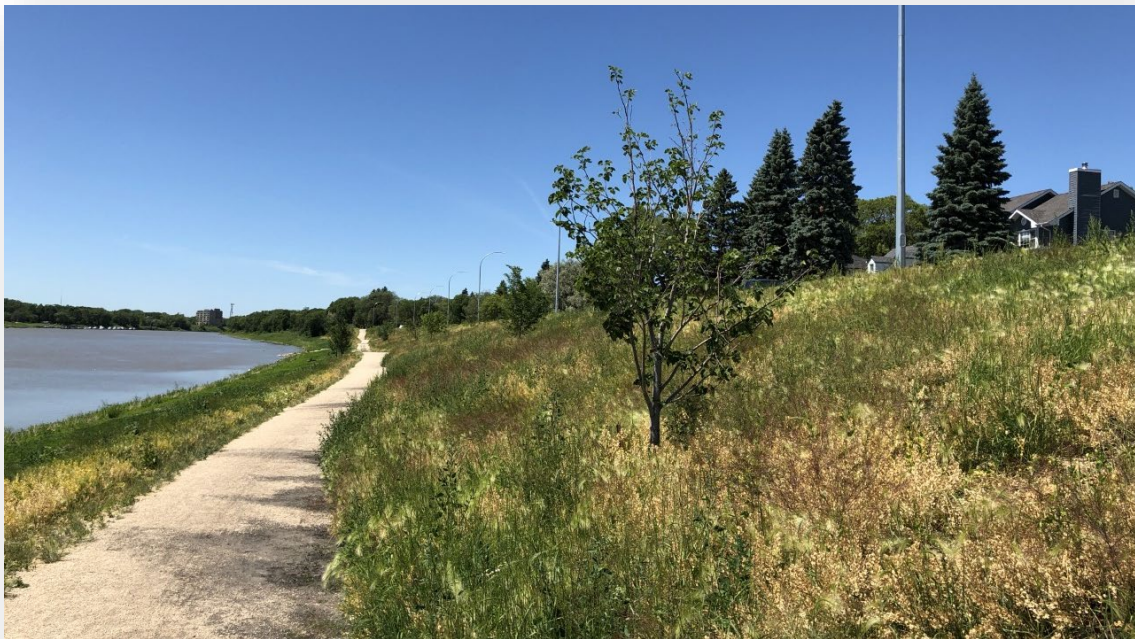
**Photo 1 - Mid-bank pathway / stabilized riverbank from Monck to Gauvin**

In 2013 and 2017, TREK was retained to design emergency and planned slope stabilization works and active transportation improvements from the WW-2 wall (Monck Avenue) upstream to Gauvin Street. This project resulted in stabilization of the 450 m stretch of riverbank with more than 400 rockfill columns, supplemental riprap below the winter ice level, construction of a new 3.0 m wide mid-bank pathway (Photo 1) and widened upper-bank sidewalk, and the decommissioning of the original (1976) timber pile wall.
