## Slope Stabilization of Stormwater Retention Basin (SRB) 6-7 **Geotechnical Investigation and Stability Assessment**

**Project Number:** 0015 035 00

**Date:** April 6, 2021

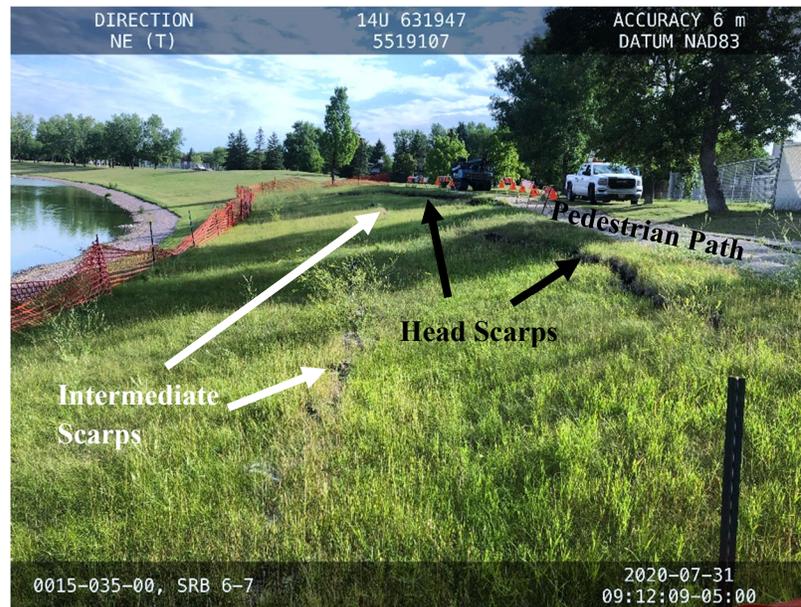
**Photo 01. Looking northeast at the instability**

A site reconnaissance was completed by TREK on January 11 and July 31, 2020 during the sub-surface investigation. The east bank is approximately 4 m high (relative to the basin floor) with an overall slope angle of about 5.5H:1V (Horizontal:Vertical). A plan view of the failure area is shown in Figure 01. The failure is approximately 55 m long defined by discontinuous head scarps up to 0.5 m high near its centre. Numerous smaller intermediate scarps on the bank downslope of the head scarp are visible but there was no visual evidence of a toe bulge above the water line. Photo 01 shows the slope failure and additional site photos are attached in Appendix A.

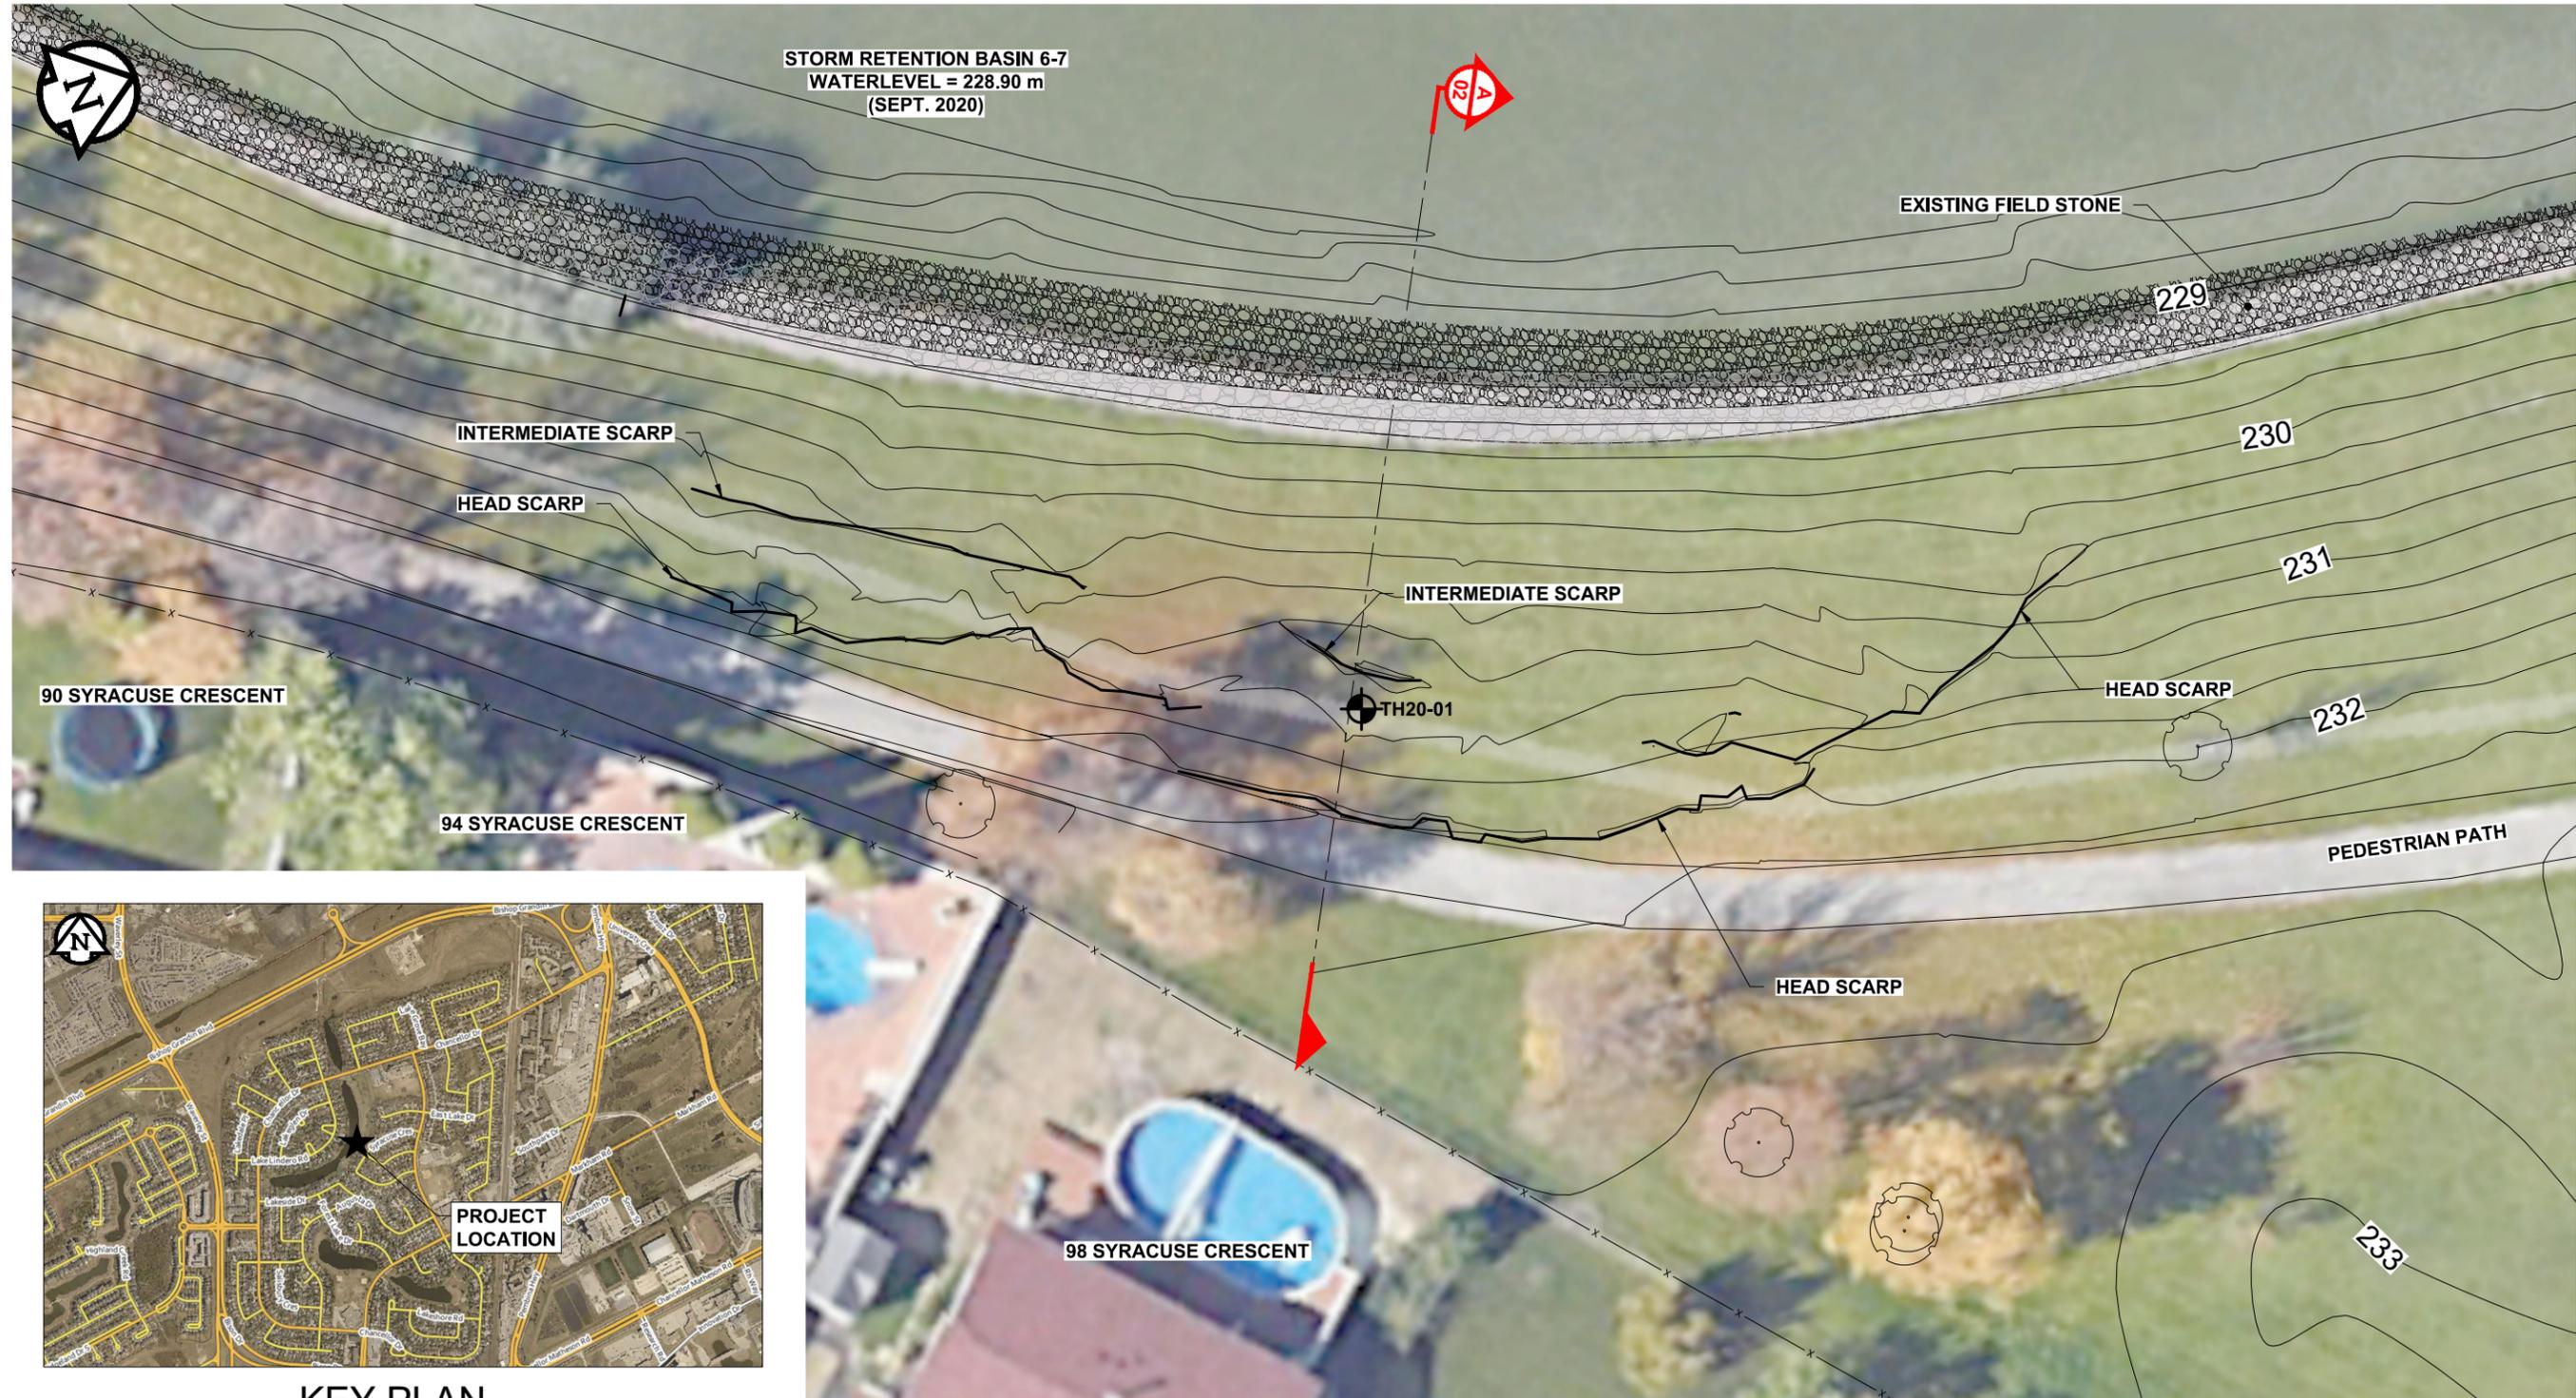
**Figure 01**  
Existing Site Conditions  
Site Plan

A topographic survey was performed on July 31, 2020 by Wanless Geo-Point Solutions Inc. Site features and elevation contours generated from the survey are shown on Figure 01 and a cross-section (Cross-Section A) through the zone of instability is shown on Figure 02.

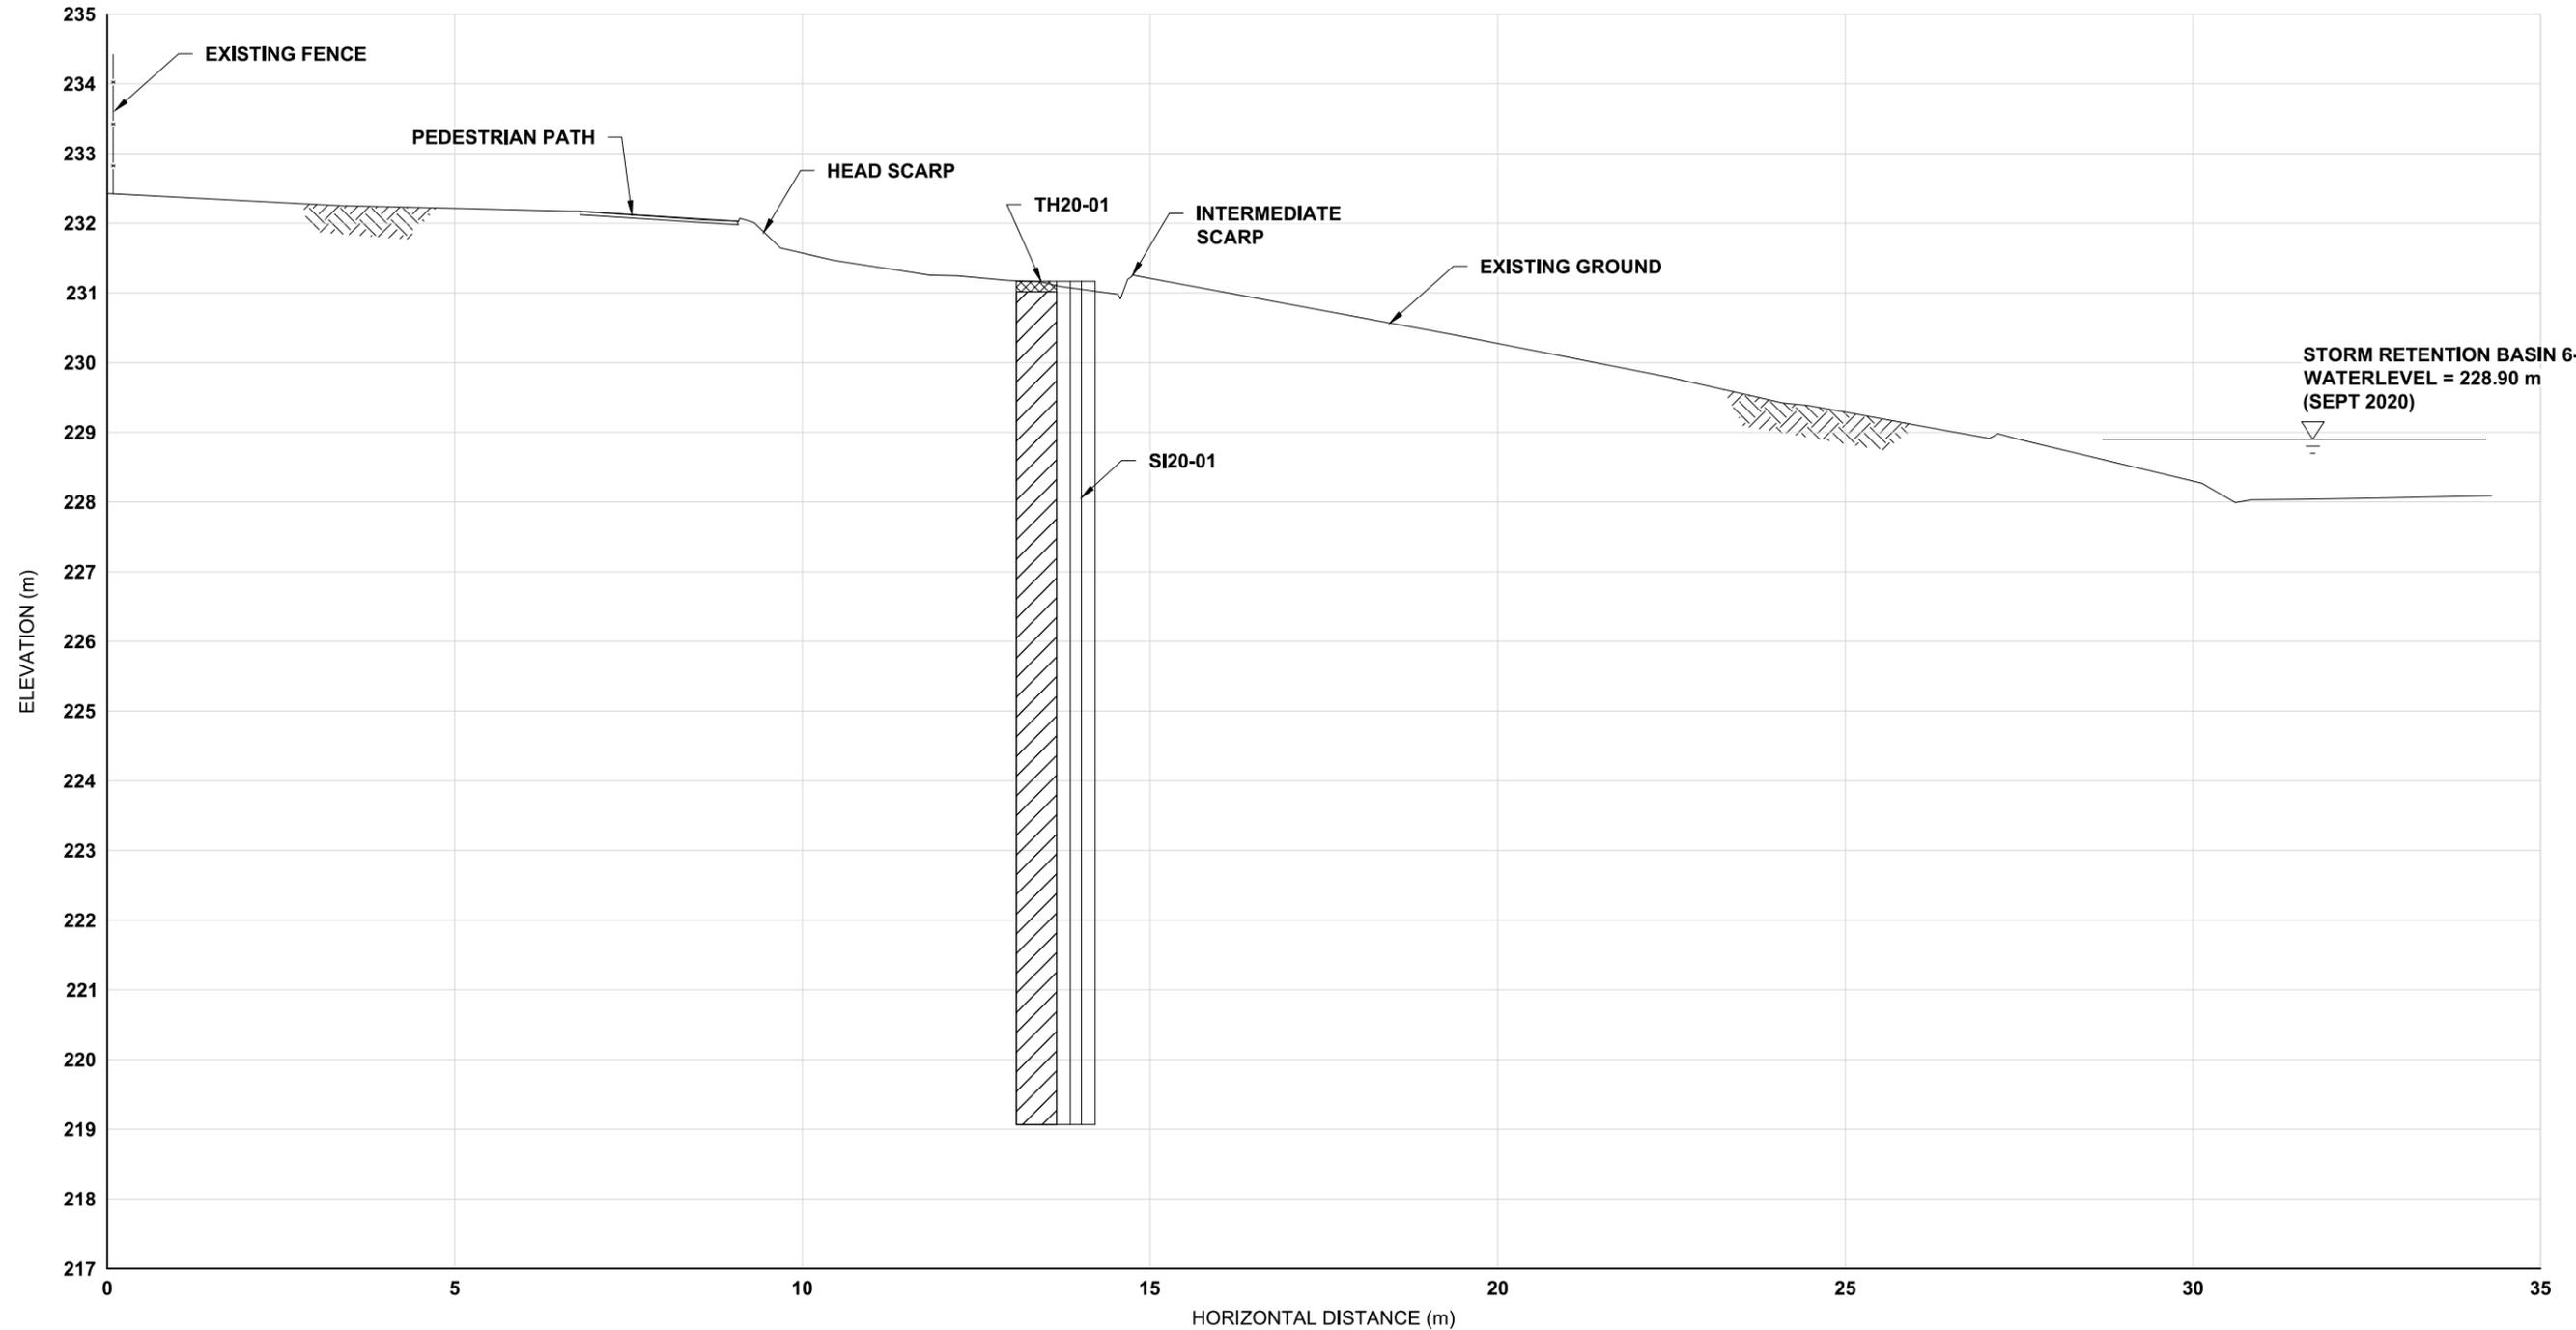
**Figure 02**  
Existing Site Conditions  
Cross Section A

The stability analysis was conducted using a limit-equilibrium slope stability model (Slope/W) from the GeoStudio 2016 software package (Geo-Slope International Ltd.). The slope stability model used the Morgenstern-Price method of slices with the half-sine inter-slice force function to calculate factors of safety, and slip surfaces were identified using a grid and radius slip surface method. A static piezometric line was used to represent GWLs and SRB water levels. Cross-section A was used for the stability analysis.

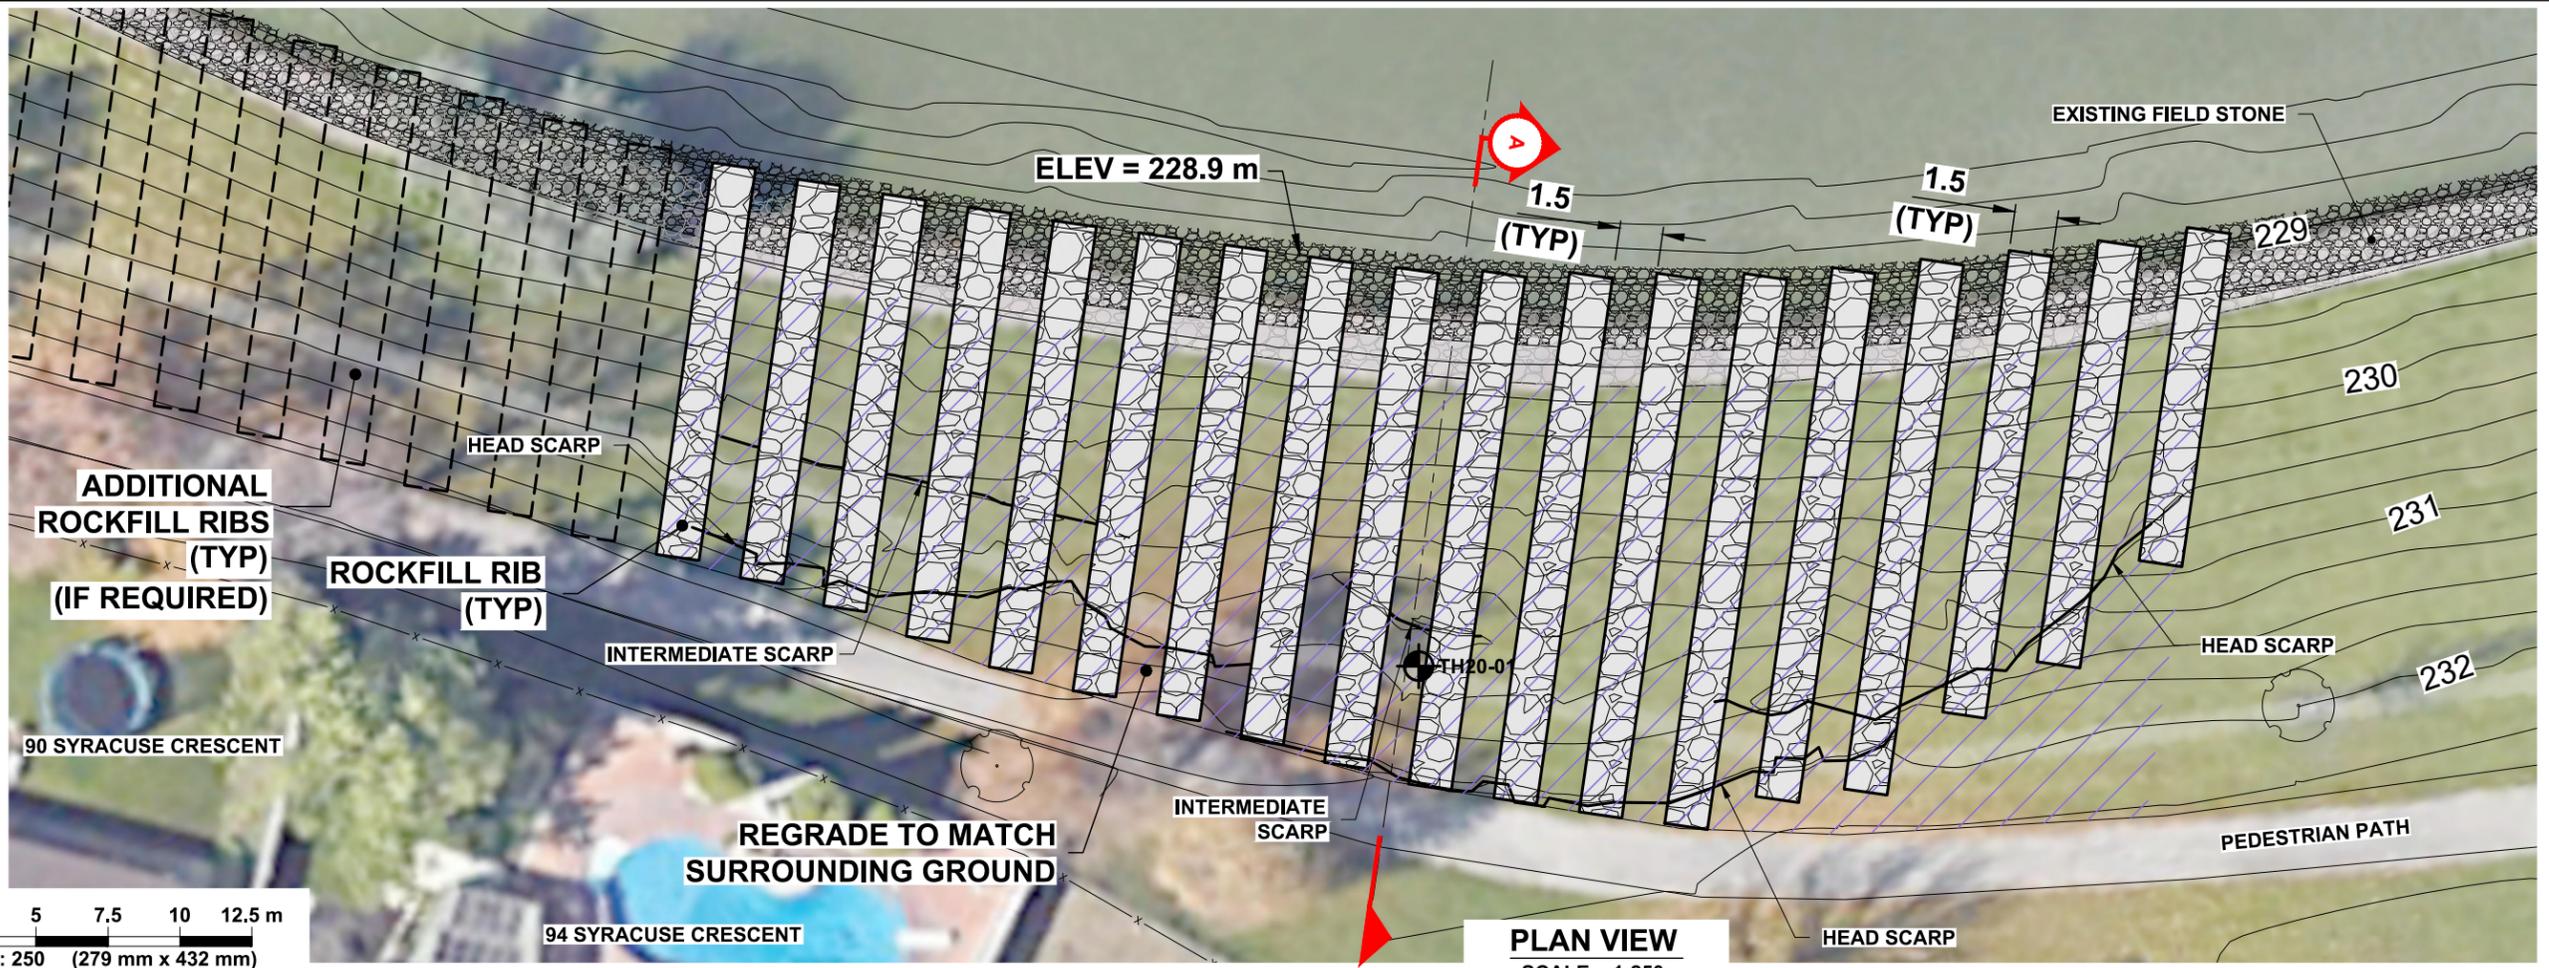
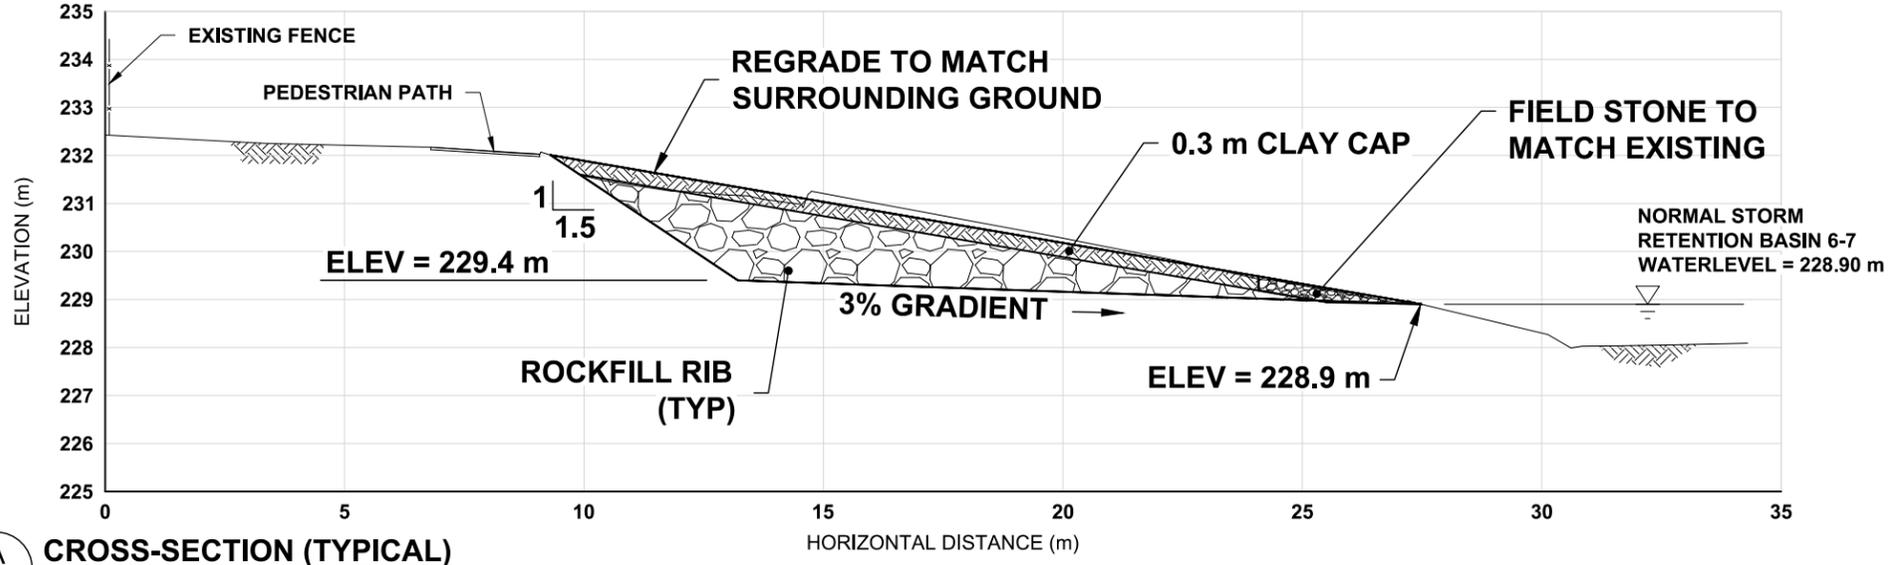
**Figure 03**  
Proposed Stabilization  
Plan and Profile

Rockfill ribs are trenches excavated perpendicular to the slope at a regular spacing and backfilled with compacted granular fill. They provide mechanical stabilization of the lower, mid and upper bank areas and prevent potential re-saturation of the bank through internal drainage, lowering of the GWL within the stabilization zone. In this regard, ribs were numerically analyzed to determine the geometry required to achieve the design objective.

The soil mass within the stabilized zone was analyzed as a composite material consisting of a 1:1 ratio of 100 mm down crushed limestone to weathered clay with the strength properties indicated in Table 01. Various rib geometries were analyzed to determine a configuration meeting the design targets, as shown in the computer outputs D-2 and D-3 in Appendix D. The results of the stability analysis are summarized in Table 02. The recommended rib configuration is shown in Figure 03 and consists of 1.5 m wide ribs, with 1.5 m clear spacing between the ribs, excavated from the outside edge of the head scarp to about EL. 229.4 m and graded at 3% to EL. 229.0 m at the toe of the ribs about 15 m downslope. The 1.5 m spacing is considered necessary to achieve the desired groundwater drawdown effect between ribs and increased shear strength.

The cost estimate is for the construction of eighteen granular ribs and reconstruction of the pedestrian pathway within the segment of the stabilization works. If funding is available, the City may wish to consider adding ribs to the south end of the works where the slope steepens to reduce the likelihood of future extensions of the failure area. The estimated unit cost per additional rib is \$5,000 to \$6,000 assuming they are constructed as part of the stabilization works. A Tender could be written to include additional rib construction in the schedule of prices but left as incremental work to be carried out at the discretion of the Owner (Scope Change).

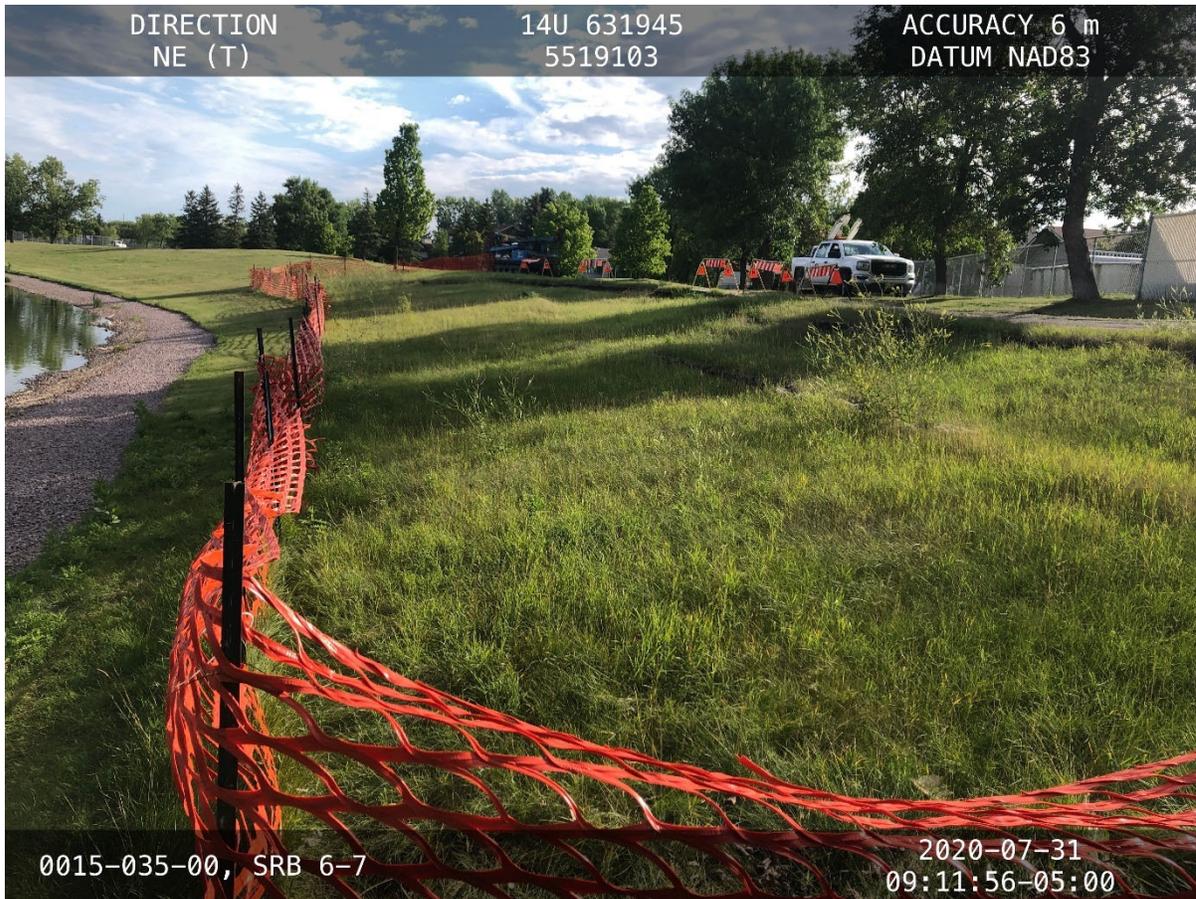
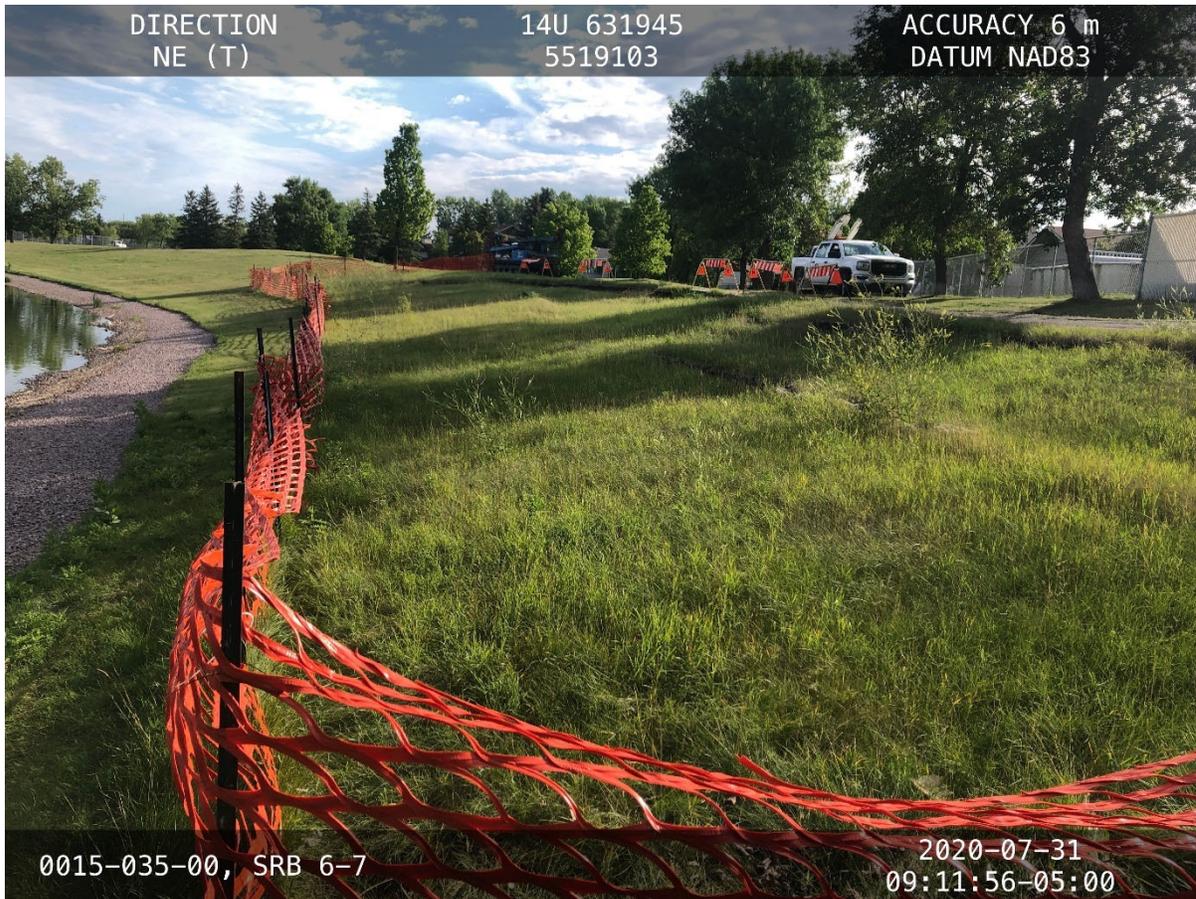
Looking northeast at the instability from toe of bank

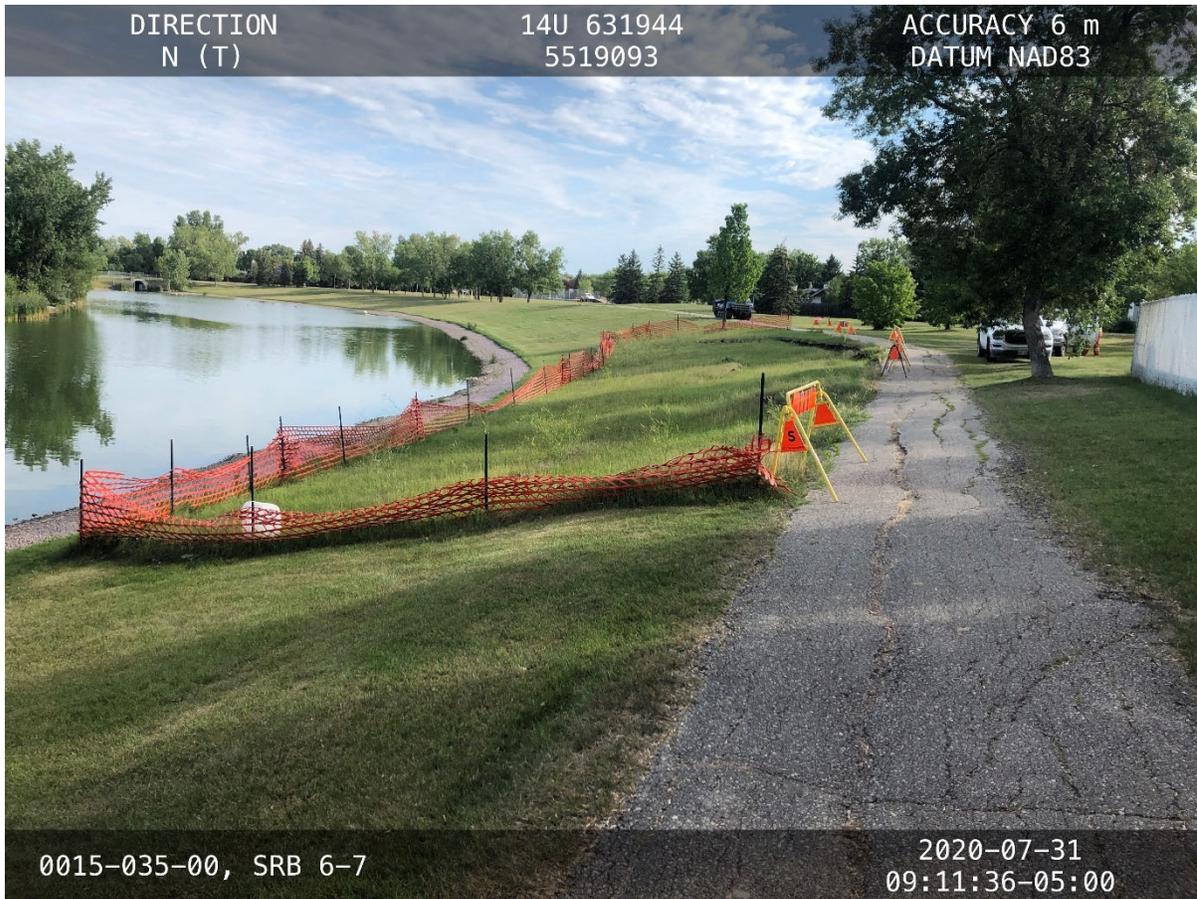
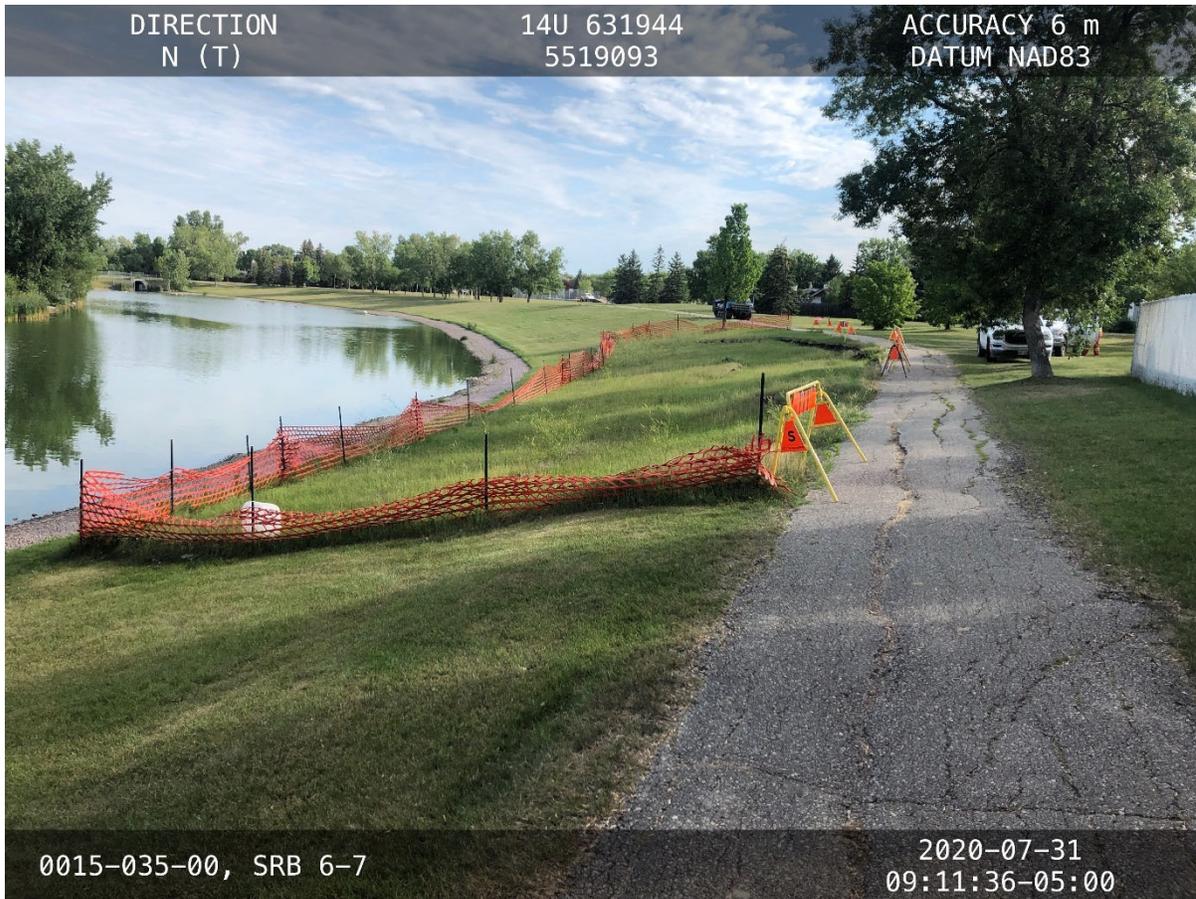
**Looking northeast at the instability from top of bank**

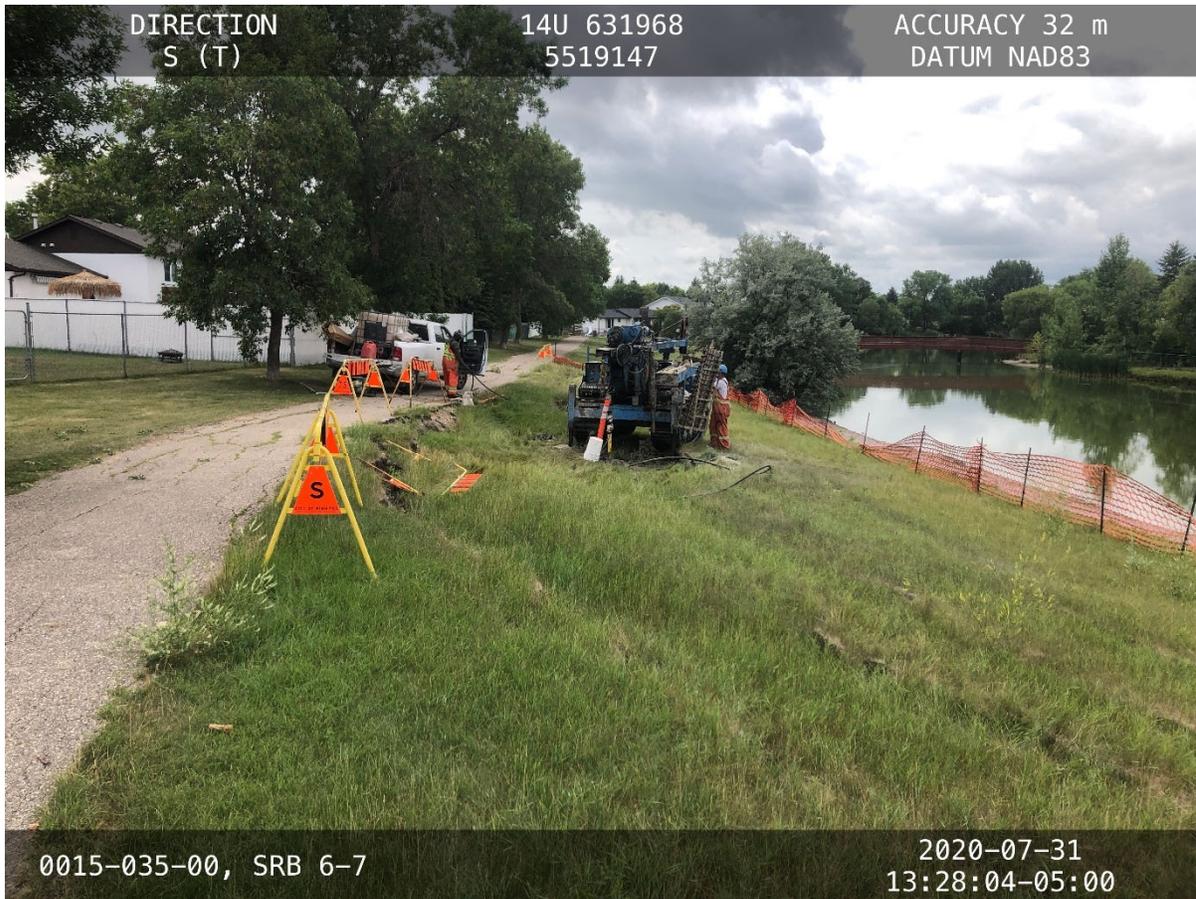
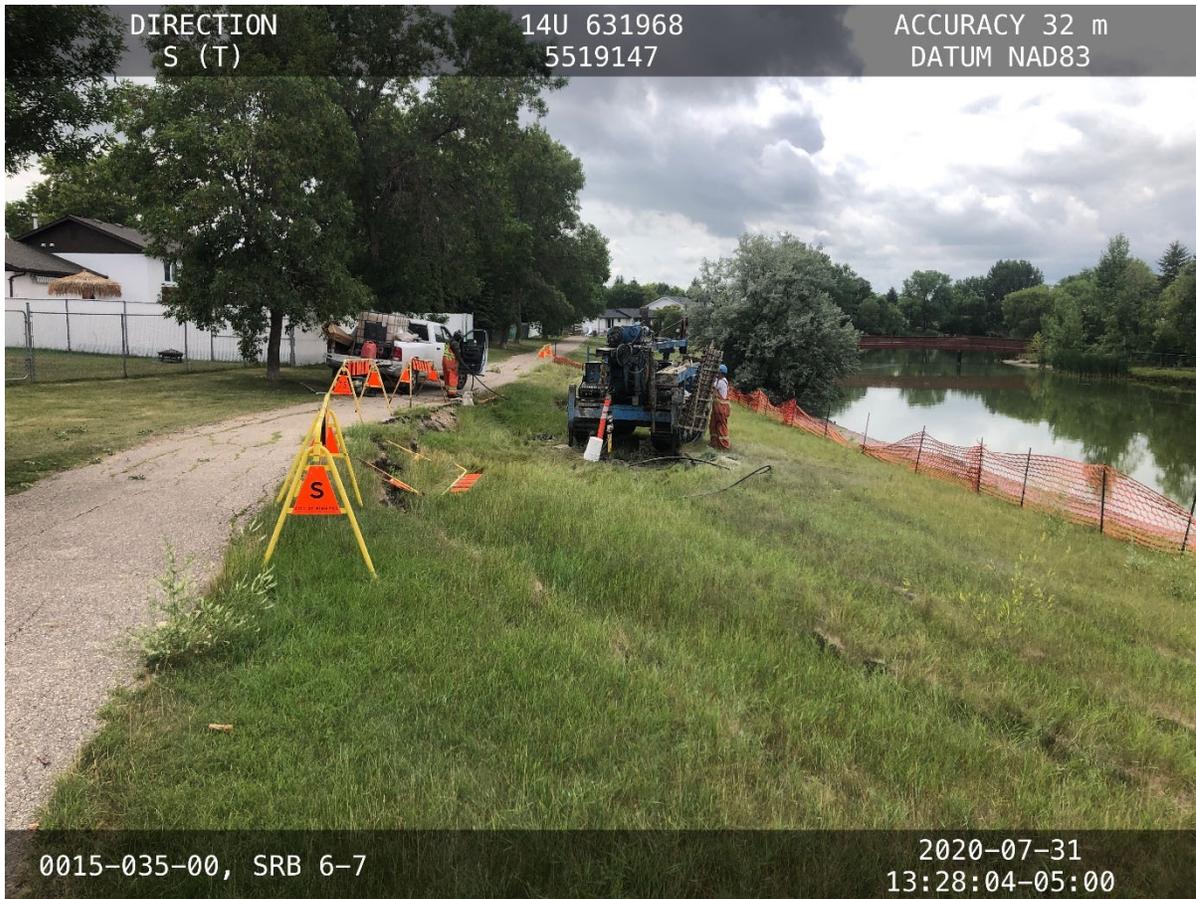
**Looking southwest at the instability from top of bank after completion of drilling**
