## Slope Stabilization of Stormwater Retention Basin (SRB) 6-7 **Geotechnical Investigation and Stability Assessment**

**Project Number:** 0015 035 00

**Date:** April 6, 2021

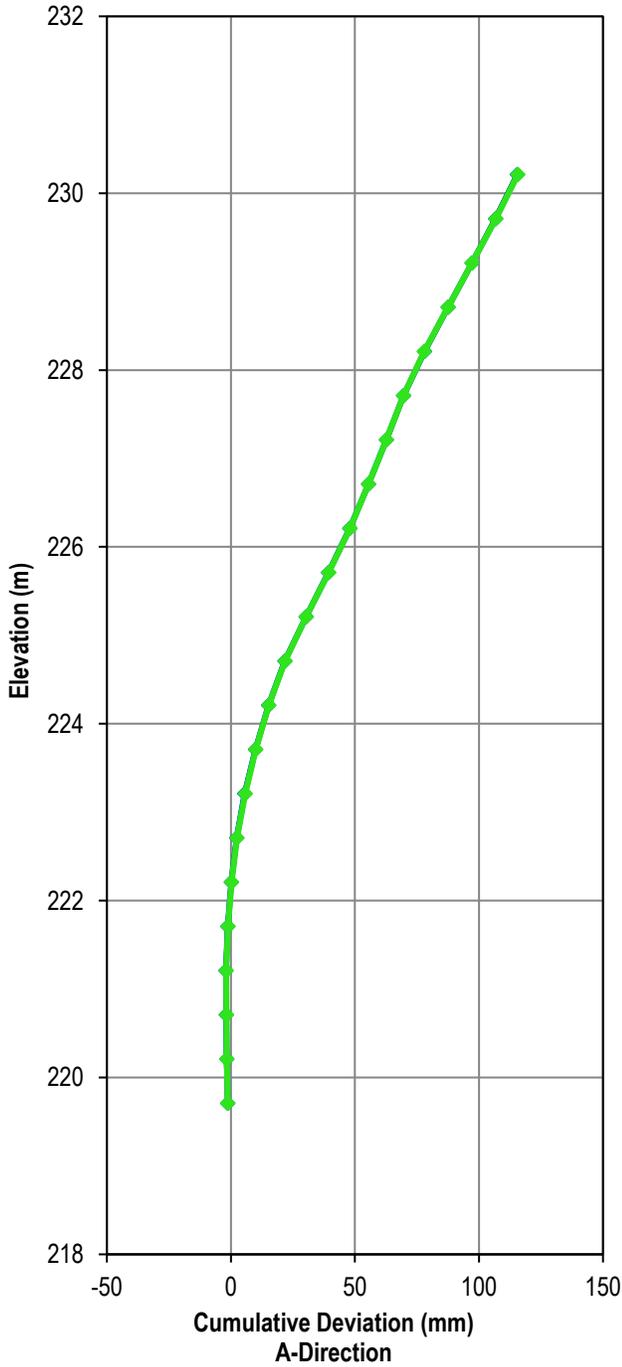
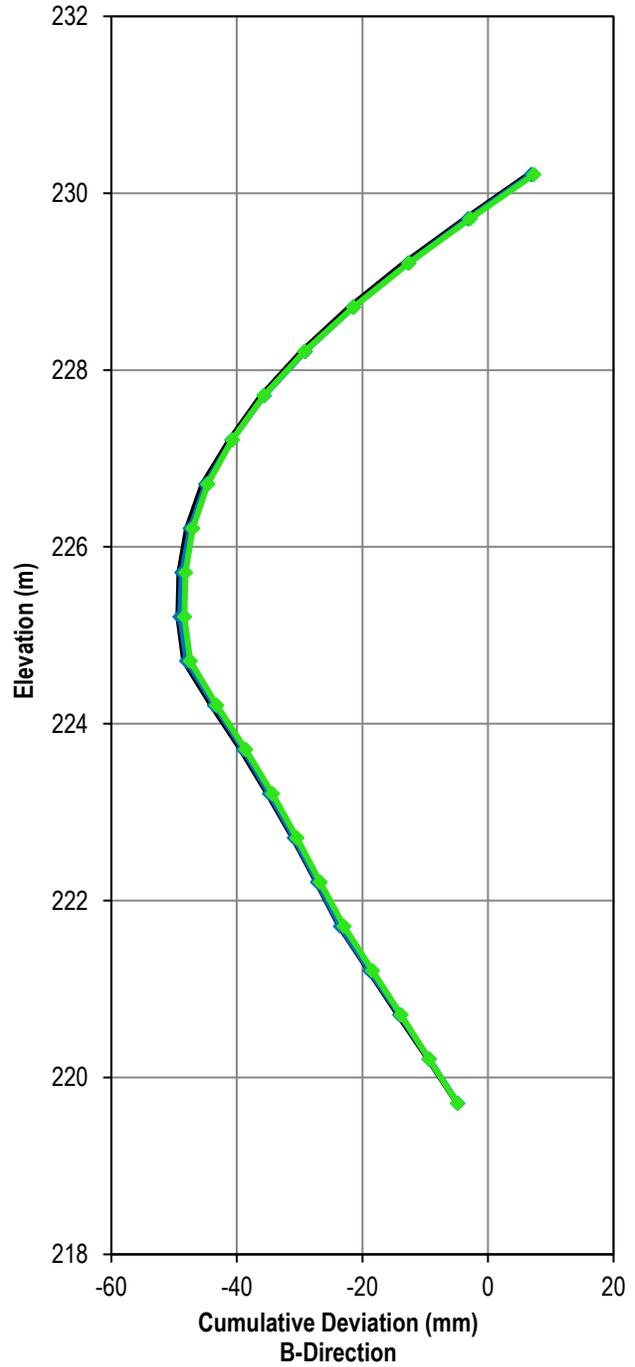
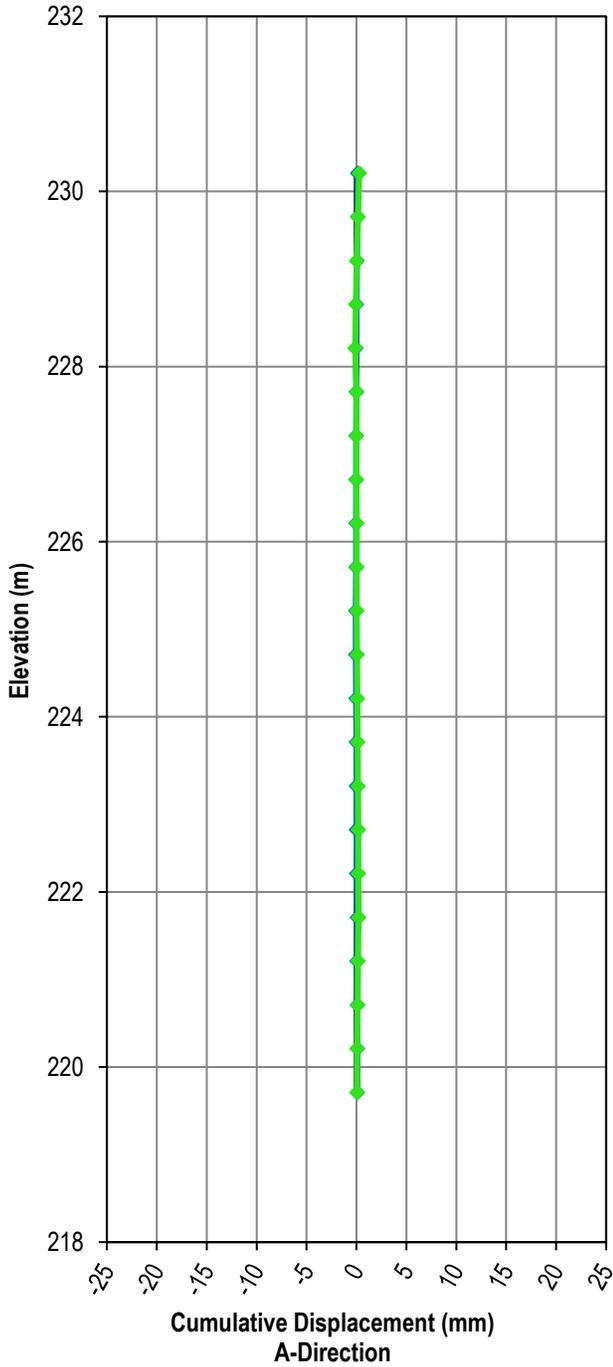
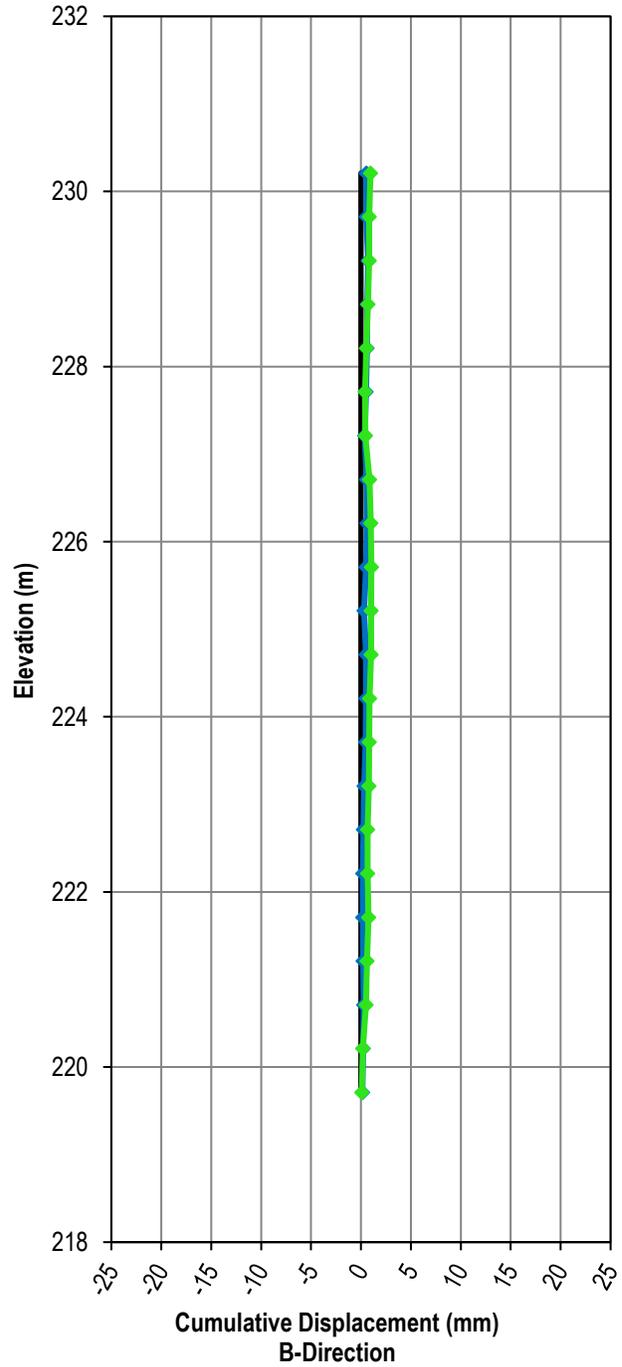
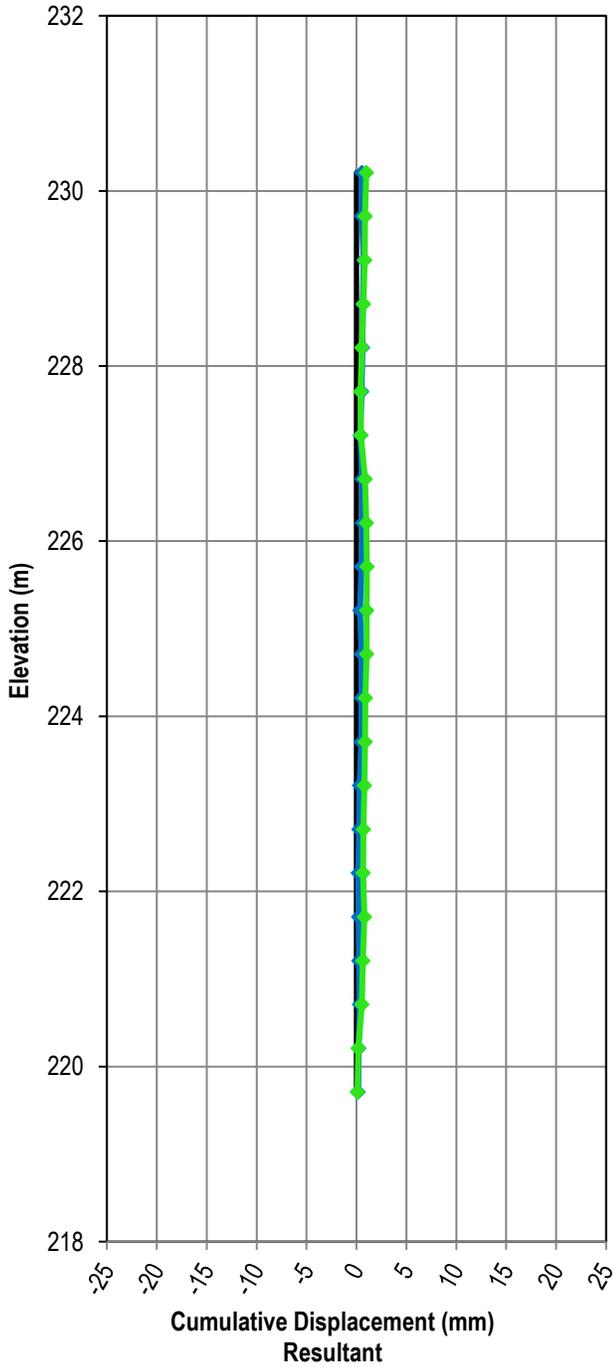
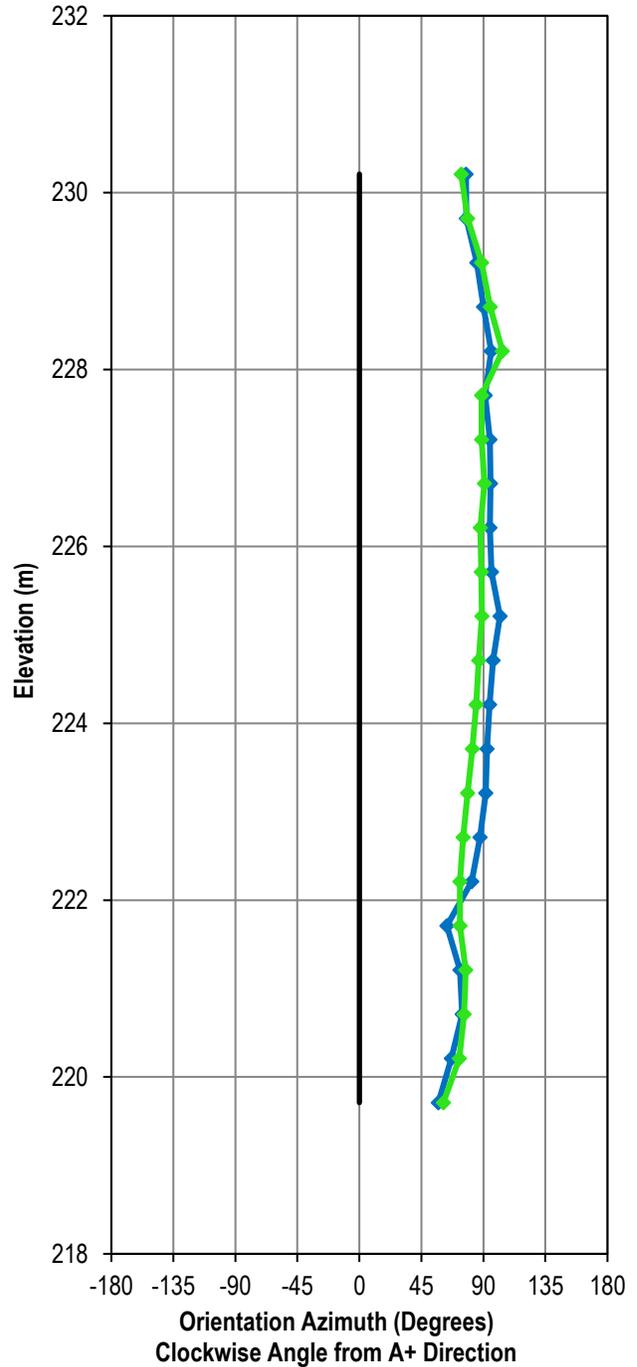
#### SI20-01

The slope inclinometer was monitored twice after installation, with the most recent monitoring event on September 16, 2020. No measurable slope movements are evident in the results to date (Appendix C).

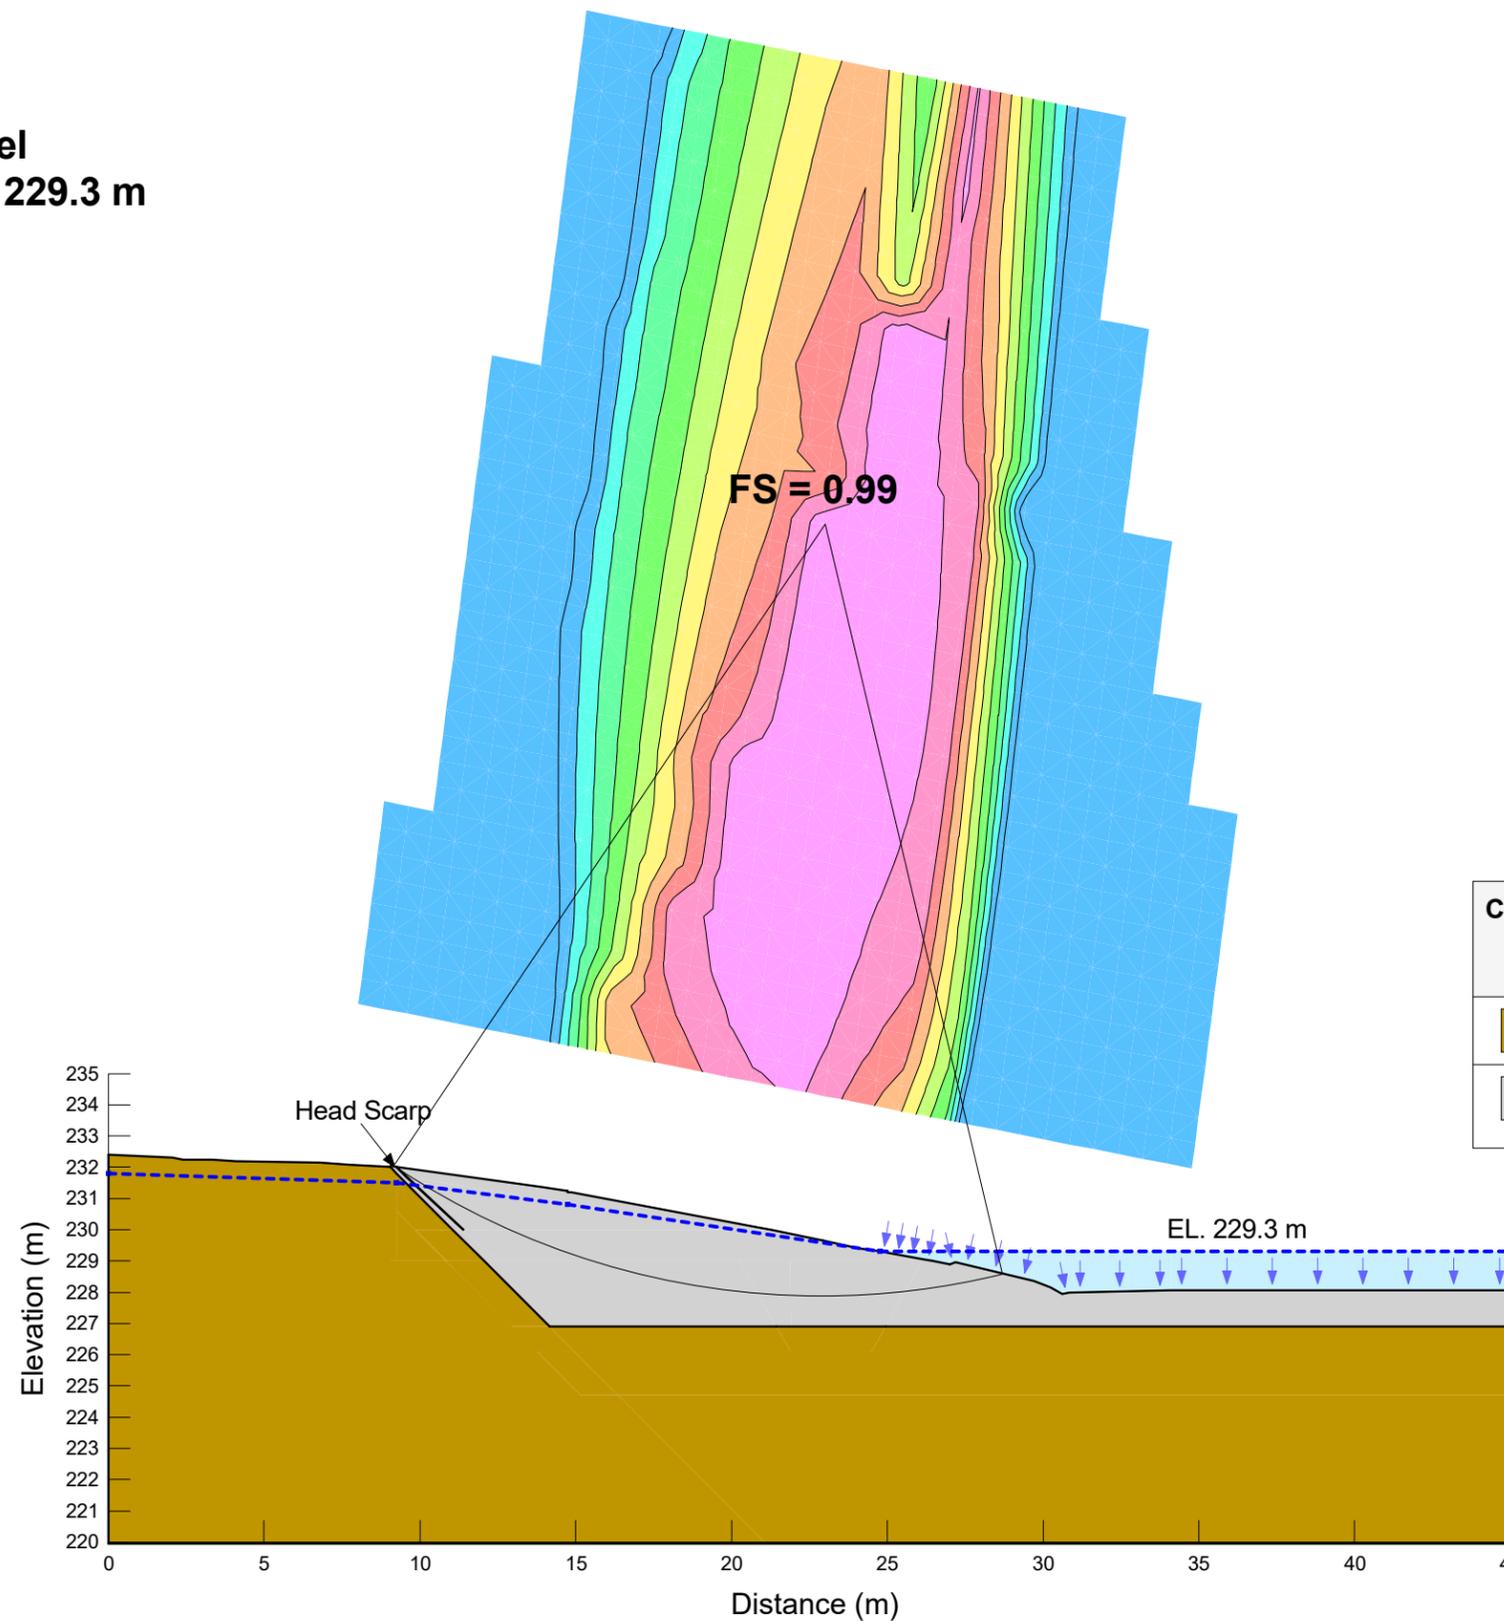
The computer output D-1 (Appendix D) shows the critical slip surface which extends to approximately 2 m below ground surface, exiting approximately 20 m downslope of the head scarps.

**Back Analysis**  
**High Groundwater Level**  
**SRB Water Level = EL. 229.3 m**

A back-analysis was completed to determine probable soil strengths and groundwater conditions at the time of failure. The following applied conditions/criteria:

- Near-saturated bank at the time of failure,
- Shallow slip (failure) surface within the upper 4 m,

- Entry point of slip surface coincides with the observed head scarps, and
- FS ~ 1.0 for the critical slip surface.

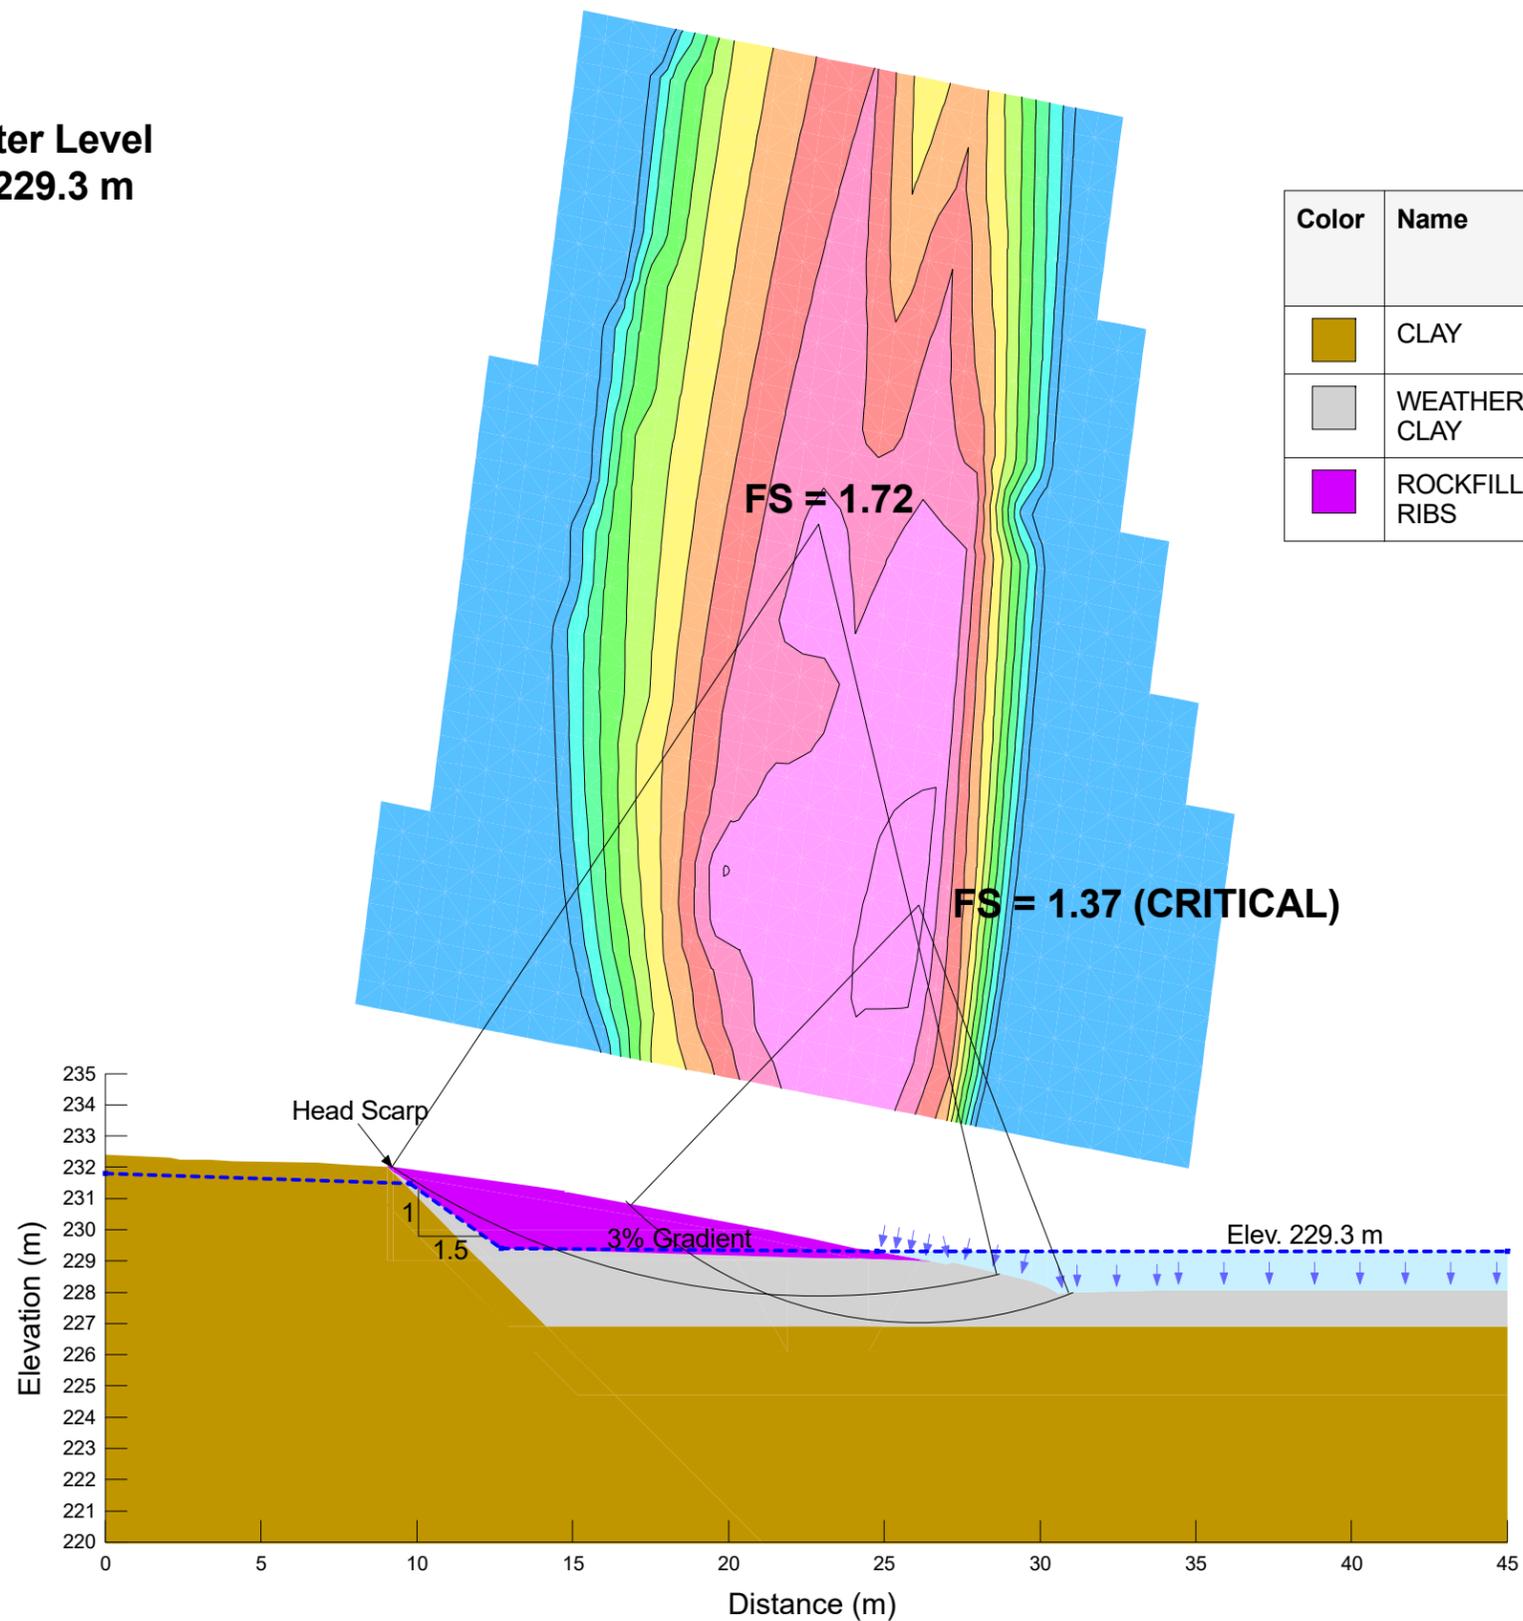
**Rockfill Ribs**  
**High GWL and SRB Water Level**  
**SRB Water Level = EL. 229.3 m**

Stability Case	GWL and SRB Water Level	Slip Surface	Target FS	Calculated FS	Figure No. (Appendix D)
Back Analysis	Short-Term	Representative of Actual Conditions	1.0	0.99	D-1
Rockfill Ribs	Short-Term	Global	1.3	1.72	D-2
		Critical		1.37	
	Long-Term	Global	1.5	1.71	D-3
		Critical		1.49

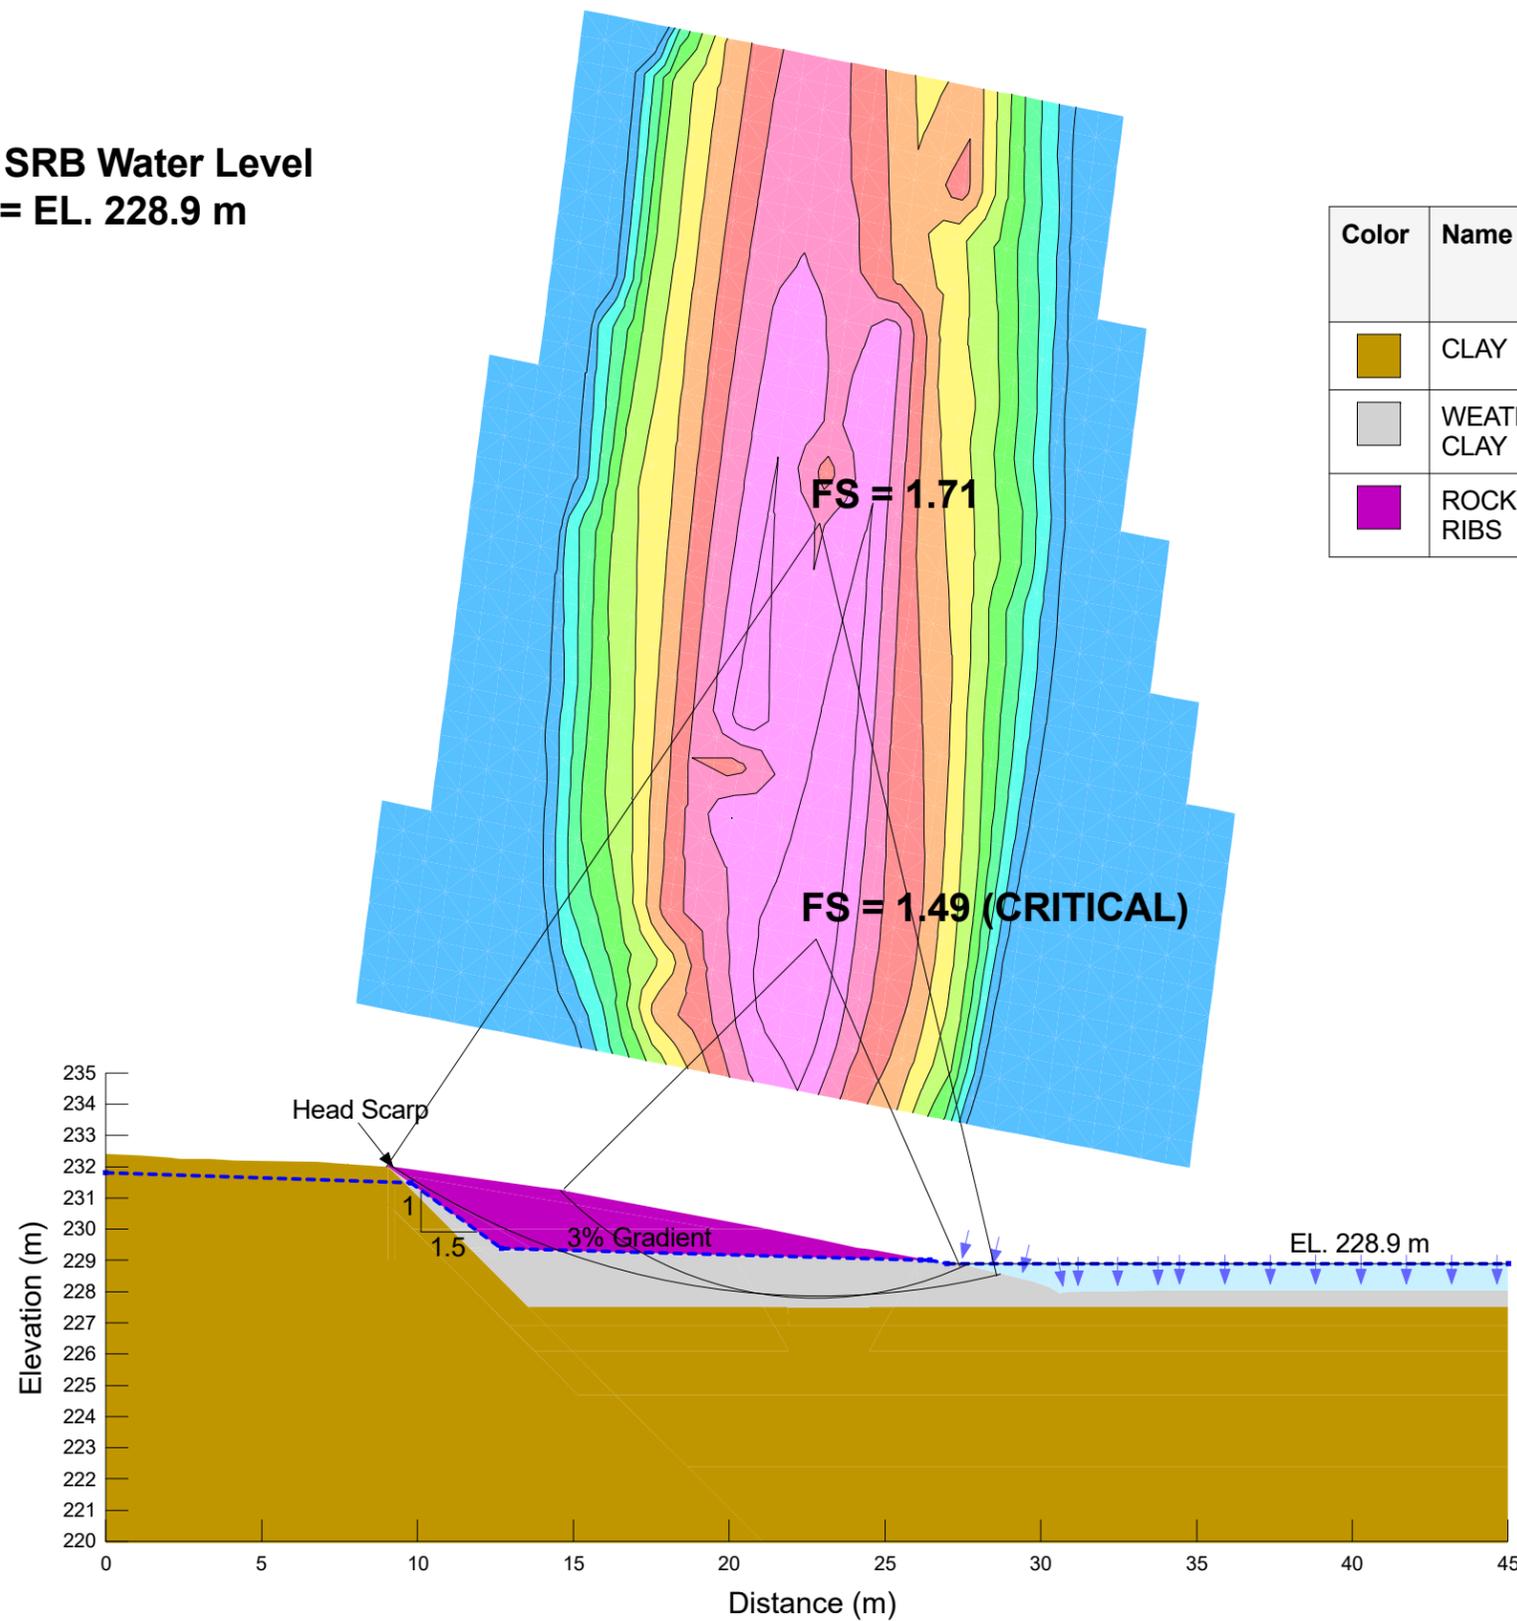
**Rockfill Ribs**  
**Normal GWL and SRB Water Level**  
**SRB Water Level = EL. 228.9 m**
