**REPORT ON THE GEOTECHNICAL INVESTIGATION  
OF THE PORTAGE AVENUE OVERPASS  
REHABILITATION PROJECT AT OMANDS CREEK**

**A. DEAN GOULD AND ASSOCIATE  
GEOTECHNICAL CONSULTANTS**

# **GEOTECHNICAL REPORT**

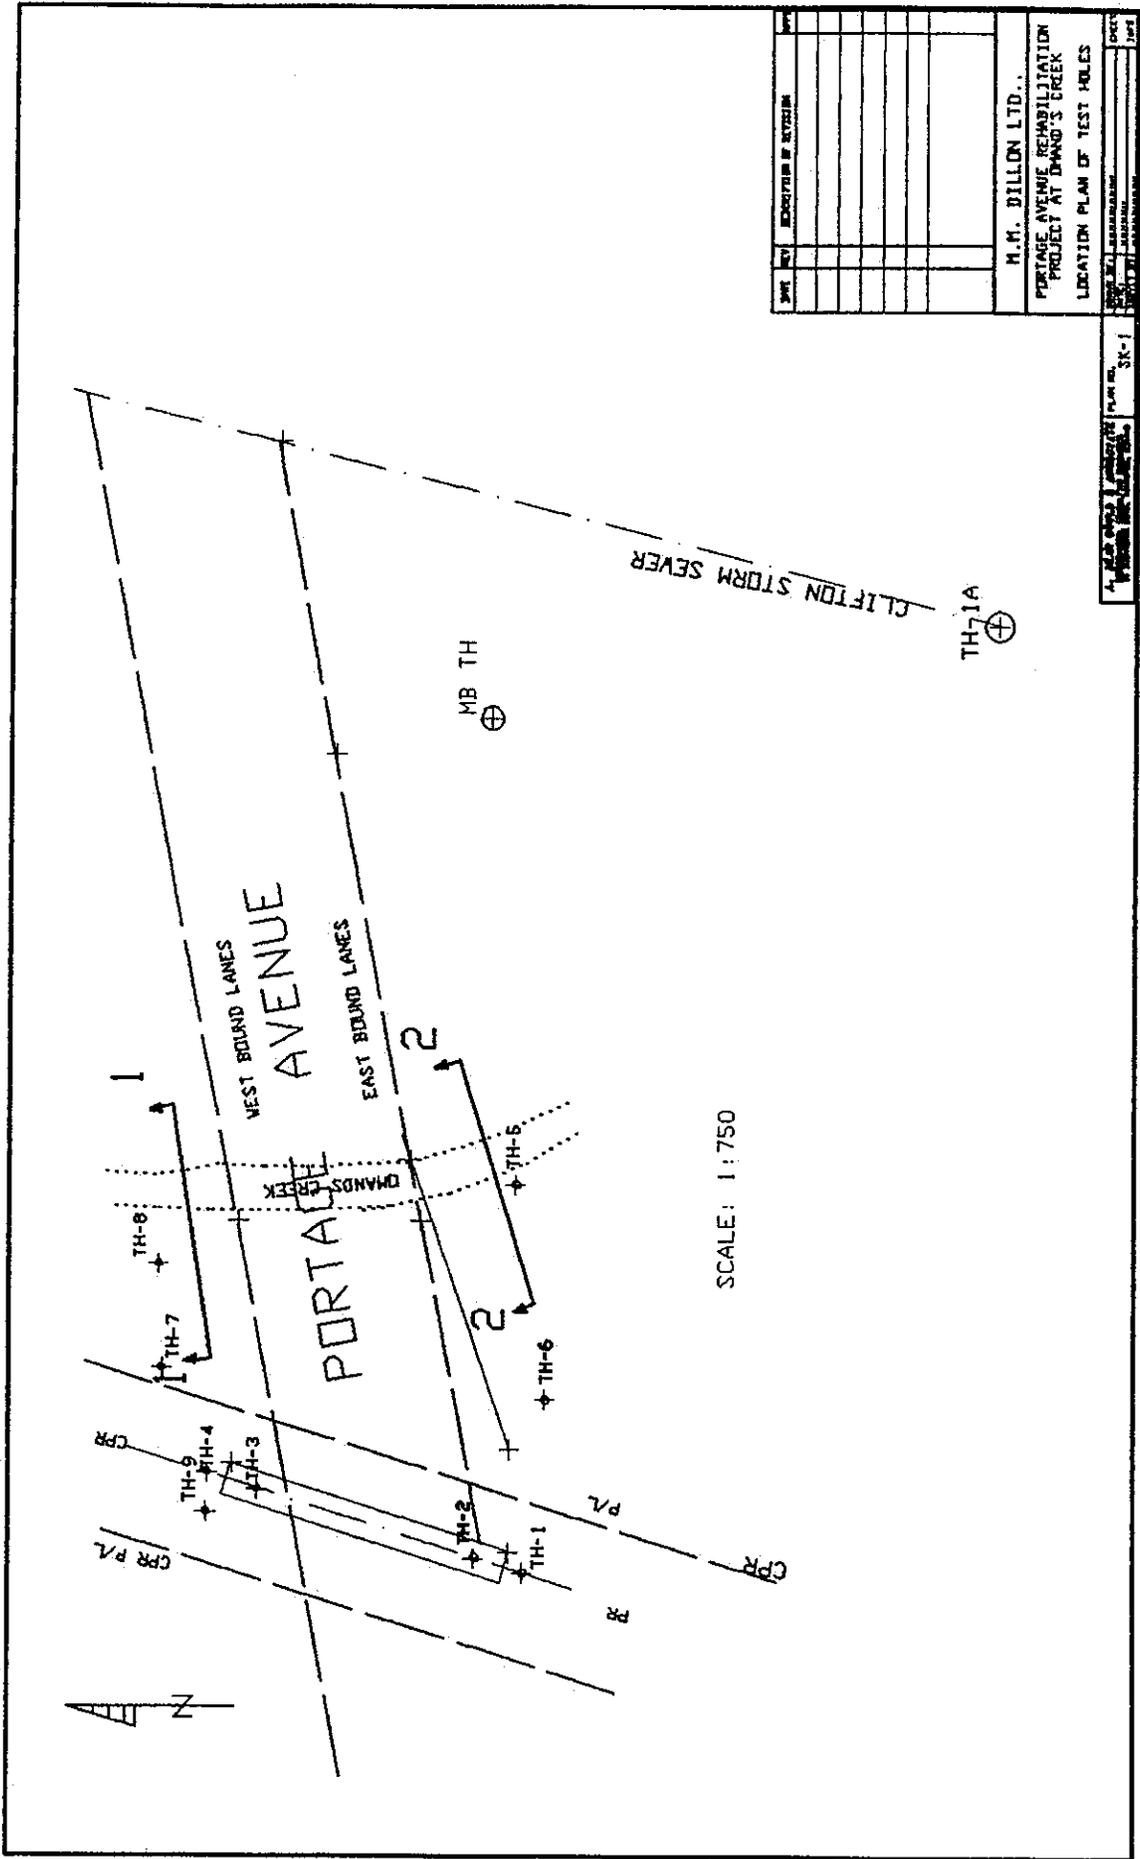
M. M. DILLON LTD.  
 PORTAGE AVENUE REHABILITATION  
 PROJECT AT DMANDS CREEK  
 LOCATION PLAN OF TEST HOLES

A subsurface investigation consisting of nine, 125 mm augured test holes was undertaken on March 9-10, 1992. The test holes, located as shown on the attached plan SK-1 in Appendix A, were drilled by Paddock Drilling Ltd., through the use of 5 -inch flight auger using a track mounted drilling rig.

Applying the parameters of Table 2 in the computer program G-Slope which utilizes the Bishop Modified method of analysis a near unity (1.0) Factor of Safety was determined for the existing slopes of Sections 1 & 2 shown on SK-1 Location Plan and in the appended 2 dimensional slope profiles with probable failure surfaces. The computer analysis enabled a rapid testing of the slope for the position of the phreatic surface and local failure conditions. It was found that;

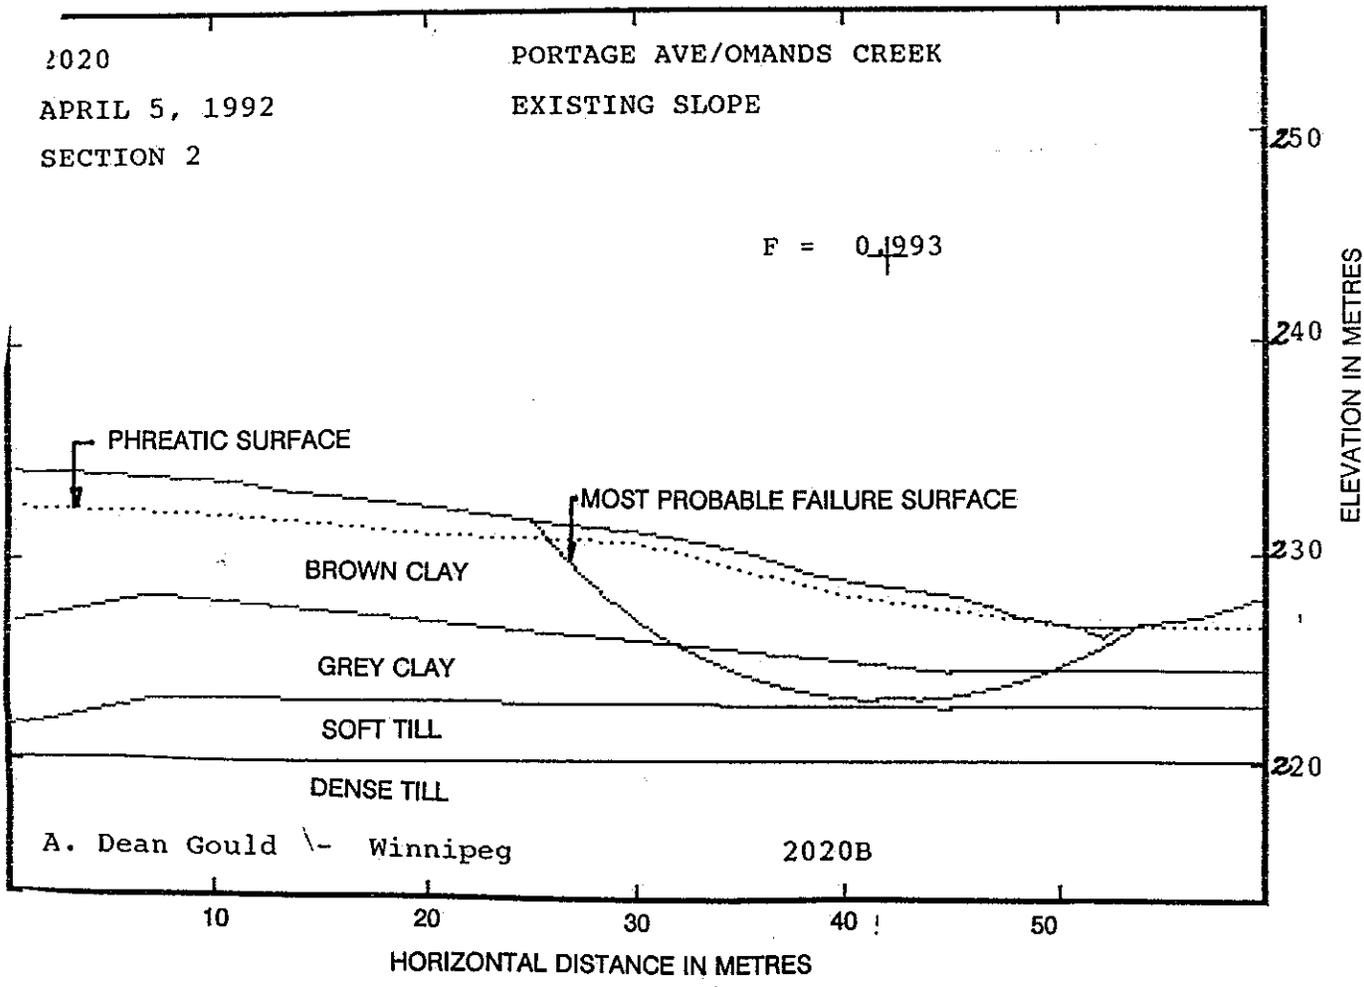
SK-2

Material	Unit Wt	Cohesion	Friction Angle	Piezo Surface	Ru Value
# 1 -CREEK WATER	9.8	0	0	0	0
# 2 -BROWN CLAY	17	0	24	1	0
# 3 -GREY CLAY	16.93	2	14	1	0
# 4 -SOFT TILL	17.67	0	26.1	1	0
# 5 -DENSE TILL	20	0	40	0	0

Appended to this report, SK-2, SK-3 profiles of the north and south embankments show the soil logs, elevations of soil stratigraphy and Omand's creek water levels as of March 12, 1992.

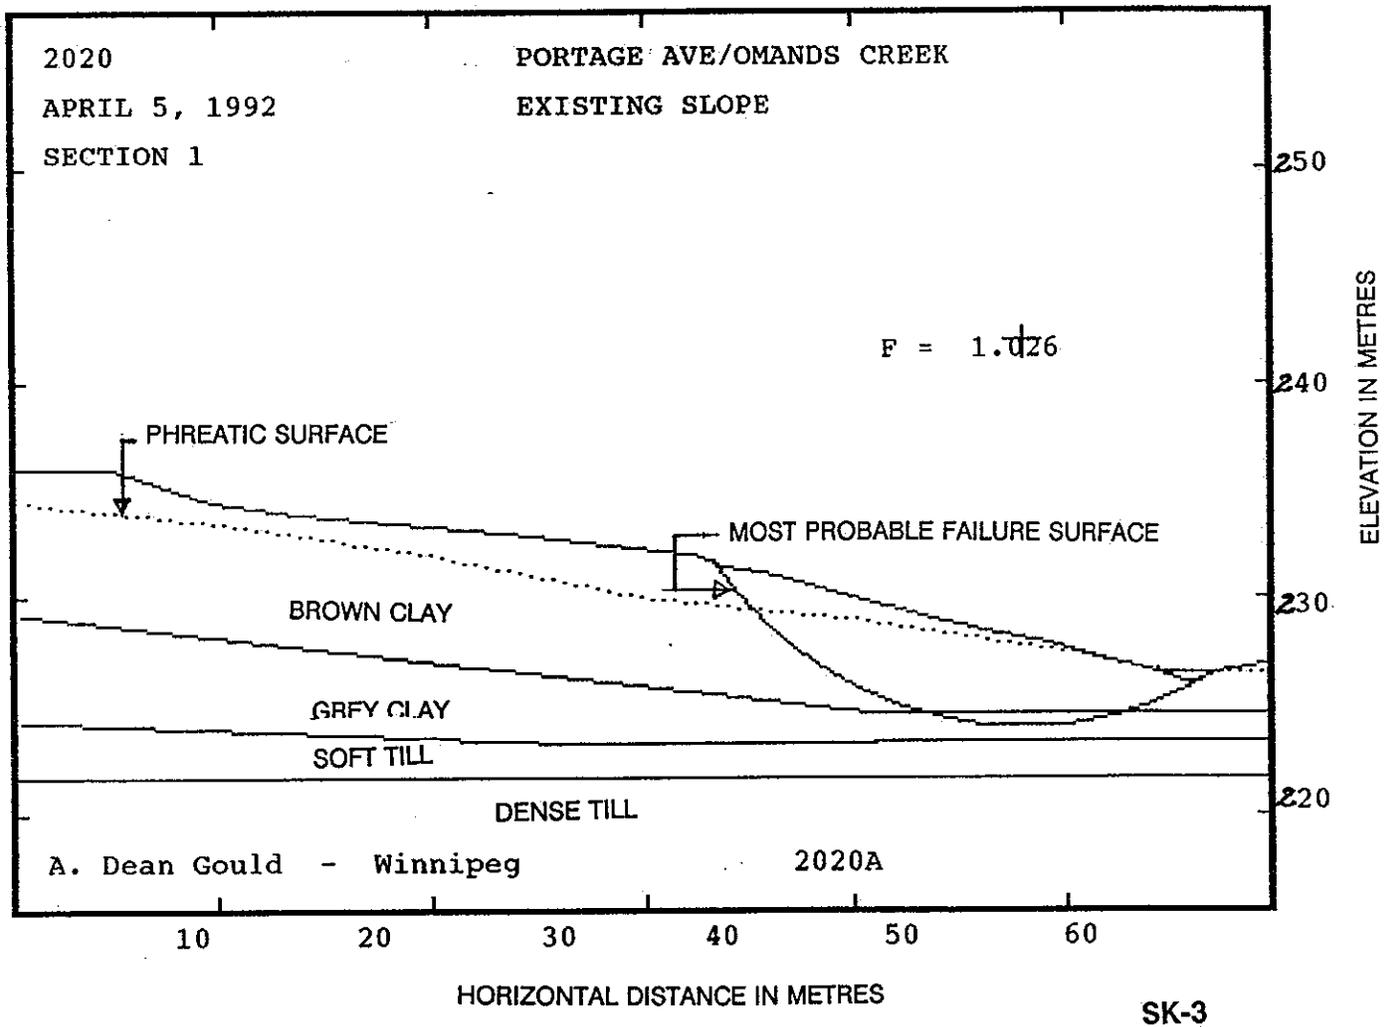
Material	Unit Wt	Cohesion	Friction Angle	Piezo Surface	Ru Value
# 1 -CREEK WATER	9.8	0	0	0	0
# 2 -ROCK TOE	15	0	45	1	0
# 3 -BROWN CLAY	17	0	24	1	0
# 4 -GREY CLAY	16.93	2	14	1	0
# 5 -SOFT TILL	17.67	0	26.1	1	0
# 6 -DENSE TILL	20	0	40	0	0

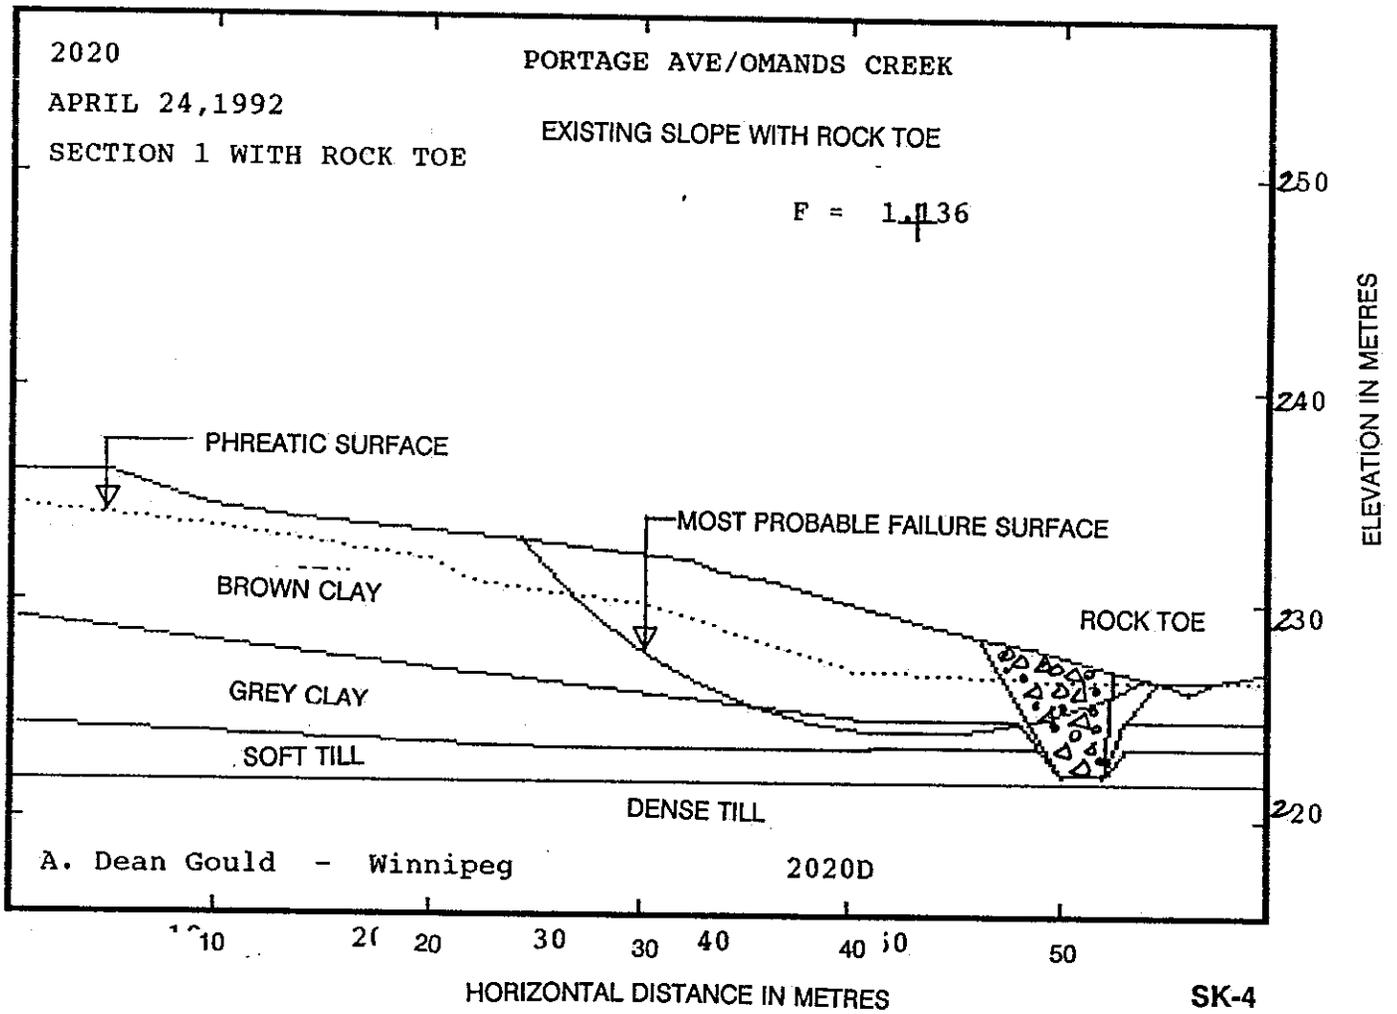
M. M. DILLON LTD.,  
PORTAGE/OMAND CR. REHABILITATION PROJECT  
SAFETY FACTOR VS PHREATIC SURFACE  
SECTION 1- NORTH WEST SLOPE

- o The slope downstream of the bridge is sensitive to the position of the phreatic surface and thus drainage incorporated into approach embankments provides a benefit to slope stability.
- o The position of the most probable deep seated failure surface which would present the greater potential damage to the structure and

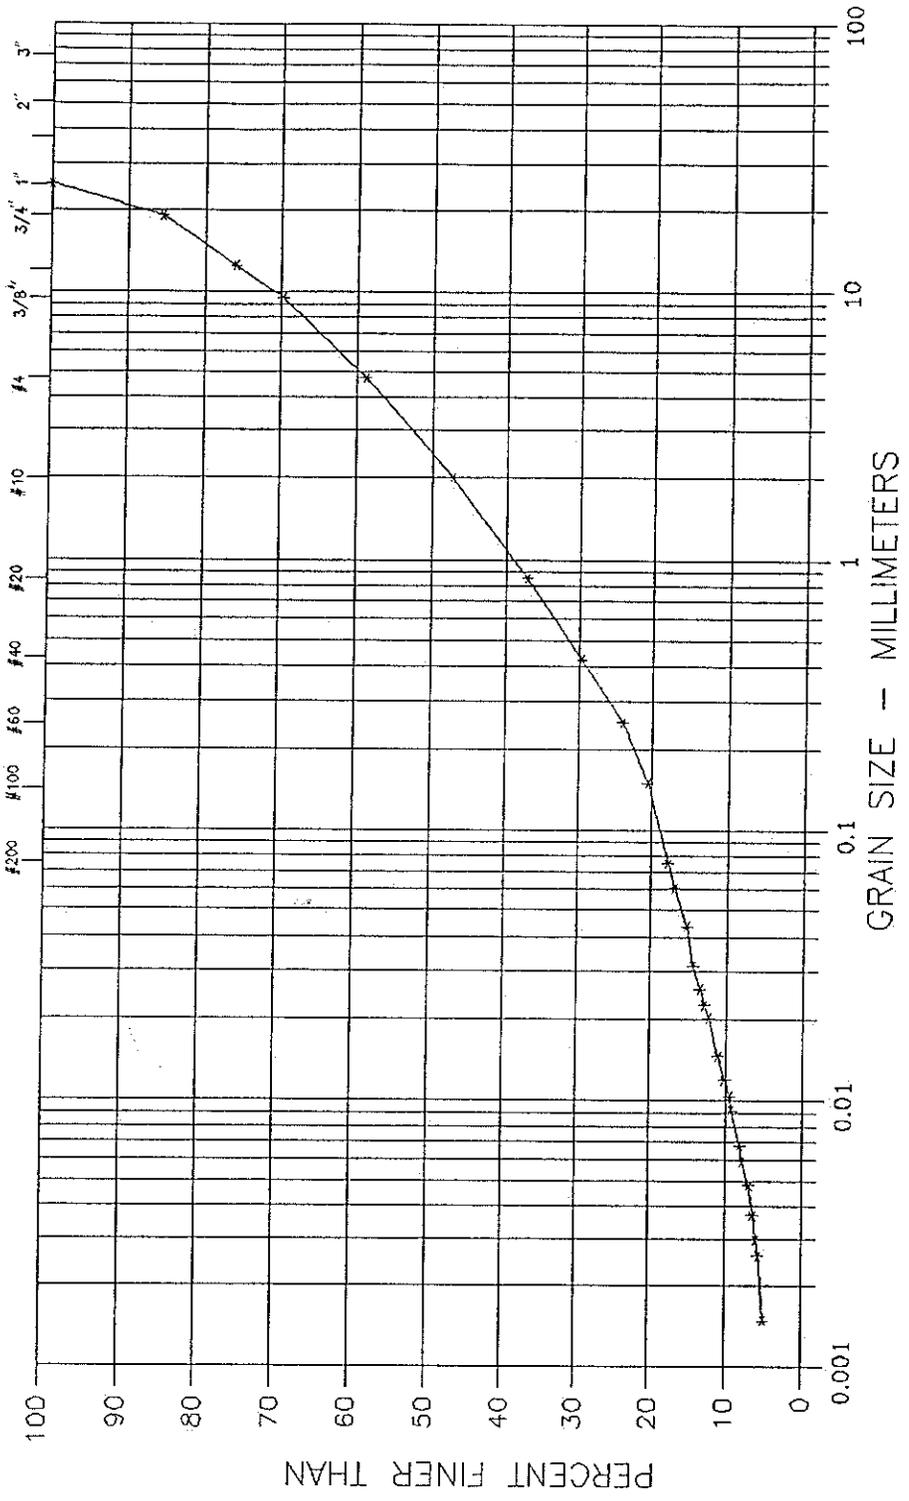
REMARKS: SILTY SAND WITH GRAVEL (SM) - TRACE OF CLAY

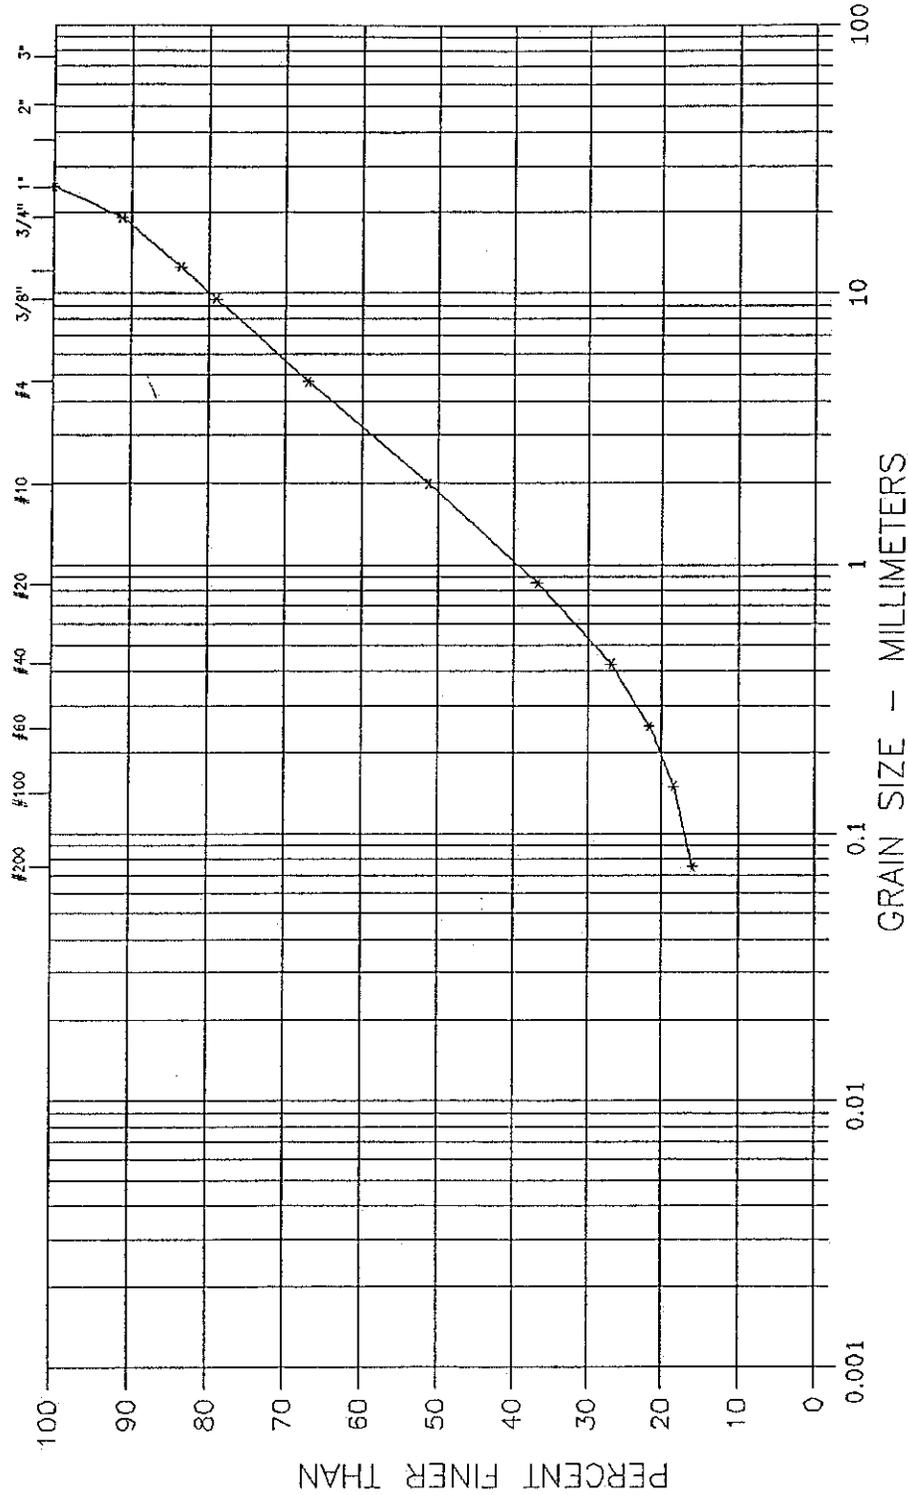
REMARKS: SILTY SAND WITH GRAVEL (SM)

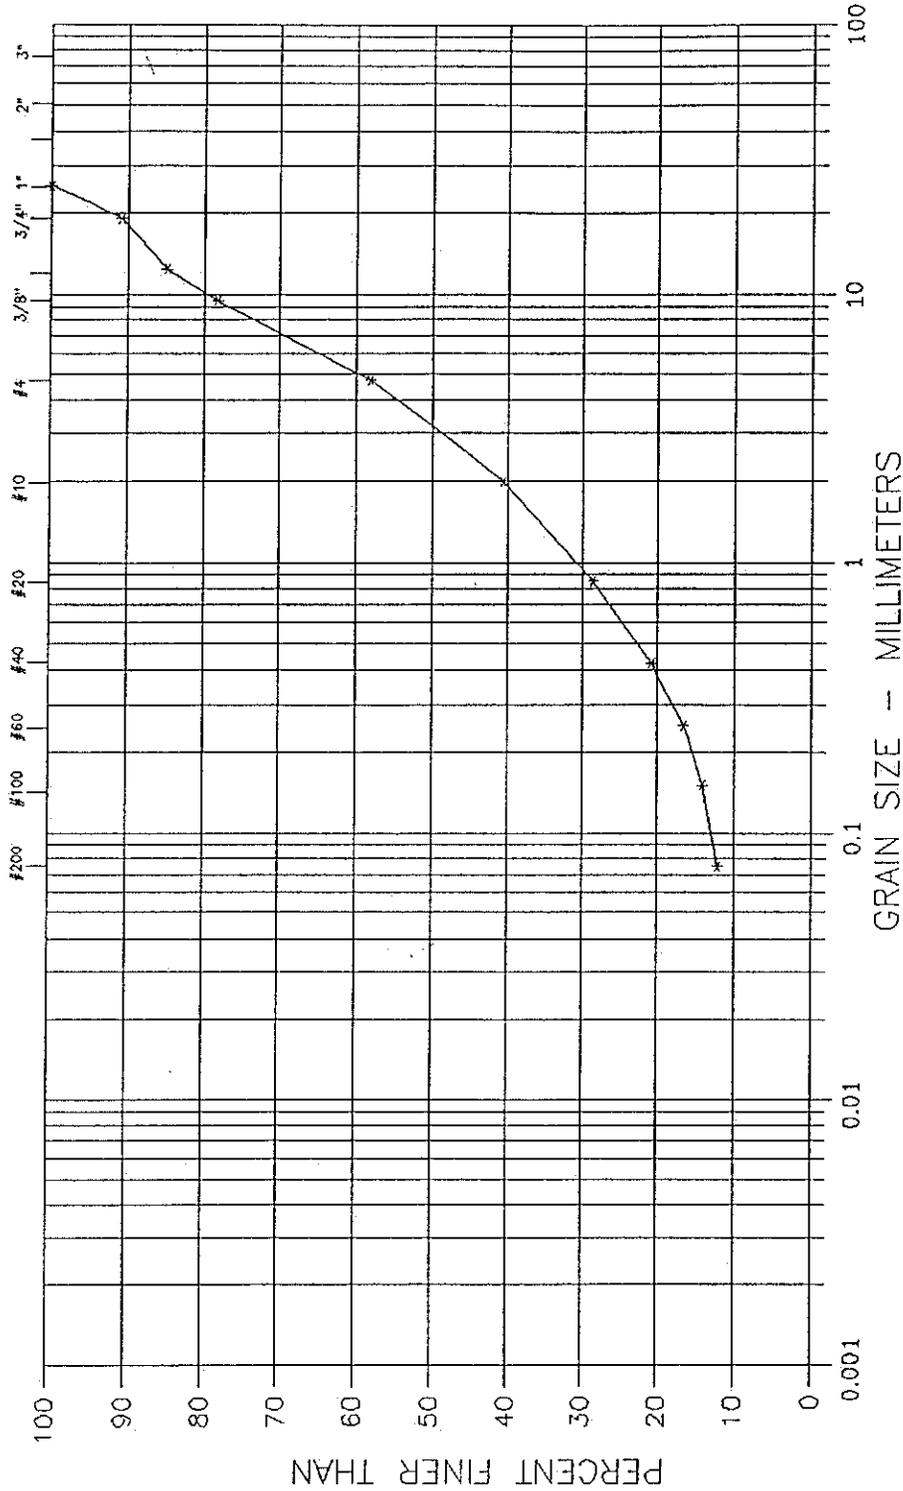
REMARKS: WELL GRADED SAND WITH SILT AND GRAVEL (SW-SM)

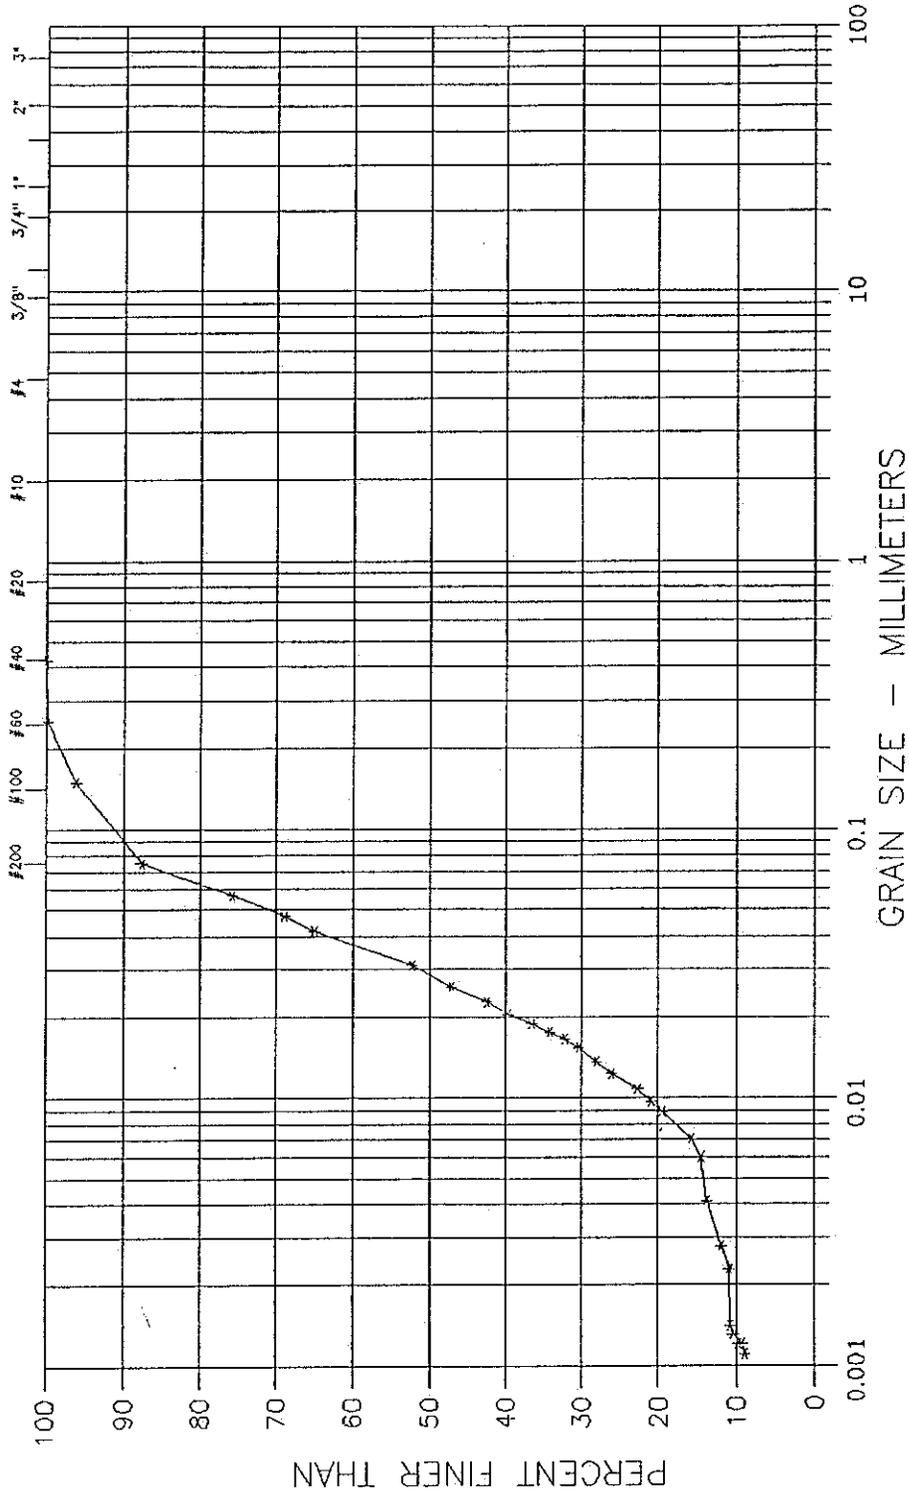
REMARKS: LIGHT BROWN SILT (ML)

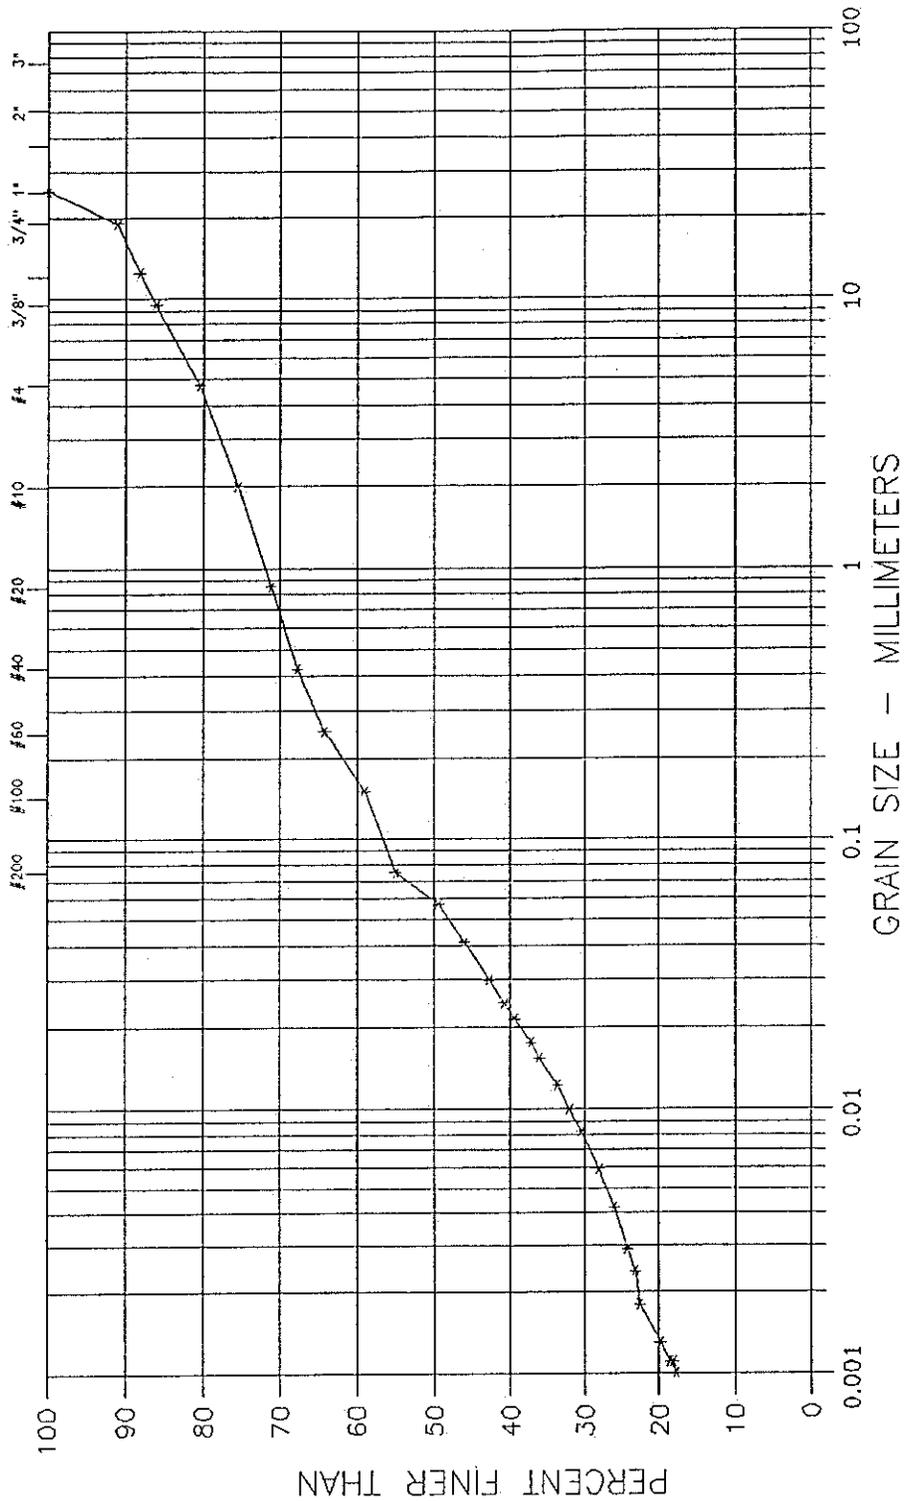
REMARKS: SANDY CLAYEY SILT WITH GRAVEL

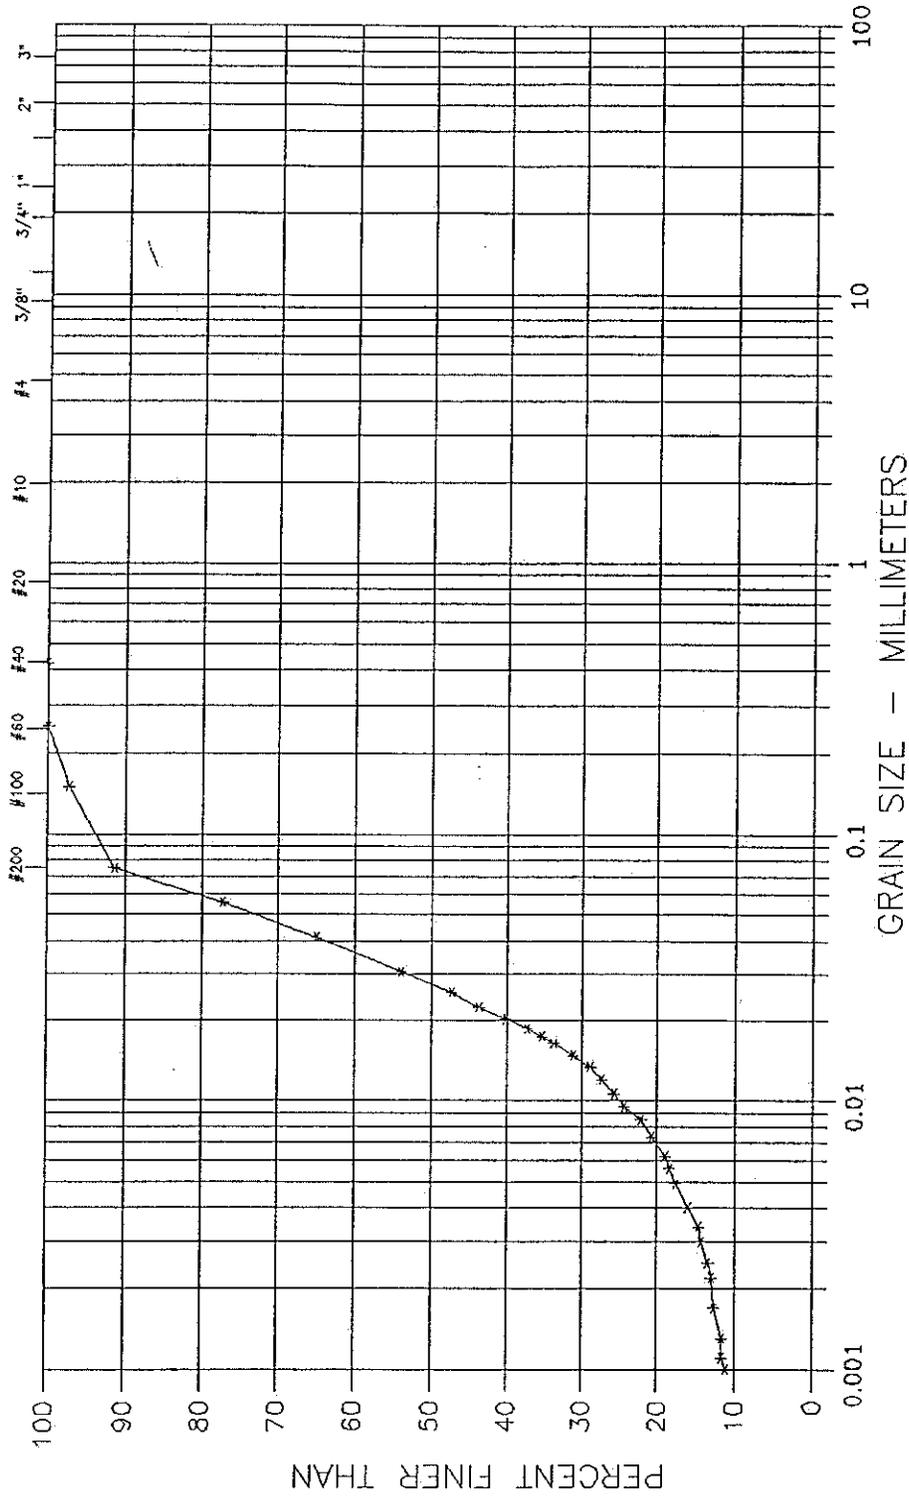
REMARKS: LIGHT BROWN SILT (ML)

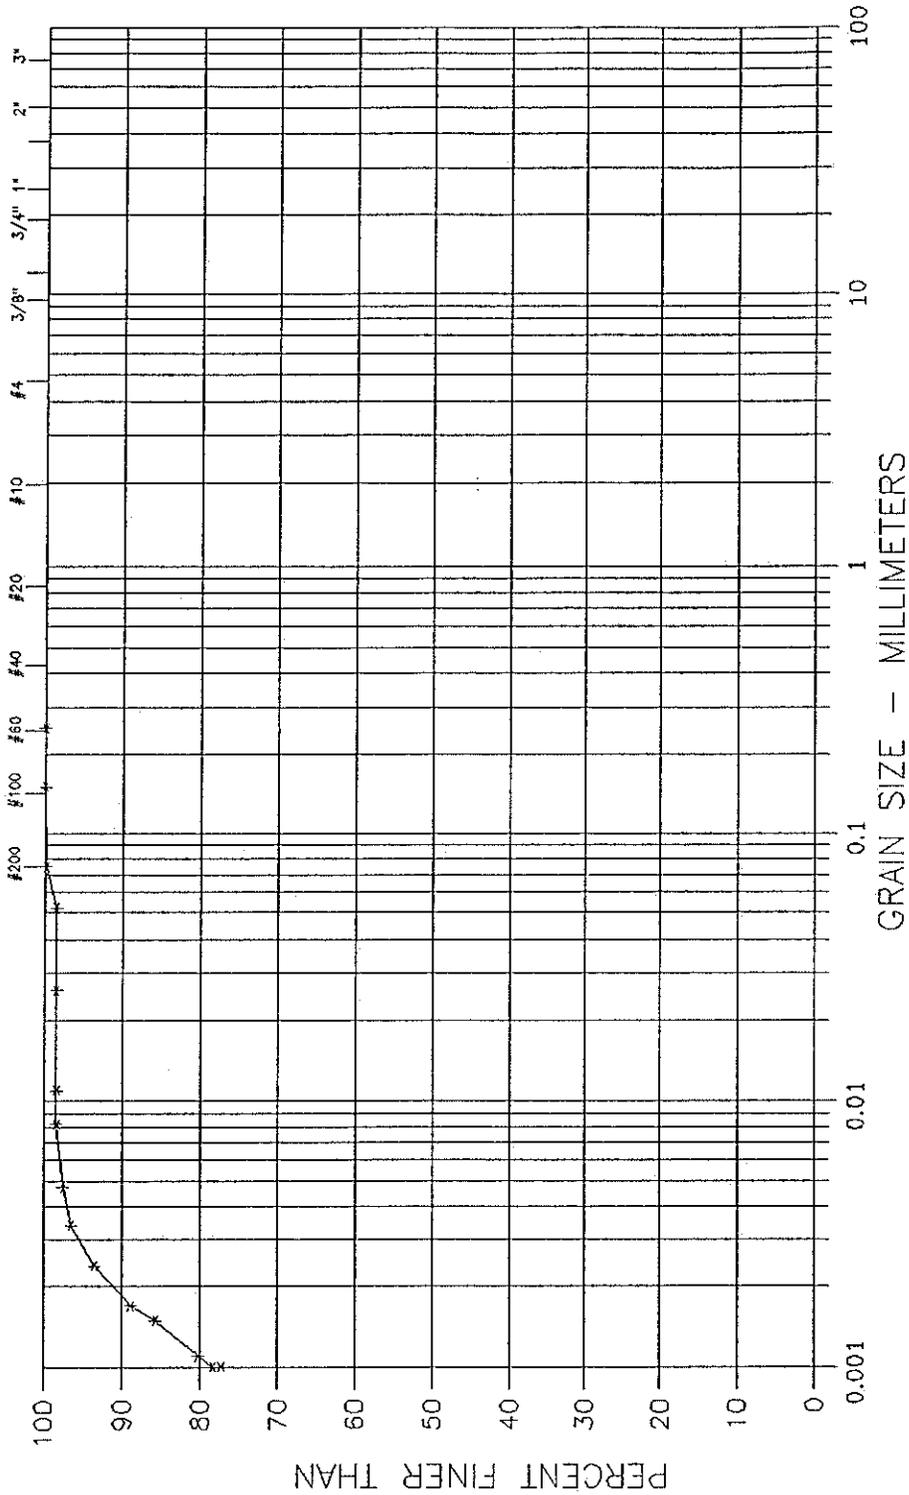
REMARKS: GREY CLAY (CH) - HIGHLY PLASTIC  
 - TRACE OF SILT POCKETS

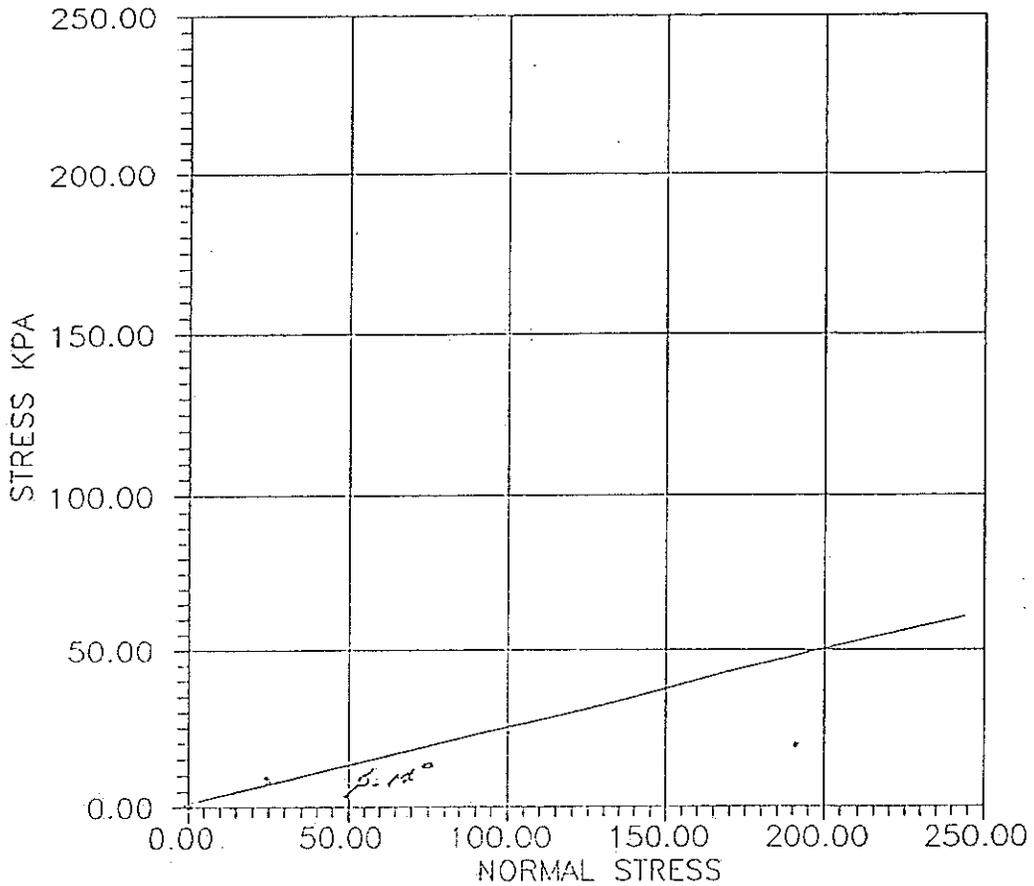
### DIRECT SHEAR TEST

Soil Characteristics: Grey Clay with till inclusions, numerous tan silt pockets and small (5mm diam) stones, occasional large stone to 25mm diam, soft, plastic consistency

Strain Rate: 0.0061 mm/m Peak      Moisture Content: 39.4 - 26. %      Normal Load: 190.95 kPa  
 0.1191 mm/m Residual      Unit Weight: 18.03-16.73 kN/cu.m.      100.1 kPa  
Initial Void Ratio: 0.915      Deg. of Sat. 88.8 %      24.36 kPa

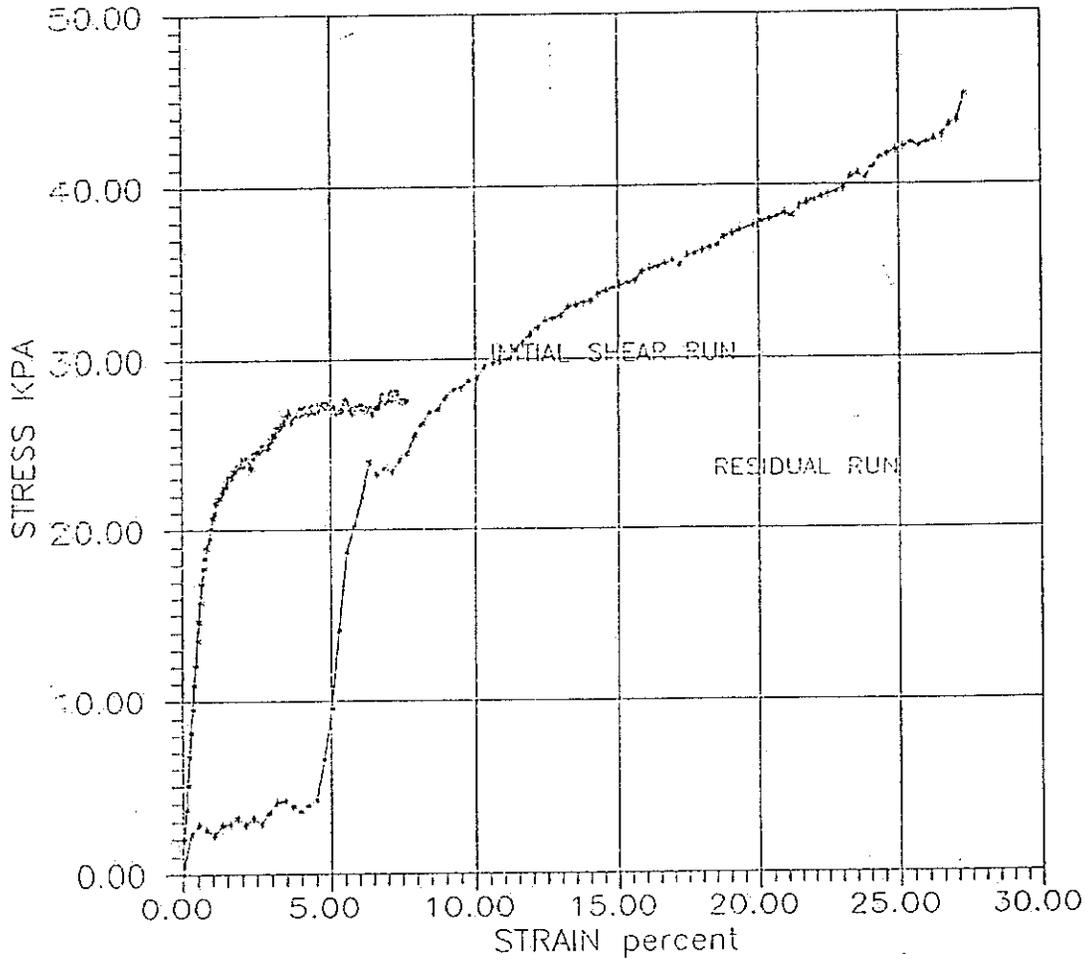
## DIRECT SHEAR TEST

**Soil Characteristics:** Grey Clay with till inclusions, numerous tan silt pockets and small (5mm diam) stones, occasional large stone to 25mm diam, soft, plastic consistency

Strain Rate; 0.0061 mm/m Peak      Moisture Content; 31.4 %      Normal Load; 100.1 kPa  
 0.1191 mm/m Residual      Unit Weight; 18.08 kN/cu.m.  
 Initial Void Ratio; 0.915      Deg. of Sat. 88.8 %

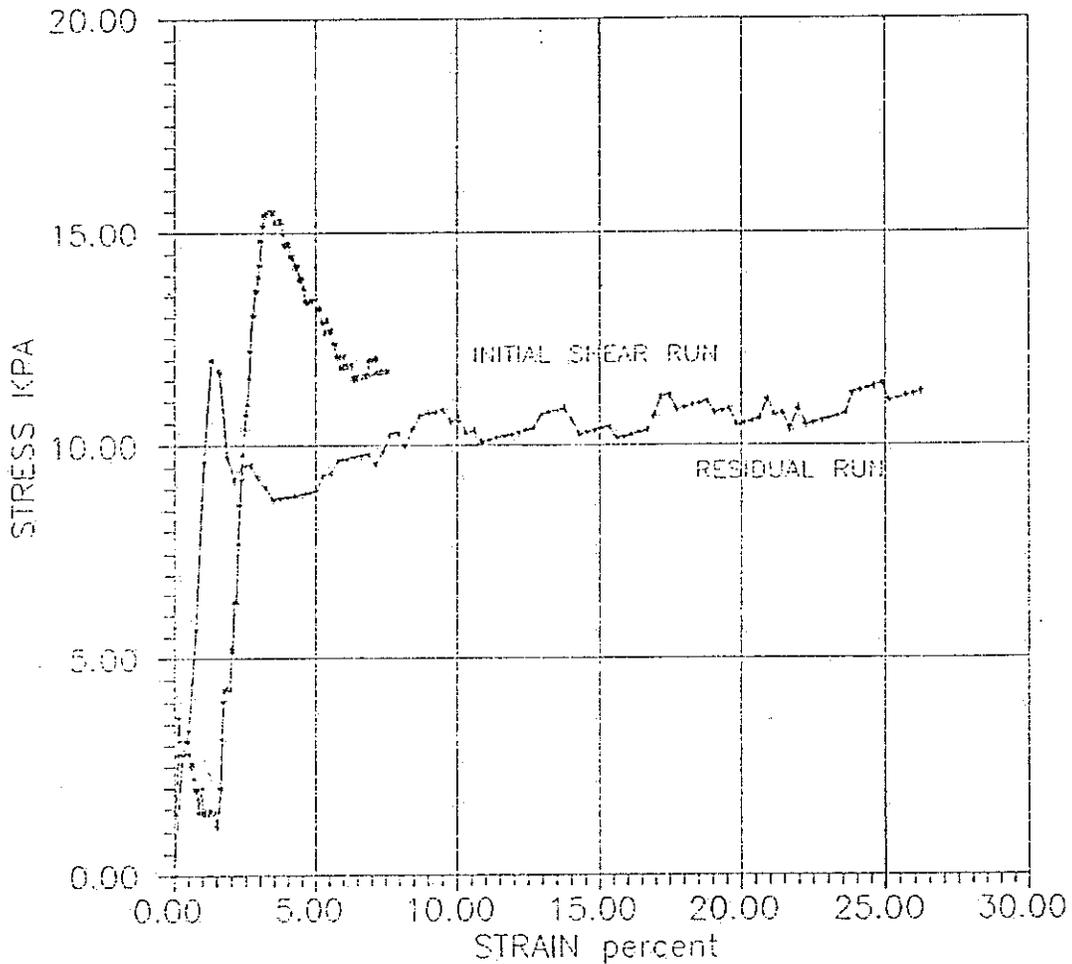
### DIRECT SHEAR TEST

**Soil Characteristics:** Grey Clay with till inclusions, numerous tan silt pockets and small (5mm diam) stones, occasional large stone to 25mm diam, soft, plastic consistency

**Strain Rate:** 0.0061 mm/m Peak      **Moisture Content:** 39.4 %      **Normal Load:** 24.36 kPa  
 0.1191 mm/m Residual      **Unit Weight:** 16.73 kN/cu.m.  
**Initial Void Ratio:** 1.393      **Deg. of Sat.** 97.1 %

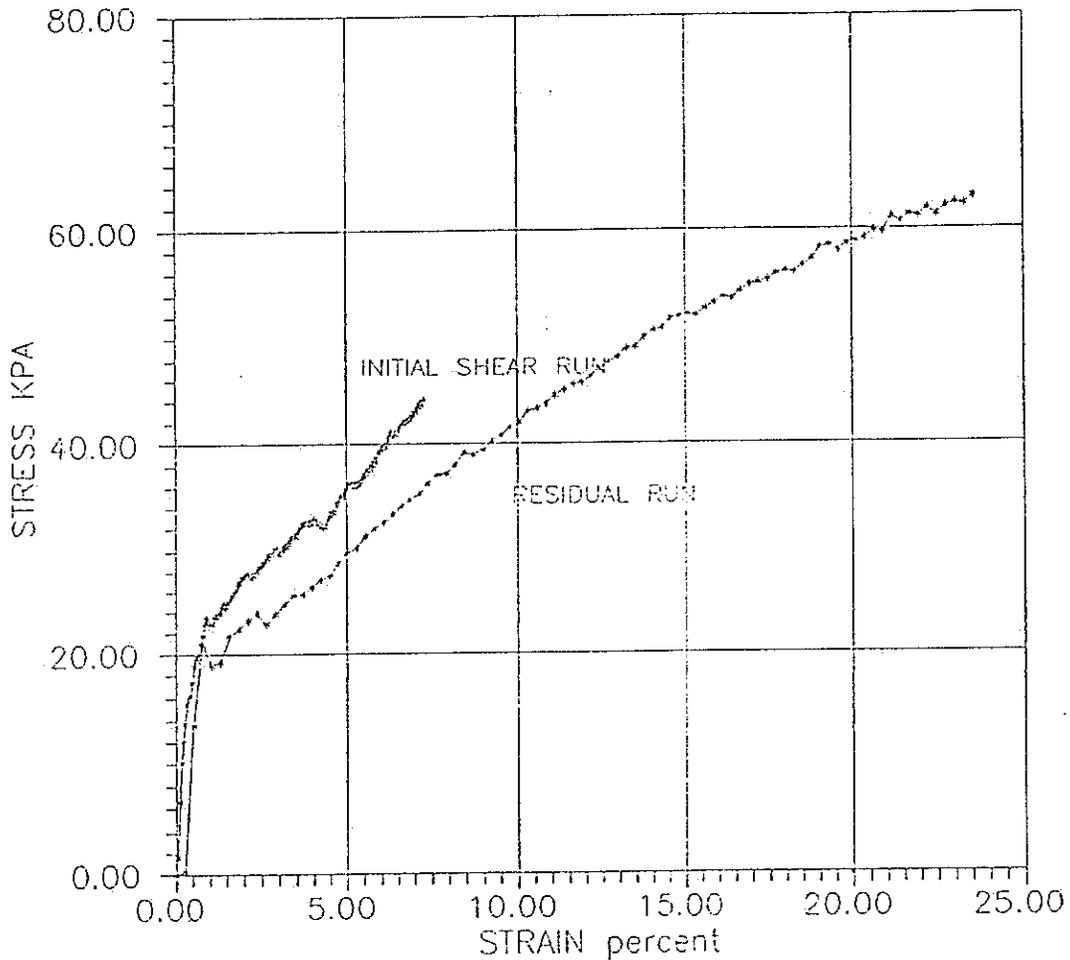
### DIRECT SHEAR TEST

**Soil Characteristics:** Grey Clay with till inclusions, numerous tan silt pockets and small (5mm diam) stones, occasional large stone to 25mm diam, soft, plastic consistency

Strain Rate: 0.0061 mm/m Peak      Moisture Content: 26.2 %      Normal Load: 190.95 kPa  
 0.1191 mm/m Residual      Unit Weight: 17.43 kN/cu.m.  
Initial Void Ratio: 1.393      Deg. of Sat. 83.2 %
