GEOTECHNICAL REPORT

**Re: 2022 Keewatin Street Northbound Renewal – Winnipeg, Manitoba
Report of Geotechnical Testing Results**

This letter summarizes KGS Group's geotechnical testing of portions of Keewatin Street in Winnipeg, Manitoba, required as part of the 2022 Keewatin Street Renewal Project.

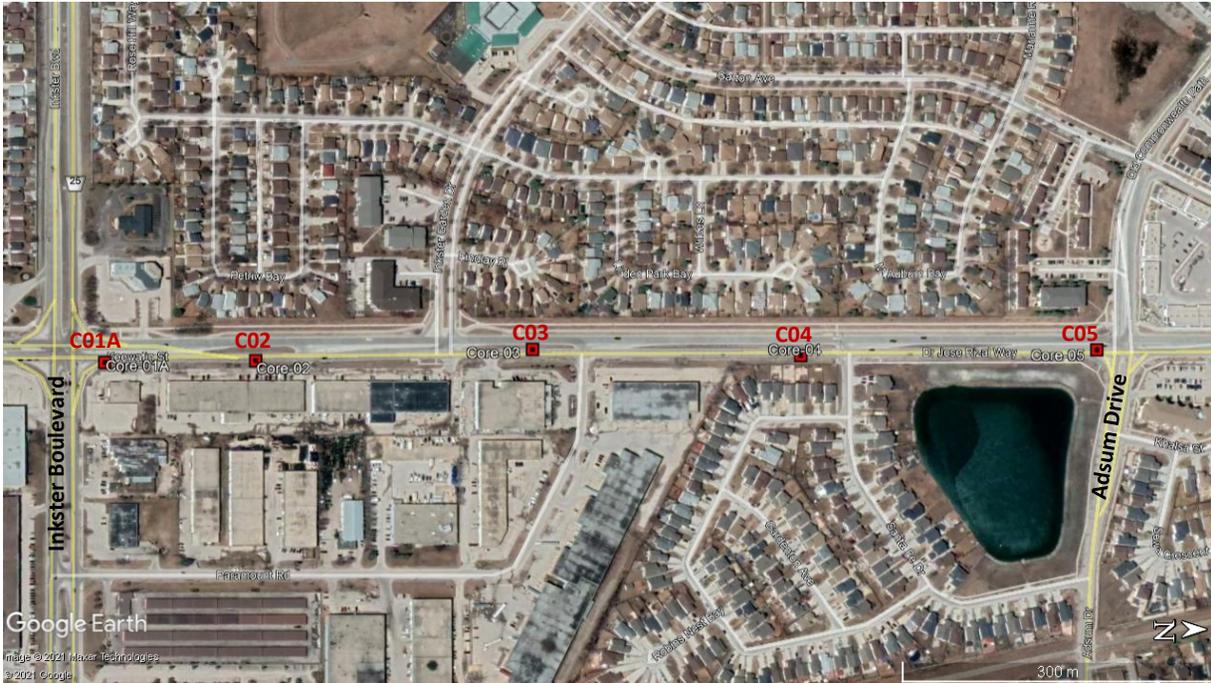
FIGURE 1: CORE HOLE LOCATIONS

The approximate locations of the core holes are shown on Figure 1 and the handheld UTM coordinates (Zone 14) for the core holes are listed in Table 1.

Core ID	Location	Approximate UTM Coordinates ¹	
		Northing (m)	Easting (m)
Core-01A	Sta. 0+091, 1.7 m from curb (curb lane)	5,534,224	629,500
Core-02	Sta. 0+235, 1.6 m from curb (curb lane)	5,534,369	629,495
Core-03	Sta. 0+500, 0.8 m from curb (median lane)	5,534,635	629,478
Core-04	Sta 0+767, 1.4 m from curb (curb lane)	5,534,893	629,478
Core-05	Sta. 1+046, 5.5 m from curb (median lane)	5,535,178	629,466

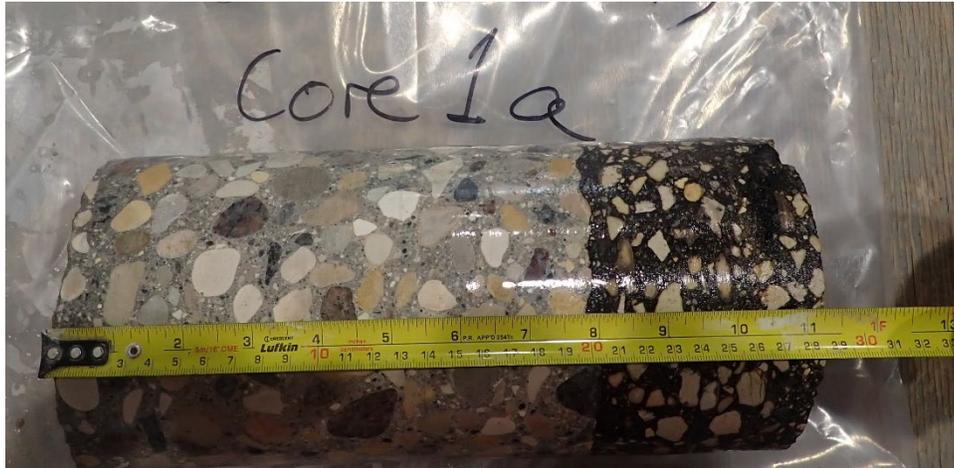
Photo 1: Core-01A (89 mm AC, 197 mm PCC)

Core ID	Asphalt Thickness (mm)	Concrete Thickness (mm)	Rebar Depth Below Grade (mm)	Corrected Concrete Compressive Strength (MPa) ²
Core-01A	89	197	none observed	28.9
Core-02	-	178	70	not tested
Core-03	-	208	none observed	49.2
Core-04 ¹	38	184	114	not testable due to crack
Core-05	-	197	none observed	41.7

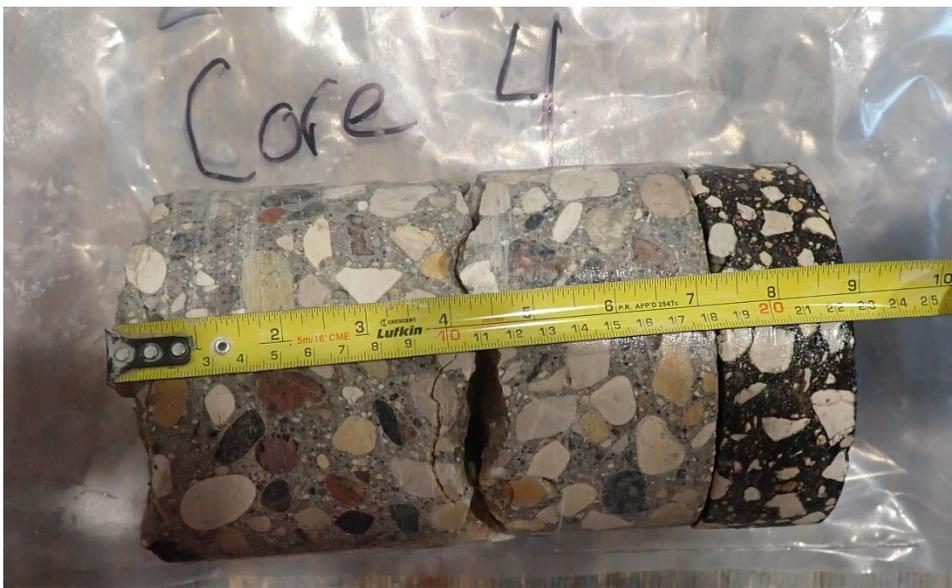
Photo 4: Core-04 (38 mm AC, 184 PCC)

Note 1: Core was cracked at the concrete/asphalt interface and again at a depth of 114 mm below the surface.

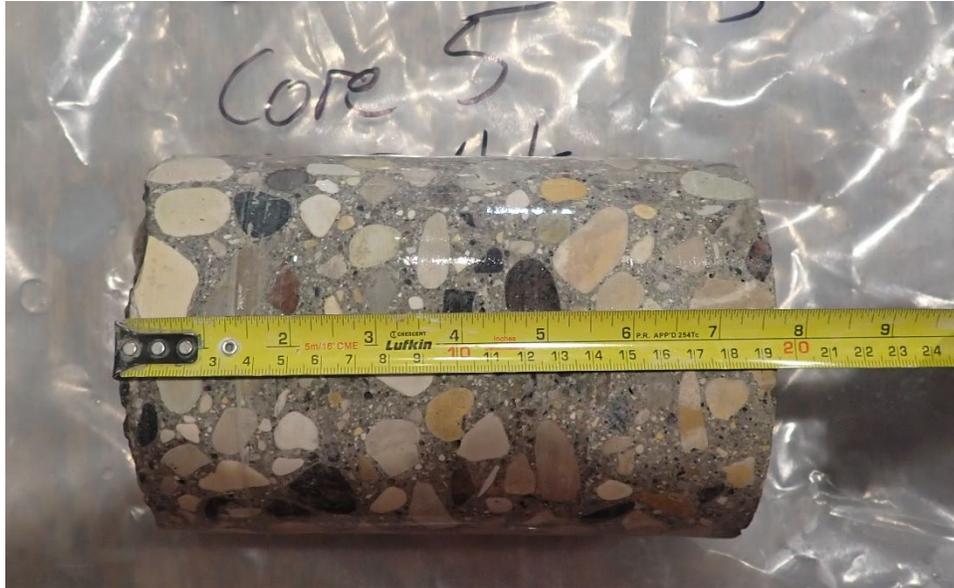
Photo 5: Core-05 (197 PCC)

1. The core sample represented by test no. 3 (Core-05) was trimmed prior to testing to avoid the reinforcing steel present.
