GEOTECHNICAL REPORT

2022 Local Streets Package 22-R-03

Project Number: 1000-043-18

Date: February 2, 2022

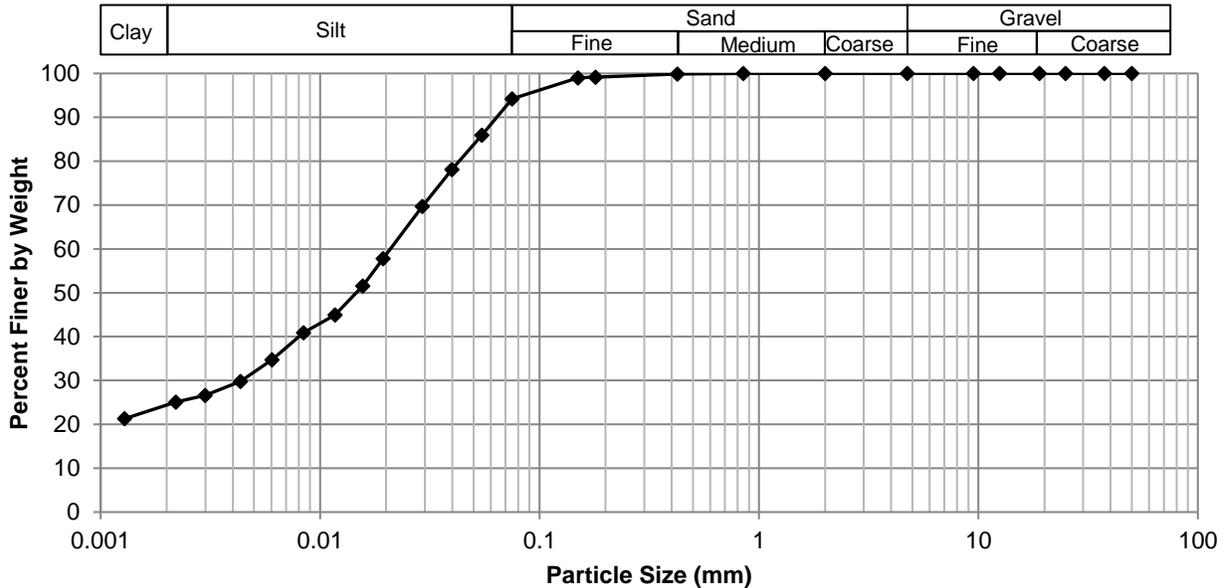
Particle Size Distribution Curve

Gravel	0.0%
Sand	5.8%
Silt	70.0%
Clay	24.3%

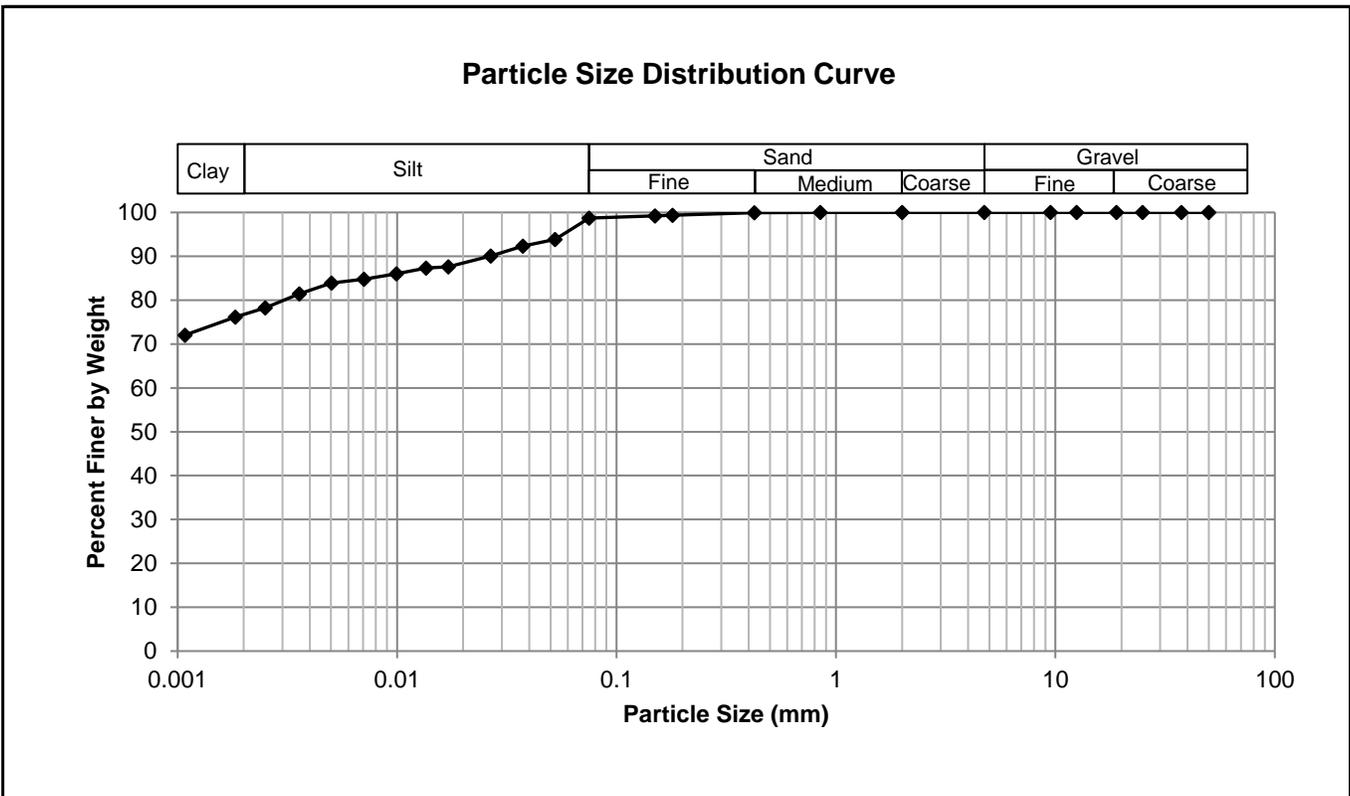
Test Hole TH22-03
Sample # G17
Depth (m) 0.8 - 0.9
Sample Date 20-Jan-22
Test Date 25-Jan-22
Technician AD

Gravel	0.0%
Sand	1.3%
Silt	22.0%
Clay	76.7%

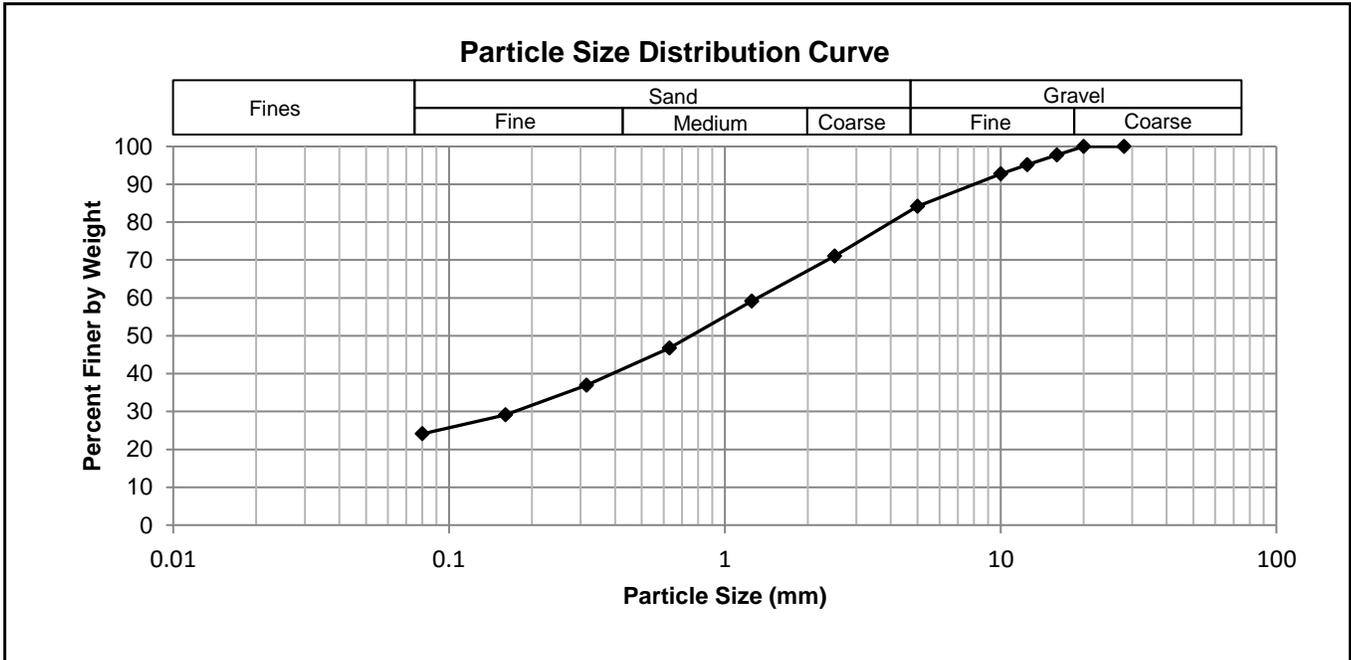
Test Hole TH22-05
Sample # G29
Depth 0.2-0.3
Date Sampled 20-Jan-22
Date Tested 25-Jan-22
Technician AD

Total Weight (g)	869.8
Gravel %	15.8
Sand %	60.1
Fines %	24.1

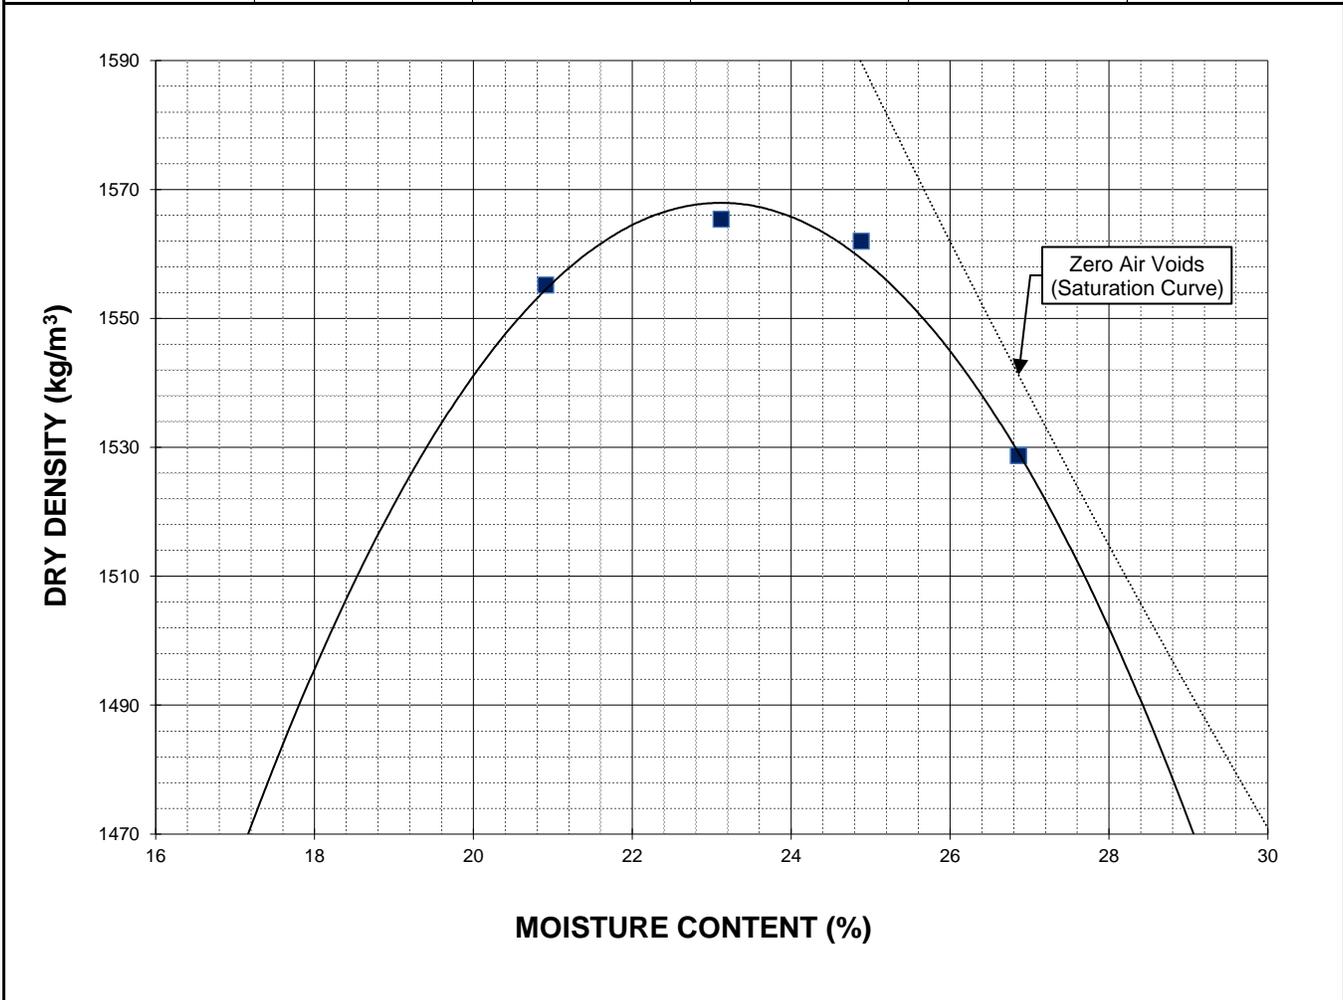
Maximum Dry Density (kg/m³)	1568
Optimum Moisture (%)	23.1

Trial Number	1	2	3	4
Wet Density (kg/m³)	1880	1927	1951	1939
Dry Density (kg/m³)	1555	1565	1562	1529
Moisture Content (%)	20.9	23.1	24.9	26.9

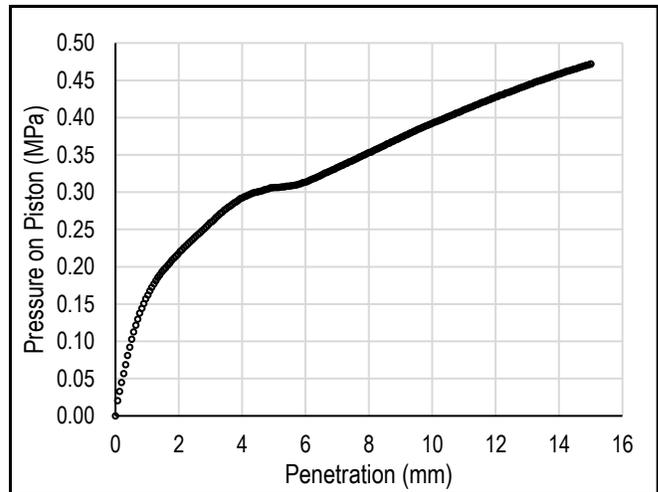
Load/Penetration Curve

Penetration (mm)	Measured Pressure (MPa)	Corrected Pressure (MPa)
0.64	0.12	0.12
1.27	0.18	0.18
1.91	0.21	0.21
2.54	0.24	0.24
3.18	0.27	0.27
3.81	0.29	0.29
4.45	0.30	0.30
5.08	0.31	0.31
7.62	0.35	0.35
10.16	0.40	0.40
12.70	0.44	0.44

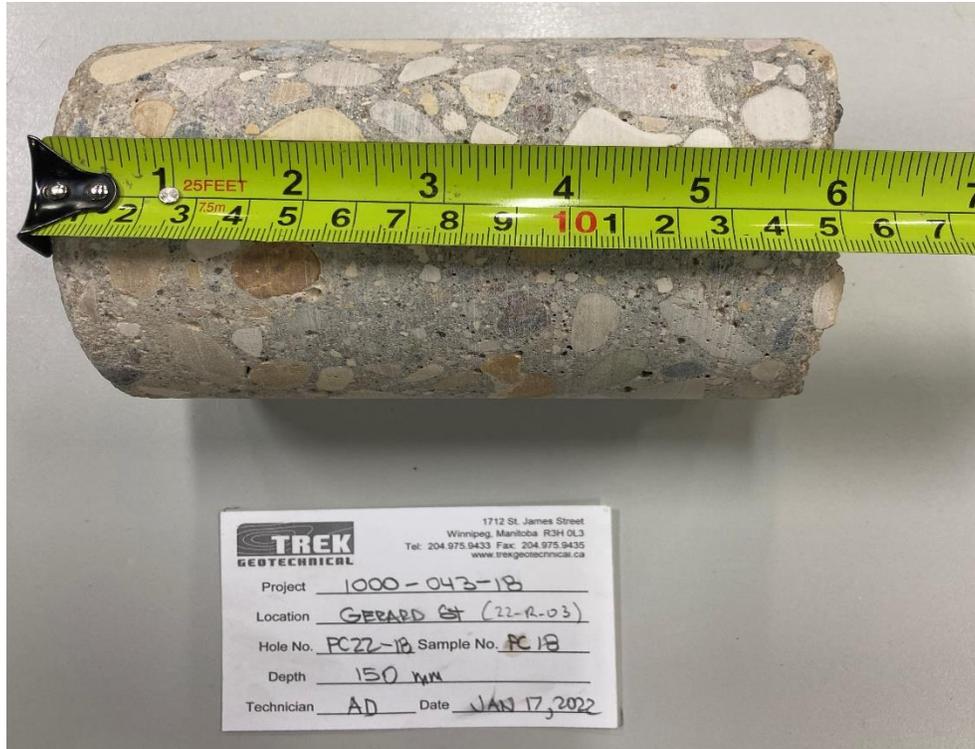
Photo 1: Pavement Core Sample at PC22-18

Pavement Core No.	Pavement Core Location	Pavement Surface		Pavement Structure Material		
		Type	Thickness (mm)	Type	Thickness (mm)	Corrected Compressive Strength (Mpa)
PC22-18	UTM : 5526760 m N, 633118 m E; Located in front of #102 Gerard St, Southbound lane, 2 m East of West curb.	Asphalt	-	Concrete	150	75.91
PC22-24	UTM : 5526790 m N, 633101 m E; Located 14 m South of Gerard St and River Ave intersection, Northbound lane, 1.5 m West of East curb.	Asphalt	-	Concrete	170	87.24
PC22-25	UTM : 5526700 m N, 633151 m E; Located 137 m South of Gerard St and River Ave intersection, Northbound lane, 1.5 m West of East curb.	Asphalt	-	Concrete	220	75.48

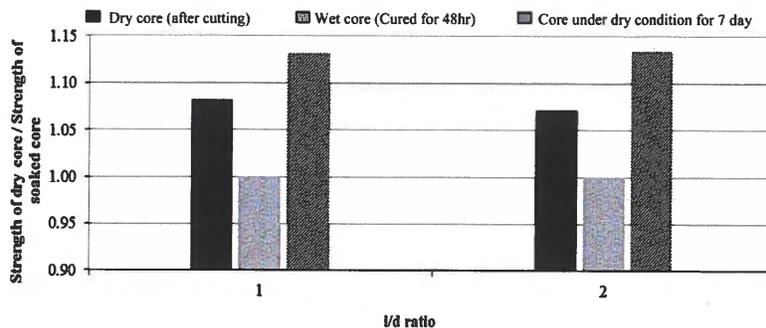
Results of about 100 cores indicate that the strength of cores left to dry in air for 7 days is on average 13% greater than that of cores soaked at least 40 h before testing. The strength of cores with negligible moisture gradient and tested after cutting is found to be 7–9% larger than that of soaked cores as shown in Fig. 20. The authors strongly recommend to use a correction factor accounting for moisture condition (F_m) equals to 1.09 and 0.96, respectively, for cores tested after 48 h soaked in water and for those tested after 7 days dry in air.

Figure 20 Effect of core moisture condition on core strength for different aspect ratios (l/d).

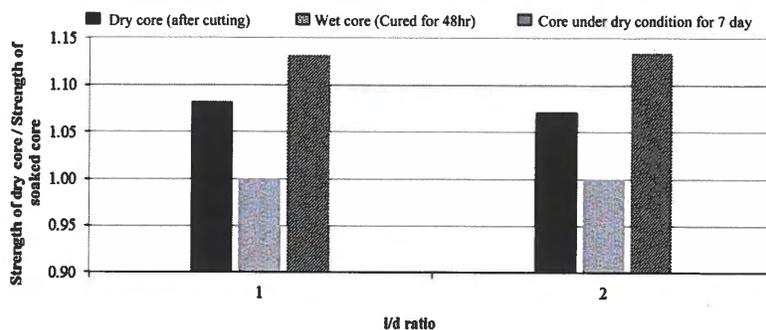
Results of about 100 cores indicate that the strength of cores left to dry in air for 7 days is on average 13% greater than that of cores soaked at least 40 h before testing. The strength of cores with negligible moisture gradient and tested after cutting is found to be 7–9% larger than that of soaked cores as shown in Fig. 20. The authors strongly recommend to use a correction factor accounting for moisture condition (F_m) equals to 1.09 and 0.96, respectively, for cores tested after 48 h soaked in water and for those tested after 7 days dry in air.

Figure 20 Effect of core moisture condition on core strength for different aspect ratios (l/d).

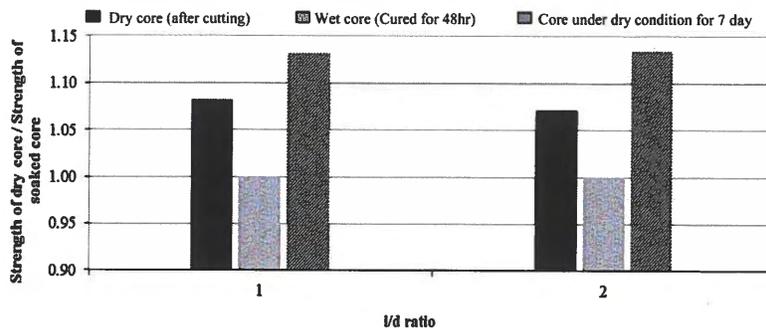
Results of about 100 cores indicate that the strength of cores left to dry in air for 7 days is on average 13% greater than that of cores soaked at least 40 h before testing. The strength of cores with negligible moisture gradient and tested after cutting is found to be 7–9% larger than that of soaked cores as shown in Fig. 20. The authors strongly recommend to use a correction factor accounting for moisture condition (F_m) equals to 1.09 and 0.96, respectively, for cores tested after 48 h soaked in water and for those tested after 7 days dry in air.

Figure 20 Effect of core moisture condition on core strength for different aspect ratios (l/d).
