APPENDIX 'A'

GEOTECHNICAL REPORT

APPENDIX 'A' - GEOTECHNICAL REPORT

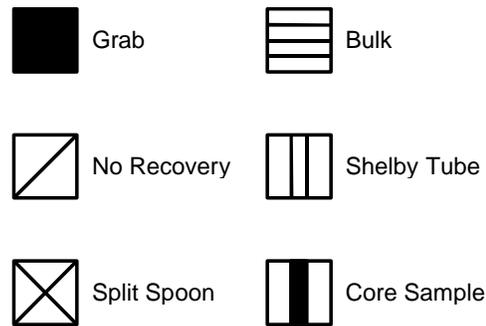
The depth, type, and condition of samples are indicated on the logs by the following symbols:

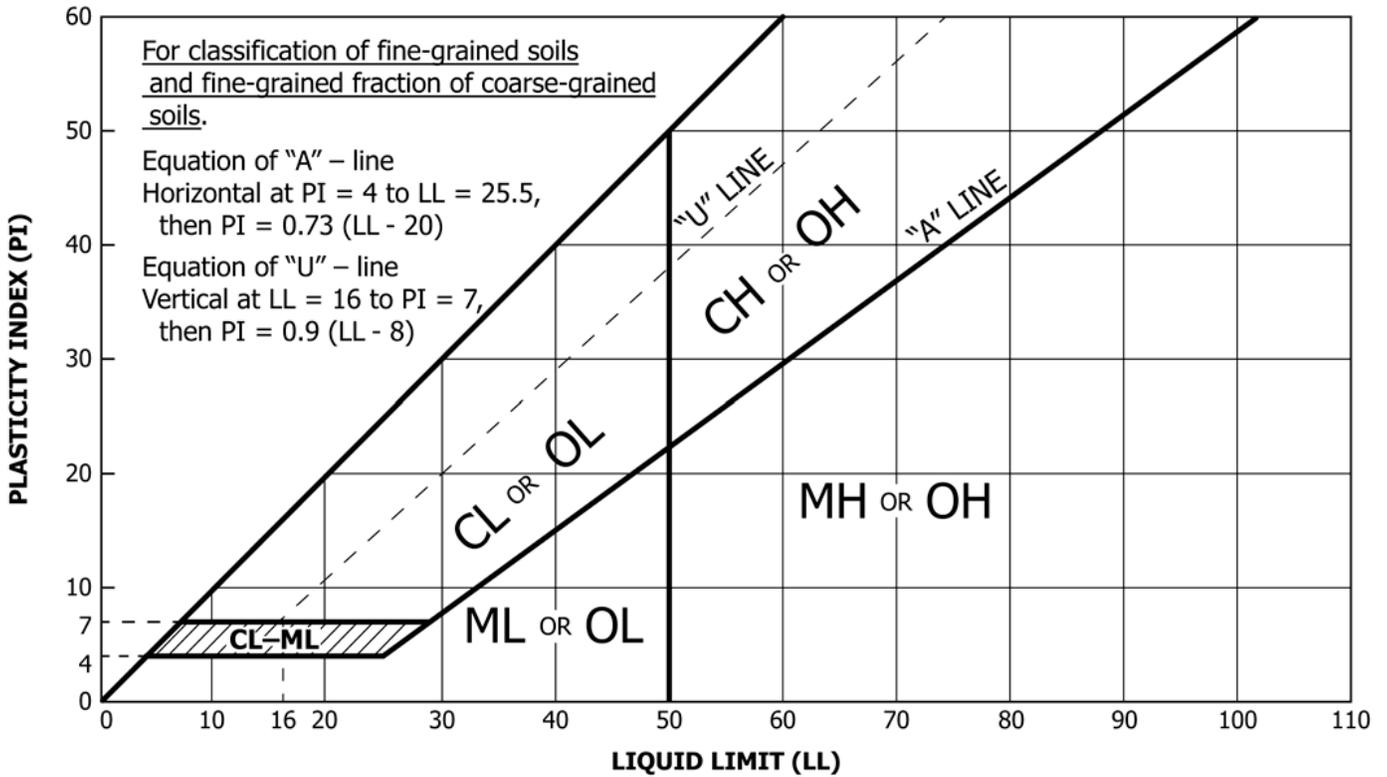
FIG. 4 Plasticity Chart

The relationship between the natural moisture content and depth is significant in determining the subsurface moisture conditions. The Atterberg Limits for a sample should be compared to its natural moisture content and plotted on the Plasticity Chart in order to determine the soil classification.

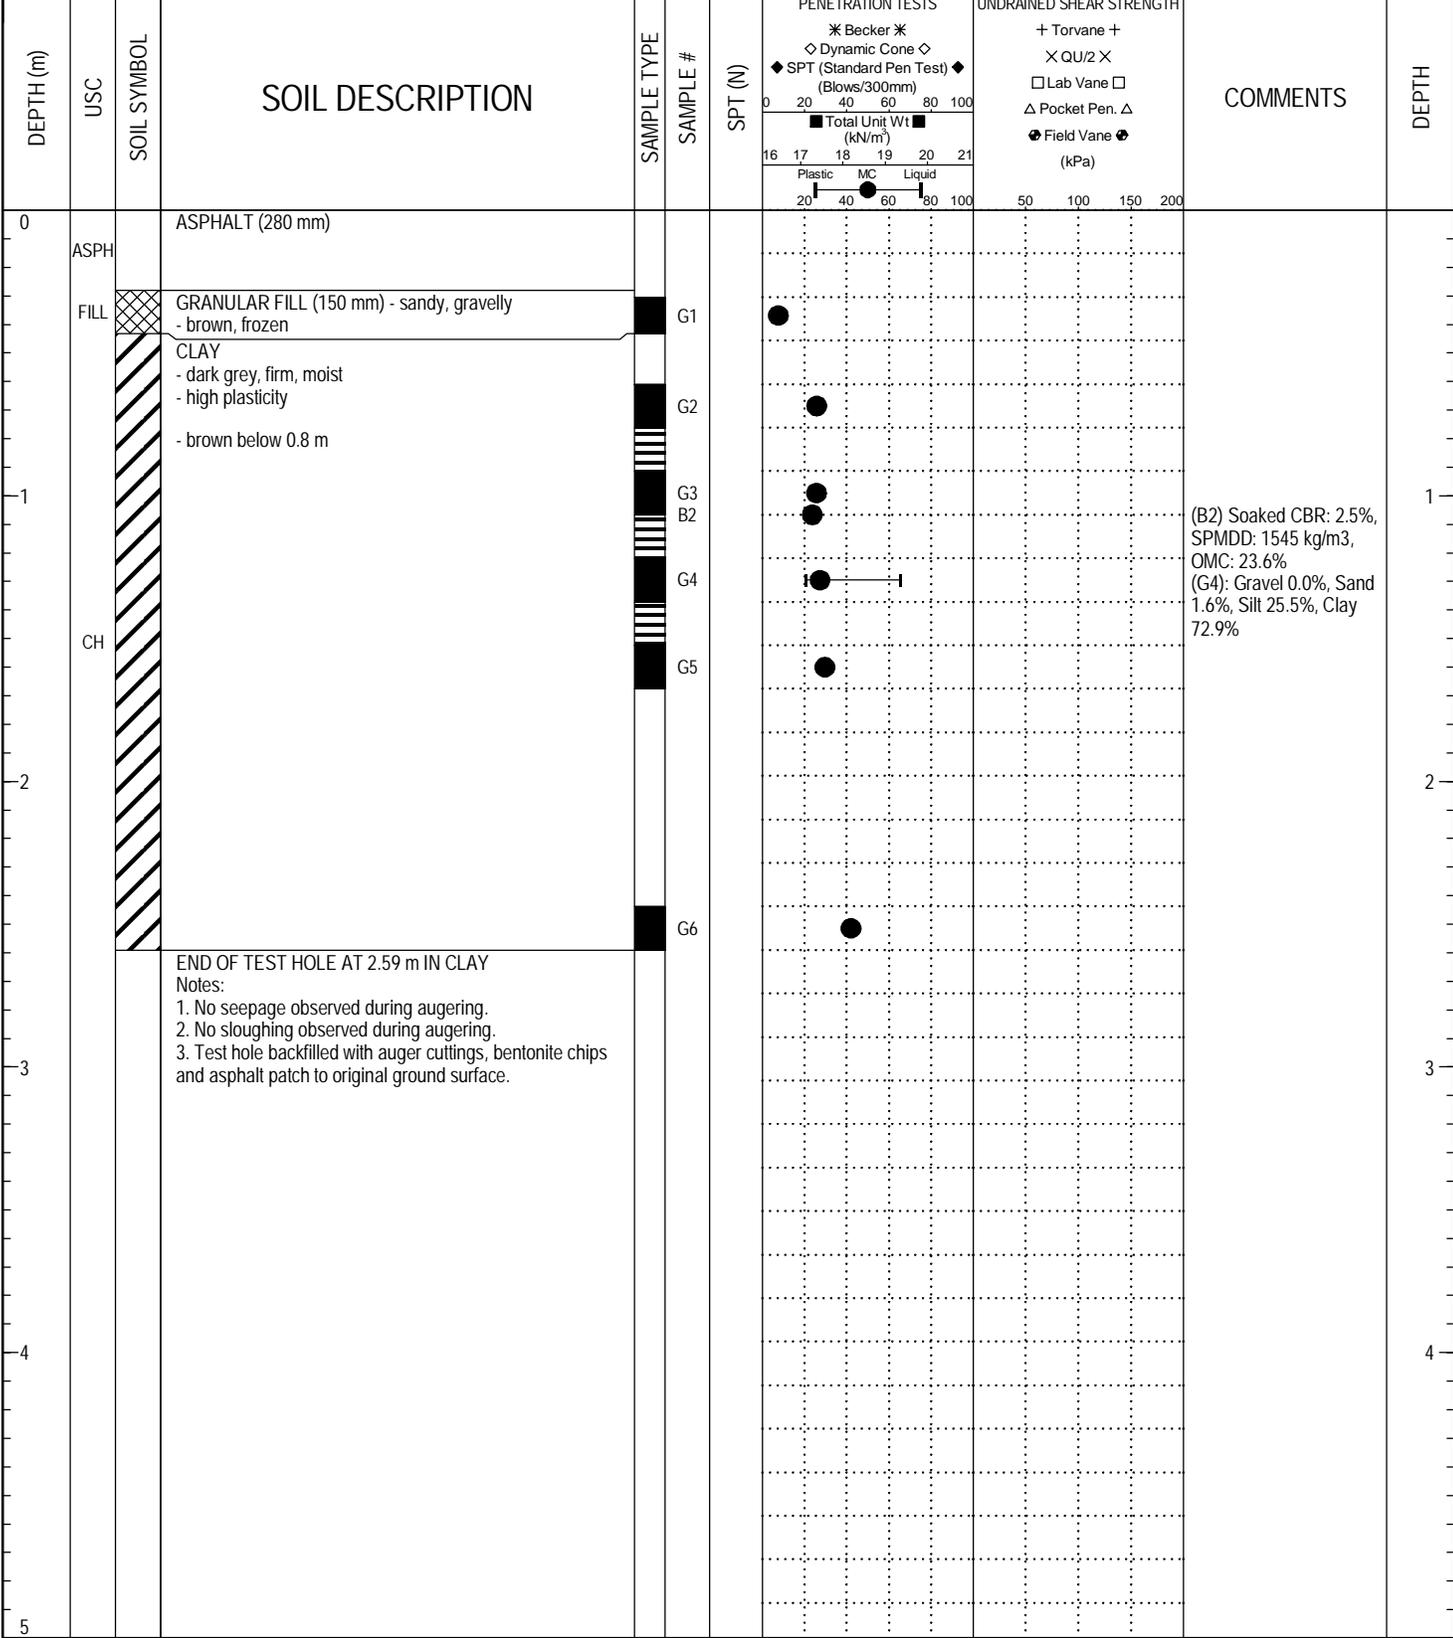
PROJECT: 2022 Local Streets Package No. 22-R-02 CLIENT: City of Winnipeg TESTHOLE NO: TH21-04B
 LOCATION: 1480 Chancellor Dr. - 2.6 m S of N curb PROJECT NO.: 60672214
 CONTRACTOR: Paddock Drilling Ltd. METHOD: Track Rig - 125 mm SSA ELEVATION (m):

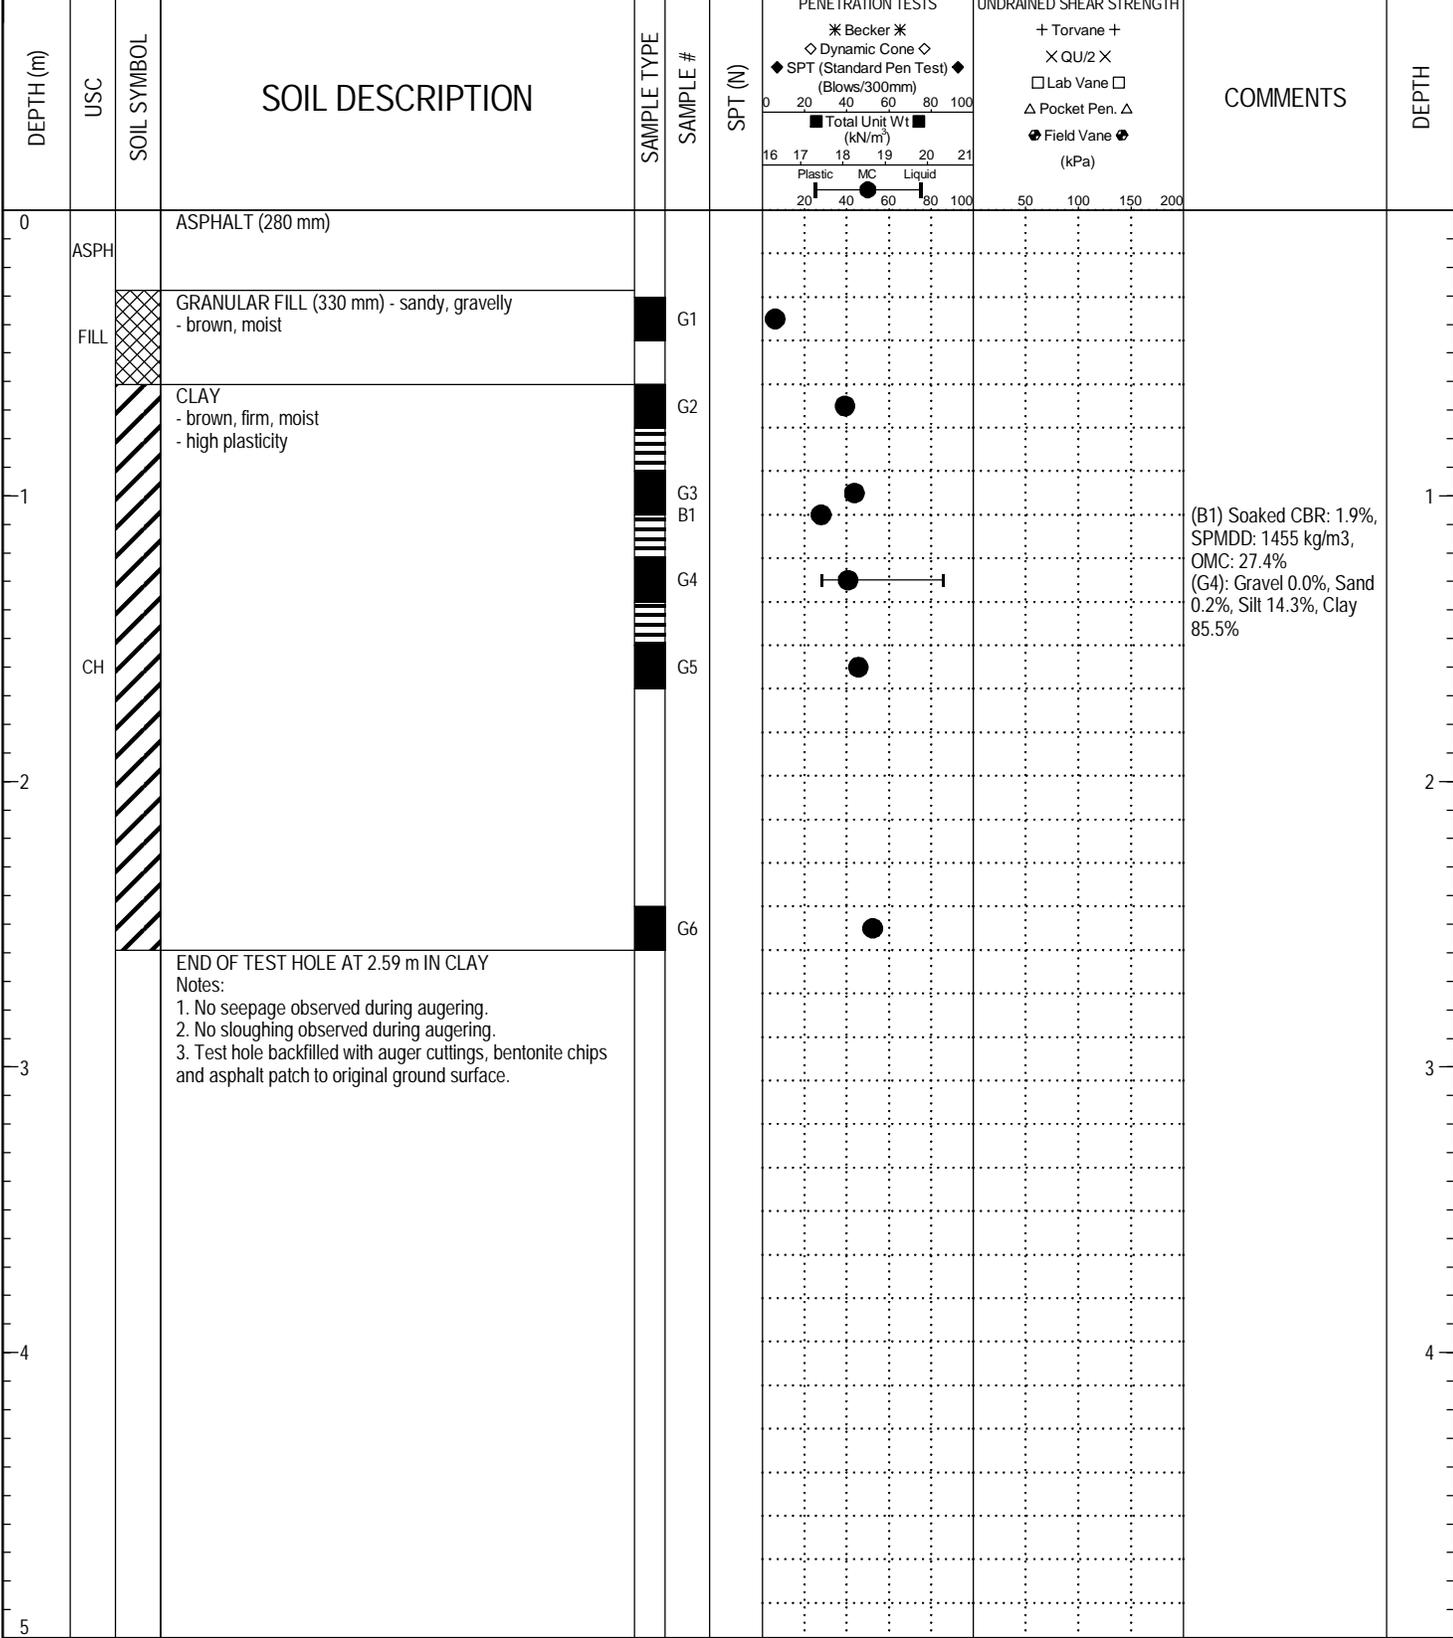
PROJECT: 2022 Local Streets Package No. 22-R-02 CLIENT: City of Winnipeg TESTHOLE NO: TH21-01E
 LOCATION: 7 Lakeshore Rd. - 1.8 m E of W curb PROJECT NO.: 60672214
 CONTRACTOR: Paddock Drilling Ltd. METHOD: Track Rig - 125 mm SSA ELEVATION (m):

END OF TEST HOLE AT 2.59 m IN CLAY
 Notes:
 1. No seepage observed during augering.
 2. No sloughing observed during augering.
 3. Test hole backfilled with auger cuttings, bentonite chips and asphalt patch to original ground surface.

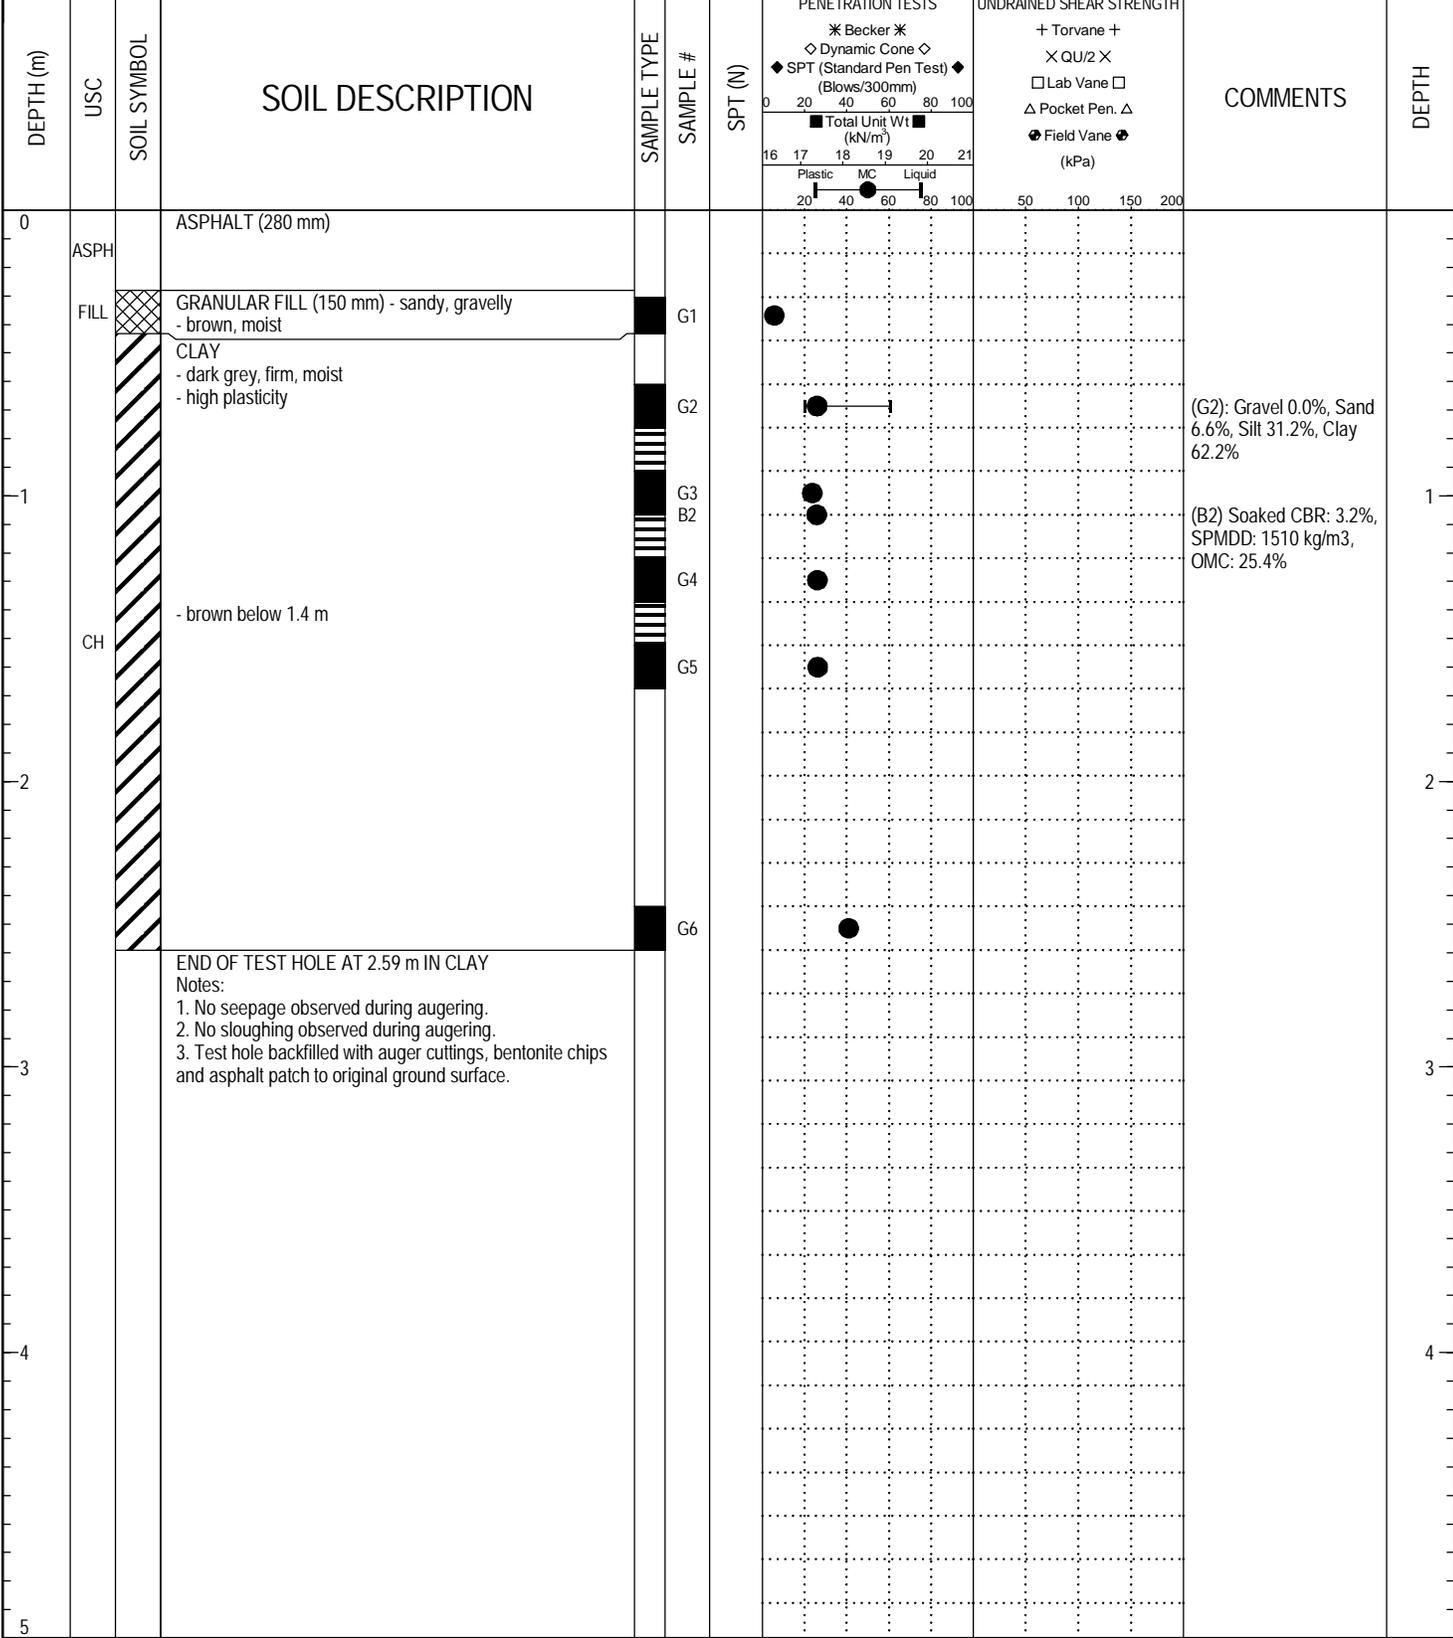
PROJECT: 2022 Local Streets Package No. 22-R-02 CLIENT: City of Winnipeg TESTHOLE NO: TH21-03E
 LOCATION: 83 Lakeshore Rd. - 2.4 m S of N curb PROJECT NO.: 60672214
 CONTRACTOR: Paddock Drilling Ltd. METHOD: Track Rig - 125 mm SSA ELEVATION (m):

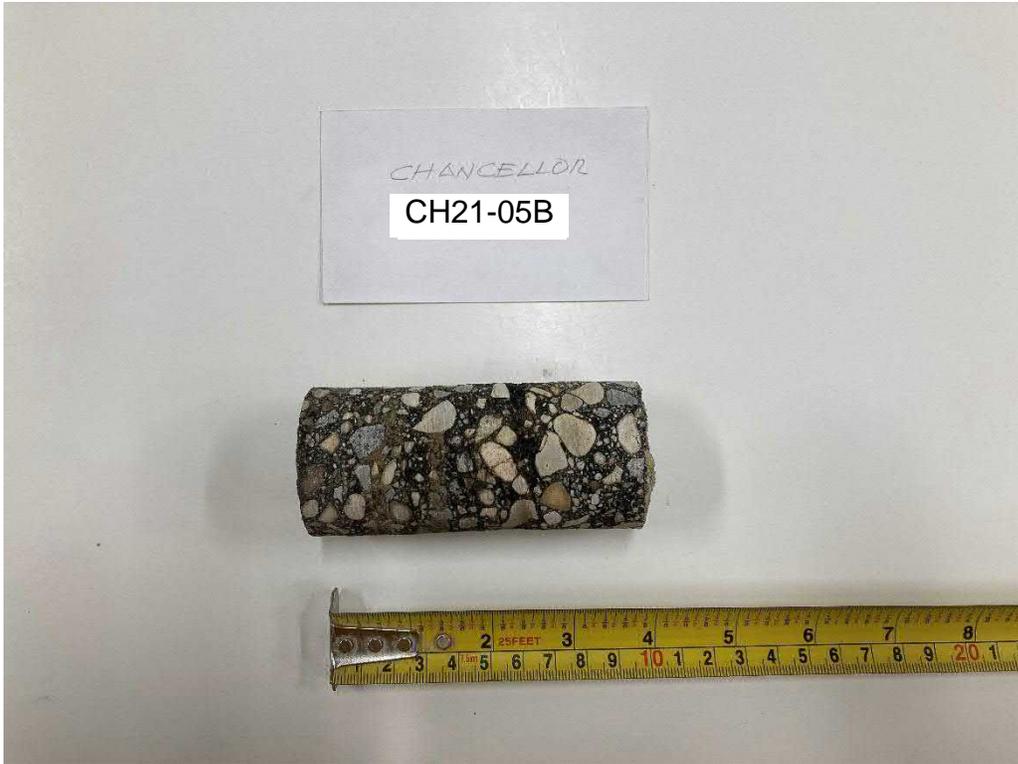
Photograph 14: CH21-05B - Chancellor Drive

Test Hole No.	Test Hole Location	Pavement Structure		Remarks	Subgrade Description *	Sample Depth (m)	Moisture Content (%)	Hydrometer Analysis				Atterberg Limits		
		Type	Thickness (mm)					Gravel (%)	Sand (%)	Silt (%)	Clay (%)	Liquid Limit (%)	Plastic Limit (%)	Plasticity Index (%)
CH21-03B	1488 Chancellor Dr. – 2.8 m S of N curb (Pavement Slab)	Asphalt	120											
		Concrete	0											
CH21-04B	1477 Chancellor Dr. – 1.6 m N of S curb (Pavement Slab)	Asphalt	125											
		Concrete	0											
CH21-05B	1398 Chancellor Dr. – 2.4 m W of E curb (Pavement Slab)	Asphalt	95											
		Concrete	0

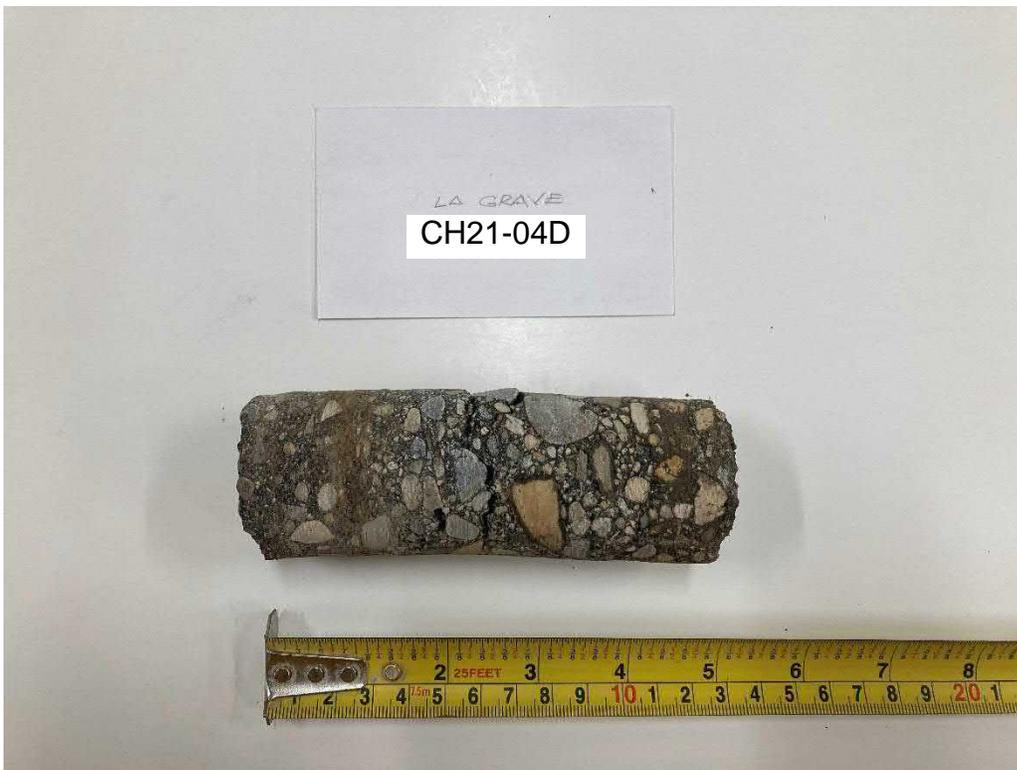
Photograph 23: CH21-04D - La Grave Street

Test Hole No.	Test Hole Location	Pavement Structure		Remarks	Subgrade Description *	Sample Depth (m)	Moisture Content (%)	Hydrometer Analysis				Atterberg Limits		
		Type	Thickness (mm)					Gravel (%)	Sand (%)	Silt (%)	Clay (%)	Liquid Limit (%)	Plastic Limit (%)	Plasticity Index (%)
CH21-01D	5 La Grave St. – 1.8 m E of W curb (Pavement Slab)	Asphalt	60											
		Concrete	0											
CH21-02D	18 La Grave St. – 2.5 m W of E curb (Pavement Slab)	Asphalt	70											
		Concrete	0											
CH21-03D	25 La Grave St. – 1.5 m E of W curb (Pavement Slab)	Asphalt	70											
		Concrete	0											
CH21-04D	38 La Grave St. – 1.6 m W of E curb (Pavement Slab)	Asphalt	120											
		Concrete	0

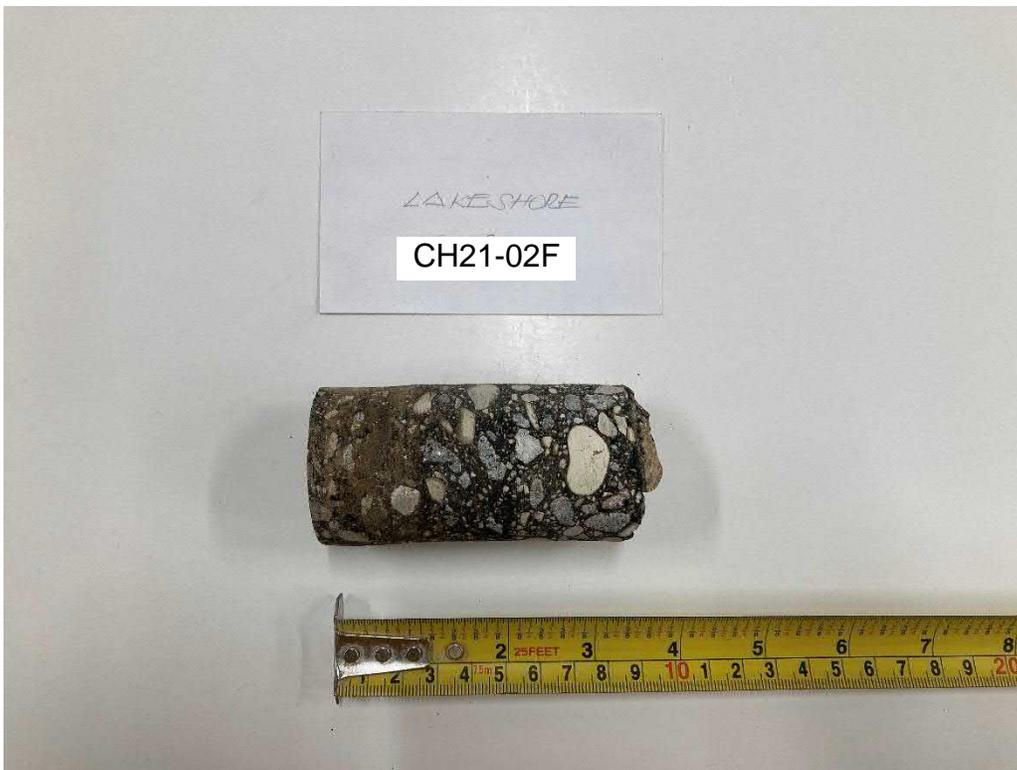
Photograph 30: CH21-02F - Lakeshore Road (Frontage)

Hole No.	Test Hole Location	Pavement Structure		Remarks	Subgrade Description *	Sample Depth (m)	Moisture Content (%)	Hydrometer Analysis				Atterberg Limits		
		Type	Thickness (mm)					Gravel (%)	Sand (%)	Silt (%)	Clay (%)	Liquid Limit (%)	Plastic Limit (%)	Plasticity Index (%)
TH21-01F	31 Lakeshore Rd. - 2.5 m E of W curb (Pavement Slab)	Asphalt	240		GRANULAR FILL	0.3	11.9							
					CLAY (CL)	0.6	19.0	0.0	4.0	51.6	44.4	45.7	15.4	30.3
		Concrete	0		CLAY (CL)	0.9	13.6							
					CLAY (CH)	1.2	14.9							
		Granular Fill	215		CLAY (CH)	1.5	23.8							
					CLAY (CH)	2.4	41.1							
CH21-01F	31 Lakeshore Rd. – 4.0 m E of W curb (Pavement Slab)	Asphalt	120											
		Concrete	0											
CH21-02F	51 Lakeshore Rd. – 2.0 m W of E curb (Pavement Slab)	Asphalt	90											
		Concrete	0

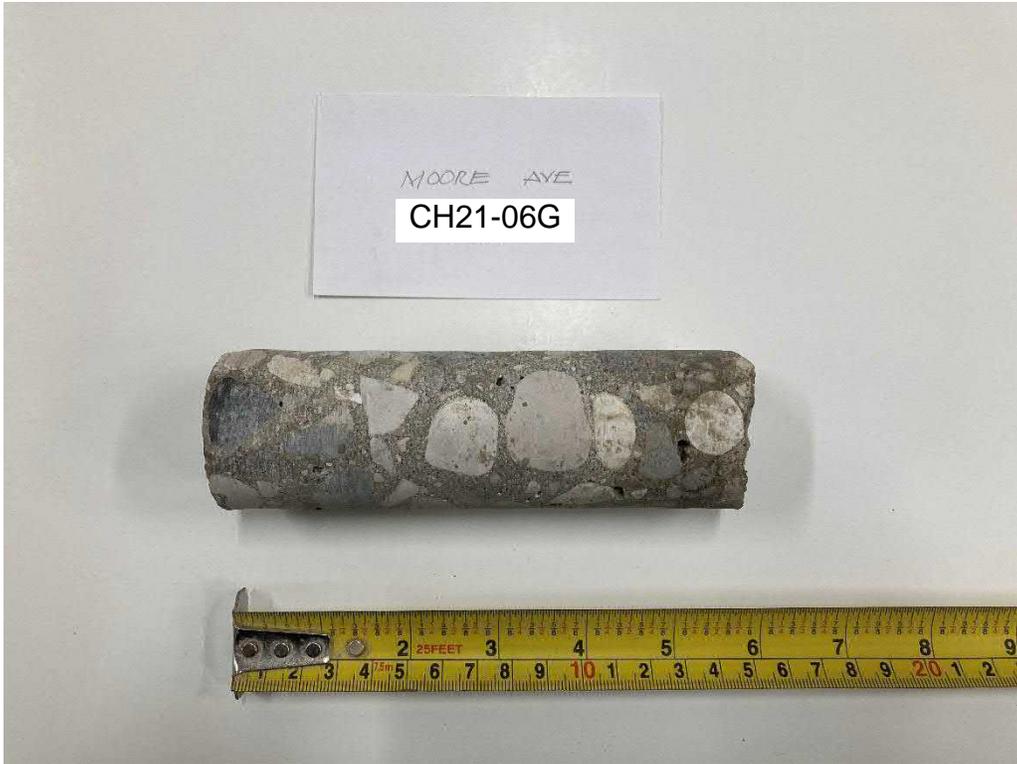
Photograph 35: CH21-06G - Moore Avenue

Test Hole No.	Test Hole Location	Pavement Structure		Remarks	Subgrade Description *	Sample Depth (m)	Moisture Content (%)	Hydrometer Analysis				Atterberg Limits		
		Type	Thickness (mm)					Gravel (%)	Sand (%)	Silt (%)	Clay (%)	Liquid Limit (%)	Plastic Limit (%)	Plasticity Index (%)
CH21-01G	Moore Ave., W bound, beside Galaxy Printing – 2.2 m S of N Curb (Pavement Joint)	Asphalt	0											
		Concrete	165											
CH21-02G	20 Moore Ave. – 1.9 m N of S Curb (Pavement Slab)	Asphalt	0											
		Concrete	160											
CH21-03G	25 Moore Ave. – 1.6 m S of N Curb (Pavement Slab)	Asphalt	0											
		Concrete	165											
CH21-04G	29 Moore Ave. – 1.8 m S of N Curb (Pavement Slab)	Asphalt	0											
		Concrete	150											
CH21-05G	36 Moore Ave. – 2.0 m N of S Curb (Pavement Joint)	Asphalt	0											
		Concrete	140											
CH21-06G	39 Moore Ave. – 1.8 m S of N Curb (Pavement Slab)	Asphalt	0

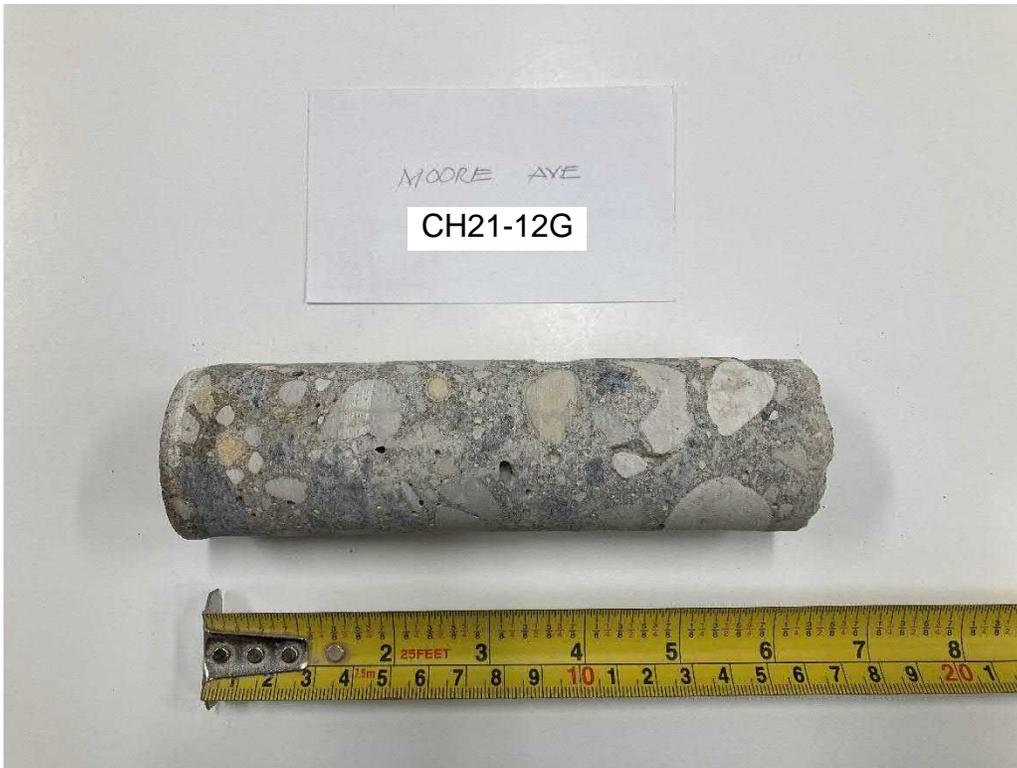
Photograph 40: CH21-12G - Moore Avenue

Test Hole No.	Test Hole Location	Pavement Structure		Remarks	Subgrade Description *	Sample Depth (m)	Moisture Content (%)	Hydrometer Analysis				Atterberg Limits		
		Type	Thickness (mm)					Gravel (%)	Sand (%)	Silt (%)	Clay (%)	Liquid Limit (%)	Plastic Limit (%)	Plasticity Index (%)
CH21-07G	42 Moore Ave. – 2.1 m N of S Curb (Pavement Slab)	Asphalt	0											
		Concrete	175											
CH21-08G	47 Moore Ave. – 2.0 m S of N Curb (Pavement Slab)	Asphalt	0											
		Concrete	140											
CH21-09G	50 Moore Ave. – 2.0 m N of S Curb (Pavement Slab)	Asphalt	0											
		Concrete	140											
CH21-10G	61 Moore Ave. – 2.0 m S of N Curb (Pavement Joint)	Asphalt	0											
		Concrete	110	No recovery. Specimen decomposed to granular and irretrievable										
CH21-11G	66 Moore Ave. – 1.8 m N of S Curb (Pavement Slab)	Asphalt	0											
		Concrete	190											
CH21-12G	81 Moore Ave. – 2.6 m S of N Curb (Pavement Slab)	Asphalt	0

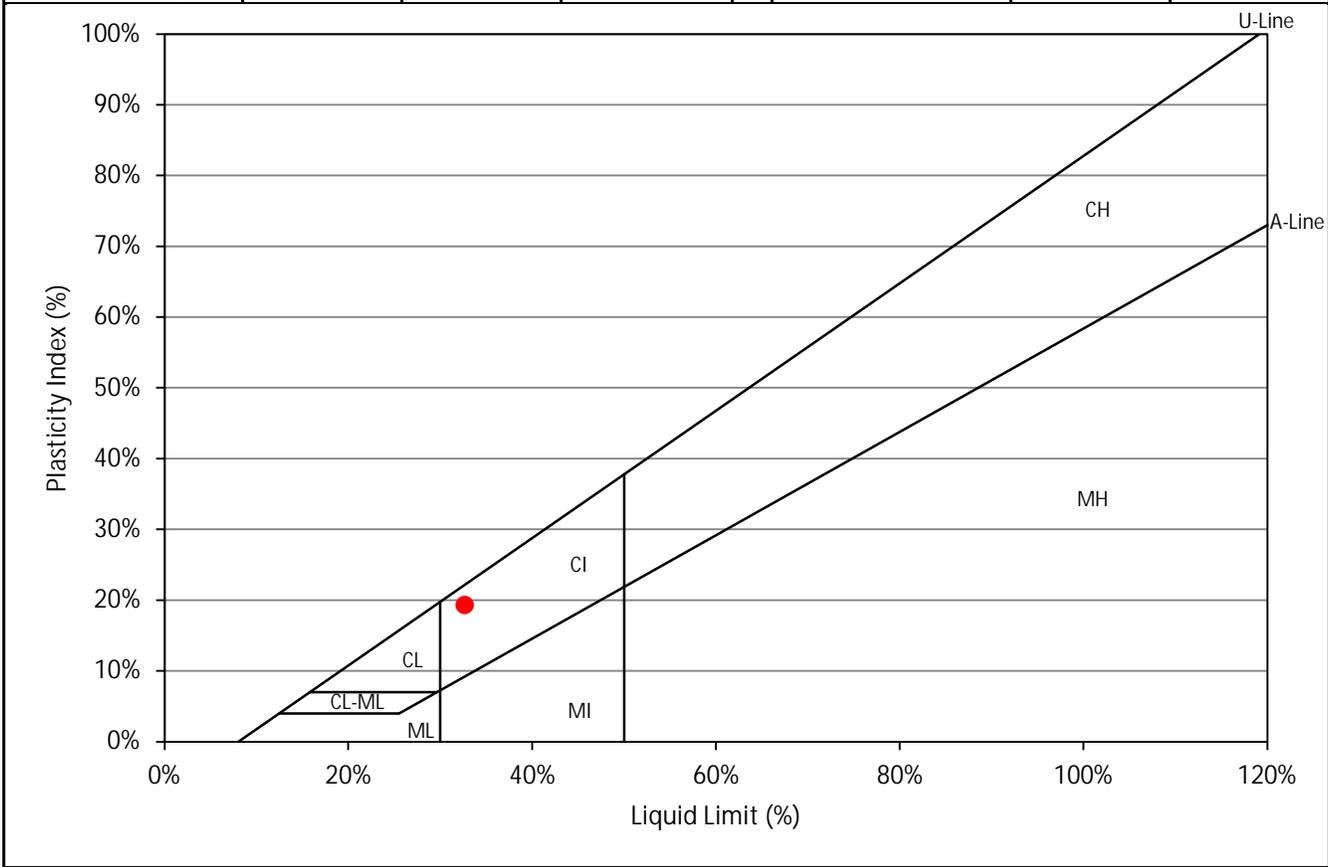
Liquid Limit			
Blows	34	25	16
Wet Sample (g)	9.4	8.7	10.7
Dry Sample (g)	7.2	6.6	7.9
Water Content (%)	31.1%	32.6%	35.0%

Plastic Limit		
Trial	1	2
Wet Sample (g)	6.2	7.7
Dry Sample (g)	5.5	6.8
Water Content (%)	13.6%	13.1%

Liquid Limit (%): 32.7%	Plastic Limit (%): 13.3%	Plasticity Index (%): 19.3%
-------------------------	--------------------------	-----------------------------

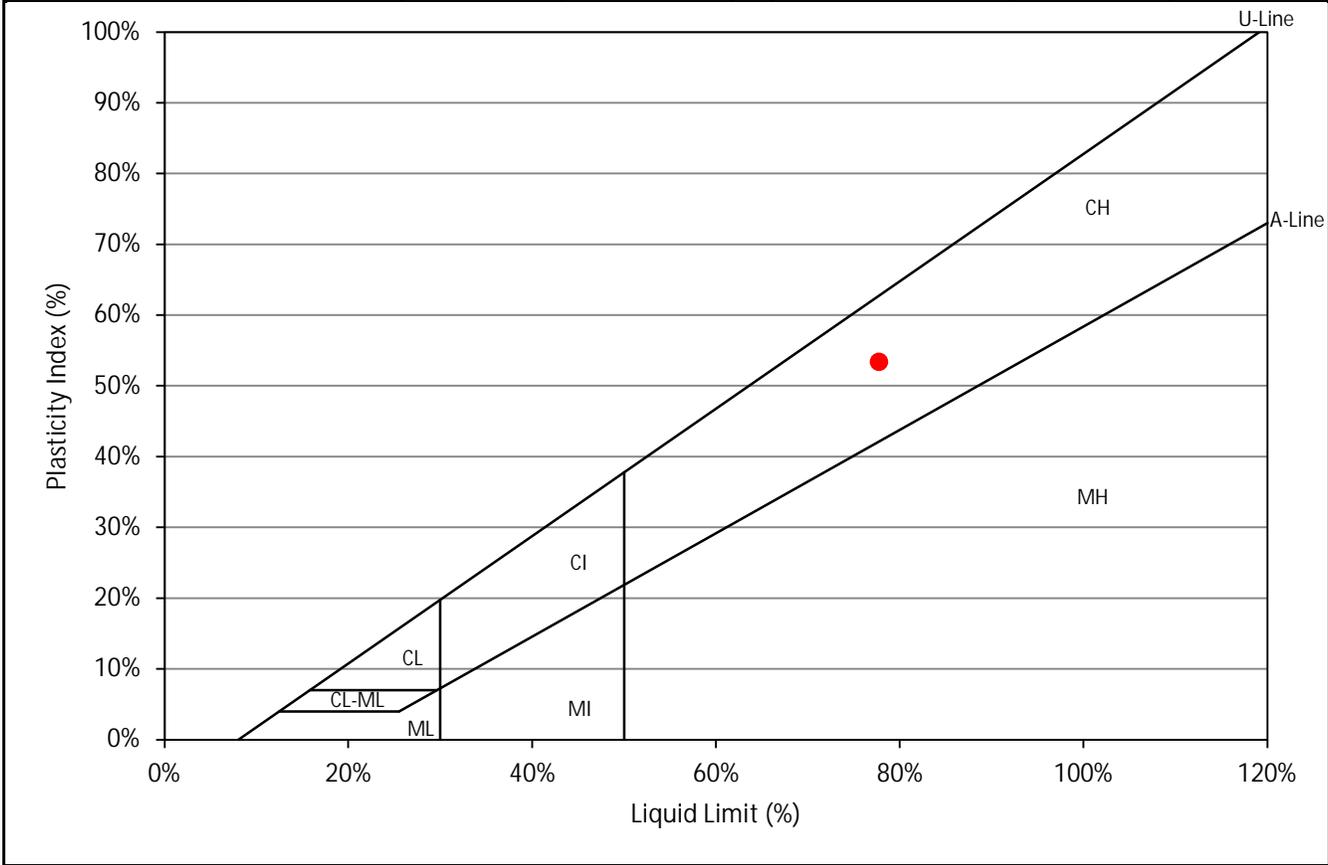
Liquid Limit		
Blows	34	29	24
Wet Sample (g)	8.6	9.7	7.4
Dry Sample (g)	5.0	5.5	4.2
Water Content (%)	73.3%	75.6%	78.5%

Plastic Limit	
Trial	1	2
Wet Sample (g)	7.6	7.6
Dry Sample (g)	6.1	6.1
Water Content (%)	24.4%	24.4%

Liquid Limit (%): 77.7% Plastic Limit (%): 24.4% Plasticity Index (%): 53.4%

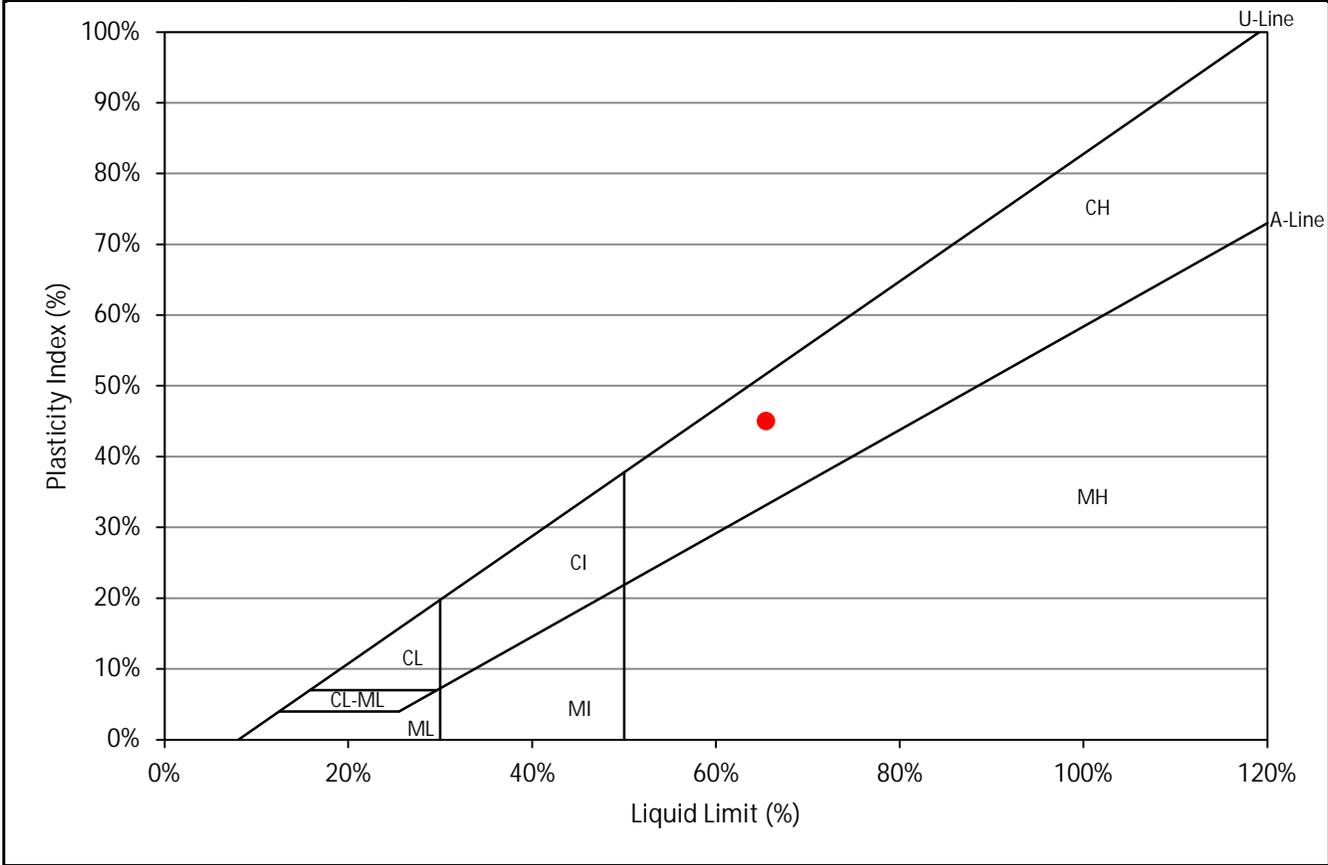
Liquid Limit		
Blows	35	29	20
Wet Sample (g)	8.0	8.6	9.0
Dry Sample (g)	5.0	5.3	5.4
Water Content (%)	62.3%	64.1%	67.6%

Plastic Limit	
Trial	1	2
Wet Sample (g)	7.2	6.7
Dry Sample (g)	5.9	5.6
Water Content (%)	20.7%	20.1%

Liquid Limit (%): 65.4% Plastic Limit (%): 20.4% Plasticity Index (%): 45.0%

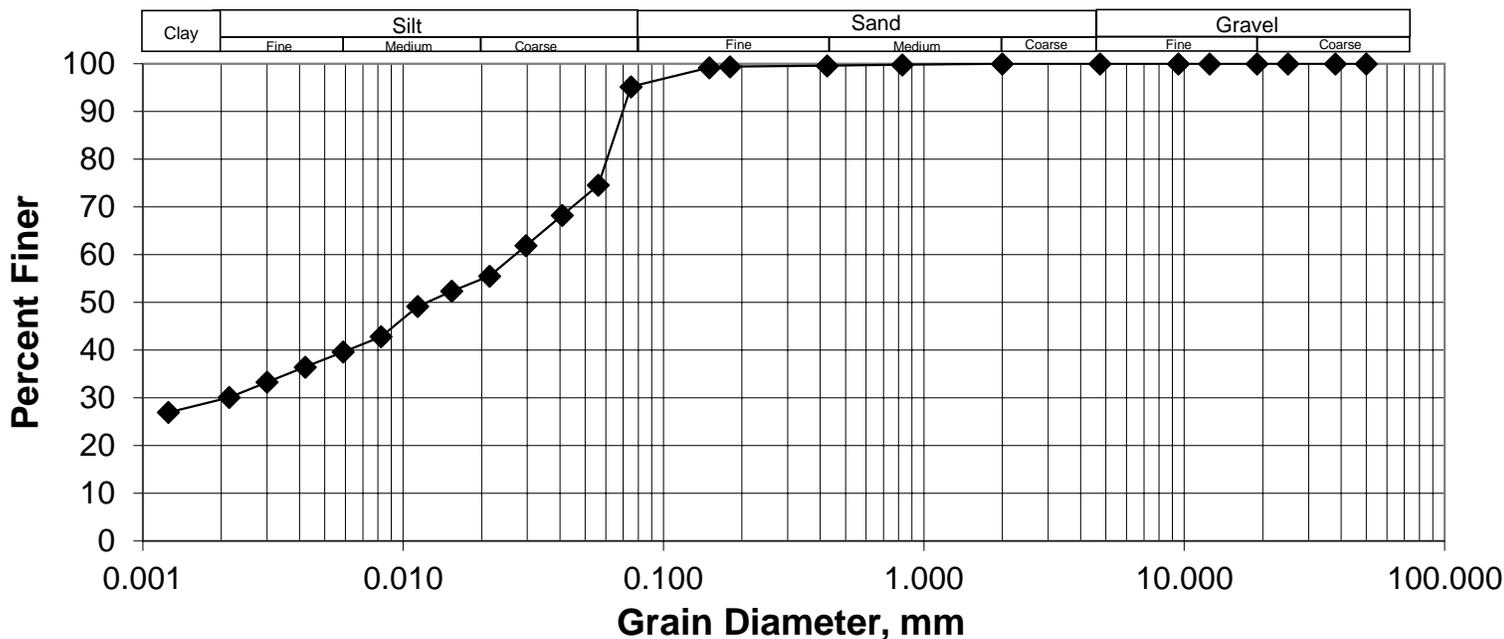
GRAIN SIZE DISTRIBUTION CURVE

GRAVEL SIZES		SAND SIZES		FINES	
Grain Size (mm.)	Total Percent Passing	Grain Size (mm.)	Total Percent Passing	Grain Size (mm.)	Total Percent Passing
50.0	100.0	4.75	100.0	0.0750	95.2
38.0	100.0	2.00	100.0	0.0561	74.6
25.0	100.0	0.825	99.8	0.0408	68.2
19.0	100.0	0.425	99.6	0.0296	61.9
12.5	100.0	0.18	99.4	0.0215	55.5
9.5	100.0	0.15	99.2	0.0154	52.3
4.75	100.0	0.075	95.2	0.0114	49.2
				0.0082	42.8
				0.0059	39.6
				0.0042	36.5
				0.0030	33.3
				0.0021	30.1
				0.0013	26.9

Gravel	0.0%	Silt	65.6%
Sand	4.8%	Clay	29.6%

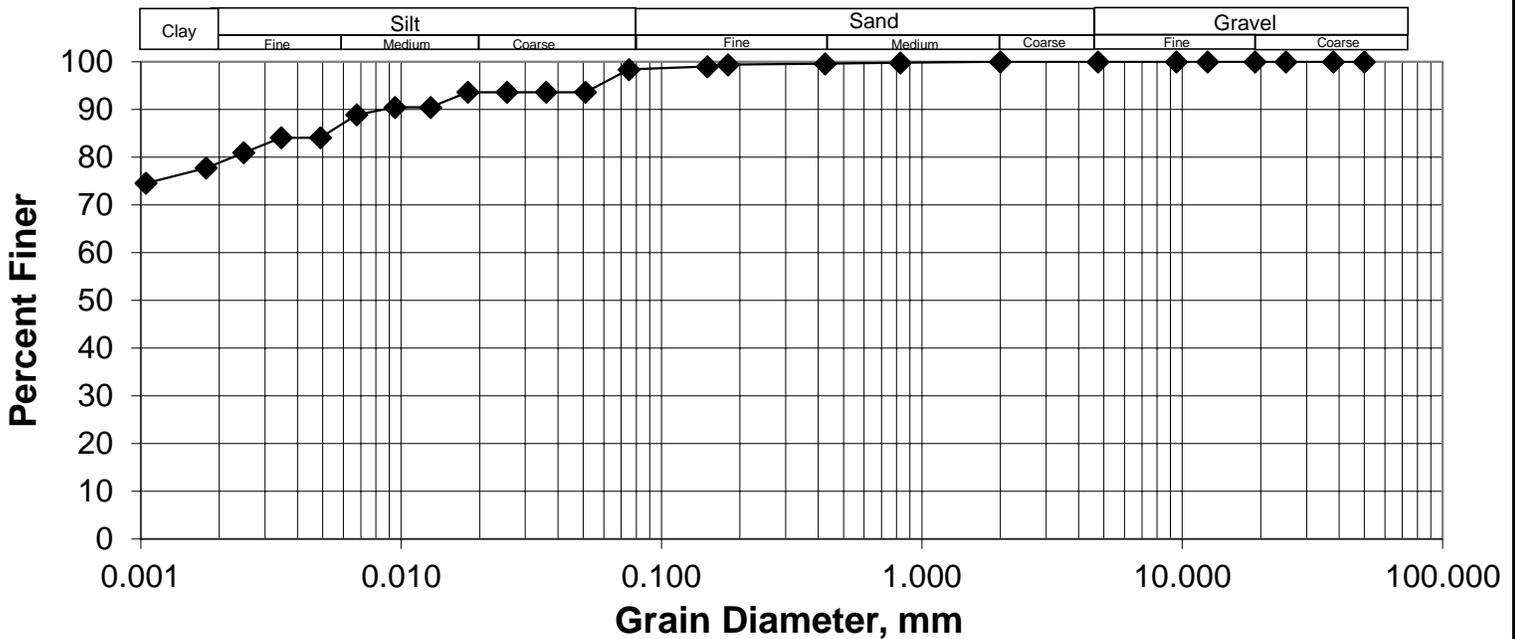
GRAIN SIZE DISTRIBUTION CURVE

GRAVEL SIZES		SAND SIZES		FINES	
Grain Size (mm.)	Total Percent Passing	Grain Size (mm.)	Total Percent Passing	Grain Size (mm.)	Total Percent Passing
50.0	100.0	4.75	100.0	0.0750	98.4
38.0	100.0	2.00	100.0	0.0510	93.6
25.0	100.0	0.825	99.8	0.0360	93.6
19.0	100.0	0.425	99.6	0.0255	93.6
12.5	100.0	0.18	99.4	0.0180	93.6
9.5	100.0	0.15	99.0	0.0130	90.5
4.75	100.0	0.075	98.4	0.0095	90.5
				0.0067	88.9
				0.0049	84.1
				0.0035	84.1
				0.0025	80.9
				0.0018	77.8
				0.0010	74.6

Gravel	0.0%	Silt	19.7%
Sand	1.6%	Clay	78.7%

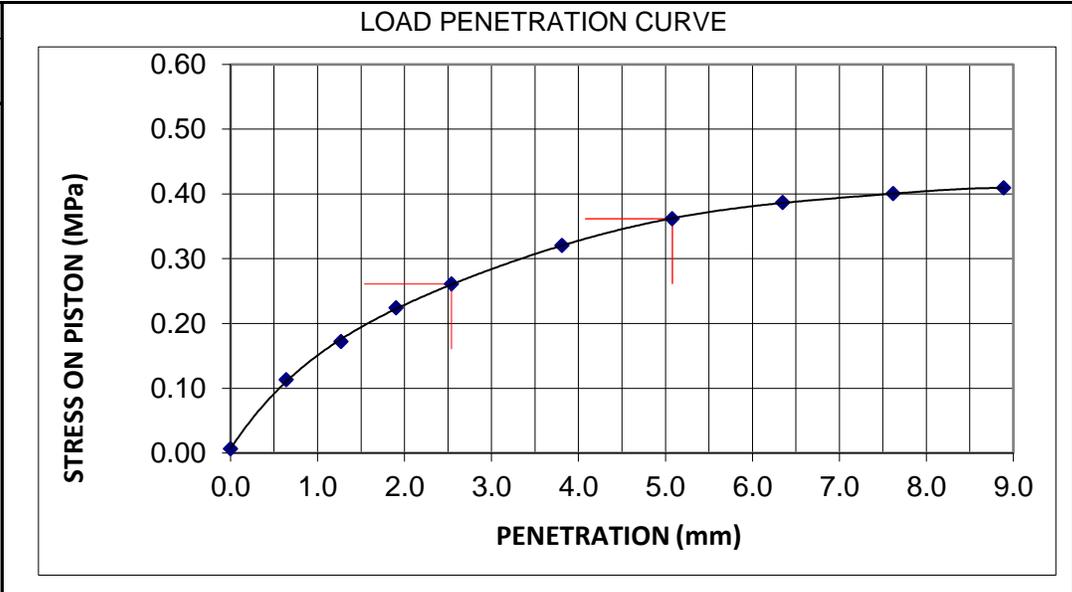
CALIFORNIA BEARING RATIO (CBR) TEST - ASTM D 1883

SAMPLE DATA		SPECIMEN DATA		
Sample Type:	Clay	DESCRIPTION	Before Soaking	After Testing
Source:	TH21-01, B1 2'-5'	Moisture Content (MC), %	18.9	
Sampled by:	Client	MC of top 25mm layer, %		23.3
Optimum Moisture Content:	18.4 %	Dry Density, kg/m ³	1684	
Maximum Dry Density:	1721 kg/cm ³	Compaction, %	98%	
Method of Compaction:	Standard Proctor	CBR, %	3.8	
Tested by:	ECS	Swell, %	1.3	
	Date Tested: 08-Feb-22

LOAD DATA	
PENETRATION mm	STRESS MPa
0	0.01
0.64	0.11
1.27	0.17
1.91	0.22
2.54	0.26
3.81	0.32
5.08	0.36
6.35	0.39
7.62	0.40
8.89	0.41

PENETRATION mm	STANDARD LOAD MPa	TEST LOAD		BEARING RATIO (soaked)	
		ACTUAL MPa	CORRECTED MPa	at 2.5 mm penetration	at 5.1 mm penetration
2.54	6.9	0.26	0.26	3.8	-
5.08	10.3	0.36	0.36	-	3.5

Remarks: 4 days soaked

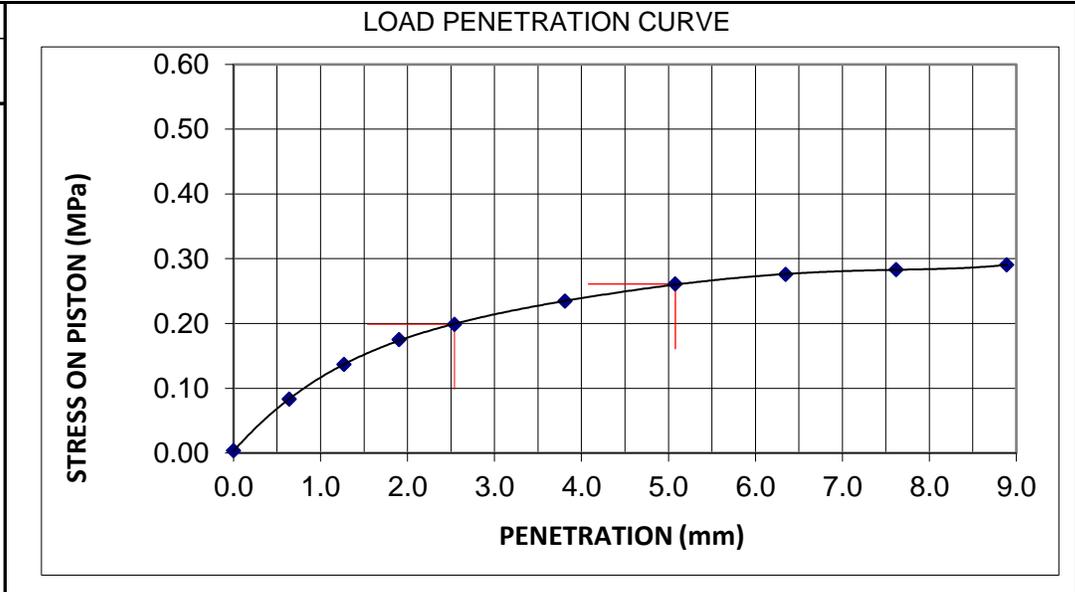
SAMPLE DATA		SPECIMEN DATA		
Sample Type:	Clay	DESCRIPTION	Before Soaking	After Testing
Source:	TH21-04, B2 2'-5'	Moisture Content (MC), %	23.6	
Sampled by:	Client	MC of top 25mm layer, %		29.6
Optimum Moisture Content:	23.6 %	Dry Density, kg/m ³	1521	
Maximum Dry Density:	1545 kg/cm ³	Compaction,%	98%	
Method of Compaction:	Standard Proctor	CBR, %	2.9	
Tested by:	ECS	Date Tested:	08-Feb-22	Swell, %
				1.6

LOAD DATA	
PENETRATION mm	STRESS MPa
0	0.00
0.64	0.08
1.27	0.14
1.91	0.18
2.54	0.20
3.81	0.23
5.08	0.26
6.35	0.28
7.62	0.28
8.89	0.29

PENETRATION mm	STANDARD LOAD MPa	TEST LOAD		BEARING RATIO (soaked)	
		ACTUAL MPa	CORRECTED MPa	at 2.5 mm penetration	at 5.1 mm penetration
2.54	6.9	0.20	0.20	2.9	-
5.08	10.3	0.26	0.26	-	2.5

Remarks: 4 days soaked

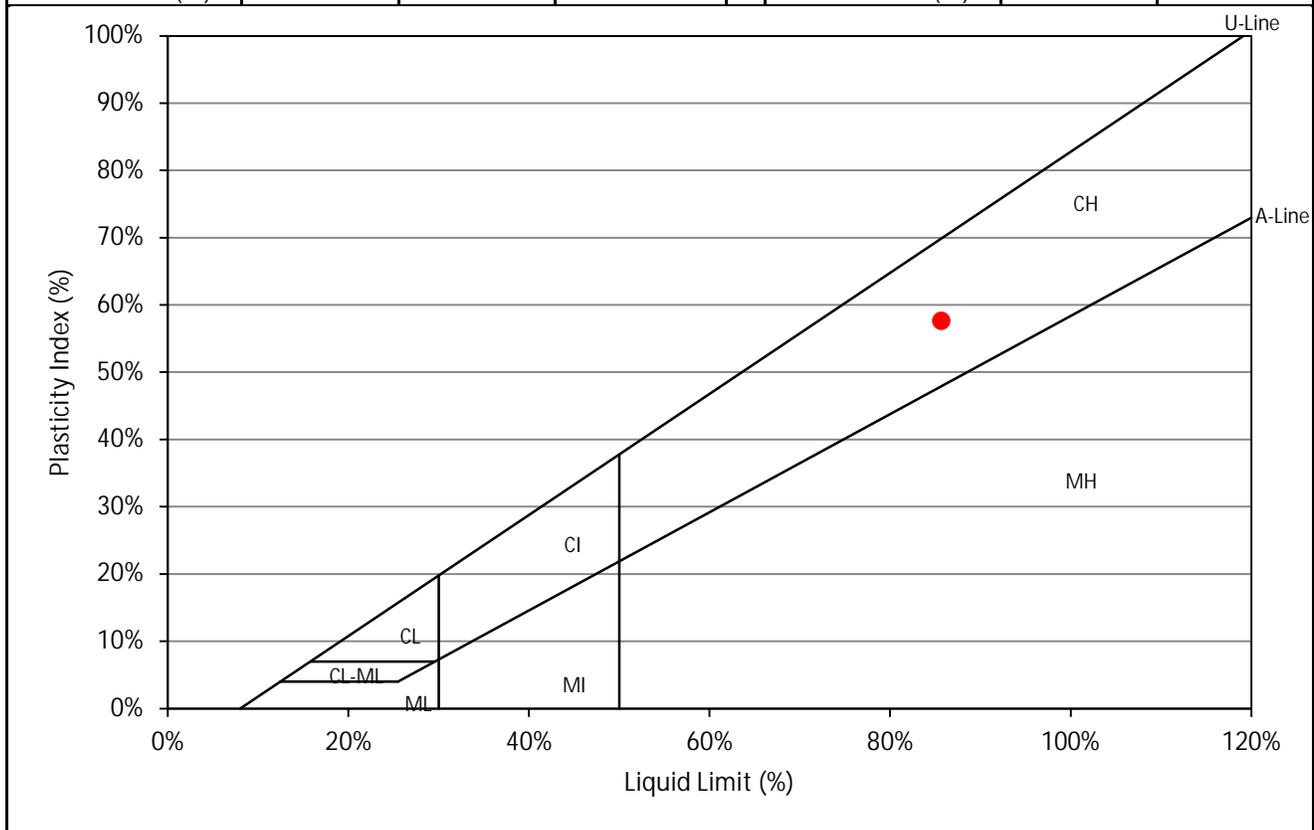
Liquid Limit		
Blows	34	28	24
Wet Sample (g)	8.2	8.5	7.5
Dry Sample (g)	4.5	4.6	4.0
Water Content (%)	82.2%	84.3%	86.3%

Plastic Limit	
Trial	1	2
Wet Sample (g)	8.1	7.6
Dry Sample (g)	6.4	5.9
Water Content (%)	27.6%	28.4%

Liquid Limit (%): 85.6%

Plastic Limit (%): 28.0%
