APPENDIX 'A'

GEOTECHNICAL REPORT

APPENDIX 'A' - GEOTECHNICAL REPORT

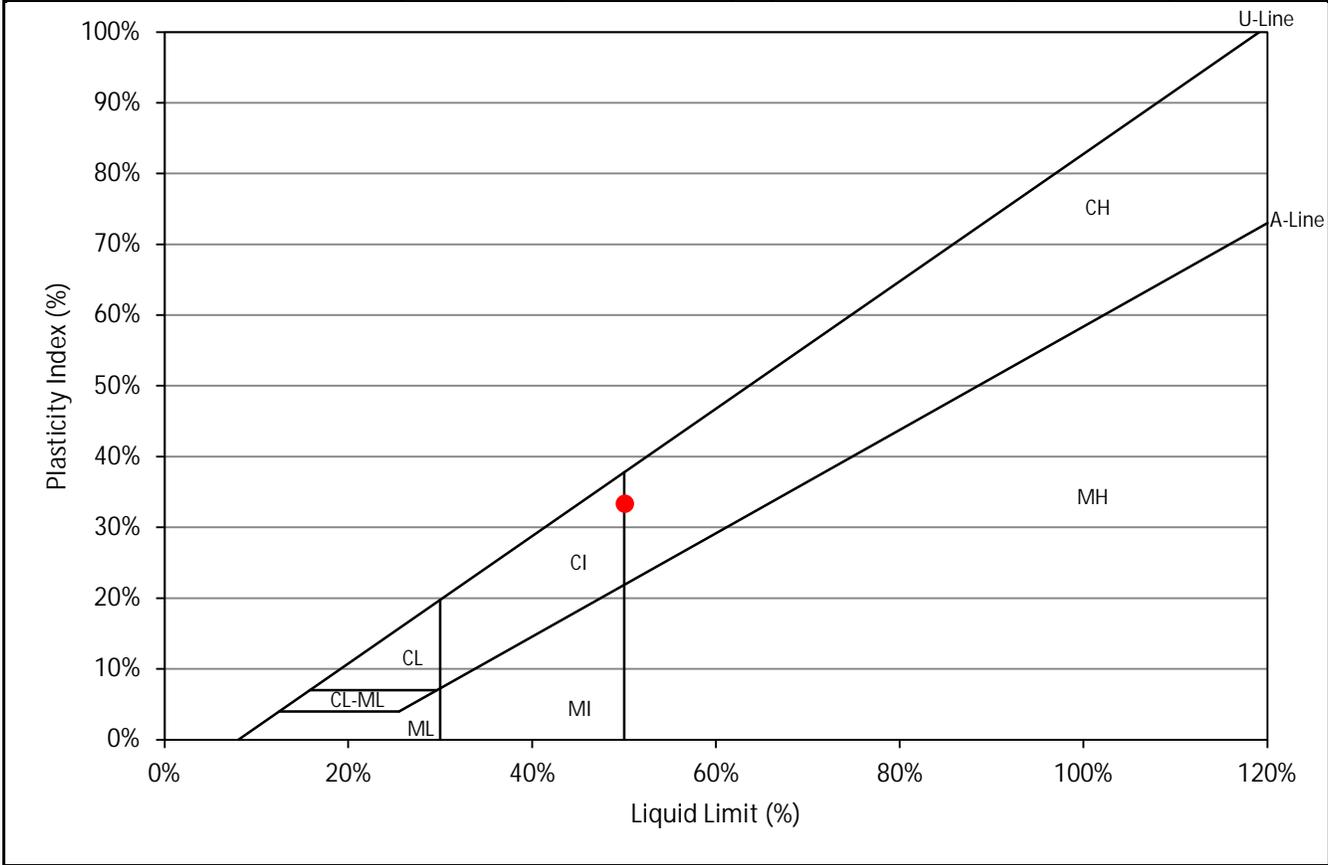
Liquid Limit			
Blows	34	28	21
Wet Sample (g)	9.1	10.2	9.7
Dry Sample (g)	6.1	6.8	6.4
Water Content (%)	47.4%	49.4%	51.5%

Plastic Limit		
Trial	1	2
Wet Sample (g)	7.1	8.2
Dry Sample (g)	6.1	7.0
Water Content (%)	16.9%	16.7%

Liquid Limit (%): 50.1%

Plastic Limit (%): 16.8%

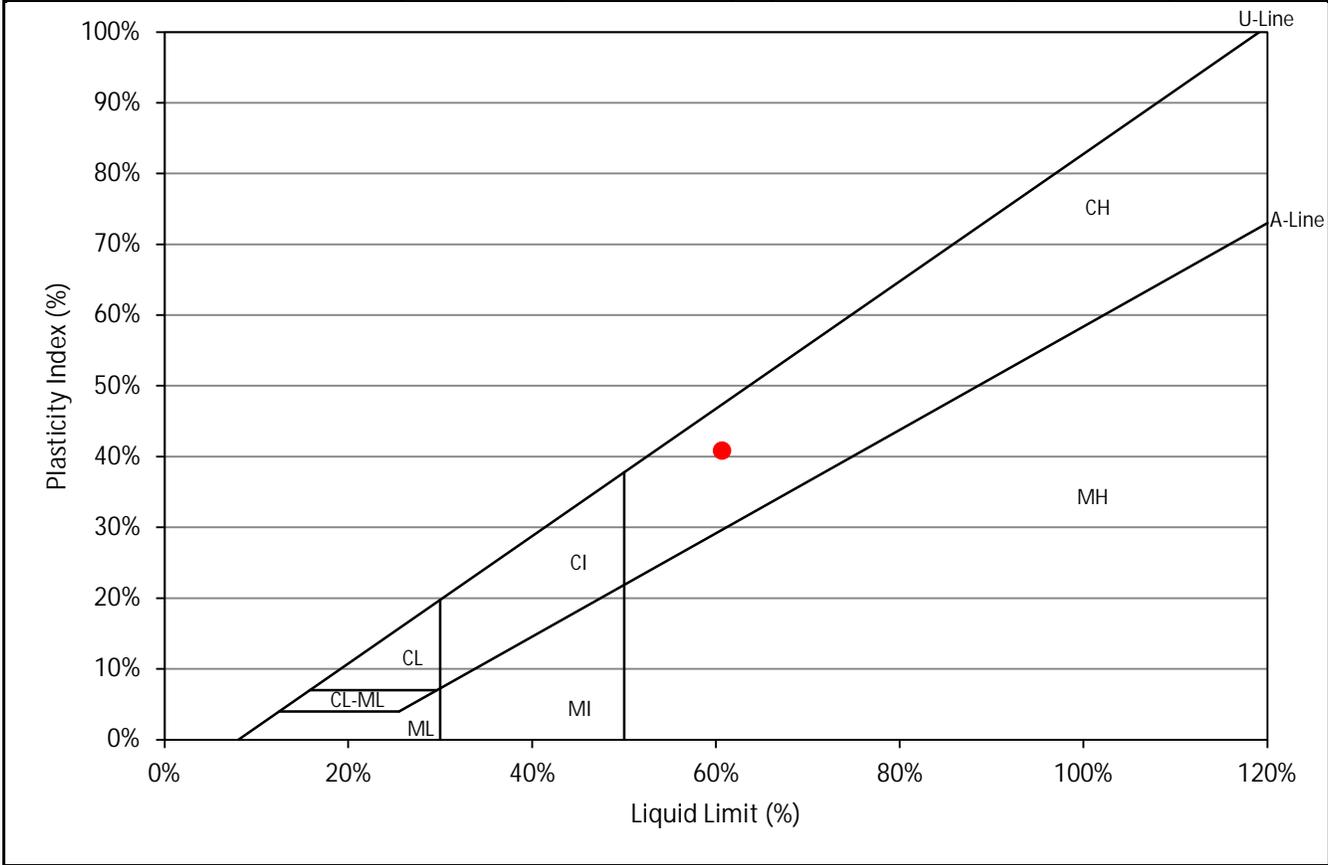
Liquid Limit			
Blows	33	24	19
Wet Sample (g)	8.5	8.7	7.5
Dry Sample (g)	5.3	5.4	4.6
Water Content (%)	59.2%	61.0%	62.3%

Plastic Limit		
Trial	1	2
Wet Sample (g)	6.2	6.6
Dry Sample (g)	5.2	5.5
Water Content (%)	19.8%	19.9%

Liquid Limit (%): 60.7% Plastic Limit (%): 19.8% Plasticity Index (%): 40.9%

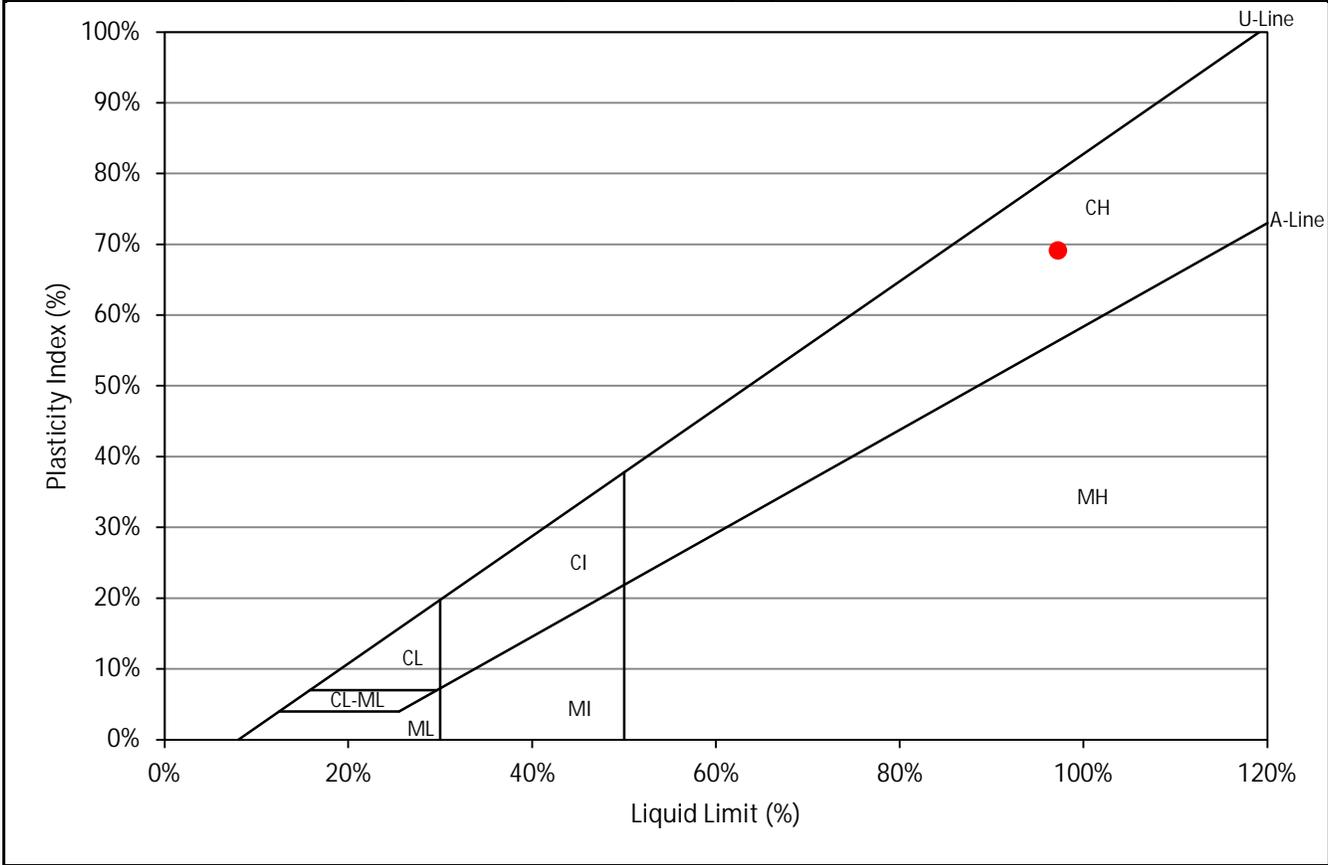
Liquid Limit			
Blows	34	30	23
Wet Sample (g)	7.7	7.8	7.2
Dry Sample (g)	4.0	4.0	3.6
Water Content (%)	93.9%	95.0%	98.2%

Plastic Limit		
Trial	1	2
Wet Sample (g)	6.5	7.2
Dry Sample (g)	5.1	5.6
Water Content (%)	28.1%	28.1%

Liquid Limit (%): 97.2% Plastic Limit (%): 28.1% Plasticity Index (%): 69.1%

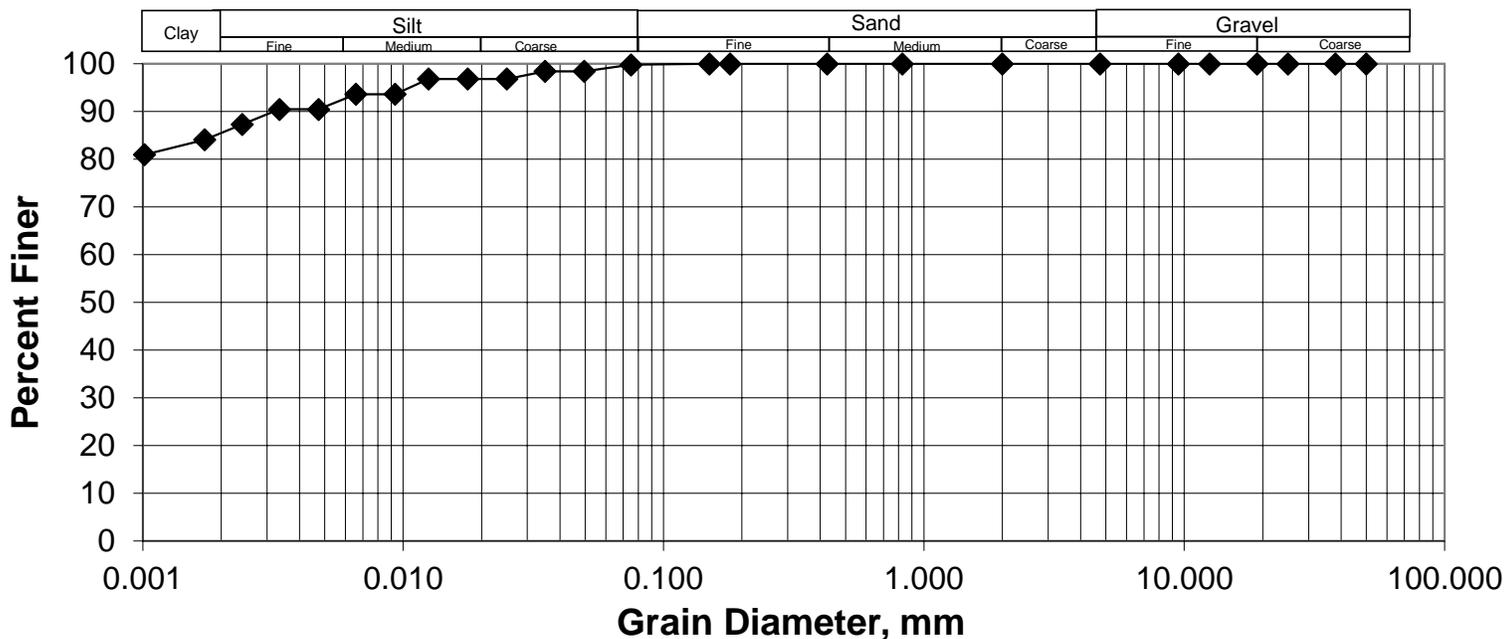
GRAIN SIZE DISTRIBUTION CURVE

Gravel	0.0%	Silt	14.3%
Sand	0.2%	Clay	85.5%

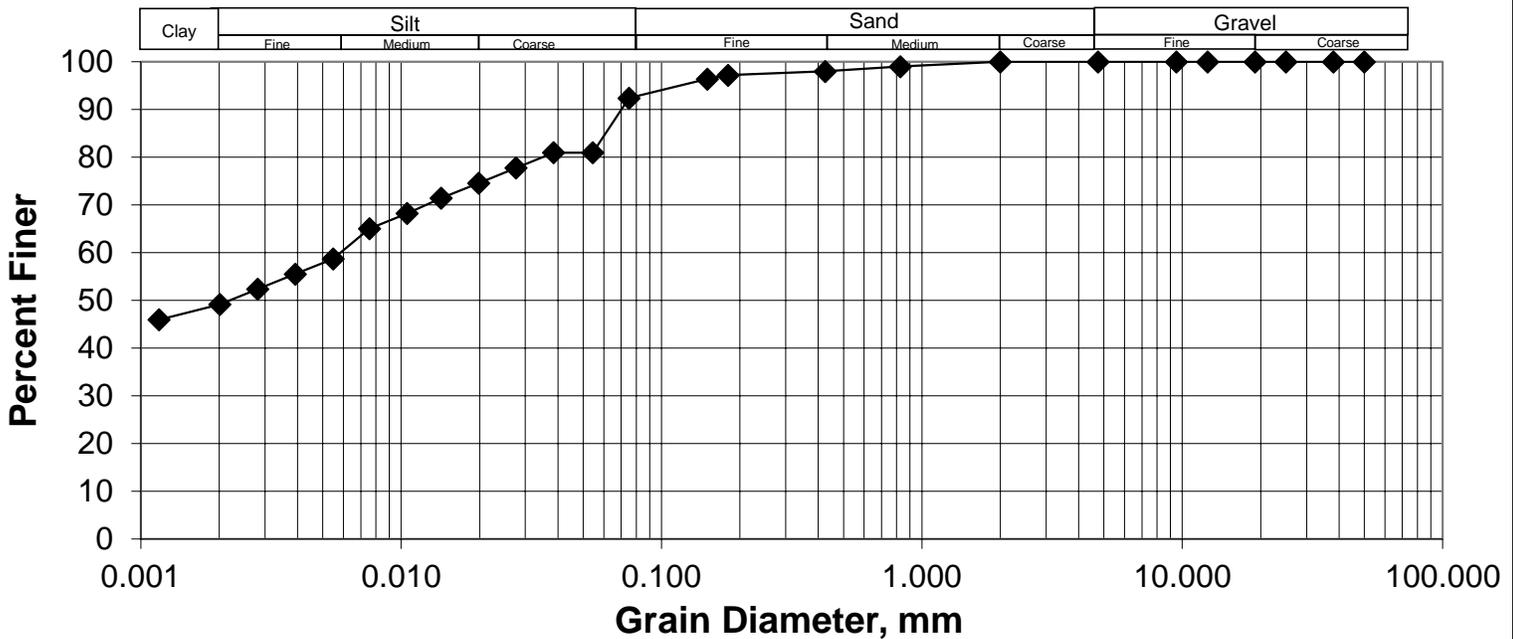
GRAIN SIZE DISTRIBUTION CURVE

Gravel	0.0%	Silt	43.2%
Sand	7.6%	Clay	49.2%

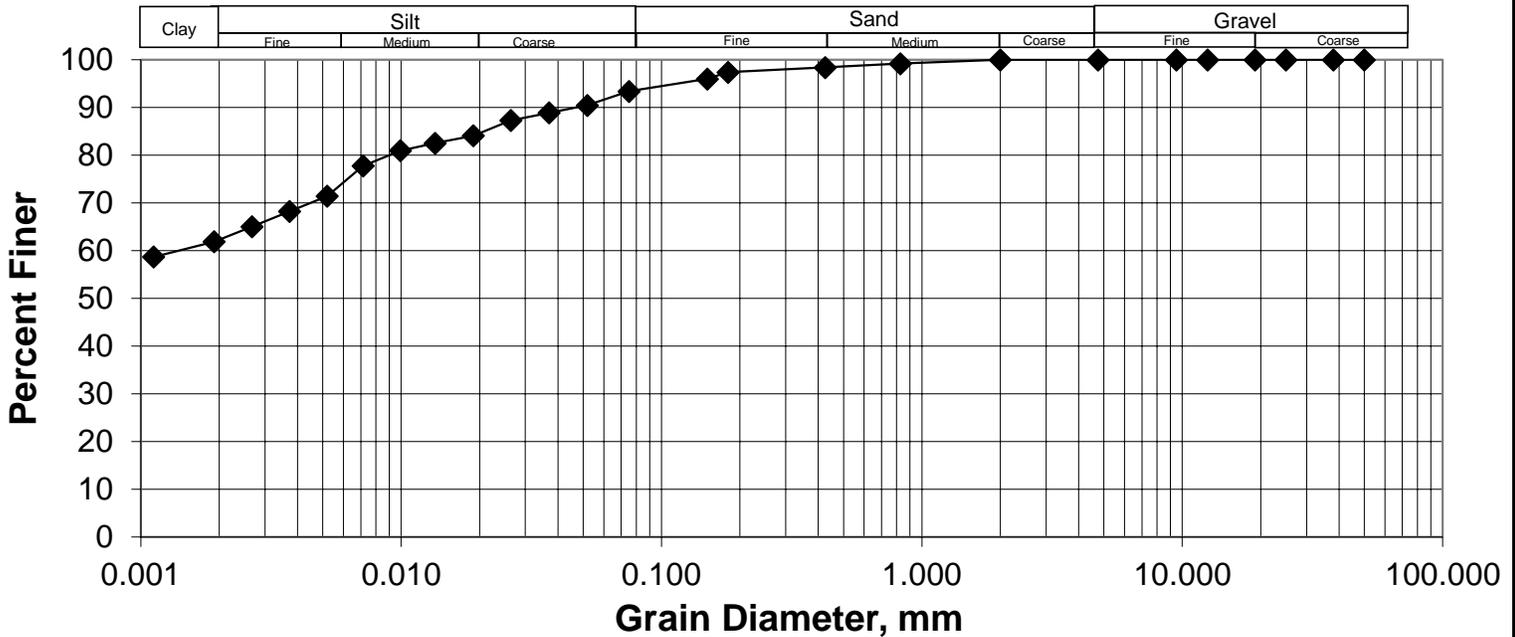
GRAIN SIZE DISTRIBUTION CURVE

Gravel	0.0%	Silt	31.2%
Sand	6.6%	Clay	62.2%

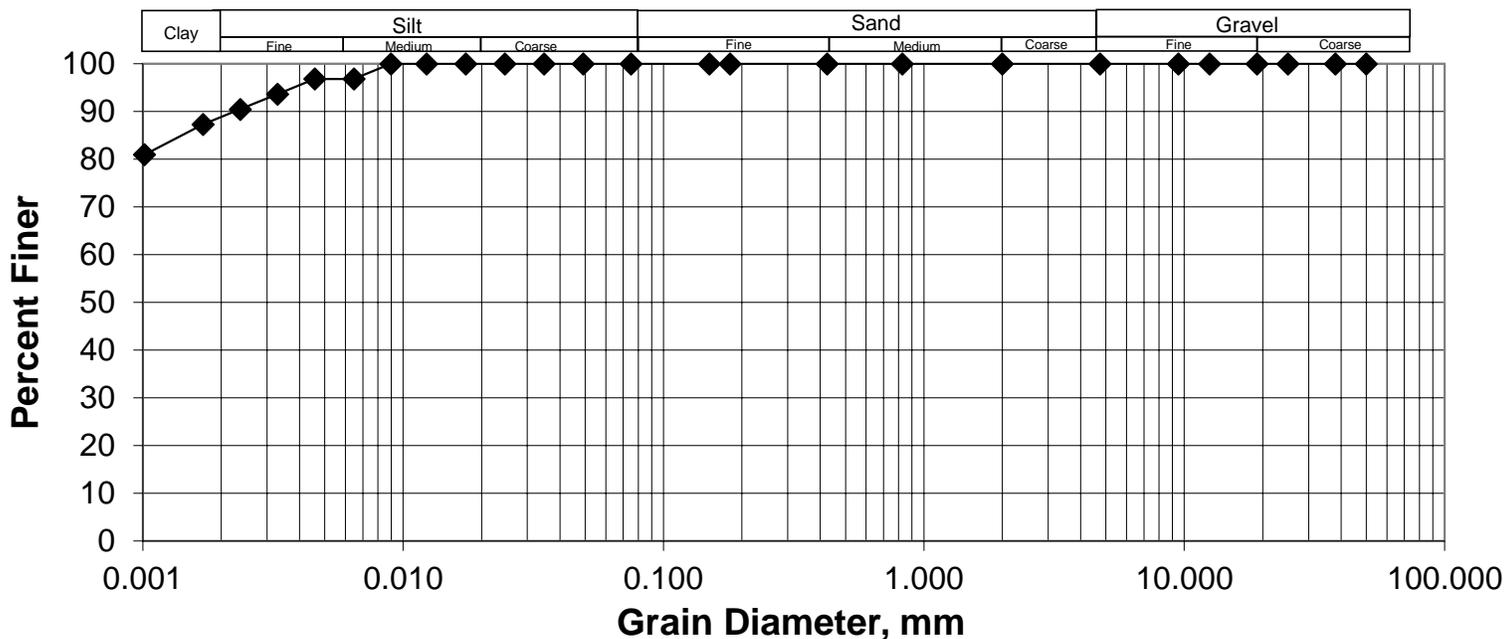
GRAIN SIZE DISTRIBUTION CURVE

Gravel	0.0%	Silt	11.3%
Sand	0.0%	Clay	88.7%

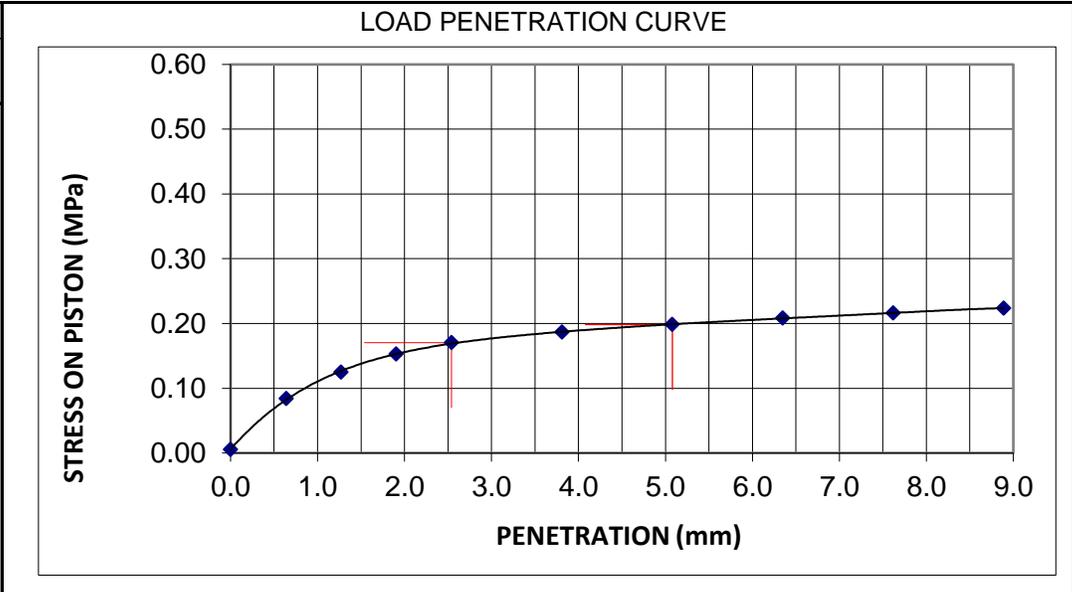
CALIFORNIA BEARING RATIO (CBR) TEST - ASTM D 1883

LOAD DATA	
PENETRATION mm	STRESS MPa
0	0.01
0.64	0.08
1.27	0.12
1.91	0.15
2.54	0.17
3.81	0.19
5.08	0.20
6.35	0.21
7.62	0.22
8.89	0.22

PENETRATION mm	STANDARD LOAD MPa	TEST LOAD		BEARING RATIO (soaked)	
		ACTUAL MPa	CORRECTED MPa	at 2.5 mm penetration	at 5.1 mm penetration
2.54	6.9	0.17	0.17	2.5	-
5.08	10.3	0.20	0.20	-	1.9

Remarks: 4 days soaked

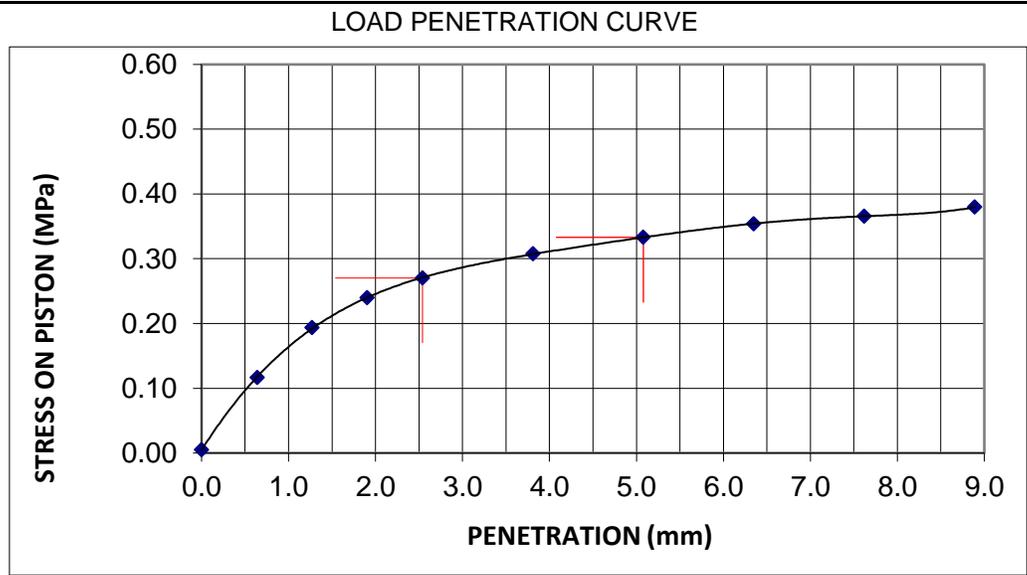
LOAD DATA	
PENETRATION mm	STRESS MPa
0	0.00
0.64	0.12
1.27	0.19
1.91	0.24
2.54	0.27
3.81	0.31
5.08	0.33
6.35	0.35
7.62	0.37
8.89	0.38

PENETRATION mm	STANDARD LOAD MPa	TEST LOAD		BEARING RATIO (soaked)	
		ACTUAL MPa	CORRECTED MPa	at 2.5 mm penetration	at 5.1 mm penetration
2.54	6.9	0.27	0.27	3.9	-
5.08	10.3	0.33	0.33	-	3.2

Remarks: 4 days soaked

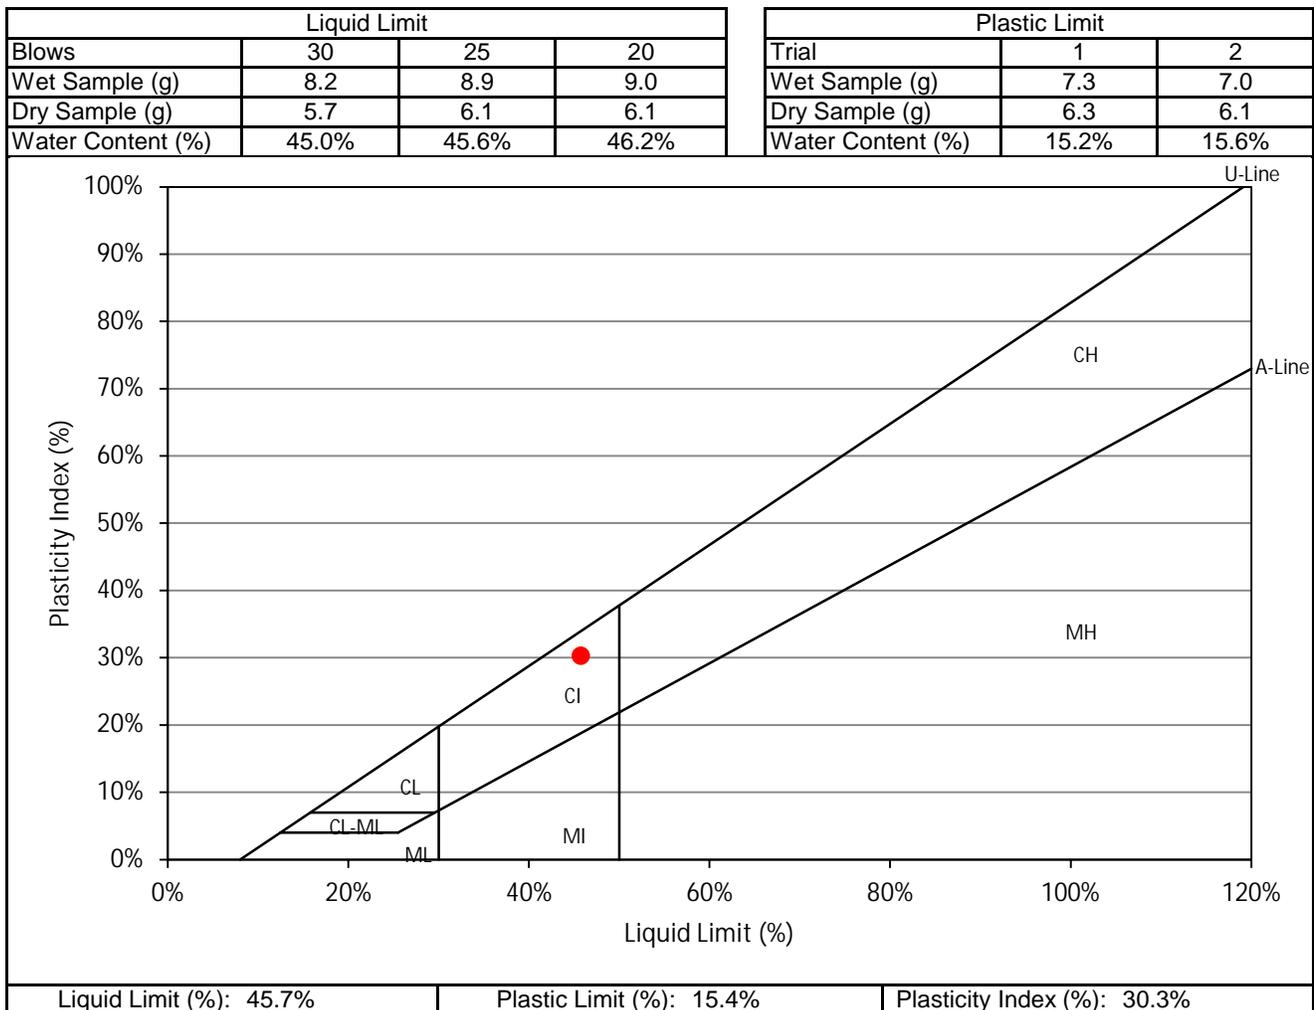
Atterberg Limits (ASTM D4318)

Standard Test Methods for Liquid Limit, Plastic Limit, and Plasticity Index of Soils

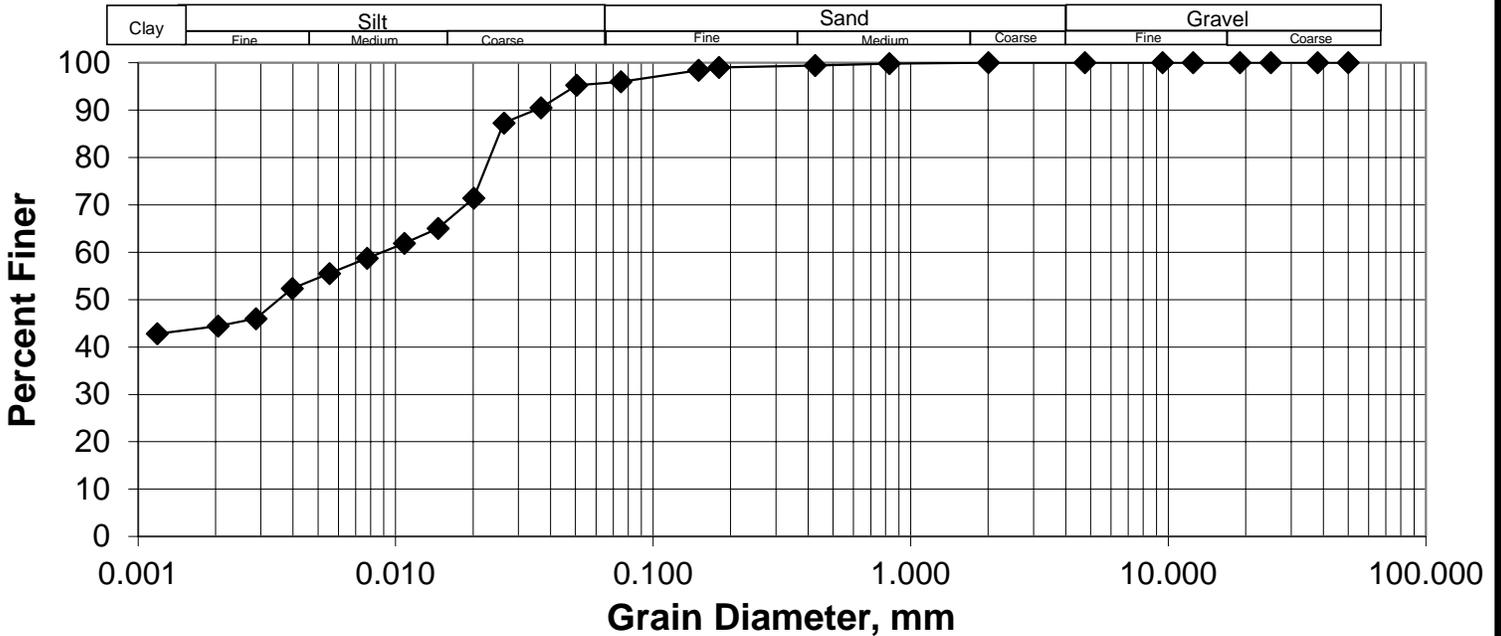
GRAIN SIZE DISTRIBUTION CURVE

Gravel	0.0%	Silt	51.6%
Sand	4.0%	Clay	44.4%
