Newton Ave Forcemain Red River Crossing  
2021 Preliminary  
Geotechnical Investigation Report

21-3913-001

October 28, 2021

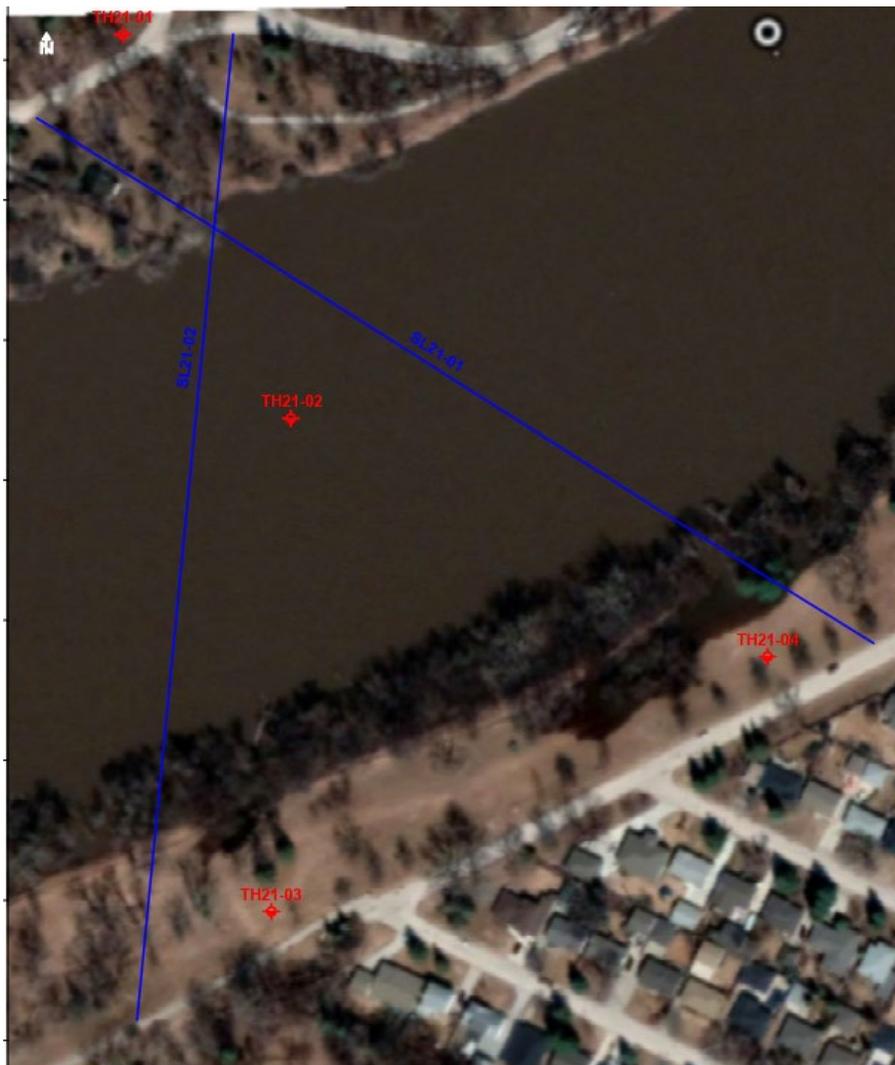
**FIGURE 1: TEST HOLE AND SEISMIC REFRACTION SURVEY LOCATIONS**

KGS Group retained the services of Frontier Geoscience Inc. to complete seismic refraction surveys along the two (2) preferred alignments on August 10 and 11, 2021. The primary objective of the geophysical survey was to obtain estimates of the depth to till and bedrock along the preferred alignments. The locations of the seismic lines are shown on Figure 1. The results of the seismic refraction survey are included in the Seismic Refraction Survey Report included in Appendix C.

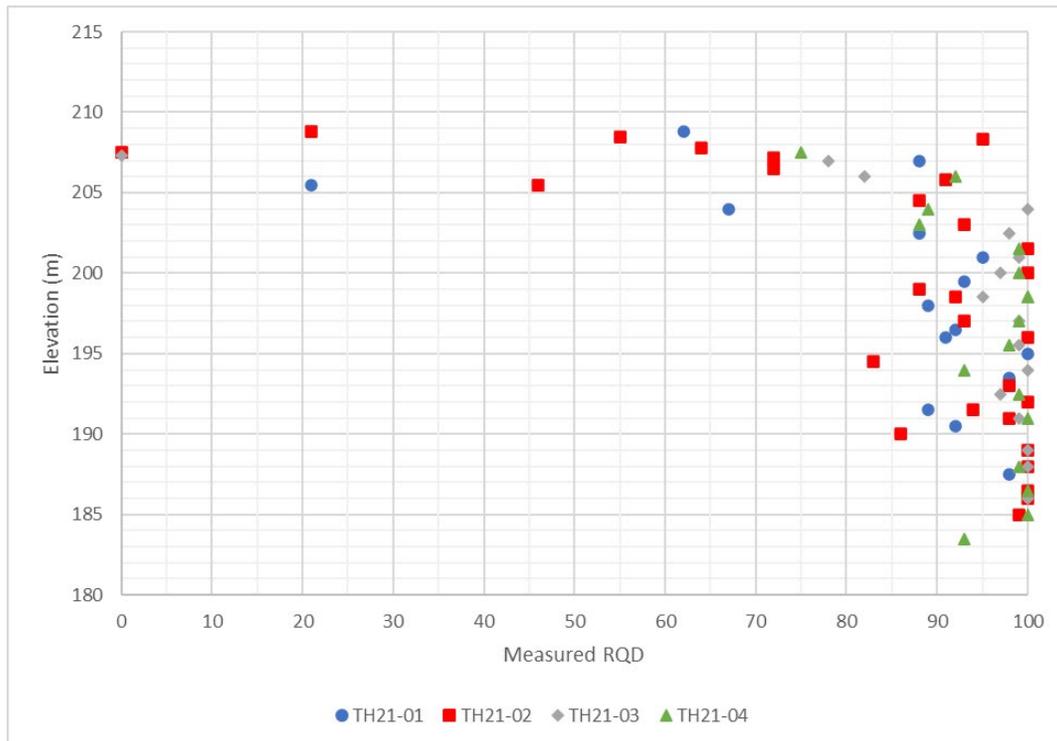
**FIGURE 2: BEDROCK RQD WITH ELEVATION**

retrieved from the borehole and the seismic survey indicate that the quality of the bedrock is generally better on the east side of the river compared to the west especially near the upper section above elevation El. 202 m. The estimated bulk compressive wave velocity ( $V_p$ ) for the upper bedrock is 4100 m/s and 3200 m/s on the east side and west side, respectively. These estimated velocities suggest that the bedrock is more fractured on the west side as indicated by the RQD values presented in Figure 2.

The bedrock consists of limestone and mottled limestone. Dolomite was observed in test hole TH21-01 from elevation 208.0 to 209.7 m. The measured RQD of the bedrock with elevation is shown Figure 2 below, and a histogram with the RQD distribution is shown on Figure 3.

The dolomite was brown in colour, and fine grained. Weaker fractured rock with closely spaced joints was generally observed above elevation 208 m. Shale was observed at elevation 208.0 m. The rock quality designation (RQD) of the dolomite was 62, classifying the rock as fair.

Limestone was generally encountered below elevations of 208.0. The limestone was white to grey colour, and medium grained. A soft clay seam 50 mm thick was observed in test hole TH21-01 at elevation 207.0 m. In some sections of the core, multiple closely spaced breaks were observed along the bedding planes. Three (3) open joints were observed in test hole TH21-02 at elevations ranging from 208.6 to 207.5 m. The RQD of the limestone ranged from 21 to 91. In general, the RQD was greater than 80 below elevation 205 m, classifying the rock as good to excellent.

Mottled limestone was encountered in all of the test holes at elevations ranging from 203.7 to 207.9 m and extending to the end of the test holes. The mottled limestone was mottled white, brown and grey in colour, medium grained and strong. The jointing was moderate to wide spaced. Weak zones of soft clay seams up to 50 mm were noted within the mottled limestone in test hole TH21-01 from elevation 203.3 to 197 m. The RQD of the mottled limestone ranged from 75 to 100, generally increasing with depth. In general, the RQD was greater than 90 below elevation 197 m, classifying the bedrock as excellent.

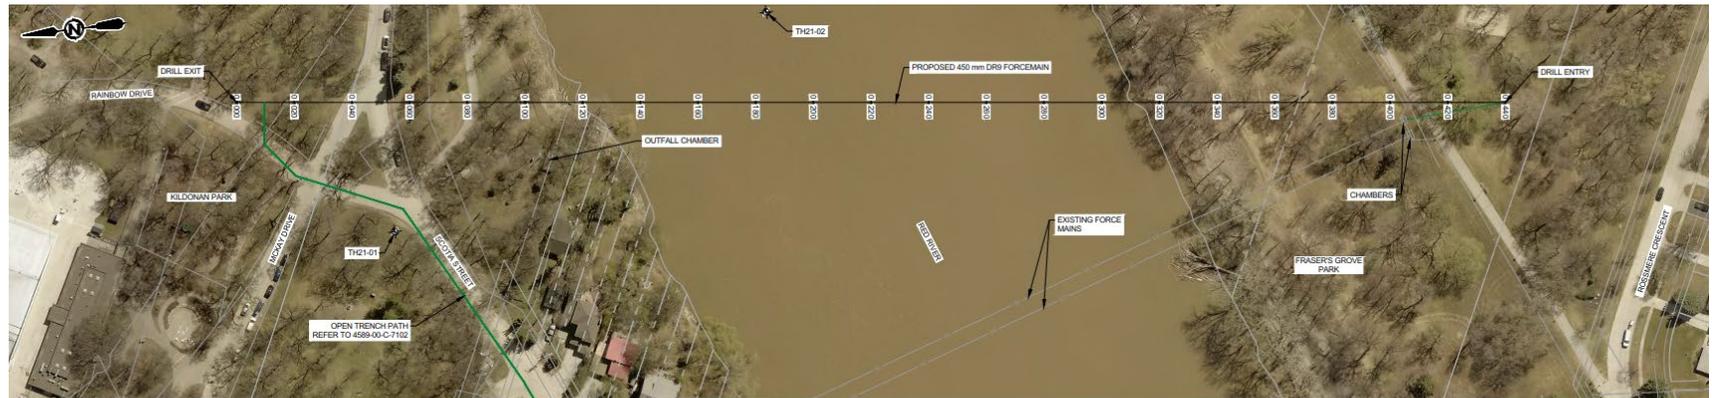
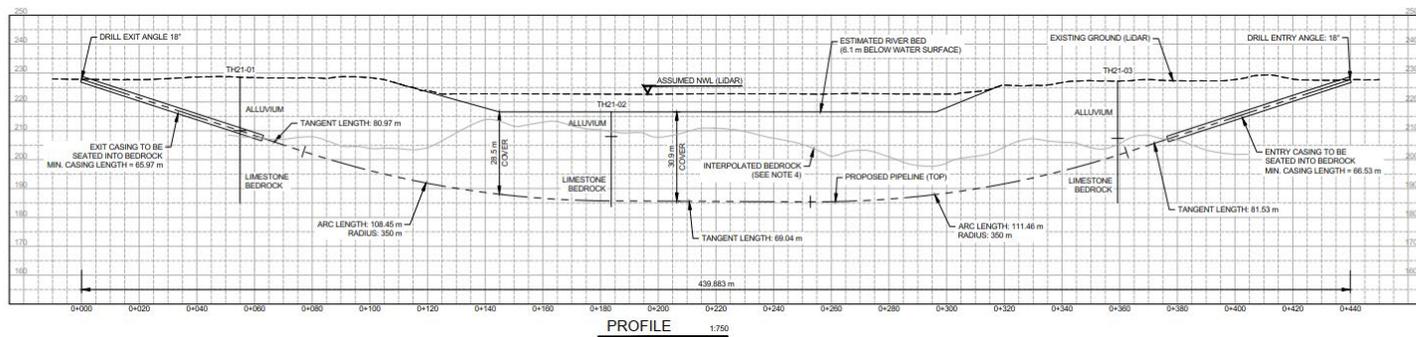
FIGURE 4: CONCEPT LEVEL BOREPATH

Figure 4 shows preliminary borepath for the proposed pipeline. The drill entry will be east of Kildonan Drive in Fraser's Grove Park, and the exit will be located west of the intersection of Rainbow Drive and Scotia Street in Kildonan Park. The borepath will enter and exit at an angle of 18 degrees, with a minimum elevation of approximately 185 m.

- NOTES:**
1. REFER TO NEWTON FORCE MAIN RED RIVER CROSSING REPLACEMENT TEST HOLE LOGS (KGS GROUP, AUGUST 2021) FOR DETAILED STRATIGRAPHY. BEDROCK INTERFACE DEPICTED ON PRELIMINARY HDD PLAN/PROFILE FOR CLARITY.
  2. EXISTING GROUND TOPOGRAPHY BASED ON AVAILABLE LIDAR DATA.
  3. RED RIVER BATHYMETRY TO BE CONFIRMED. ESTIMATED RIVER BED ELEVATION BASED ON KGS GROUP TEST HOLE LOG TH21-02 NOTE 4: DEPTH OF RED RIVER IS 8.1 m.
  4. BEDROCK SURFACE FROM INTERPRETED SEISMIC REFRACTION DEPTH SECTION SL21-02. REFER TO NEWTON AVE. FORCEMAIN RED RIVER CROSSING 2021 PRELIMINARY GEOTECHNICAL INVESTIGATION REPORT (KGS GROUP, SEPTEMBER 2021) APPENDIX C SEISMIC REFRACTION SURVEY (FRONTIER GEOSCIENCES).

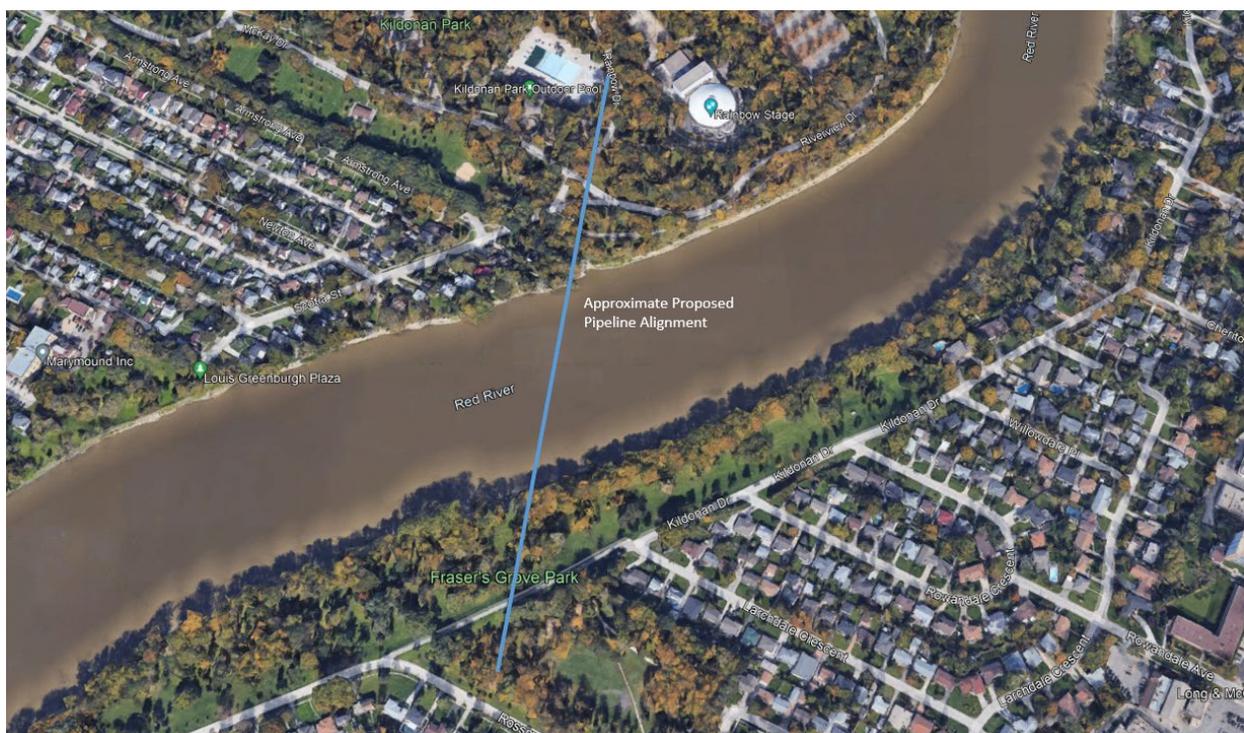
**FIGURE 5: SITE LOCATION**

As part of the field investigation, a visual inspection of the riverbank was completed for the east and west riverbanks. The site is located at the start of a gradual bend in the river, with the west side of the river being on the inside of the bend and the east side on the outside as shown on Figure 4. Erosion is typically observed on the outside bend of rivers.

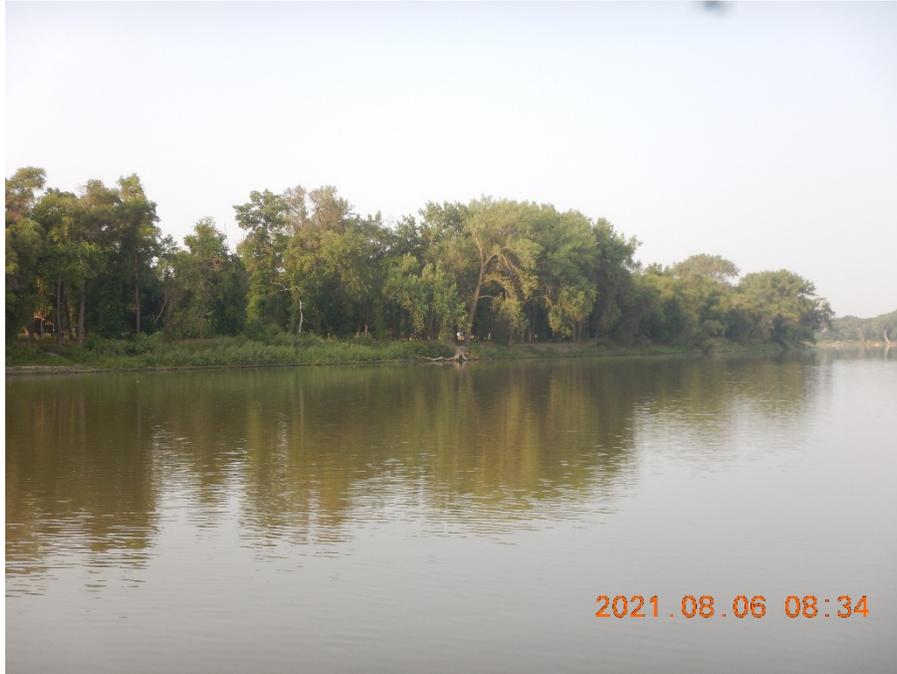
The east side of the riverbank is approximately 8 m high with benches at approximately elevations 222.5 and 225.9 m. These elevations generally coincide with approximate average summer river level and ordinary high water level (2-year flood level), respectively. The slope of the riverbank at the top of bank above the upper bench at EL. 225.9 m was approximately 3H:1V, from the upper bench to lower bench the slope was approximately 3.5H:1V and below the lower bench to the bottom of channel the slope was approximately 8H:1V. The benching and shallow slope of the riverbank suggests historical erosion along this segment of the river.

At the time of the site inspection there were no visual signs of deep-seated slope movement including slumps, sloughing, headscrapes, or tension cracking. The downstream slope was vegetated with tall grass and shrubs and mature trees at the top of the bank. Photos of east bank are shown below.

**PHOTO 1: EAST RIVERBANK LOOKING SOUTH**

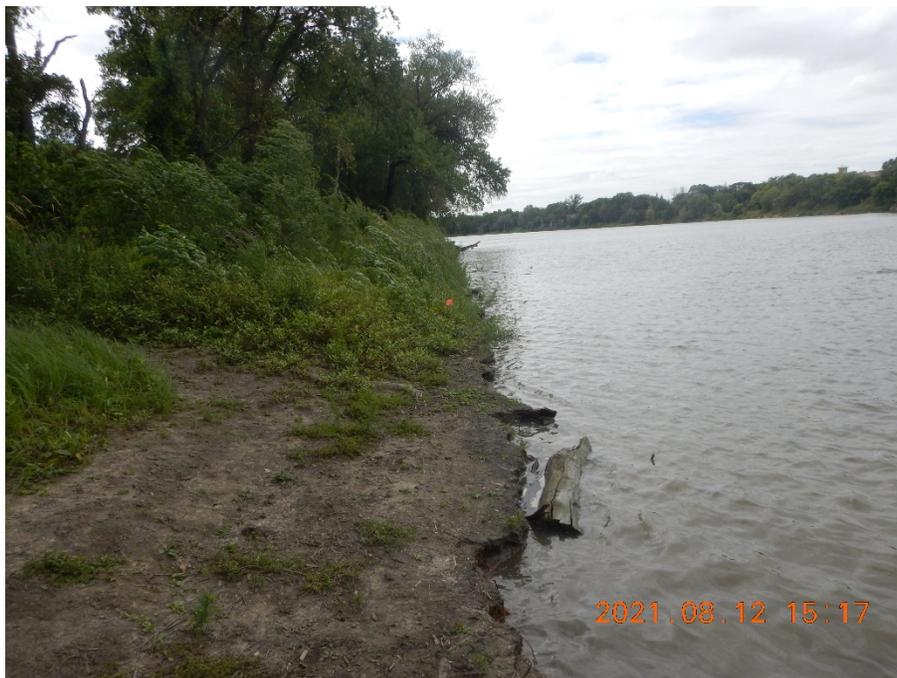
**PHOTO 2: EAST RIVERBANK LOOKING SOUTH**

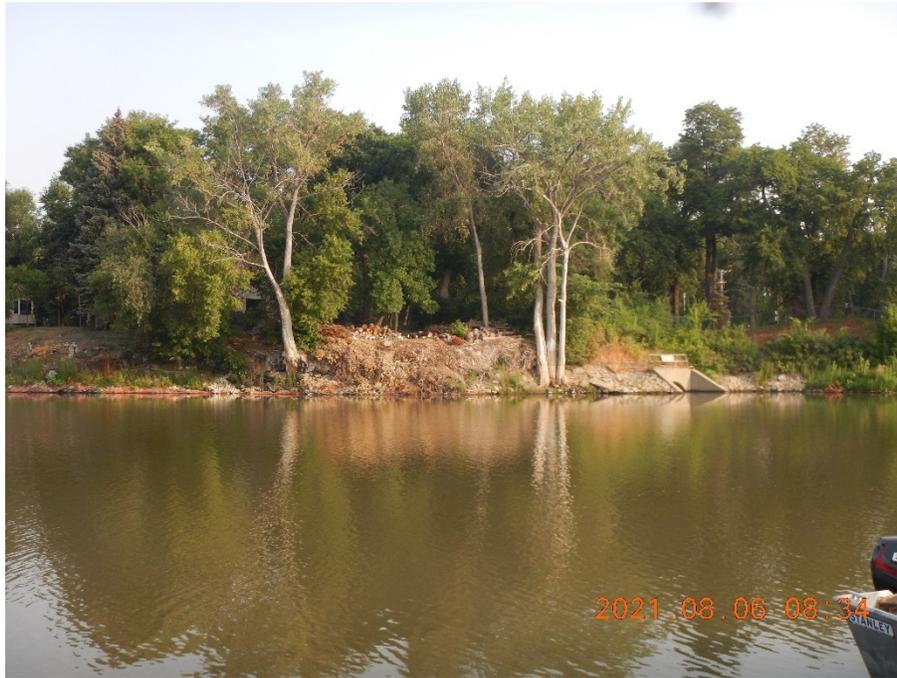
The west side of the riverbank is approximately 10 m high with a bench at approximate the normal summer water level (El. 222.5 m). The slope of the riverbank above to the bench was at a slope of approximately 4H:1V and the lower slope to the channel was approximately 5H:1V. The riverbank slope flattens

downstream of the site. An existing headscrap was observed downstream of the outfall pipe during the site inspection. At the time of the site inspection, no additional visual signs of deep seated slope instability such as slumps, sloughing, headscrap, or tension cracking with exception of the historical headscrap downstream were noted. The downstream slope was vegetated with tall grass and shrubs and mature trees at the top of the bank. Photos of the west bank are shown below.

**PHOTO 3: WEST RIVERBANK LOOKING WEST**

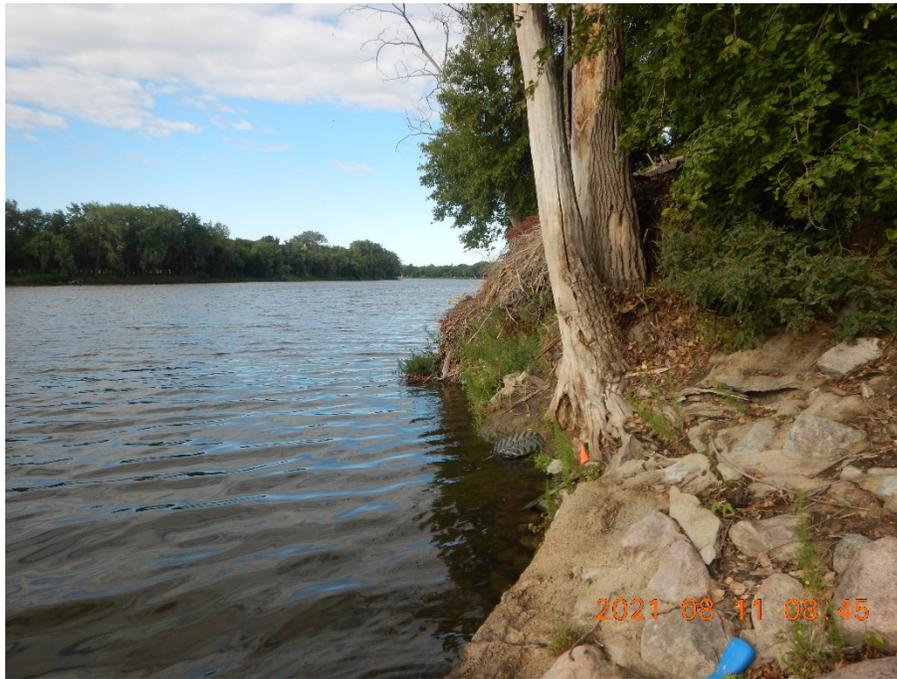
**PHOTO 4: WEST RIVERBANK LOOKING SOUTH  
(UPSTREAM OF OUTLET)**

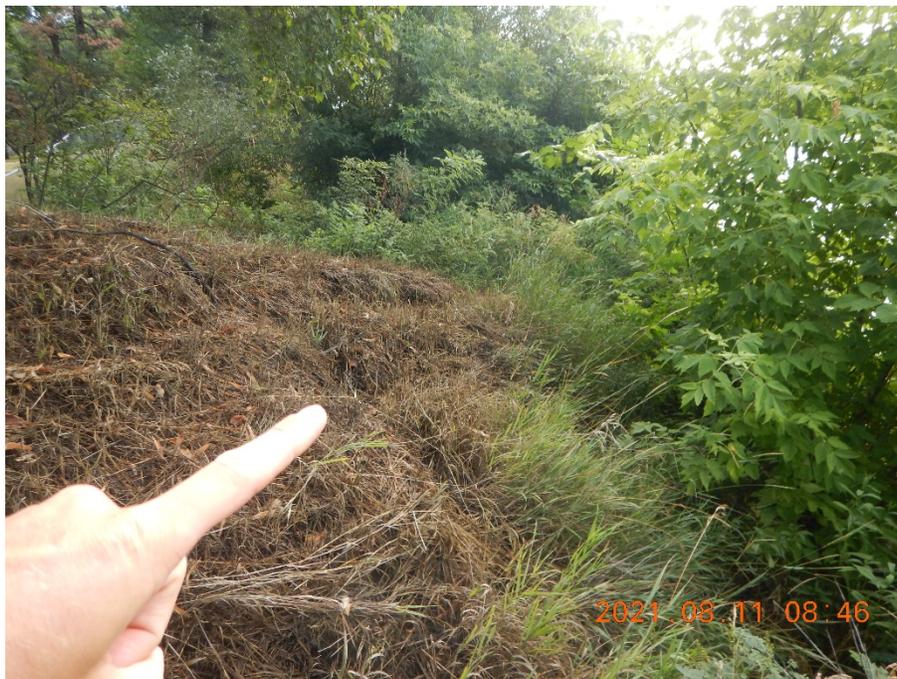
**PHOTO 5: WEST RIVERBANK LOOKING NORTH  
NOTE HISTORICAL HEADSCRAP**

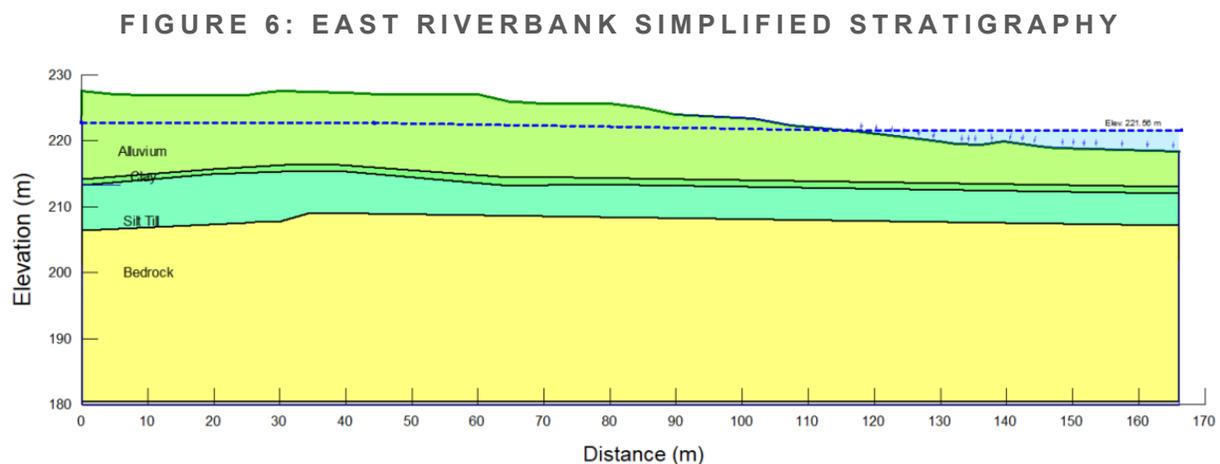
Two (2) cross-sections were analyzed, one (1) on the east side and one (1) on the west side of the Red River at the proposed crossing to evaluate the stability of the riverbanks. The riverbank geometry was obtained from LiDAR data provided by the City of Winnipeg and the soil stratigraphy was developed from the test hole drilling and seismic refraction survey results. The cross sections for the slope stability analysis are shown in Figures 6 and 7 below.

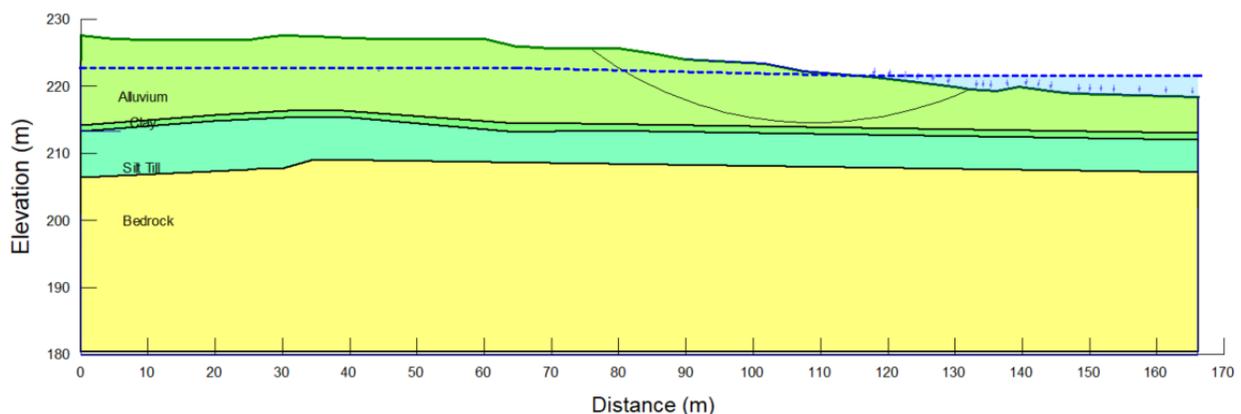
**FIGURE 8: EAST RIVERBANK TYPICAL SLIP SURFACE**

Based on the visual inspection, the east riverbank has benching and shallow slopes which suggests historical erosion along this segment of the river. Additionally, it is located on an outside bend which are known to be susceptible to erosion. No erosion protection was observed along the east shoreline during the visual inspection. It is recommended that a riprap blanket be placed in the lower bank area within the normal summer river level range to minimize the potential for toe erosion which will result in a reduction in the stability over time. The riprap blanket should extend a minimum of 1.5 m above and below the normal summer river level.

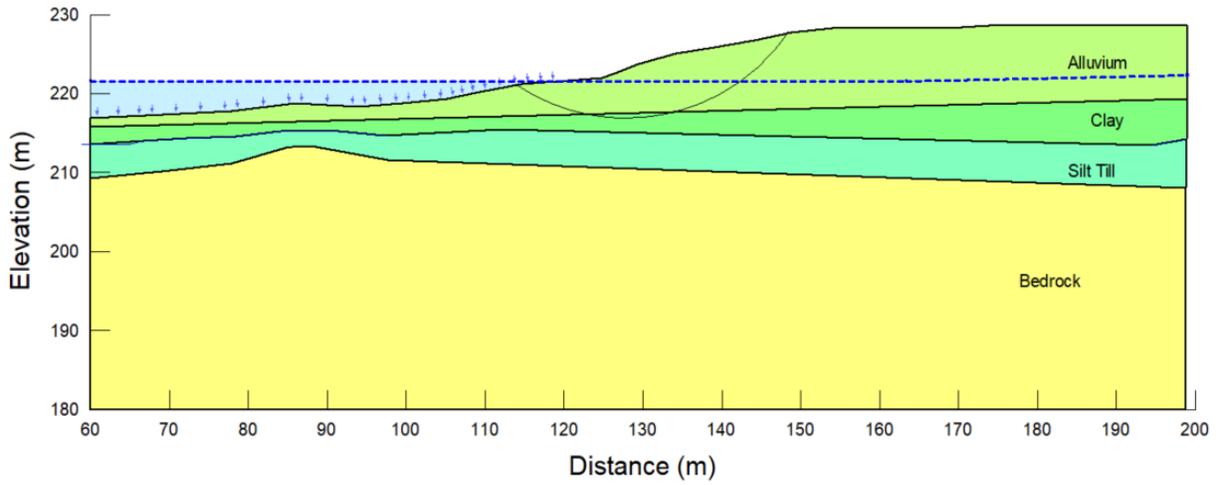
FIGURE 9: WEST RIVERBANK TYPICAL SLIP SURFACE

KGS Group completed limit equilibrium (LE) slope stability analyses to determine the current stability of the riverbank on both sides of the proposed crossing. The slope stability analysis approach incorporates LE techniques based on two-dimensional slope stability analysis using SLOPE/W software by Geo-Slope International Ltd. The Morgenstern-Price method of analysis was employed for the slope stability assessment using the LE method. This method considers both shear and normal interslice forces, and it satisfies both moment and force equilibrium.

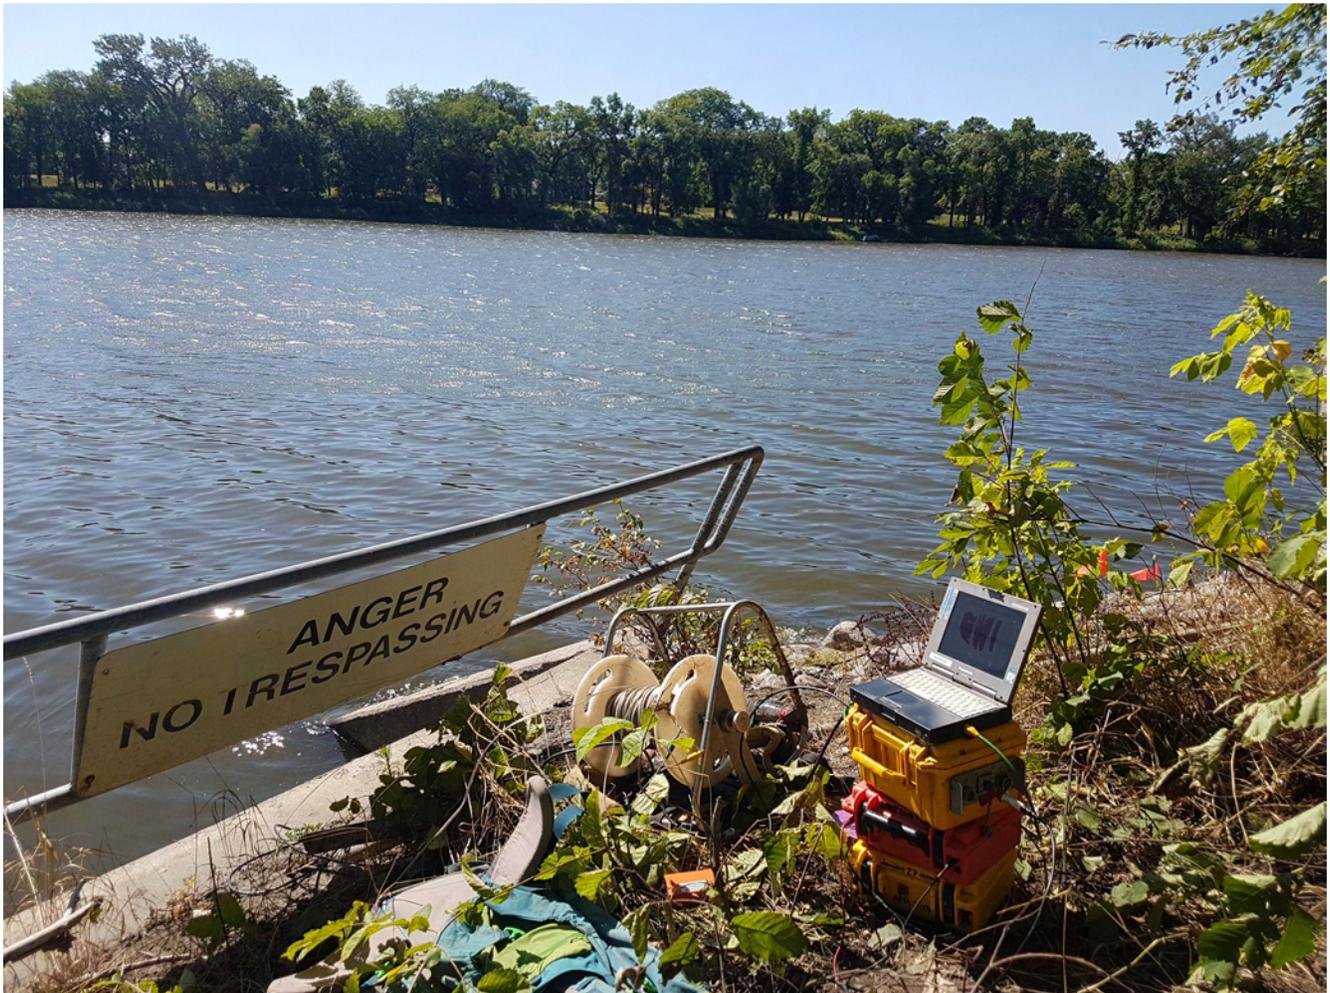
*Example of Survey Setup at the River's Edge*

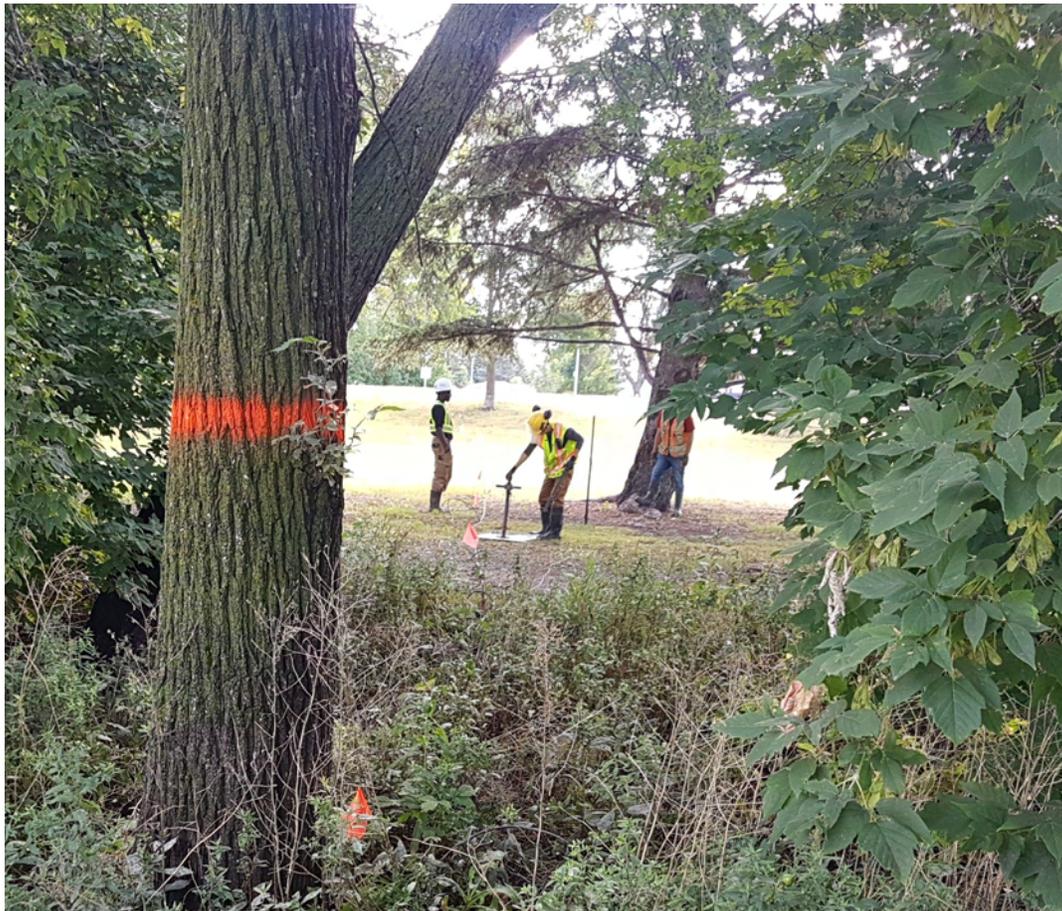
*Seismic Shotgun Operation on Terrestrial Lines*

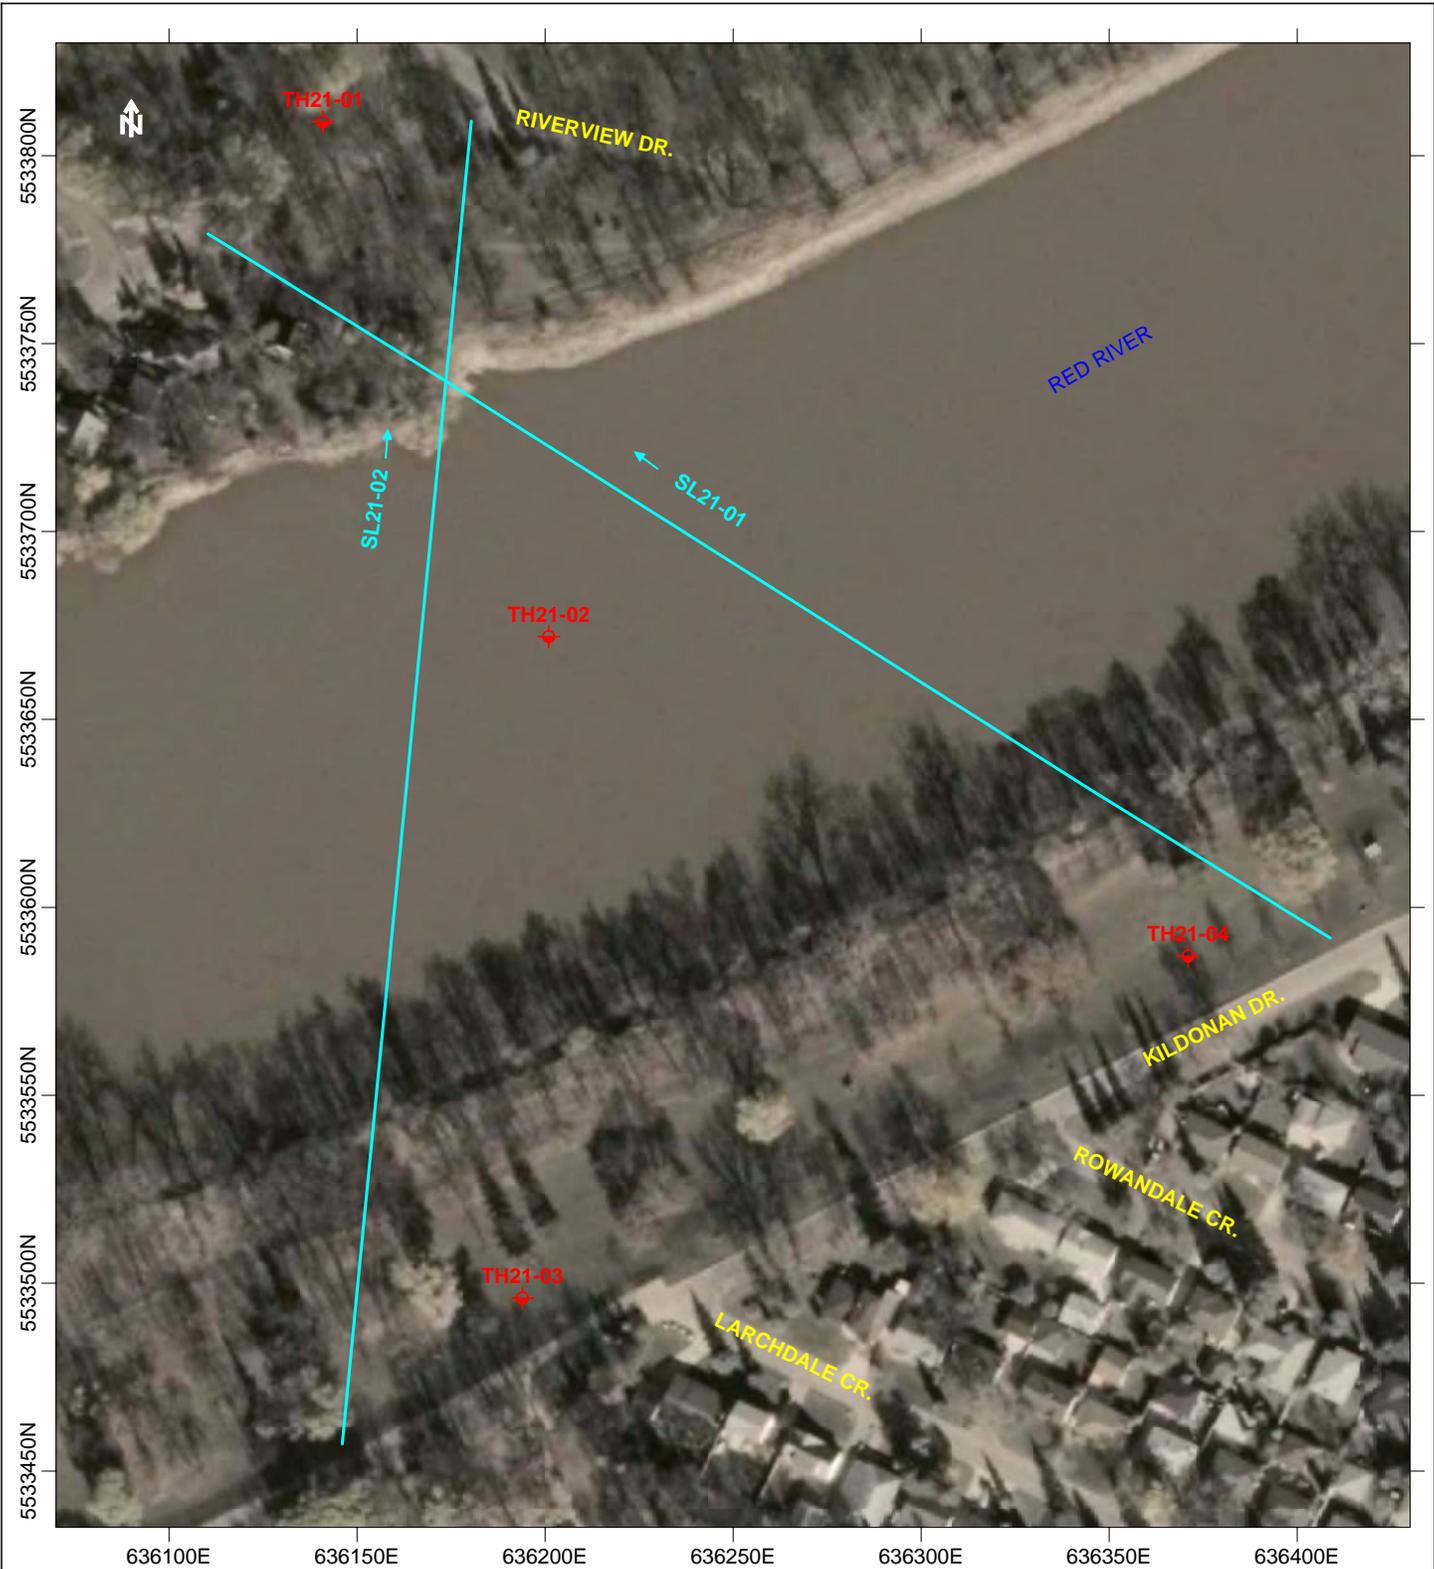
<b>KGS GROUP</b> NEWTON FORCE MAIN RED RIVER CROSSING REPLACEMENT SEISMIC REFRACTION SURVEY		
SITE PLAN		
<b>FRONTIER GEOSCIENCES INC.</b>		
DATE: AUG. 2021	SCALE 1:2,000	FIG. 2

The purpose of the geophysical survey was to obtain overburden and bedrock compressional wave velocity information, in support of the Newton Force Main Red River Crossing Replacement project. A total of 705 metres of seismic refraction data was collected along two separate seismic lines. A Site Plan showing the locations of the lines is presented at a 1:2,000 scale in Figure 2, in the Appendix.

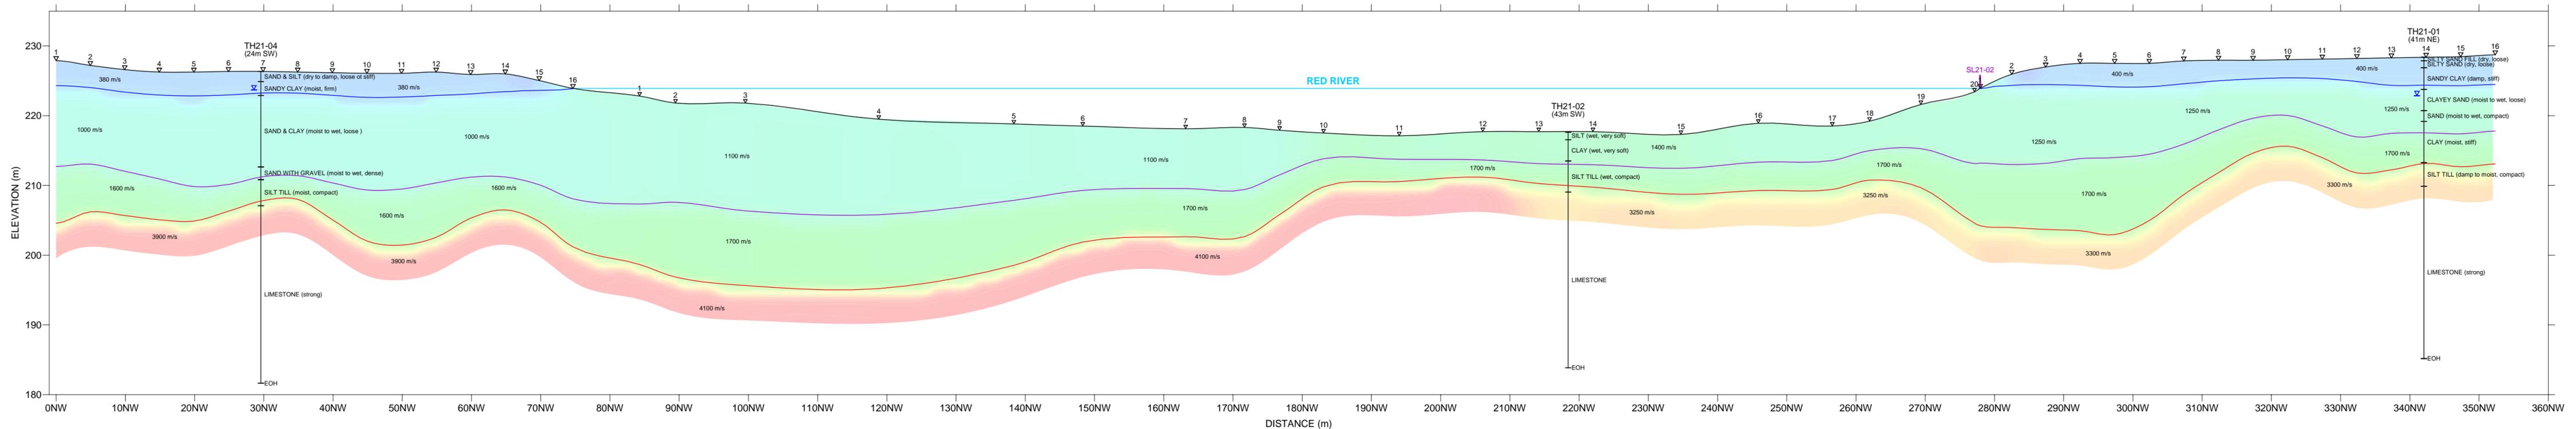
<b>KGS GROUP</b>		
NEWTON FORCE MAIN RED RIVER CROSSING REPLACEMENT		
SEISMIC REFRACTION SURVEY		
INTERPRETED SEISMIC REFRACTION DEPTH SECTION SL21-01		
<b>FRONTIER GEOSCIENCES INC.</b>		
DATE: AUG. 2021	SCALE: 1:500	FIG. 3

The interpreted results of the seismic refraction lines are illustrated in profile in Figures 3 and 4, at a scale of 1:500, in the Appendix. The seismic velocity layer interfaces are marked on the seismic profiles in blue, purple and red. The interface line colours are not a specific velocity contour, but rather the interpreted discrete boundary above which velocities are defined within a certain range and below which velocities are within a significantly increased velocity range.

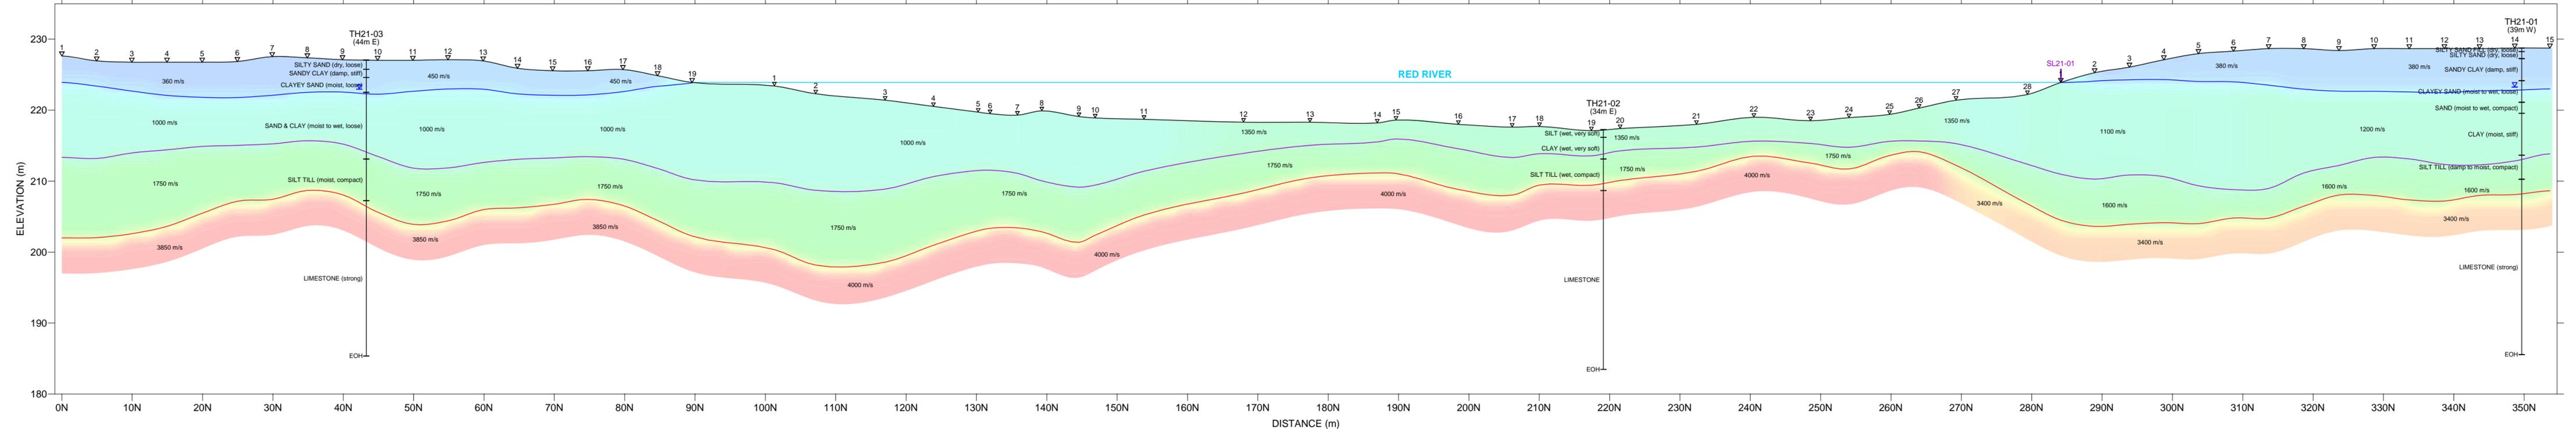
<b>KGS GROUP</b>		
NEWTON FORCE MAIN		
RED RIVER CROSSING REPLACEMENT		
SEISMIC REFRACTION SURVEY		
INTERPRETED SEISMIC REFRACTION		
DEPTH SECTION		
SL21-02		
<b>FRONTIER GEOSCIENCES INC.</b>		
DATE: AUG. 2021	SCALE 1:500	FIG. 4
