APPENDIX 'A' - GEOTECHNICAL REPORT

PAVEMENT CORES FOR:

Buler Street from Gilbert Avenue to Manitoba Avenue – Concrete Rehabilitation
Manitoba Avenue from Chudley Street to Keewatin Street – Concrete Rehabilitation
Pacific Avenue from Sherbrook Street to Tecumseh Street – Asphalt Rehabilitation
Tecumseh Street from Pacific Avenue to Alexander Avenue – Concrete Rehabilitation

RE: Contract 2 – 2022 Local Street Renewal Program 22-R-01C

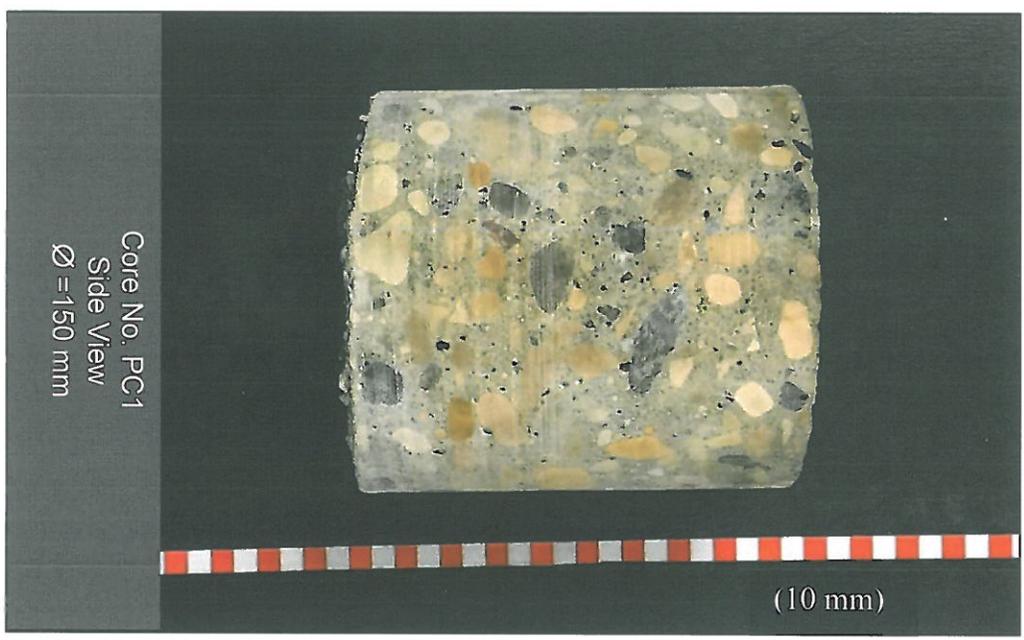
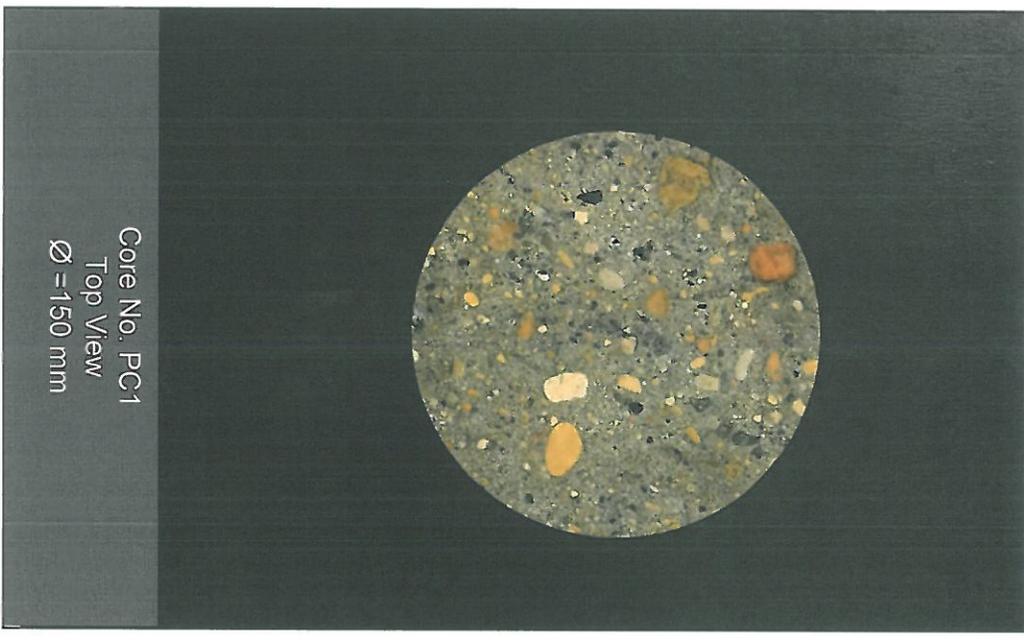
Photograph 1: Specimens from Buller Avenue

| Core No. | Date Collected | Lane Direction | Test Hole Location | | Pavement Surface | | |
|---|---|---|---|---|---|---|---|
| PC1 | November 17, 2021 | Southbound | 5532657 | 630091 | Asphalt | 150 | 0 |
| | | | | | Concrete | 150 | 156 |

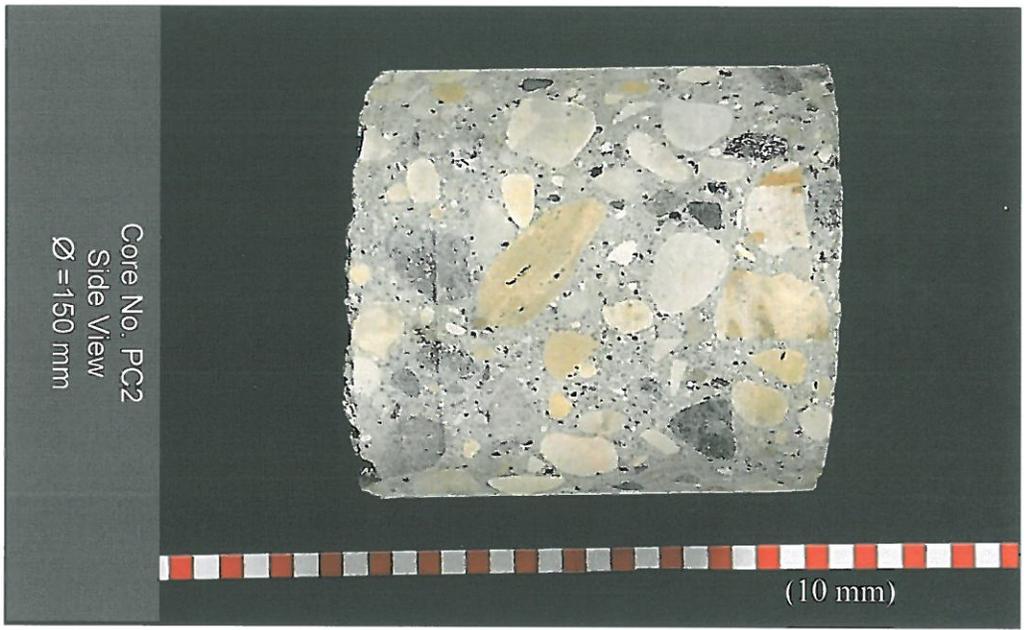
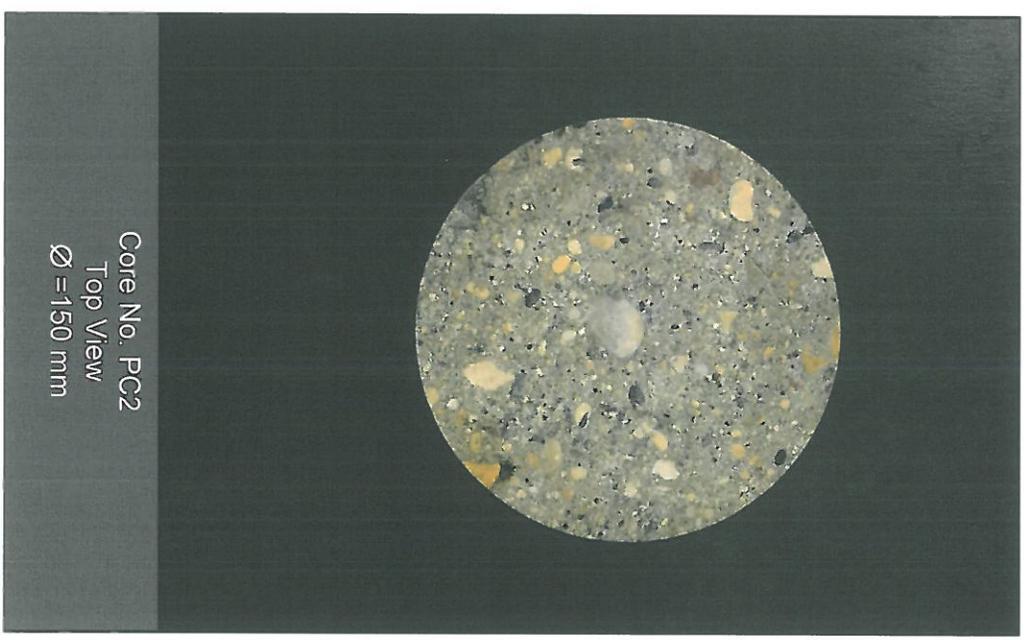
Photograph 2: Specimens from Buller Avenue

| Core No. | Date Collected | Lane Direction | Test Hole Location | | Pavement Surface | | |
|---|---|---|---|---|---|---|---|
| PC2 | November 17, 2021 | Northbound | 5532558 | 630042 | Asphalt | 150 | 0 |
| | | | | | Concrete | 150 | 155 |

Core No. PC2
Side View
Ø = 150 mm

Core No. PC2
Top View
Ø = 150 mm

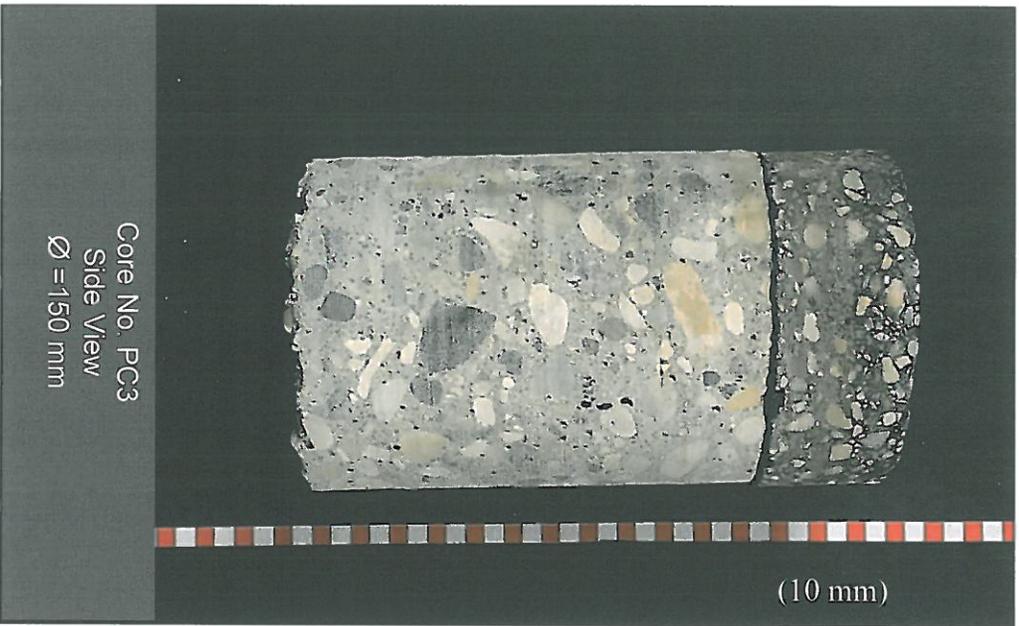
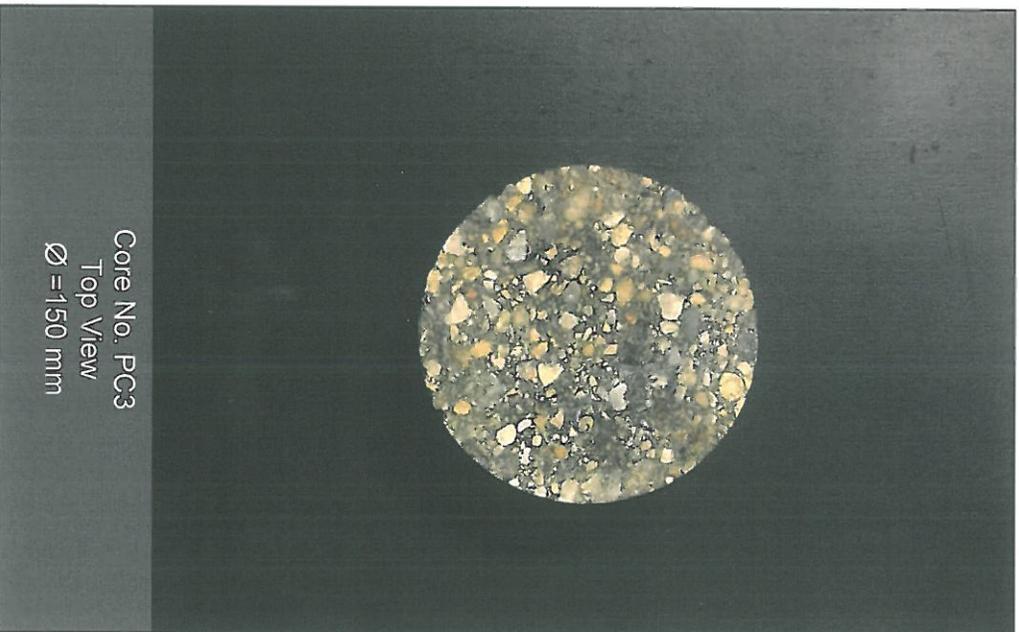
Photograph 3: Specimens from Manitoba Avenue

| Core No. | Date Collected | Lane Direction | Test Hole Location | | Pavement Surface | | |
|---|---|---|---|---|---|---|---|
| PC3 | November 17, 2021 | Eastbound | 5532629 | 629798 | Asphalt | 150 | 56 |
| | | | | | Concrete | 150 | 195 |

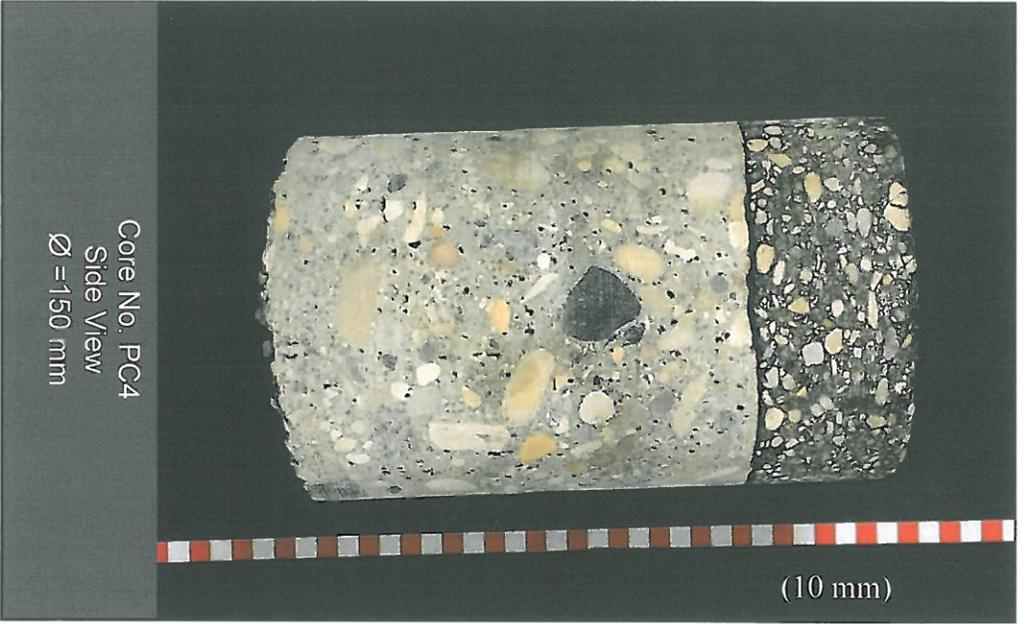
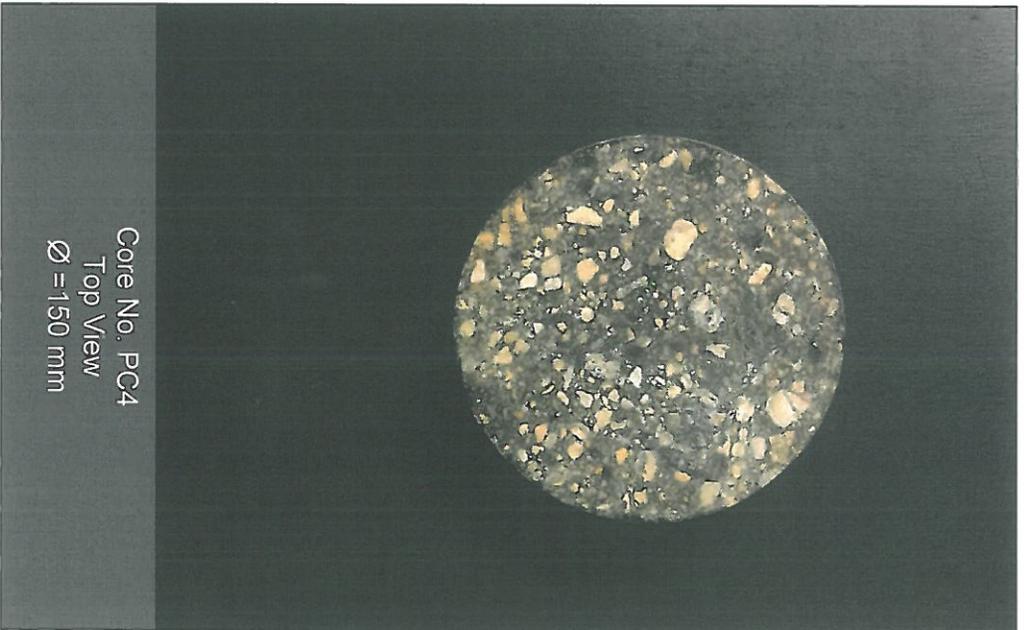
Photograph 4: Specimens from Manitoba Avenue

| Core No. | Date Collected | Lane Direction | Test Hole Location | | Pavement Surface | | |
|---|---|---|---|---|---|---|---|
| PC4 ¹ | November 17, 2021 | Westbound | 5532684 | 629686 | Asphalt | 150 | 60 |
| | | | | | Concrete | 150 | 178 |

1. Core No.'s PC4 and PC9 contained reinforcing steel bars.
2. Core No. PC6 was composed largely of asphalt cement with little to no visible aggregate below 75mm depth. Refer to photograph 6
3. Core No. PC7 contained a layer of asphalt cement with no visible aggregate near the bottom of the core. Refer to photograph 7

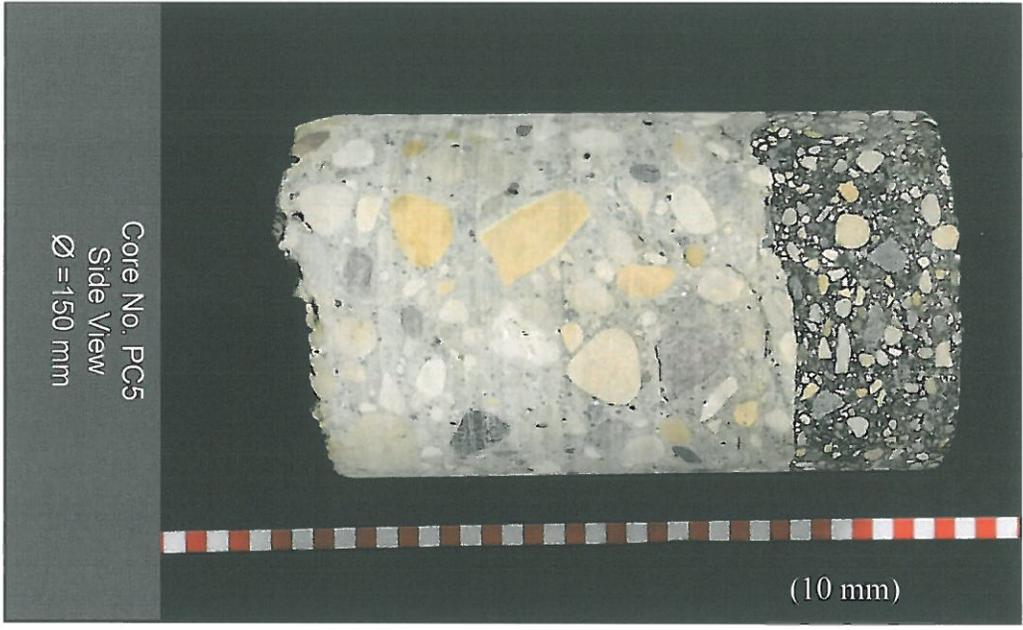
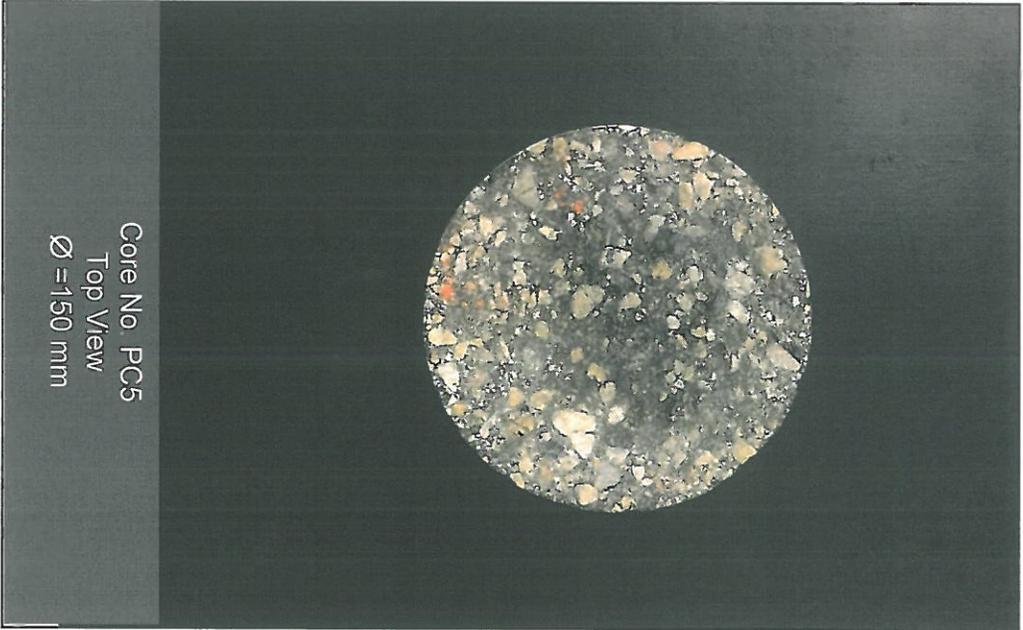
Photograph 5: Specimens from Manitoba Avenue

| Core No. | Date Collected | Lane Direction | Test Hole Location | | Pavement Surface | | |
|---|---|---|---|---|---|---|---|
| PC5 | November 17, 2021 | Westbound | 5532728 | 629591 | Asphalt | 150 | 63 |
| | | | | | Concrete | 150 | 181 |

Core No. PC5
Side View
Ø = 150 mm

Core No. PC5
Top View
Ø = 150 mm

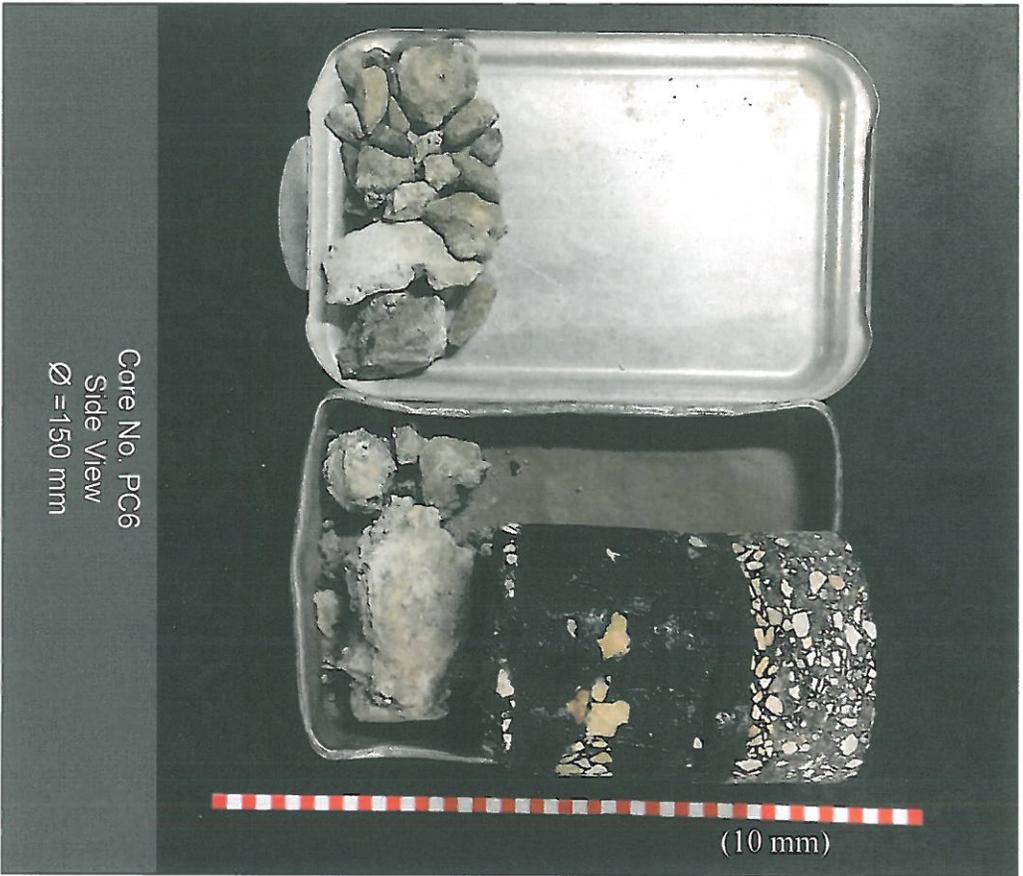
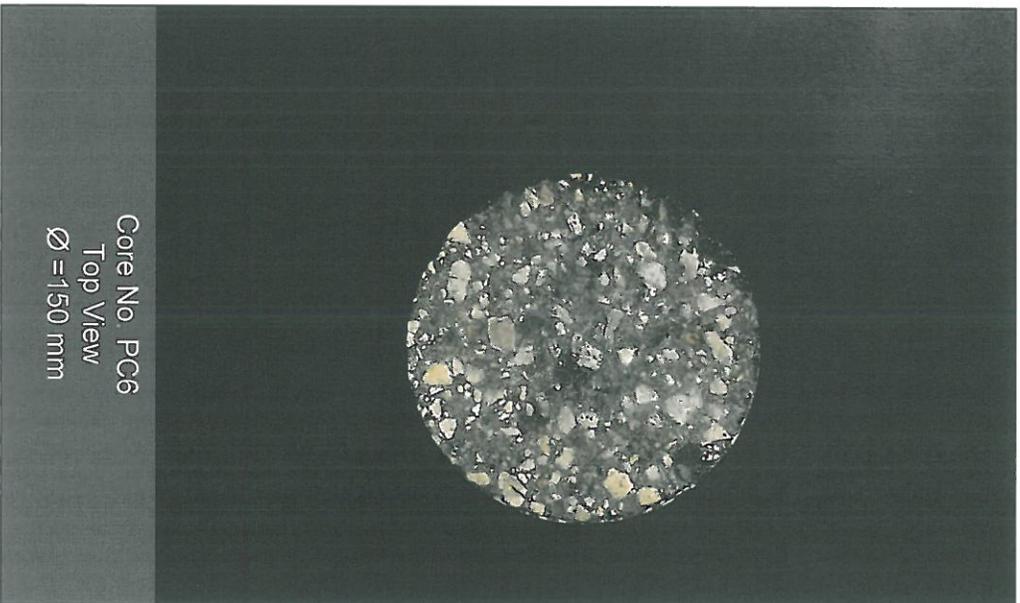
Photograph 6: Specimens from Pacific Avenue

| Core No. | Date Collected | Lane Direction | Test Hole Location | | Pavement Surface | | |
|---|---|---|---|---|---|---|---|
| PC6 ² | November 17, 2021 | Eastbound | 5529888 | 632520 | Asphalt | 150 | 209 |
| | | | | | Concrete | 150 | 90 |

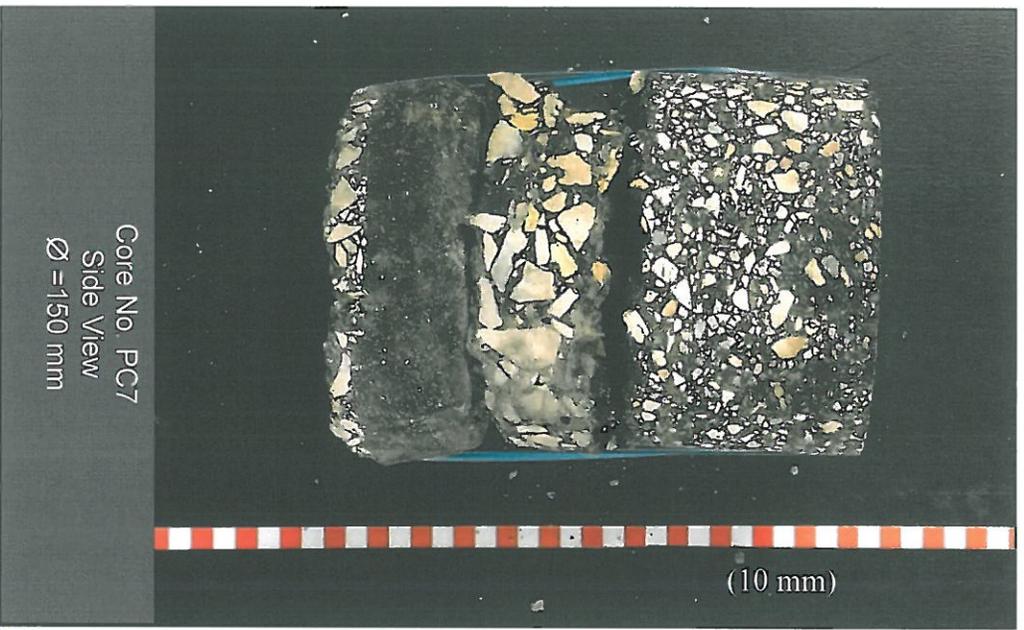
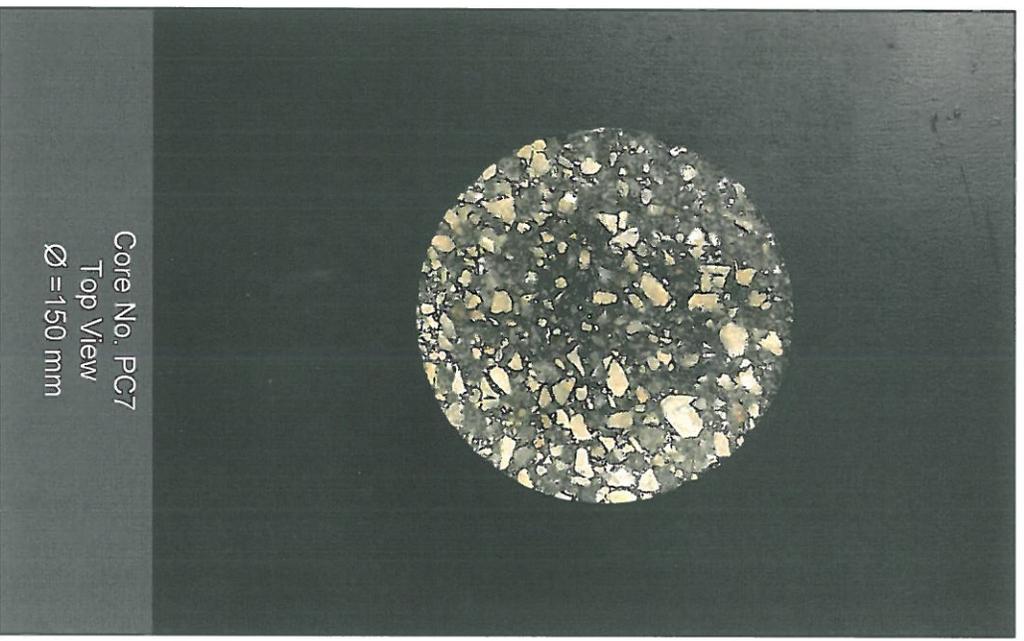
Photograph 7: Specimens from Pacific Avenue

| Core No. | Date Collected | Lane Direction | Test Hole Location | | Pavement Surface | | |
|---|---|---|---|---|---|---|---|
| PC7 ³ | November 17, 2021 | Eastbound | 5530007 | 632279 | Asphalt | 150 | 204 |
| | | | | | Concrete | 150 | 0 |

Core No. PC7
Side View
Ø = 150 mm

Core No. PC7
Top View
Ø = 150 mm

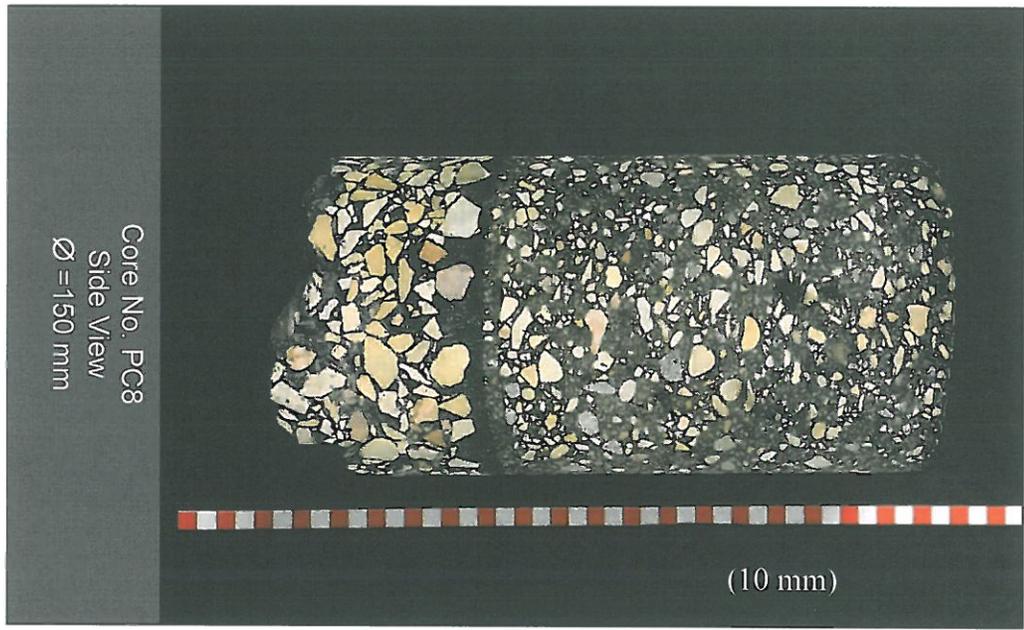
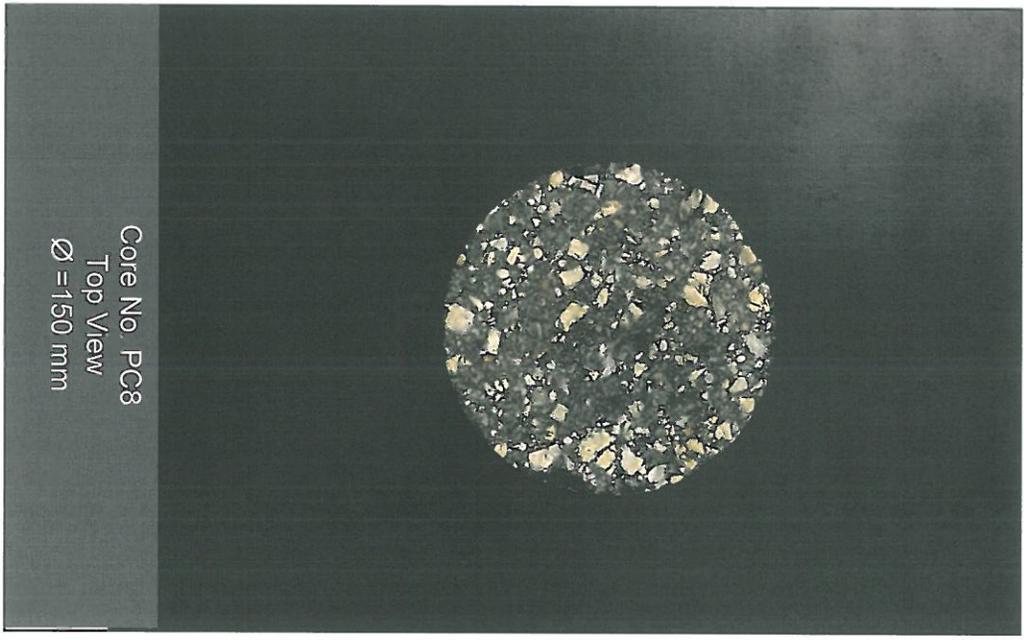
Photograph 8: Specimens from Pacific Avenue

| Core No. | Date Collected | Lane Direction | Test Hole Location | | Pavement Surface | | |
|---|---|---|---|---|---|---|---|
| PC8 | November 17, 2021 | Westbound | 5530057 | 632174 | Asphalt | 150 | 277 |
| | | | | | Concrete | 150 | 0 |

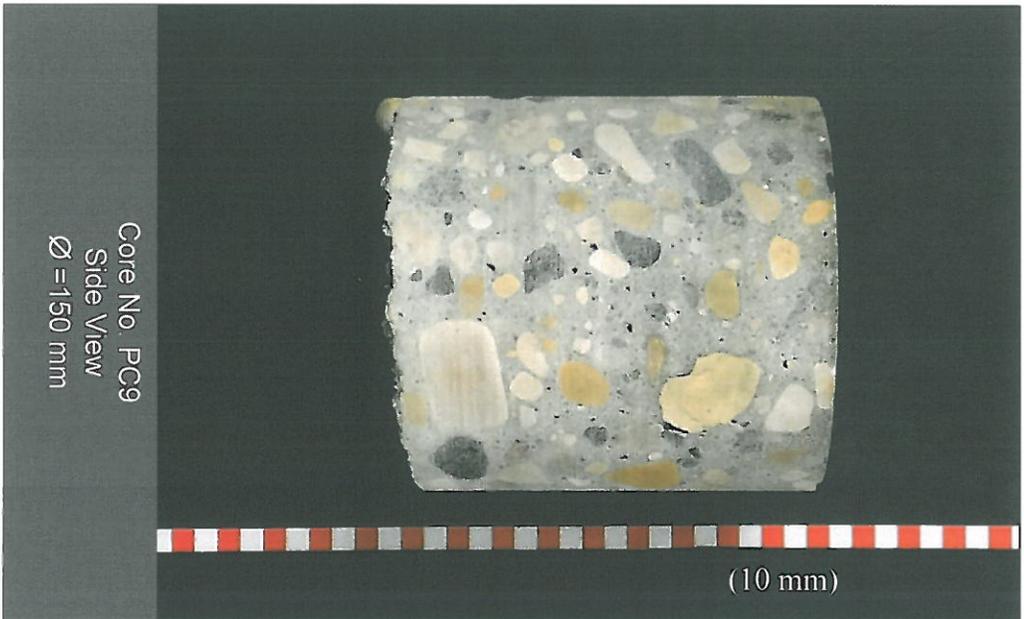
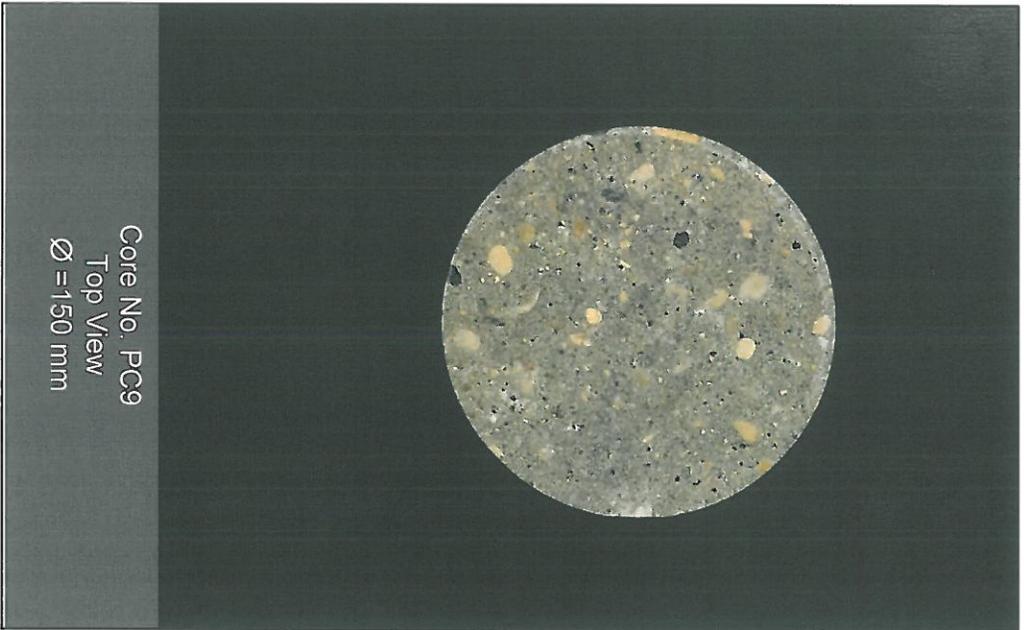
Photograph 9: Specimens from Pacific Avenue

| Table 4 - Summary of Pavement Core Structure Tecumseh Street between Pacific Avenue and Alexander Avenue | | | | | | | |
|---|---|---|---|---|---|---|---|
| PC9 ¹ | November 17, 2021 | Northbound | 5532728 | 6295891 | Asphalt | 150 | 0 |
| | | | | | Concrete | 150 | 153 |

Core No. PC9
Side View
Ø = 150 mm

Core No. PC9
Top View
Ø = 150 mm
