# **GEOTECHNICAL REPORT**

**Re: 2022 Redwood Avenue Reconstruction – Winnipeg, Manitoba  
Report of Geotechnical Investigation and Test Results**

This letter summarizes KGS Group’s geotechnical results for the 2022 Redwood Avenue Reconstruction Project in Winnipeg, Manitoba. KGS Group’s scope of services for this project was outlined in our proposal no. 22-000-0100 titled “2022 Redwood Avenue Reconstruction - Geotechnical” dated February 3, 2022.

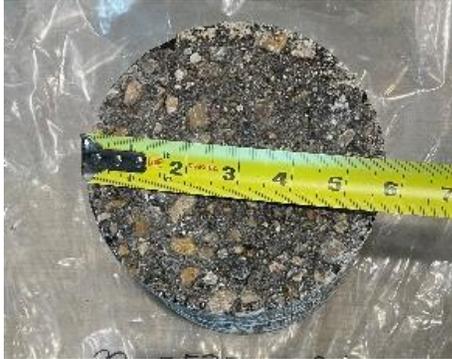
Photo 1: TH22-01 Core Surface

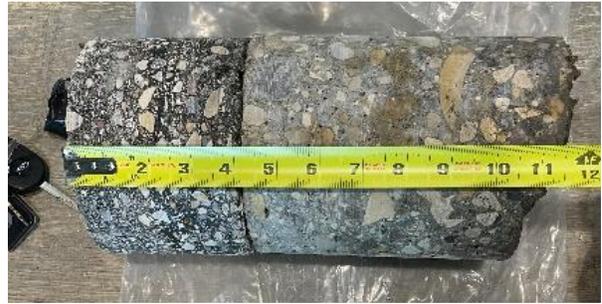
Photo 2: TH22-01 Core Profile

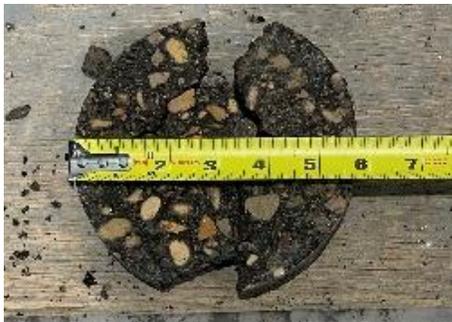
Photo 3: TH22-02 Core Surface

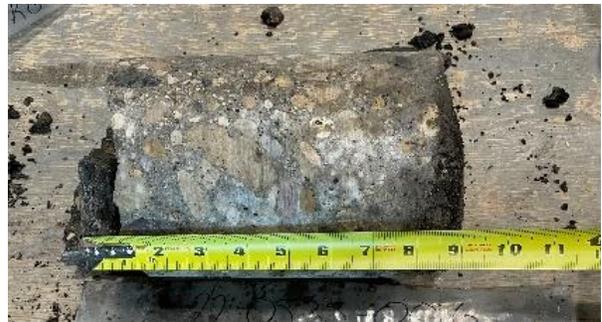
Photo 4: TH22-02 Core Profile

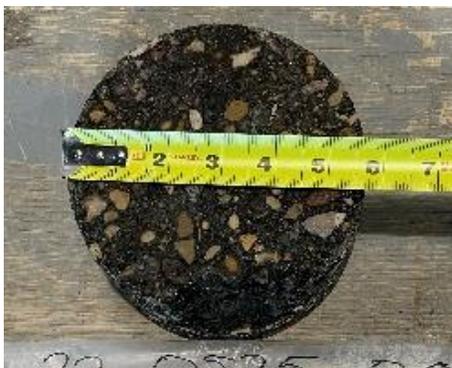
Photo 5: TH22-03 Core Surface

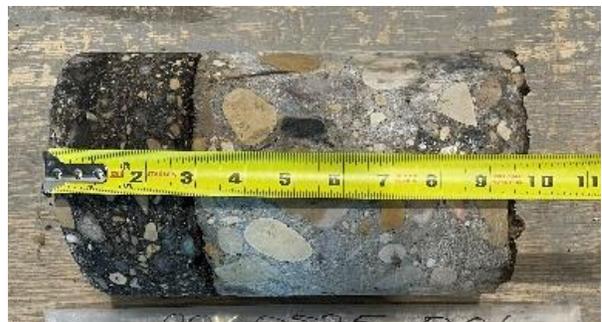
Photo 6: TH22-03 Core Profile

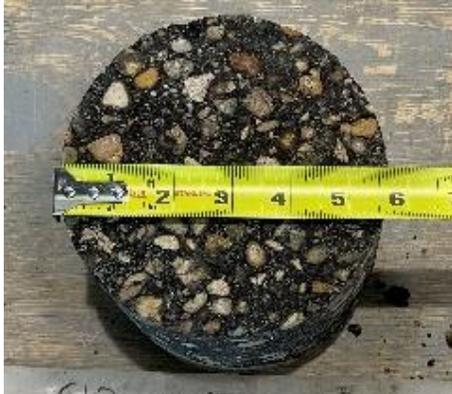
Photo 7: TH22-04 Core Surface

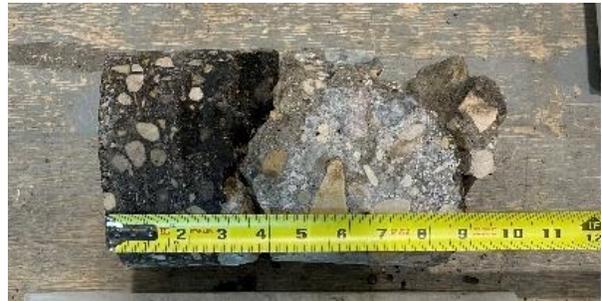
Photo 8: TH22-04 Core Profile

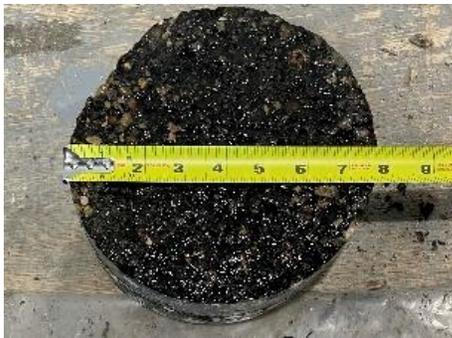
Photo 9: TH22-05 Core Surface

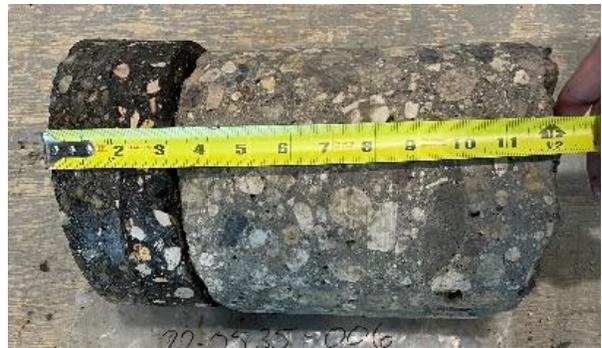
Photo 10: TH22-05 Core Profile
