Riviera Crescent Outfall Fisheries Act Authorization Report and Offsetting Plan

Final:
Rev 0

KGS Group Project:
20-0107-010

Date:
June 16, 2022

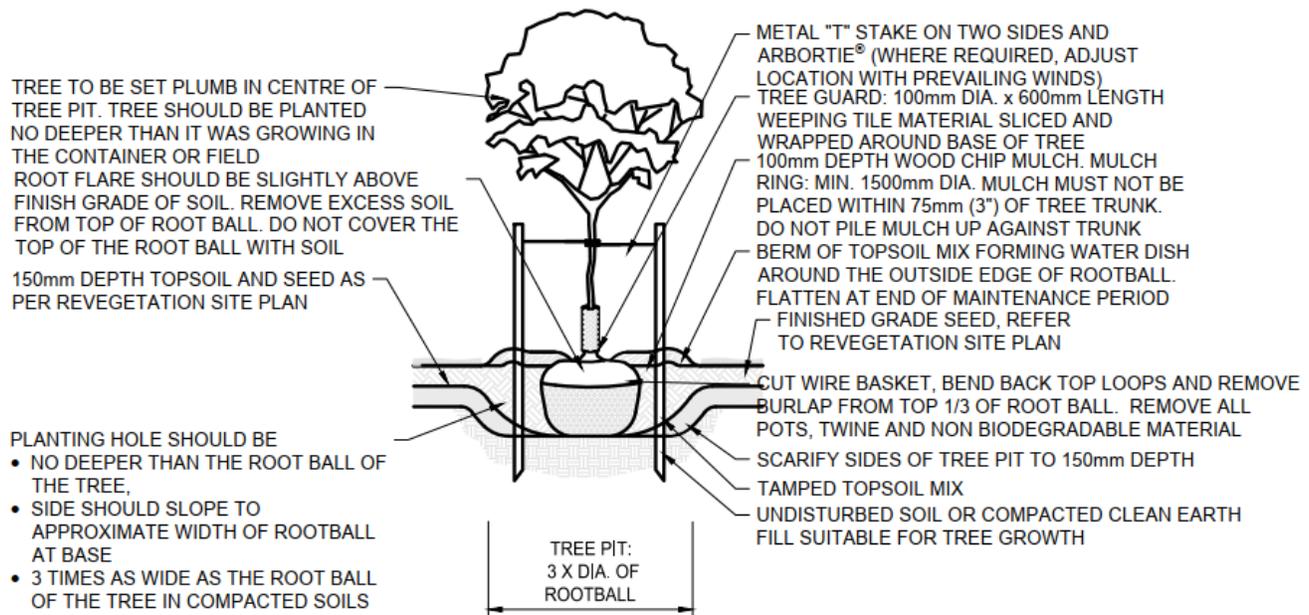
FIGURE 1: TYPICAL TREE PLANTING SECTION

with basswood and Manitoba maple acceptable options to also be planted. Likewise, willow and dogwood shrubs will make up at a minimum 60% of the shrub species that will be planted, with nanny berry, rose, saskatoon and snow berry acceptable options to also be planted. It is proposed that 10 caliper trees (>75 mm caliper size), 12 container stock trees (5 gallon or larger container size) and 38 shrubs will be planted in the 250 m² riparian native revegetation area. The proposed plan will be to plant trees and shrubs directly into the soil and minimally disturb the stability and erosion control that the existing vegetation already provides at the site. To decrease the competition that the trees and shrubs will face in their establishing years, an area three-times the size of the plants root ball will be dug out and backfilled with soil and topped with bark mulch. This allows the plant to have sufficient space to establish their roots while not competing for resources. Details for the planting of trees and shrubs, including materials used and installation methods are shown below in Figure 1.

The site revegetation design includes planting a diverse mix of shrubs and trees endemic to the environment (plant hardiness zone 3) and observed along the banks of the Red River (Appendix D – Photos 7-9). Cottonwood and peach leaf willow will make up at a minimum 60% of the tree species that will be planted,

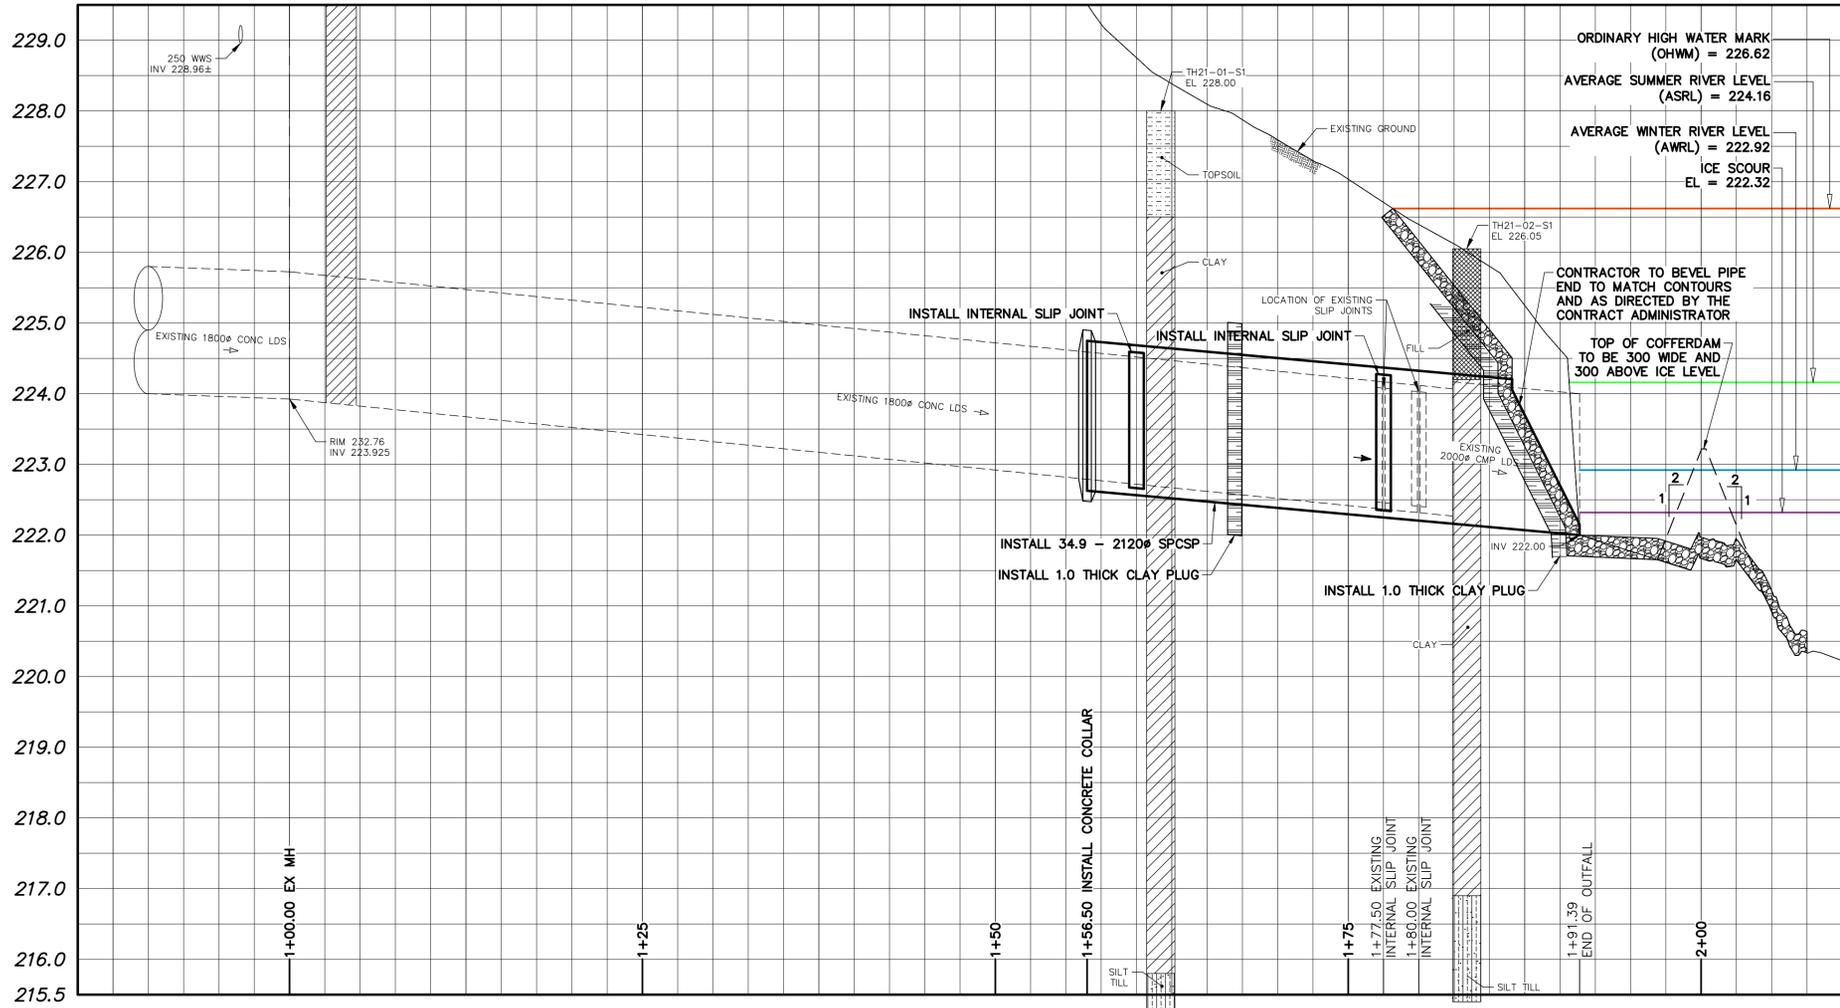
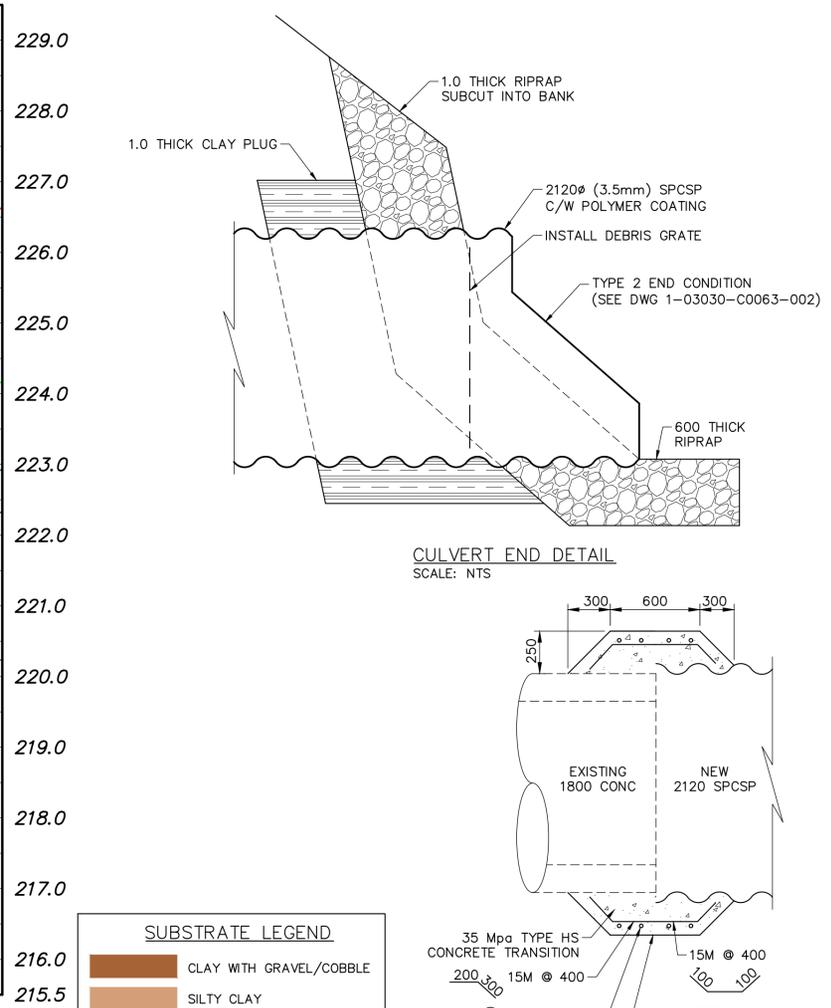
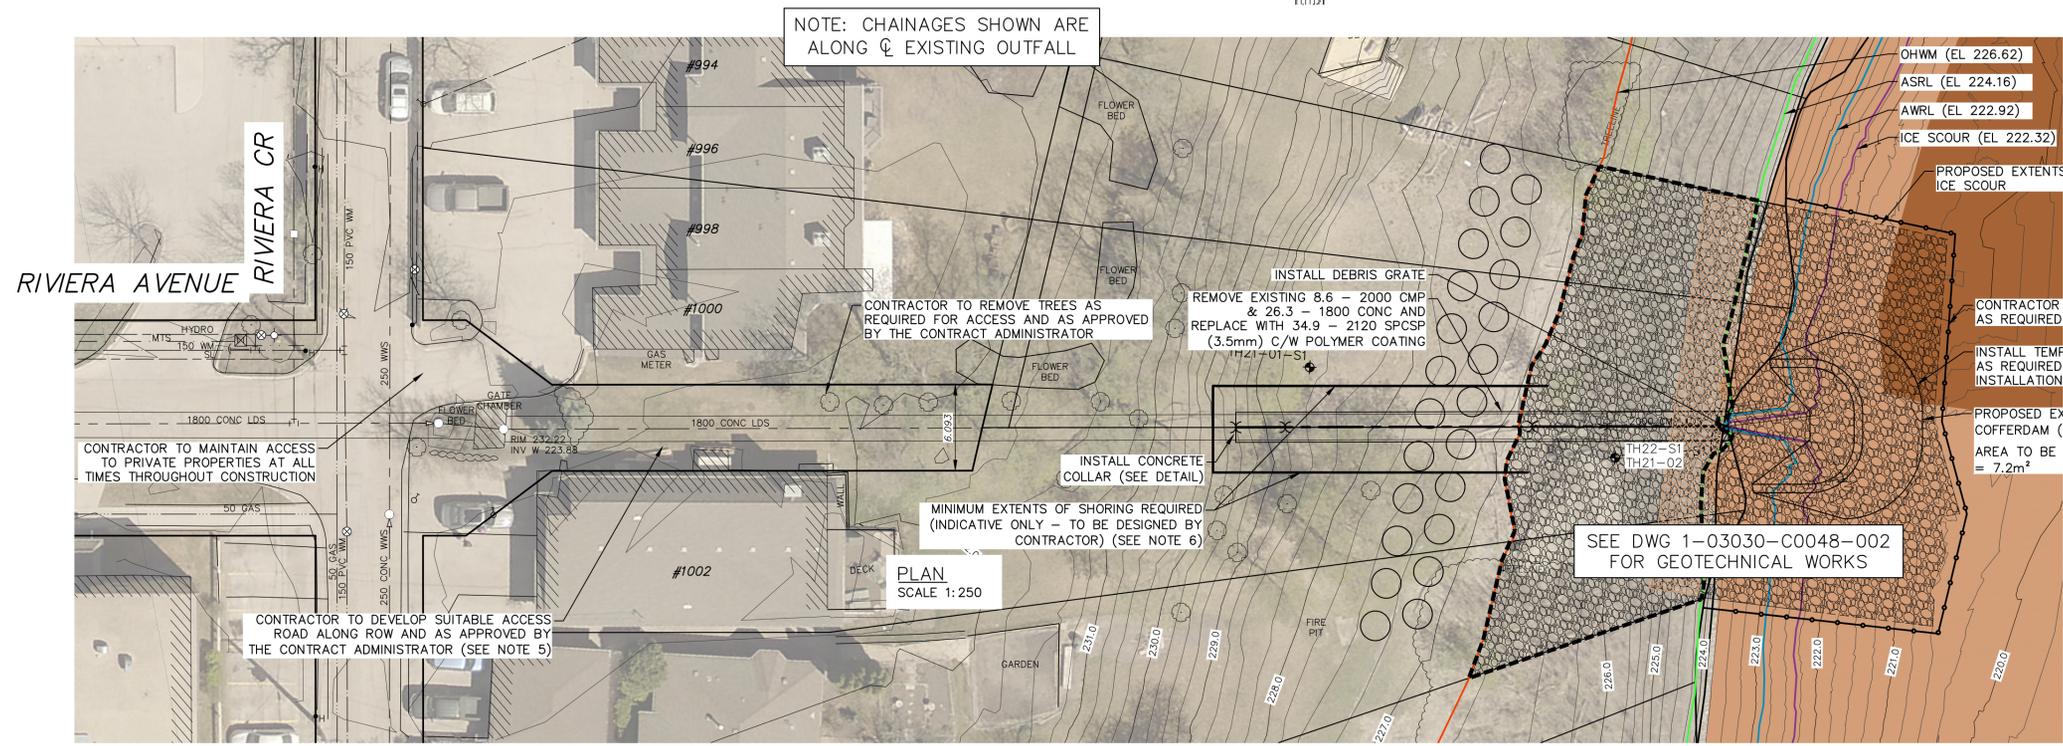
SHEET 11 OF 27
CITY DRAWING NUMBER: 1-03030-C0048-001

2020-2021 OUTFALL PROGRAM
RENEWAL AND REHABILITATION
RIVIERA CRESCENT OUTFALL
PLAN AND PROFILE
S-MA70007648

Works that will occur below the OHWM includes a temporary cofferdam, culvert repairs, installation of a rockfill shear key, riverbank regrading and installation of an 869.0 m² riprap blanket encompassing the entire project footprint below the OHWM. The project will alter 869.0 m² of fish habitat and affect 47.0 m² of potentially suitable Mapleleaf mussel habitat. The detailed project design is shown in Appendix B – Design Drawings 001 and 002.

A set of renewal and rehabilitation design drawings (PP-R-C0048-001 & -002) showing the proposed works for the Riviera Crescent Outfall Permanent Works is provided in Appendix B.

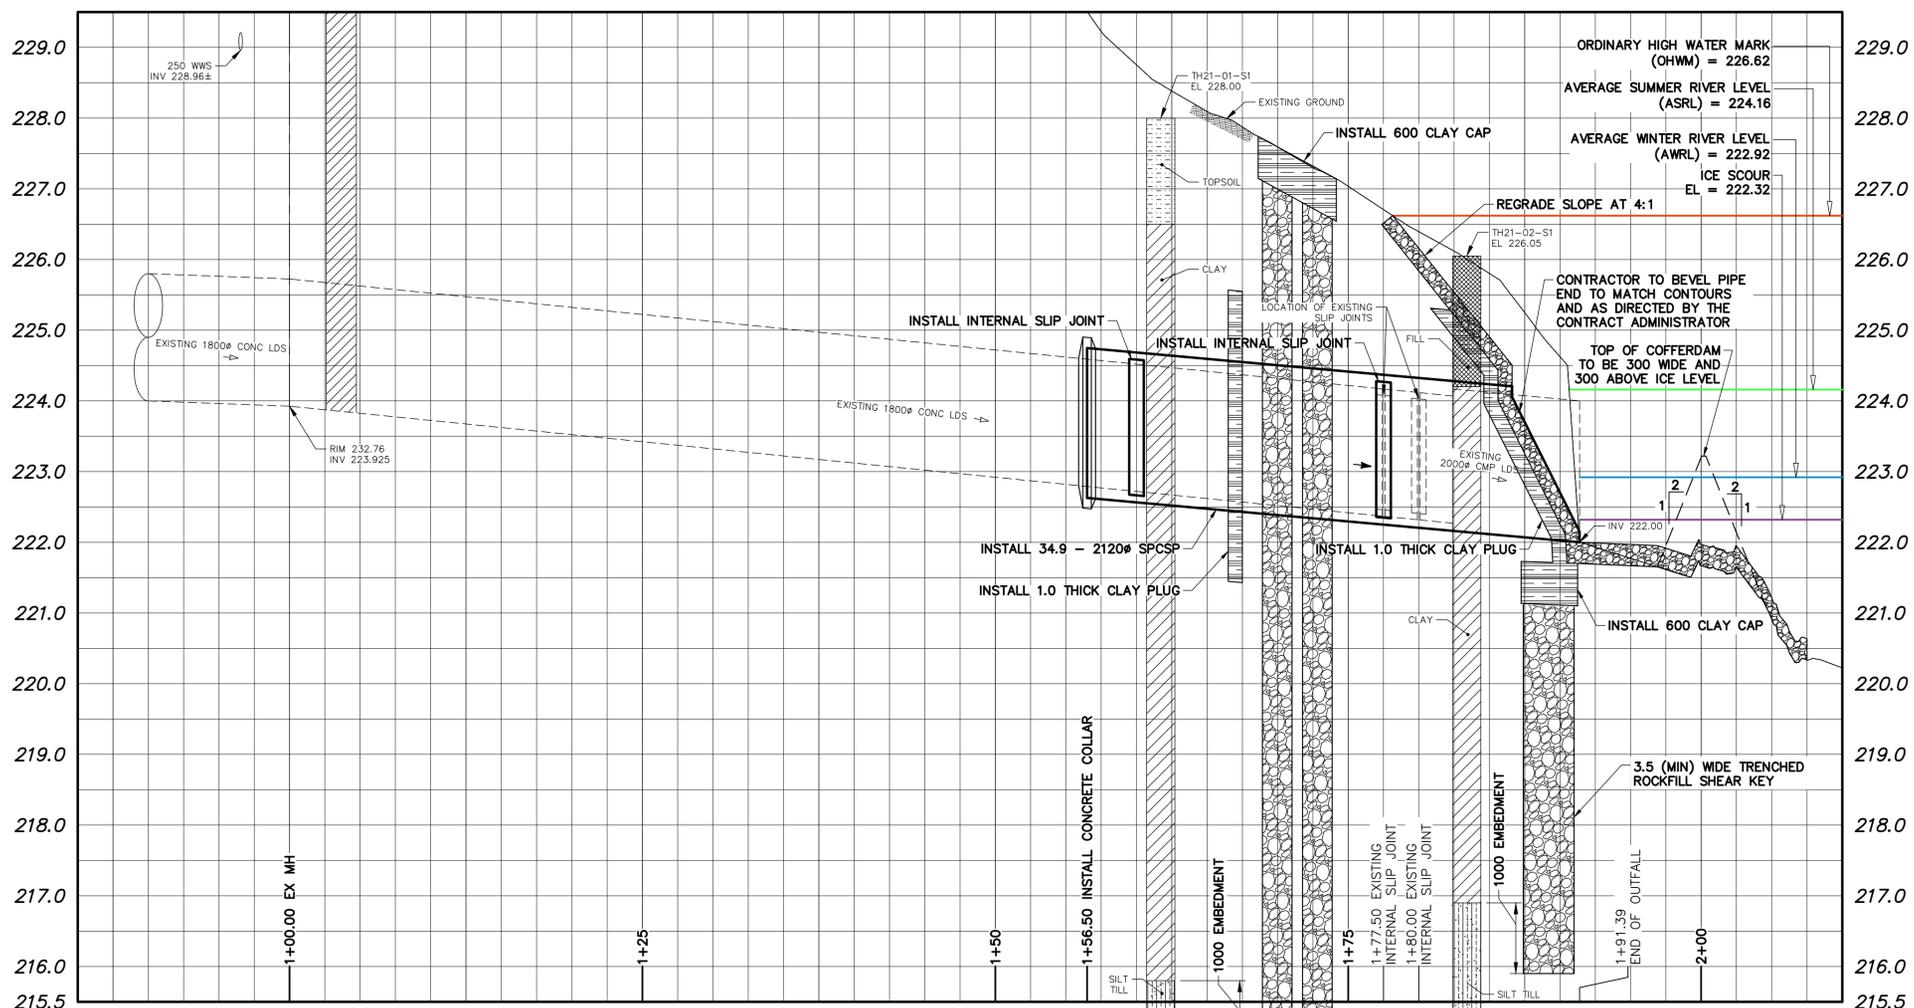
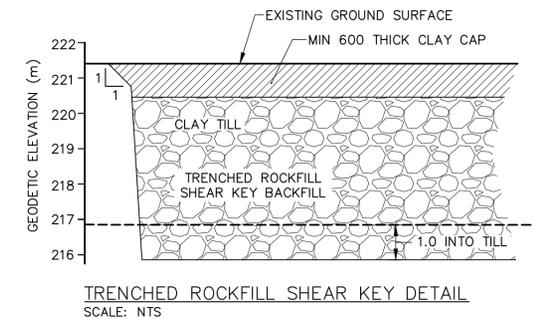
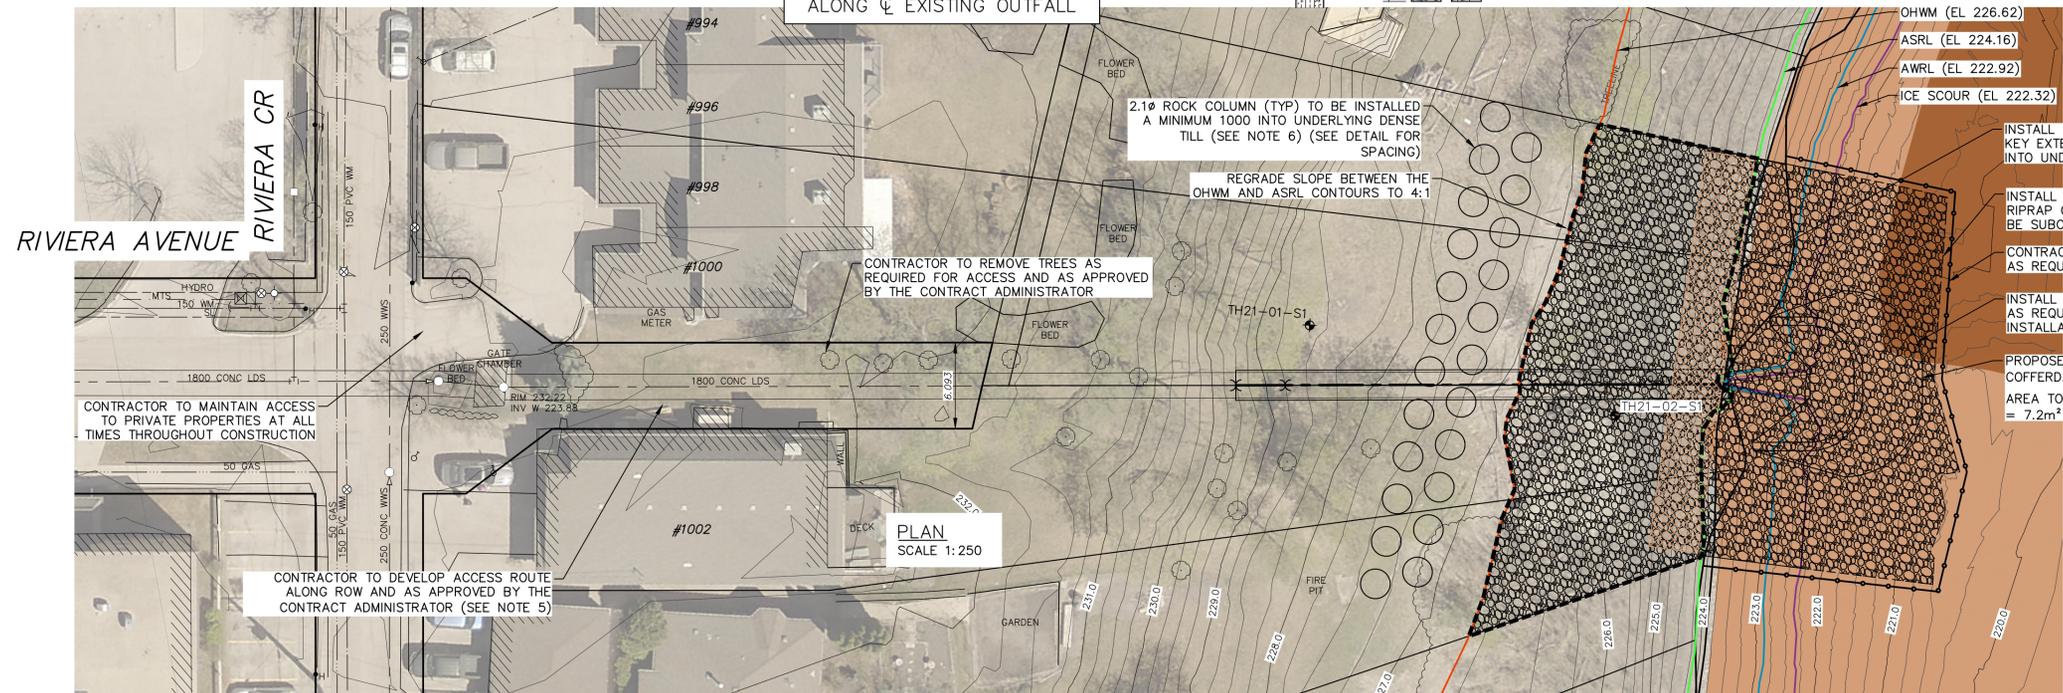
- VIBRATION MONITORS SHALL BE INSTALLED AT ADJACENT PRIVATE PROPERTIES PRIOR TO CONSTRUCTION (ALLOWANCE INCLUDED IN CONTRACT).
 - CONTRACTOR SHALL VIBROCOMPACT ROCKFILL COLUMNS AND SHEAR KEY STARTING IN THE MIDDLE/AT PIPE ALIGNMENT AND WORK TOWARDS NORTH EXTENT. COLUMNS AND SHEAR KEY SOUTH OF THE PIPE ALIGNMENT SHALL BE VIBROCOMPACTED FOLLOWING THE NORTH HALF COMPACTION. VIBROCOMPACTION OF ROCKFILL COLUMNS AND SHEARKEY SHALL BE COMPLETED IN ADVANCE OF PIPE INSTALLATION WORKS.

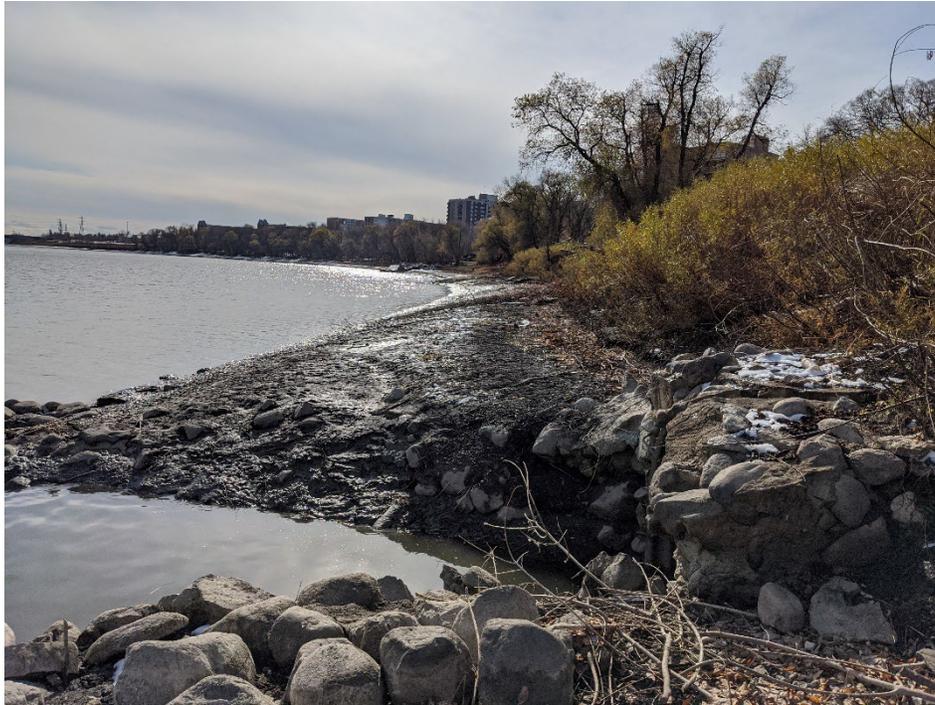
Photo 1: Toe of the bank looking upstream

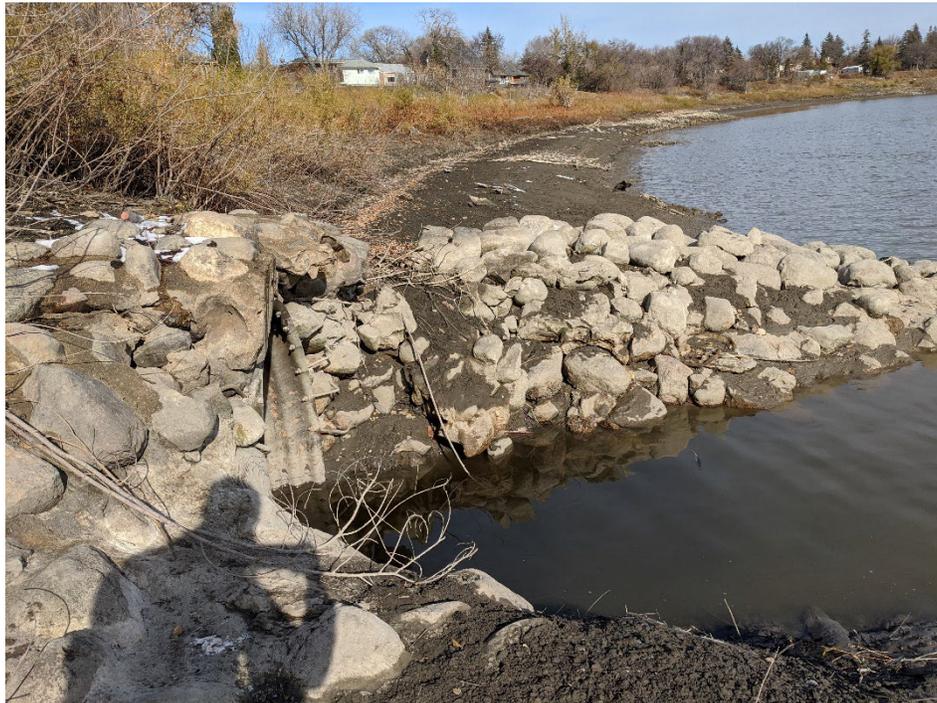
Photo 2: Toe of the bank looking downstream

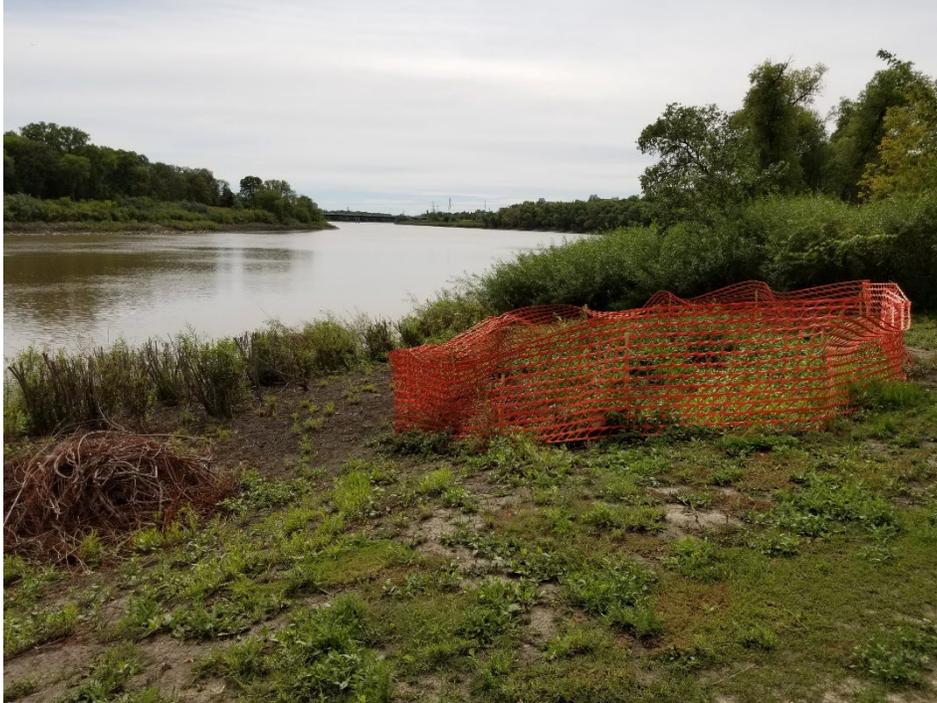
Photo 3: Mid-bank looking upstream (fencing around previous sink hole repaired March 2021)

The need for emergency repairs was identified at the Riviera Crescent Outfall during the summer of 2020 due to a large sinkhole that had opened up along the riverbank just below the Ordinary High Water Mark (OHWM, EL. 226.62 m). A Request for Review was submitted to Fisheries and Oceans Canada (DFO) on November 12, 2020, for the proposed emergency repairs. DFO issued a Letter of Advice (LoA) on December 16, 2020 (DFO File No. 20-HCAA-02308) stating, with implemented mitigation measures, the proposed emergency repairs could proceed. The emergency sink hole repair was completed in March 2021.

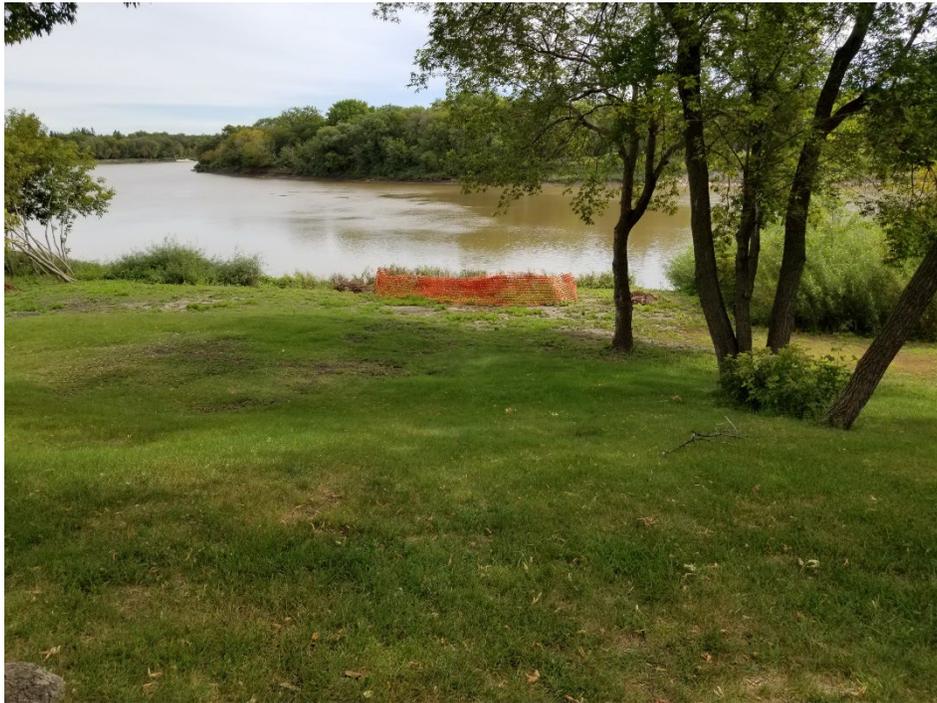
Photo 4: Mid-bank looking towards Assiniboine River and downstream

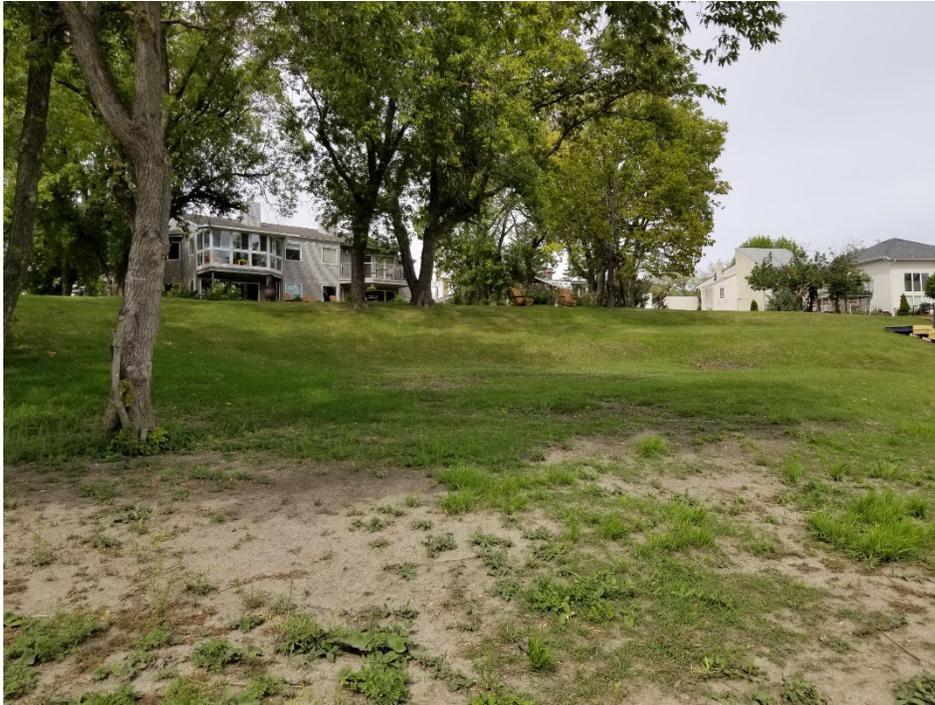
Photo 5: Mid-bank looking towards top of the bank

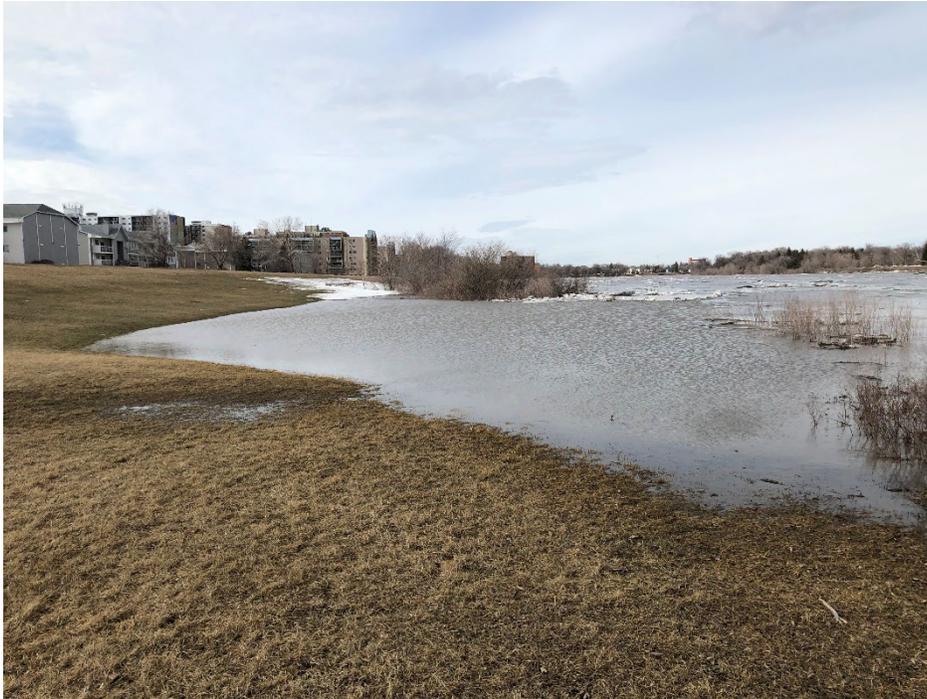
Photo 7: Looking downstream at the offsetting site (April 2022- flooded conditions)

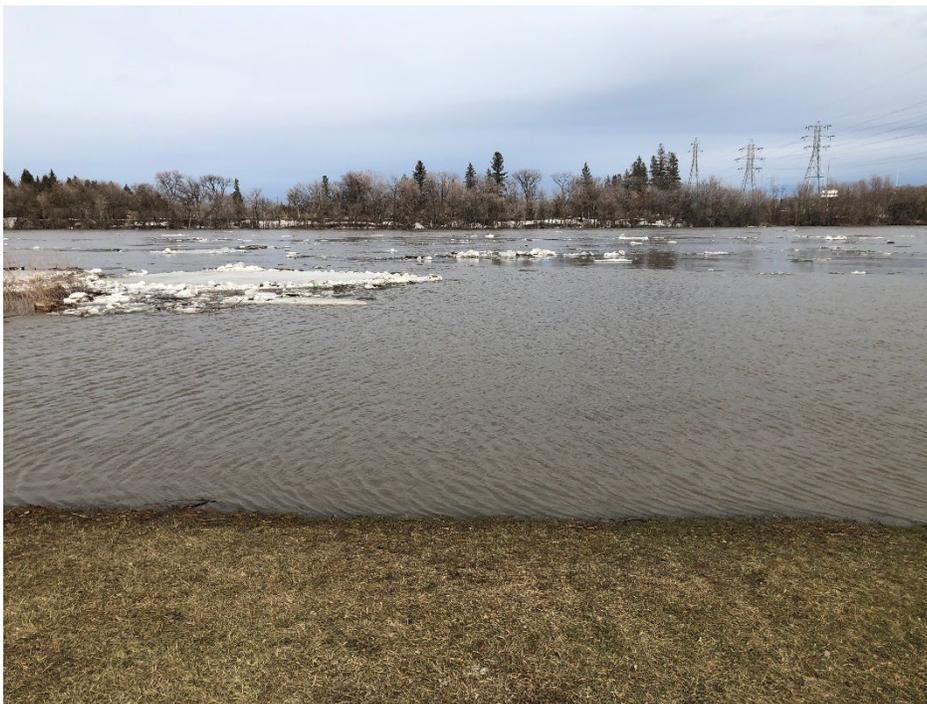
Photo 8: Looking East at the Red River at the offsetting site (April 2022- flooded conditions)

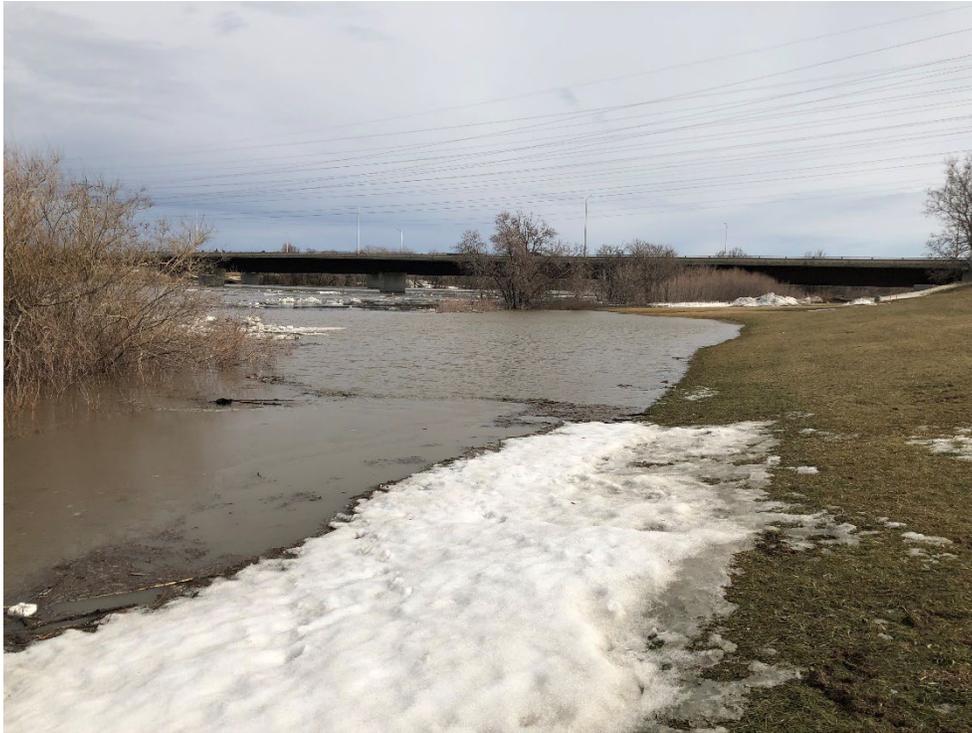
Photo 9: Looking upstream at the offsetting site (April 2022- flooded conditions)

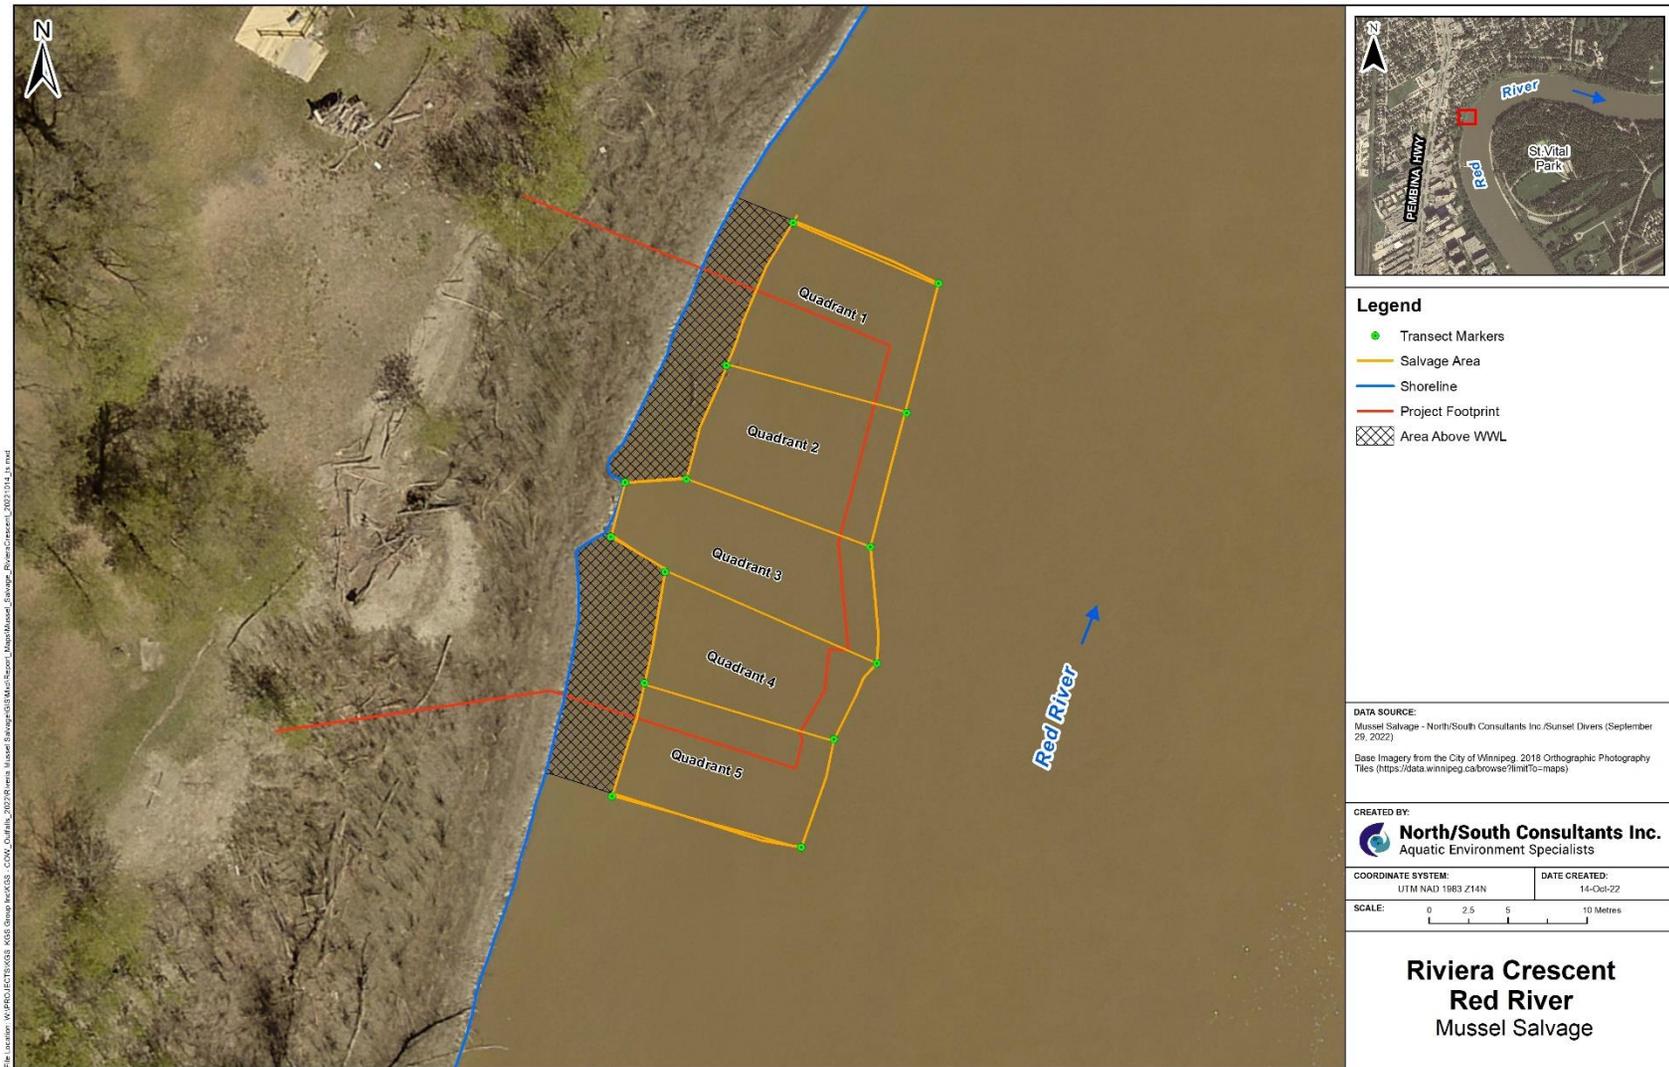
Figure 2. Riviera Crescent Outfall Project search area showing numbered quadrats used during the mussel relocation.

A semi-quantitative sampling approach was used for the Riviera Crescent mussel survey. The PSA was stratified into smaller search quadrats. The smaller search quadrats were marked with floats at the corners and their locations were determined using a survey-grade Trimble GPS capable of sub-meter accuracy. Each quadrat was searched (by touch) by divers. If any mussels were found by the divers, they were transferred to NSC staff on site before continuing to the next quadrat. Because of the water depth characteristics at this site, no mussel raking was conducted. Tubs filled with well oxygenated water were available to hold any mussels captured. Captured mussels were identified to species, measured for length, width and height with representative photographs recorded; photographs included end view, top view and lateral view. A suitable relocation site upstream of the PSA was chosen before the relocation.

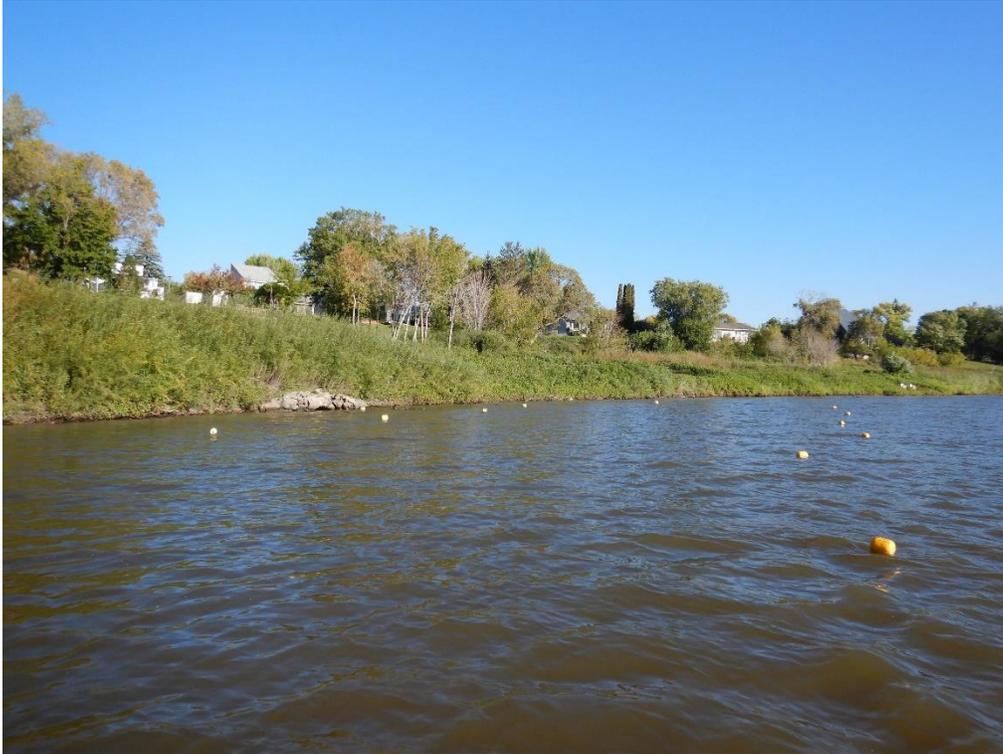
Photo 1. Project search area showing marker buoys used to delineate quadrats.

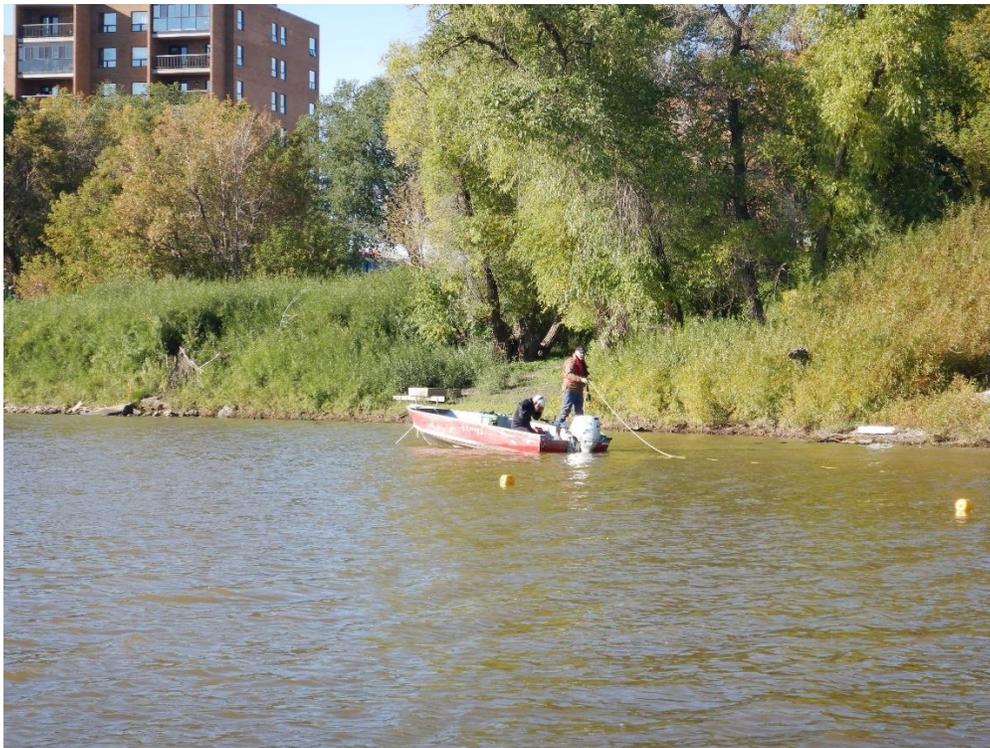
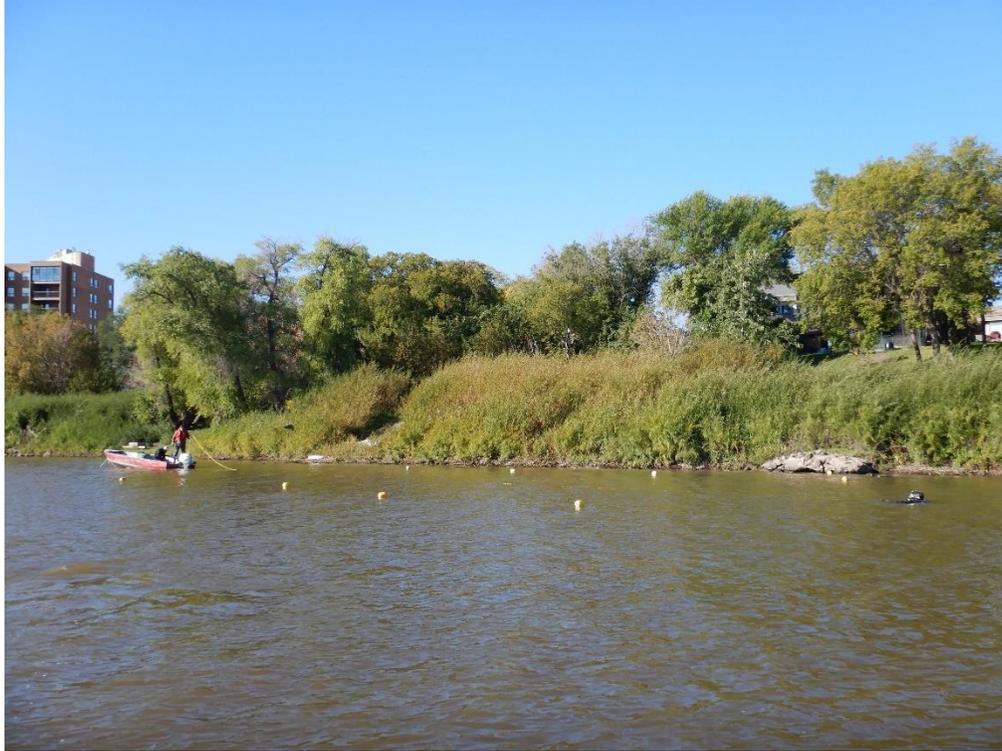
Photo 2. Divers conducting the mussel relocation at the Riviera Crescent Outfall location

Photo 3. Divers conducting the mussel relocation at the Riviera Crescent Outfall location
