CITY OF WINNIPEG

McLeod Creek Drainage Improvements Geotechnical Investigation Report

Final Rev 1

May 5, 2023

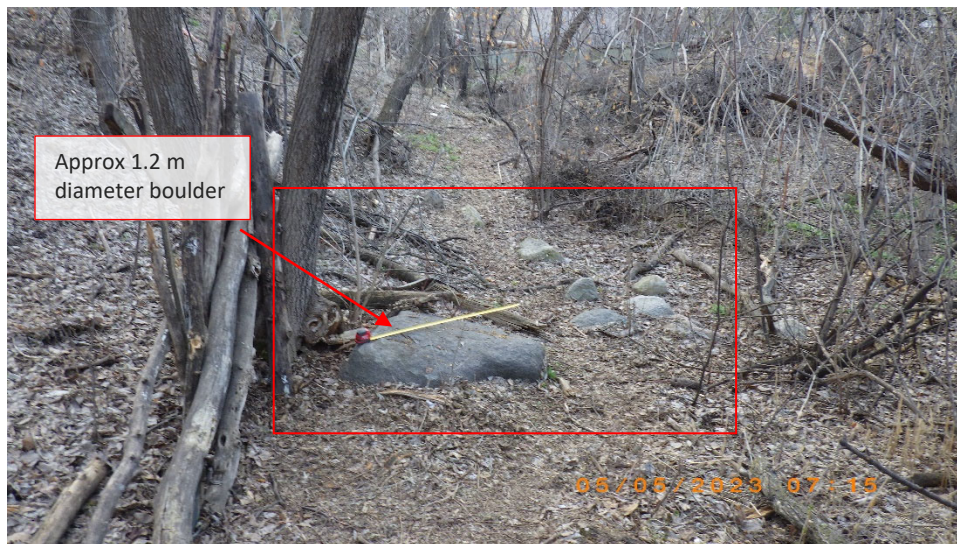
Cobbles and boulders up to 1.2 m in diameter were observed to be exposed at ground surface along the south slope and toe areas of the Bergen cutoff embankment in the vicinity of the proposed pipe alignment as shown in Photos 1 to 3. The Contractor should select an appropriate installation method to handle the boulder-sized material below grade.

PHOTO 1: BOULDERS OBSERVED EAST OF EXISTING CONCRETE ARCH CULVERT

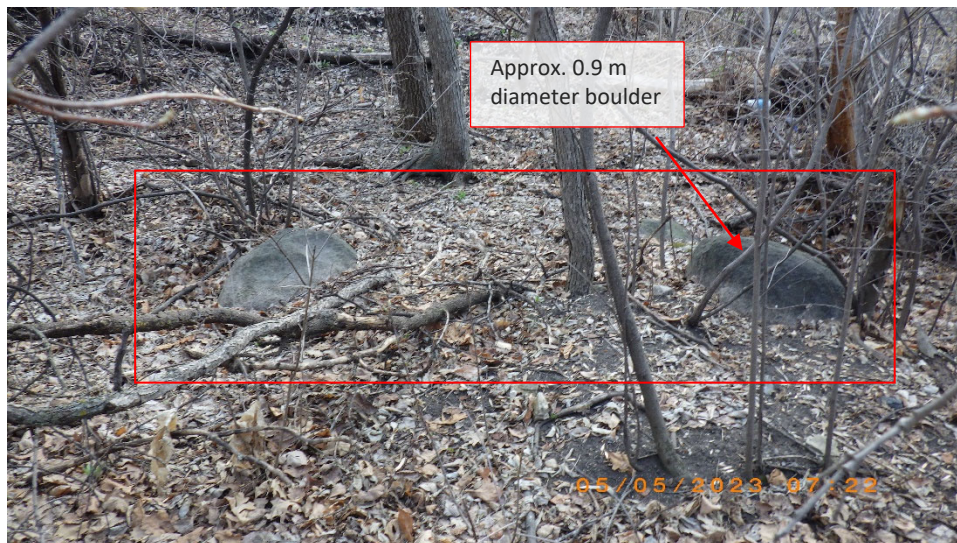
PHOTO 3: BOULDERS OBSERVED WEST OF PROPOSED PIPE ALIGNMENT
