**GEOTECHNICAL REPORT**

WSP Project No.: 20M-01243-00  
June 21, 2023

**Subject: Additional Assessment – Keewatin Slope Stability Review, Winnipeg, MB**

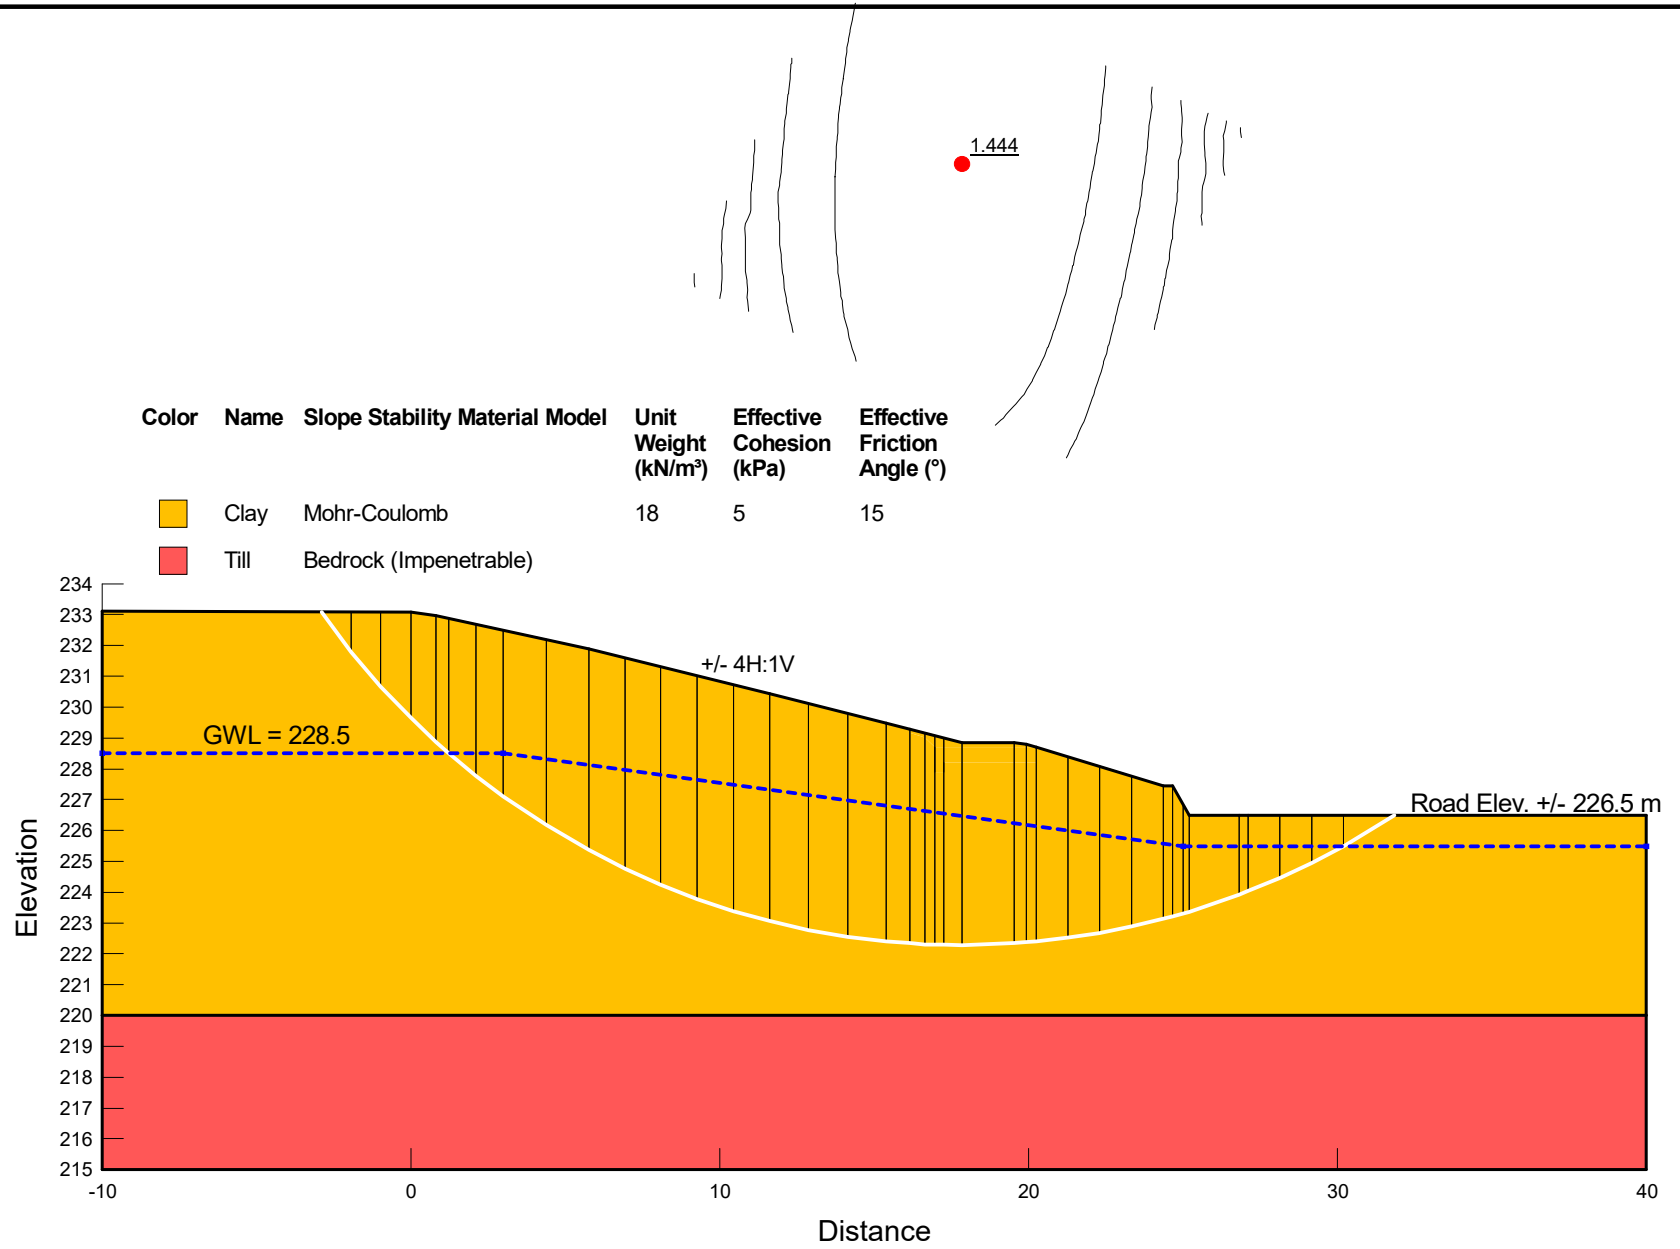
Pre-construction	
XS near 1+70	
Critical Slip Surface PSS1	FS= 1.44

Color	Name	Slope Stability Material Model	Unit Weight (kN/m³)	Effective Cohesion (kPa)	Effective Friction Angle (°)
Yellow	Clay	Mohr-Coulomb	18	5	15
Grey	Concrete	Mohr-Coulomb	23.5	100	40
Red	Till	Bedrock (Impenetrable)

PSSs		Factor of Safety (FS)	
		Pre-Construction	Post-Construction
XS-01 near STA 1+70	Critical, PSS1	1.44	1.44
	PSS2	1.90	1.97 (+3.6%)*

From the FS values outlined in Table 2, it is clear to conclude that the proposed sidewalk widening will not have a negative impact on the critical FS at PSS1. Instead, it has slightly improved the FS values at the upper bank (i.e. PSS2) since the clayey soils near the sidewalk were replaced with stronger concrete material.
