**APPENDIX B**  
**GEOTECHNICAL DATA REPORT**

# CentrePort South Regional Water & Wastewater Servicing Geotechnical Data Report

Draft Rev B

February 7, 2024

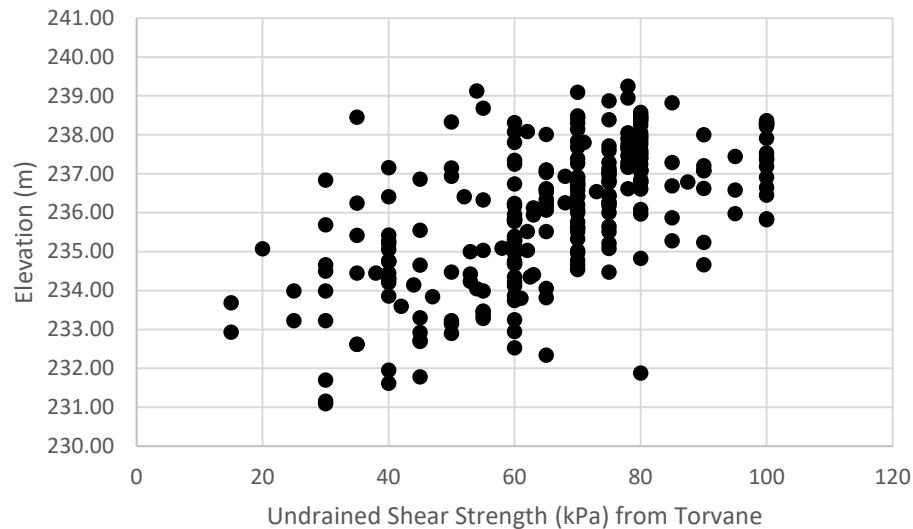
**FIGURE 4-2: UNDRAINED SHEAR STRENGTH WITH ELEVATION FOR GLACIOLACUSTRINE CLAY**

Undrained shear strengths measured from unconfined compression tests are generally higher within the upper clay zone (~ top 2 to 3 m), typically in the order of 70 to 100 kPa. Below a depth of about 4 to 5 metres, strengths typically decrease approximately uniformly with increasing depth. As the underlying till layer is approached, strengths are typically in the order of 40 kPa but may be as low as 25 kPa. The higher undrained shear strengths with the upper brown clay and lower shear strengths at depth near the till is caused by weathering near the ground surface and decreasing over consolidation ratios to approximately normally consolidated conditions near the bottom of the deposit. They may also reflect artesian ground water conditions (and therefore low vertical effective stresses).

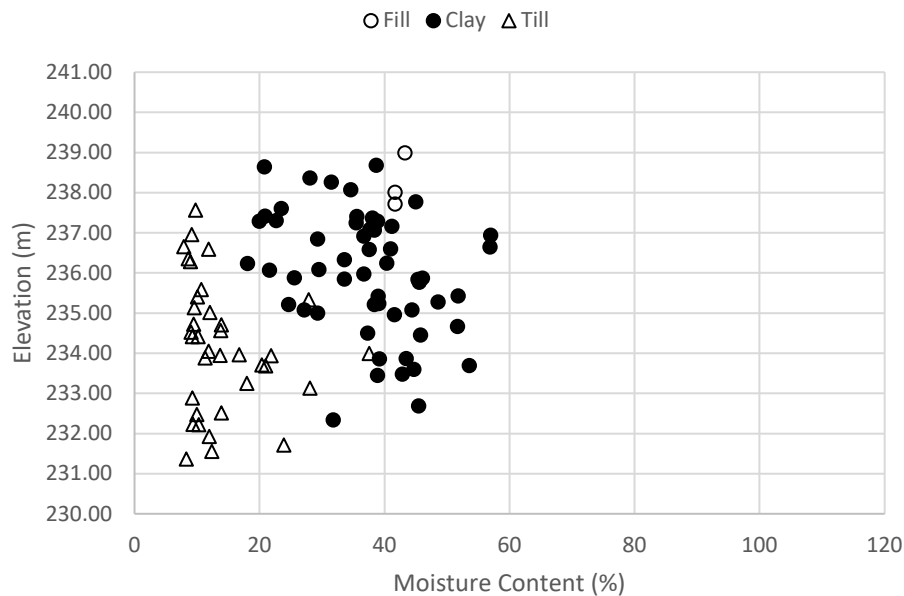
The variability of moisture content in the overburden with elevation in the project area is shown in Figure 4-3.

FIGURE 4-3: MOISTURE CONTENT OF OVERBURDEN WITH ELEVATION

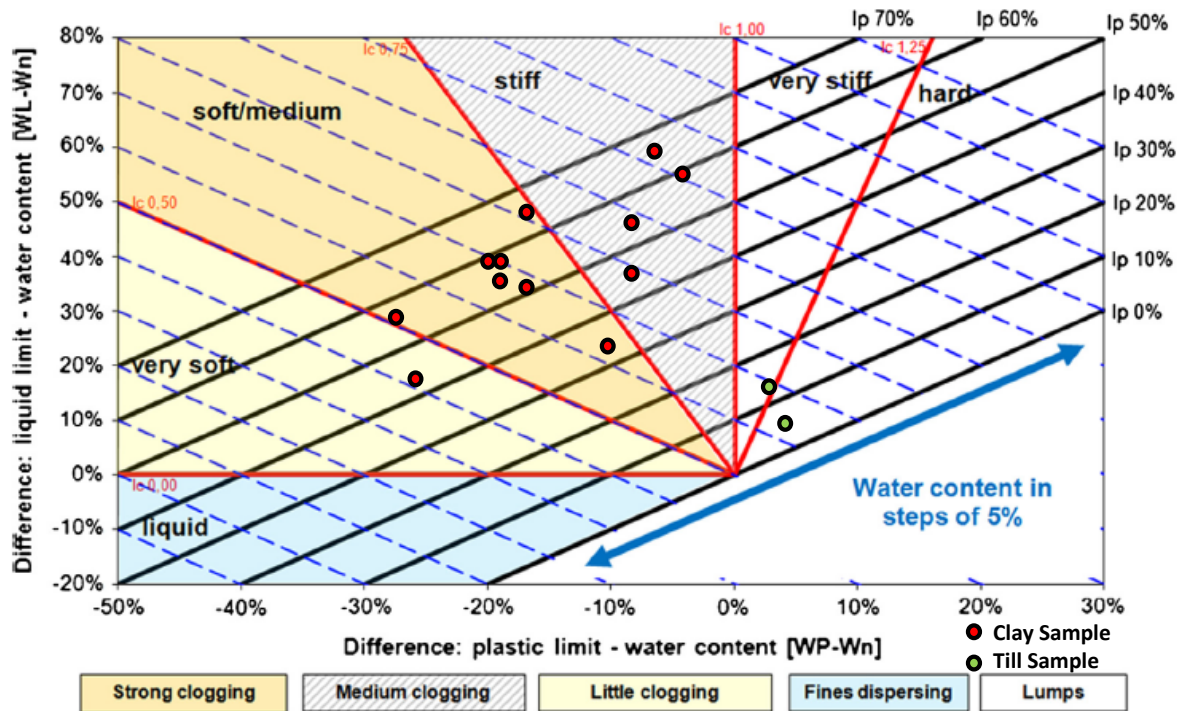
FIGURE 4-4: STICKINESS POTENTIAL OF COHESIVE SOIL

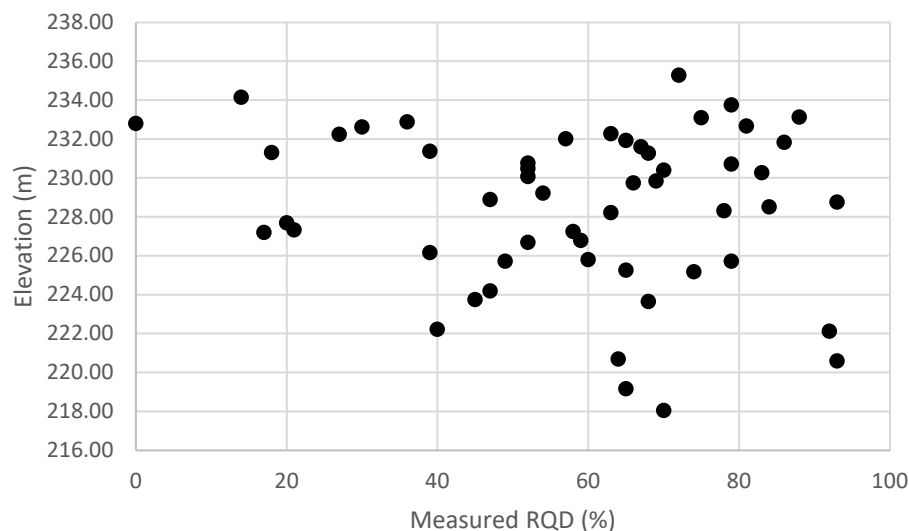
**FIGURE 4-7: BEDROCK RQD WITH ELEVATION**

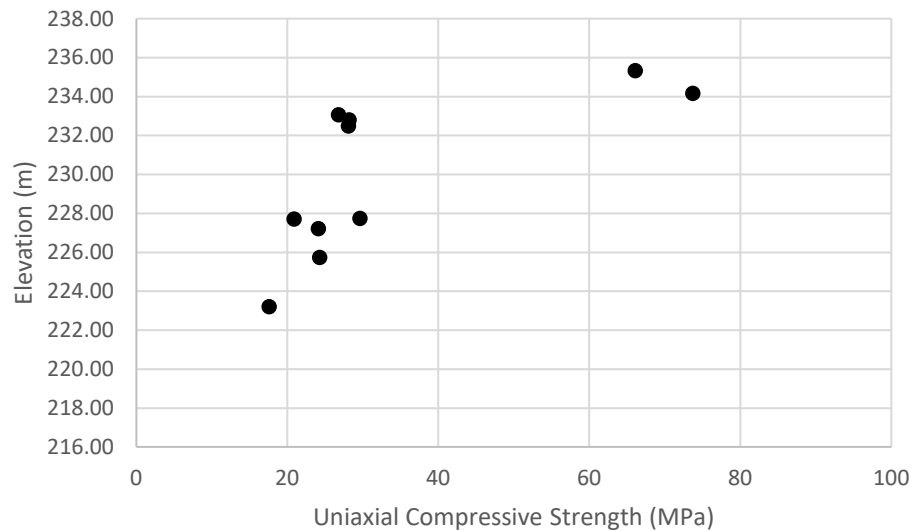
**FIGURE 4-10: UCS OF BEDROCK WITH ELEVATION**

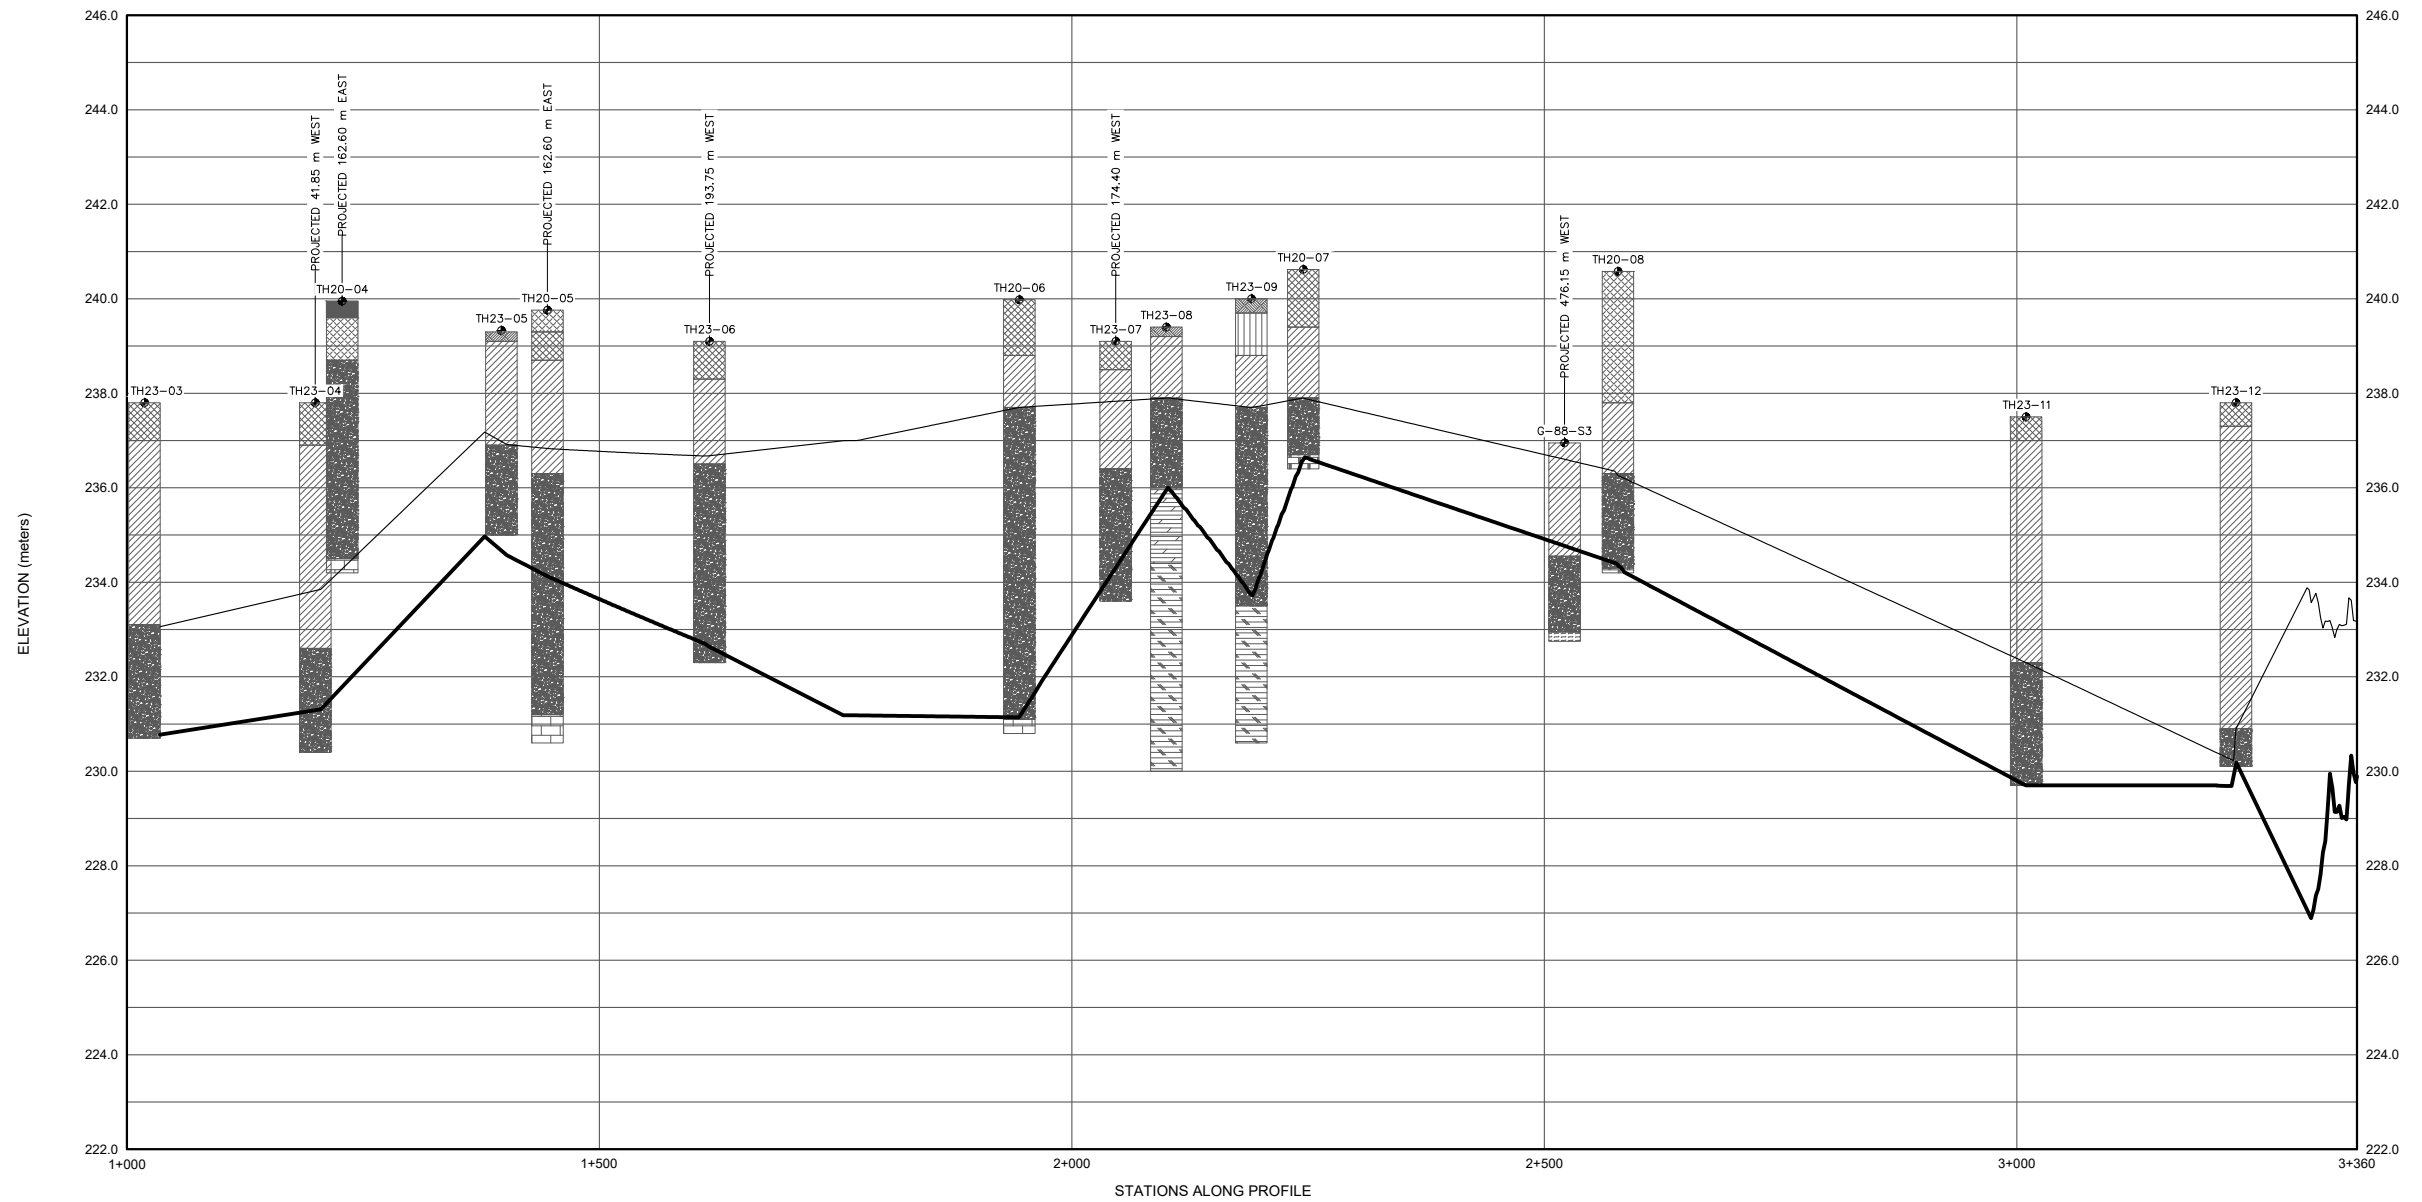
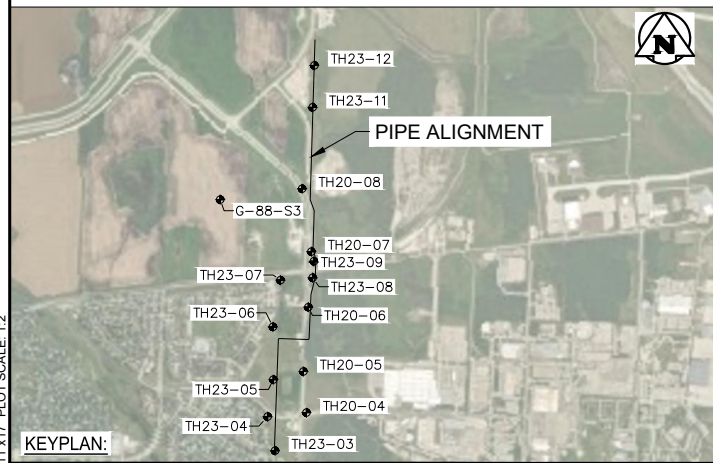
B	24/02/07	REV B - ISSUED WITH DRAFT REPORT	GH
NO.	YYMMDD	DESCRIPTION	BY
REVISIONS / ISSUE			
CENTREPORT SOUTH REGIONAL WATER & WASTEWATER SERVICING GEOTECHNICAL DATA REPORT FEEDER MAIN ALIGNMENT			
FEBRUARY 2024		FIGURE 2	REV B

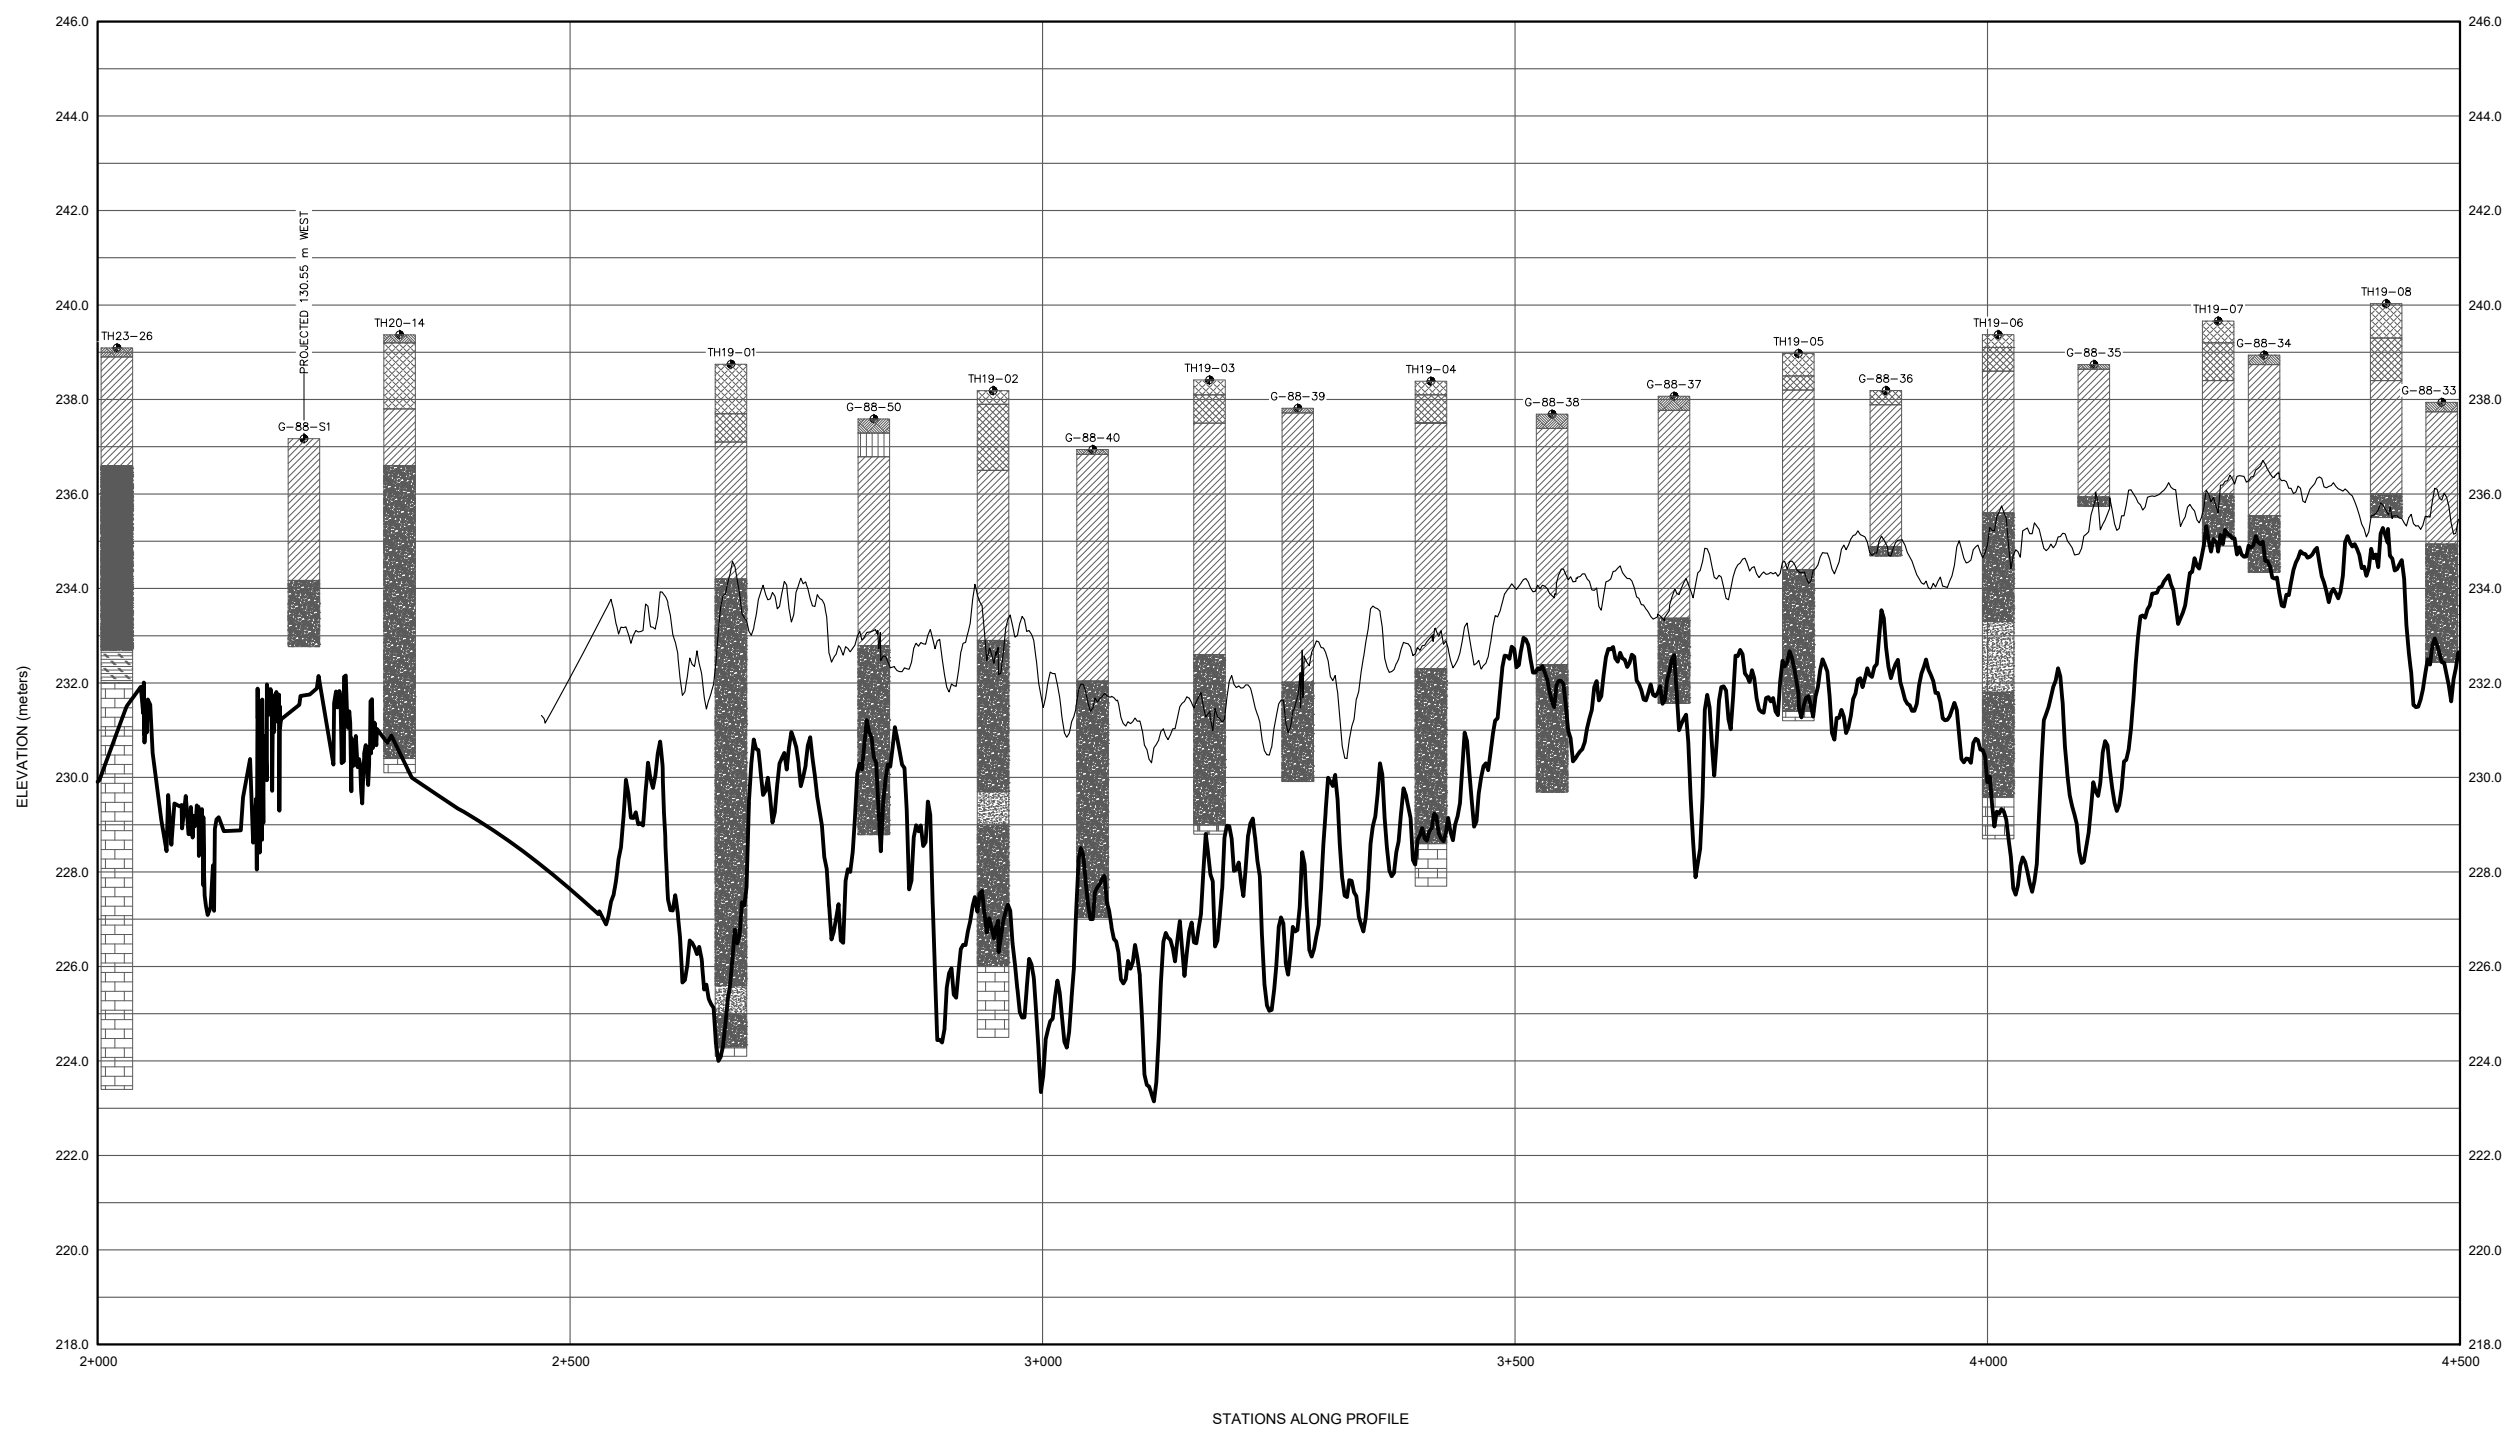
B	24/02/07	REV B - ISSUED WITH DRAFT REPORT	GH
NO.	YYMMDD	DESCRIPTION	BY
REVISIONS / ISSUE			
CENTREPORT SOUTH REGIONAL WATER & WASTEWATER SERVICING GEOTECHNICAL DATA REPORT FORCE MAIN ALIGNMENT 01			
FEBRUARY 2024		FIGURE 4	REV B

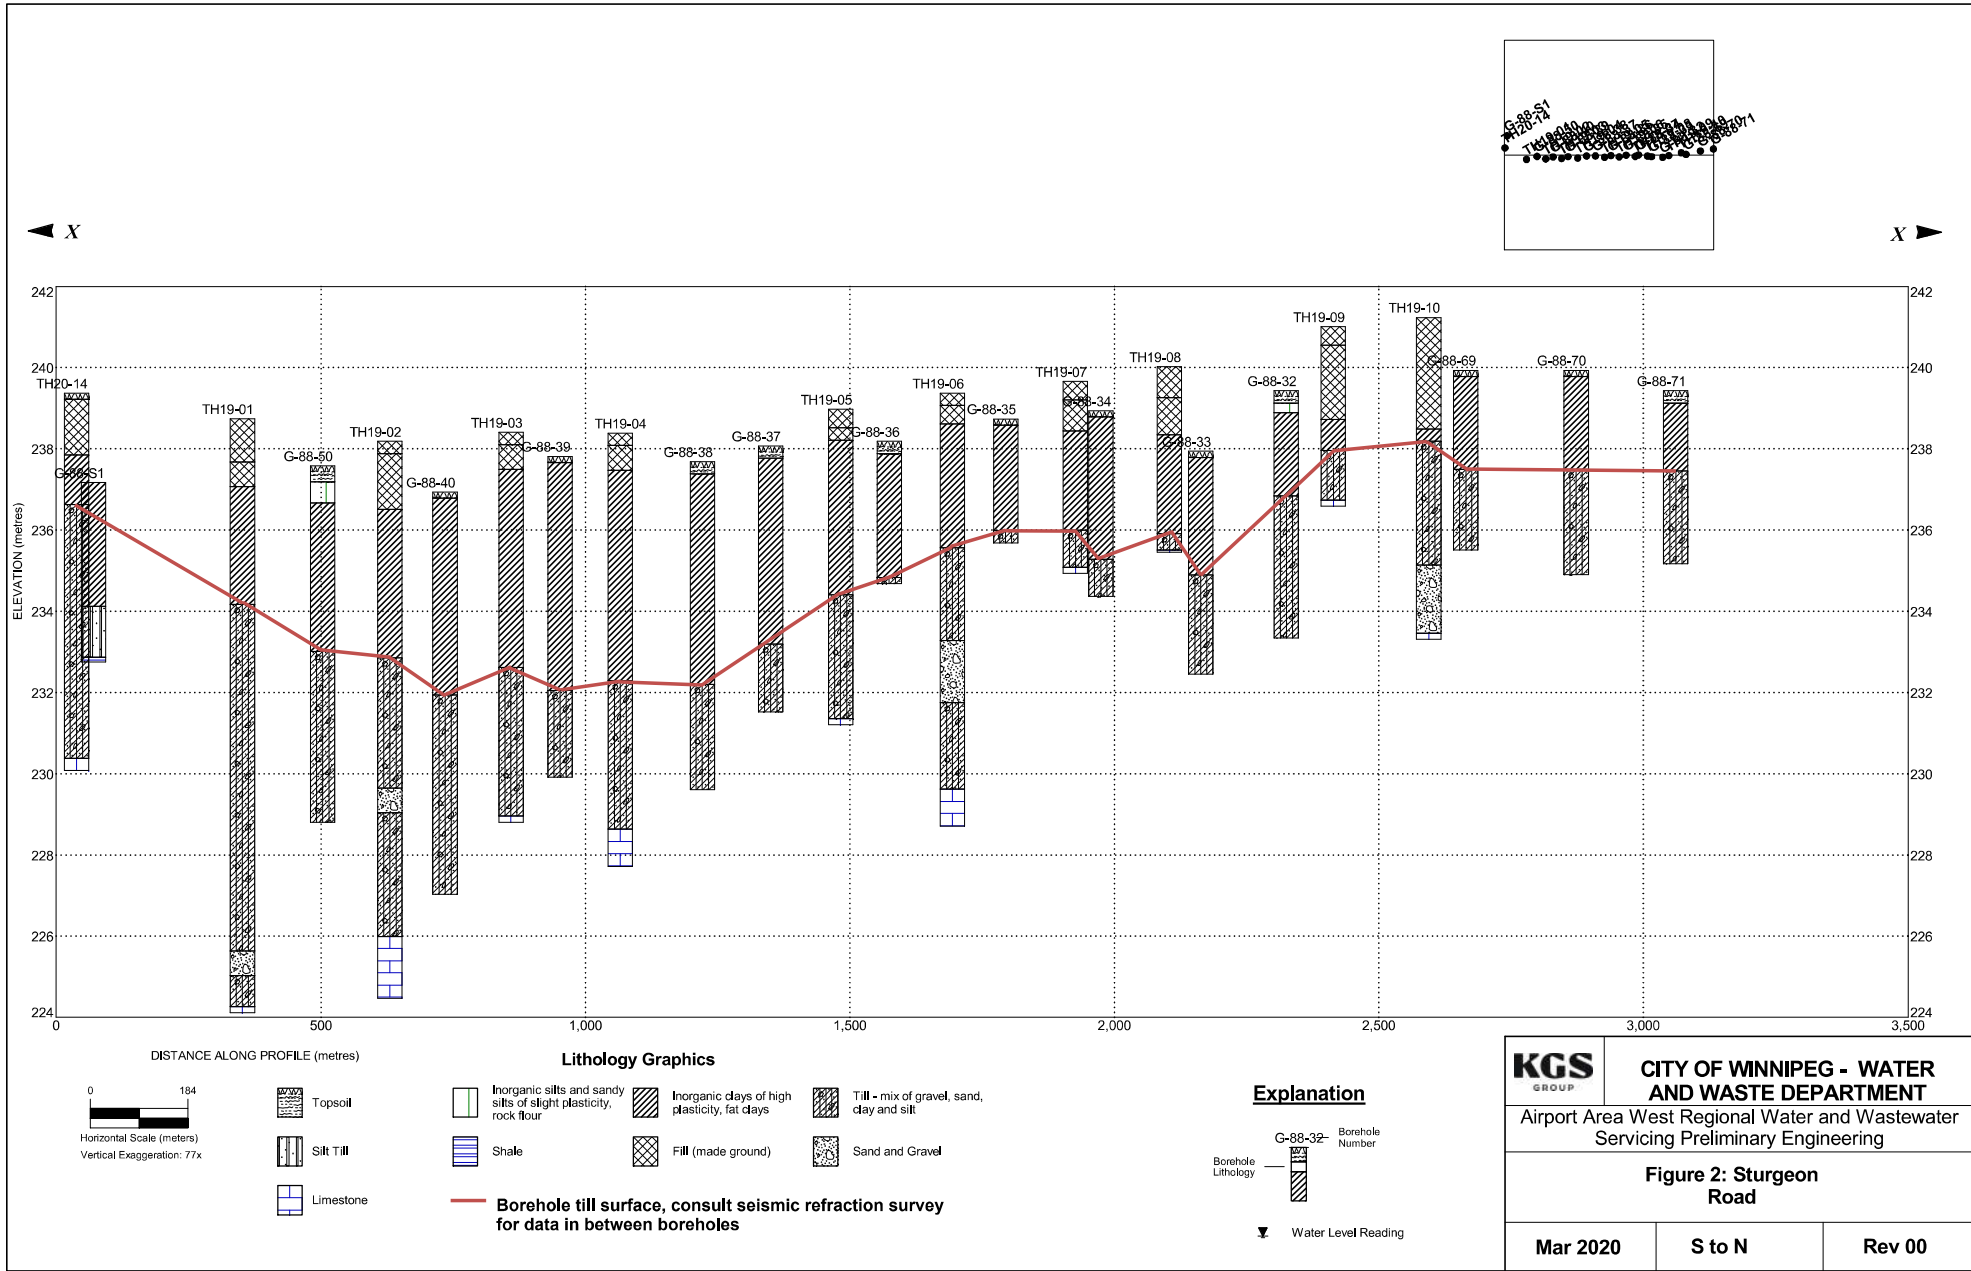
<b>KGS</b> GROUP	<b>CITY OF WINNIPEG - WATER AND WASTE DEPARTMENT</b>	
	Airport Area West Regional Water and Wastewater Servicing Preliminary Engineering	
<b>Figure 2: Sturgeon Road</b>		
Mar 2020	S to N	Rev 00

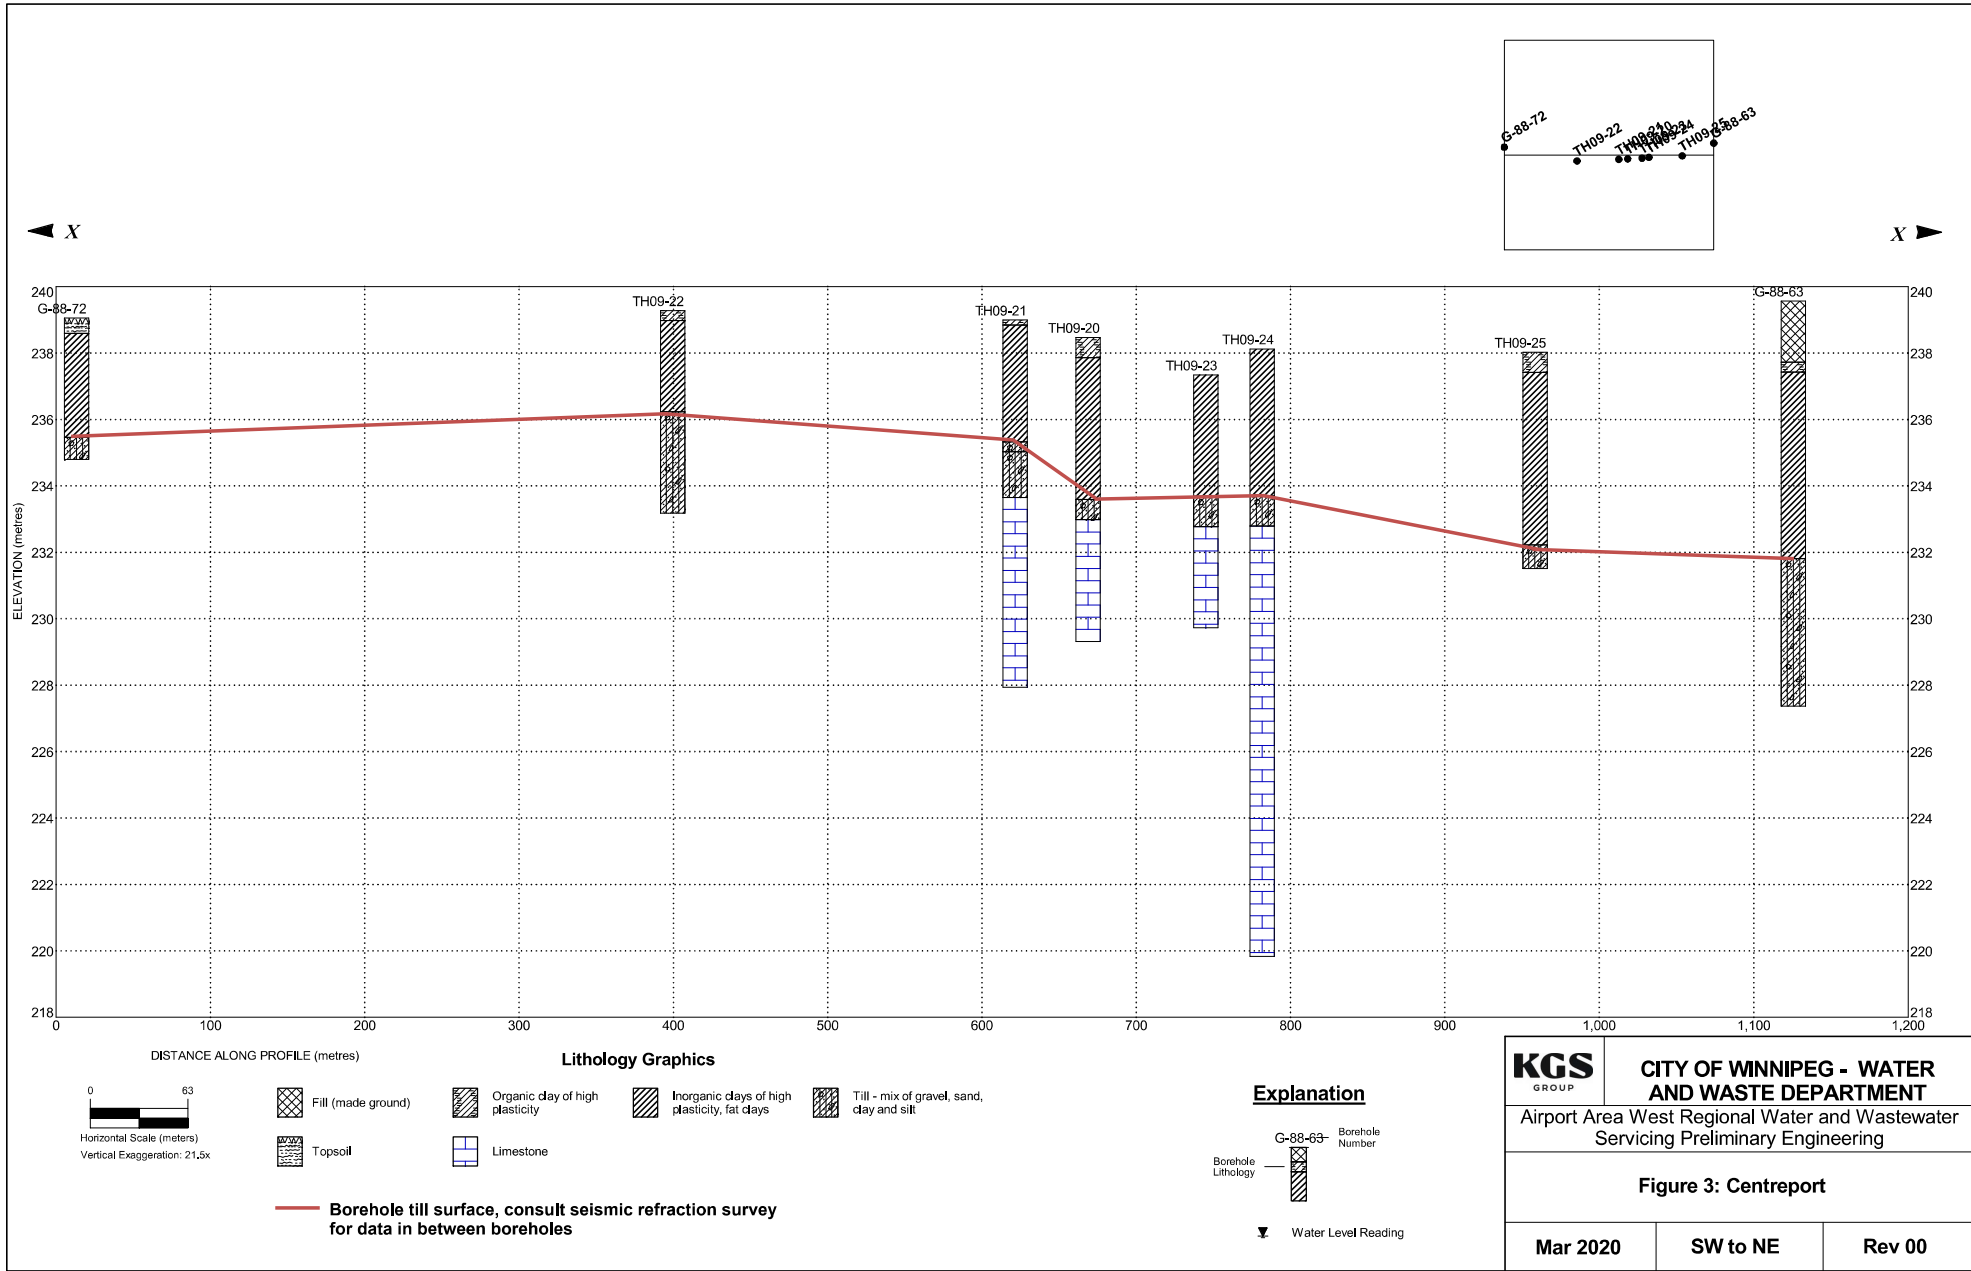
<b>CITY OF WINNIPEG - WATER AND WASTE DEPARTMENT</b>	
	Airport Area West Regional Water and Wastewater Servicing Preliminary Engineering	
<b>Figure 3: Centreport</b>		
<b>Mar 2020</b>	<b>SW to NE</b>	<b>Rev 00</b>

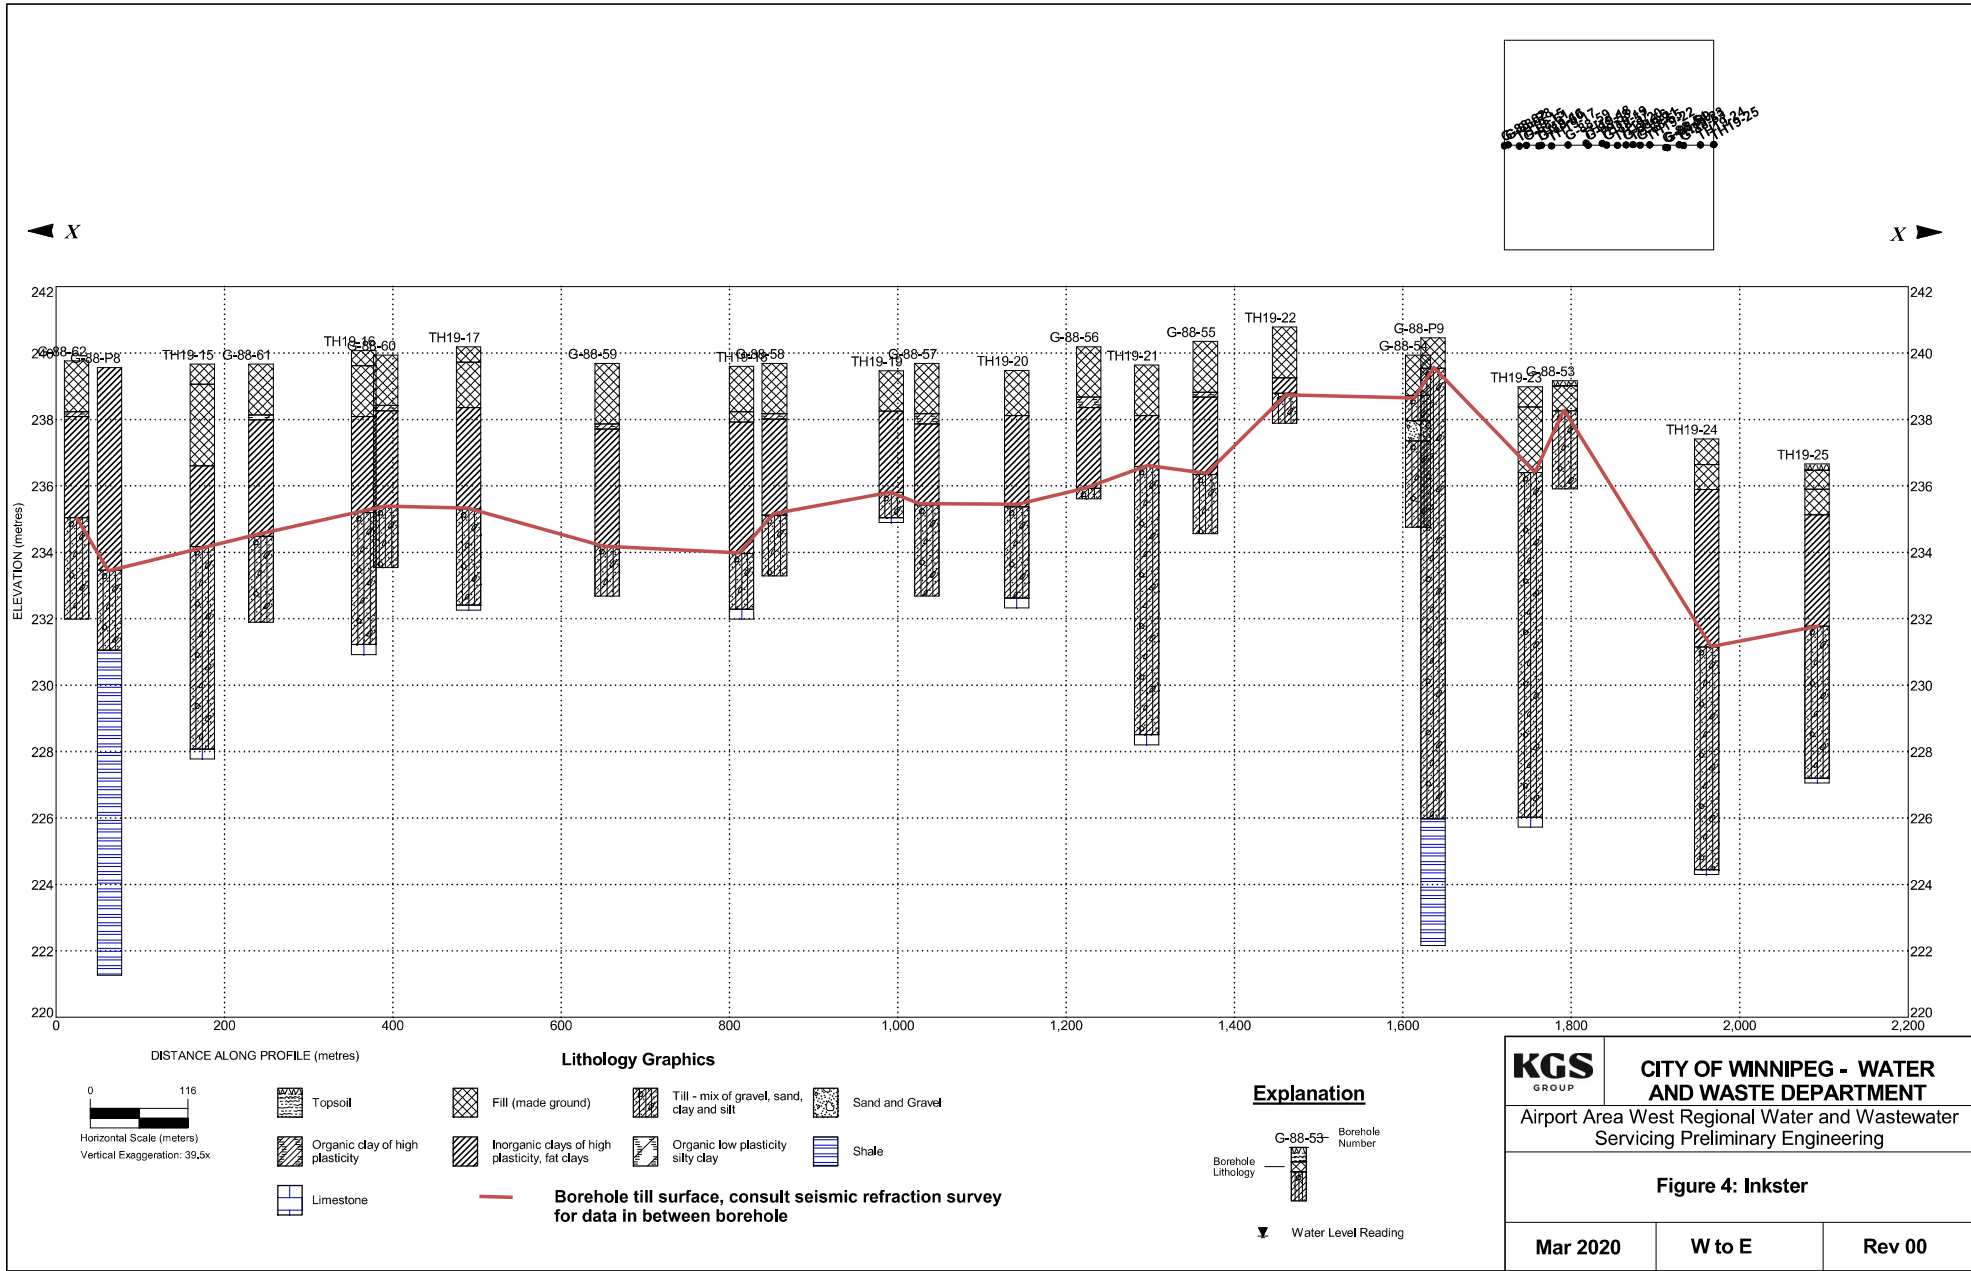
<b>KGS</b> GROUP	<b>CITY OF WINNIPEG - WATER AND WASTE DEPARTMENT</b>	
	Airport Area West Regional Water and Wastewater Servicing Preliminary Engineering	
<b>Figure 4: Inkster</b>		
Mar 2020	W to E	Rev 00

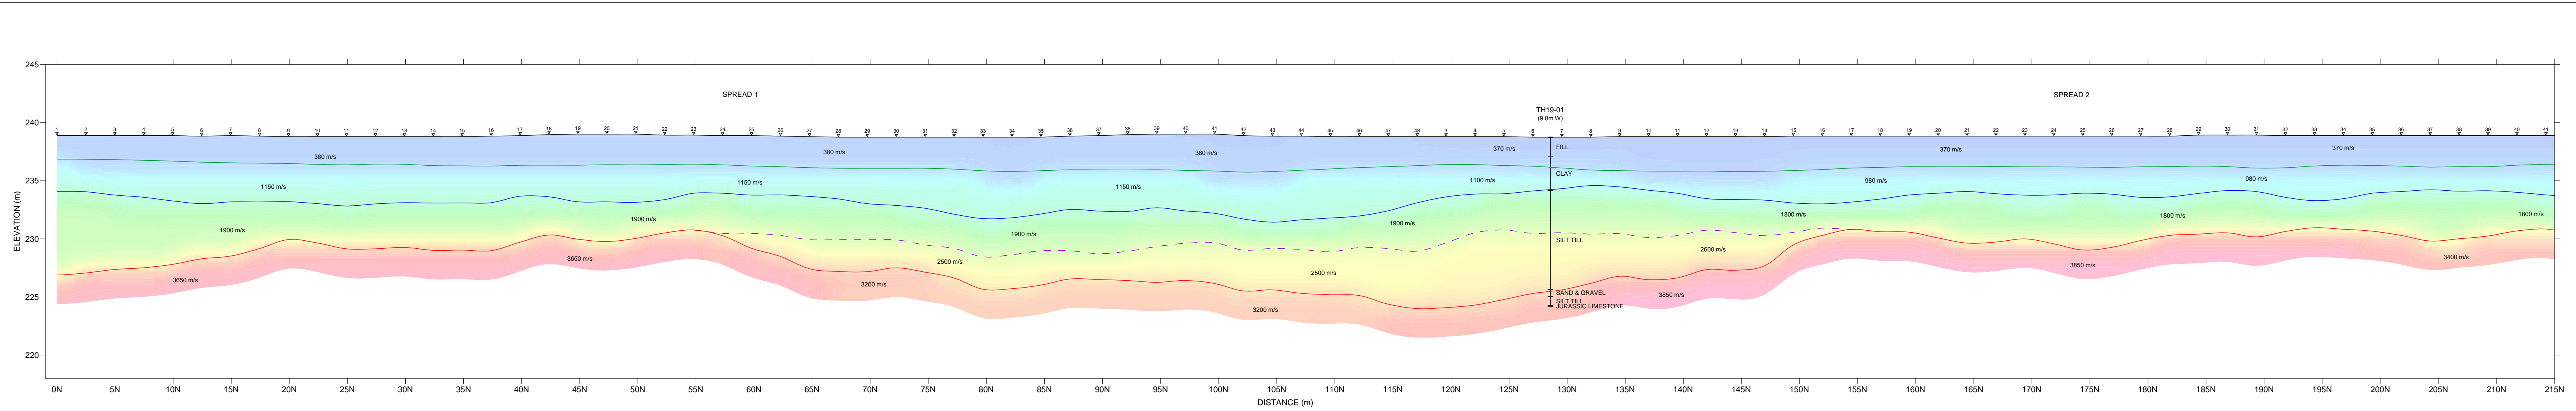
KGS GROUP WINNIPEG RICHARDSON INTERNATIONAL AIRPORT, MB		
SEISMIC REFRACTION SURVEY		
INTERPRETED DEPTH SECTION SL19-01A		
FRONTIER GEOSCIENCES INC.		
DATE: OCT. 2019	SCALE 1:250	FIG. 3

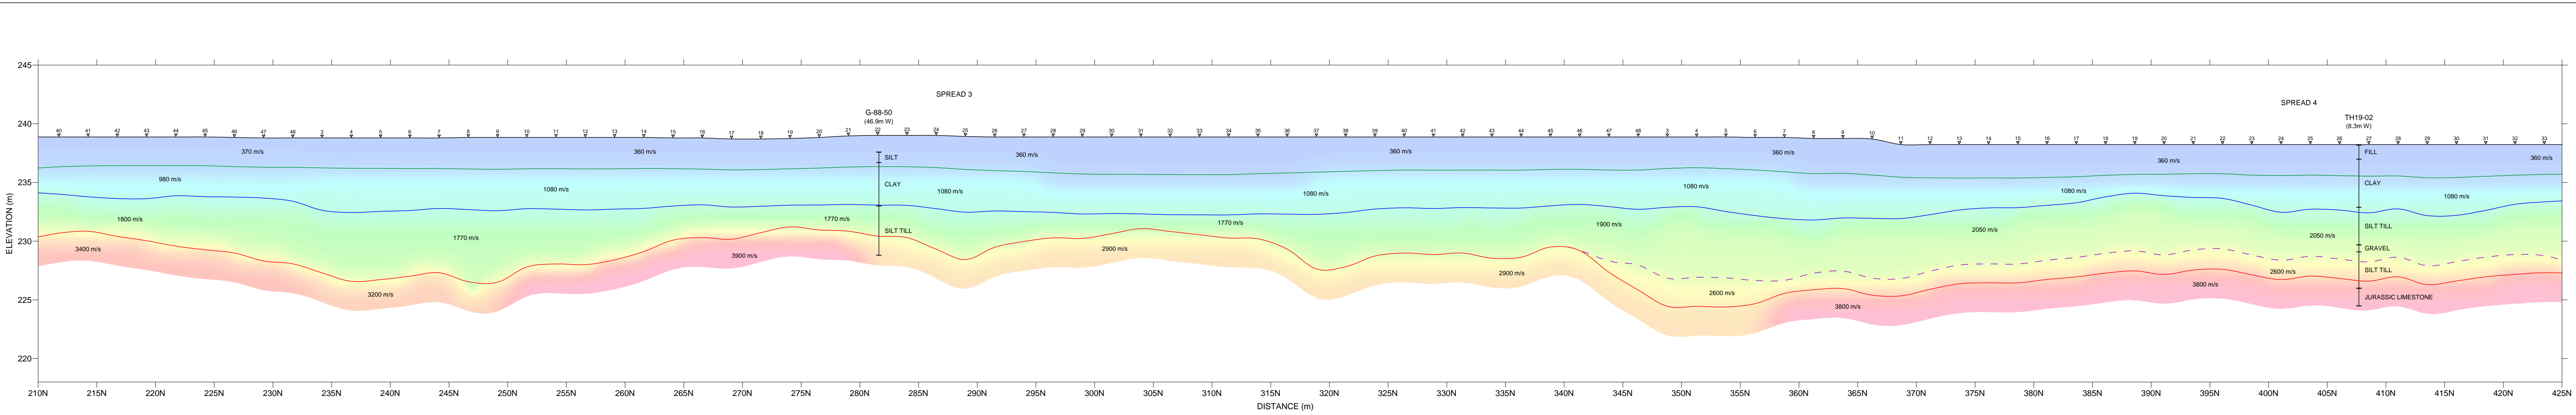
KGS GROUP		
WINNIPEG RICHARDSON INTERNATIONAL AIRPORT, MB		
SEISMIC REFRACTION SURVEY		
INTERPRETED DEPTH SECTION		
SL19-01B		
FRONTIER GEOSCIENCES INC.		
DATE: OCT. 2019	SCALE 1:250	FIG. 4

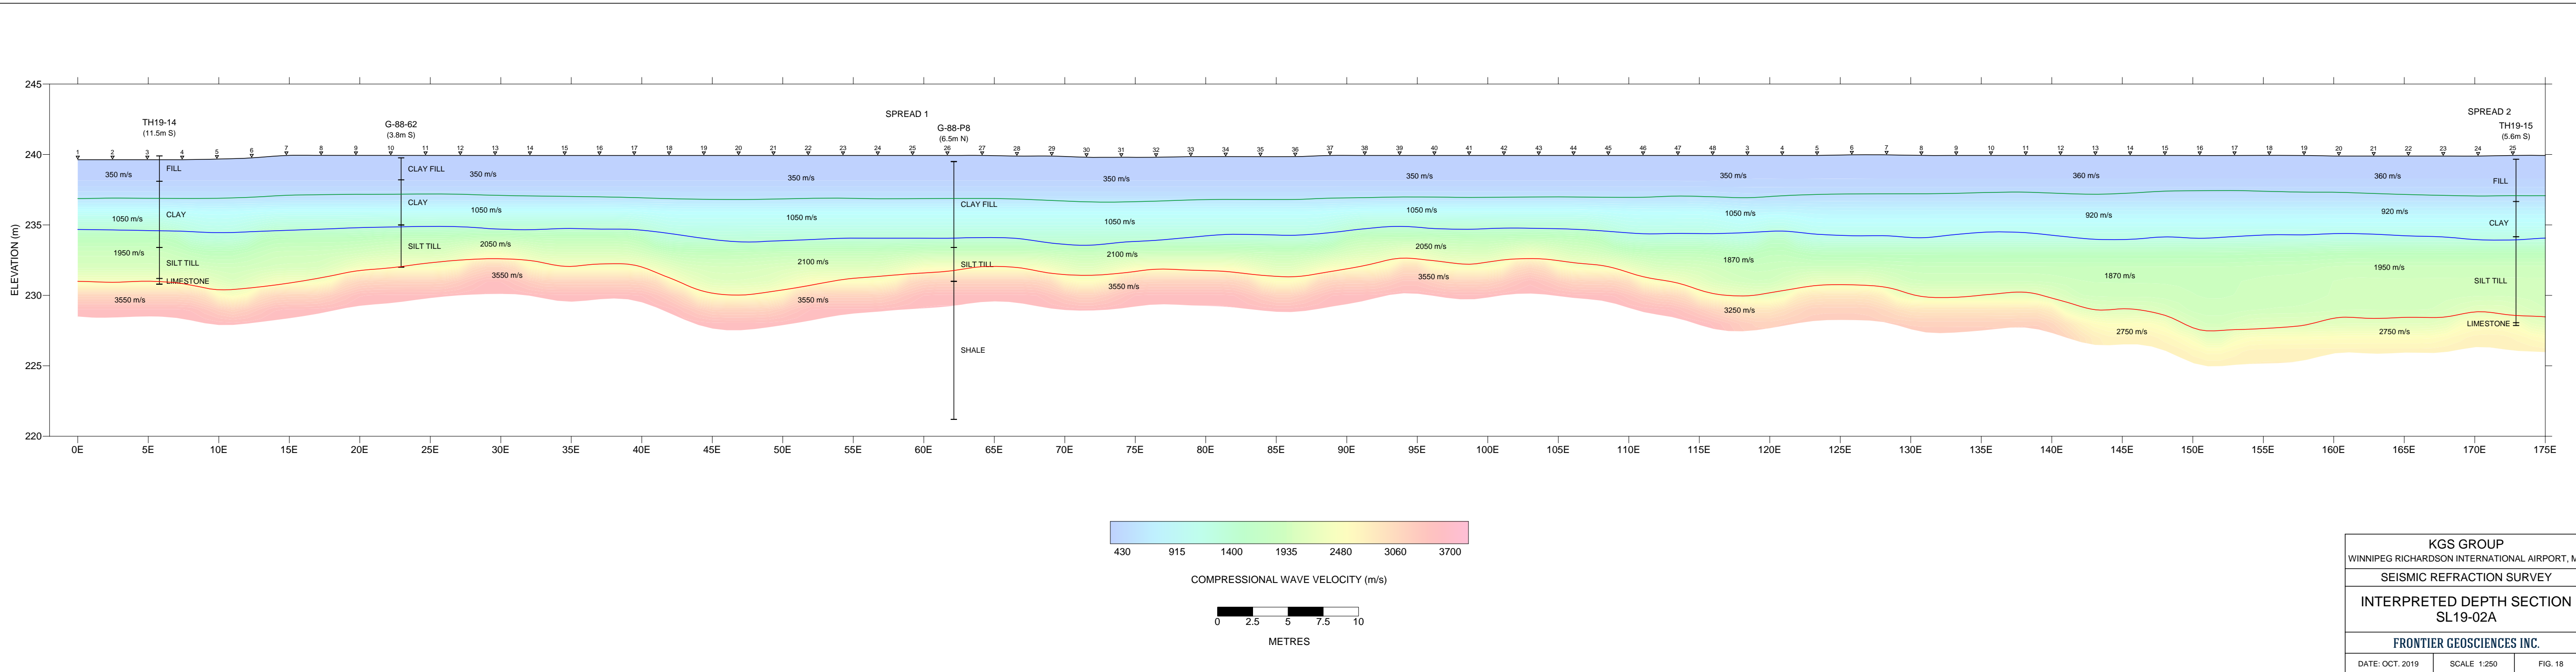
<b>KGS GROUP</b>		
WINNIPEG RICHARDSON INTERNATIONAL AIRPORT, MB		
SEISMIC REFRACTION SURVEY		
INTERPRETED DEPTH SECTION SL19-02A		
<b>FRONTIER GEOSCIENCES INC.</b>		
DATE: OCT. 2019	SCALE 1:250	FIG. 18
