**APPENDIX B**  
**GEOTECHNICAL DATA REPORT**

# CentrePort South Regional Water & Wastewater Servicing Geotechnical Data Report

Draft Rev B

February 7, 2024

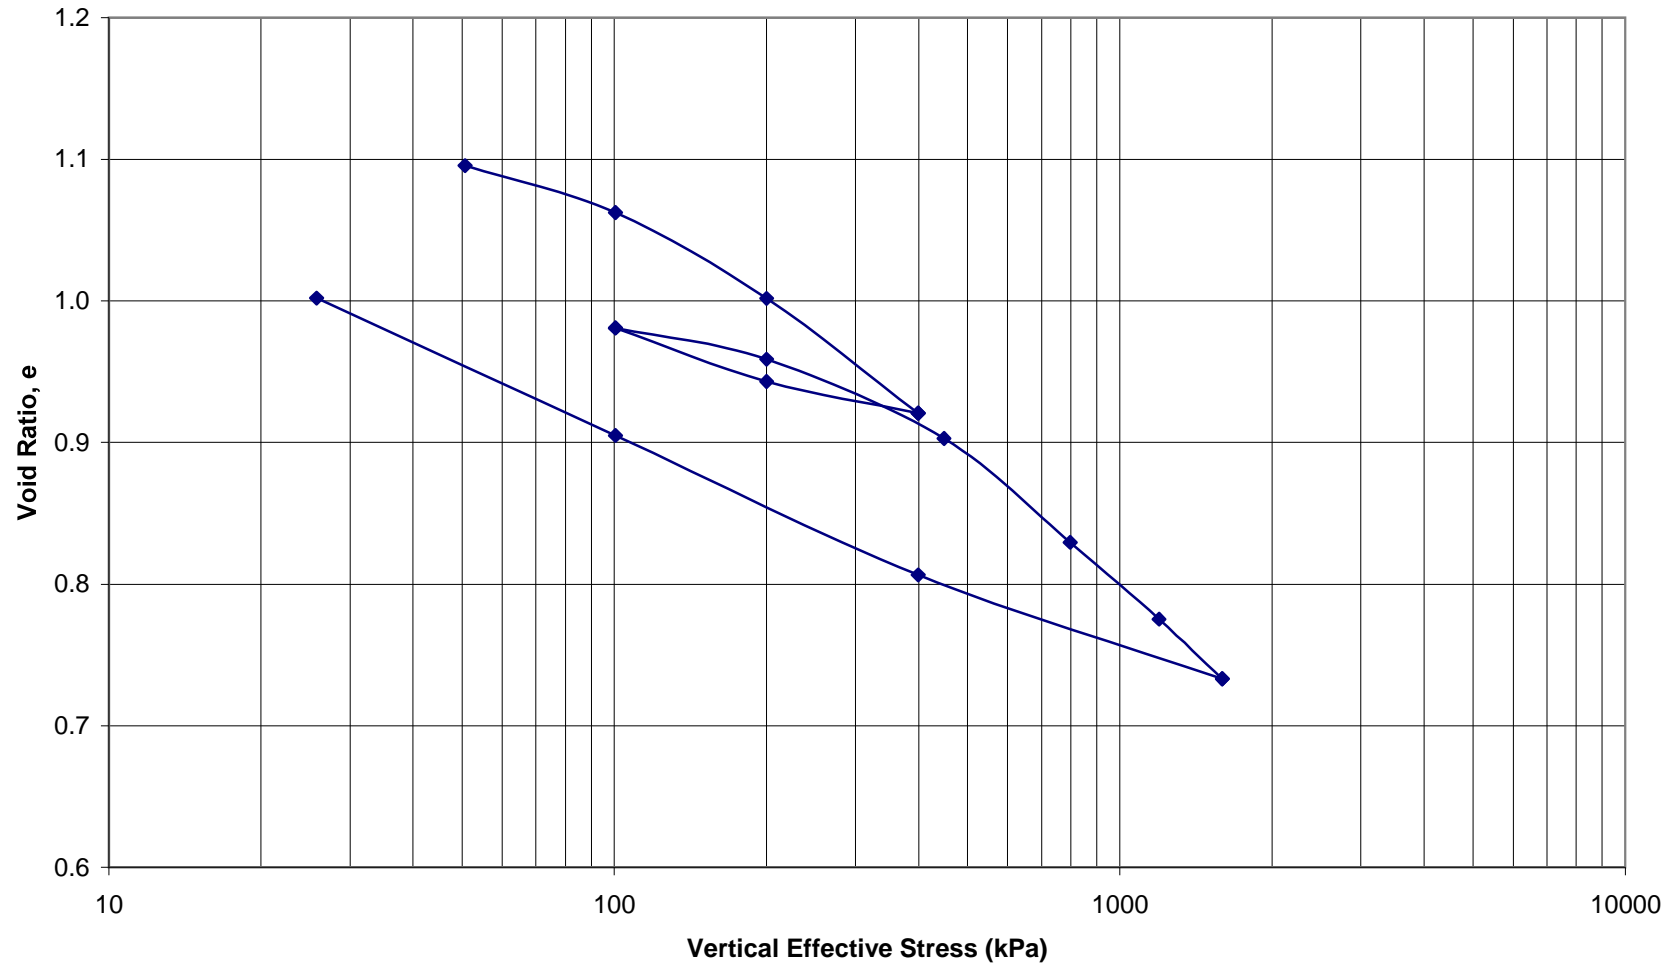
**Void Ratio vs. Vertical Effective Stress**  
**TH09 - 21F S4**

TH09-21F S4  
26, 36, 41, 46, 51 kPa

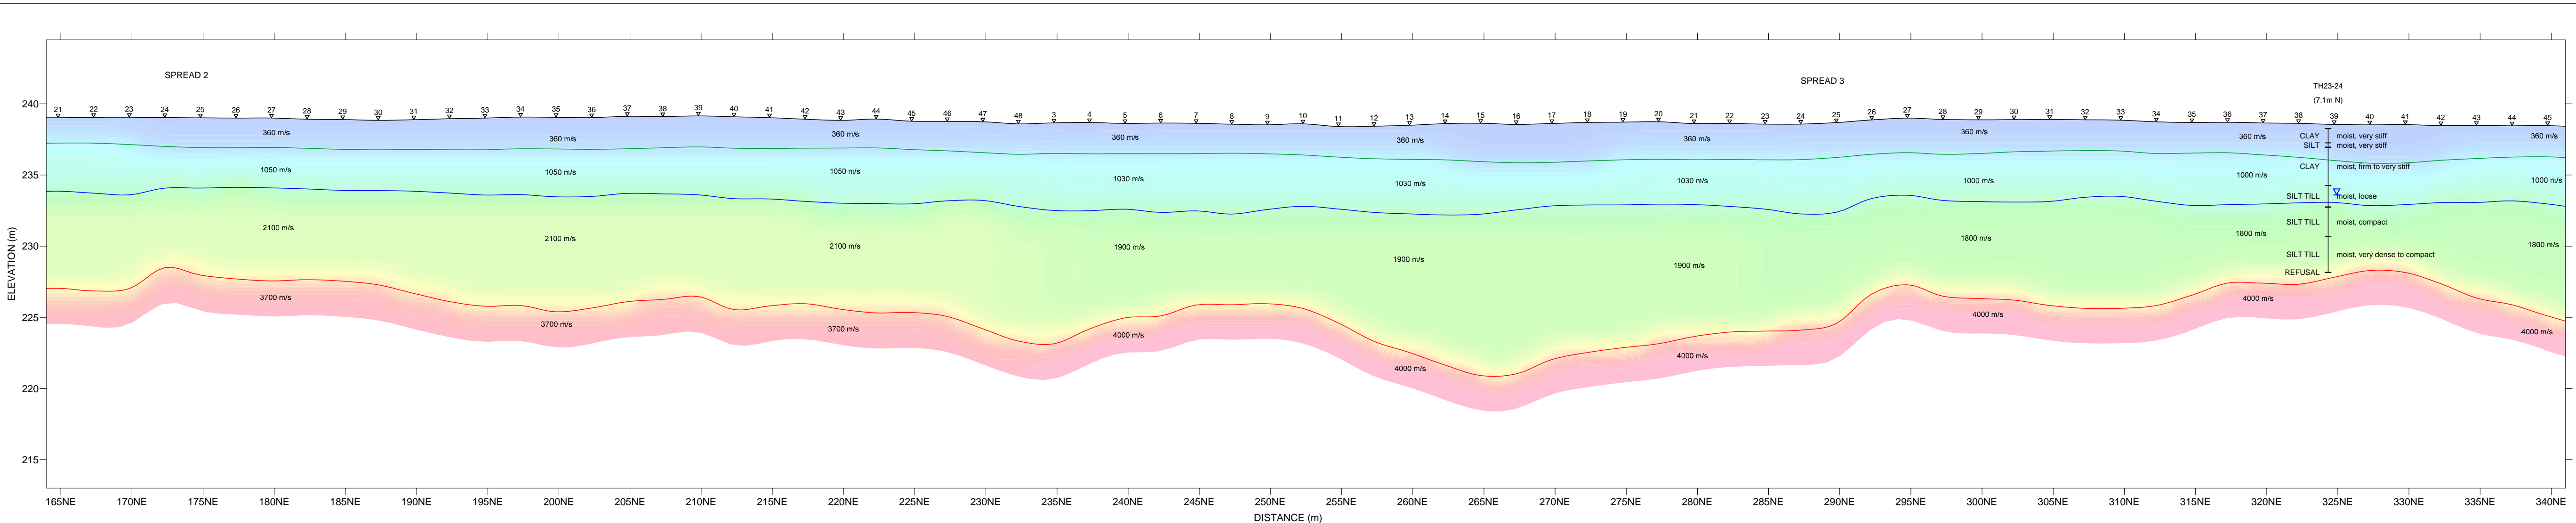
<b>KGS GROUP</b>		
CENTREPORT REGIONAL S&W SERVICING WINNIPEG, MB		
SEISMIC REFRACTION SURVEY		
INTERPRETED SEISMIC REFRACTION DEPTH SECTION SL23-01B		
<b>FRONTIER GEOSCIENCES INC.</b>		
DATE: NOV. 2023	SCALE 1:250	FIG. 4
