CITY OF WINNIPEG

CentrePort South Regional Water &  
Wastewater Servicing Project  
CPKC Mile 3.28 Glenboro Subdivision  
Crossing Geotechnical Report

Revision:  
Final / Rev 0

KGS Group Project:  
23-0107-009

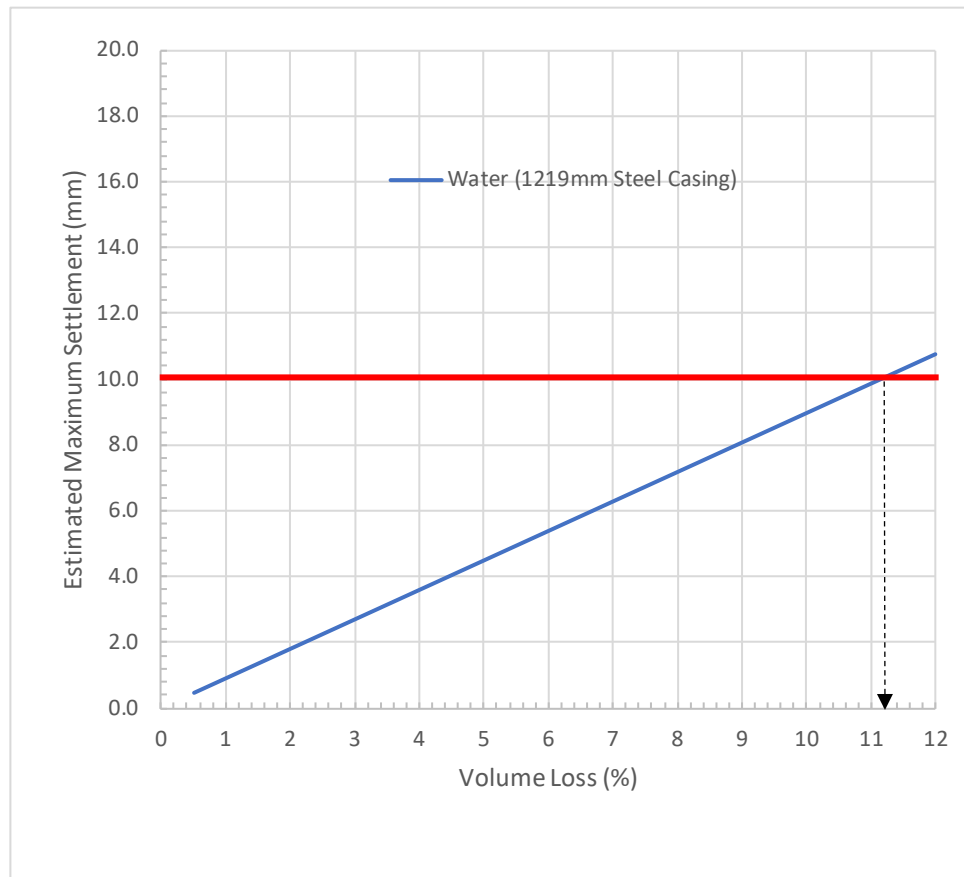
**FIGURE 6-1: ESTIMATED SURFACE SETTLEMENT**

Assumed Volume Loss (%)	Estimated Maximum Settlement (mm)
	FDM (1219mm Steel Casing)
0.5	0.4
1	0.9
2	1.8
4	3.6
6	5.4
10	9.0
12	10.7

The CPKC rail line for this project is defined as a Class 3 track. Settlement thresholds of 10 mm (Warning) and 19 mm (Critical) are recommended in accordance with CPKC's Geotechnical Protocol.

Based on the results as outlined in Table 6-1 or Figure 6-1, the allowable radial overcut should be no greater than 25 mm for the FDM steel casing pipe, to ensure the potential settlement is below the Warning threshold of 10 mm. The maximum allowable overcut in the technical specifications outlines a maximum overcut of 19 mm and 25 mm for the down-the-hole hammer and microtunnelling applications respectively. It should be noted that if microtunnelling is the selected method by the contractor, the tunnel annular space will also be filled with bentonite slurry to provide lubrication for the pipe jacking string, and to mitigate collapse of the annular space.

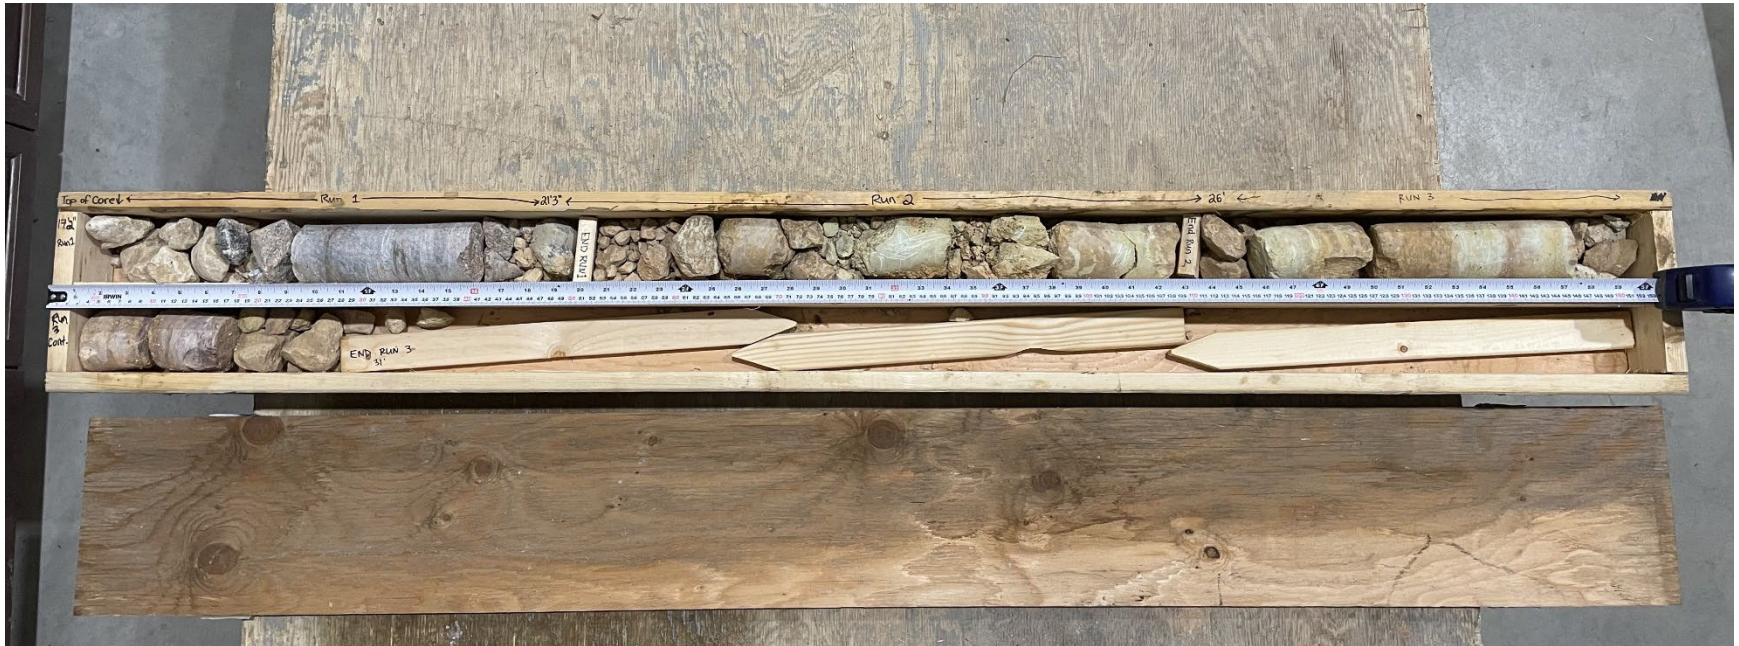
TH23-09 Photo 6: Bedrock Core, 6.45 m to 9.75 m (21 ft-3 in to 32 ft)

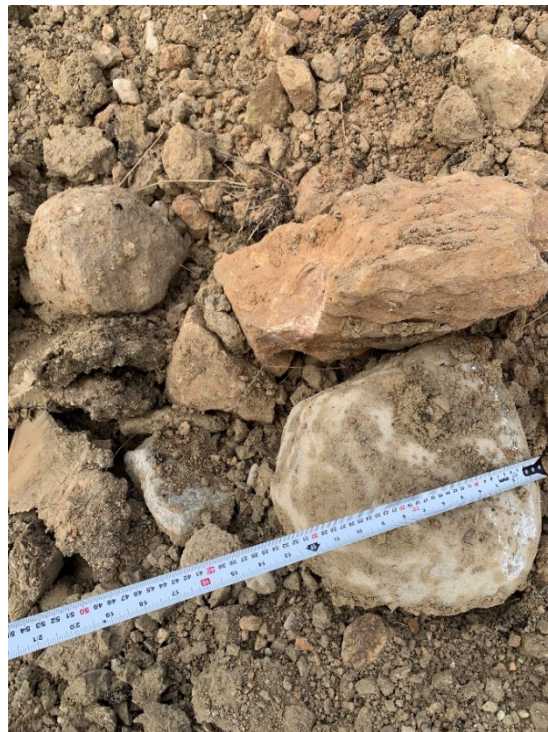
**TP24-01 Photo 4:** Boulders from Silt Till

Cobbles and boulders were encountered in TP24-01 and TP24-02 and were comprised of sedimentary and igneous rock. The average size of the boulders observed was 300 to 380 mm (12 to 15 in), and the maximum size observed was 600 mm (24 in). The frequency of the boulders (larger than 300 mm diameter) in the test pits was estimated to be 2 to 4 boulders per cubic meter of excavated till material.

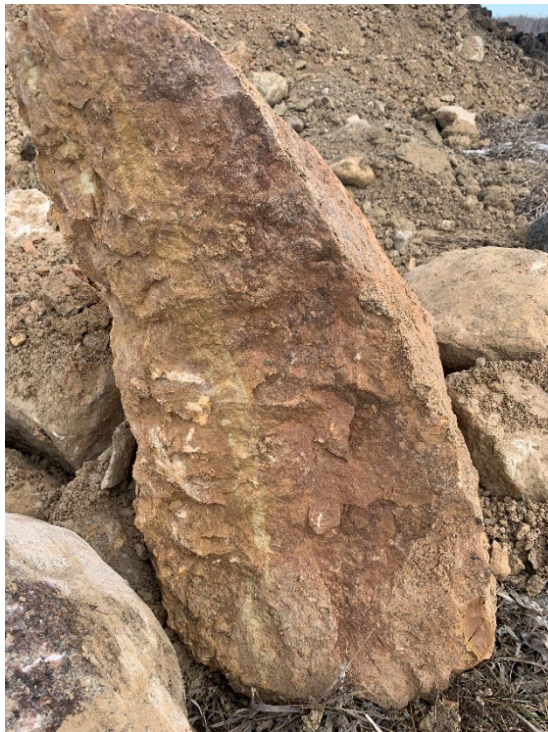
**TP24-01 Photo 8: Reddish Brown Argillaceous Bedrock at 5.1 m.**

Argillaceous dolomite bedrock was observed in both boreholes between El. 233.5 and 234.4 m± and extended to the end of borehole depth. Argillaceous dolomite was observed at the bedrock surface in TP24-01 and appeared to be highly weathered and rippable with the excavator bucket. The argillaceous dolomite was described as mottled reddish-grey to green, fine grained, fossiliferous, and moderately strong to strong. The RQD of the material ranged from 0% to 79% (i.e. Very Poor to Good). Broken lost core zones were observed throughout the argillaceous dolomite. Increased shale content was observed in the bedrock below El. 231.9 m± and 233.5 m± in TH23-08 and TH23-09, respectively. One uniaxial compressive strength test was performed on the argillaceous dolomite in TH23-08 at El. 234.3 m± resulting in a value of 73.7 Mpa.

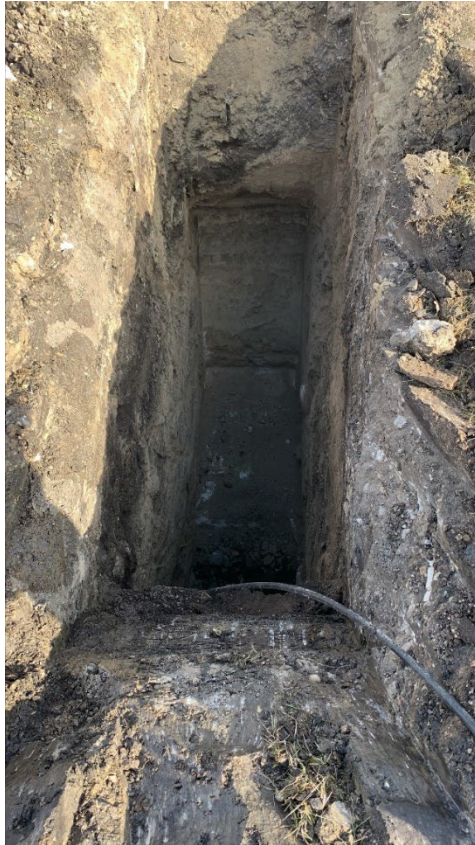
**TP24-02 Photo 1:** Top of bedrock encountered at 4.6 m

In TH23-08, dolomite bedrock was observed between El. 236.0 and 234.4 m±. Dolomite was also observed at the bedrock surface in TP24-02 and was not rippable with the excavator bucket. The dolomite was described as mottled yellow-white, fine grained, massive, very strong, and contained trace vugs. The rock quality designation (RQD) of the dolomite was 72% (i.e. Fair). A 100 mm broken lost core zone was observed at El. 234.5 m±. One uniaxial compressive strength test was performed on the dolomite in TH23-08 at El. 235.4 m± resulting in a value of 66.1 MPa.

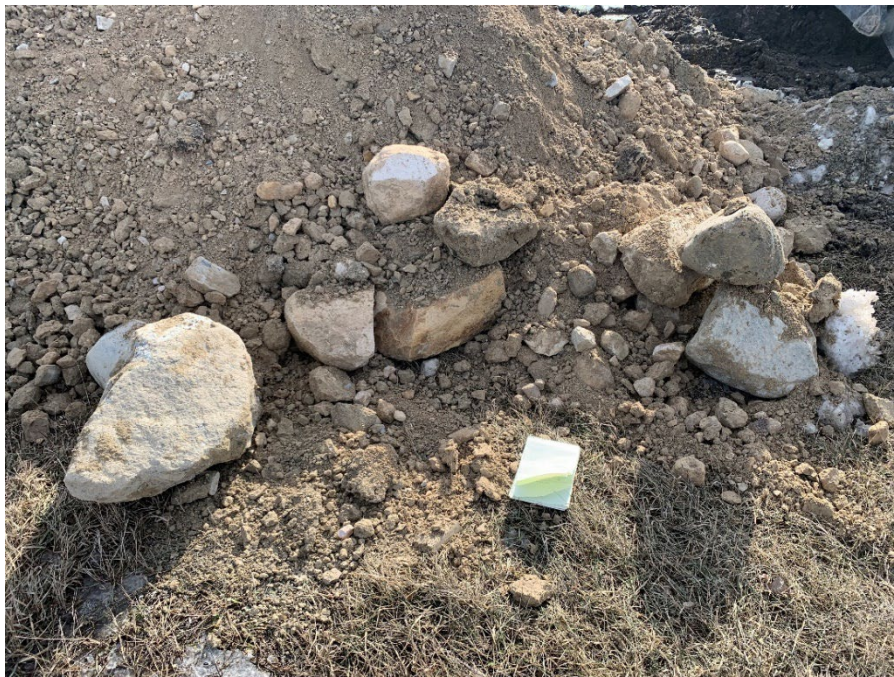
**TP24-02 Photo 2:** Cobbles and Boulders from silt till

Cobbles and boulders were encountered in the glacial till deposit in borehole TH23-09, TP24-01, and TP24-02. An average boulder size of 300 to 380 mm (12 to 15 in) was observed in the test pits with maximum size up to 600 mm (24 in) observed. The boulders were sub-angular to rounded and contained sedimentary and igneous rock types. Cobbles and boulders have also been observed within the lacustrine clay near the interface with the silt till and within the silt till in a majority of the boreholes that have been completed in the larger regional project area. Based on previous works completed by the City of Winnipeg in the vicinity of this project, it is understood that installation of the new pipelines near the clay/till interface and within the till will encounter cobbles and boulders during excavation and trenchless installation.

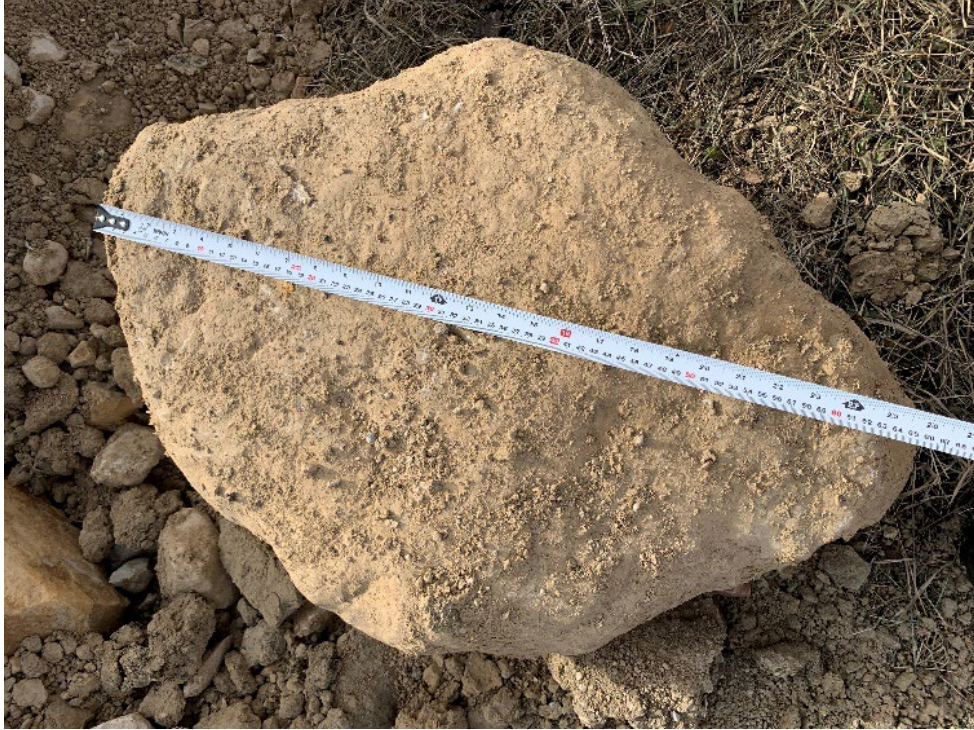
**TP24-02 Photo 5: Boulder from silt till (24 inches)**
