CITY OF WINNIPEG, WATER AND WASTE DEPARTMENT
FERRY ROAD AND RIVERBEND CSR PROJECT
CONTRACT 6 – RUTLAND TRUNK SEWER
GEOTECHNICAL DATA REPORT
WINNIPEG, MANITOBA

RE: City of Winnipeg Ferry Road and Riverbend CSR Project – Contract 6 Rutland Trunk Sewer Geotechnical Investigation

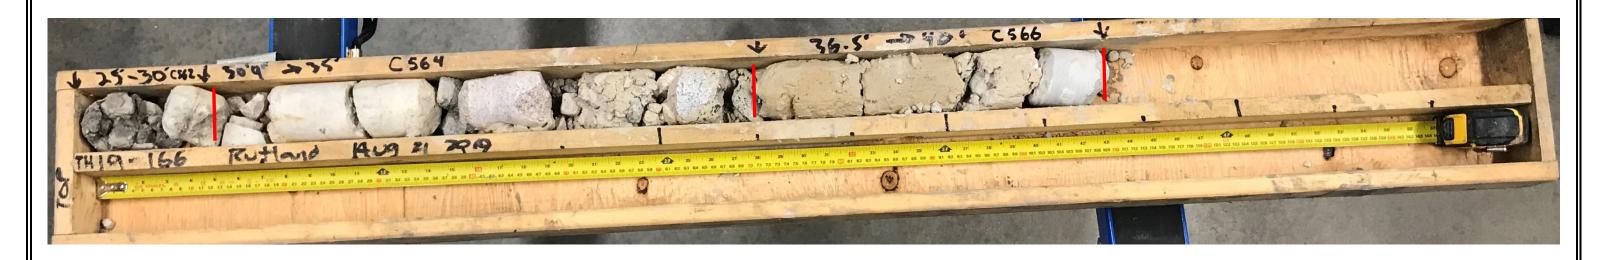
C562) Core Depth: 25 – 30 ft (7.6 – 9.1 m) – 8% recovery C564) Core Depth: 30.8 – 35 ft (9.3 – 10.7 m) – 45% recovery C566) Core Depth: 36.5 – 40 ft (11.1 – 12.2 m) – 33% recovery

BINSON INC. INICAL ENGINEERS			Ferry Road & Riverbend CSR – Rutland Trunk Sewer Glacial Till Core Photograph – Test Hole 19-166
SCALE:	MADE BY:	CHKD BY:	PROJECT NO.	DATE:

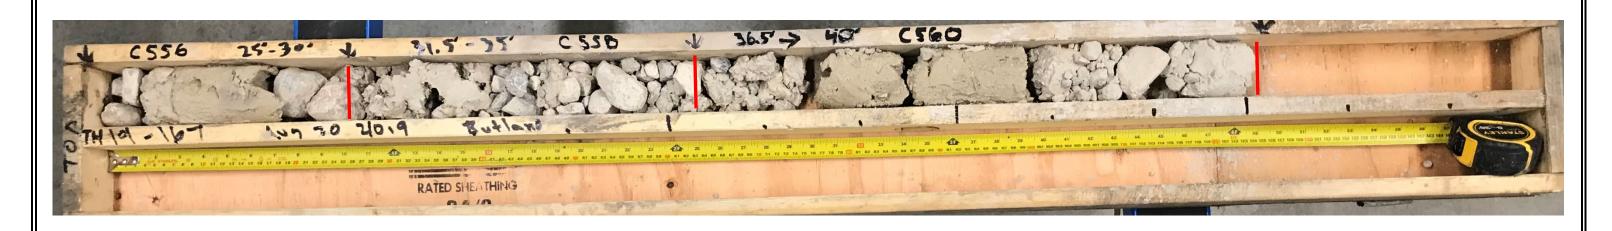
C556) Core Depth: 25 – 30 ft (7.6 – 9.1 m) – 18% recovery C558) Core Depth: 31.5 – 35 ft (9.5 – 10.7 m) – 33% recovery C560) Core Depth: 36.5 – 40 ft (11.1 – 12.2 m) – 57% recovery

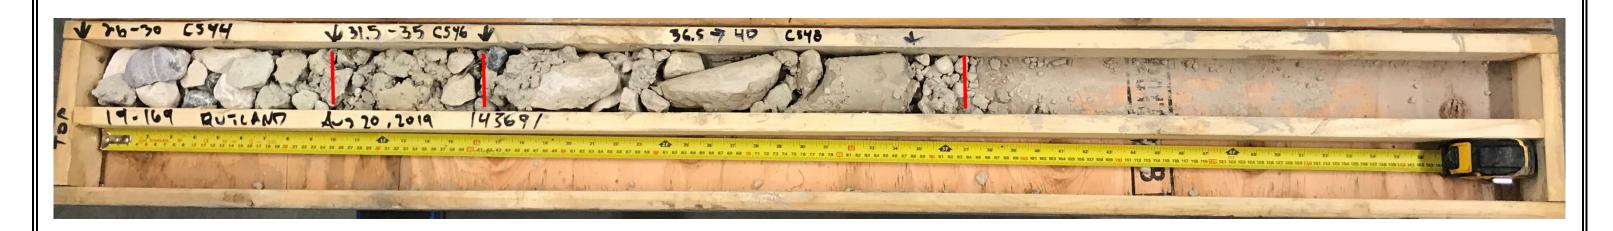
BINSON INC.			Ferry Road & Riverbend CSR – Rutland Trunk Sewer Glacial Till Core Photograph – Test Hole 19-169
SCALE:	MADE BY:	CHKD BY:	PROJECT NO.	DATE:	FIGURE C4
NTS	AA	GR	143691.7	November 2019	FIGURE C4

C544) Core Depth: 26 – 30 ft (7.9 – 9.1 m) – 20% recovery C546) Core Depth: 31.5 – 35 ft (9.5 – 10.7 m) – 12% recovery C548) Core Depth: 36.5 – 40 ft (11.1 – 12.2 m) – 43% recovery

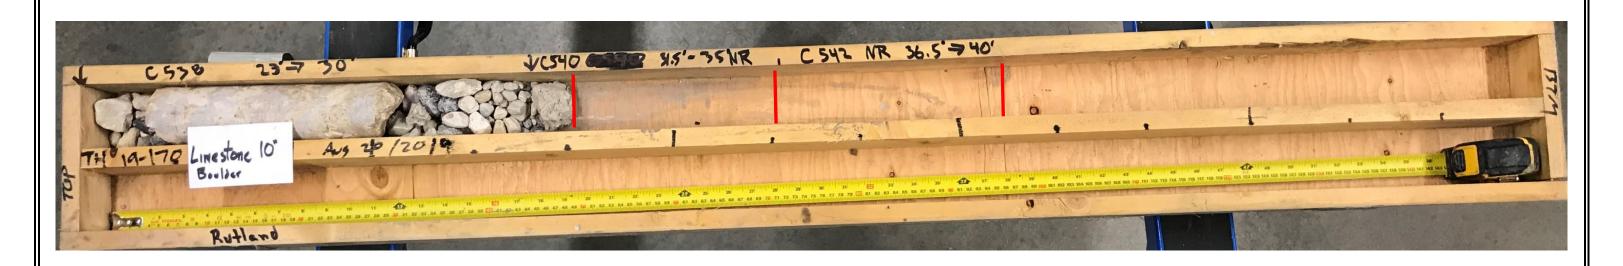
Ferry Road & Riverbend CSR – Rutland Trunk Sewer Glacial Till Core Photograph – Test Hole 19-170			BINSON INC. INICAL ENGINEERS		
FIGURE CS	DATE: November 2019	PROJECT NO. 143691.7	CHKD BY: GR	MADE BY: AA	SCALE: NTS

C538) Core Depth: 23 – 30 ft (7.0 – 9.1 m) - 20% recovery including limestone cobble / boulder

C540) Core Depth: 31.5 – 35 ft (9.5 – 10.7 m) - No sample recovery C542) Core Depth: 36.5 – 40 ft (11.1 – 12.2 m) - No sample recovery

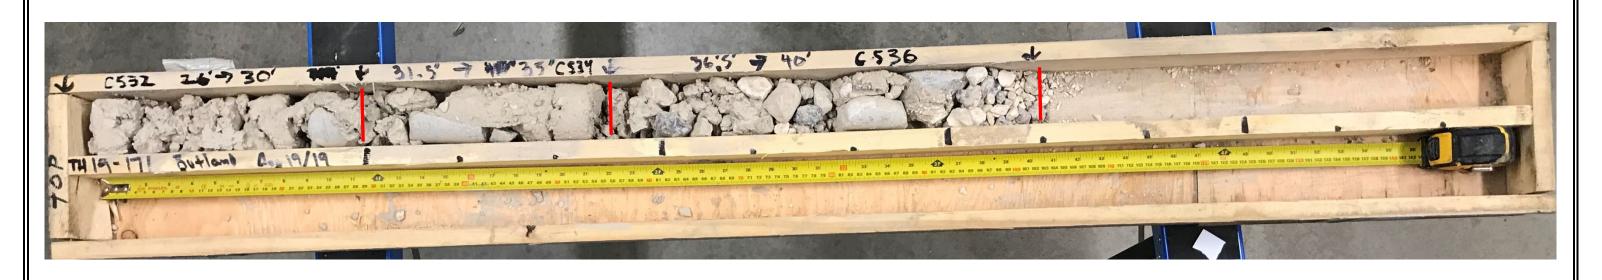
C532) Core Depth: 26 – 30 ft (7.9 – 9.1 m) - 25% recovery C534) Core Depth: 31.5 – 35 ft (9.5 – 10.7 m) - 24% recovery C536) Core Depth: 36.5 – 40 ft (11.1 – 12.2 m) - 40% recovery

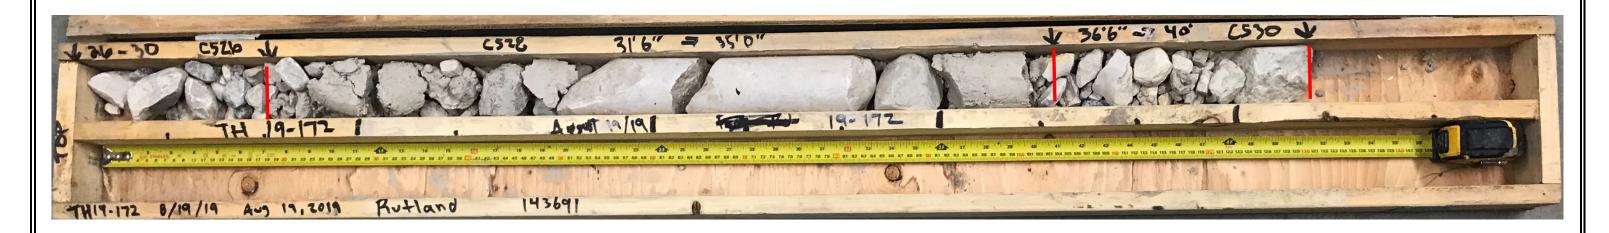
C526) Core Depth: 26 – 30 ft (7.9 – 9.1 m) - 16% recovery

C528) Core Depth: 31.5 – 35 ft (9.5 – 10.7 m) - 76% recovery including limestone cobble / boulder

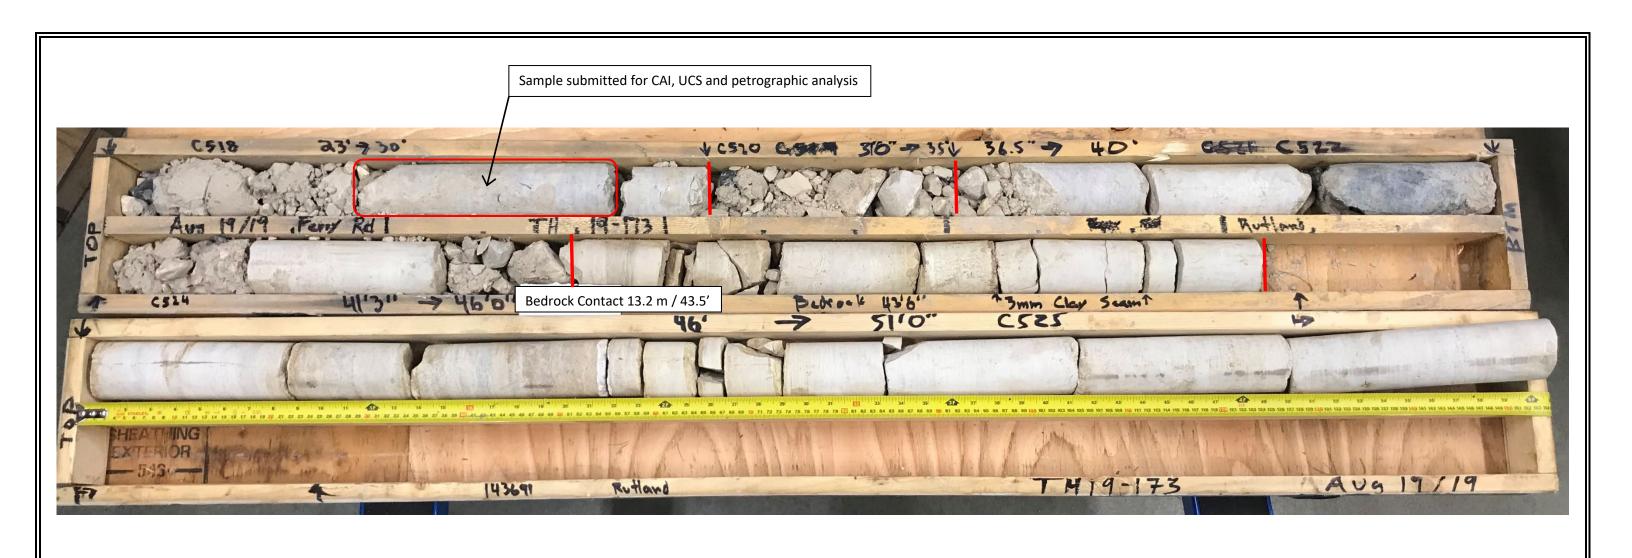
C518) Core Depth: 23 – 30 ft (7.0 – 9.1 m) - 31% recovery including limestone boulder

C520) Core Depth: 31.5 – 35 ft (9.5 – 10.7 m) - 24% recovery

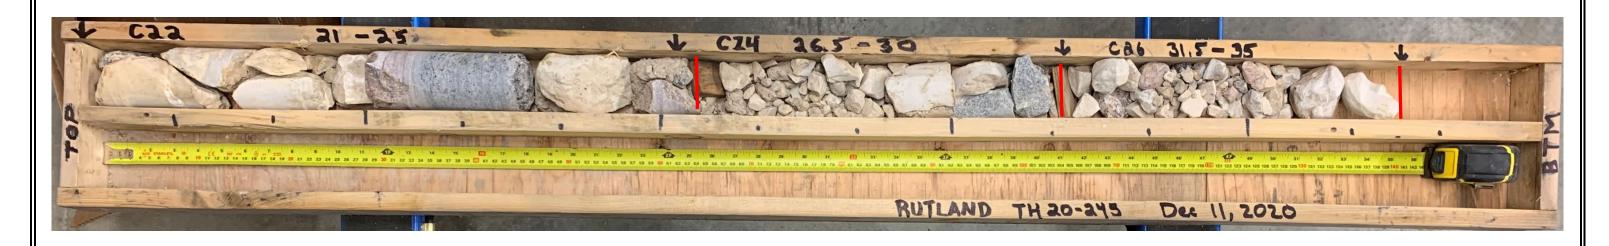
C22) Core Depth: 21 – 25 ft (6.4 – 7.6 m) - 52% recovery including limestone & granite cobbles

C24) Core Depth: 26.5 - 30 ft (8.1 - 9.1 m) - 38% recovery C26) Core Depth: 31.5 - 35 ft (9.6 - 10.7 m) - 31% recovery

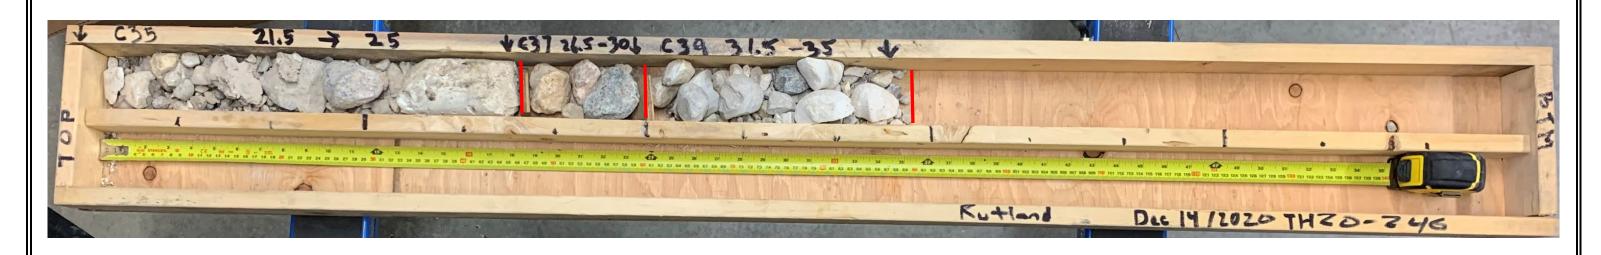
FIGURE C11

C35) Core Depth: 21.5 – 25 ft (6.5 – 7.6 m) - 43% recovery C37) Core Depth: 26.5 – 30 ft (8.1 – 9.1 m) - 12% recovery C39) Core Depth: 31.5 – 35 ft (9.6 – 10.7 m) - 24% recovery

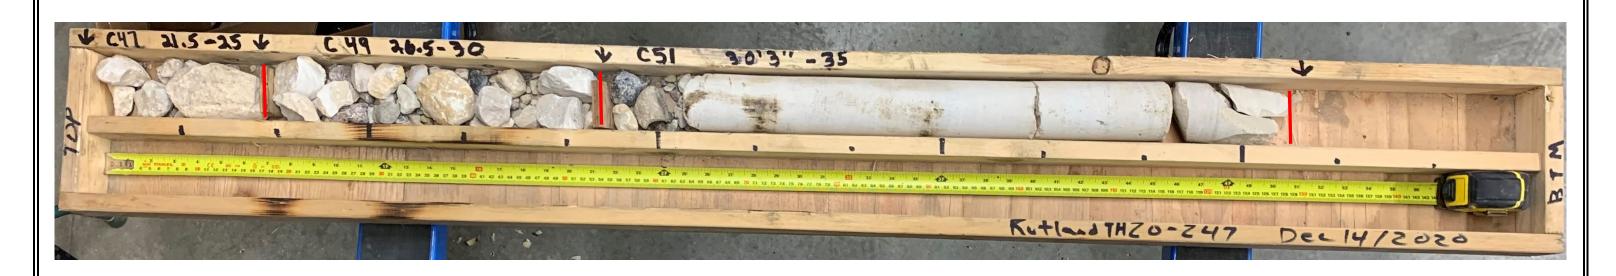
BINSON INC. HNICAL ENGINEERS			Ferry Road & Riverbend CSR – Rutland Trunk Sewer Glacial Till Core Photograph – Test Hole 20-247	
SCALE: NTS	MADE BY: AA	CHKD BY: GR	PROJECT NO. 143691.7	DATE: December 2020		FIGURE C12

C47) Core Depth: 21.5 – 25 ft (6.5 – 7.6 m) - 15% recovery C49) Core Depth: 26.5 – 30 ft (8.1 – 9.1 m) - 33% recovery

C51) Core Depth: 30.3 – 35 ft (9.1 – 10.7 m) - 49% recovery including limestone

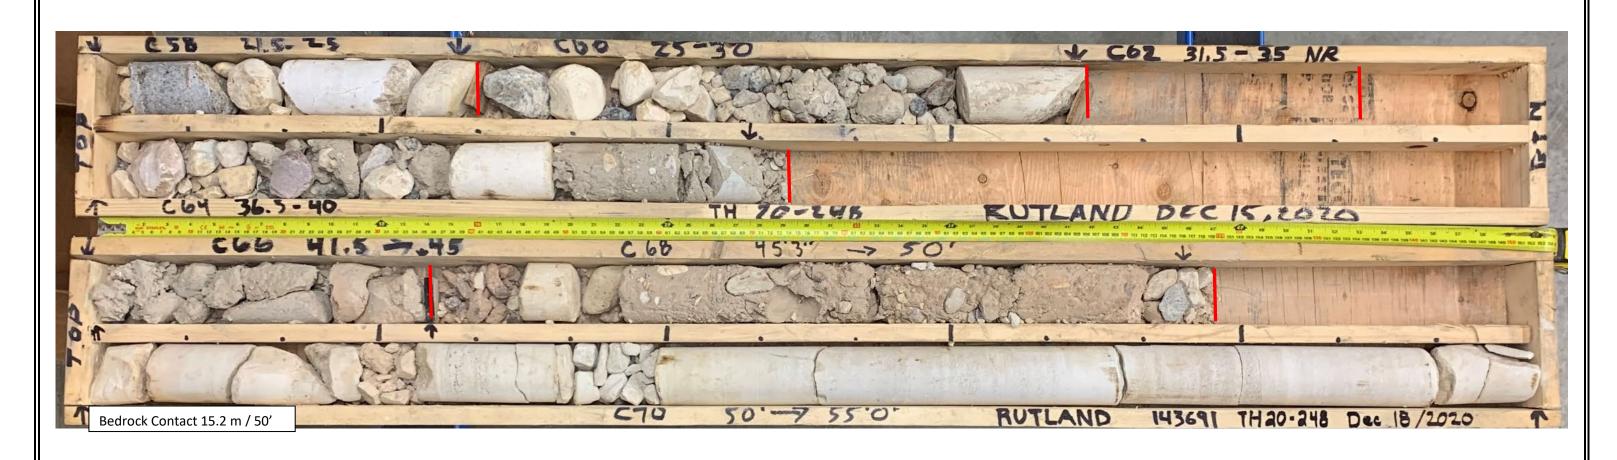
C58) Core Depth: 21.5 – 25 ft (6.6 – 7.6 m) - 38% recovery C60) Core Depth: 25 – 30 ft (7.6 – 9.1 m) - 42% recovery

C62) Core Depth: 31.5 – 35 ft (9.6 – 10.7 m) - 0% recovery

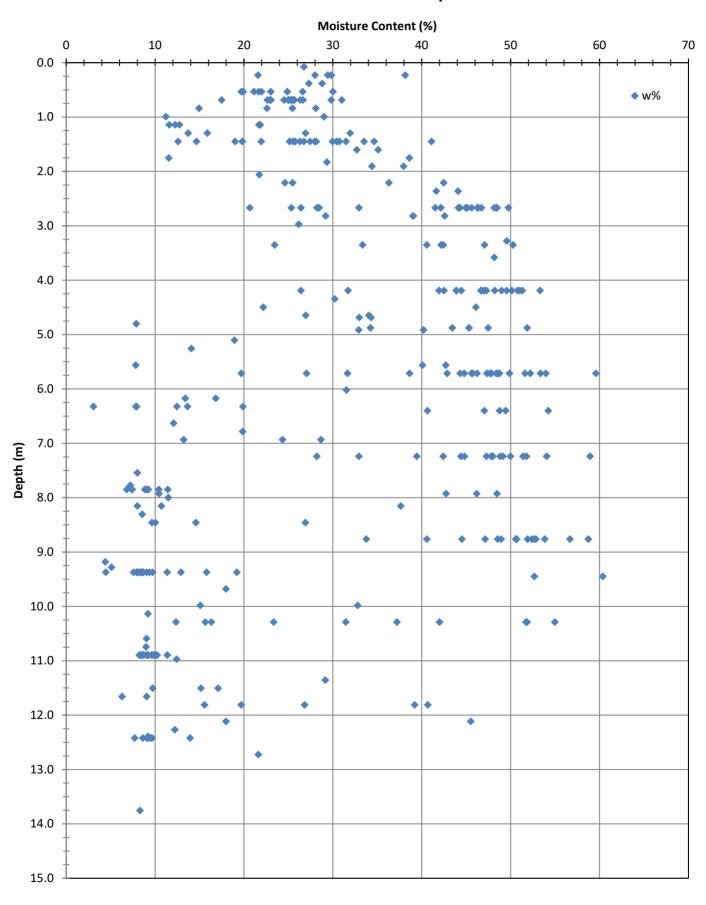
# Ferry Road & Riverbend CSR - Rutland Trunk Sewer Moisture Content vs Depth

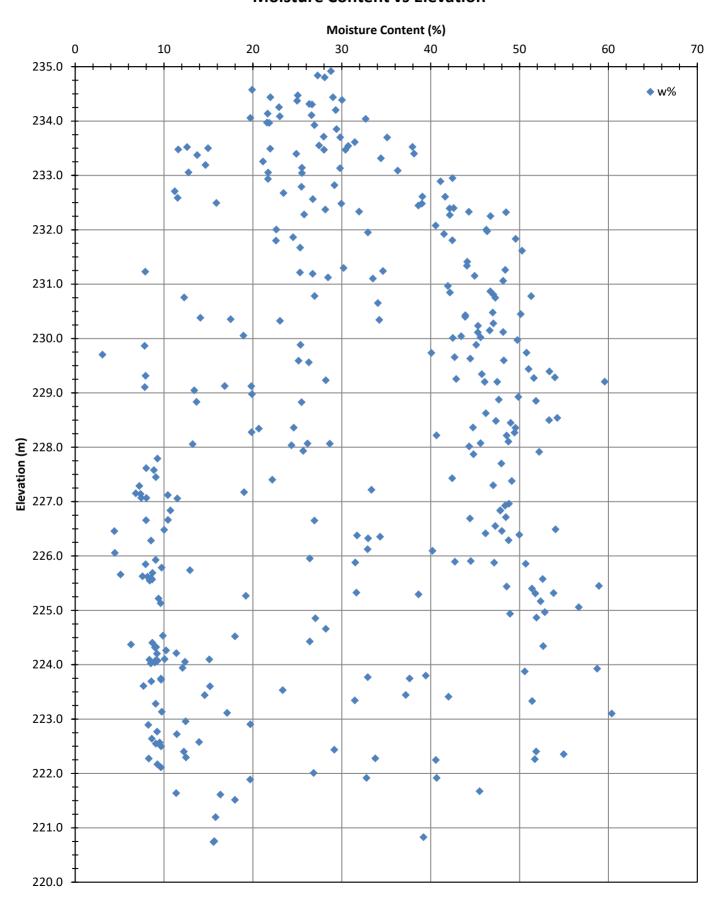
# Ferry Road & Riverbend CSR - Rutland Trunk Sewer Moisture Content vs Elevation

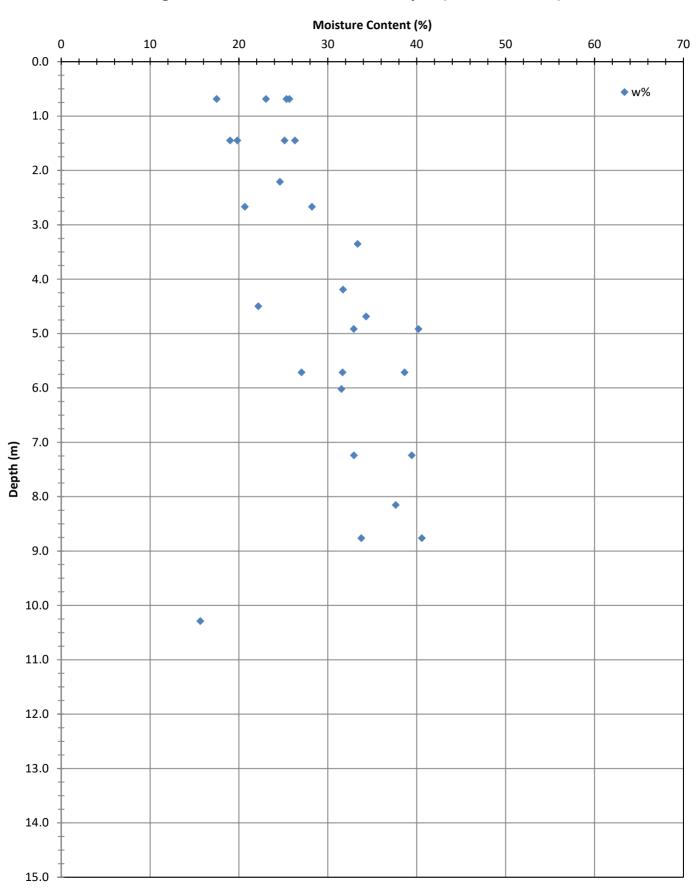
## Ferry Road & Riverbend CSR - Rutland Trunk Sewer Figure E1: Moisture Content vs Depth (CLAY - Alluvial)

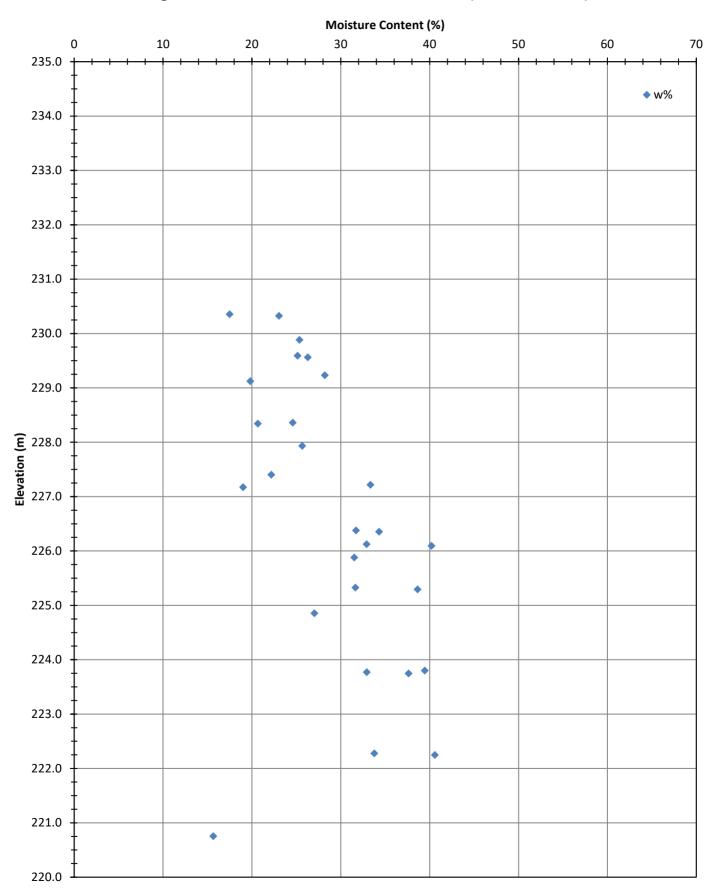
## Ferry Road & Riverbend CSR - Rutland Trunk Sewer Figure E2: Moisture Content vs Elevation (CLAY - Alluvial)

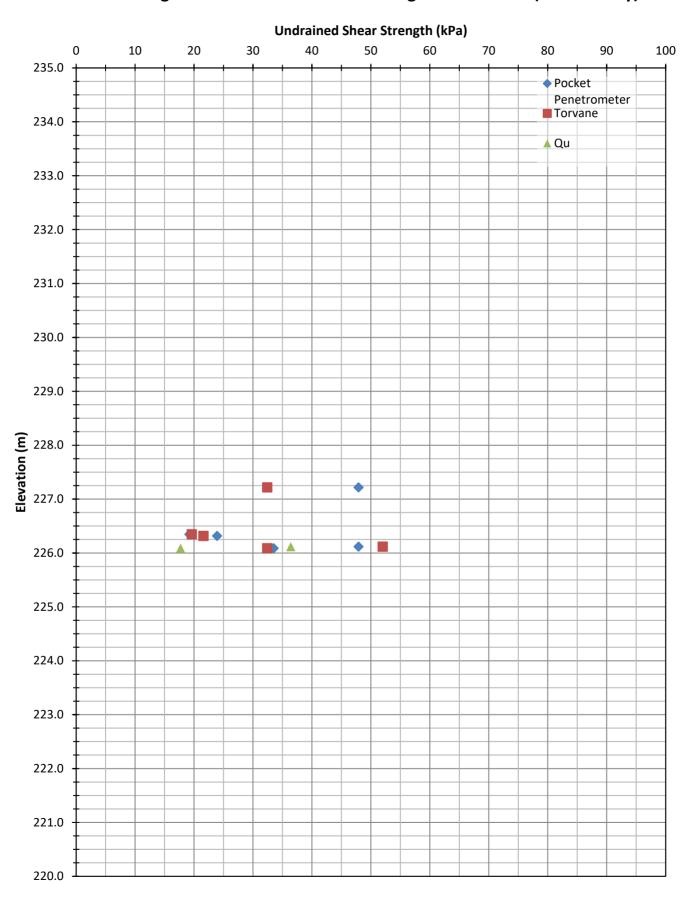
## Ferry Road & Riverbend CSR - Rutland Trunk Sewer Figure E4: Undrained Shear Strength vs Elevation (Alluvial Clay)

The clay contains variable amounts of silt (some silt to silty) and is brown in color, dry to moist with a firm to stiff consistency in the upper portion of the test holes. With depth, the clay trended towards being moist to wet and soft to firm. A few thin layers of sand were observed within the clay zones and the sand was saturated. The various clay layers encountered in the test holes range in thickness from 0.6 m to 6.5 m and the moisture contents ranged from about 15 to 41 percent with an average of 29 percent. The moisture content profiles with depth and elevation are provided on Figures E1 and E2 (Appendix E). Undrained shear strengths of the clay from the Shelby tube samples were measured using Torvane, penetrometer, and unconfined compressive strength methods. The strengths ranged from about 20 to 50 kPa with an average value around 30 kPa. The bulk unit weight of the clay is about 17.5 kN/m³. The undrained shear strength profile with depth and elevation are provided on Figures E3 and E4 (Appendix E).

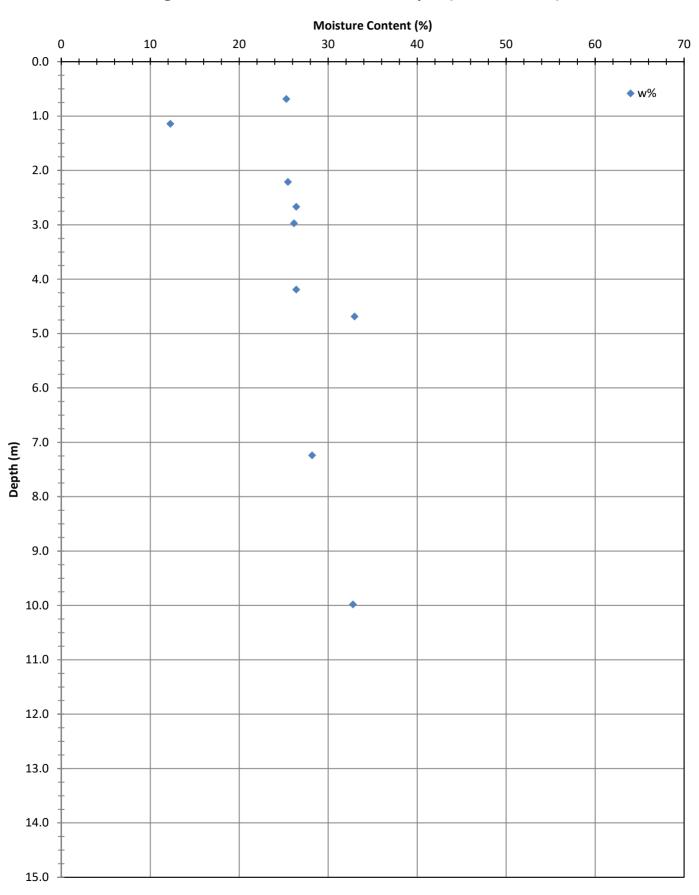
## Ferry Road & Riverbend CSR - Rutland Trunk Sewer Figure E5: Moisture Content vs Depth (SILT - Alluvial)

The silt layers contain variable amounts of clay (trace to some) and traces of sand. It is brown to grey in color and moist becoming wet with depth. The silt has low to medium plasticity, depending on the clay content, and it has a loose (soft) condition. The moisture contents ranged from about 12 to 33 percent with an average of 26 percent. The moisture content profiles with depth and elevation are provided on Figures E5 and E6 (Appendix E).

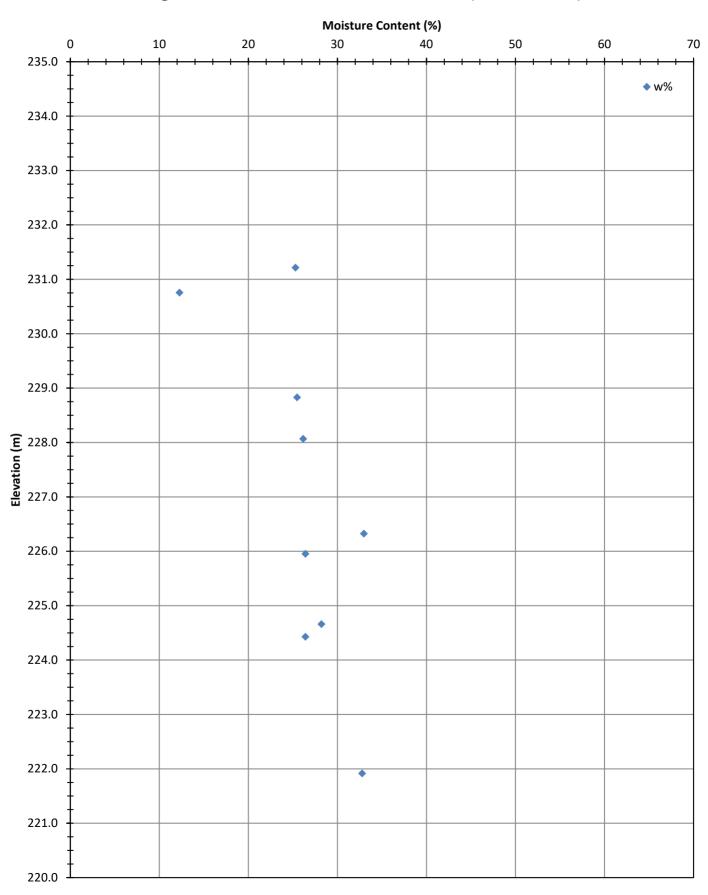
## Ferry Road & Riverbend CSR - Rutland Trunk Sewer Figure E6: Moisture Content vs Elevation (SILT - Alluvial)

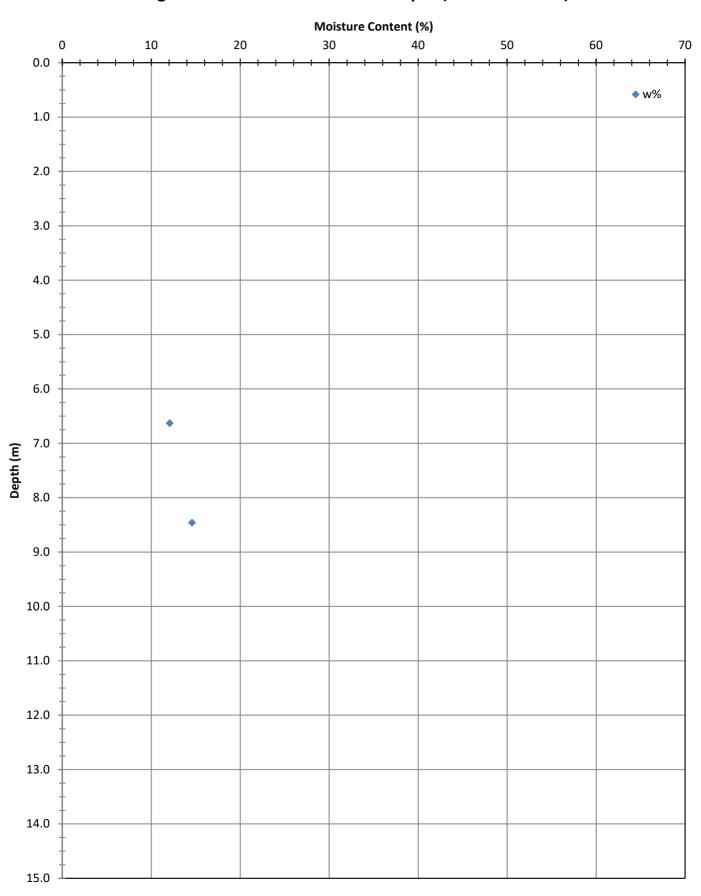
## Ferry Road & Riverbend CSR - Rutland Trunk Sewer Figure E7: Moisture Content vs Depth (SAND - Alluvial)

Sand layers were encountered in Test Holes 19-148 and 19-150 at depths of 6.4 m and 8.2 m, respectively. The sand was 300 to 600 mm thick and is brown, wet (saturated), coarse grained and has a loose compactness condition. The moisture contents from two samples were 12.1 percent and 14.6 percent. The moisture contents with depth and elevation are provided on Figures E7 and E8 (Appendix E).

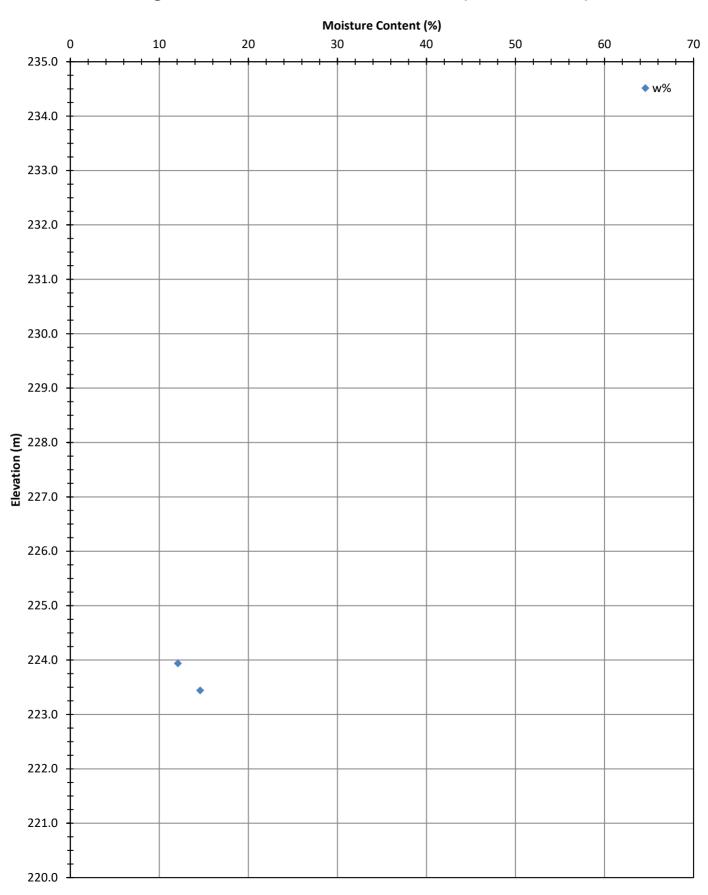
## Ferry Road & Riverbend CSR - Rutland Trunk Sewer Figure E8: Moisture Content vs Elevation (SAND - Alluvial)

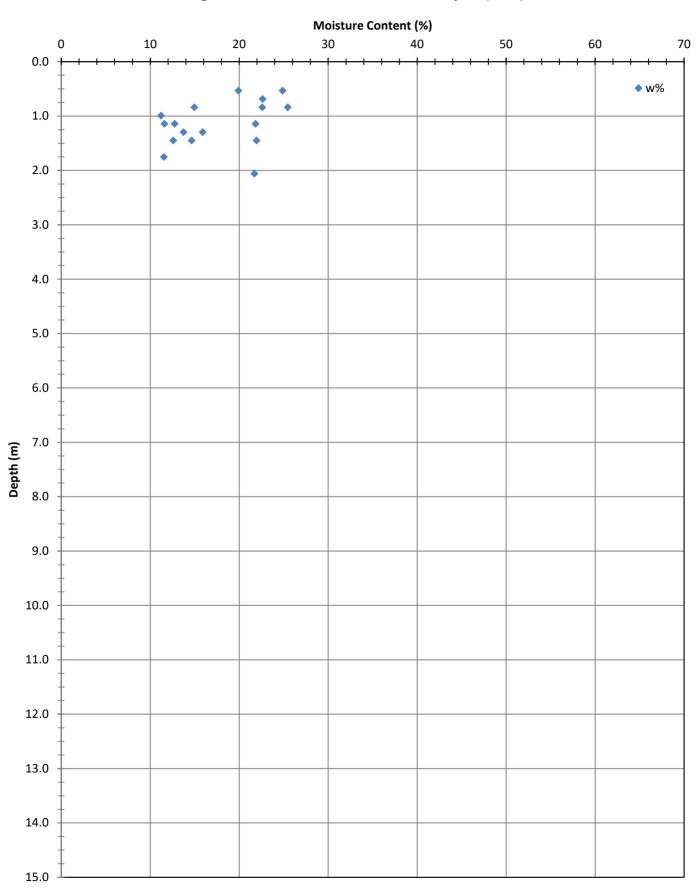
## Ferry Road & Riverbend CSR - Rutland Trunk Sewer Figure E9: Moisture Content vs Depth (SILT)

Silt was encountered in 13 test holes (in the area from Test Holes 19-152 to 19-168). It was typically encountered within 1 m of ground level and was generally around 600 mm thick but ranges in thickness from 600 mm to 2100 mm. It is light brown in color and dry to moist with a loose compactness condition. The moisture contents of the silt ranged from about 11 to 26 percent with an average of 18 percent. The moisture content profiles with depth and elevation are provided on Figures E9 and E10 (Appendix E).

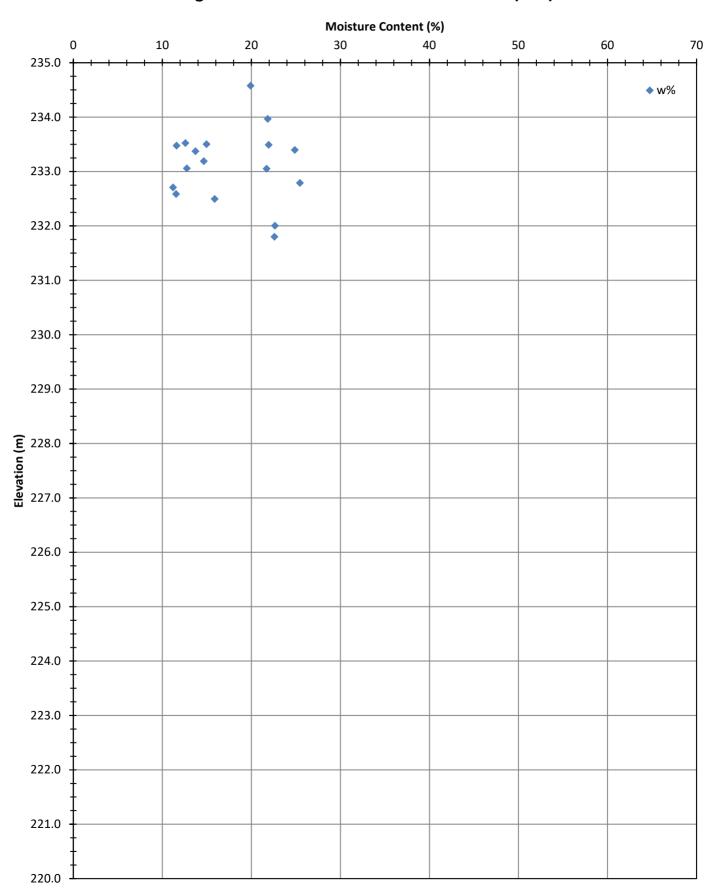
## Ferry Road & Riverbend CSR - Rutland Trunk Sewer Figure E10: Moisture Content vs Elevation (SILT)

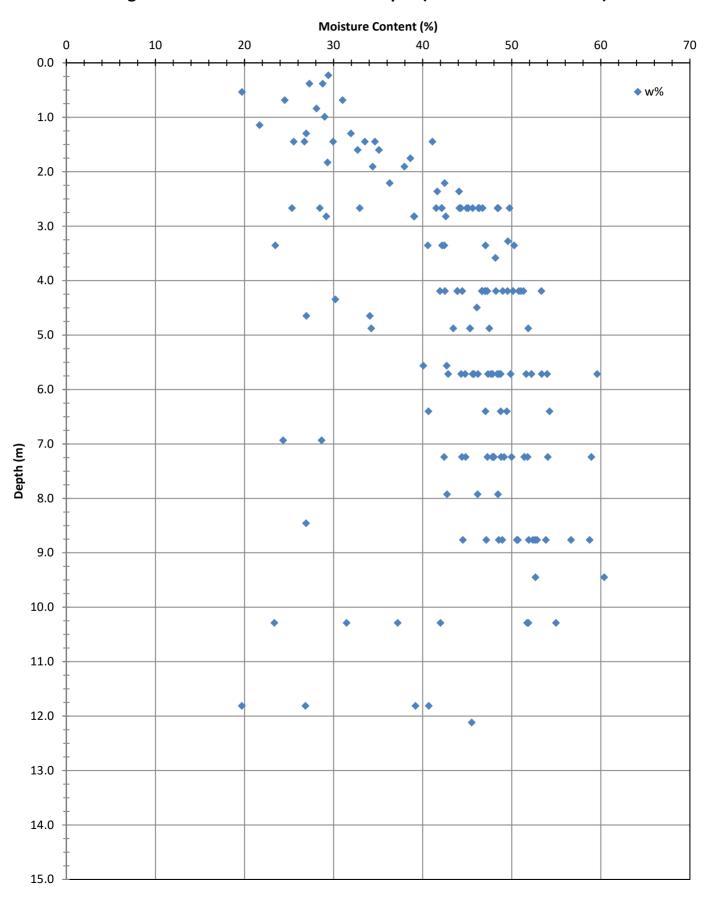
## Ferry Road & Riverbend CSR - Rutland Trunk Sewer Figure E11: Moisture Content vs Depth (SILTY CLAY - Lacustrine)

The upper clay layer, and the upper 1.5 m of the main clay deposit where no silt layer is present, is black in color and contains traces of organics. Below the black clay, it is mottled brown and grey to a depth of about 6 to 7 m below which it is grey. It is moist with a stiff consistency to a depth of about 6 m and below it has a firm consistency. The clay typically has high plasticity, contains trace silt inclusions, traces of sand and gravel and trace till inclusions. The till inclusions occur towards the bottom of the clay deposit. Of interest is Test Hole 19-157, where a 1.7 m thick layer of glacial till was encountered in the clay at a depth of 9.9 m and clay was present below the till down to 12.2 m. The first test holes south (Test Hole 19-156) and north (Test Hole 19-158) of Test Hole 19-157 both had clay down to 12.2 m and no till was encountered when the target test hole depth was achieved. Till layers within the clay are not common but may be a result of a large pocket of glacial till falling off the glacial ice sheet after glacial Lake Agassiz formed. Boulders are also occasionally encountered in the clay layer and are likely deposited in a similar manner as this till layer found within the clay. The moisture contents of the clay are in the range of 20 to 40 percent in the upper 2 m of the test holes. Below 2 m, the moisture contents range from 40 to 60 percent with an average 48 percent. Some of the clay samples at depth in the test holes have moisture contents in the range of 20 to 40 percent, which is attributed to the till inclusions observed in the clay at depth. The moisture content profiles with depth and elevation are provided on Figures E11 and E12 (Appendix E).

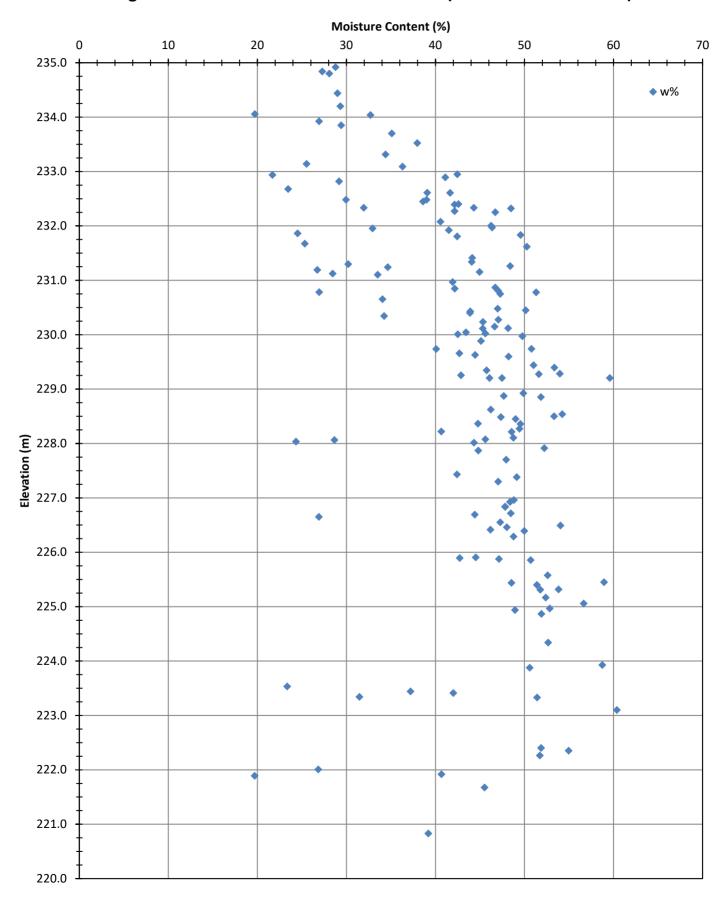
## Ferry Road & Riverbend CSR - Rutland Trunk Sewer Figure E12: Moisture Content vs Elevation (SILTY CLAY - Lacustrine)

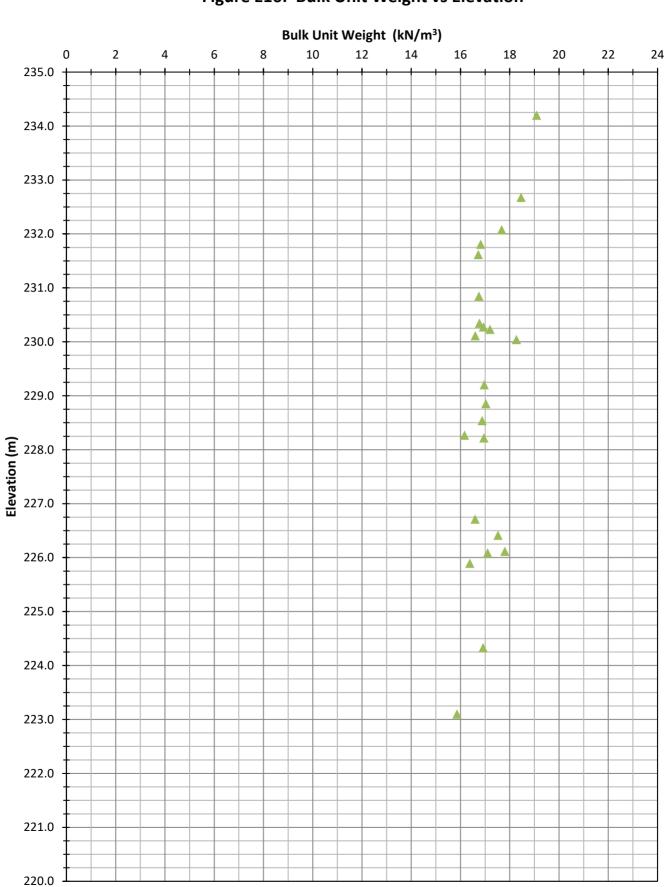
## Ferry Road & Riverbend CSR - Rutland Trunk Sewer Figure E16: Bulk Unit Weight vs Elevation

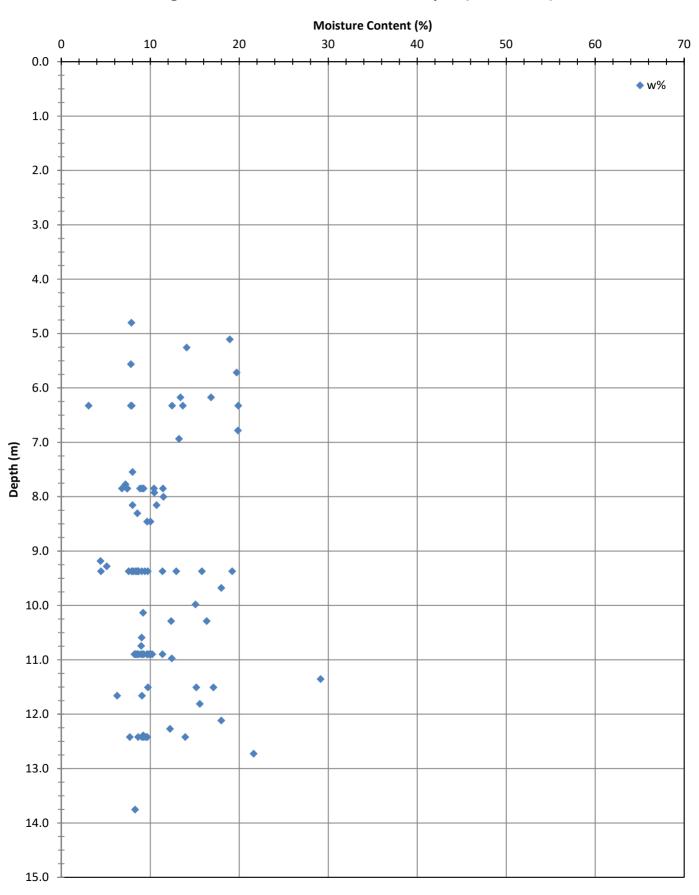
## Ferry Road & Riverbend CSR - Rutland Trunk Sewer Figure E17: Moisture Content vs Depth (Glacial Till)

dense to very dense with depth. The moisture content of the till ranges from 3 to 29 percent with an average of 11 percent. The moisture content profiles with depth and elevation are provided on Figures E17 and E18 (Appendix E).

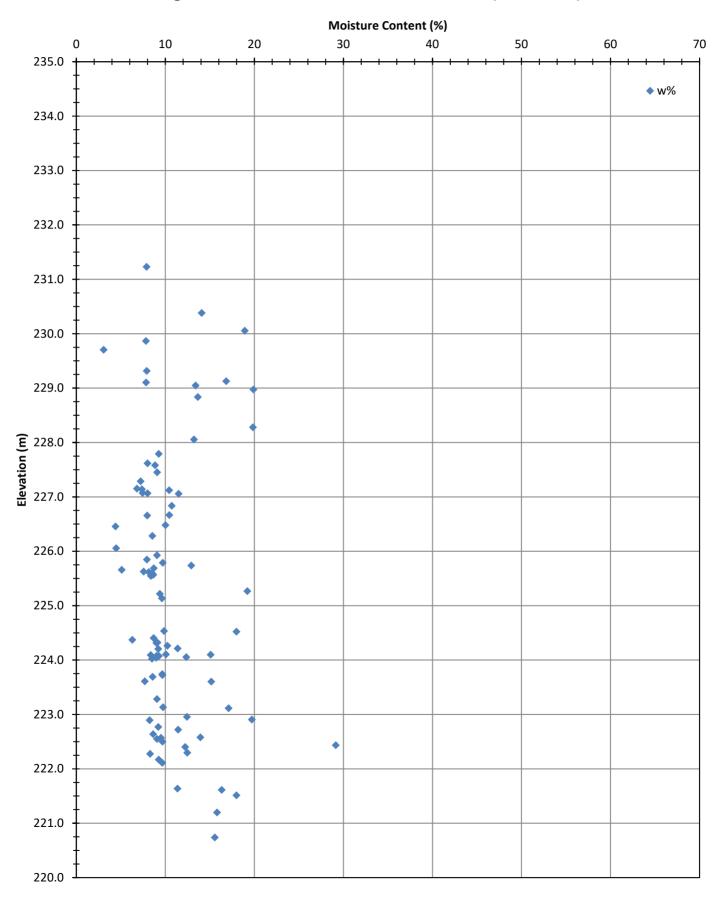
## Ferry Road & Riverbend CSR - Rutland Trunk Sewer Figure E18: Moisture Content vs Elevation (Glacial Till)

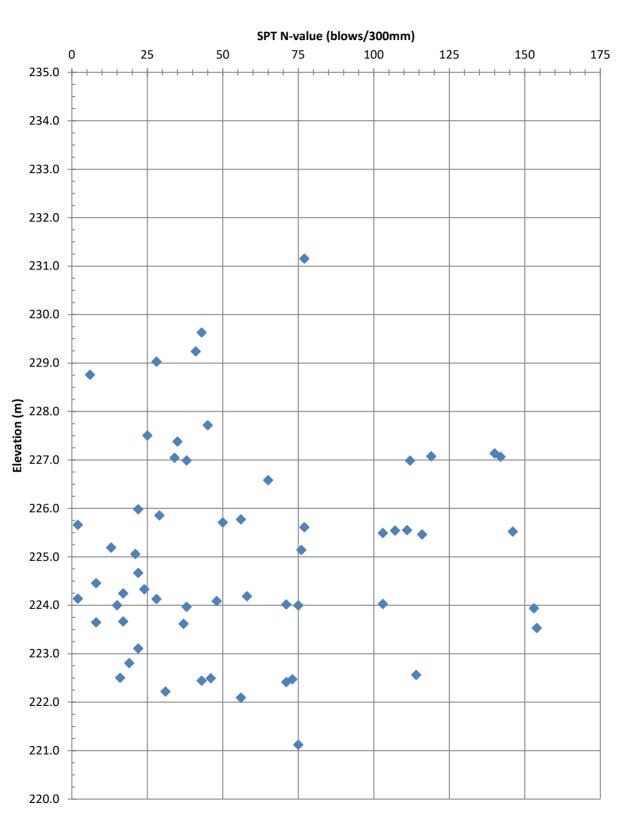
## Ferry Road & Riverbend CSR - Rutland Trunk Sewer Figure F2: SPT-Profile vs Elevation (Glacial Till)

Sixty-five standard penetration tests (SPT) were attempted and fifty-eight were successfully completed. The SPT's ranged from 2 to 154 with an average of 57. The test results are summarized on Table F1 in Appendix F. The SPT profiles with depth and elevation are provided on Figures F1 and F2 (Appendix F). Figure F3 shows the SPT-N values versus moisture content.

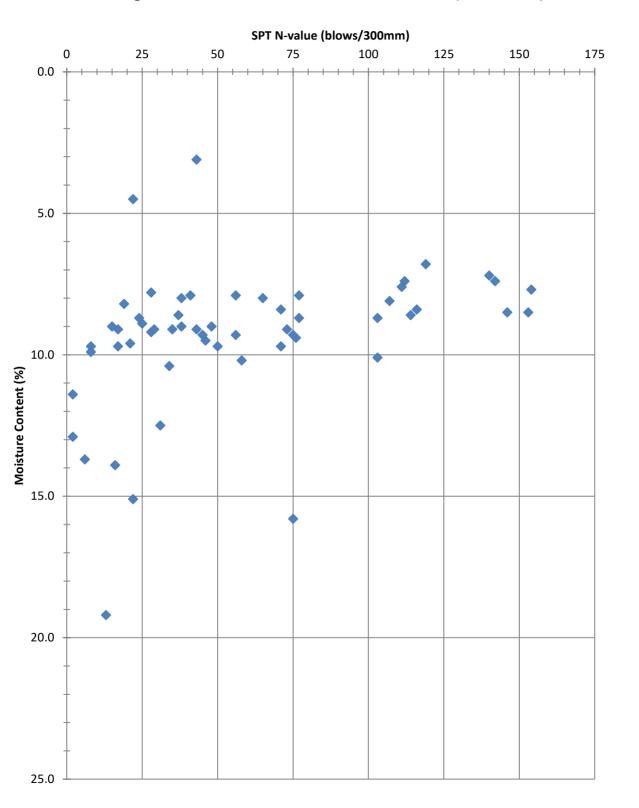
## Ferry Road & Riverbend CSR - Rutland Trunk Sewer Figure F3: SPT-Profile vs Moisture Content (Glacial Till)

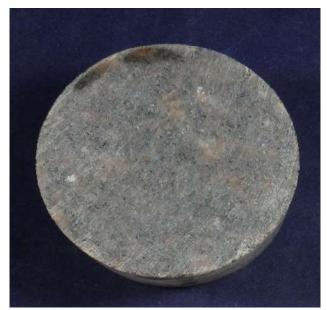
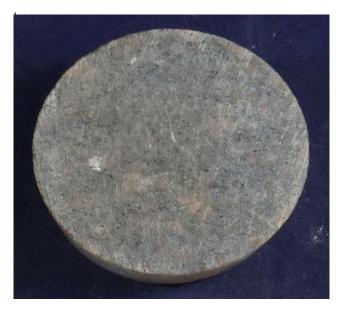
**Sample ID:** TH-19-168, C550 @ 27'

Before

After

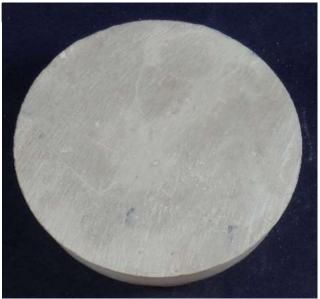
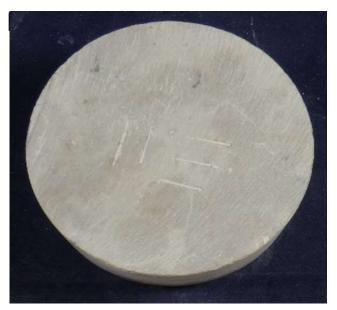
**Sample ID:** TH 19-173, C518 @ 26'

Before

After

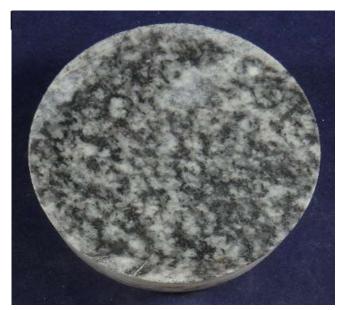
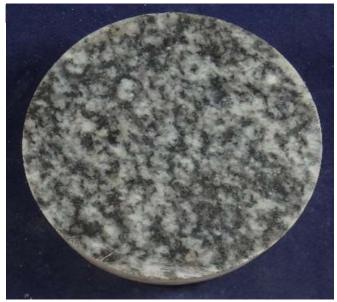
**Sample ID:** TH 20-244, C8 @ 24'

Before

After

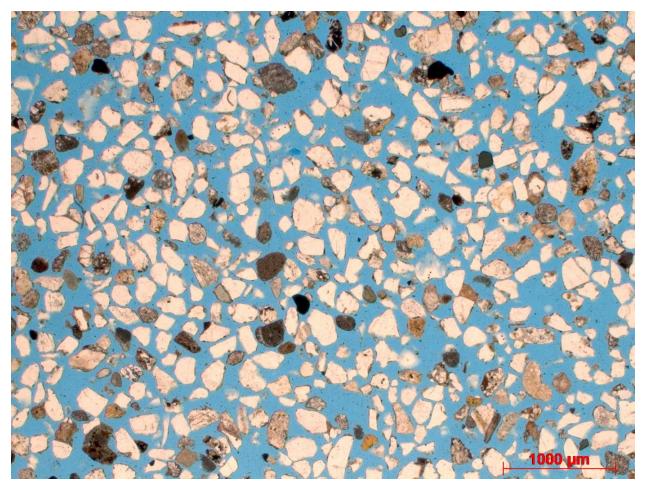
539\_Sand\_1\_2\_5x\_ppl\_001 Litharenitic Loose Sand

**Thin Section Image 01.** General overview of the loose sand shows a variety if angular to subangular sand grains that are fine sand-sized (average grain size 223 microns; minimum 59 microns; maximum 485 microns) according to the Wentworth grain size scale. Most of the grains are quartz and feldspar (white) with a subordinate amount of darker lithic fragments. Plane-polarized light. 2.5x Magnification. Field of View 5.5 mm. Scale bar = 1000 microns or 1 mm.

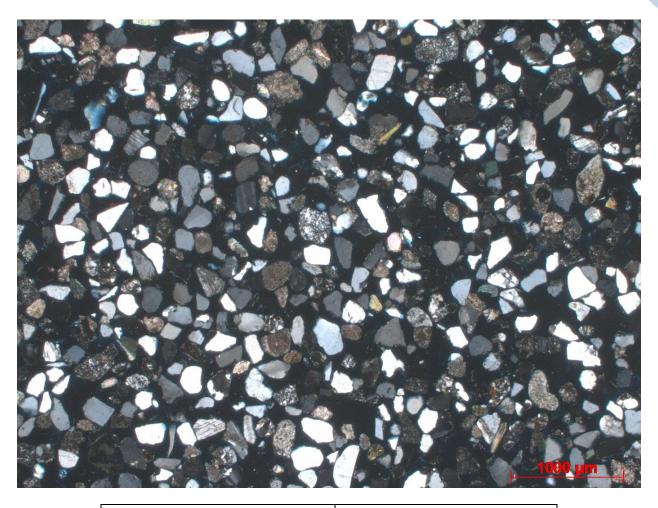
539\_Sand\_1\_2\_5x\_xpl\_002

**Thin Section Image 02**. The same image as in TS\_001 but under crossed-polarized light illustrates abundant quartz grains at various states of optical extinction from the white to gray first order interference colors. Various rock fragments include abundant chert grains from the salt-and-pepper speckled appearance of microcrystalline quartz. Other darker lithics include mudstone and carbonate fragments. Cross-polarized light. 2.5x Magnification. Field of View 5.5 mm. Scale bar = 1000 microns or 1 mm.

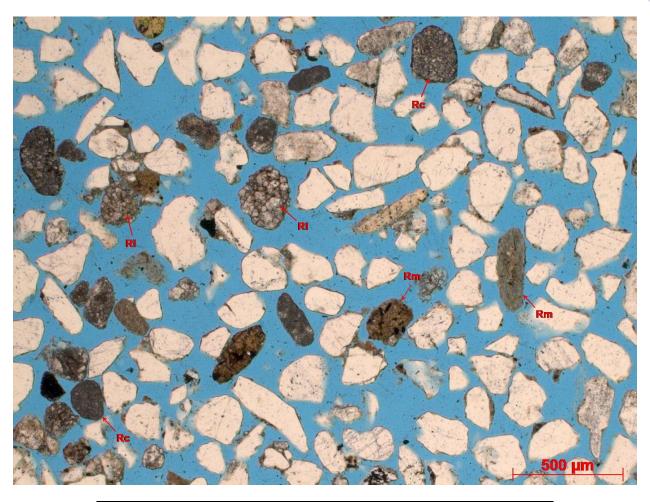
539\_Sand\_1\_5x\_ppl\_003 Litharenitic Loose Sand

**Thin Section Image 03**. Greater magnification of the Litharenitic loose sand shows abundant angular grains of quartz and minor feldspar (white), with lesser amounts of darker brown to gray rock fragments. Most of the rock fragments are mudstone (Rm) or chert (Rc), but a small amount include limestone fragments (Rl) composed of sparry calcite. Plane-polarized light. 5x Magnification. Field of View 2.82 mm. Scale bar = 500 microns or 0.5 mm.

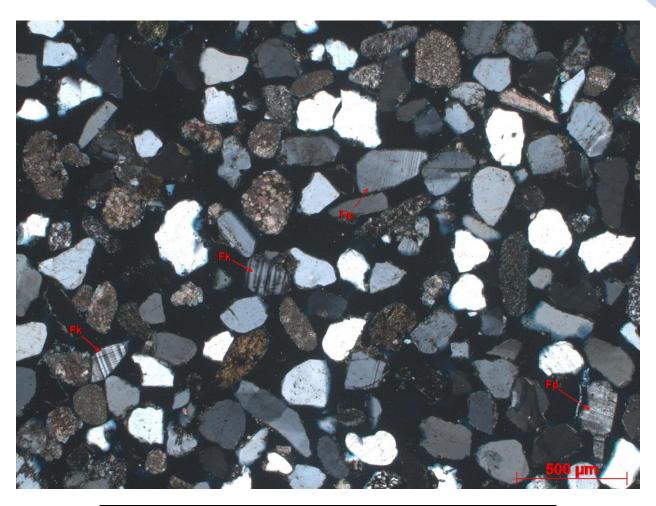
539\_Sand\_1\_5x\_xpl\_004 Litharenitic Loose Sand

**Thin Section Image 04**. The same view as in TS\_003 but under crossed polarized light reveals abundant angular and subangular grains dominated by quartz (white and gray). A smaller amount of feldspar grains are recognizable from their polysynthetic twinning of plagiolcase (Fp) and tartan twinning of microcline variant of potassium feldspar (Fk). The rock fragments noted in the previous image illustrate specked brown and gray colors. Cross-polarized light. 5x Magnification. Field of View 2.82 mm. Scale bar = 500 microns or 0.5 mm.

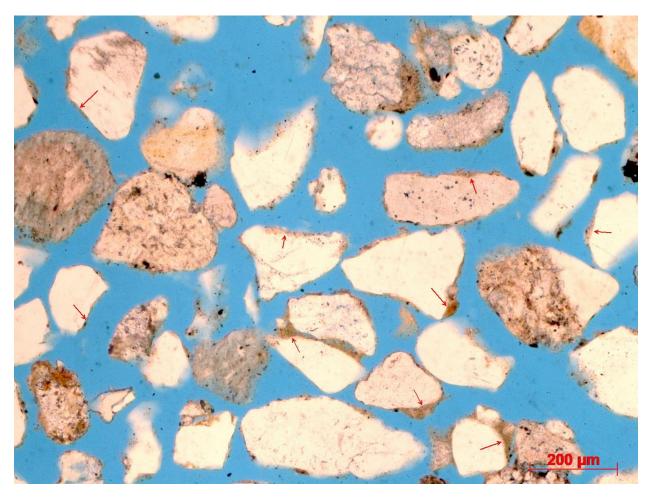
539\_Sand\_1\_10x\_ppl\_005 Litharenitic Loose Sand

**Thin Section Image 05**. Closer inspection of the Litharenitic loose sand better illustrates the high angularity of the grains indication a low textural maturity of the sand. Also note the thin clay coatings on most grains (arrows) that are likely composed of illite, kaolinite, and chlorite. Plane-polarized light. 10x Magnification. Field of View 1.46 mm. Scale bar = 200 microns or 0.2 mm.

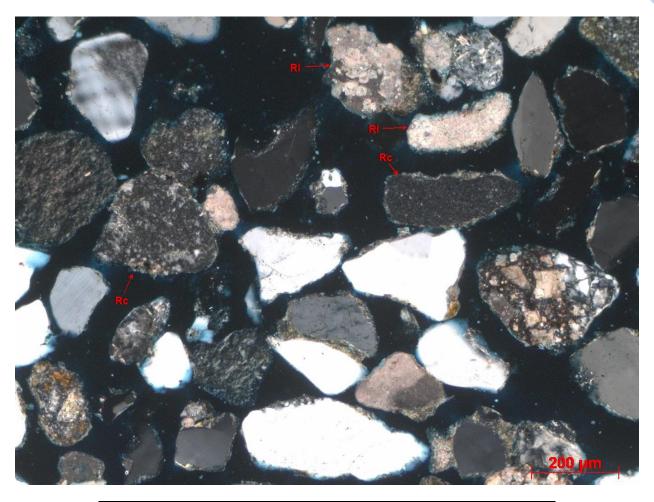
539\_Sand\_1\_10x\_xpl\_006 Litharenitic Loose Sand

**Thin Section Image 06**. The same view as TS\_05 but under crossed-polarized light illustrating the variety of lithic fragments from salt-and-pepper chert (Rc) to limestone fragments (RI) that show both sparry and microcrystalline calcite. Other fragments include those of minor volcanic and metamorphic origin. Cross-polarized light. 10x Magnification. Field of View 1.46 mm. Scale bar = 200 microns or 0.2 mm.
