CITY OF WINNIPEG, WATER AND WASTE DEPARTMENT
FERRY ROAD AND RIVERBEND CSR PROJECT
CONTRACT 6 – RUTLAND TRUNK SEWER
GEOTECHNICAL DATA REPORT
WINNIPEG, MANITOBA

RE: City of Winnipeg Ferry Road and Riverbend CSR Project – Contract 6 Rutland Trunk Sewer Geotechnical Investigation

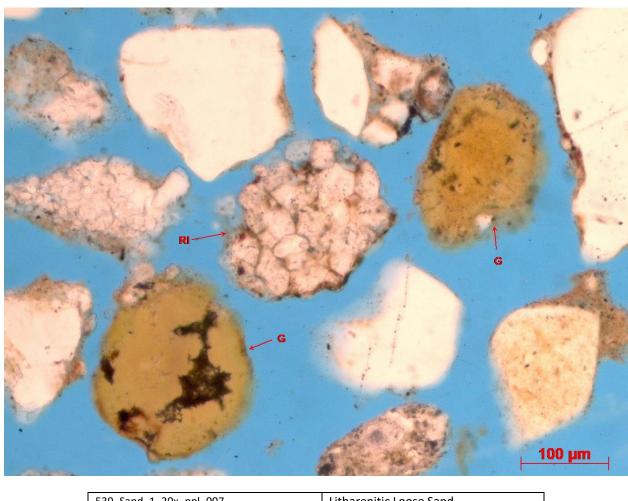
539\_Sand\_1\_20x\_ppl\_007 Litharenitic Loose Sand

**Thin Section Image 07**. More magnified view of the Litharenitic loose sand illustrates two rare rounded glauconite pellets (G) between and limestone fragment (RI) composed of sparry calcite crystals. Plane-polarized light. 20x Magnification. Field of View 0.72 mm. Scale bar = 100 microns or 0.1 mm.

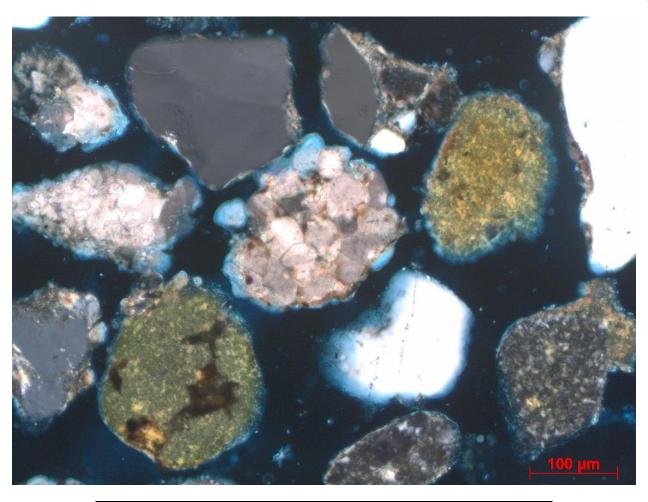
539\_Sand\_1\_20x\_xpl\_008 Litharenitic Loose Sand

**Thin Section Image 08**. The same view as in TS\_07 but under crossed-polarized light better illustrates the glauconite pellets from the dull green-and-yellow speckled color. The prominent quartz grains illustrate first order white to gray interference colors at various states of optical extinction. A small chert fragment is noted at lower-right from its speckled salt-and-pepper pattern. Cross-polarized light. 20x Magnification. Field of View 0.72 mm. Scale bar = 100 microns or 0.1 mm.

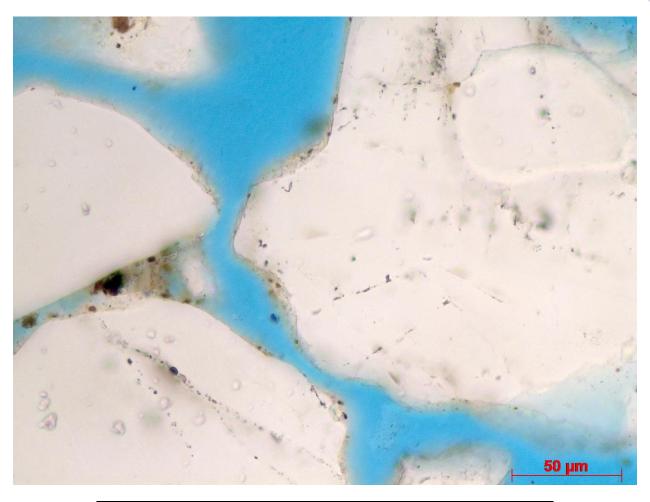
539\_Sand\_1\_50x\_ppl\_009 Litharenitic Loose Sand

**Thin Section Image 09.** Highest magnification detail of the Litharenitic loose sand illustrates quartz and feldspar grains that are coated with a small amount of brown clays likely composed of illite, kaolinite, and chlorite. A small opaque mineral at left is likely pyrite or magnetite. Field of View 0.28 mm. Scale bar = 50 microns or 0.05 mm.

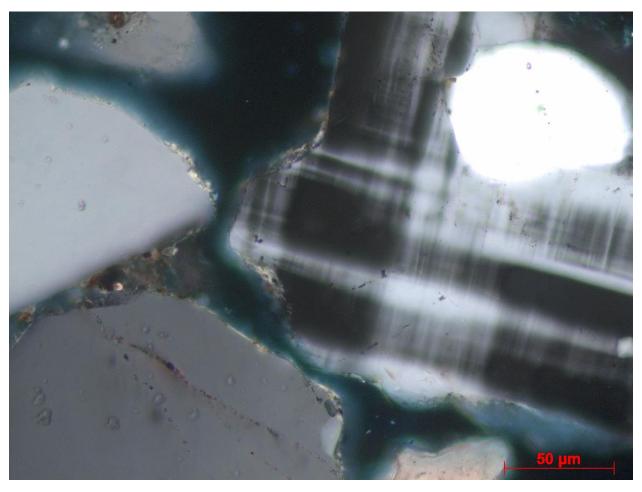
539\_Sand\_1\_50x\_xpl\_010 Litharenitic Loose Sand

**Thin Section Image 10**. The same view as TS\_09 under crossed-polarized light illustrates the tartan twinning of microcline variation of potassium feldspar. Note that the clays that coat the grains show bright white to yellow interference colors that are characteristic of illite. Cross-polarized light. 50x Magnification. Field of View 0.28 mm. Scale bar = 50 microns or 0.05 mm.

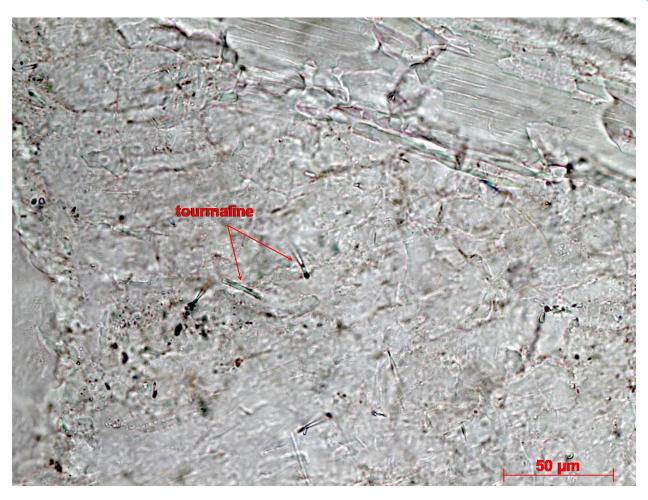
TH19-168\_C550@27'\_50x\_ppl\_009 Alkali-Feldspar Granite

**Thin Section Image 09**. Highest magnification view of the alkali-feldspar granite exhibits prismatic green tourmaline crystals that are hosted by a plagiolcase feldspar crystal with associated myrmekite intergrowths of quartz. Plane-polarized light. 50x Magnification. Field of View 0.28 mm. Scale bar = 50 microns or 0.05 mm.

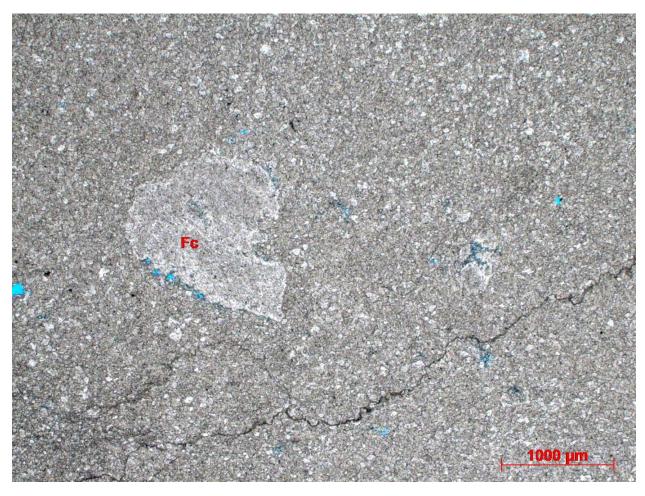
TH19-173\_C518@26'\_2\_5x\_ppl\_011 Limestone (Crystalline Carbonate/Sparstone)

Thin Section Image 11. General overview of a limestone. Depending upon the classification scheme, this rock can be classified as a crystalline carbonate (Dunham, 1962) or as a sparstone (Write, 1992). The matrix is composed of interlocking calcite crystals that range in size from 15-30 microns (finely crystalline). A minor amount of calcareous shell fragments includes broken pieces of crinoid plates (Fc). At bottom are thin black stringers that are interpreted to be insoluble bitumen or some form or organic matter and not stylolites. Plane-polarized light. 2.5x Magnification. Field of View 5.5 mm. Scale bar = 1000 microns or 1 mm.

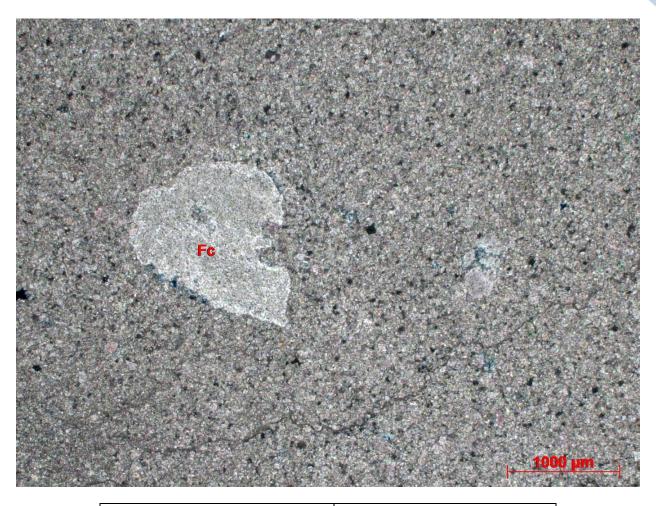
TH19-173\_C518@26'\_2\_5x\_xpl\_012 Limestone (Crystalline Carbonate/Sparstone)

**Thin Section Image 12**. The same image as in TS\_011 but under crossed-polarized light illustrates abundant interlocking calcite crystals, the crinoid plate fragment (Fc), and the organic stringers at the bottom of the image. Cross-polarized light. 2.5x Magnification. Field of View 5.5 mm. Scale bar = 1000 microns or 1 mm.

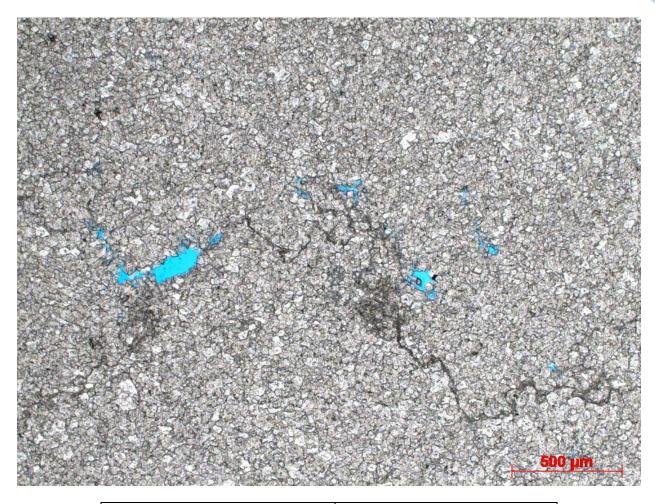
TH19-173\_C518@26'\_5x\_ppl\_013
Limestone (Crystalline Carbonate/Sparstone)

**Thin Section Image 13**. Greater magnification of the limestone shows sparry calcite cement crystals that are finely crystalline that are cemented together into an interlocking matrix. Note the porous vugs that show the blue dye added to the thin section epoxy. At center and lower right are more of the organic stringers mentioned previously. Plane-polarized light. 5x Magnification. Field of View 2.82 mm. Scale bar = 500 microns or 0.5 mm.

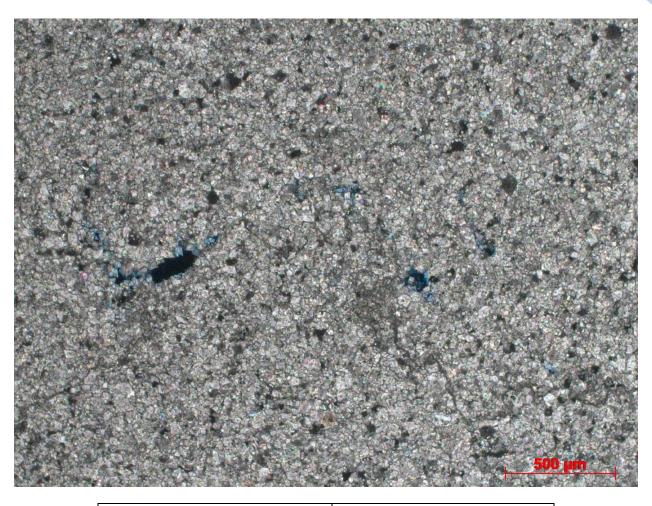
TH19-173\_C518@26'\_5x\_xpl\_014 Limestone (Crystalline Carbonate/Sparstone)

**Thin Section Image 14**. The same view as in TS\_013 but under crossed-polarized light better illustrates the high order, white-edged interference colors of calcite. The vuggy areas will appear isotropic from the background glass slide. Cross-polarized light. 5x Magnification. Field of View 2.82 mm. Scale bar = 500 microns or 0.5 mm.

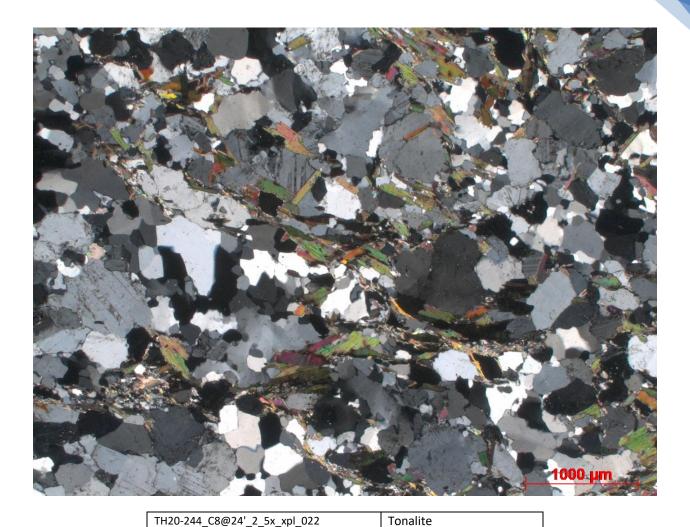
**Thin Section Image 22**. The same view as in TS 21 but under crossed polarized light better illustrates the abundant polycrystalline quartz (45% by visual estimate) from the low-first order grey and white interference colors and undulose extinction. Plagioclase feldspar is also common, but in lesser amounts (35% by visual estimate). Biotite (15% by visual estimate) is widespread and exhibits strong birefringence with up to middle third-order interference colors of yellow, green, pink, and

red. Cross-polarized light. 2.5x Magnification. Field of View 5.5 mm. Scale bar = 1000 microns or 1 mm.

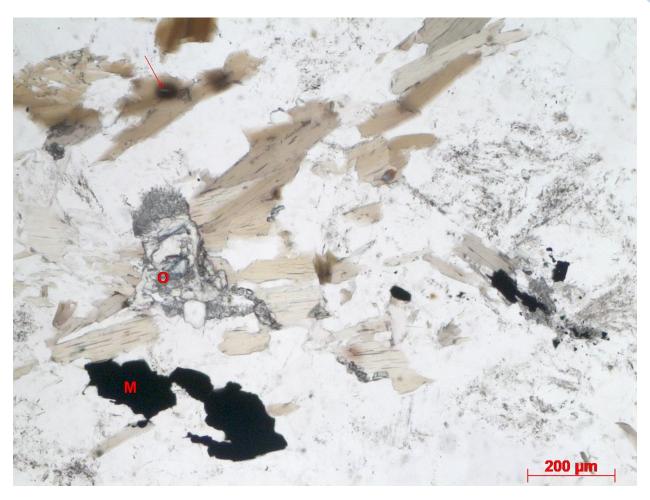
**Thin Section Image 25**. Medium magnification view of the tonalite shows abundant crystals of white polycrystalline quartz and plagiolcase feldspar that host subordinate amounts of light to dark-brown biotite and hornblende. Other accessory minerals include opaque magnetite (M), high-relief olivine (O), and rare apatite crystals enclosed in biotite (arrow). Plane-polarized light. 10x Magnification. Field of View 1.46 mm. Scale bar = 200 microns or 0.2 mm.

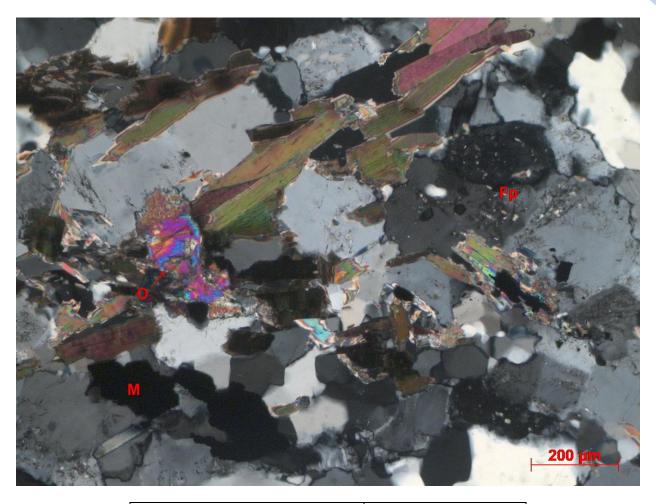
**Thin Section Image 26**. The same image as in TS25 but under crossed-polarized light illustrates the high second-order blue, pink, and orange interference colors of the olivine (O) and the abundant polycrystalline quartz (white to gray) and biotite (green to pink). A plagioclase feldspar at right (Fp) exhibits partial replacement by bright sericite. Cross-polarized light. 10x Magnification. Field of View 1.46 mm. Scale bar = 200 microns or 0.2 mm.

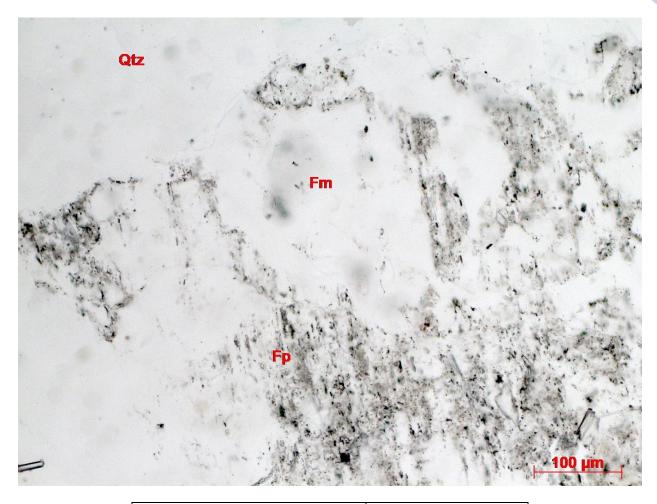
**Thin Section Image 27**. Highly magnified view of the tonalite illustrates a microcline variation of alkali-feldspar (Fm) that is replaced by plagiolcase feldspar (Fp). The plagiolcase, in-turn, is partially replaced by sericite and calcite cement (dark gray flecks). At top is polycrystalline quartz (Qtz). Plane-polarized light. 20x Magnification. Field of View 0.72 mm. Scale bar = 100 microns or 0.1 mm.

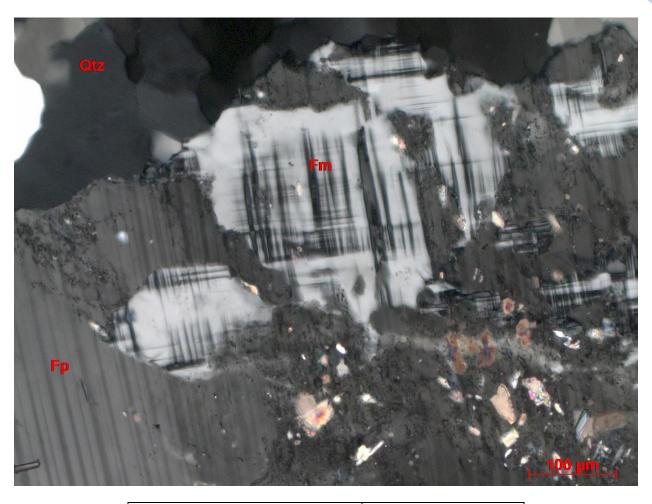
**Thin Section Image 28**. The same image as TS27 but under crossed-polarized light better illustrates the difference in the microcline (Fm) and the plagiolcase (Fp). Polycrystalline quartz (Qtz) is adjacent to the feldspar. Accessory calcite and sericite are rare and partially replaces the plagioclase (bright interference colors). Cross-polarized light. 20x Magnification. Field of View 0.72 mm. Scale bar = 100 microns or 0.1 mm.

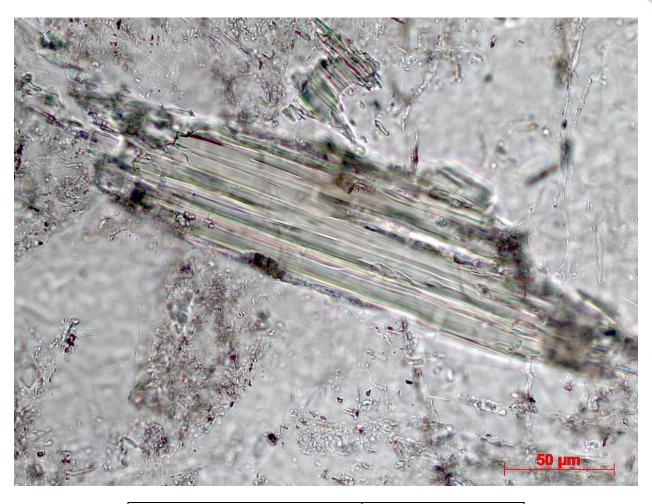
**Thin Section Image 29**. Highest magnification view of the tonalite emphasizes a light green pleochroic hornblende crystal adjacent to polycrystalline quartz crystals (white). Plane-polarized light. 50x Magnification. Field of View 0.28 mm. Scale bar = 50 microns or 0.05 mm.

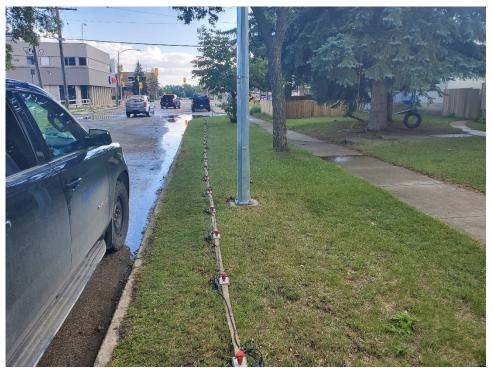
Photo 1 - Landstreamer setup

Seismic data was collected by David McBean, P.Geo. (Alberta), and Jordan Augruso, P.Geo. (Alberta), between August 16 and August 18, 2020. The seismic system used for the survey was a Geometrics' 24-channel seismograph with 4.5 Hz geophones at a 1 m spacing. A sledgehammer striking a metal plate was used as the seismic source. Data was collected using an off-end shot location of 10 m.

The geophones were mounted on a landstreamer, with ground coupling achieved through a metal plate. This setup allows the geophones to be moved along the line efficiently, increasing the speed of data collection. The survey setup is shown below in Photo 1.

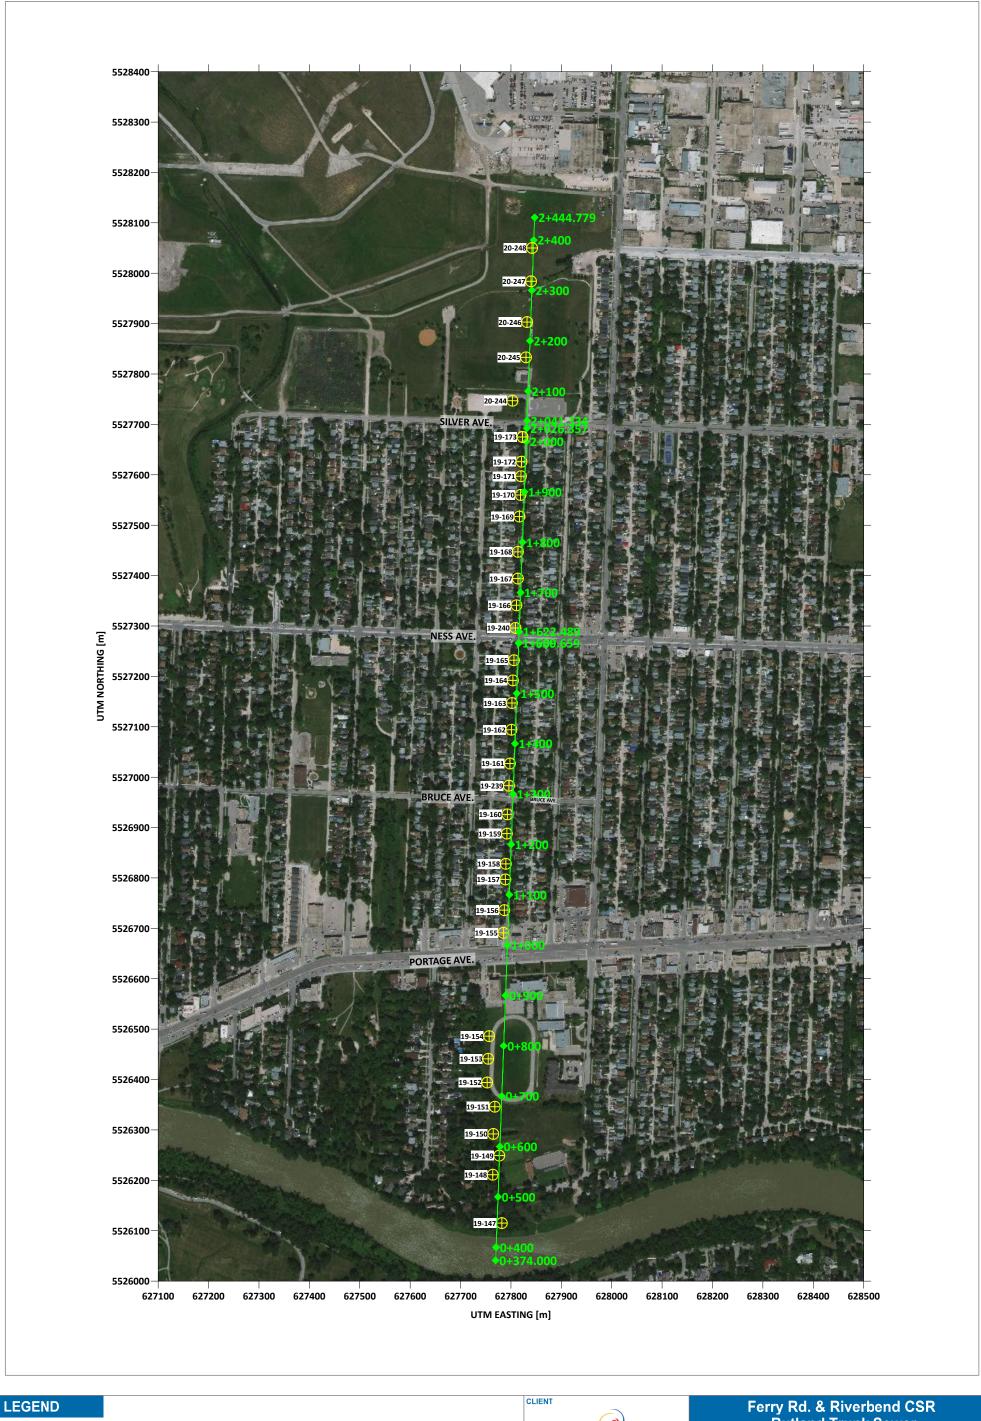
Data was collected along a profile approximately 2 km in length, extending from the Assiniboine River at the south end of the alignment to the Winnipeg James Armstrong Richardson International Airport at the north end. Seismic data was collected at 5 m increments along the profile. No data was collected on active roadways; therefore, the seismic profile contains four gaps in data coverage at Portage Avenue, Bruce Avenue, Ness Avenue, and Silver Avenue. Figure 1 provides a plan view site map of the survey area.

SEISMIC READING LOCATION BOREHOLE **TUNNEL PATH CHAINAGE TUNNEL PATH**
