**CITY OF WINNIPEG, WATER AND WASTE DEPARTMENT**

**FERRY ROAD AND RIVERBEND CSR PROJECT**

**CONTRACT 6 – RUTLAND TRUNK SEWER**

**GEOTECHNICAL DATA REPORT**

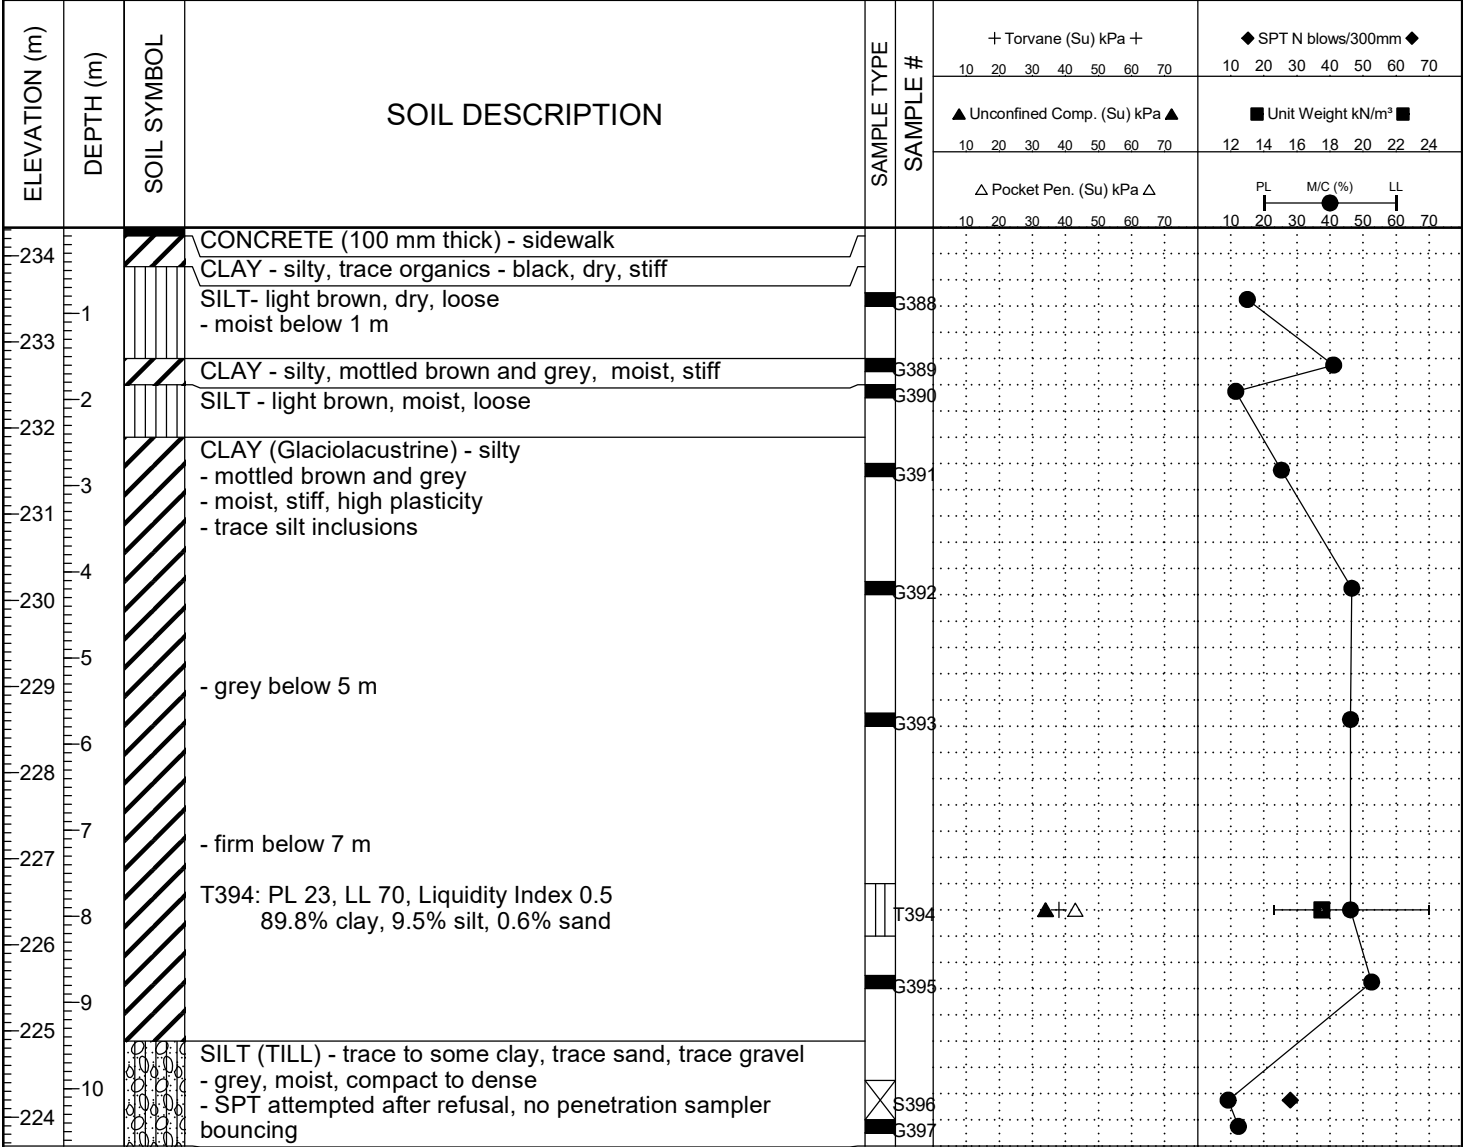
PROJECT: Ferry Rd. & Riverbend CSR - Rutland Trunk Sewer		CLIENT: Tetra Tech Canada Inc.		TEST HOLE NO: 19-162		
LOCATION: UTM 14U: 5527094 m N, 627801 m E				PROJECT NO.: 143691		
CONTRACTOR: Paddock Drilling Ltd.		METHOD: ACKER SS Drill w/125 mm SS Augers		ELEVATION (m): 234.342		
SAMPLE TYPE	GRAB	SHELBY TUBE	SPLIT SPOON	BULK	NO RECOVERY	CORE
BACKFILL TYPE	BENTONITE	GRAVEL	SLOUGH	GROUT	CUTTINGS	SAND

END OF TEST HOLE AT 10.7 m IN SILT(TILL) (AUGER REFUSAL)  
 NOTES:  
 1. No sloughing or seepage observed.  
 2. Upon completion of drilling, test hole open to 10.7 m & dry.  
 After auger refusal, air was blowing out of the test hole.  
 3. Test hole backfilled with auger cuttings and bentonite chips.  
 Sidewalk patched with concrete.

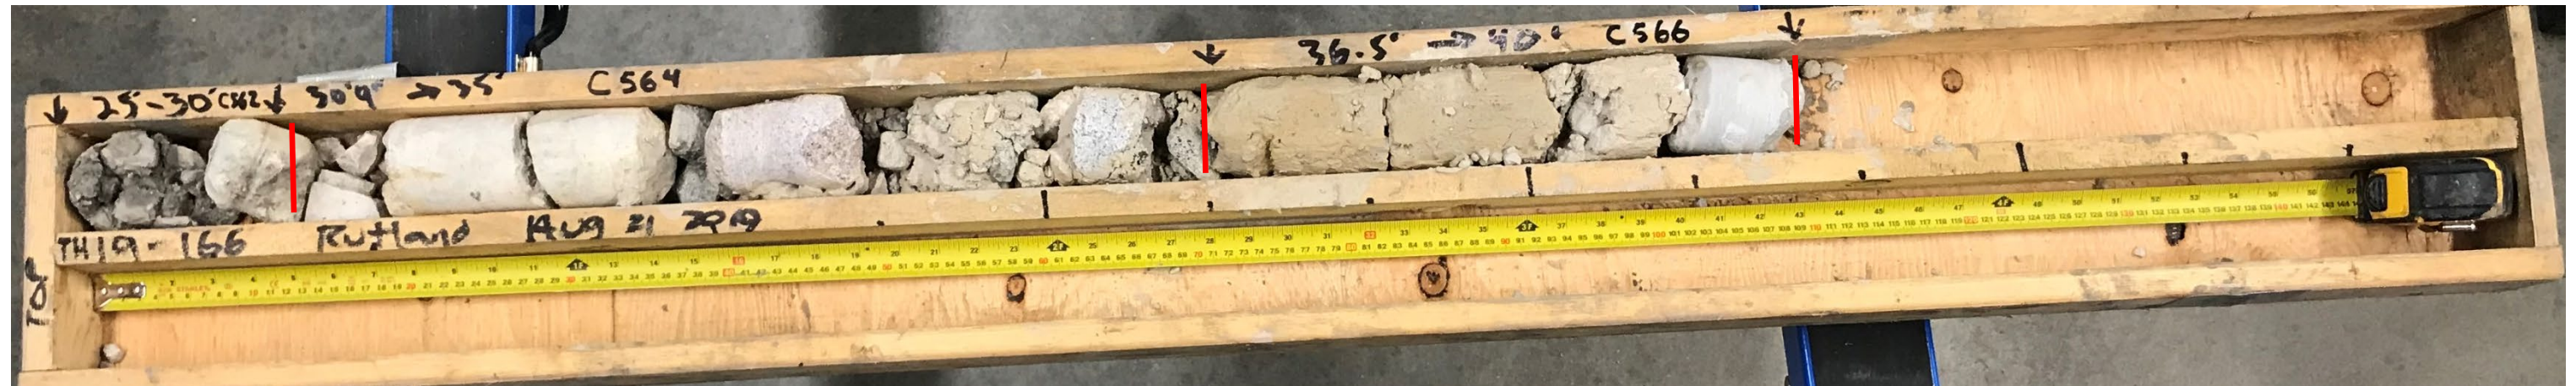
**FIGURE C1**

C562) Core Depth: 25 – 30 ft (7.6 – 9.1 m) – 8% recovery  
 C564) Core Depth: 30.8 – 35 ft (9.3 – 10.7 m) – 45% recovery  
 C566) Core Depth: 36.5 – 40 ft (11.1 – 12.2 m) – 33% recovery

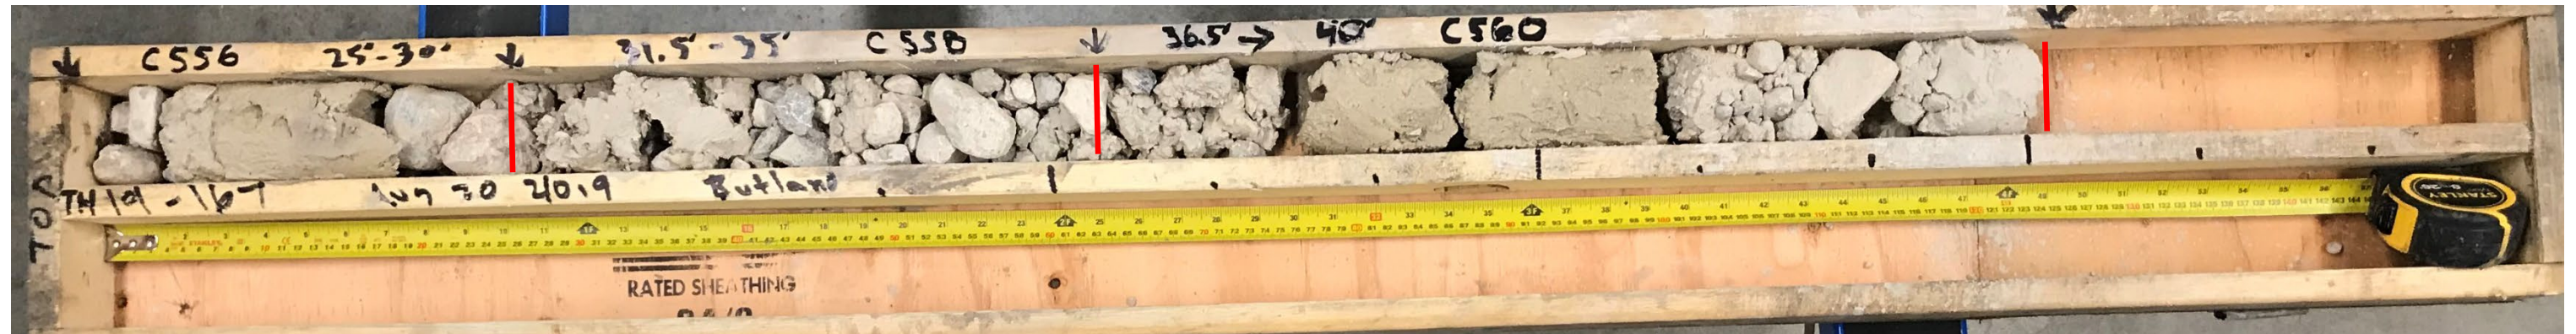
C556) Core Depth: 25 – 30 ft (7.6 – 9.1 m) – 18% recovery  
 C558) Core Depth: 31.5 – 35 ft (9.5 – 10.7 m) – 33% recovery  
 C560) Core Depth: 36.5 – 40 ft (11.1 – 12.2 m) – 57% recovery

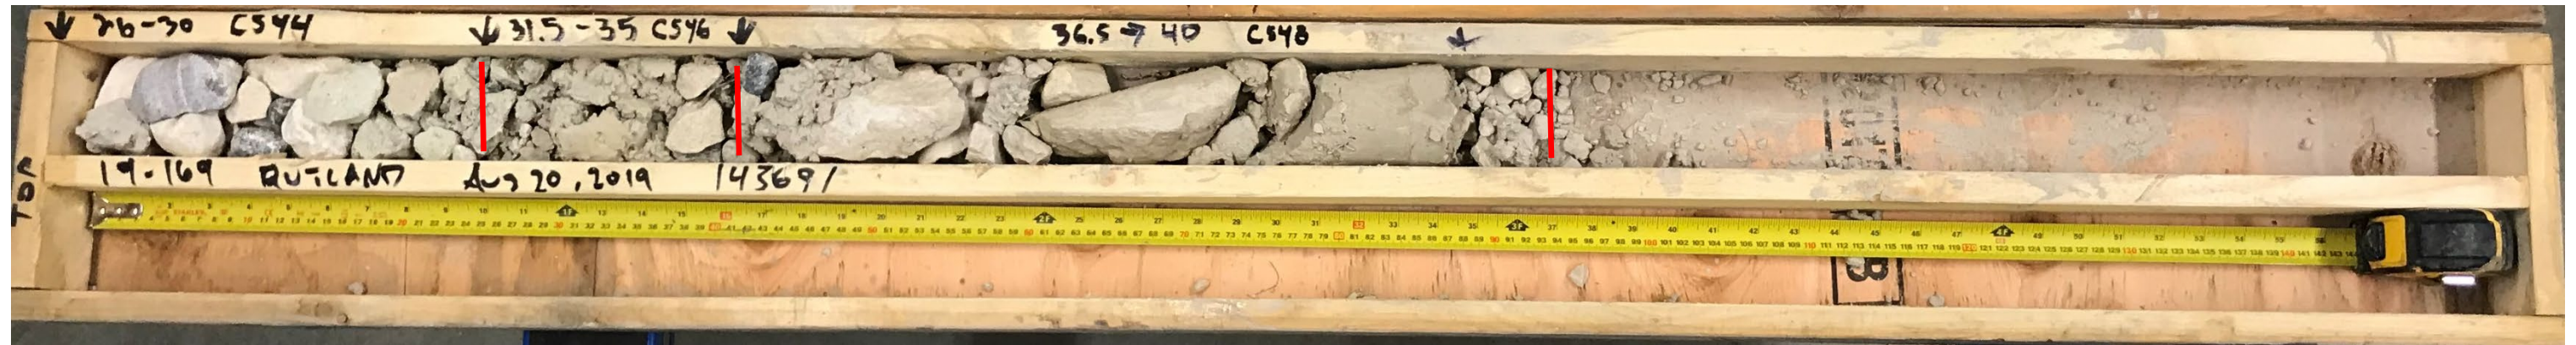
**FIGURE C4**

C544) Core Depth: 26 – 30 ft (7.9 – 9.1 m) – 20% recovery  
 C546) Core Depth: 31.5 – 35 ft (9.5 – 10.7 m) – 12% recovery  
 C548) Core Depth: 36.5 – 40 ft (11.1 – 12.2 m) – 43% recovery

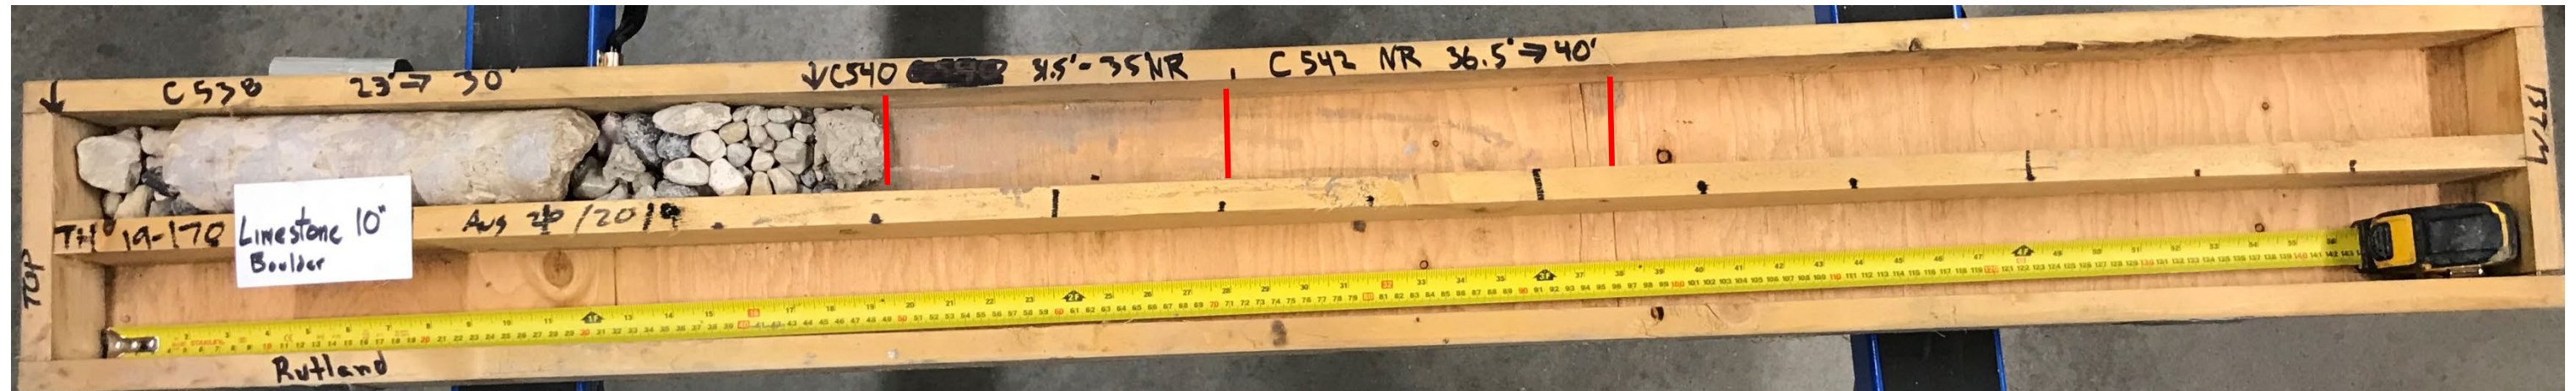
**FIGURE C5**

C538) Core Depth: 23 – 30 ft (7.0 – 9.1 m) - 20% recovery including limestone cobble / boulder  
 C540) Core Depth: 31.5 – 35 ft (9.5 – 10.7 m) - No sample recovery  
 C542) Core Depth: 36.5 – 40 ft (11.1 – 12.2 m) - No sample recovery

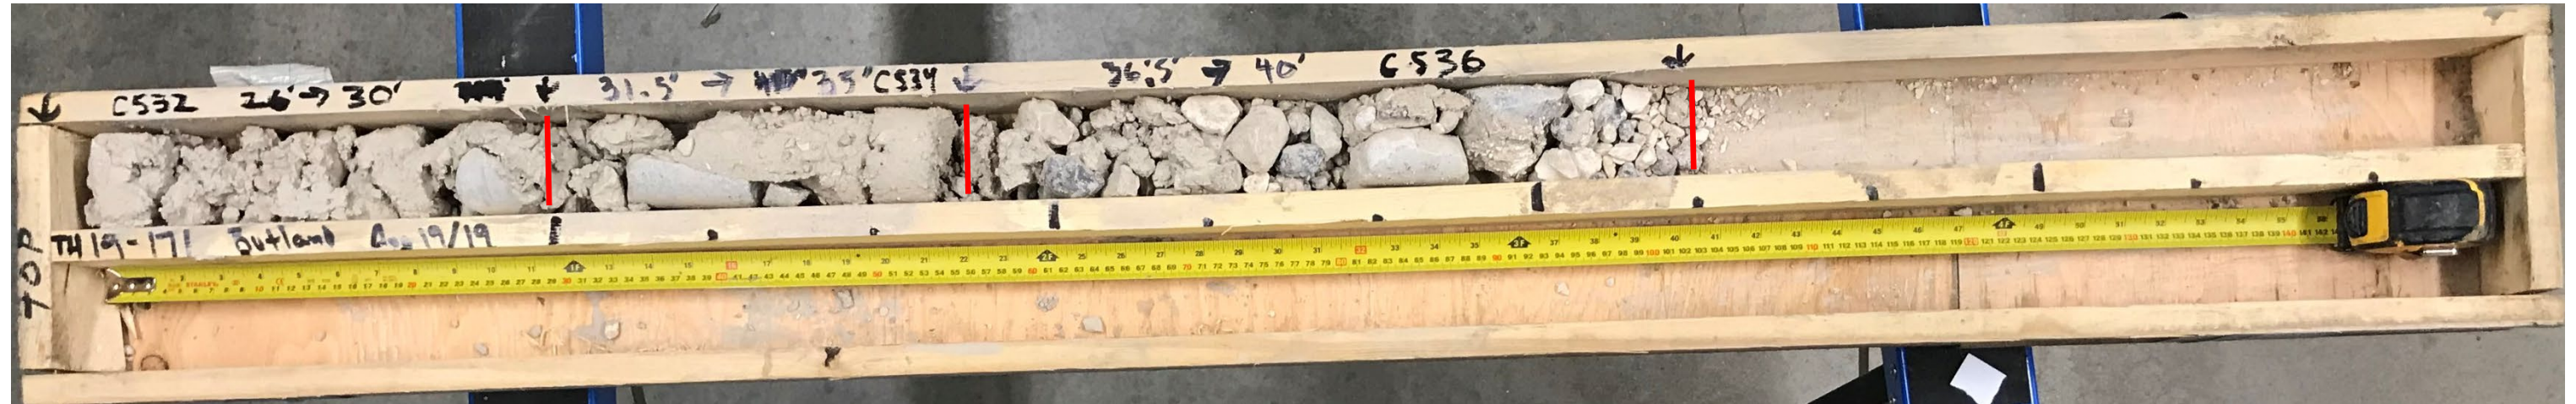
C532) Core Depth: 26 – 30 ft (7.9 – 9.1 m) - 25% recovery  
 C534) Core Depth: 31.5 – 35 ft (9.5 – 10.7 m) - 24% recovery  
 C536) Core Depth: 36.5 – 40 ft (11.1 – 12.2 m) - 40% recovery

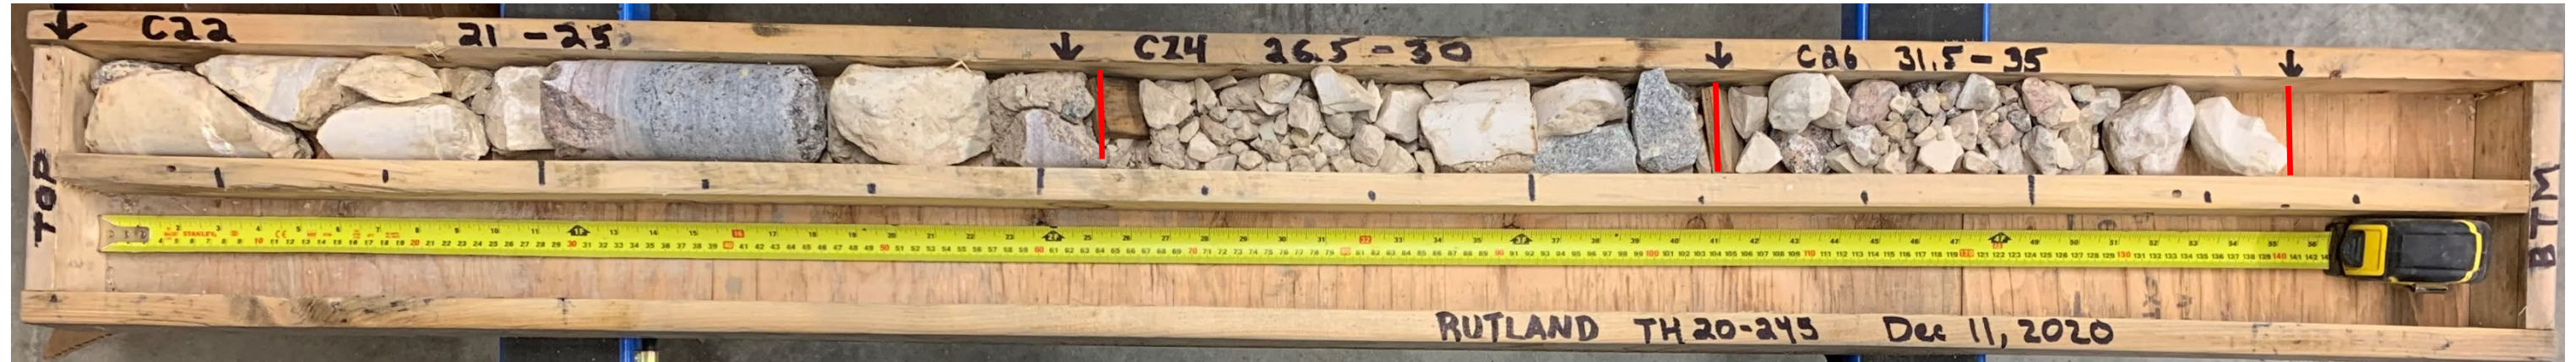
FIGURE C10

C22) Core Depth: 21 – 25 ft (6.4 – 7.6 m) - 52% recovery including limestone & granite cobbles  
 C24) Core Depth: 26.5 – 30 ft (8.1 – 9.1 m) - 38% recovery  
 C26) Core Depth: 31.5 – 35 ft (9.6 – 10.7 m) - 31% recovery

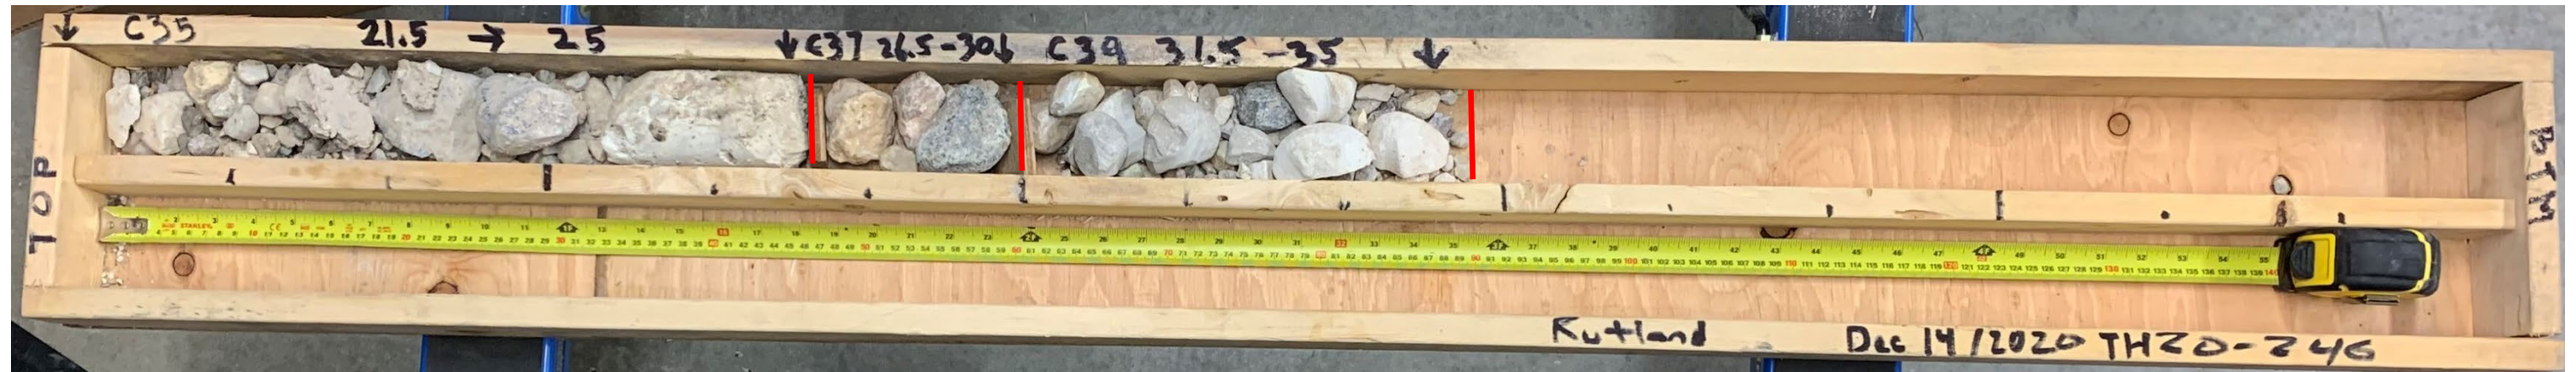
**FIGURE C11**

C35) Core Depth: 21.5 – 25 ft (6.5 – 7.6 m) - 43% recovery  
 C37) Core Depth: 26.5 – 30 ft (8.1 – 9.1 m) - 12% recovery  
 C39) Core Depth: 31.5 – 35 ft (9.6 – 10.7 m) - 24% recovery

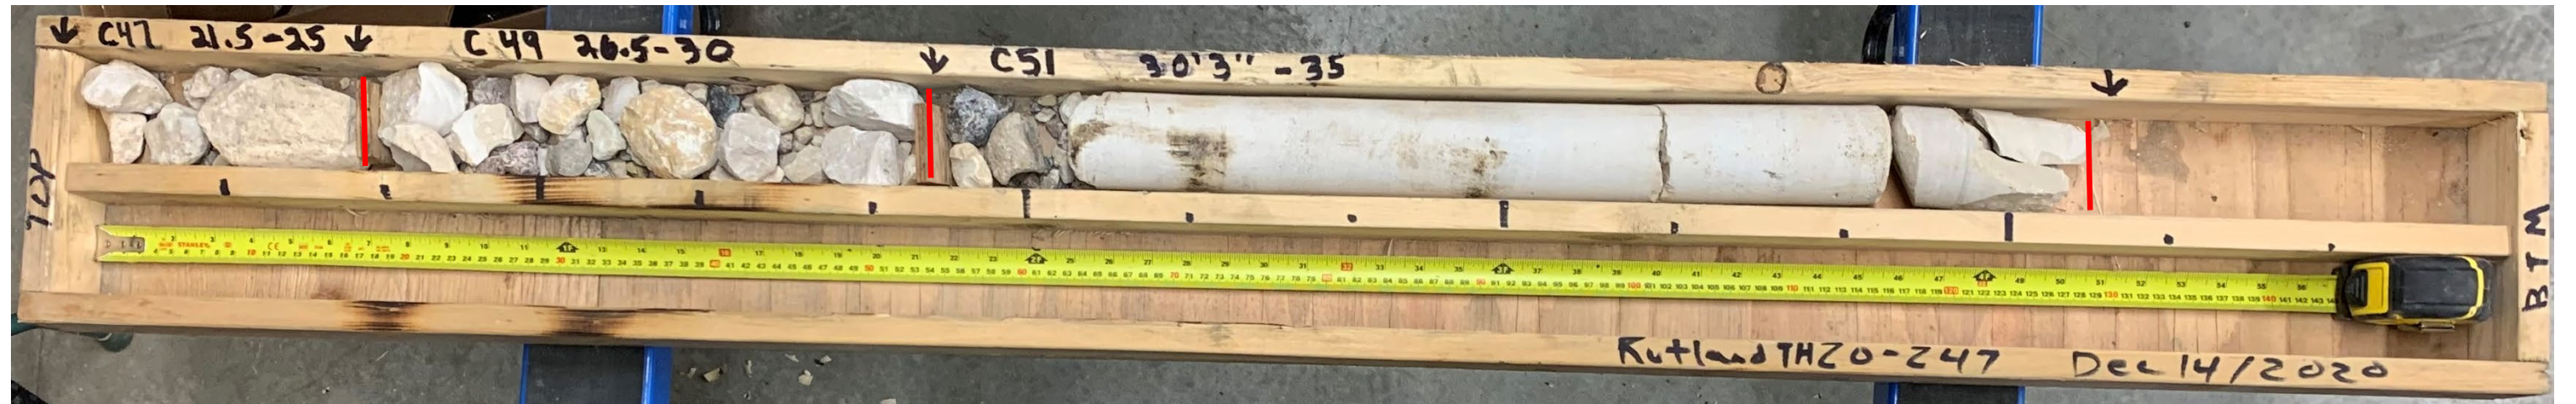
C47) Core Depth: 21.5 – 25 ft (6.5 – 7.6 m) - 15% recovery  
 C49) Core Depth: 26.5 – 30 ft (8.1 – 9.1 m) - 33% recovery  
 C51) Core Depth: 30.3 – 35 ft (9.1 – 10.7 m) - 49% recovery including limestone

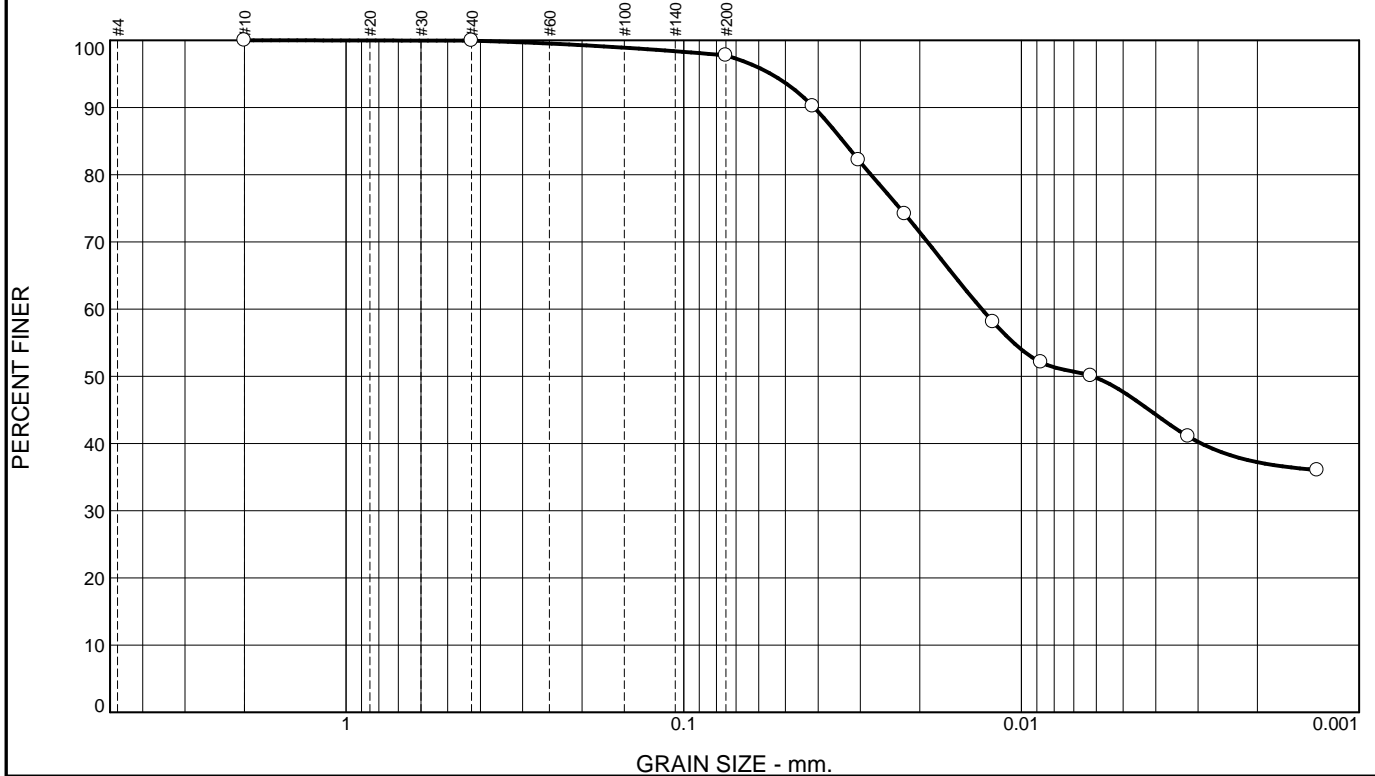
# Particle Size Distribution Report

% Gravel		% Sand			% Fines	
Fine	Coarse	Medium	Fine	Silt	Clay	
0.0	0.0	0.1	2.2	50.0	47.7

SIEVE SIZE	PERCENT FINER	SPEC.* PERCENT	PASS? (X=NO)
#10	100.0		
#40	99.9		
#200	97.7		
0.0415 mm.	90.2		
0.0304 mm.	82.2		
0.0222 mm.	74.2		
0.0121 mm.	58.1		
0.0088 mm.	52.1		
0.0062 mm.	50.1		
0.0032 mm.	41.0		
0.0013 mm.	36.0

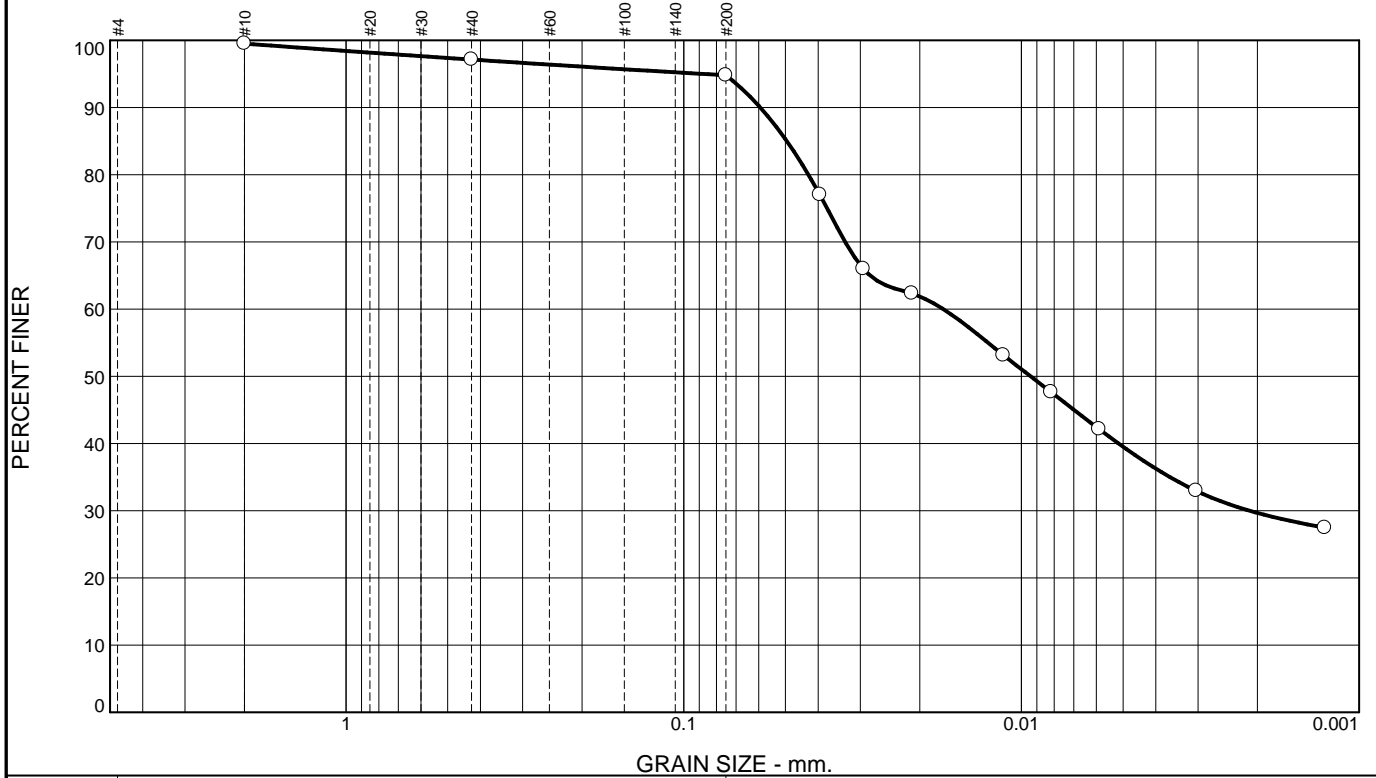
# Particle Size Distribution Report

% Gravel		% Sand		% Fines	
Fine	Coarse	Medium	Fine	Silt	Clay
		2.4	2.3	55.3	39.5

SIEVE SIZE	PERCENT FINER	SPEC.* PERCENT	PASS? (X=NO)
#10	99.5		
#40	97.1		
#200	94.8		
0.0395 mm.	77.0		
0.0294 mm.	66.0		
0.0211 mm.	62.3		
0.0113 mm.	53.1		
0.0082 mm.	47.6		
0.0059 mm.	42.1		
0.0030 mm.	33.0		
0.0013 mm.	27.5

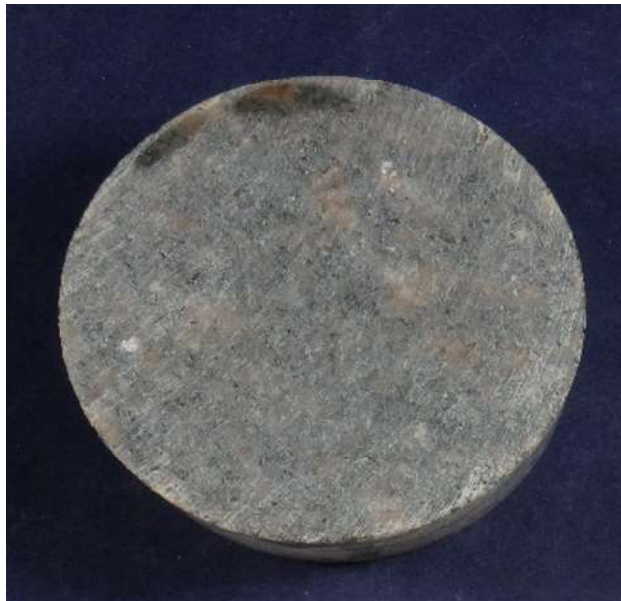
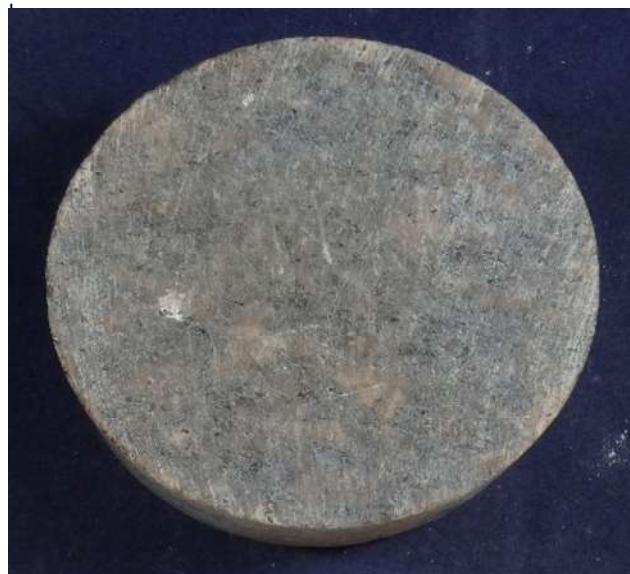
**Pictures of Sample Before and After**  
**Cerchar Abrasivity Index**

<b>Client Name:</b> Dyregrov Robinson Inc	<b>EMI#</b> 539
<b>Project Name:</b> Rutland Trunk Sewer	<b>Date:</b> 4/23/2021
<b>Sample ID:</b> TH-19-168, C550 @ 27'

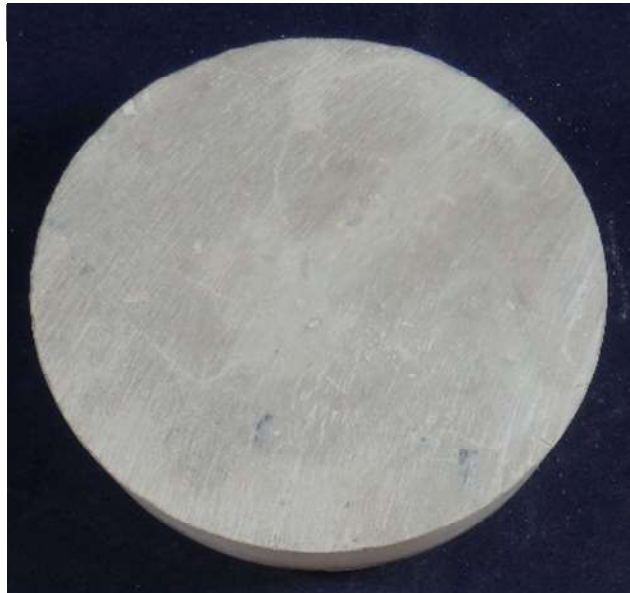
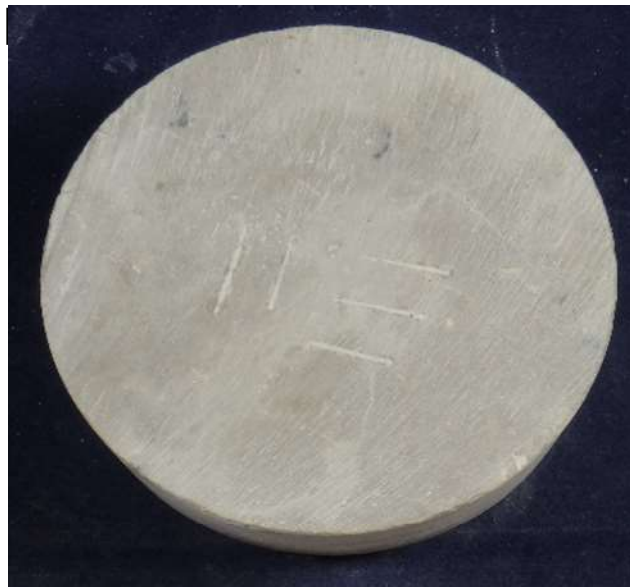
**Pictures of Sample Before and After**  
**Cerchar Abrasivity Index**

<b>Client Name:</b> Dyregrov Robinson Inc	<b>EMI#</b> 539
<b>Project Name:</b> Rutland Trunk Sewer	<b>Date:</b> 4/23/2021
<b>Sample ID:</b> TH 19-173, C518 @ 26'

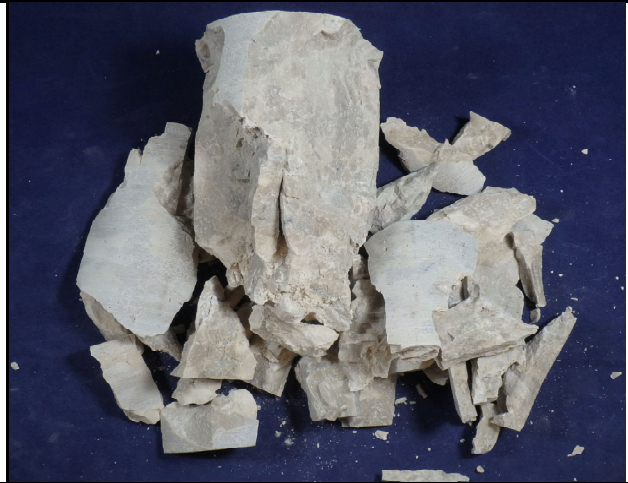
**Client:** Dyregrob Robinson Inc.  
**Project:** Rutland Trunk Sewer  
**Location:** N/A  
**Rock Type:** Sedimentary  
**Rock Name:** N/A  
**Characteristics:** N/A  
**Test Performed By:** JD, SS  
**Date Tested:** 4/20/2021  
**Data Reduced By:** MP  
**Date Reduced:** 4/30/2021  
**Core ID:** TH 19-173, C518 @ 26'  
**File Name:** TH 19-173, C518 @ 26'\_UCS  
**EMI Project No.:** 539

Core Length		Core Diameter		L/D Ratio	Density		
in	cm	in	cm		lb/ft <sup>3</sup>	g/cm <sup>3</sup>	
5.417	13.76	2.487	6.32	2.2	165	2.65	
Failure Load	Failure Stress	UCS 2:1		Static E		Static v	Failure Mode
lbf	psi	psi	MPa	ksi	GPa		
68,873	14,172	14,433	99.5	N/A	N/A	N/A	Non - Structural
P - Wave		S - Wave		Dynamic E		Dynamic v	
ft/s	m/s	ft/s	m/s	ksi	GPa		
N/A	N/A	N/A	N/A	N/A	N/A	N/A

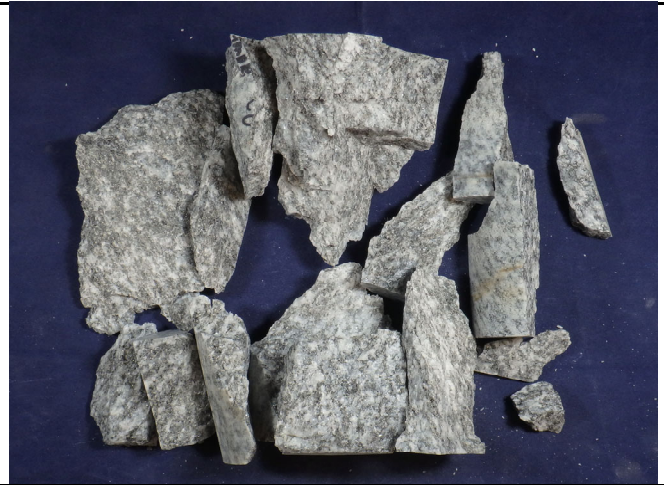
**Client:** Dyregrob Robinson Inc.  
**Project:** Rutland Trunk Sewer  
**Location:** N/A  
**Rock Type:** Metamorphic  
**Rock Name:** N/A  
**Characteristics:** N/A  
**Test Performed By:** JD, SS  
**Date Tested:** 4/20/2021  
**Data Reduced By:** MP  
**Date Reduced:** 4/30/2021  
**Core ID:** TH 20-244, C8 @ 24'  
**File Name:** TH 20-244, C8 @ 24'\_PP.dat  
**EMI Project No.:** 539

Core Length		Core Diameter		L/D Ratio	Density		
in	cm	in	cm		lb/ft <sup>3</sup>	g/cm <sup>3</sup>	
5.545	14.08	2.469	6.27	2.2	167	2.68	
Failure Load	Failure Stress	UCS 2:1		Static E		Static v	Failure Mode
lbf	psi	psi	MPa	ksi	GPa		
139,797	29,199	29,830	205.7	N/A	N/A	N/A	Non - Structural
P - Wave		S - Wave		Dynamic E		Dynamic v	
ft/s	m/s	ft/s	m/s	ksi	GPa		
N/A	N/A	N/A	N/A	N/A	N/A	N/A

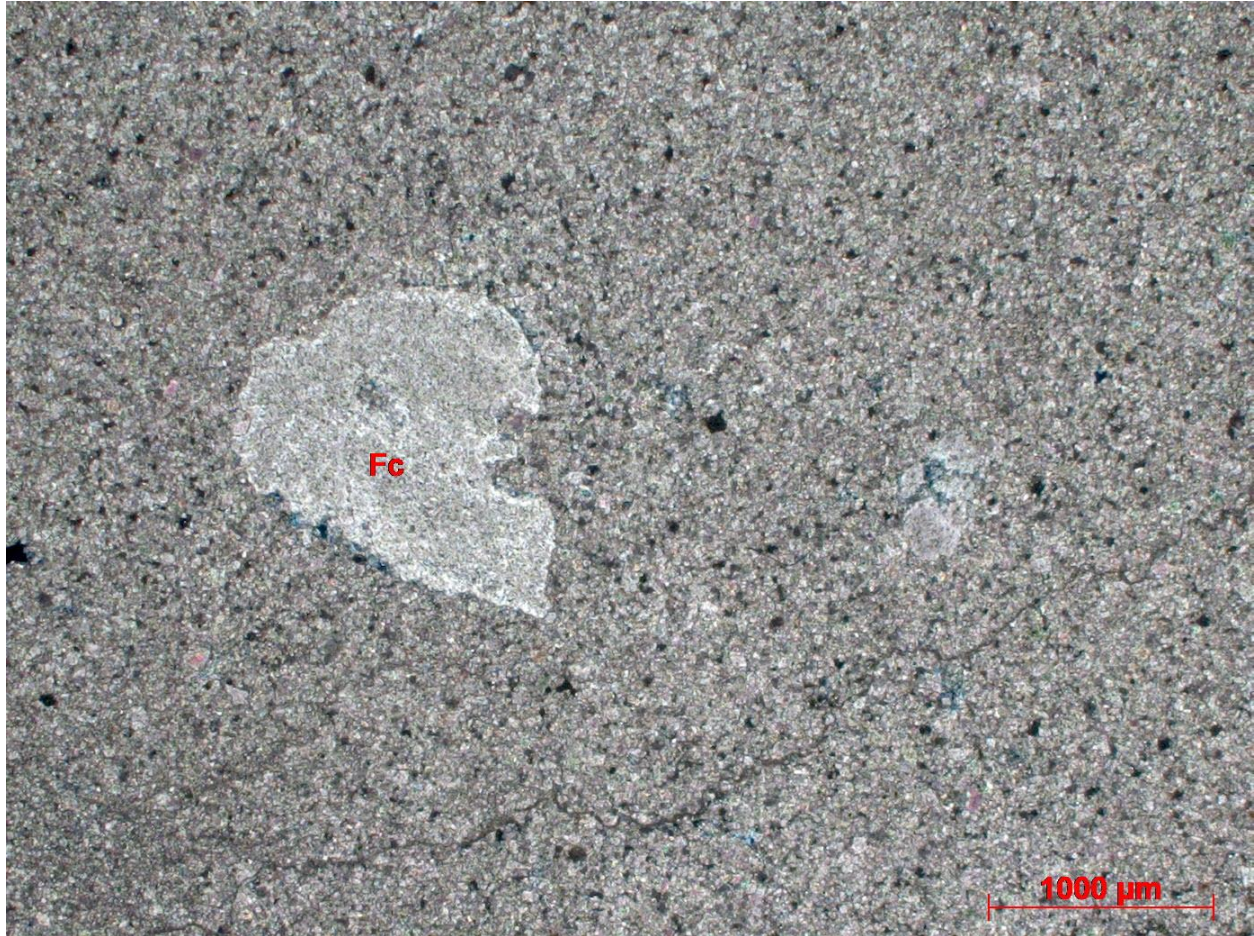
TH19-173\_C518@26'\_2\_5x\_xpl\_012

Limestone (Crystalline  
Carbonate/Sparstone)

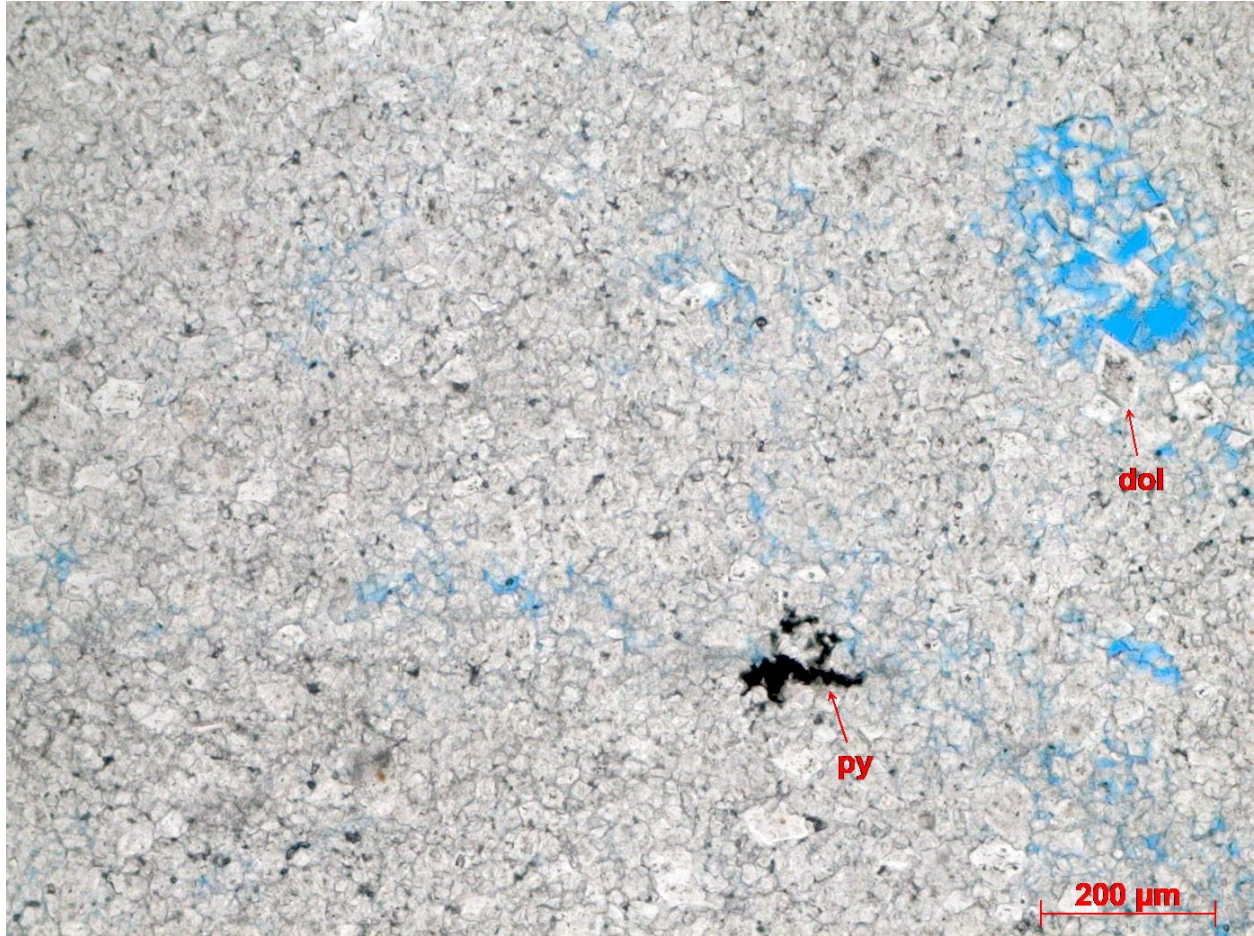
TH19-173\_C518@26'\_10x\_ppl\_015

Limestone (Crystalline  
Carbonate/Sparstone)

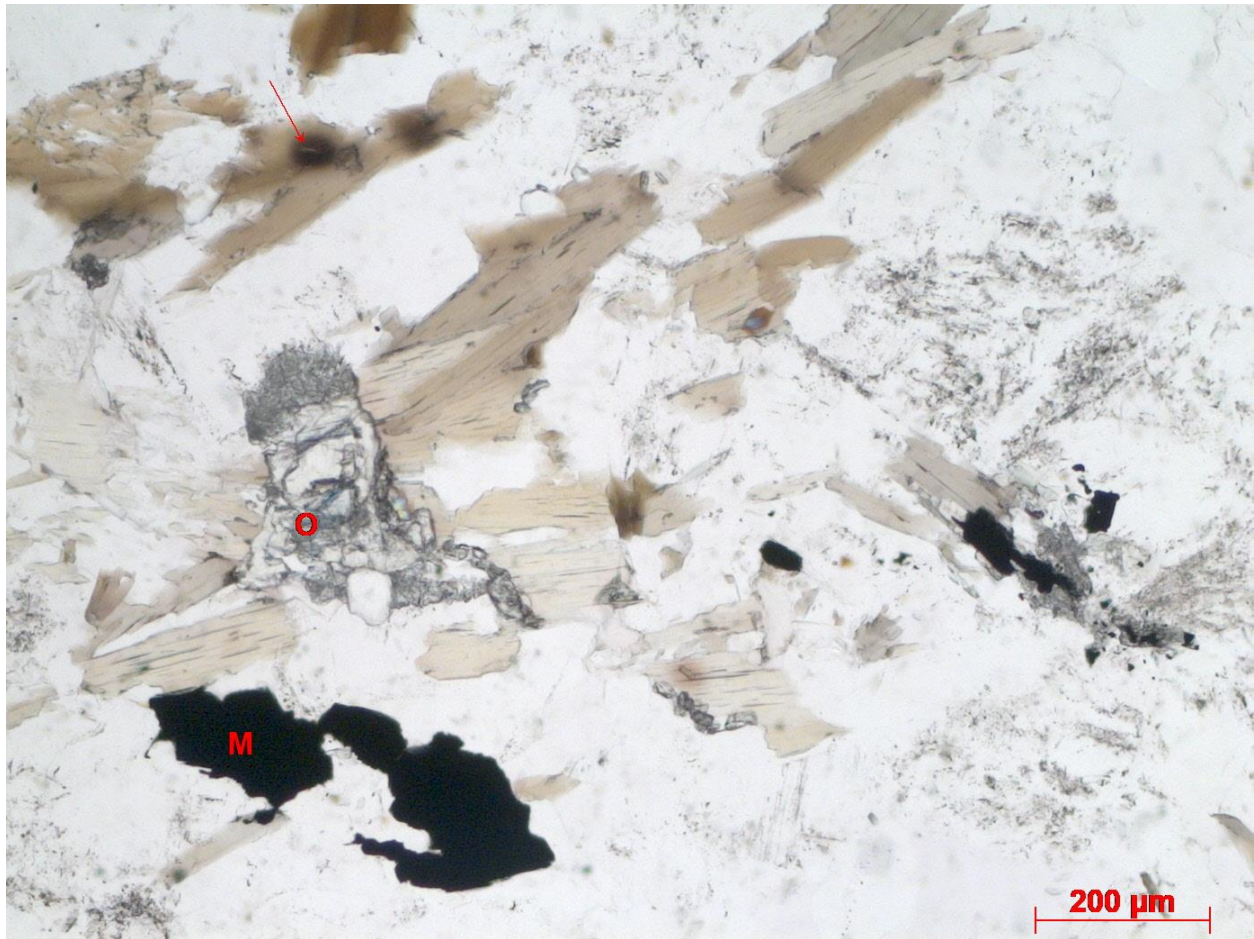
TH20-244_C8@24'_10x_ppl_025	Tonalite
-----------------------------	----------

**Thin Section Image 25.** Medium magnification view of the tonalite shows abundant crystals of white polycrystalline quartz and plagioclase feldspar that host subordinate amounts of light to dark-brown biotite and hornblende. Other accessory minerals include opaque magnetite (M), high-relief olivine (O), and rare apatite crystals enclosed in biotite (arrow). Plane-polarized light. 10x Magnification. Field of View 1.46 mm. Scale bar = 200 microns or 0.2 mm.

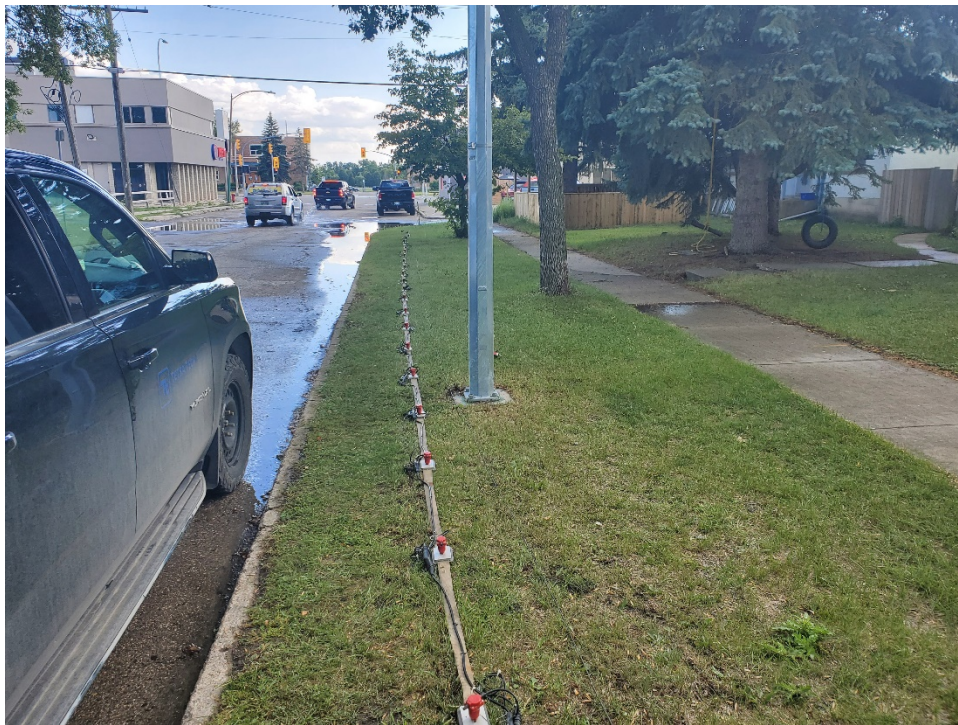
**Photo 1 – Landstreamer setup**

Seismic data was collected by David McBean, P.Ge. (Alberta), and Jordan Augruso, P.Ge. (Alberta), between August 16 and August 18, 2020. The seismic system used for the survey was a Geometrics' 24-channel seismograph with 4.5 Hz geophones at a 1 m spacing. A sledgehammer striking a metal plate was used as the seismic source. Data was collected using an off-end shot location of 10 m.

The geophones were mounted on a landstreamer, with ground coupling achieved through a metal plate. This setup allows the geophones to be moved along the line efficiently, increasing the speed of data collection. The survey setup is shown below in Photo 1.
