**CITY OF WINNIPEG, WATER AND WASTE DEPARTMENT**

**FERRY ROAD AND RIVERBEND CSR PROJECT**

**CONTRACT 6 – RUTLAND TRUNK SEWER**

**GEOTECHNICAL DATA REPORT**

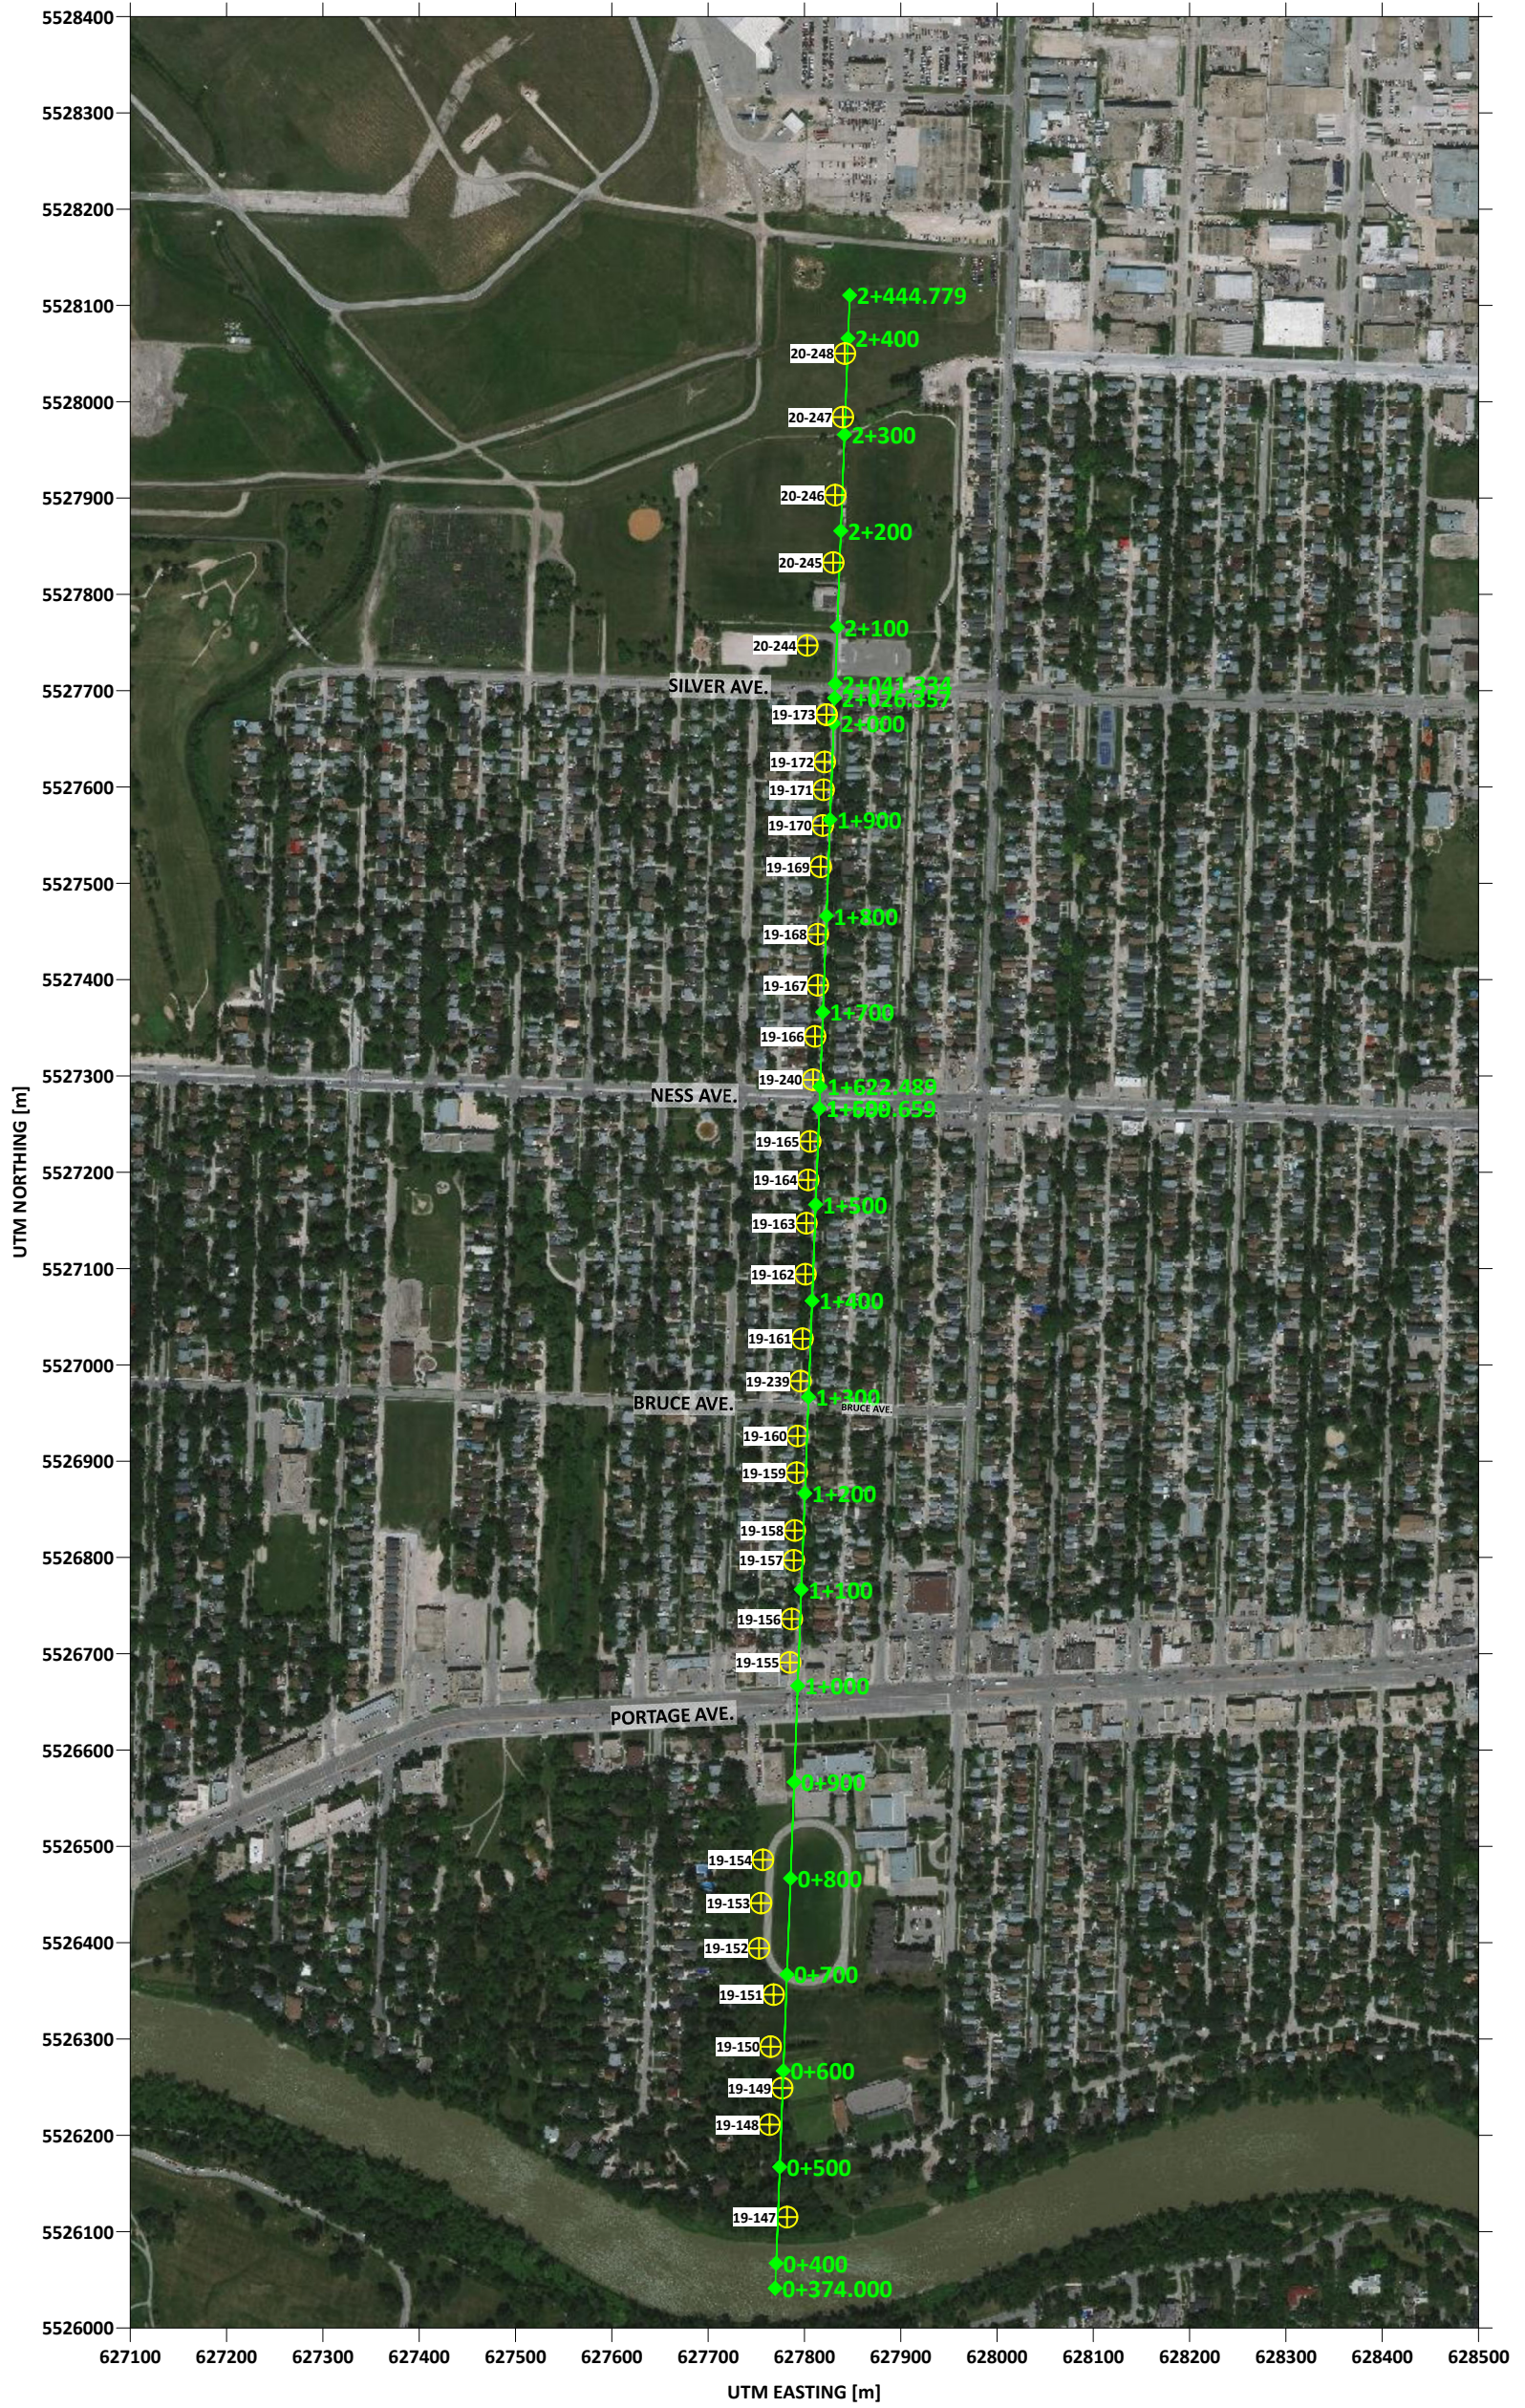
**Figure 1**

- Figure 1      Seismic Data Coverage Overview Map
- Figure 2      Seismic Profile MASW Refraction Data Segment 1
- Figure 3      Seismic Profile MASW Refraction Data Segment 2

Data was collected along a profile approximately 2 km in length, extending from the Assiniboine River at the south end of the alignment to the Winnipeg James Armstrong Richardson International Airport at the north end. Seismic data was collected at 5 m increments along the profile. No data was collected on active roadways; therefore, the seismic profile contains four gaps in data coverage at Portage Avenue, Bruce Avenue, Ness Avenue, and Silver Avenue. Figure 1 provides a plan view site map of the survey area.
